**INDEPENDENT ASSESSMENT ON EARTHQUAKE PERFORMANCE
OF
Bedford Row Car Park Building**

**FOR
Royal Commission of Inquiry into building failure
caused by the Canterbury Earthquakes**

**Report prepared by Peter C Smith and Jonathan W Devine
OF
Spencer Holmes Ltd**

January 2012

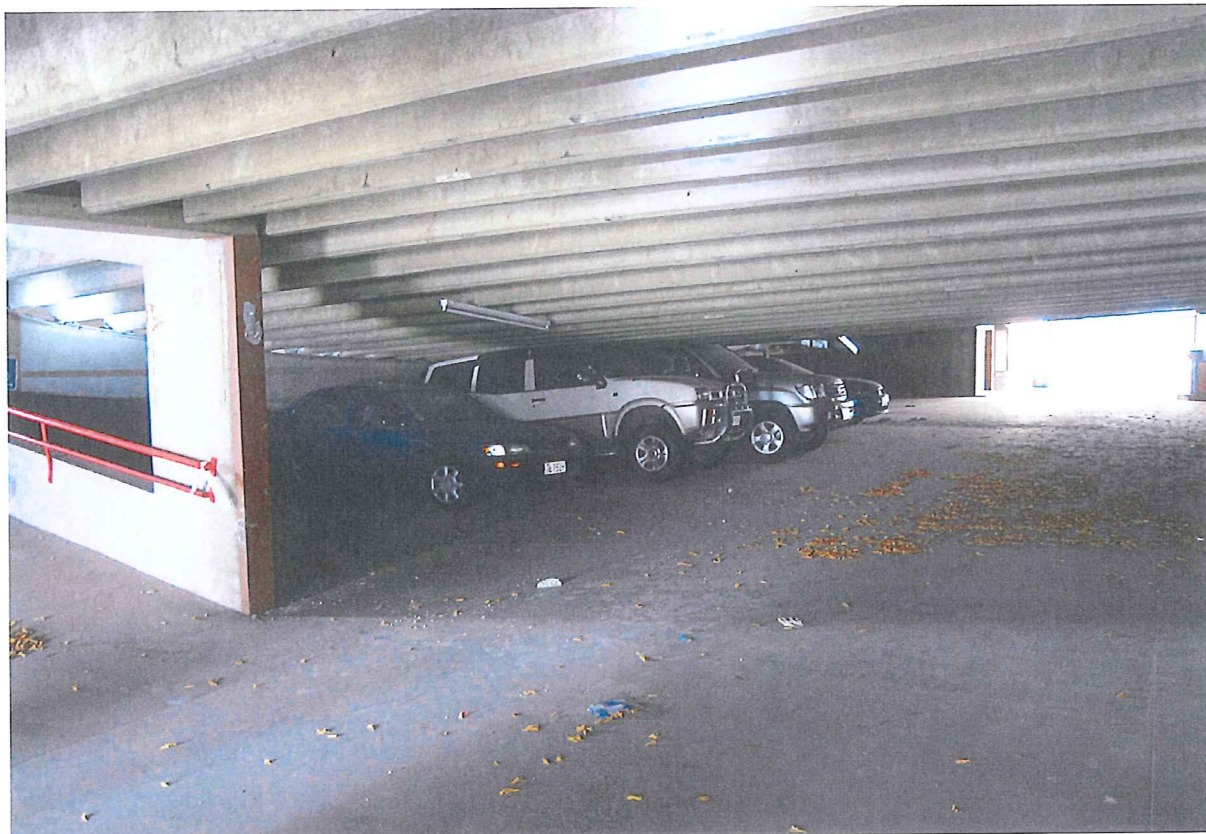
Failure of the third floor along the central column line was assessed to be due to wedging of the third floor and supporting beams in a restrictive recess in the central column.

As the floor was not connected to the central column, deformations of the building under the 22nd February, 2011 earthquake resulted in rotations of the supporting beam. These rotations induced excessive load into the corbel supporting the 3rd floor and caused failure of the corbel.

Failure of level 3 floor, viewed from level 3

It is recommended that structural components not required as part of the lateral load resisting system should be capable of accepting the deformations of the lateral load resisting system with a margin at the ultimate limit state without inducing secondary forces in the structure.

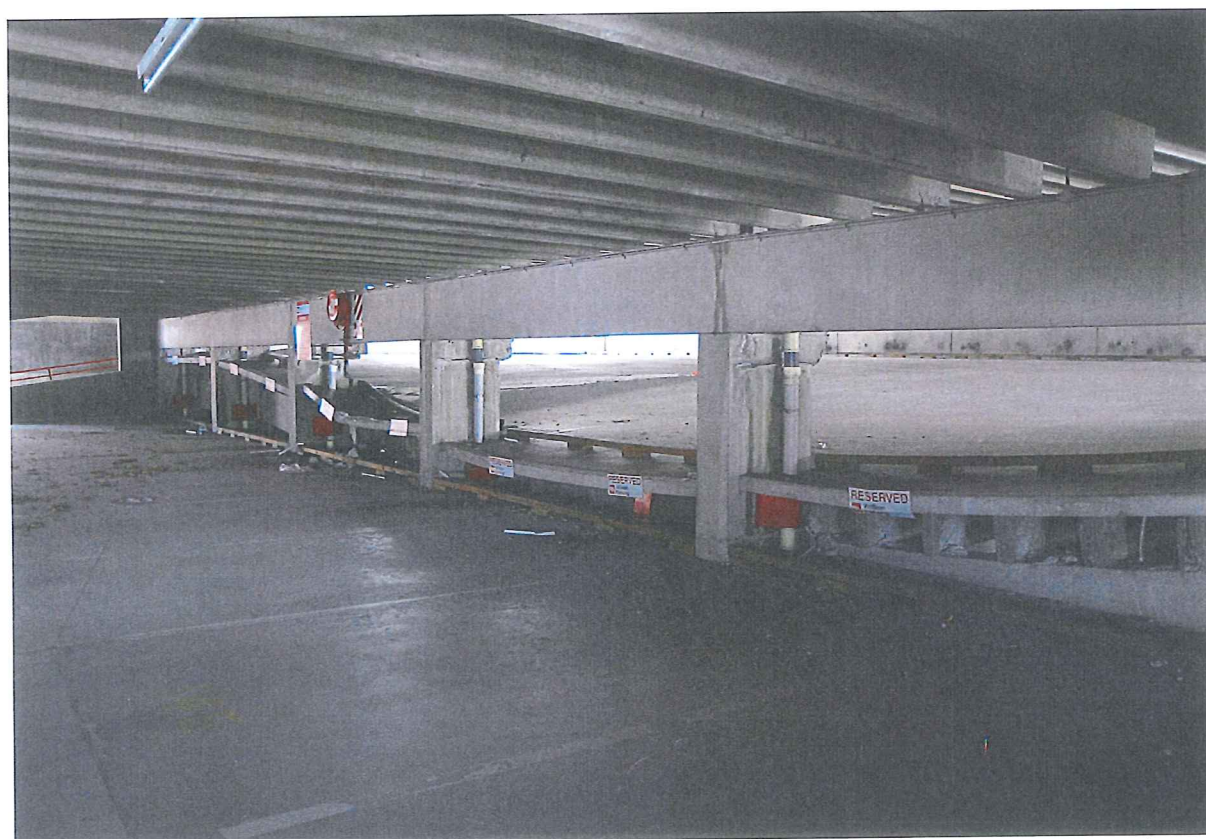
It is assessed that there was sufficient translation of the third floor diaphragm relative to the central column to cause rotation of the pre-cast beam supporting the Double Tee flooring. By rotating the pre-cast beam, the load on the corbel supporting the pre-cast beam increased through wedging of the floor and pre-cast beam in the rebate in the central columns, there being no direct load transfer mechanism between the central columns and the floors. The increased vertical load resulted in the failure of the corbel supporting the pre-cast beam over the central portion of Level 3.

We are of the opinion that had a gap been left between the top of the floor topping to the Level 3 slab and the underside of the recess in the central columns for the Level 3 slab, the movement would have occurred without inducing a wedging action which significantly increased the load on the corbel supporting the pre-cast beam.

Failure of level 3 floor, viewed from level 2

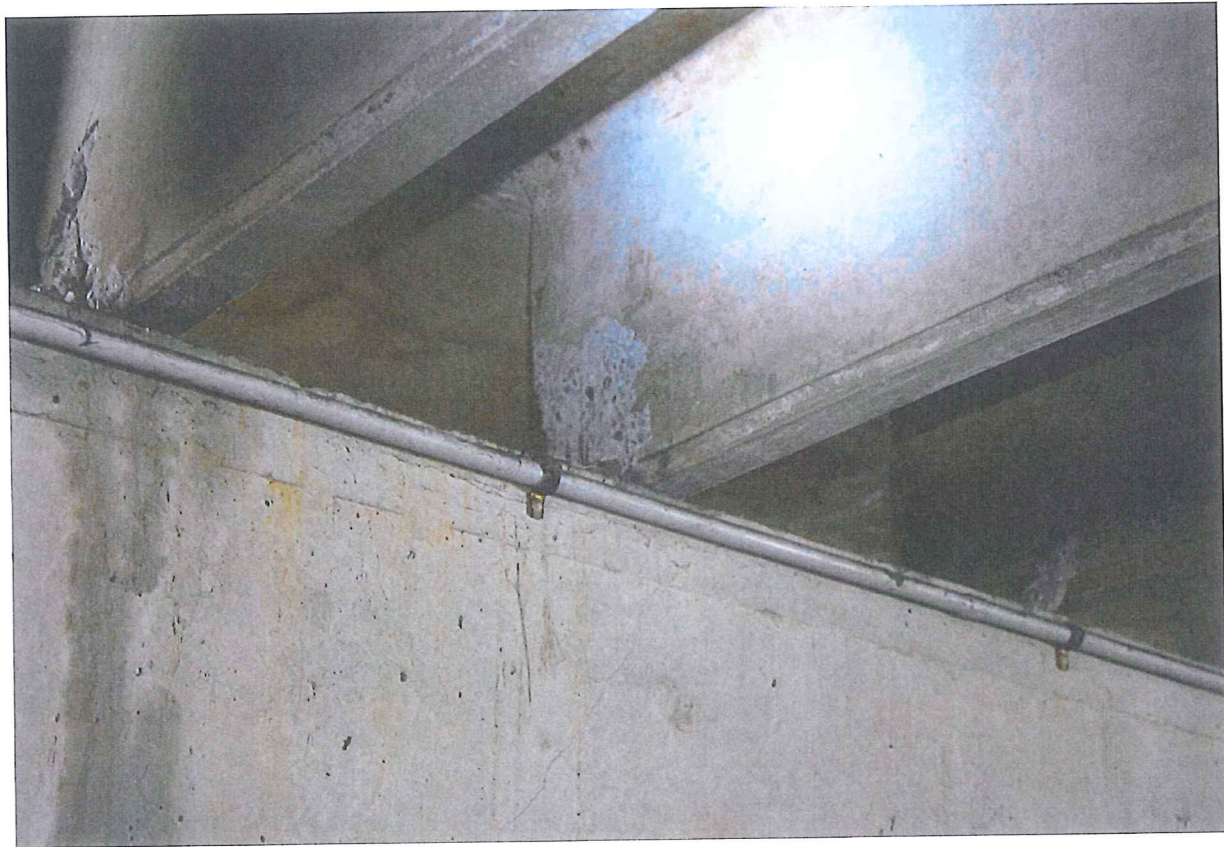
Extensive spalling to the webs of the Double Tee floor units which seat on the continuous concrete supporting corbels cast in the east and west walls.

Damage to Double Tee flooring units

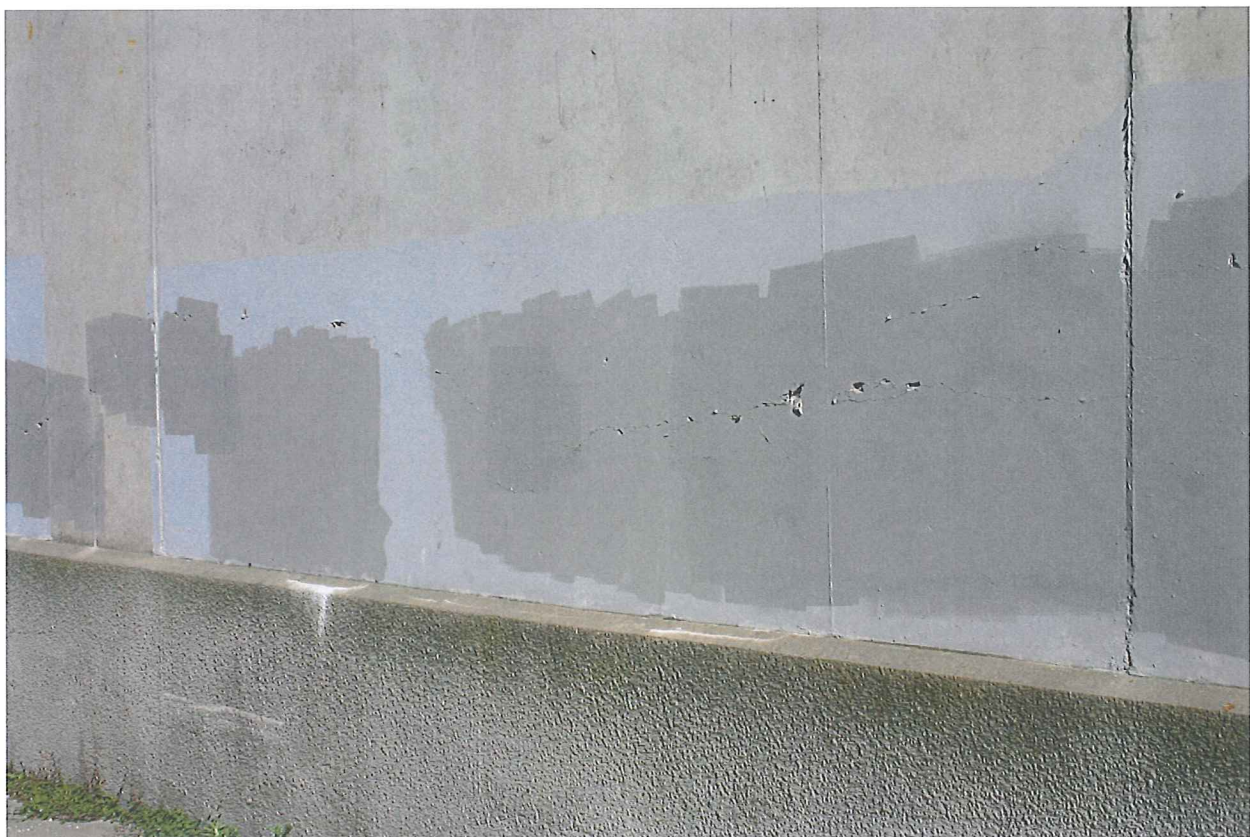
Diagonal shear cracking and sliding shear cracking in the pre-cast concrete walls which generally act as shear walls resisting earthquake loading.

Our interpretation of the reinforcement in the pre-cast concrete panels at the lower level is 4 – D16 at each side of the panel. Calculations indicate that the tensile strength of the concrete may have exceeded the tensile capacity of the reinforcement at the ends of these units. It is likely that the single cracking which has occurred near the base of the units has caused strain hardening of the reinforcing steel at these locations as the tension capacity of the reinforcing steel is insufficient to promote more distributed cracking at the base of these panels.

Damage to east wall panels

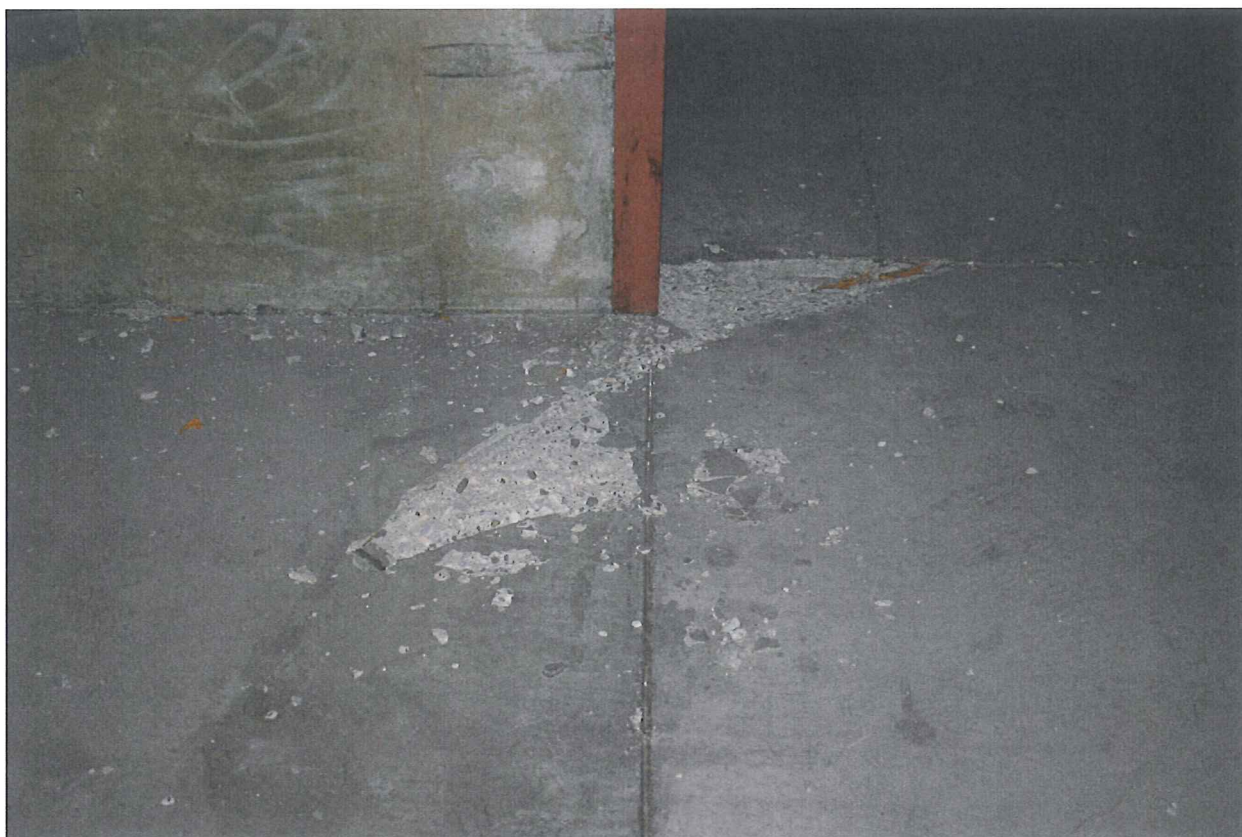
Severe fracturing and spalling of the concrete ramps at most levels. This was particularly evident adjacent to the north and south shear walls.

Damage of ramps

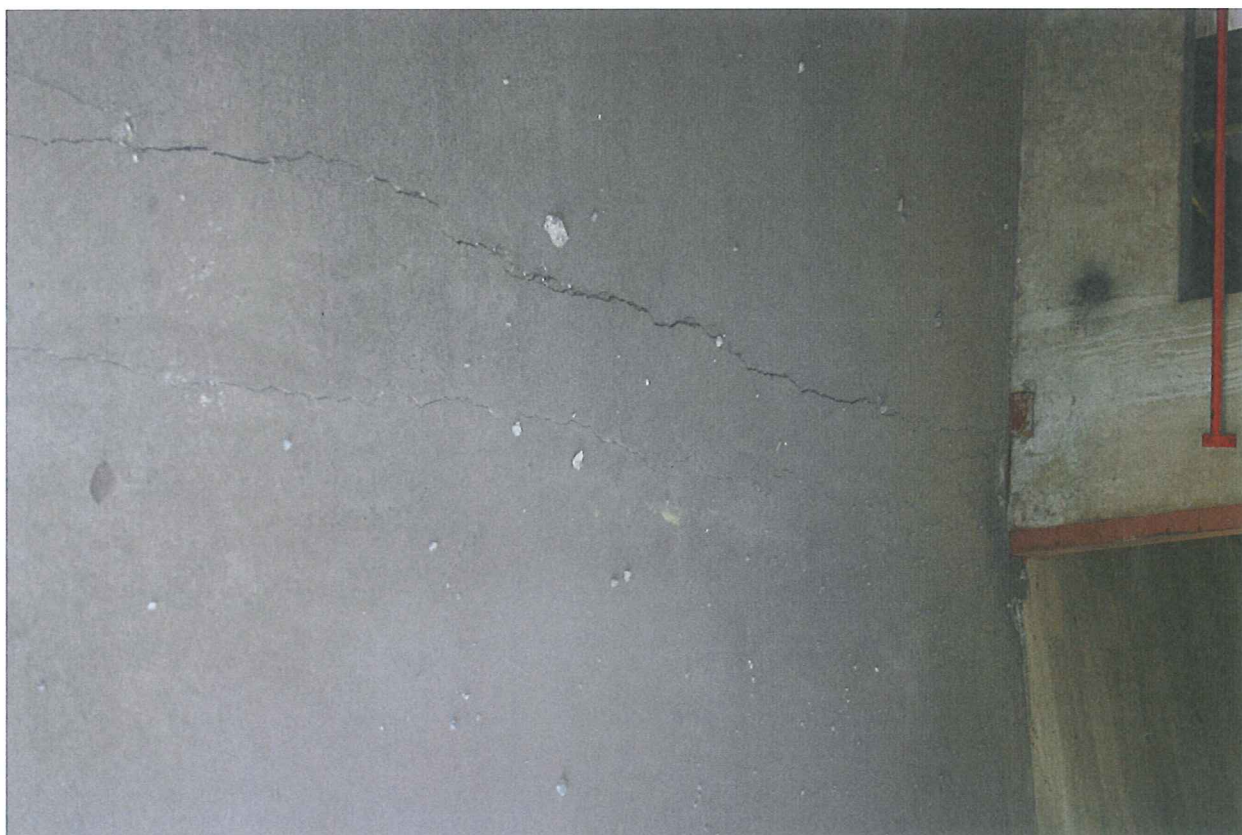
The load transfer mechanism was complex and damage was caused to the junction of the ramps and the diaphragm due to the abrupt change in the direction of the structural elements transferring the seismic shears into the lateral load resisting shear wall element. Further, while no damage occurred within the floor diaphragm at the joints between the pre-cast concrete panels/blockwork walls on the east and west walls, we do not consider that the detailing of the diaphragm at the junction between the panels was sufficiently robust to provide a reliable diaphragm for the transfer of seismic shears in the east west direction.

Damage at ramps
