**Brief of evidence of Jeffrey Gavin Matthews relating to 242 - 246 High
Street for hearing week commencing 13 February 2011**

Date: 8 February 2012

SITE REPORT

Christchurch Eq RAPID Assessment Form - LEVEL 2

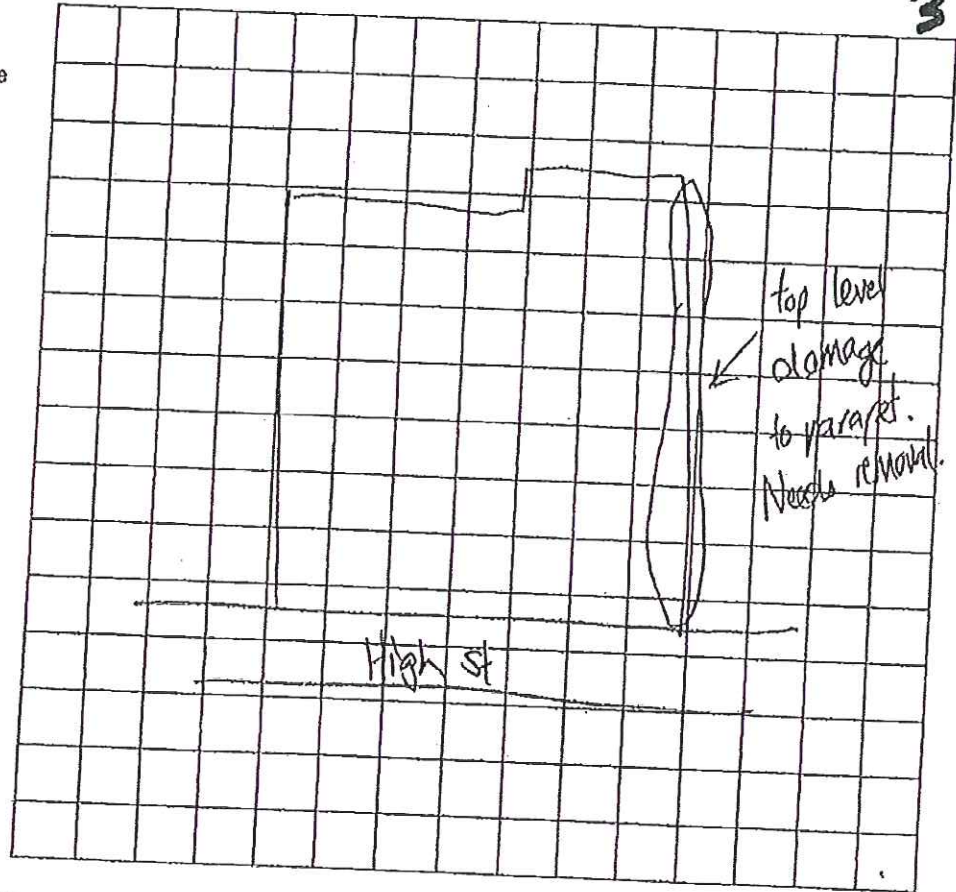
✓
 Sketch (optional)
 Provide a sketch of the entire
 building or damage points. Indicate
 damage points.

On the top of the building there is damage to the parapet/chimneys. One had fallen through a sky light and landed on the floor inside the building. Others are cracked and couple topple given an aftershock.

Structural Hazards/ Damage	Minor/None	Moderate	Severe	Comments
Foundations	<input checked="" type="checkbox"/>	<input type="checkbox"/>	<input type="checkbox"/>	
Roofs, floors (vertical load)	<input checked="" type="checkbox"/>	<input type="checkbox"/>	<input type="checkbox"/>	
Columns, pilasters, corbels	<input checked="" type="checkbox"/>	<input type="checkbox"/>	<input type="checkbox"/>	
Diaphragms, horizontal bracing	<input checked="" type="checkbox"/>	<input type="checkbox"/>	<input type="checkbox"/>	
Pre-cast connections	<input checked="" type="checkbox"/>	<input type="checkbox"/>	<input type="checkbox"/>	
Beam	<input checked="" type="checkbox"/>	<input type="checkbox"/>	<input type="checkbox"/>	
Non-structural Hazards / Damage				
Parapets, ornamentation	<input type="checkbox"/>	<input checked="" type="checkbox"/>	<input type="checkbox"/>	RHS parapet are damaged & unstable will require removal.

- parapet on right hand side of the bldg needs to be secured or removed prior to bldg being occupied.

Neighbouring building to the right of 242 ~~is~~ is currently green placarded but ~~is~~ it is recommended that it's changed to ~~orange~~ yellow due to the danger from the damaged parapet.
