EXPERT PANEL REPORT

Structural Performance of Christchurch CBD Buildings in the 22 February 2011 Aftershock

February 2012

Report of an Expert Panel
appointed by the New Zealand Department of Building and Housing

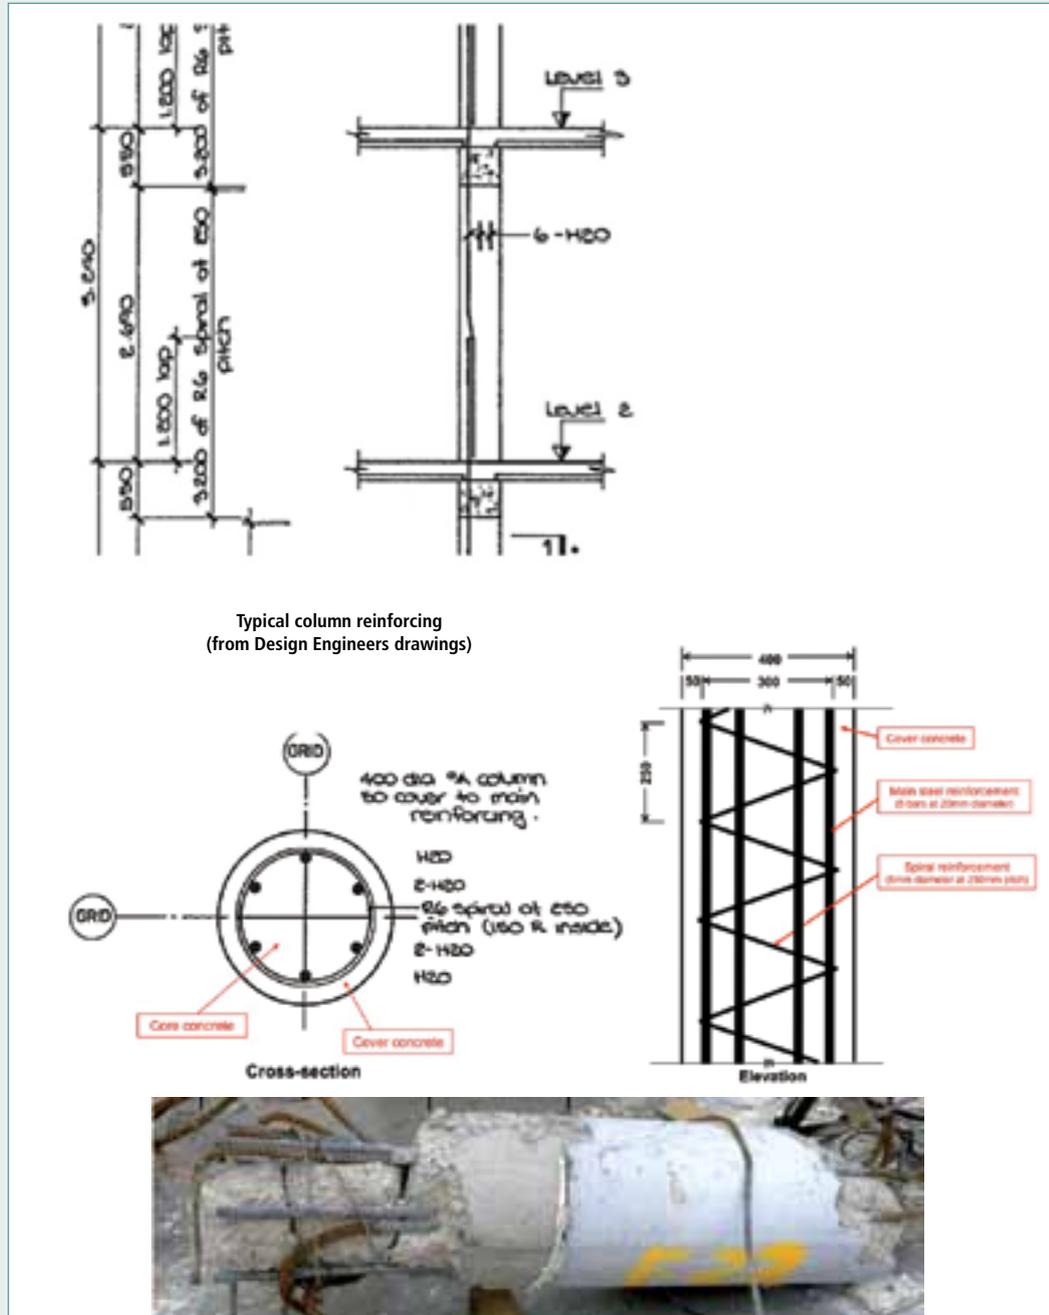
Figure 5.4: Typical 400mm diameter column

The lack of ductility in the columns made them particularly vulnerable and they were the prime focus of the analyses. The ability of a column to sustain earthquake-induced lateral displacements depends on its stiffness, strength and ductility. Established methods were used to estimate the capacity of critical columns to sustain the predicted displacements without collapse.

Typical column reinforcing (from Design Engineers drawings)

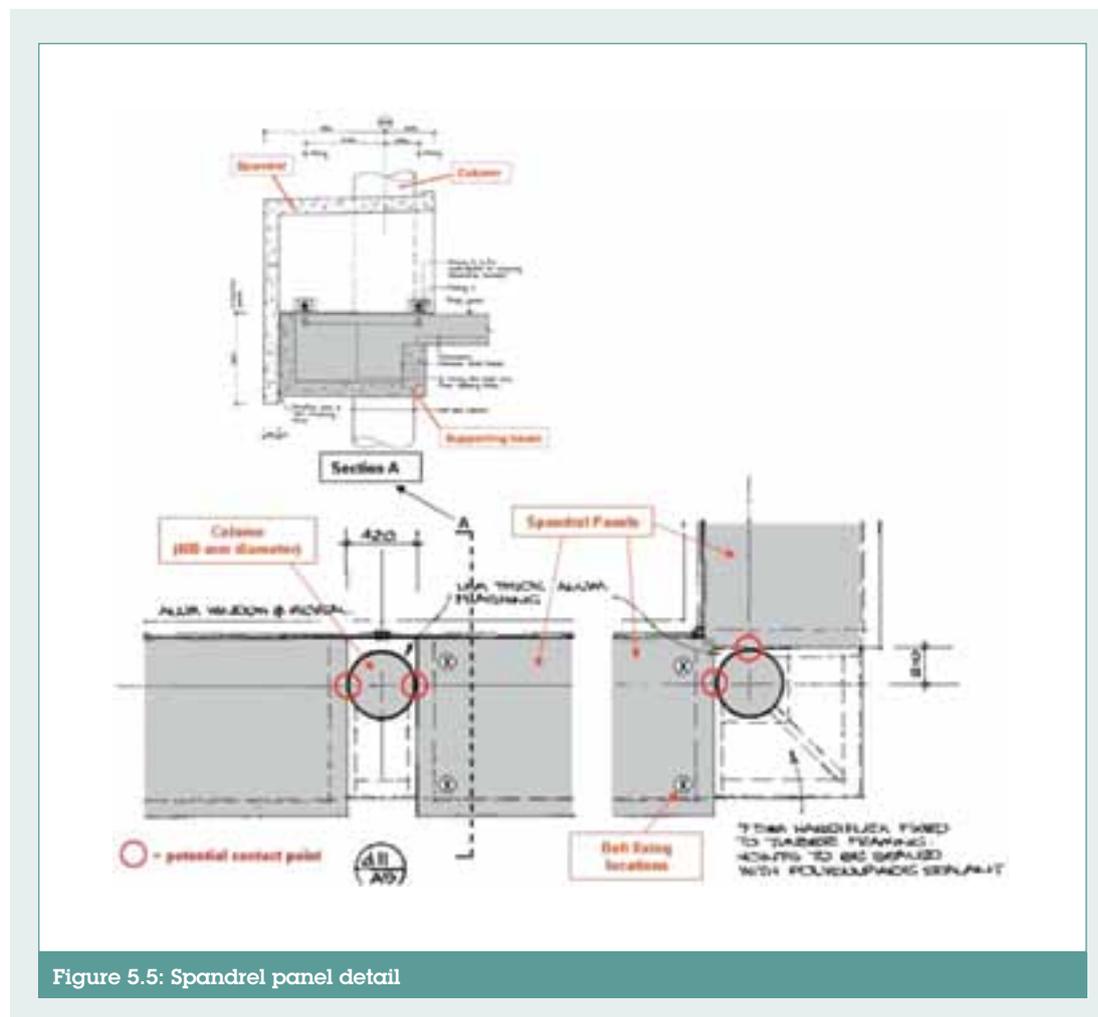
Figure 5.5: Spandrel panel detail

A plan and a cross-section of the typical column and spandrel panel arrangement are shown in Figure 5.5.

The pre-cast reinforced concrete spandrel panels were fixed to the floor slab and were placed between columns. The gap between the ends of adjacent spandrels was specified to be 420mm giving a nominal 10mm gap either side between the spandrel and the column. It is possible that these gaps varied from the nominal 10mm and it is estimated they may have ranged between 0 and 16mm. It is not known what the sizes of the gaps actually were, but analyses showed a significant reduction in column drift capacity for the case where no gap was achieved. Forensic evidence indicated that interaction may have occurred between some columns and adjacent spandrel panels in the 22 February 2011 event. There were also indications of cracking reported in some of the upper level columns after the September earthquake that may have indicated some interaction with the spandrel panels.

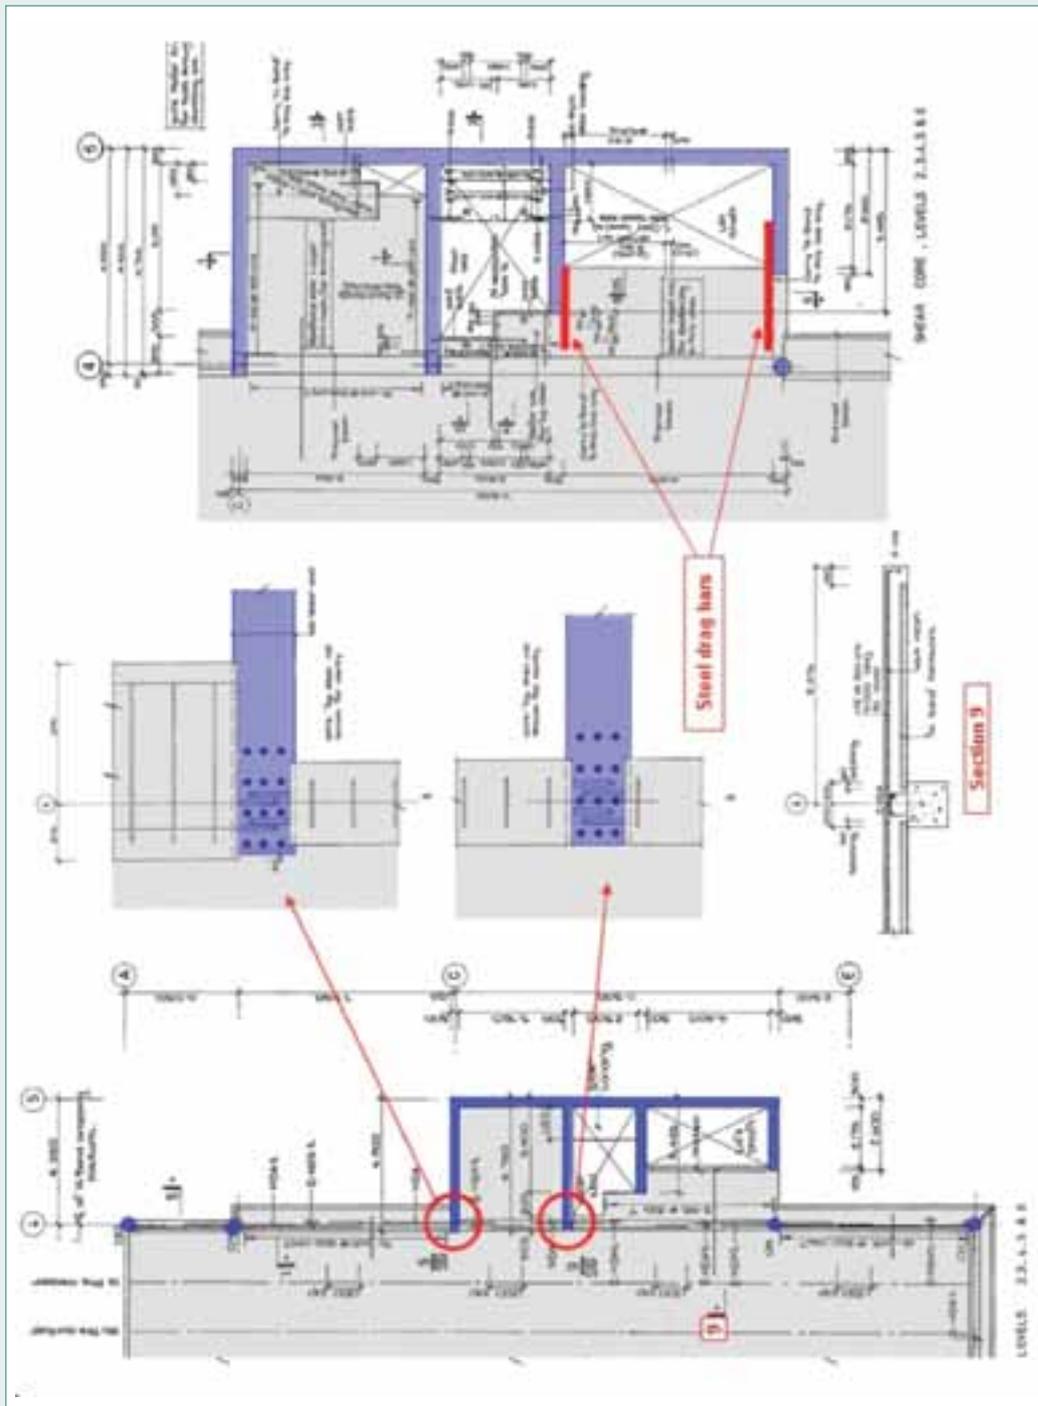
Figure 5.7: Diaphragm connections at north core

Figure 5.7 shows plans of the area where a typical floor slab (shaded grey) meets the stabilising walls of the north core (shaded blue). The large lateral forces from the floor slab must be transferred to the walls at the (limited) places where slab and wall elements meet and through the drag bars (shaded red) which were added at Levels 4, 5 and 6 in October 1991. These connections were seen as vulnerable and there was a possibility that the diaphragm (slab) would separate from the walls, resulting in increased lateral displacements and higher demands on critical columns.

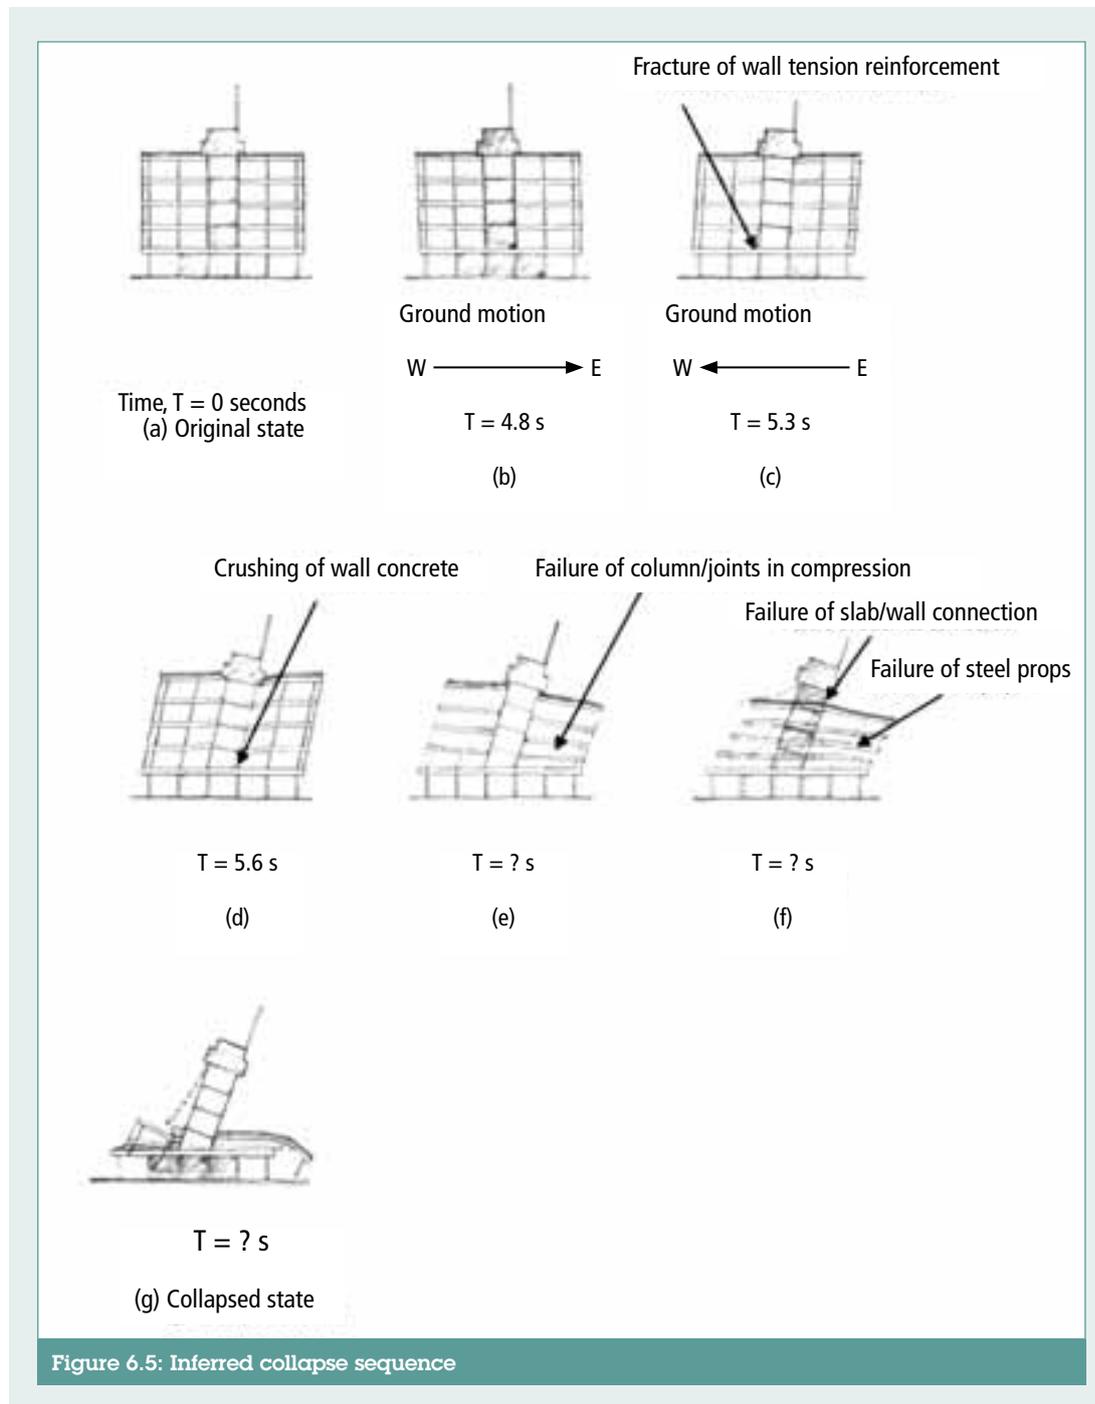
The reason the PGC Building collapsed was that the shaking experienced in the east-west direction was almost certainly several times more intense than the capacity of the structure to resist it. In addition, the connections between the floors and the shear-core, and between the perimeter beams and columns, were not designed to take the distortions associated with the core collapse. Neither foundation instability nor liquefaction was found to be a factor in the collapse.

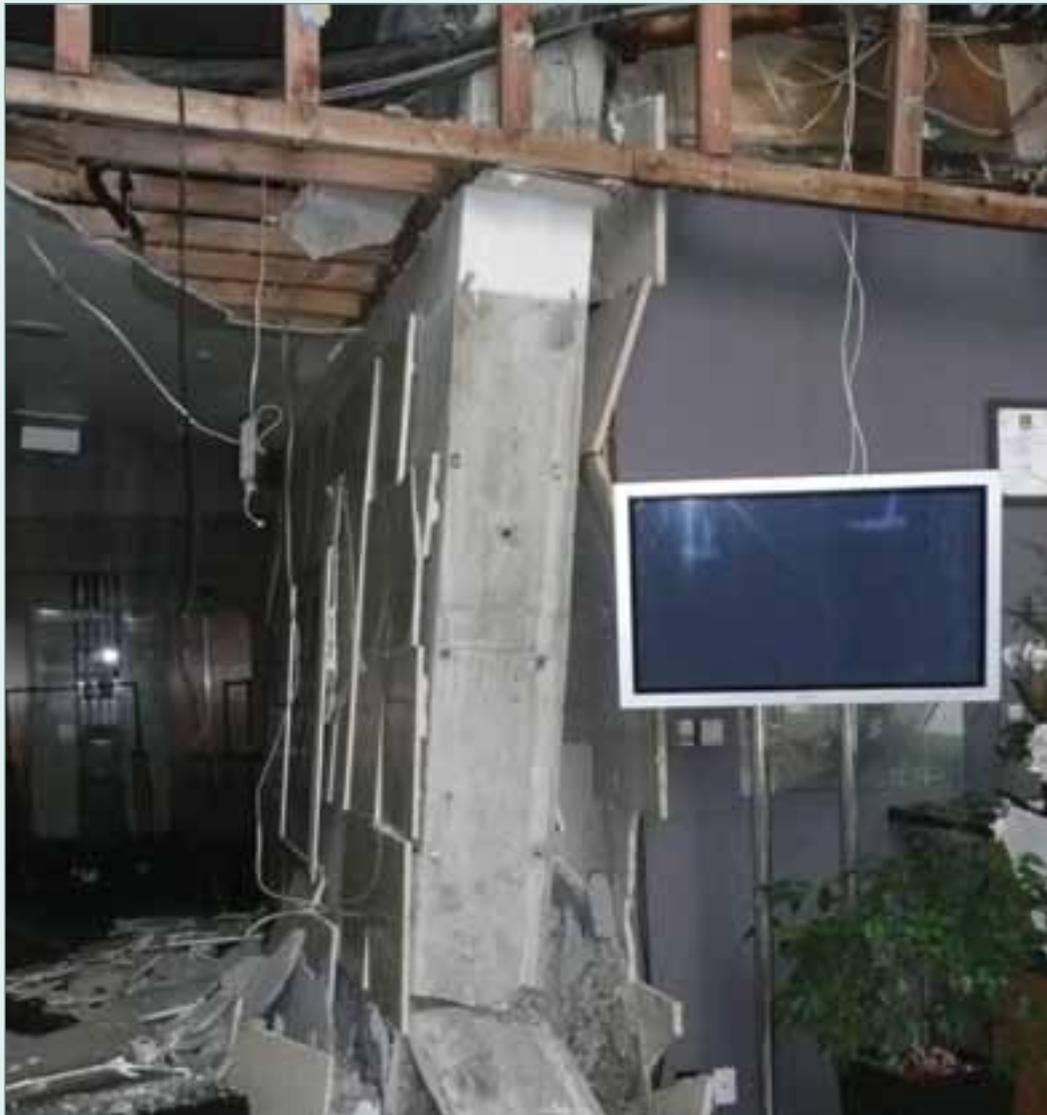
Figure 7.4: Shear wall D5-6 base failure (in the hotel foyer)

During the approximate 12 seconds of intense shaking that occurred in the 22 February 2011 aftershock, the Hotel Grand Chancellor Building suffered a major structural failure with the brittle rupture of a shear wall (D5-6, refer to Figure 7.3) in the south-east corner of the building. This shear wall provided vertical support for approximately one-eighth of the building's mass and was also expected to carry a portion of lateral earthquake loads. Damage to the base of the shear wall is shown in the photograph in Figure 7.4.

As a result of the wall failure, the south-east corner of the building dropped by approximately 800mm and developed an accompanying horizontal lean of approximately 1300mm at the top of the building. This major movement induced other damage including column failure at the underside of the podium, beam yielding, stair collapse and pre-cast panel dislodgement. The collapse of the stairs, in particular, was dependent on the wall failure. Other more minor structural damage was consistent with what may have been expected in a well-performing reinforced concrete structure in a seismic event of this nature.

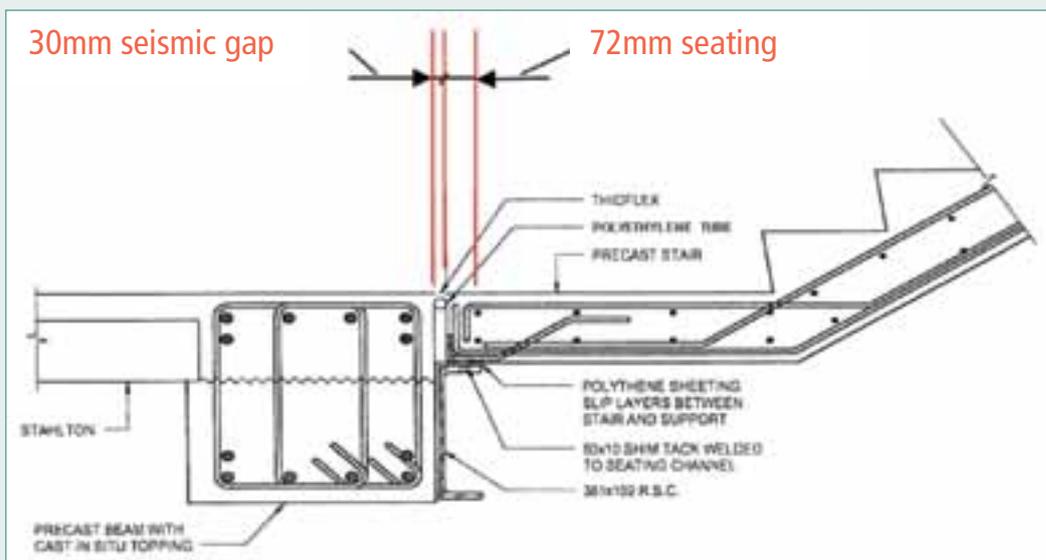
Figure 8.4: Typical stair bottom support detail

The stairs are orientated diagonally within the tower in a north-east/south-west direction. The majority of the stair flights were pre-cast units cast into the landing at their upper ends, and seated on a steel channel at their lower ends which, in an earthquake, allowed the lower end to slide within limits. This provided a horizontal gap specified at 30mm wide for the closing cycle and 72mm for opening (refer to Figure 8.4).
