**IN THE MATTER OF ROYAL COMMISSION OF INQUIRY INTO BUILDING
FAILURE CAUSED BY CANTERBURY EARTHQUAKES**

**STATEMENT OF EVIDENCE OF STEPHEN JAMES MCCARTHY IN RELATION TO
THE FORSYTH BARR BUILDING**

DATE OF HEARING: 23 – 24 FEBRUARY 2012

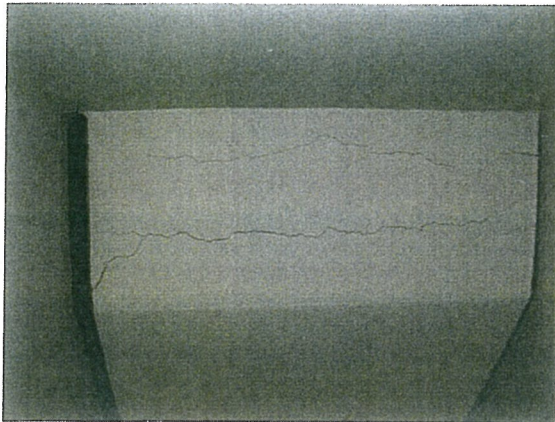
- Beam and connections supporting the base of the stair (~380-PFC) appeared to be in good condition.
- Fire proofing material was intact.
- Flexural cracking in the base of the lower knee of the scissor flight has resulted in residual deformation of the stair, with the stair settled by ~40mm at that location.

The majority of the stair flights had similar damage, although it is believed that level 7 was the most damaged and therefore representative of the remaining stairs. Although the deformations in the stairs are significant, we believe that the stairs still contain sufficient capacity for normal use.

Photo 1. Flexural cracking in base of stair

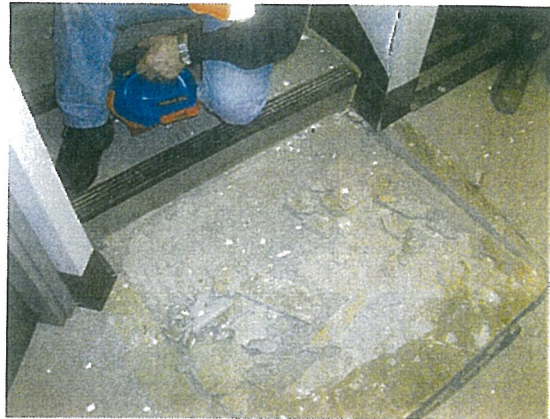
Photo 2. Spalling of concrete at stair knee.

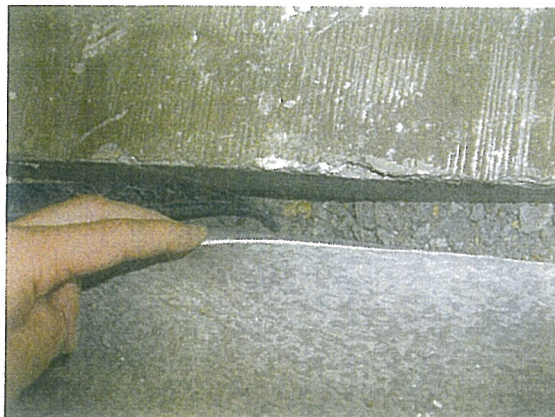
Photo 3. Debris in Seismic separation

- Cleaning of loose debris from the seismic separations at the base of all stairs.
- Propping of Car ramp beam to level 2 slab below, and a further prop from that slab to the level 1 slab below that.

- *The scissor stairs are available for normal use after health and safety issues have been addressed.*
- *The loose debris should be cleared from the seismic separated gaps at the end of each stair flight to allow movement as originally intended.*
- *The current temporary propping to the car park ramp beam at level 2 will allow pedestrian access but not vehicle access to the supported ramp.*

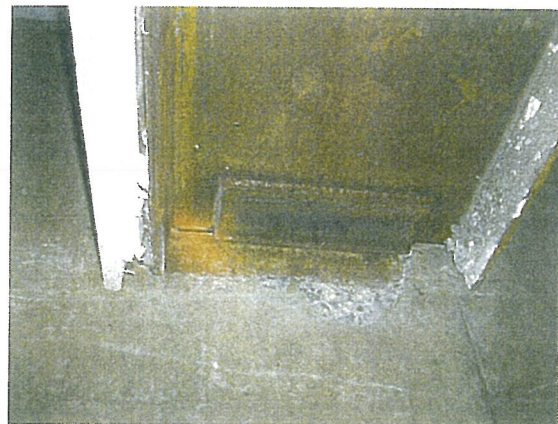
As noted in the Level 2 assessment, a failed weld in the beam supporting the car ramp on Level 2 has failed resulting in ~40mm of settlement. *Temporary* propping will be required from the beam down to the level 2 slab, then also down from level 2 to level 1 slab. *down to the slab.*

Photo 4. Broken Weld

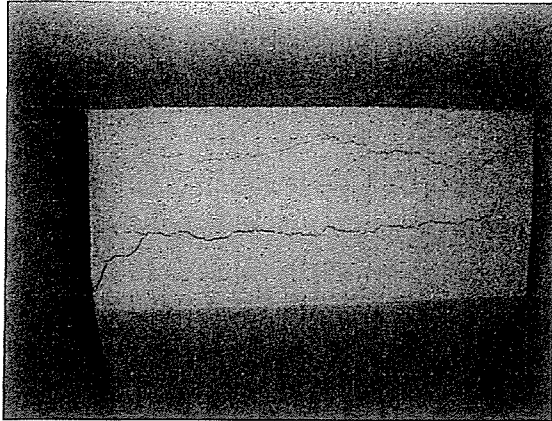
- ▣ Beam and connections supporting the base of the stair (~380-PFC) appeared to be in good condition.
- ▣ Fire proofing material was intact.
- ▣ Flexural cracking in the base of the lower knee of the scissor flight has resulted in residual deformation of the stair, with the stair settled by ~40mm at that location.

The majority of the stair flights had similar damage, although it is believed that level 7 was the most damaged and therefore representative of the remaining stairs. Although the deformations in the stairs are significant, we believe that the stairs still contain sufficient capacity for normal use.

Photo 1. Flexural cracking in base of stair

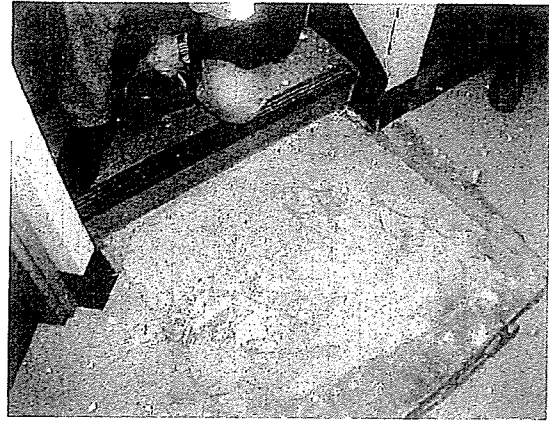
Photo 2. Spalling of concrete at stair knee.

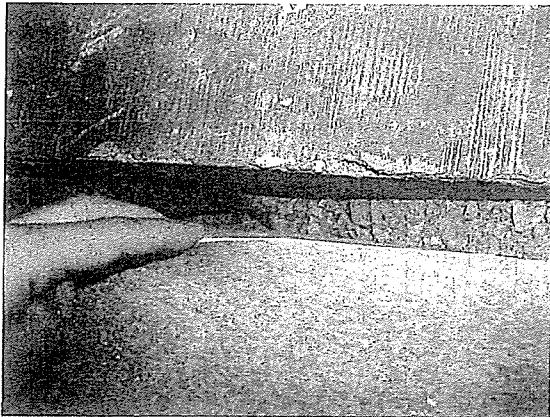
Photo 3. Debris in Seismic separation

- ▣ Cleaning of loose debris from the seismic separations at the base of all stairs.
- ▣ Propping of Car ramp beam to level 2 slab below, and a further prop from that slab to the level 1 slab below that.
- ▣ The scissor stairs are available for normal use after health and safety issues have been addressed.
- ▣ The loose debris should be cleared from the seismic separated gaps at the end of each stair flight to allow movement as originally intended.
- ▣ The current temporary propping to the car park ramp beam at level 2 will allow pedestrian access but not vehicle access to the supported ramp.

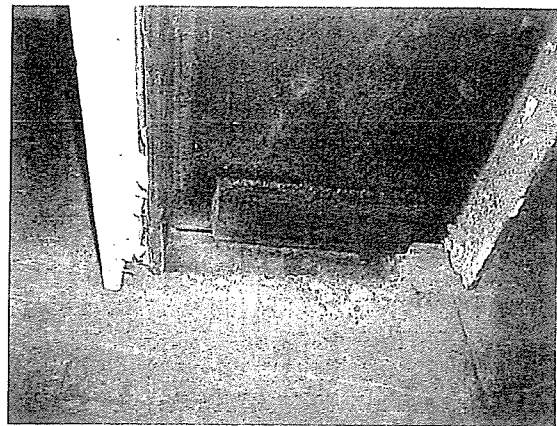
As noted in the Level 2 assessment, a failed weld in the beam supporting the car ramp on Level 2 has failed resulting in ~40mm of settlement. Propping will be required from the beam down to the level 2 slab, then also down from level 2 to level 1 slab.

Photo 4. Broken Weld
