**INDEPENDENT ASSESSMENT ON EARTHQUAKE PERFORMANCE
OF
753 - 759 Colombo Street**

**FOR
Royal Commission of Inquiry into building failure
caused by the Canterbury Earthquakes**

**Report prepared by Peter C Smith and Jonathan W Devine
OF
Spencer Holmes Ltd**

December 2011

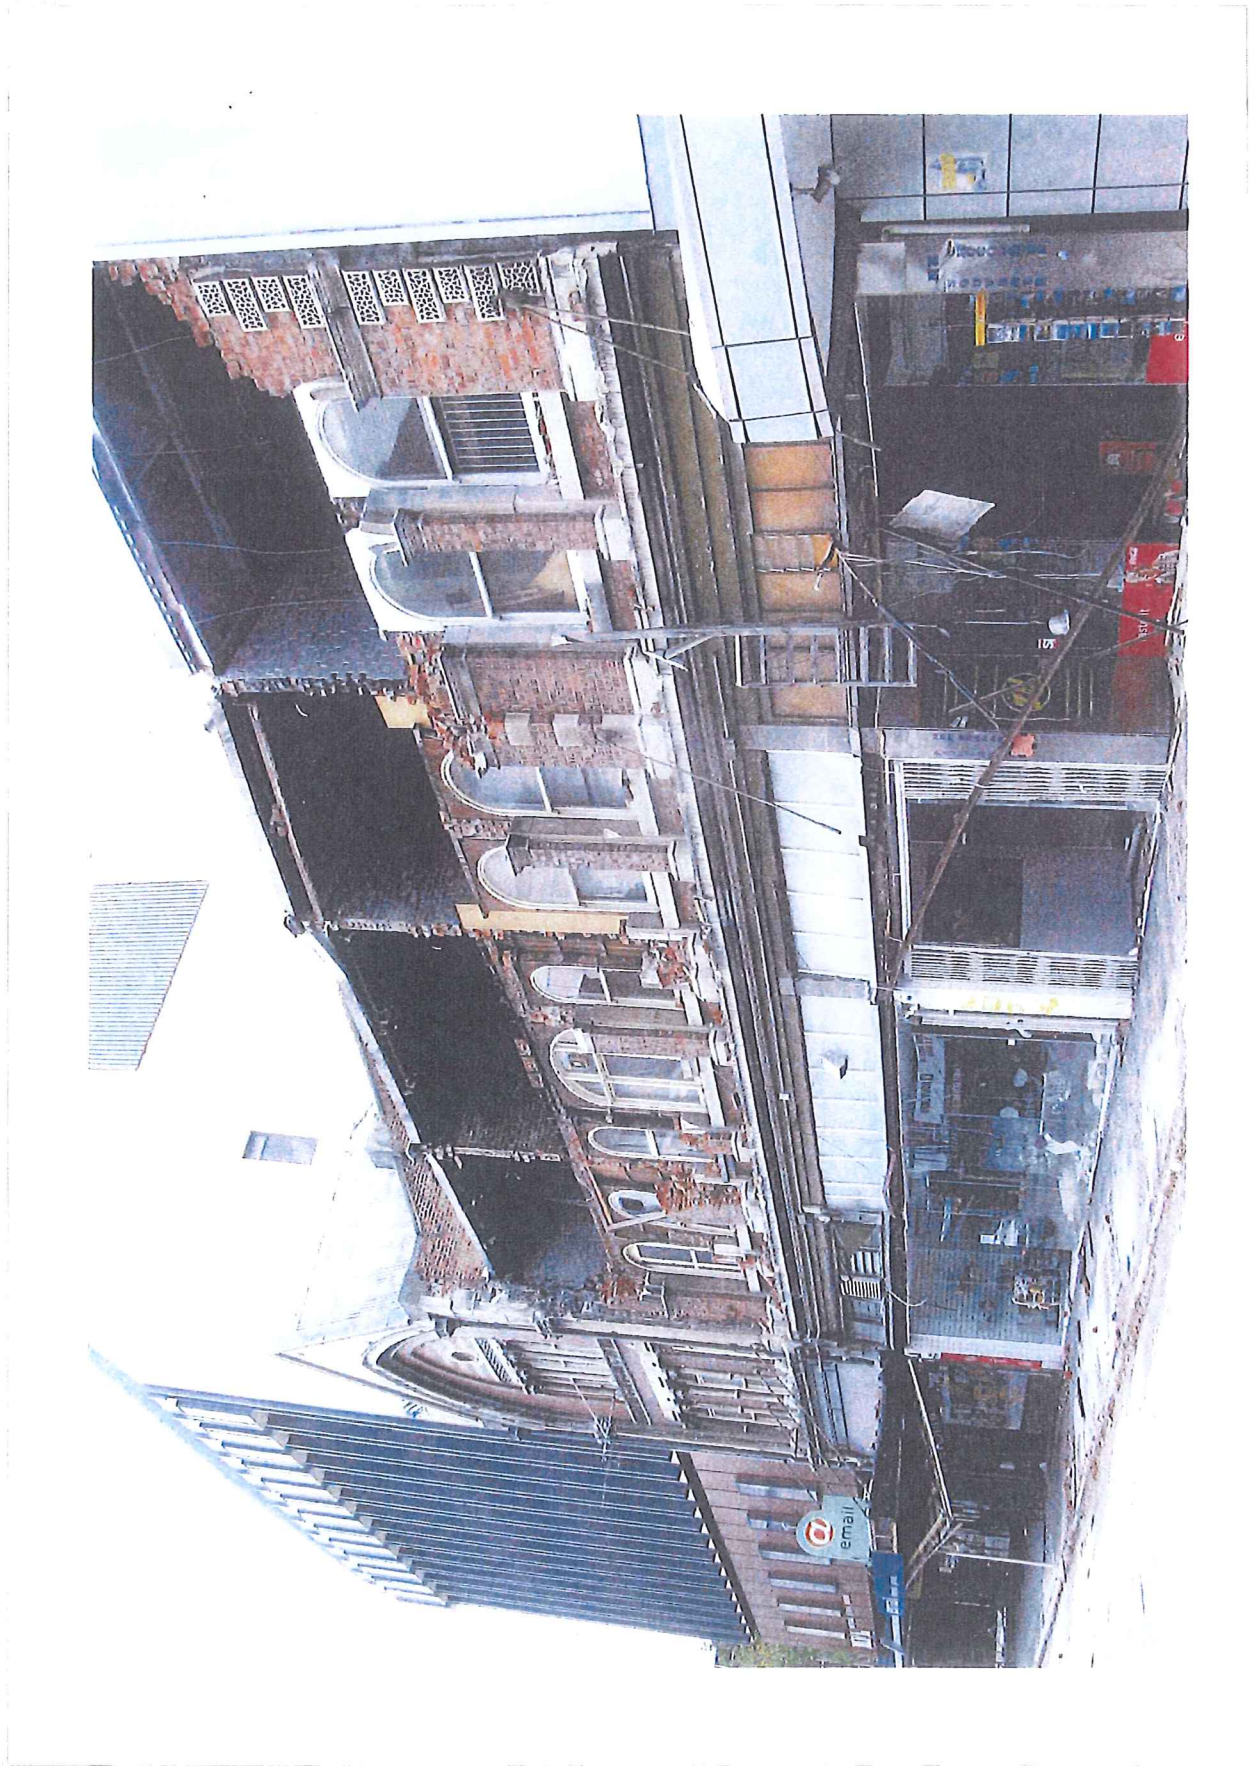
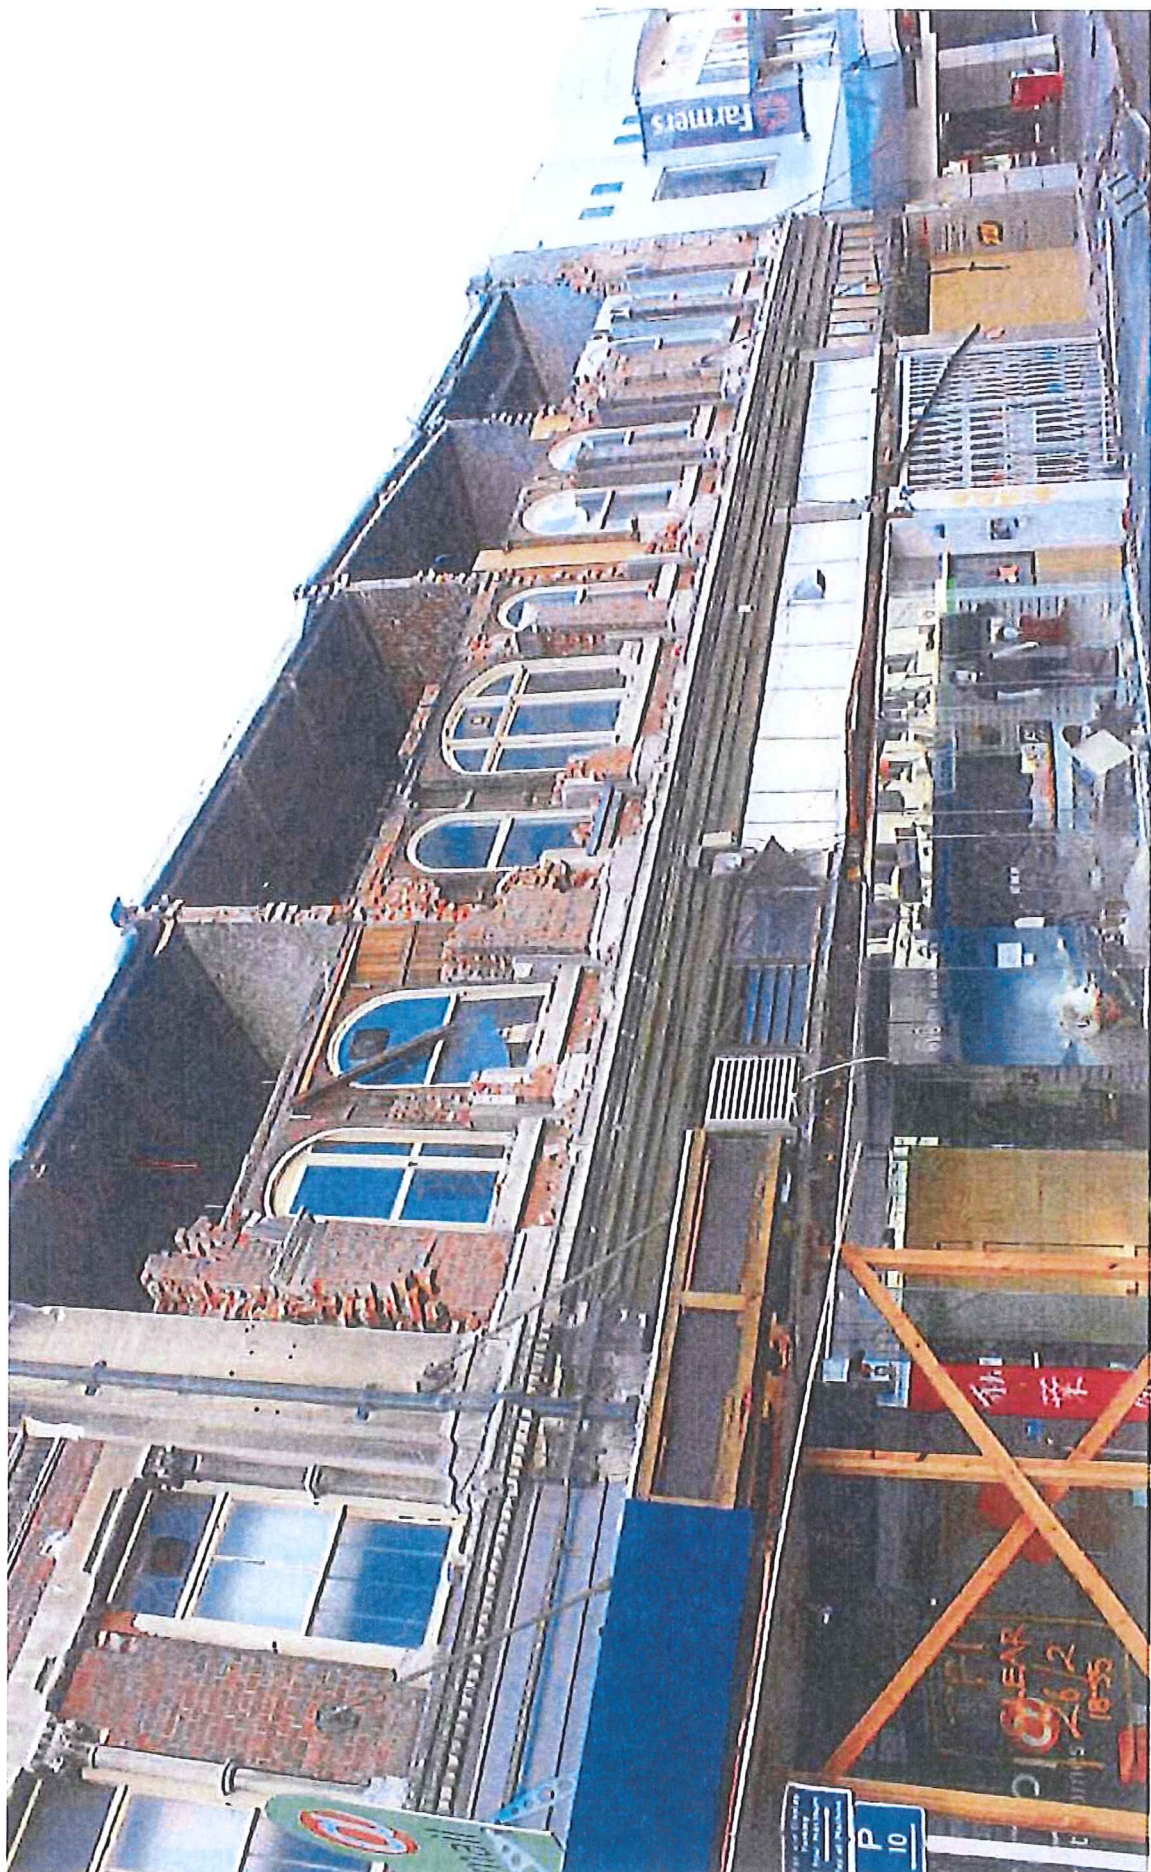
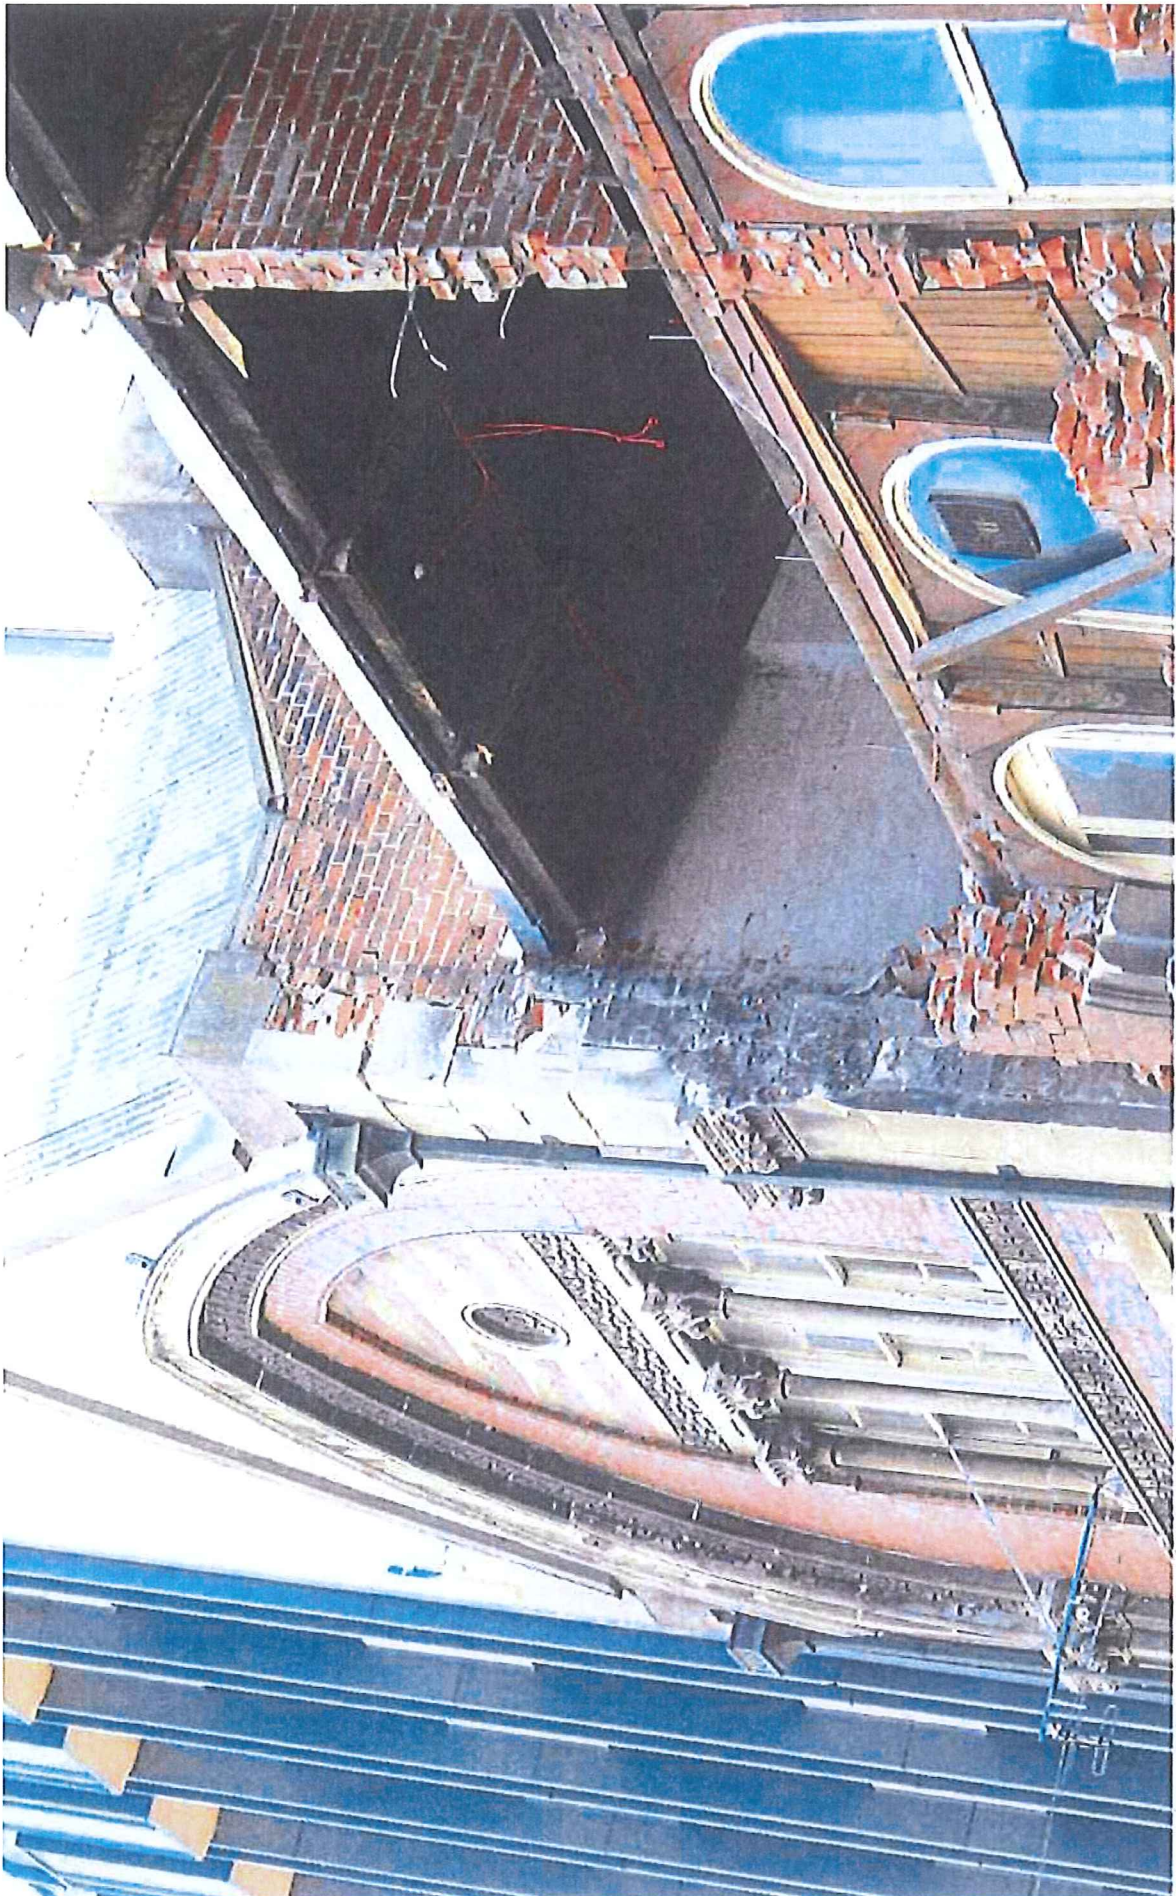
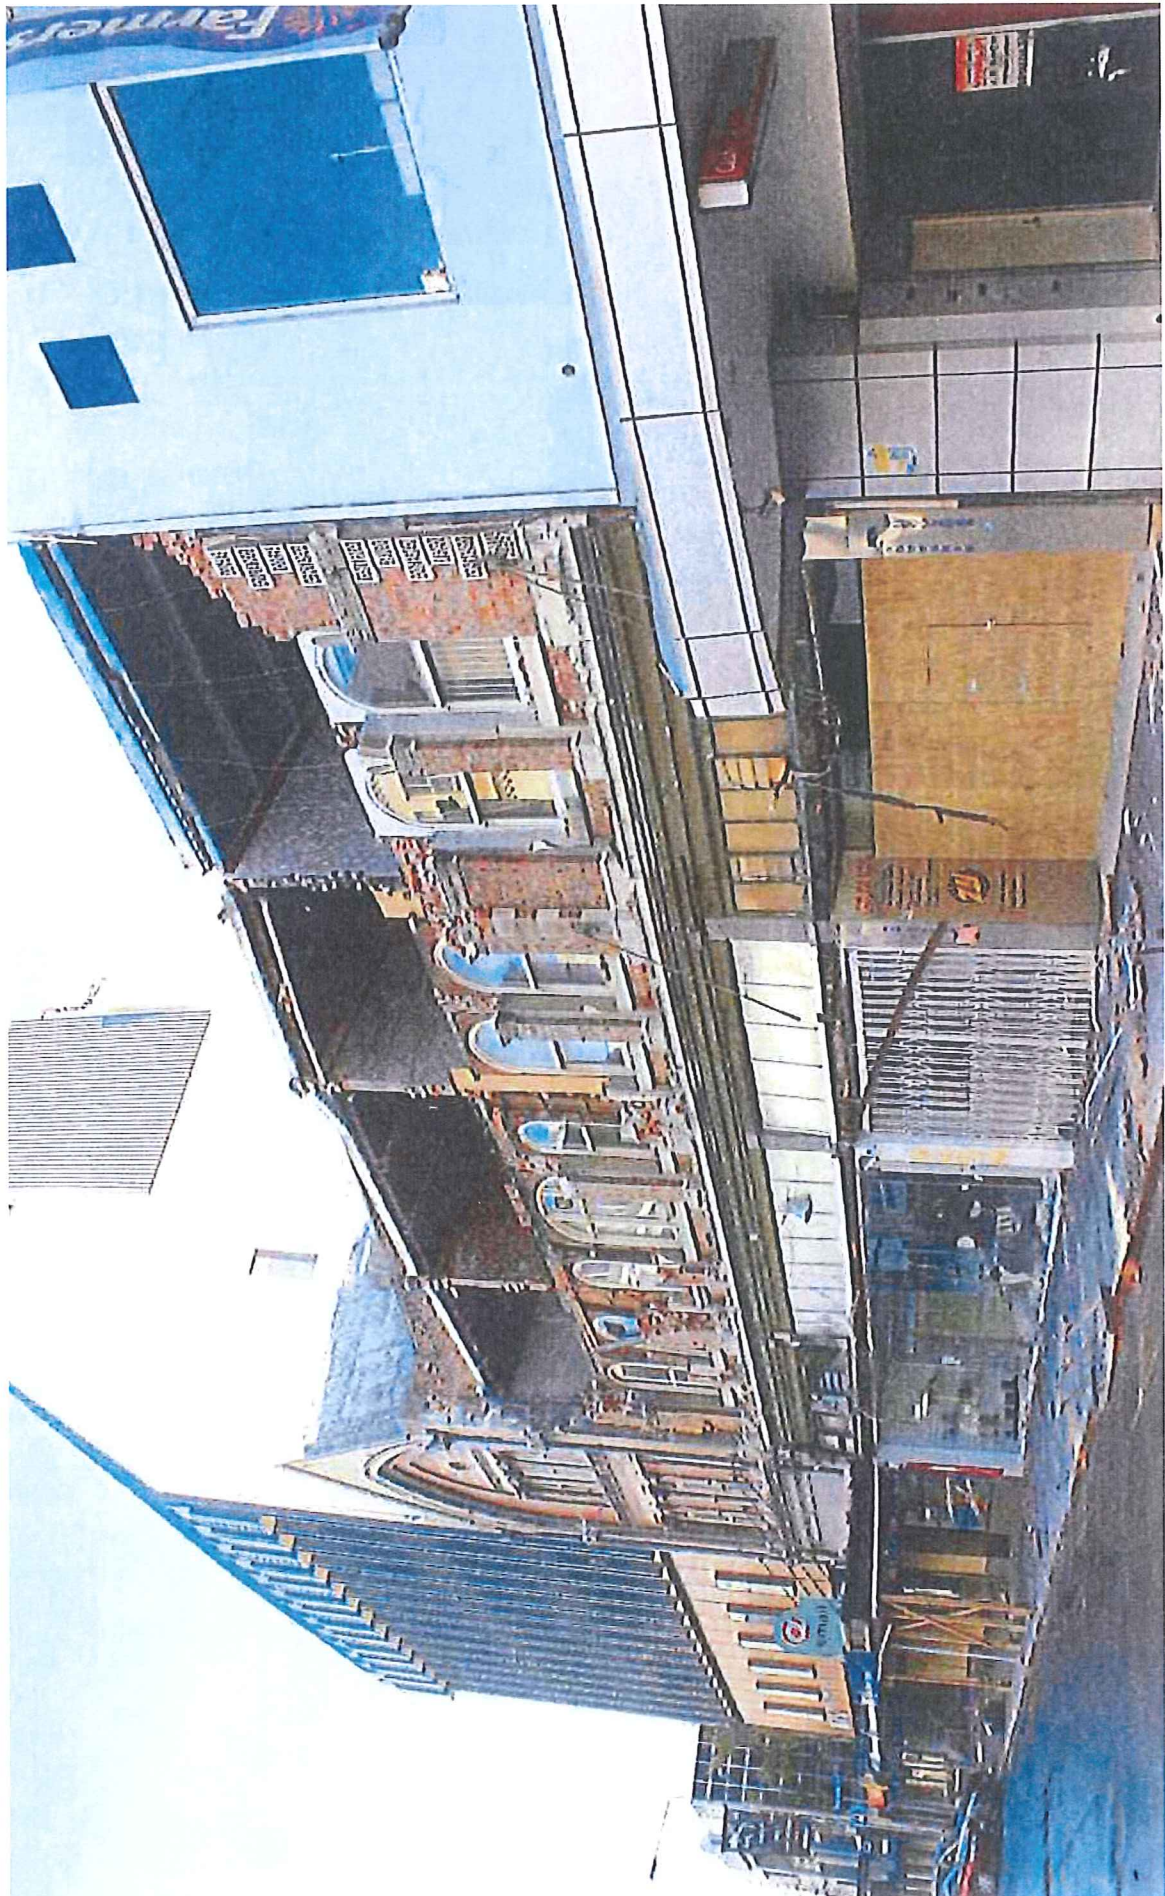
The buildings suffered significant damage in the 22nd February, 2011 earthquake. A rapid assessment – Level 1 was undertaken on the 12th March, 2011 which identified that the upper storey façades had collapsed. T. M. Consultants inspected the buildings and reported on the 22 March, 2011 that the buildings were not structurally safe to occupy.

Although we were unable to inspect the buildings prior to demolition, we have been able to review photos of the damage prior to demolition. From the photographs it would appear that the front façades above window head level rotated outwards from the support at the window head level, collapsing onto the footpath in Colombo Street.

The code lateral load coefficient for a façade to an elastic responding structure in Christchurch at the time of the earthquake sequence was 0.86g. Based on GNS Science records of measurements of accelerations in the Christchurch CBD during the 22nd February, 2011 earthquake, the building was likely to have been subjected to a ground accelerations of 0.9g. This level of ground acceleration equates to an acceleration of 1.25g at first floor level. The above figures demonstrate that the partially secured facade could not be expected to have withstood the severity of shaking that occurred on the 22nd February, 2011.

Photos of damage following 22nd February, 2011 earthquake

There is a need to adequately secure the upper level walls of earthquake prone buildings, particularly the facades of buildings which present a fall hazard over public spaces or adjoining buildings. These buildings pose a serious risk to the public and those that work in or near the building in the event of a significant earthquake.

Consideration should be given to prioritising the strengthening and upgrading of parapets, facades and other elements that have the potential to cause loss of life in public spaces and adjoining buildings in a significant earthquake.
