**ADDENDUM TO REPORT**  
**INDEPENDENT ASSESSMENT ON EARTHQUAKE PERFORMANCE**  
**OF**

**43 LICHFIELD STREET**  
**(Ballentynes – Anderson Building)**

**FOR**  
**Royal Commission of Inquiry into building failure caused by the Canterbury**  
**Earthquakes**

**February 2012**

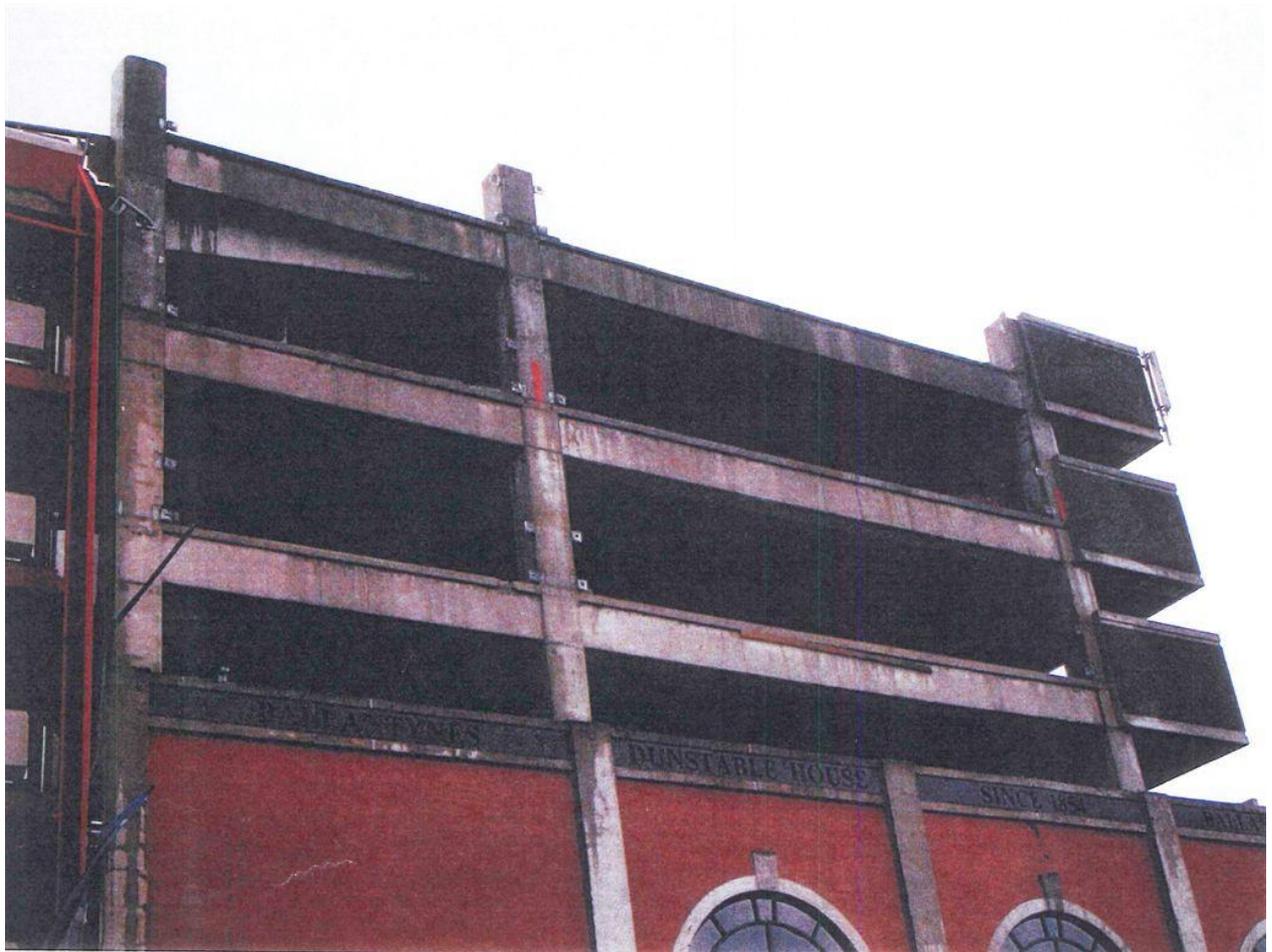
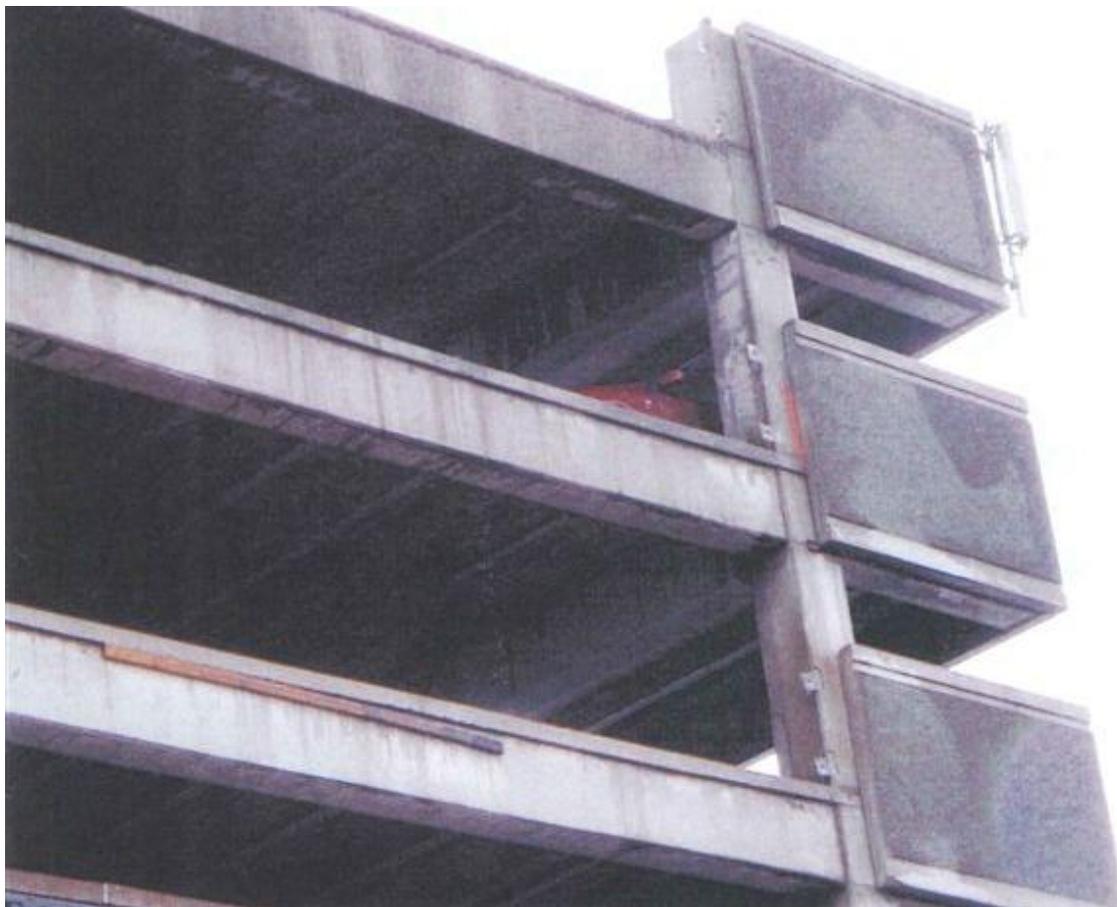
### **Condition of Building following 22<sup>nd</sup> February 2011**

Unfortunately the failed panels and the remnants of the connections attached to the building were unable to be inspected to reliably identify the mode of failure. A review of the photos taken of the building following the earthquake indicated that at some connections the failure occurred between the 150x100x10mm Angle cleat and the 100x100x10mm Angle cast into the column, while in other instances the failure occurred through shear failure of the bolt connecting the 150x100x10mm Angle to the precast panel. In these instances the 150x100x10 Angle appears to have suffered little deformation.

While we remain of the opinion that interstorey deformations are likely to have contributed to the failure, it is evident that other failure modes occurred.

As the panels connections were significantly understrength and the earthquake shaking was in excess of the code design requirements failure of the panels was almost inevitable.

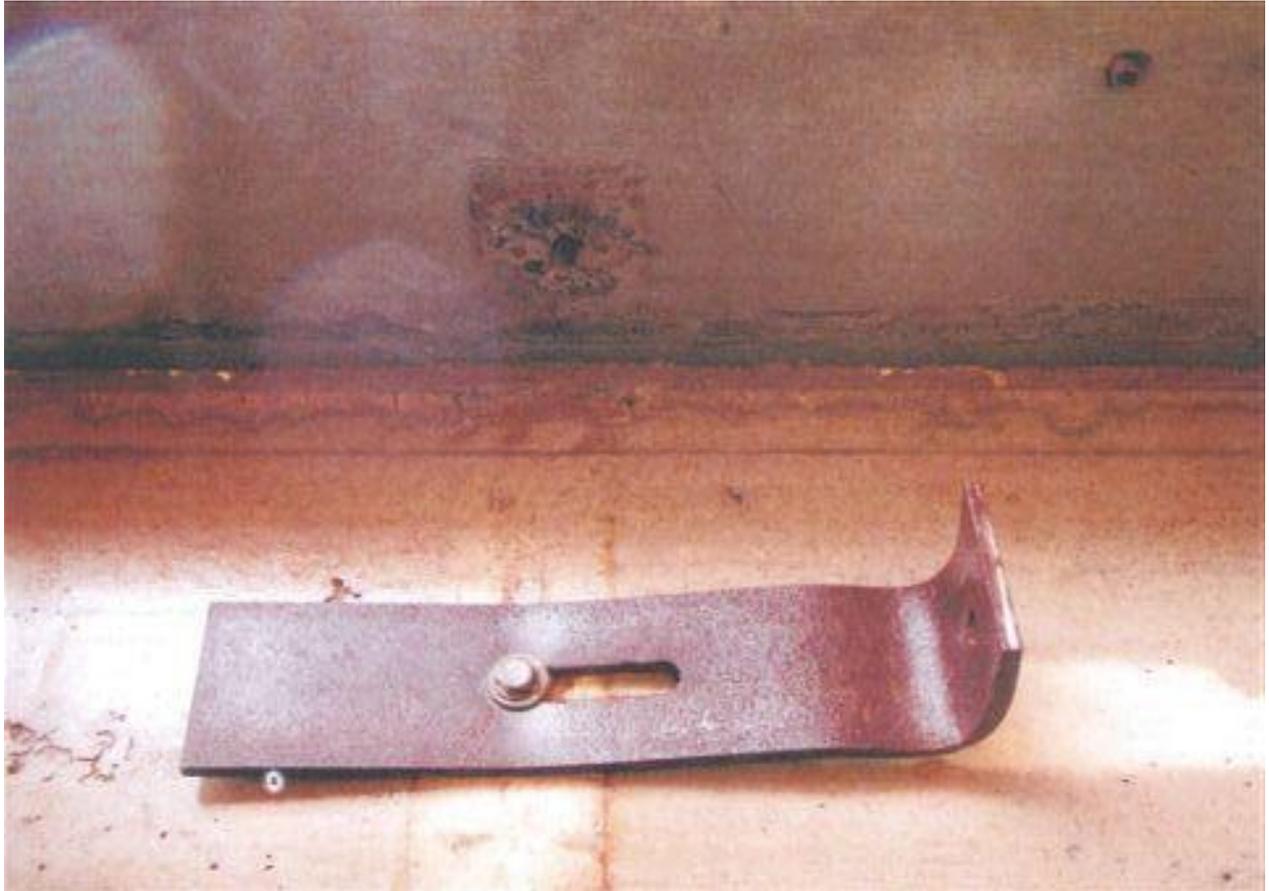
### **Additional Panel Fixings not Detailed**

In reviewing the documentation for this project we were aware that there may have been additional fixings provided from the floor to the panel. A typical photograph of such a fixing which applied to a panel that did not fail in the 22<sup>nd</sup> February, 2011 earthquake is appended. It is evident that this fixing failed as a result of the loads imposed on 22<sup>nd</sup> February, 2011 earthquake. The failure appears to have been a failure of the proprietary fixing into the panel. It is evident that the metal cleat suffered severe distortion as a result of forces induced by the earthquake. We are uncertain as to the purpose of the slotted hole or of the location of the bolt located within the slotted hole securing the bracket to the floor at the time of construction.

We are uncertain as to whether a series of these brackets were placed at the junction of the precast panels and the floor during construction as a variation to the contract. As we have not had an opportunity of inspecting the building or the panels prior to removal, we are unable to

comment on whether sufficient of these connections were provided to achieve a restraint of the pre-cast panels under the code loading applying at the time of construction.

Example of typical additional fixing (not detailed in drawings) to panels that remained after 22<sup>nd</sup> February 2011 earthquake.

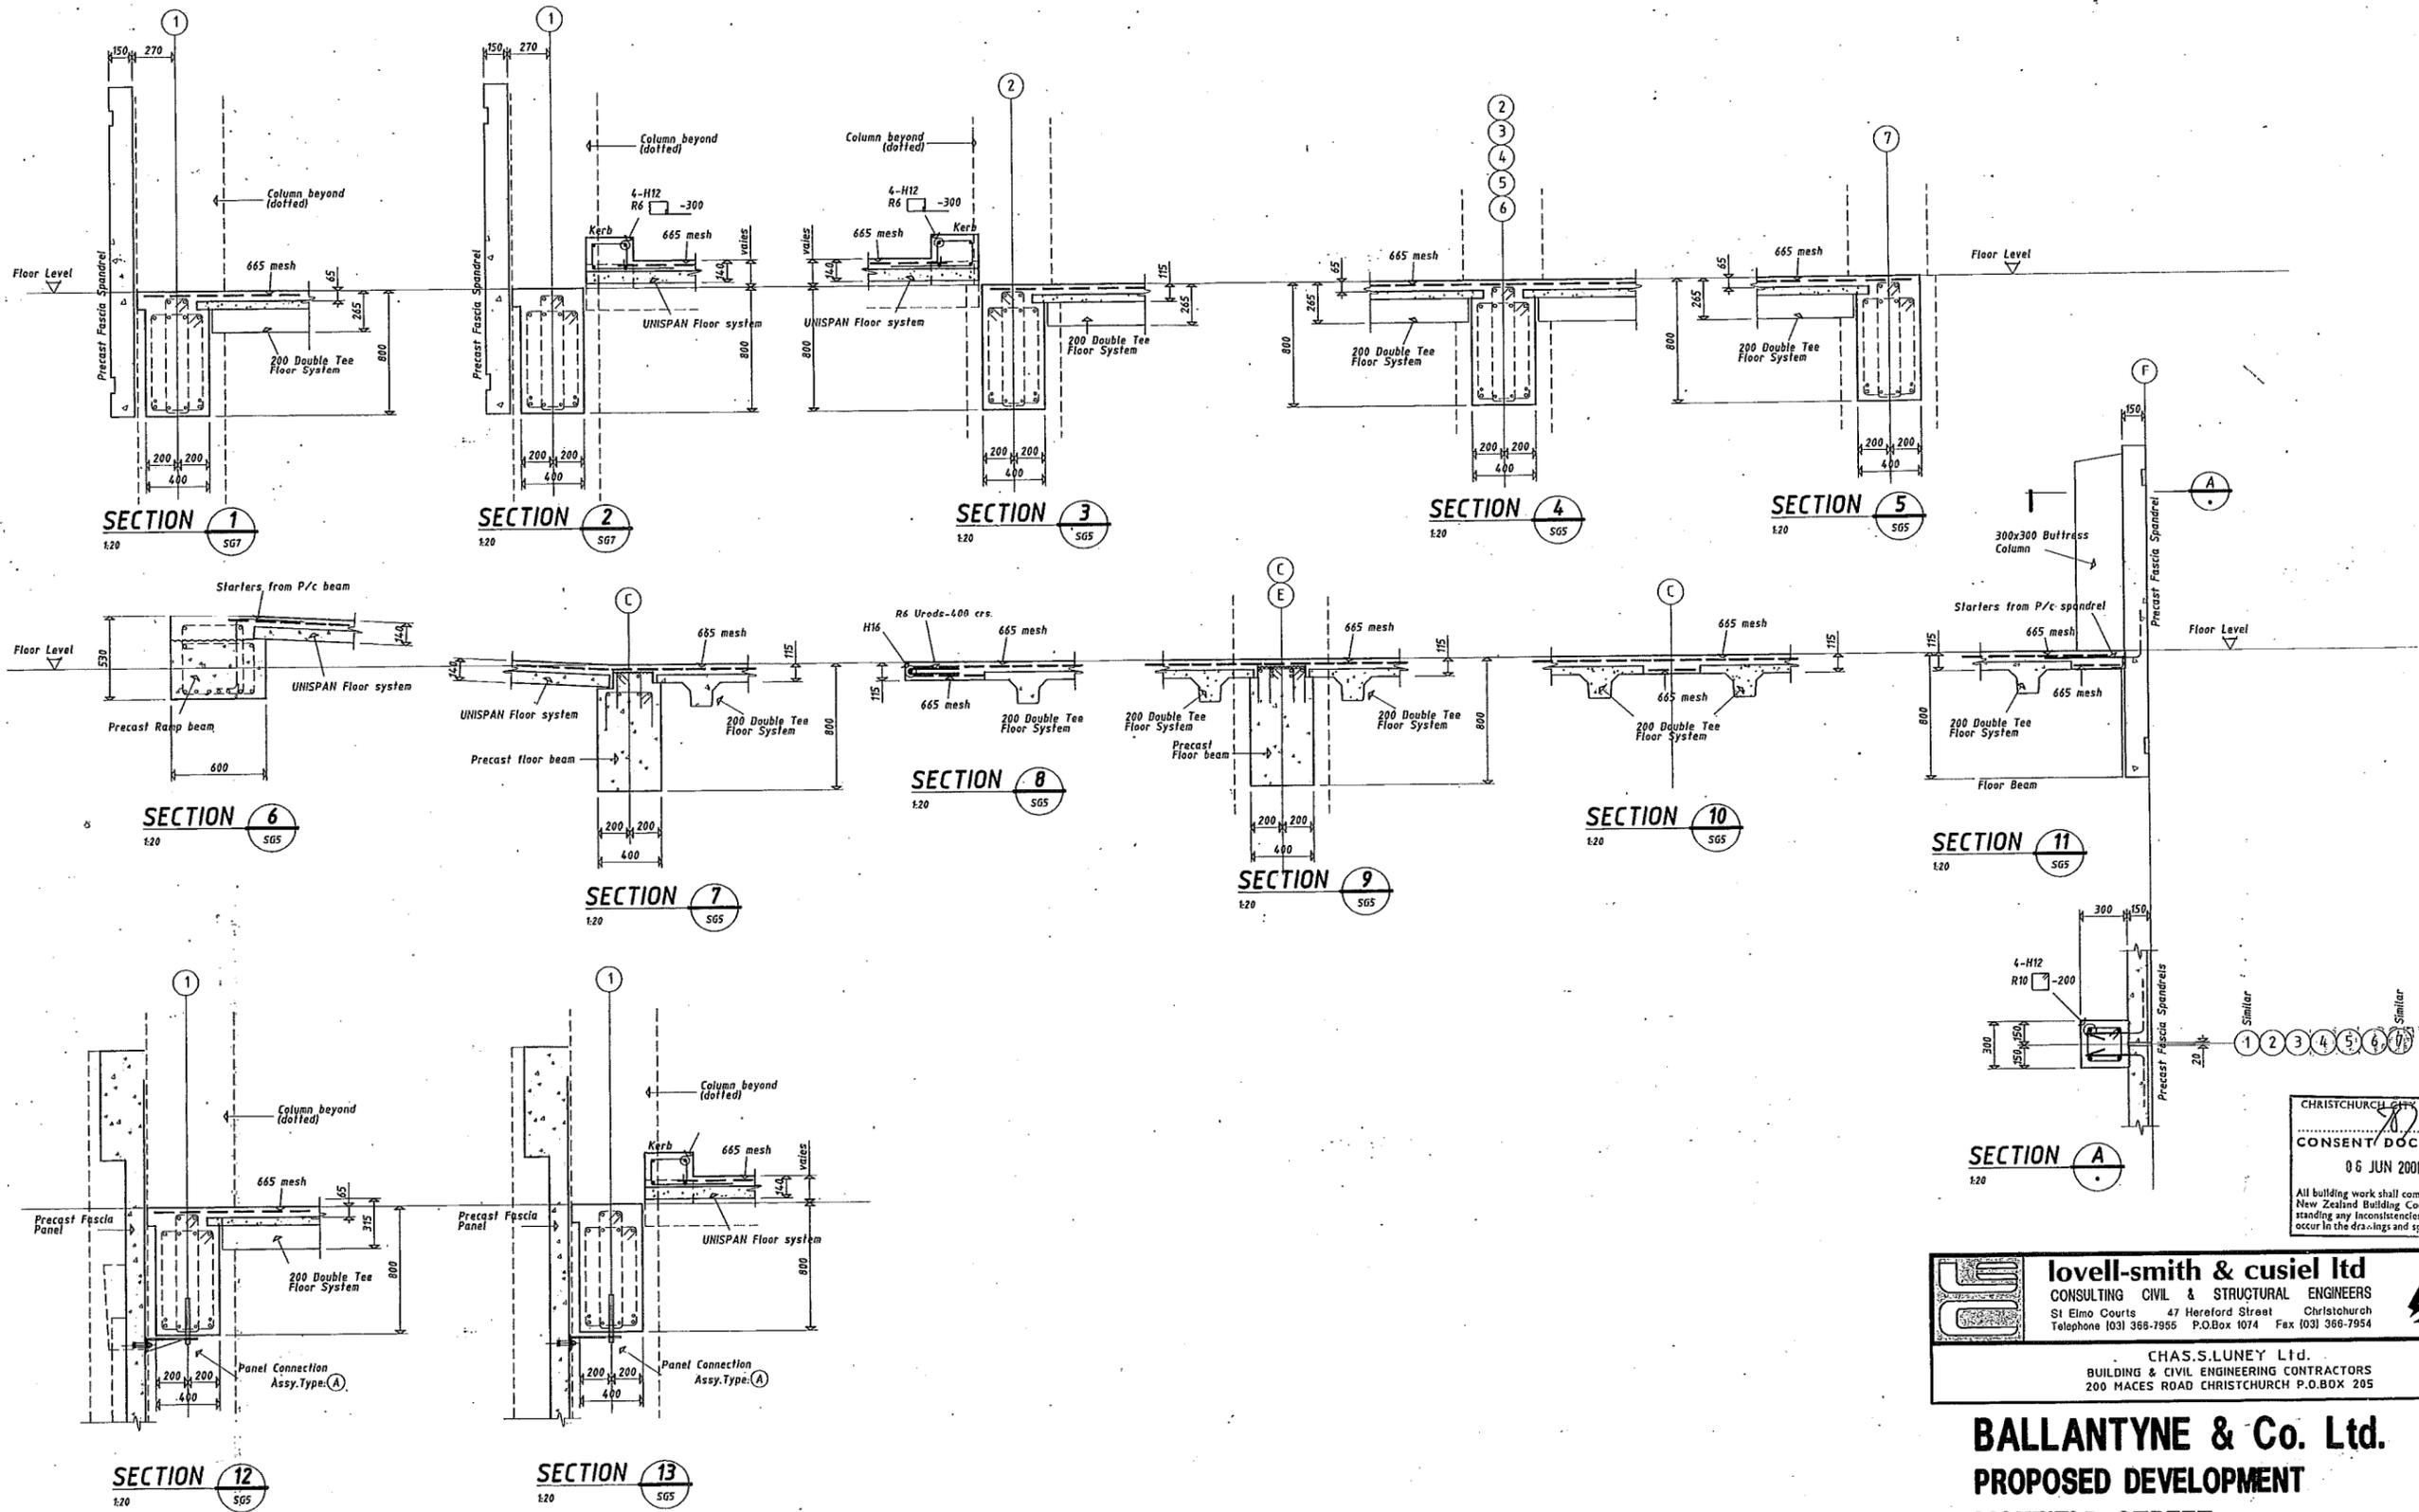
Typical Floor Sections			
DESIGNED	D.CUSIEL	JOB No.	<b>4654</b>
DRAWN	R.L.CRAW	SHEET No.	<b>SG6</b>
CHECKED		OF	<b>41</b>
DATE	June 2000		
REV	DATE	BY	AMENDMENT

Temporary support for panels S1, S2, S3 was achieved using a seating bracket. In addition to the H12–300 starters cast into the topping of the floor, these panels were restrained by a short column constructed above the main transverse floor beams on Grids 1 to 7 respectively. These columns were 300x300mm reinforced concrete columns reinforced with 4xH12 rods and R10 stirrups at 200 centres. Details of the construction was shown in Section 11 on drawing 4654 SG6

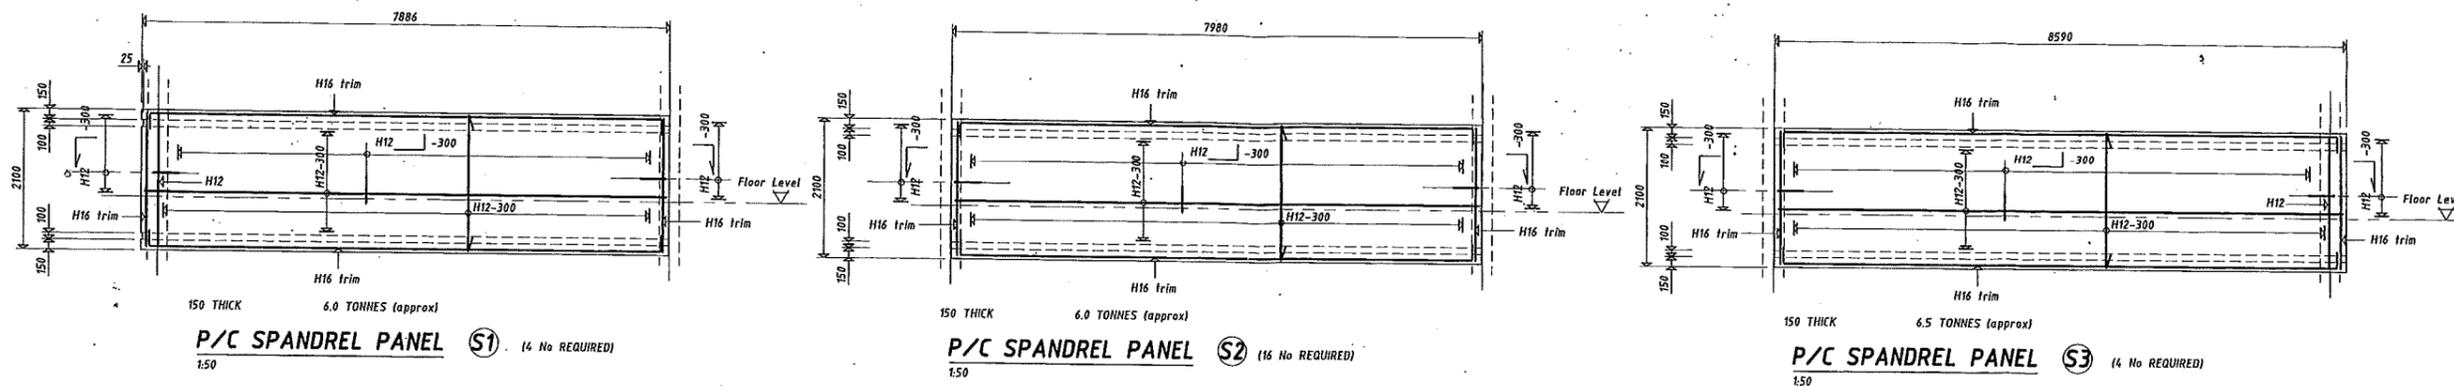
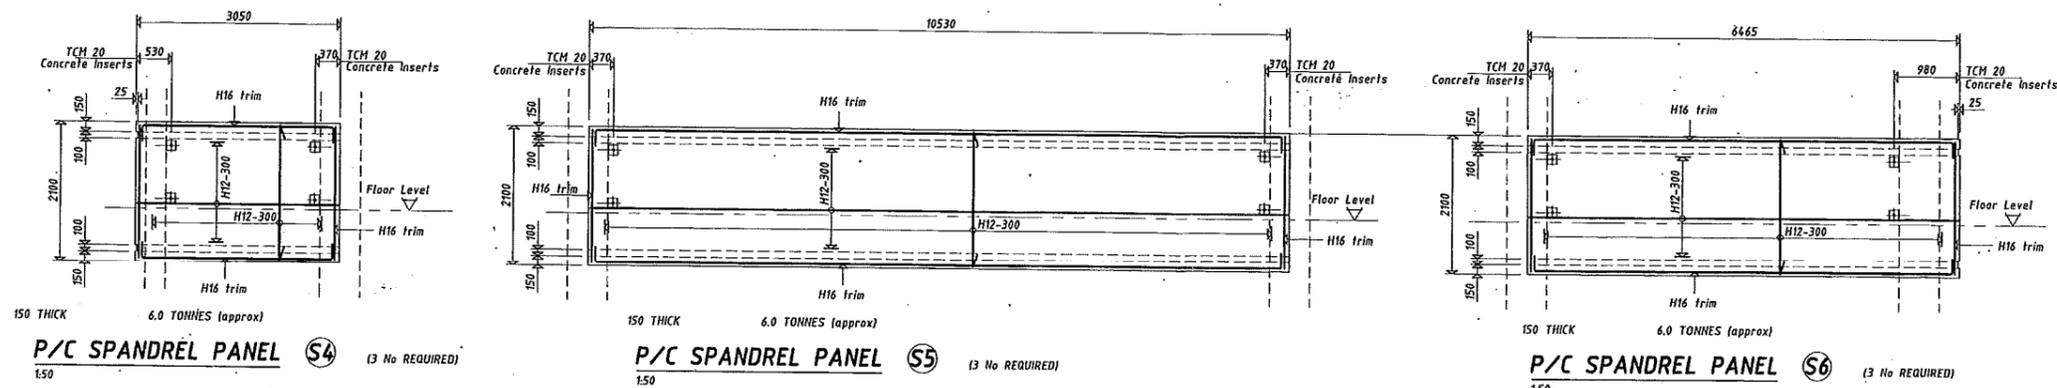
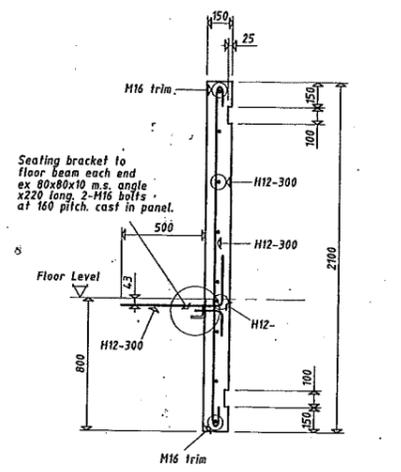
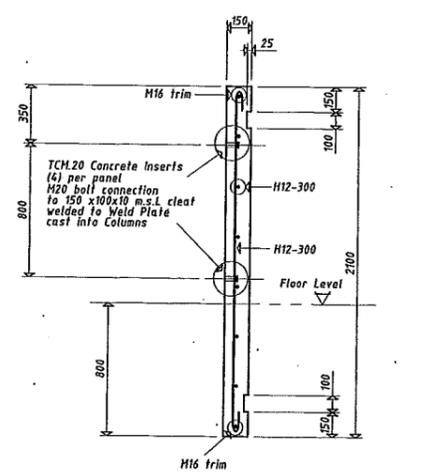
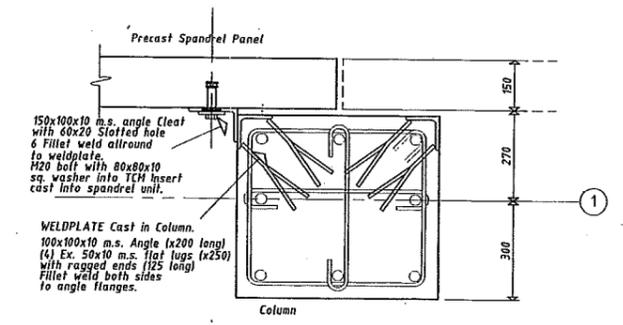
Precast Spandrel Panels			
DESIGNED D.CUSIEL	JOB No. <b>4654</b>		
DRAWN R.L.CRAW	SHEET No.		
CHECKED	DATE		
07.12.00 07.07.00	June 2000	OF	<b>SP7</b> 41
REV	DATE	BY	AMENDMENT

The panels that failed during the 22<sup>nd</sup> February, 2011 earthquake were along the southern (Lichfield Street) frontage of the building at levels 5, 6 and 7 of the carpark. They are identified as spandrel panels S5 and S6 on drawing 4654-SP7. Essential features of these panels are as follows:

The typical fixing details for the panels along Gridline 1 (the Lichfield Street frontage) are shown on drawing 4654-SP7 as "*Typical Connection Details Spandrel Panels Grid 1*".

The panel fixing is detailed with "*100x100x10 m.s. Angle cleat (x200 long) (4) Ex. 50x10 m.s. flat lugs (x250) with ragged ends (125 long) Fillet weld both sides to angle flanges.*". This 100x100x10 angle and attached metalwork was cast into the corner of the concrete columns.

The panels were detailed with a TCM insert cast into the panel for an M20 bolt. The panel was fixed to the angle embedded in the concrete column with a "*150x100x10 m.s. Angle Cleat with 60x20 Slotted hole*". The connection between the 150x100x10 mild steel angle and the 100x100x10 mild steel angle was detailed as a 6mm fillet weld all round to weldplate.

The fixing of the spandrel panels on Gridline 1 (South Wall) differed significantly from the spandrel panel fixing adopted for the support of the spandrel panels to Gridline F (East Wall). The connection of the panels to the east wall was achieved with H12-300 starters embedded in the pre-cast panel and subsequently cast into the 65mm topping to the floor. Refer typical sections for Pre-cast Spandrel Panels S1, S2, S3 on drawing 4654-SP7.

Clearly the panel fixings as detailed on the drawings did not comply with the current code NZS 4203:1992.
