# Investigation into the collapse of the stairs in the Forsyth Barr building

Mr Rob Jury and Dr Richard Sharpe

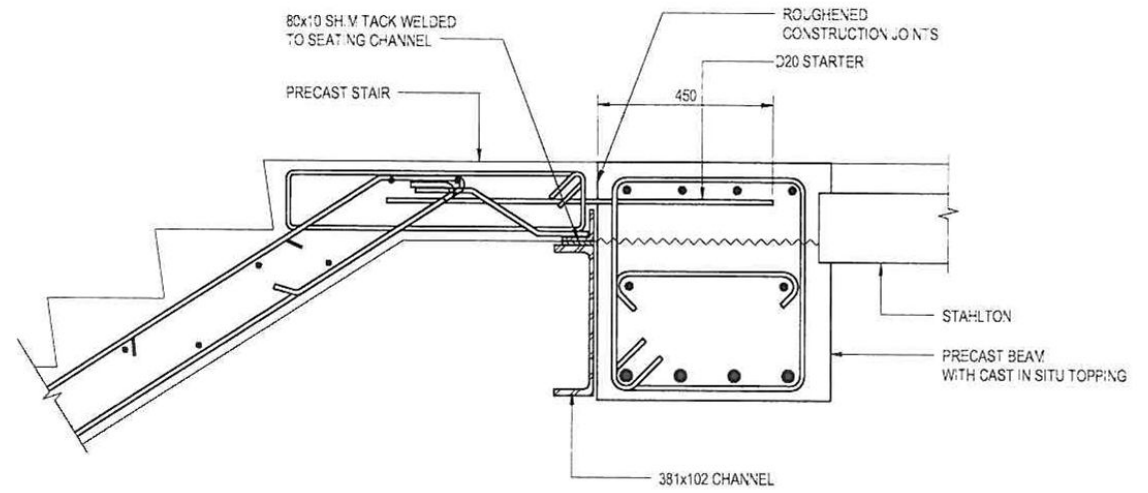
Typical Stair Top Support Detail

30 mm seismic gap

72 mm seating

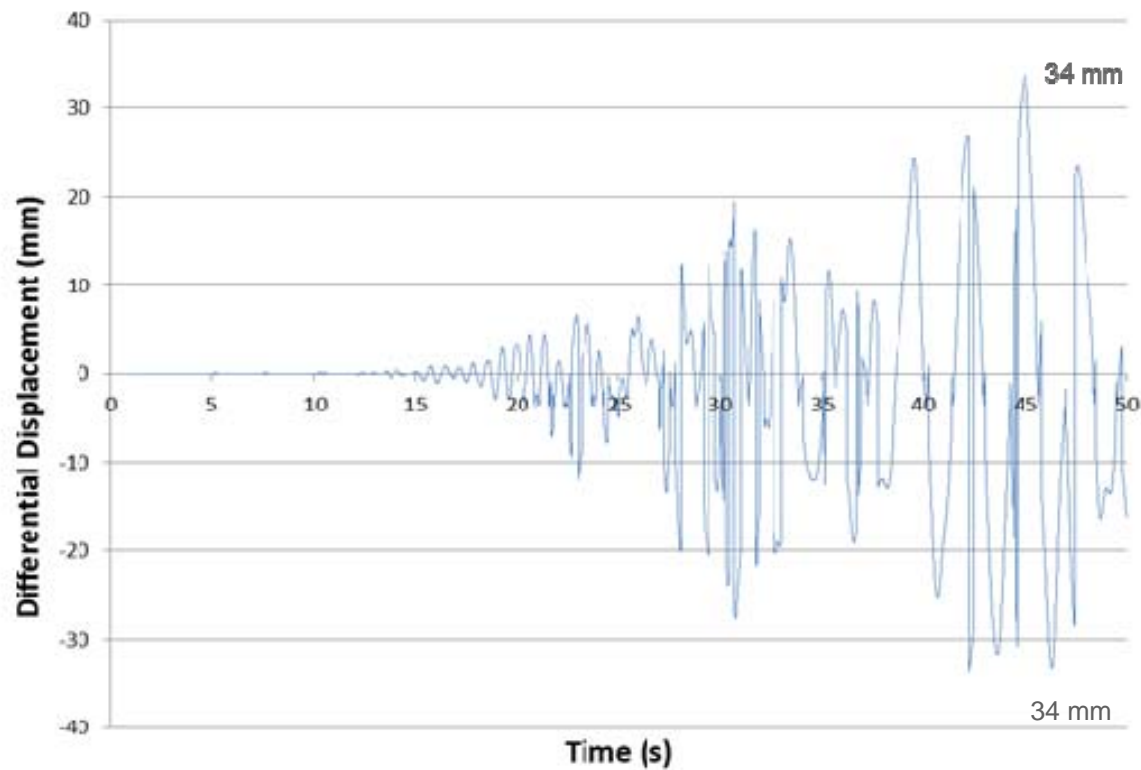
Interstorey drifts during 4 September 2010 Earthquake

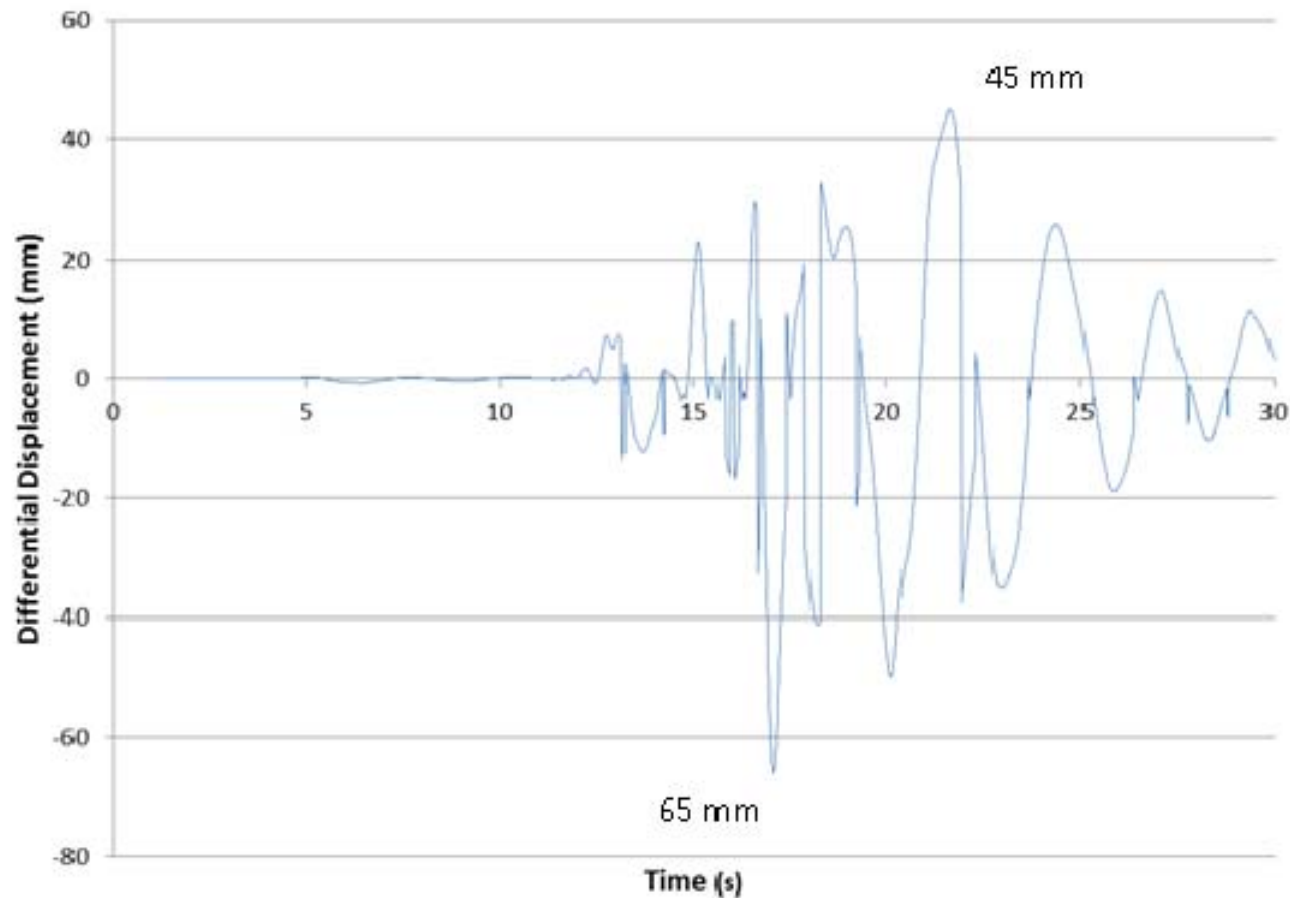
Interstorey drifts during 22 February 2011 Earthquake

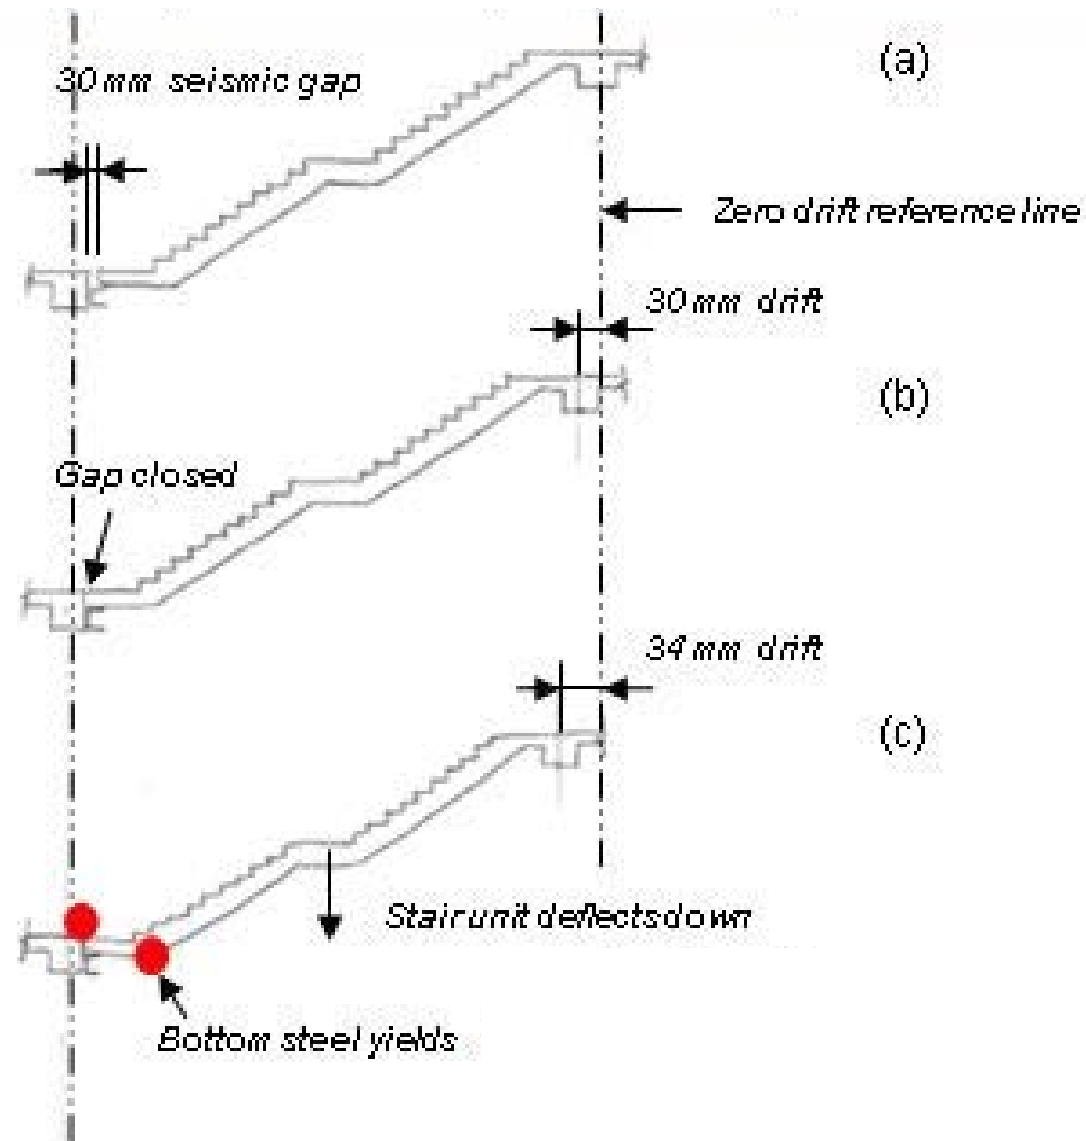
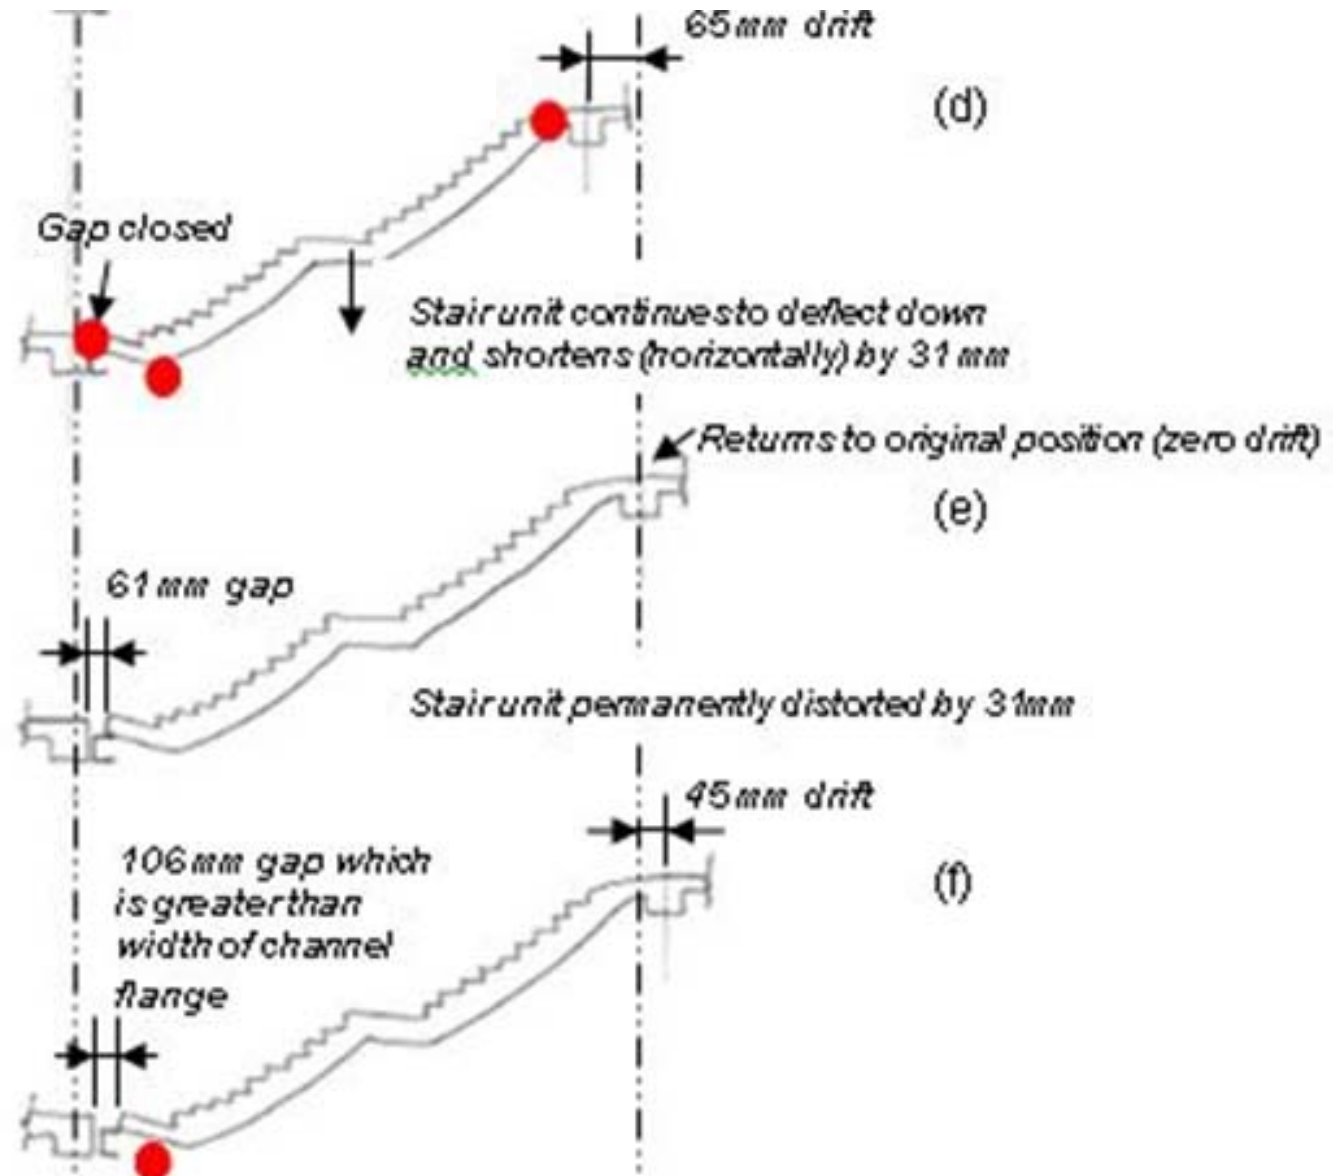
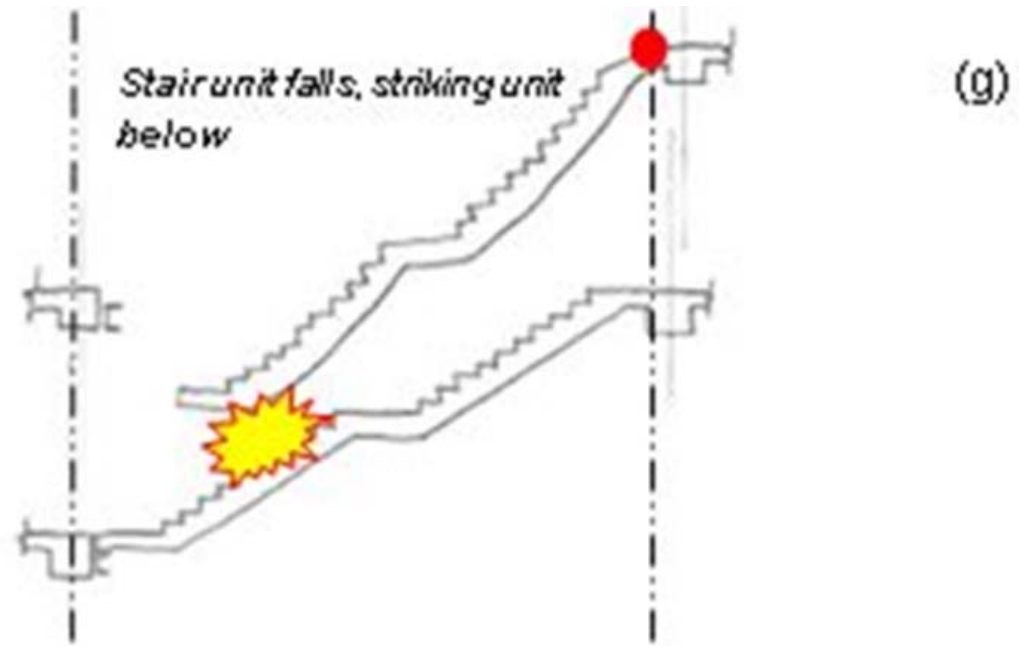
# Inferred Collapse Sequence

- The shaking experienced on 22nd February led to between-floor displacements that were larger than those for which the the stairs were designed.
  - One or more stairs fell off their lower seating at around the 15<sup>th</sup> floor.
  - A domino effect collapsed stairs below.
