Seismic Performance Investigation
Draft Report

Clarendon Tower
78 Worcester Street
Christchurch, New Zealand

Clarendon Tower

February 2012

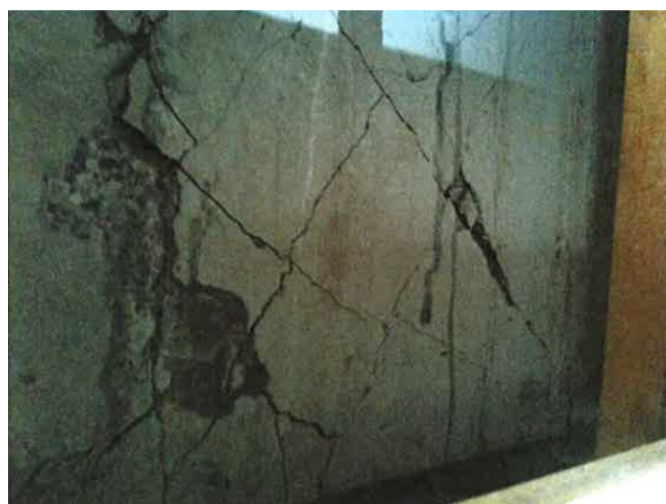
Investigation after the Darfield earthquake noted flexural cracking within the span and vertical cracking at the column faces of the south frame beams which are assumed also to occur at the north frame [2]. These cracks were in the process of being epoxy injected, which may have been completed, when the Lyttelton event occurred. Immediately after the Lyttelton event, 2mm shear cracks were observed in the north and south frame beams and it was noted that the connection did not appear to have activated properly [26]. Later 10-15mm diagonal shear cracks were discovered appearing around levels seven and eight in addition to a vertical offset, referred to as vertical stepping, at the beam midspan connection as shown in Figure 6 [28, 29]. Frame elongation was noted as more severe for the north frame, somewhere between 20 and 50mm, although it was documented for the south frame as well [28, 34]. See Figure 7.

Figure 6: Shear Link Connection Damage in Clarendon Tower's North Frame [28]

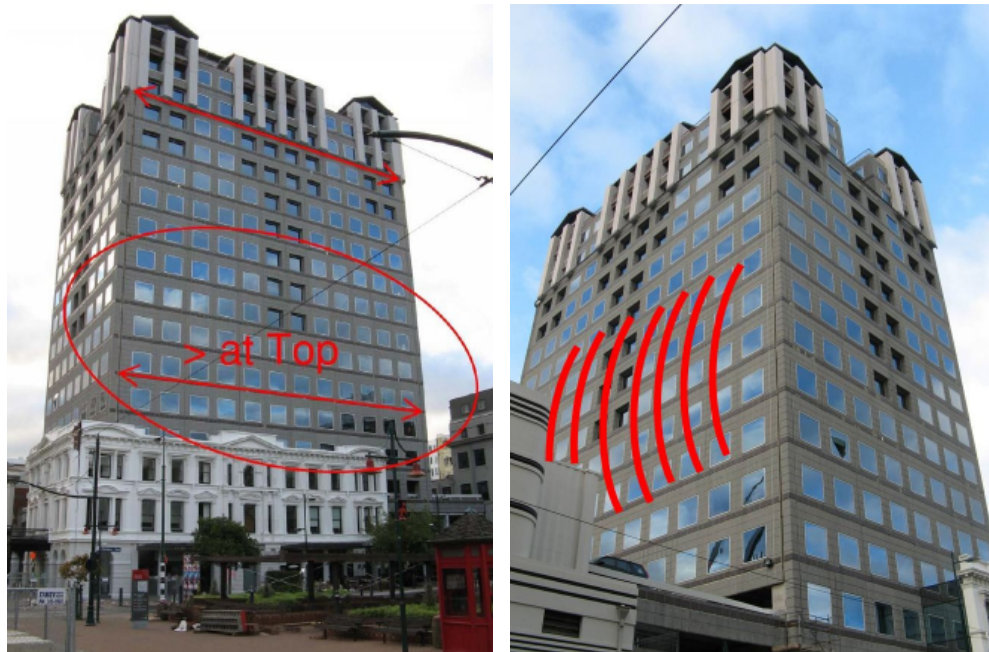
Flexural cracks in addition to a vertical crack between the precast beam and the cast-in-place column were observed on the west frame after the Darfield event [2]. These types of cracks in beams were subsequently repaired through penetration injection [13]. After the Lyttelton earthquake, new 2mm flexural cracks at the column face were observed and extensive rebar yielding was assumed to have occurred [26, 32]. Frame elongation is thought to have caused movement of the north and south frame approximately 100mm farther apart at levels five to nine in addition to resulting in bulging at levels five to eleven as shown on the left and right of Figure 9, respectively [31, 34]. The bulging that appears in Figure 9 is said to result from an outward movement of the east and west frame columns as sketched in Figure 8. The yielding of the rebar has also brought up the issue of low cycle fatigue and it is unclear, without further analysis, how much remaining capacity exists in the east and west frame beams after undergoing repeated earthquake excitation [31].

Figure 9: Frame Elongation (left) and Bulging at levels 5 to 11 (right) [31]

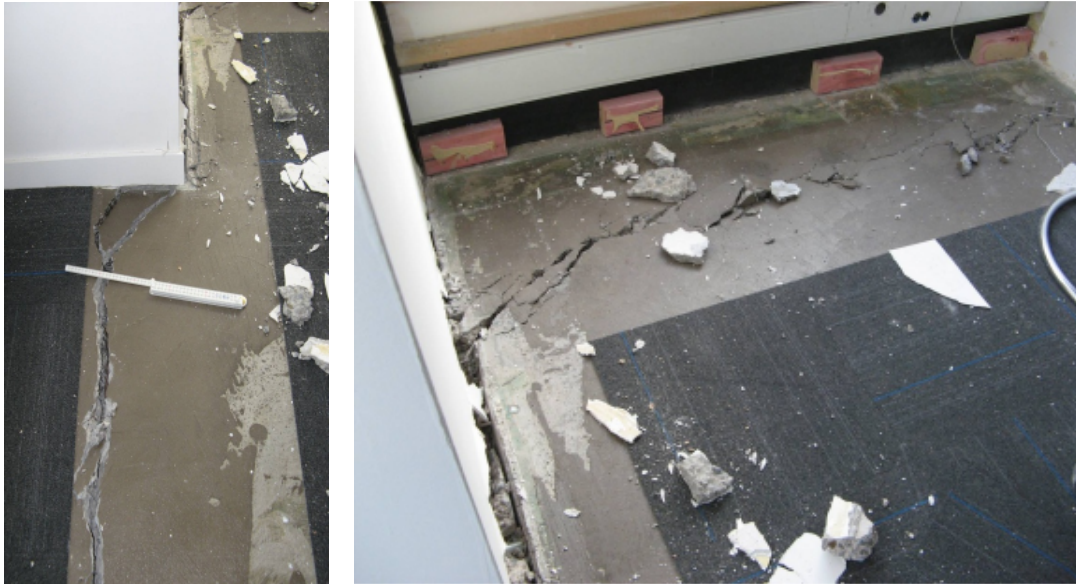
Large cracks between double-T units was observed after the Darfield earthquake, concentrating between levels seven and nine [2]. The cold-drawn wire mesh was fractured in at least one location at the eighth floor. Many of these diaphragm cracks were repaired before the Lyttelton event occurred. The effectiveness of the repair method is unclear though since extensive diaphragm cracking was observed at both the north and south frame lines, albeit more pronounced at the north, after the Lyttelton event. These east-west oriented cracks generally form between the frame beams and the precast double-T units and are of approximately 20-30 and 10-20mm width on the north and south frames, respectively [26]. See Figure 10. Mesh fracture also accompanied large crack widths as seen on the left of Figure 11.

Diaphragm cracking is thought to be caused by elongation of the exterior frames as sketched in Figures 7 and 8 [31]. Since these diaphragm cracks indicate reduced seating for the flange hung double-Ts, steel ties were installed across the building to restrain the floor against further expansion. Partial floor collapse was thought to be the most likely collapse scenario for this structure [27]. A sketch of the implemented scheme is provided on the left of Figure 14. There was also concern that the nearly full-

Figure 10: Diaphragm Cracking [31]

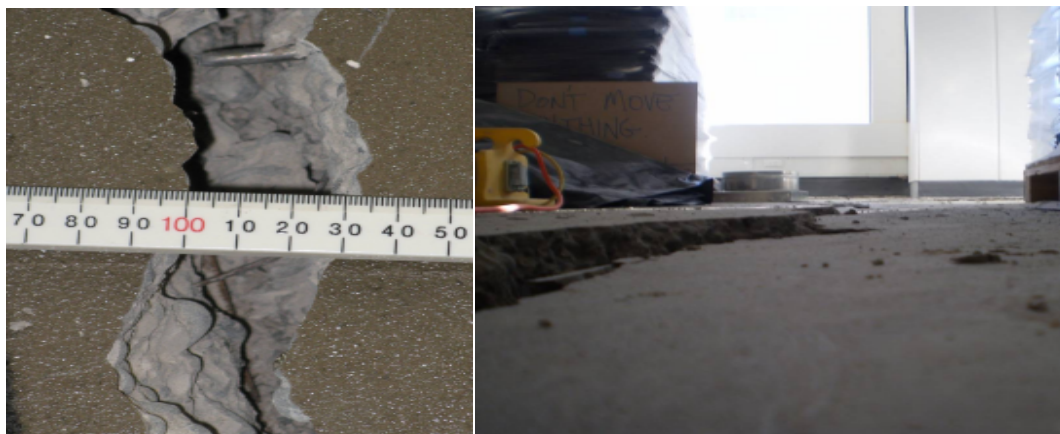
Additionally, north-south oriented cracks formed where the double-T units met the precast beams on lines B, E, I and L, being most pronounced immediately adjacent to the north and south frames and tapering off as you move away. Widths of these cracks tend to be of the order of 10mm as shown in Figures 12 and 13 [28]. In at least one location these cracks were accompanied by a vertical offset of 27mm which is thought to indicate partial double-T loss of seating. See right picture of Figure 11.

Figure 11: Cold-Drawn Wire Mesh Fracture (left) and Partial Double-T Loss of Seating (right) [31]

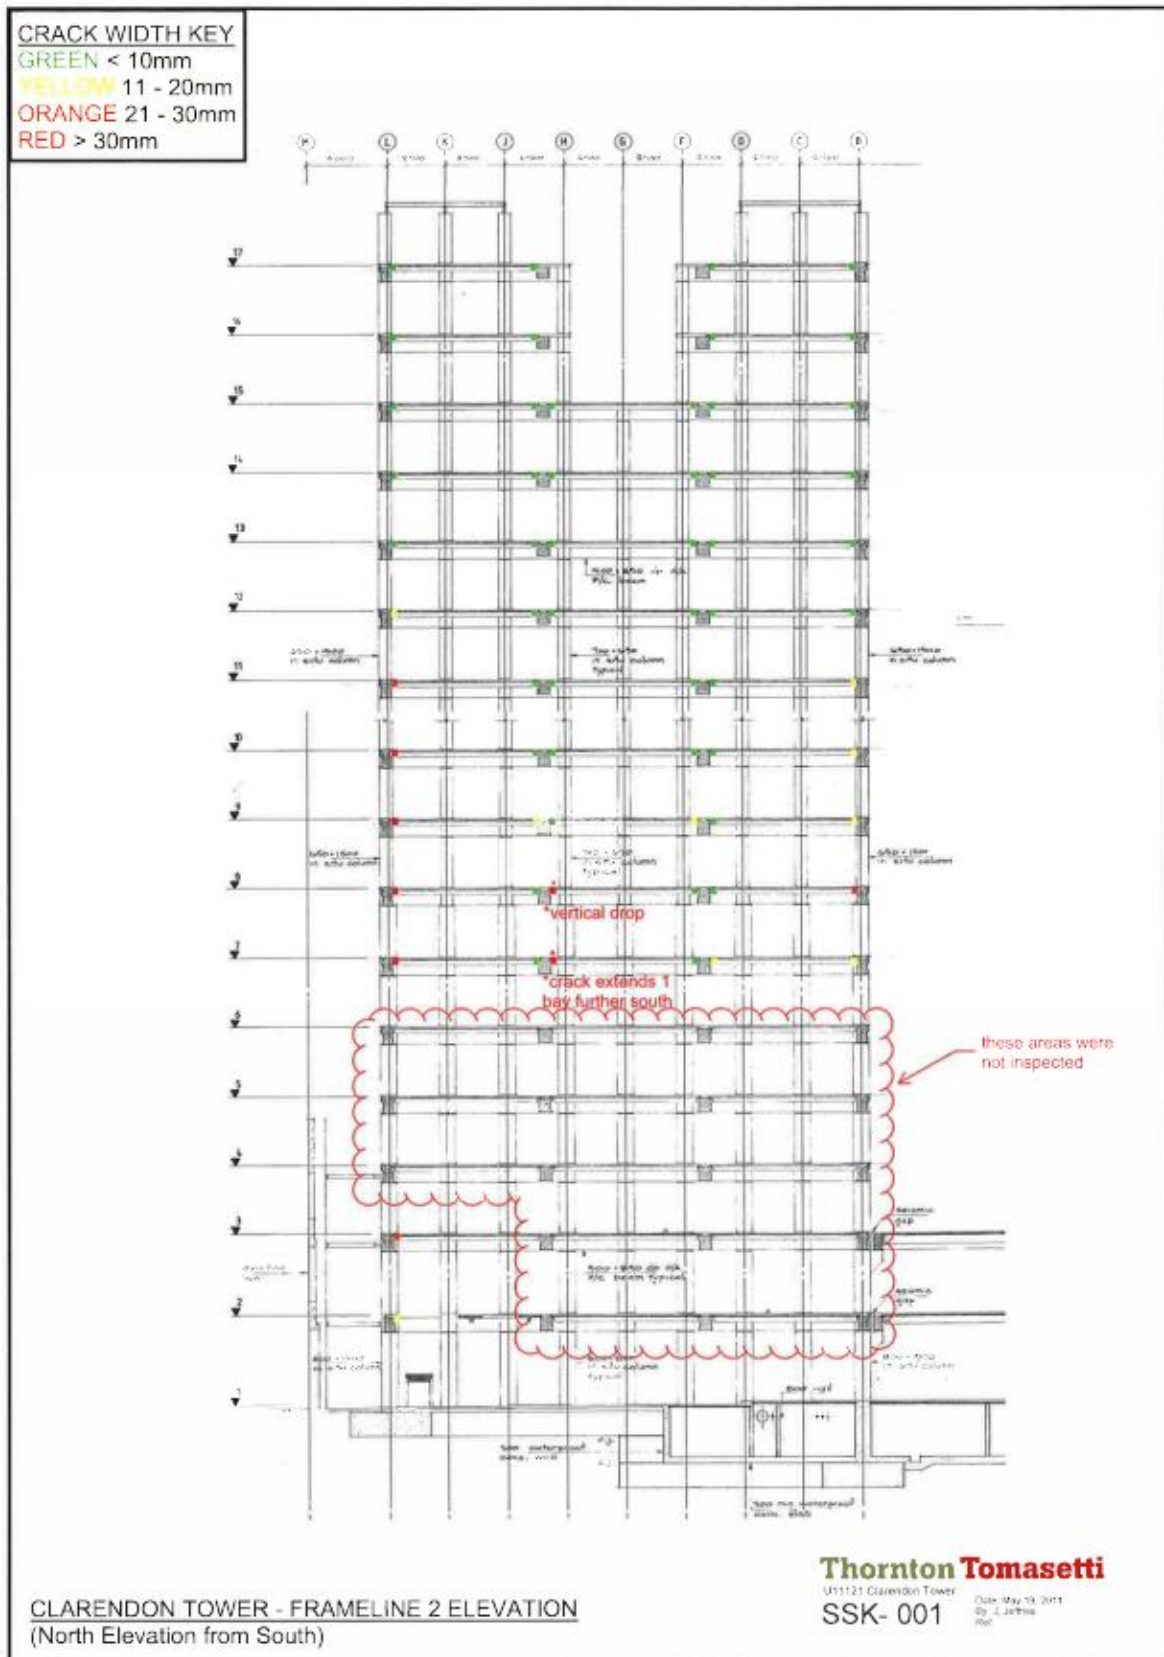
Crack widths are reported to apparently increase 5-10mm with successive significant aftershocks except at the north frame indicating north frame stiffness degradation and increased torsional response [30]. Figures 12 and 13 show a crack width survey conducted by Thornton Tomasetti. Accounting for the lack of survey data at the lower floors, significant cracking tends to span from levels three to eleven and levels seven to nine on the north and south ends of the building, respectively.

Figure 12: Crack Width Survey [30]

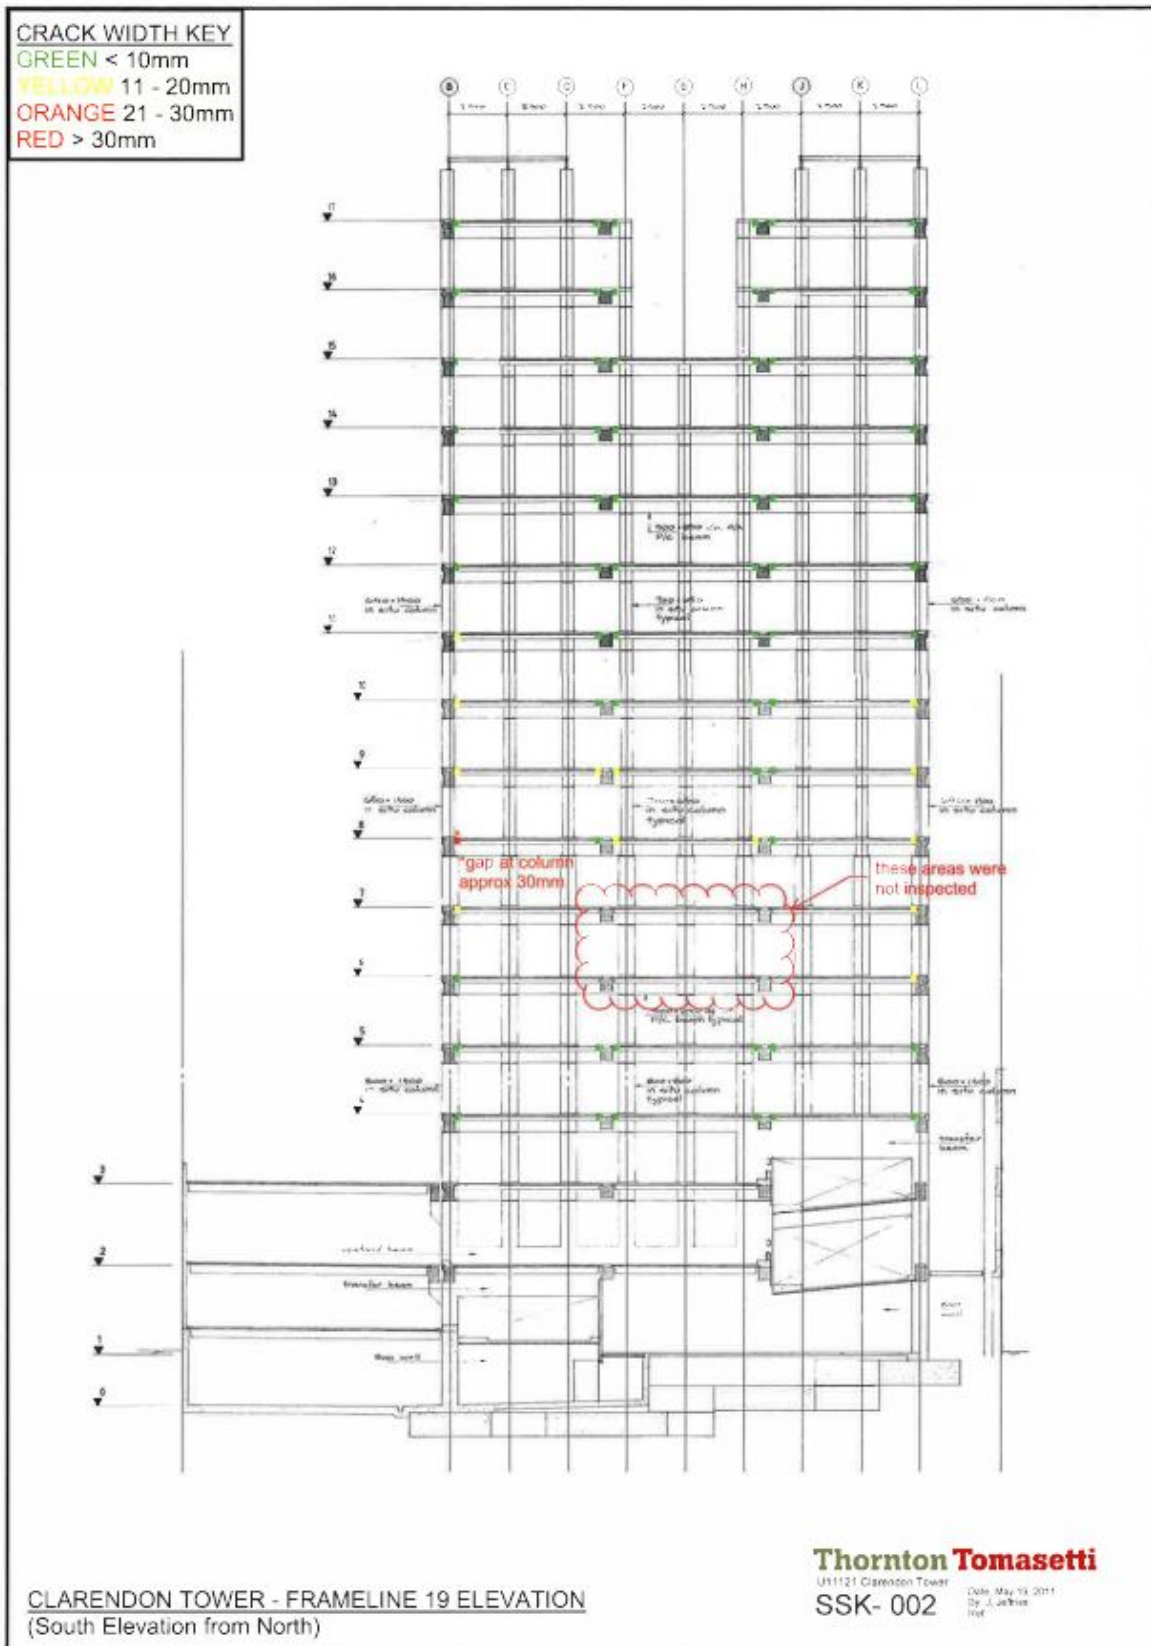
Figure 13: Crack Width Survey [30]

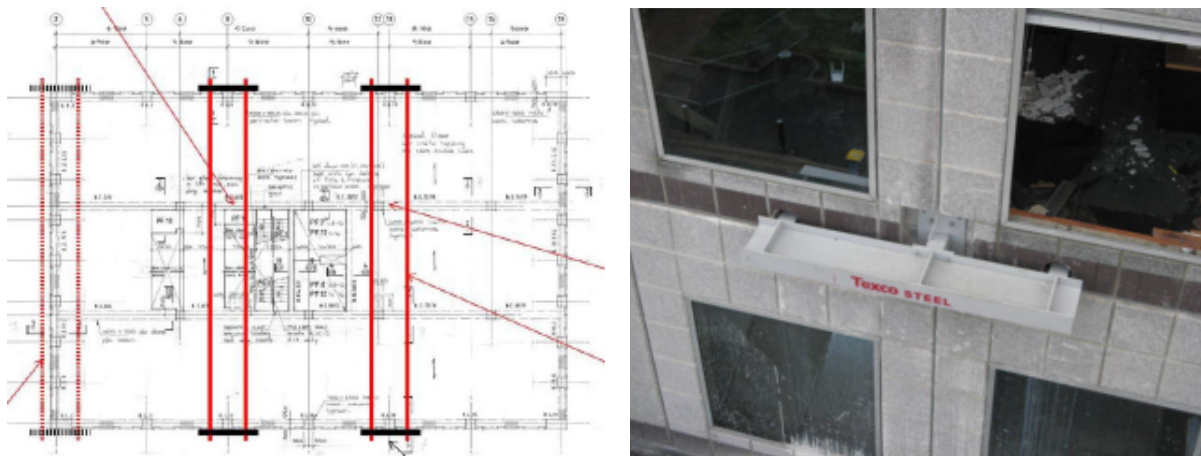
Figure 14: "Turfering" Scheme Sketch (left) and Picture (right) [30, 31]

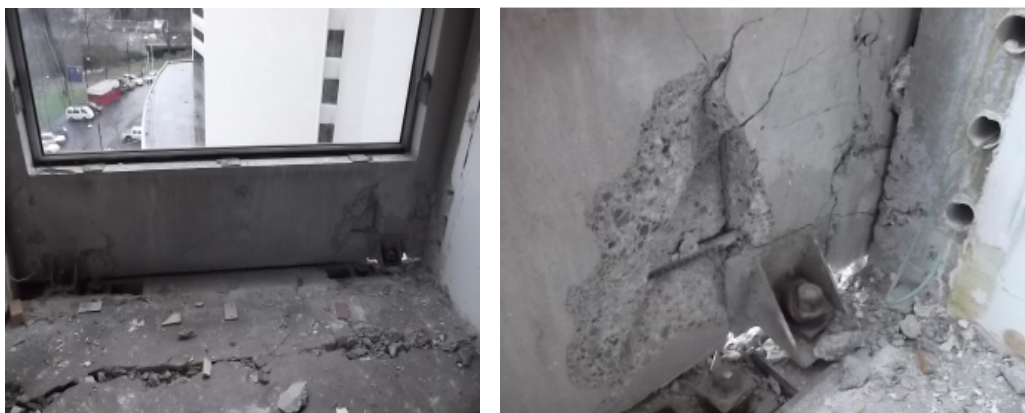
No damage to the precast cladding was observed following the Darfield event. The connection between the precast cladding and frame is shown in Figure 15. One site report noted that opening occurred between approximately eight panels of the tower cladding units on the north frame [34]. Investigations conducted after subsequent aftershocks noted failed panel cladding connections on the north face and potential danger of panels being shaken off the building [35]. Damage to the precast cladding has generally been attributed to frame elongation effects [32].

Figure 15: Precast Panel Connection Damage [31]

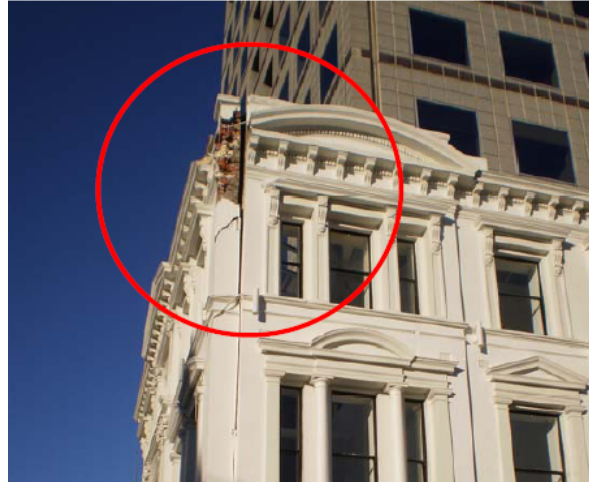
In the Darfield event the historic facade was observed to crack and bulge slightly [3]. A falling hazard was remediated by clearing out the loose plaster [15]. The northwest corner of the historic facade was further damaged in the Lyttelton event with the north face apparently moving away from the tower [26]. Spalling of the historic facade is thought to result from frame elongation effects [32].

Figure 16: Historic Facade Damage [31]

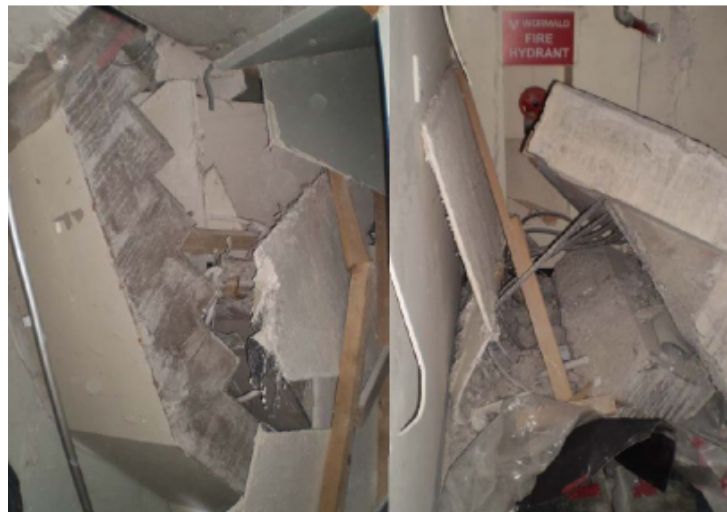
Movement of the stairways was recorded following the Darfield event with a 2mm crack at the construction joint between precast stairs and in-situ topping concrete measured at the north stair on the third floor [1, 8]. As part of the repair work, the seismic gap between the bottom of the stairs and the concrete floor was reinstated [11]. The north stair collapsed over several stories under the Lyttelton earthquake which occurred as a result of compression hinging in the center of the stair run due to inadequate seismic gaps widths or improper sliding [26]. The south stair also partially collapsed [32].

Figure 17: Stairway Damage [31]
