**INDEPENDENT ASSESSMENT ON EARTHQUAKE PERFORMANCE
OF**

CRAIGS INVESTMENT PARTNERS HOUSE - 90 ARMAGH STREET

**Royal Commission of Inquiry into building failure caused by the Canterbury
Earthquakes**

**Report prepared by Peter C Smith and Jonathan Devine
Spencer Holmes Limited**

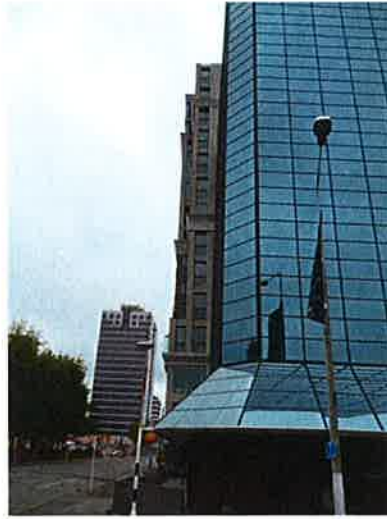
The primary effect of the seismic events on the building has been the rotation, settlement and resulting tilting of the building. The raft foundation has rotated and settled as a consequence of the shallow founding depth of the foundation and ground liquefaction and lateral spreading damage.

View of building tilting to south

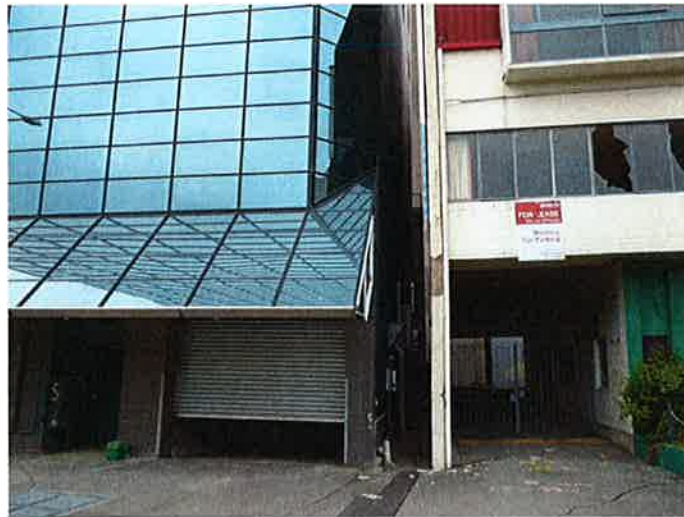
Separation to building to the south

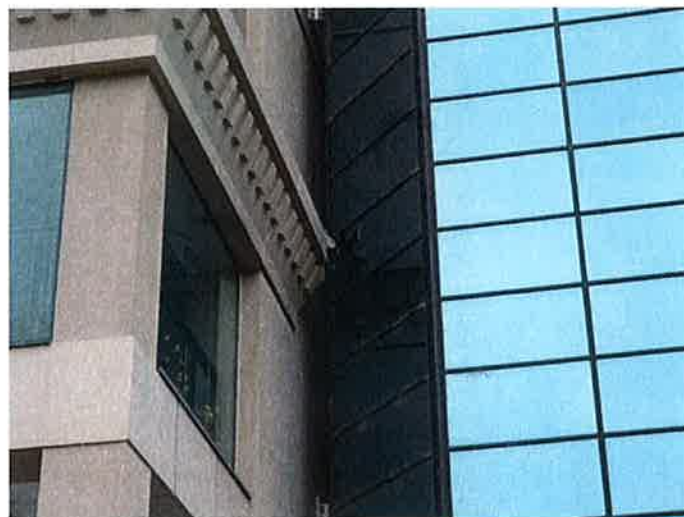
- Pounding damage between the building and the building to the east at 100 Armagh Street. The damage is minor and only appears to be the glazing from the building at 90 Armagh Street that has been damaged. The movement between the buildings was significant as evidenced by the drainage pipes from 100 Armagh Street being crushed between the buildings, indicating up to 200mm relative movement at the top of the building.

Pounding damage with the building at 100 Armagh Street

It is important that buildings are located such that they do not pound against one another, and that all items of the building are excluded from the seismic gap.

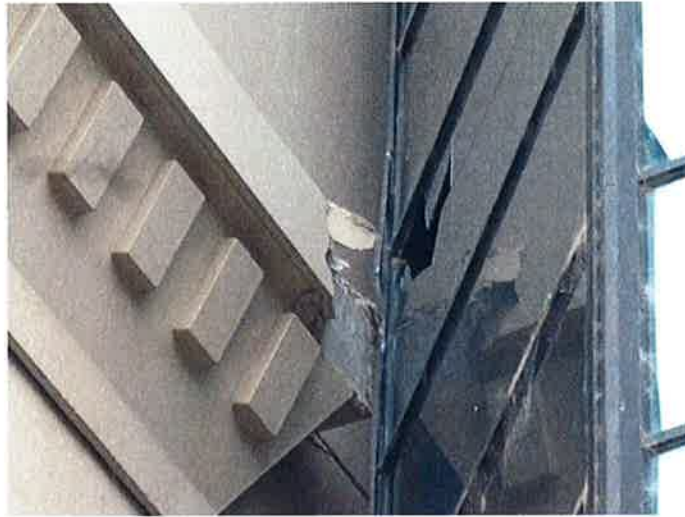
However, the glazing damage was due to a decorative detail from the façade of 100 Armagh Street extending into the seismic gap, and the drainage pipes were also located in the seismic gap. The drainage pipes would be very difficult to repair given the limited space between the buildings. The building at 90 Armagh Street was set 120mm from the boundary to the east from the drawings, which is not a significant building as this building would deflect approximately 500mm with 1.5% drift.

Close view of pounding damage

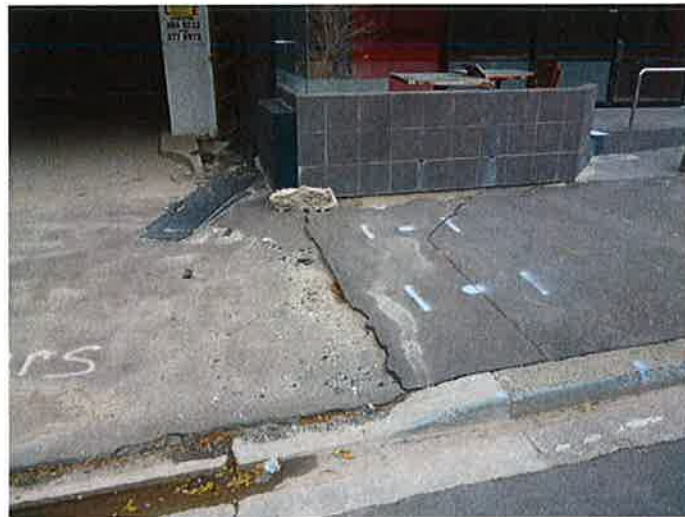
Damage to ground adjacent to the building at 100 Armagh Street

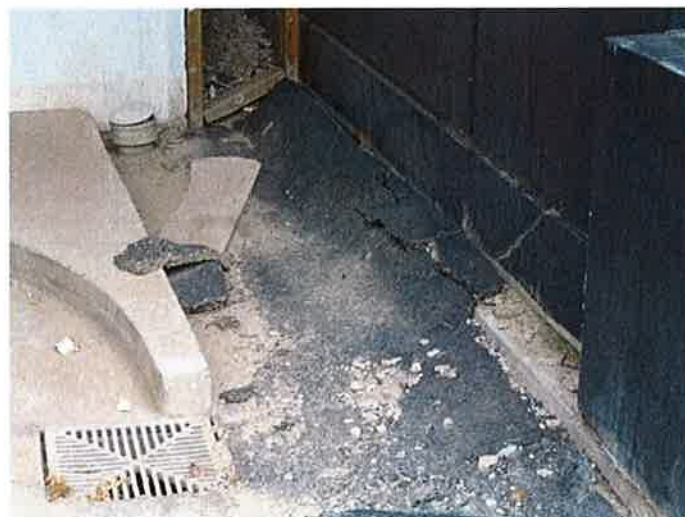
Damage to ground adjacent to the building at 100 Armagh Street

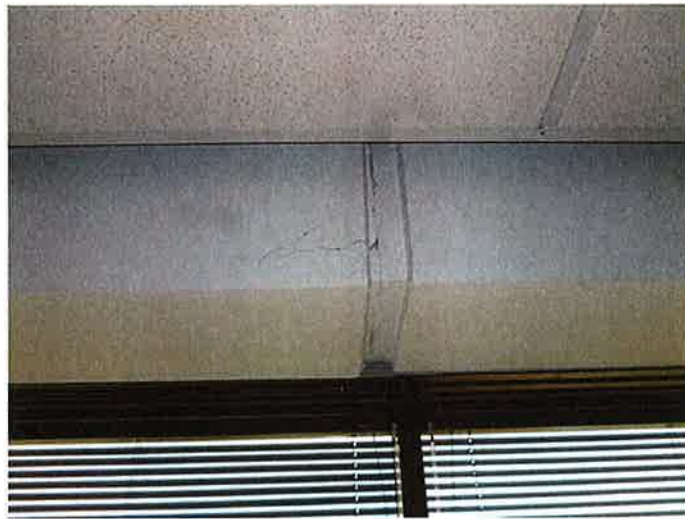
Cracking at insitu splice to beam

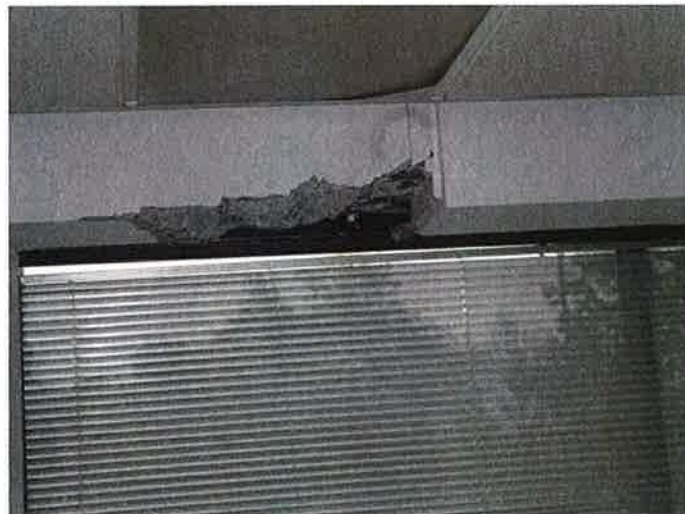
There was damage to some of the insitu concrete mid-beam splices at the lower levels where the cover concrete to the reinforcing had spalled off the precast section adjacent to the splice.

Spalled concrete to insitu splice of beam

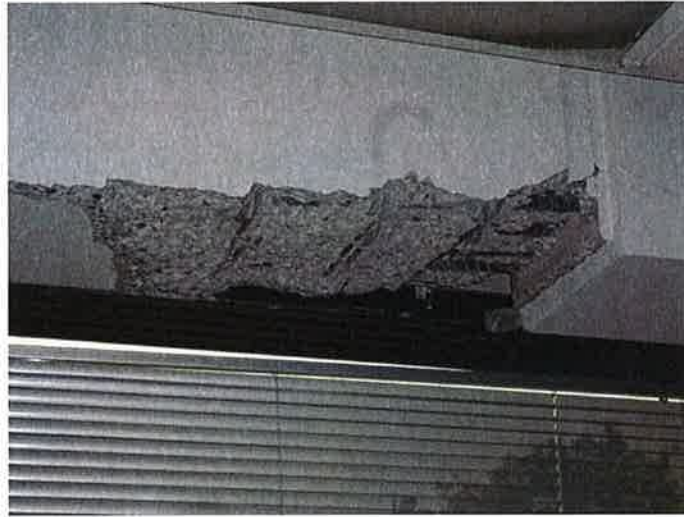
Spalled concrete to in-situ splice of beam

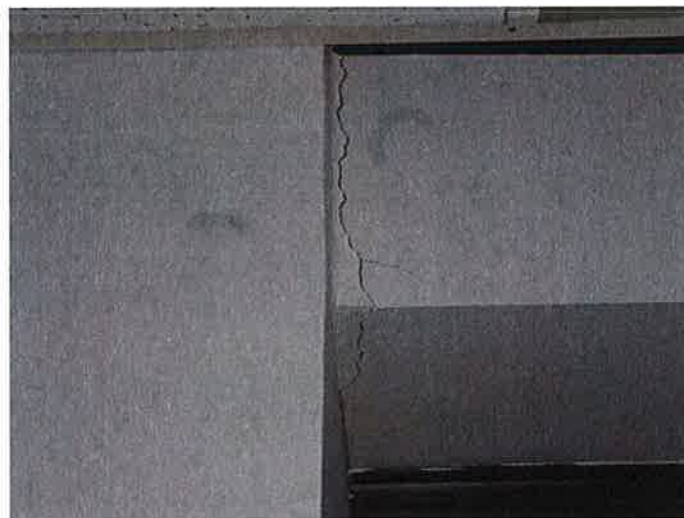
Inspection of the moment resisting frames establishes they have performed well. There was cracking of an expected nature to the beams in the plastic hinge zone adjacent to the face of the columns. The beam cracking seen below level 7 is similar to other buildings in Christchurch, which has been of a single vertical crack mode to the face of the columns, however, some of these cracks show the expected fan of diagonal cracking.

Typical single crack to beam column joint

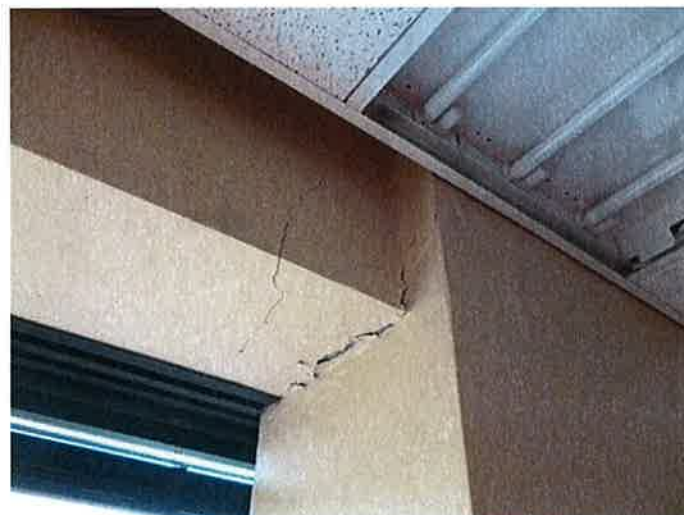
Typical single crack to beam column joint

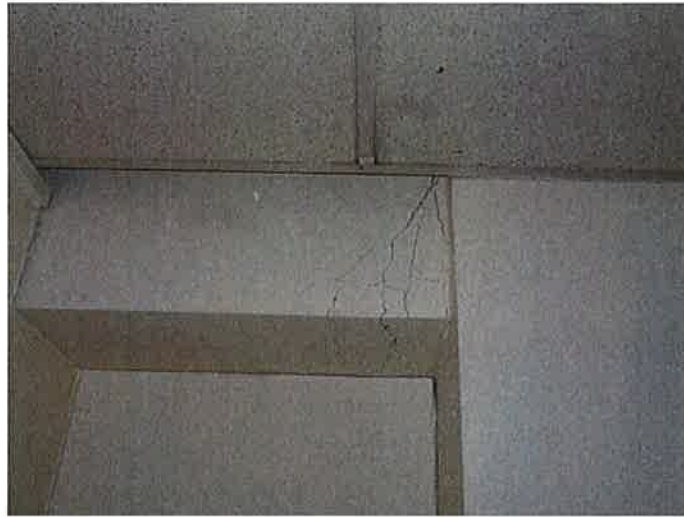
Fan cracking to beam adjacent to column

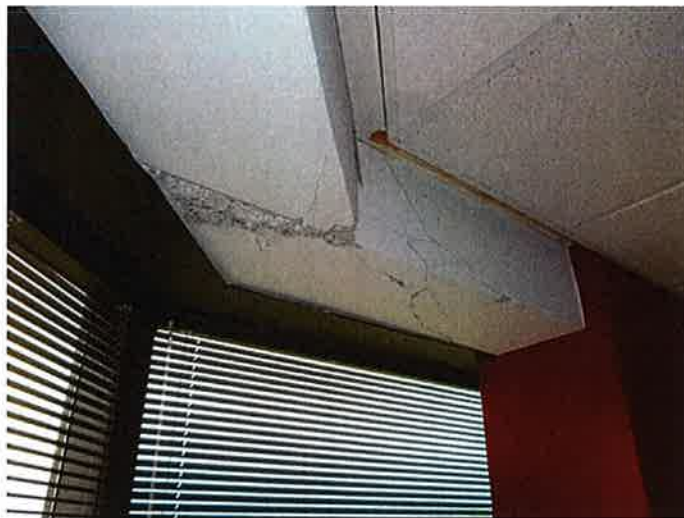
- The corner precast beams that trim between the two exterior frames show cracking damage and cracks extend to the cantilever beam portion of the seismic frame.

The precast section of beam located in the corners of the building that effectively truncates the corner of the building was detailed to be located with a pin connection at each end. However this section effectively allowed the force and any effects of beam elongation from the frame to transfer around the corner. This is evident in the cracking into the cantilever section of the precast beams adjacent to the corner.

Damage to corner beam

The designers need to be aware of the importance of achieving a pin connection where a pin connection is assumed in the analysis or for considering the affect that member restraint can induce in the adjoining structure under severe earthquake.

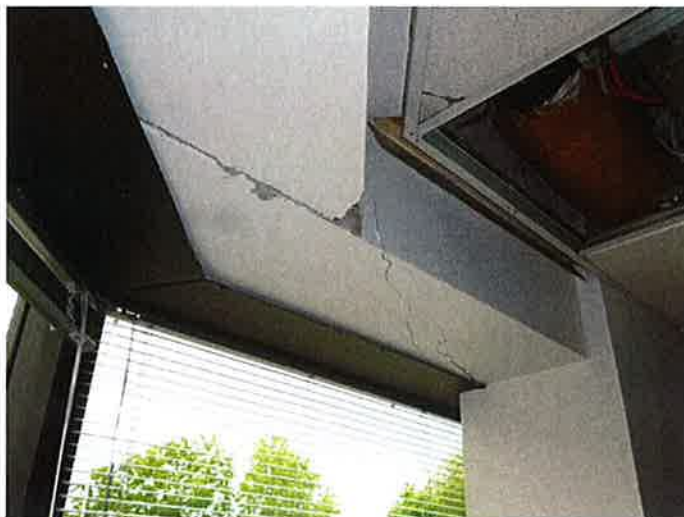
Damage to corner beam

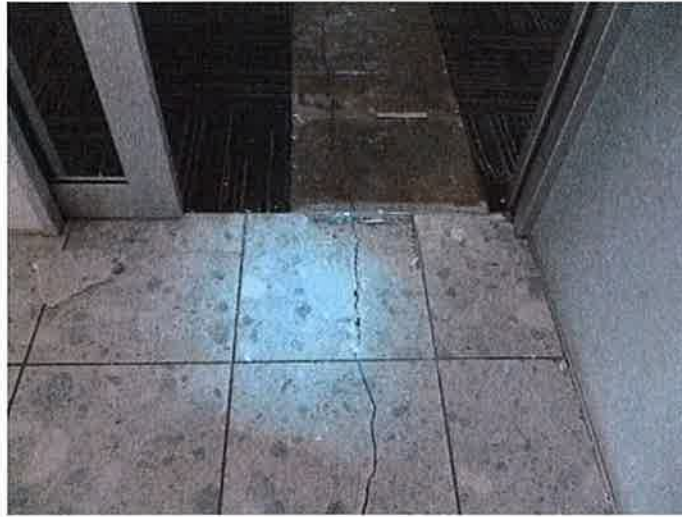
- *The diaphragms in first to fifth floor have fractured through, with crack sizes approximately 4mm observed. There is no indication of any reinforcement continuity across these cracks, so we expect that this has fractured. We*

The floor slab of this building was torn through the middle of the building, primarily due to the combined factors of the 65mm thickness, a lack of sufficient ductile reinforcing, the concentration of the beam elongation, and the cutout for the stairs and lift shaft that created a “neck” to the slab.

Floor diaphragm crack

The floor slab of this building is irregular due to the openings in the floor and the use of a precast floor unit, and has a “neck” through the centre of the slab where the stresses are highest. In recent years, the importance of proper consideration for the design of floor diaphragms has been emphasised within the industry and the need to adequately design the diaphragm for the forces it is expected to transfer.

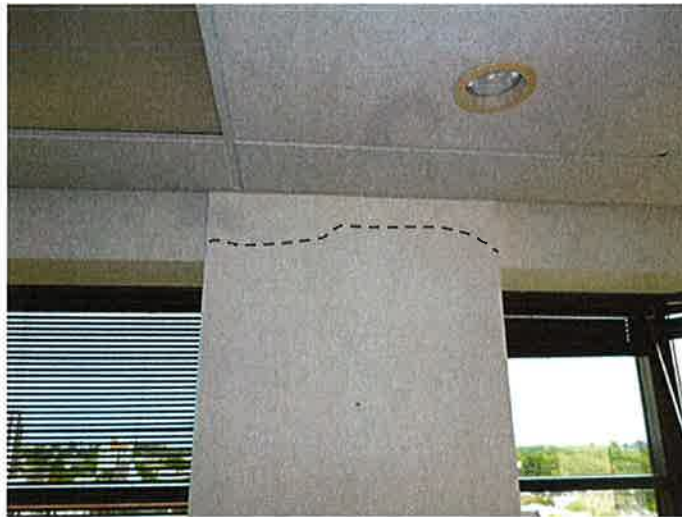
- From levels 7 to 9 of the building a horizontal crack is apparent that is located under the beam-column joint and curves upwards across the lower area of the panel zone of the joint. This cracking appears to become prevalent in the upper levels of the building as the plastic hinge beam cracking that appears to the lower levels of the building reduces in nature.

The columns were detailed with high strength reinforcing, grade 380MPa, and the beams with mild reinforcing, grade 275MPa, and as such were of a “weak beam/ strong column” design philosophy. Therefore, the horizontal crack to the column is more likely to be a result of severe vertical acceleration in combination with the frame action.

Horizontal crack to column typical above level 7

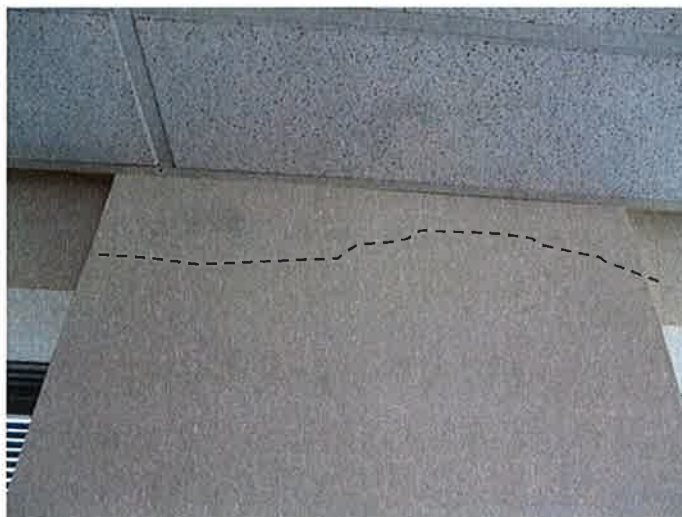
Horizontal crack to column typical above level 7

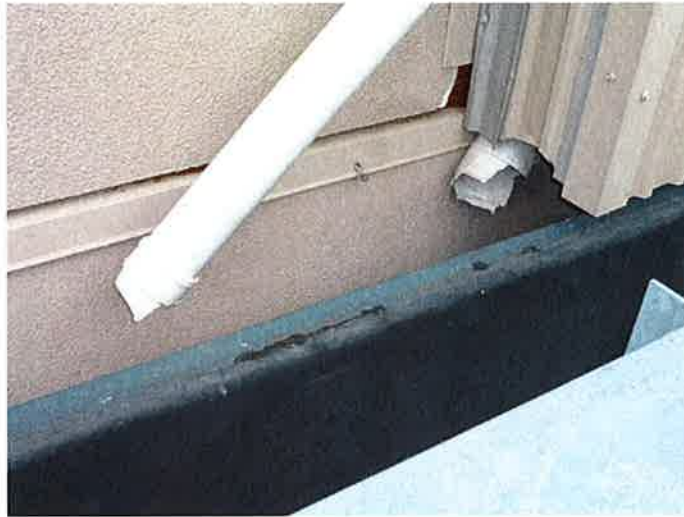
Broken drainage pipe to building at 100 Armagh Street due to pounding

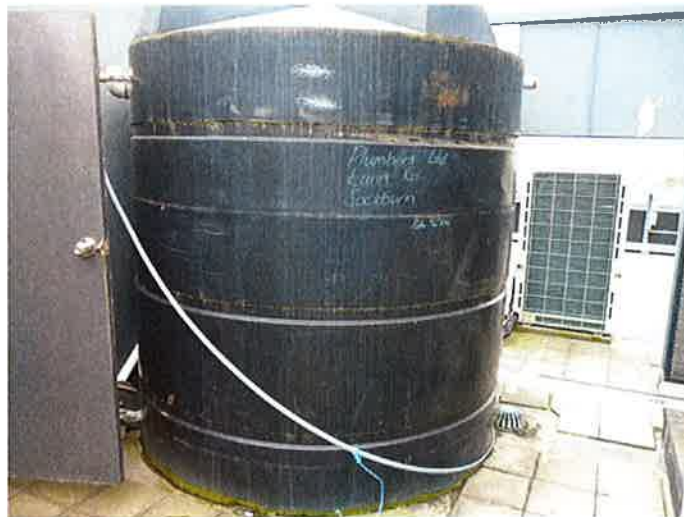
- The restraints to the water tanks to the roof were ineffective as the fixings for the steel strap were screws into concrete walls that pulled out.

Strapping to water tank to roof loose
