## EARTHQUAKE RESISTANCE OF BUILDINGS AT 734-744 COLOMBO STREET

**RE: EARTHQUAKE DAMAGE TO BUILDING AT 738 COLOMBO STREET "OK GIFT SHOP"**

**RE: EARTHQUAKE DAMAGE TO BUILDINGS AT**  
**736-738 COLOMBO ST, CHRISTCHURCH**

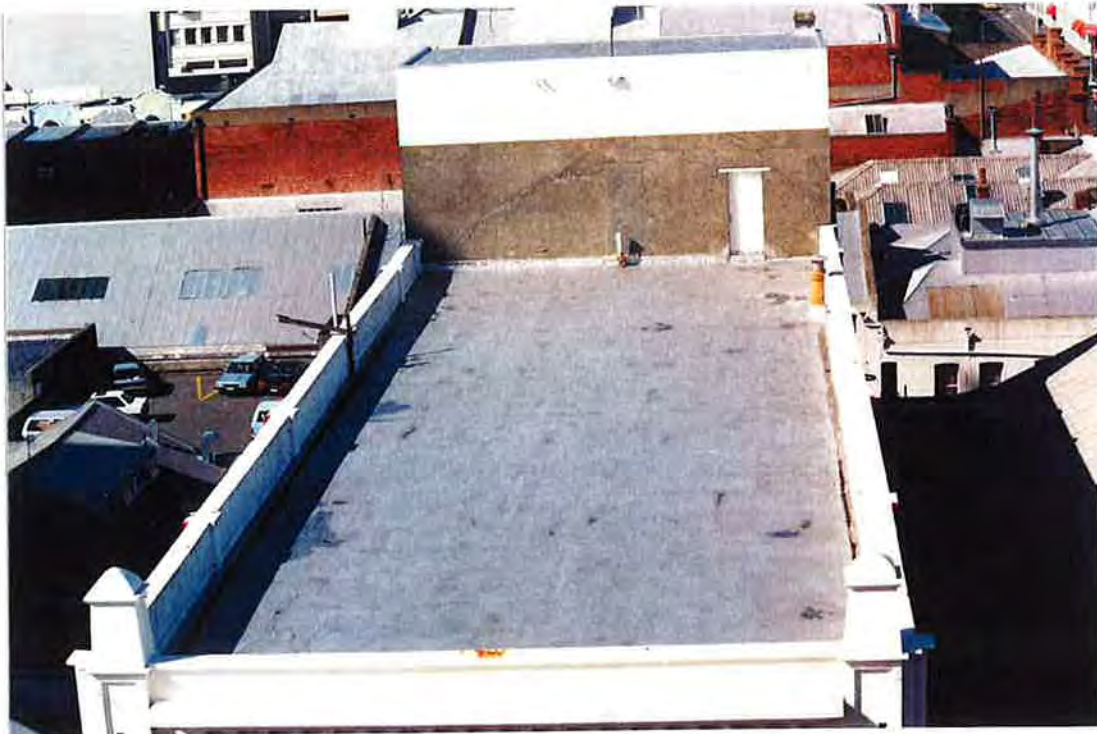
"Spikes" on top of parapet are hazardous.  
 Cornices are hazardous.

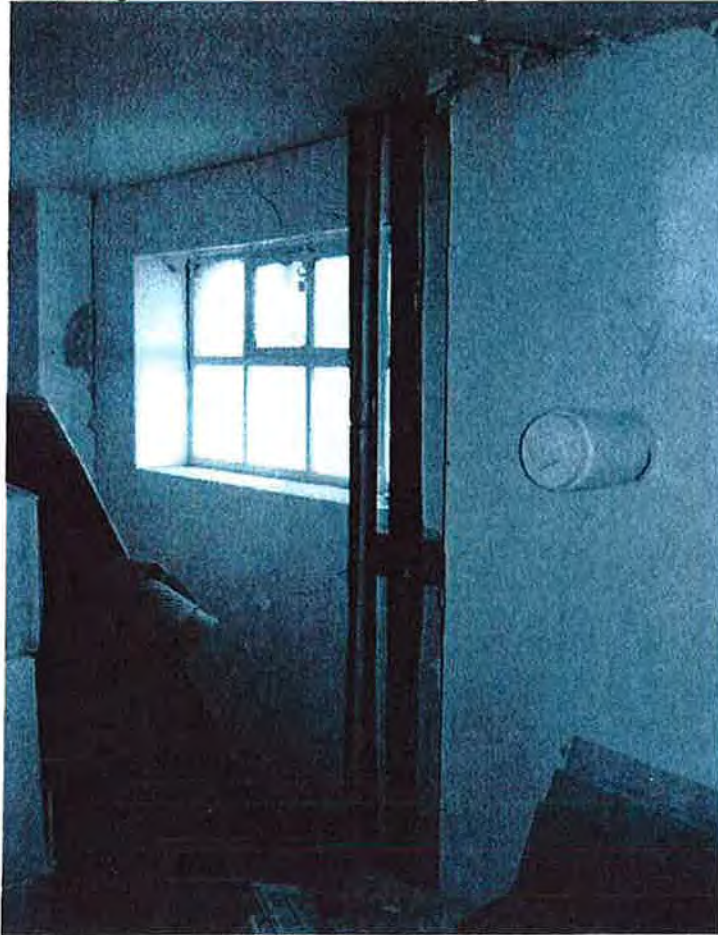
Cracking and stress/shear cracking to rear wall

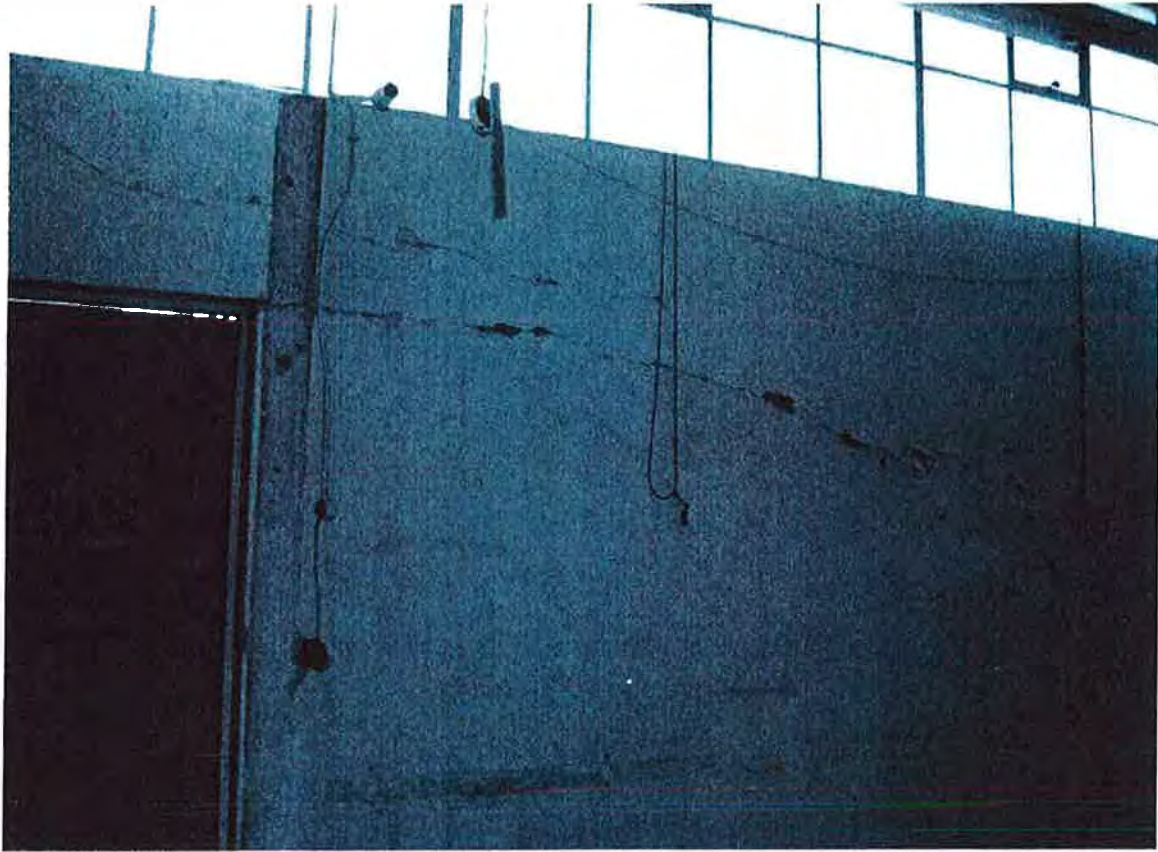
Cracking to north wall.

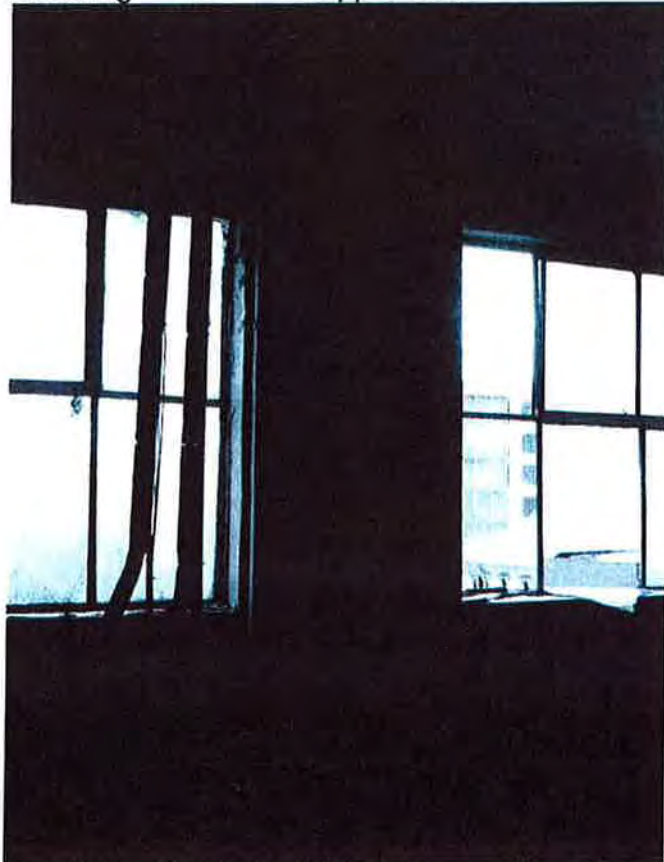
Cracking to column at upper level 736

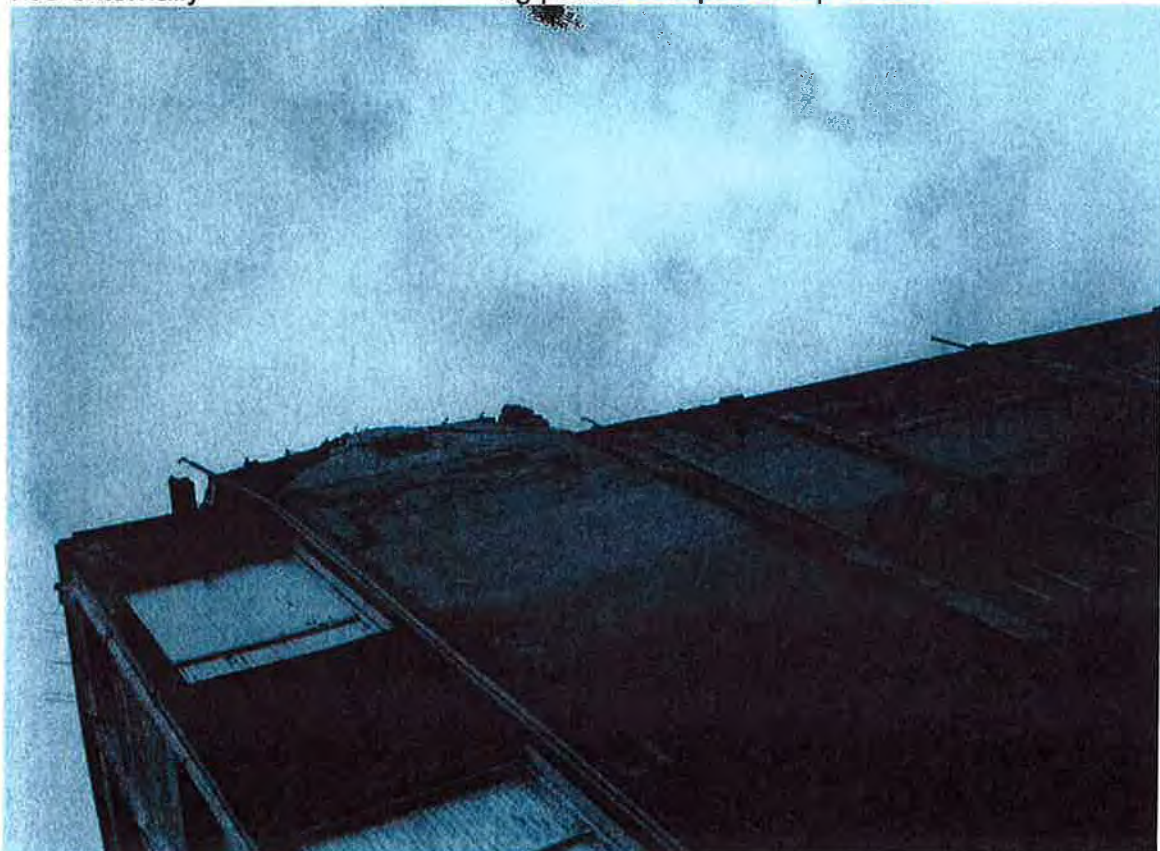
736 externally from northeast showing partial collapse of top section

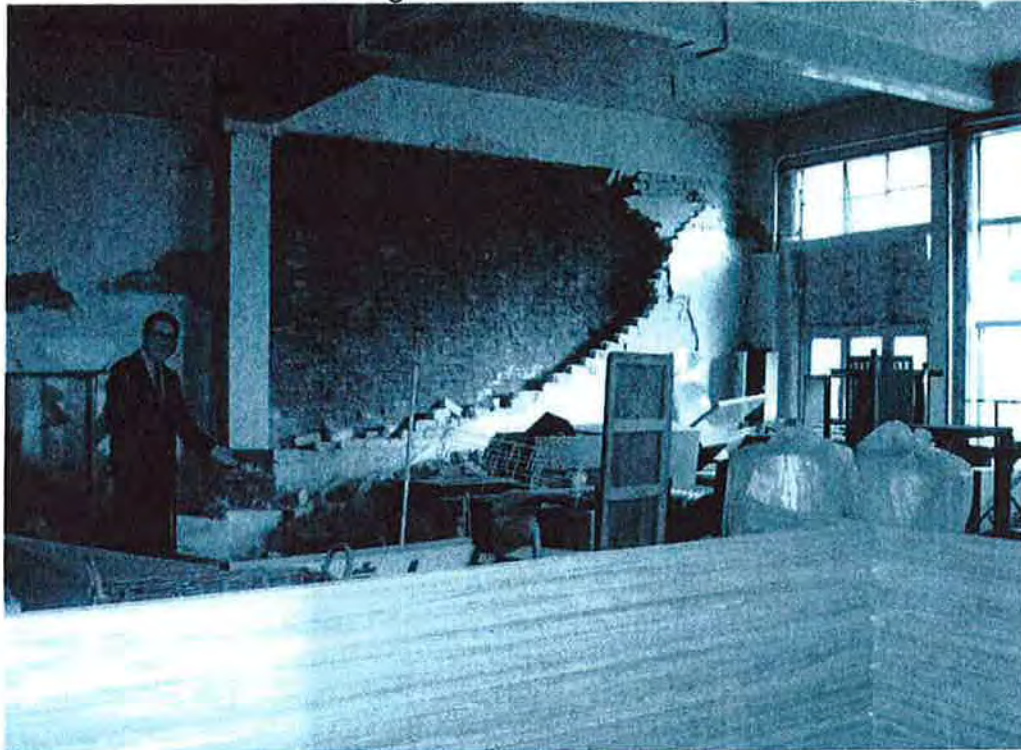
736/738 at first level showing failure of south wall infill and cracking to SW column

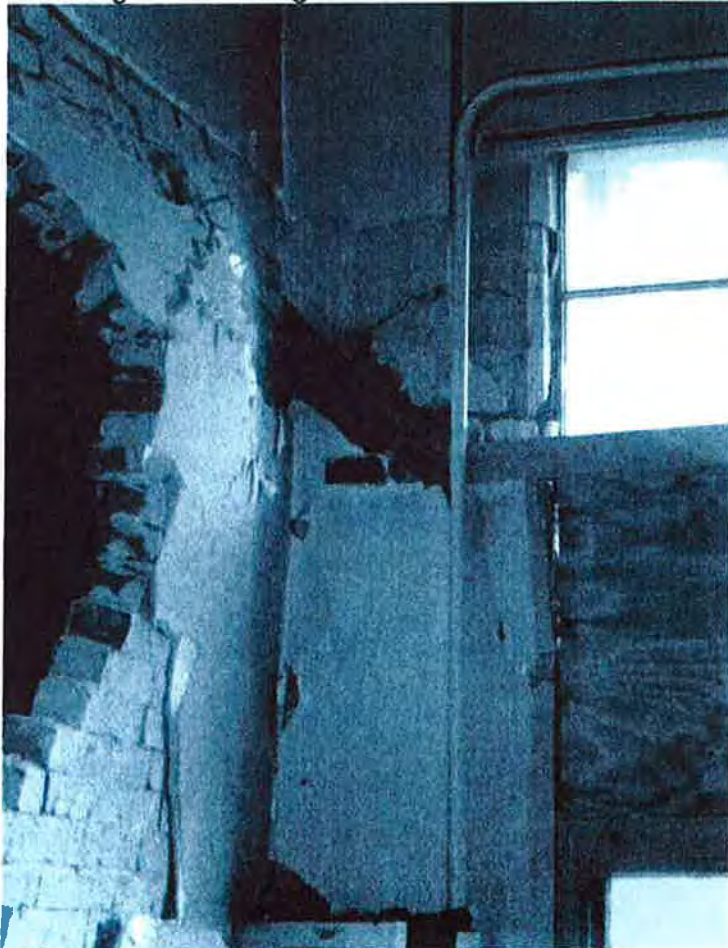
Cracking and breakage to SW column.
