Earthquake strengthening targets

Building condition

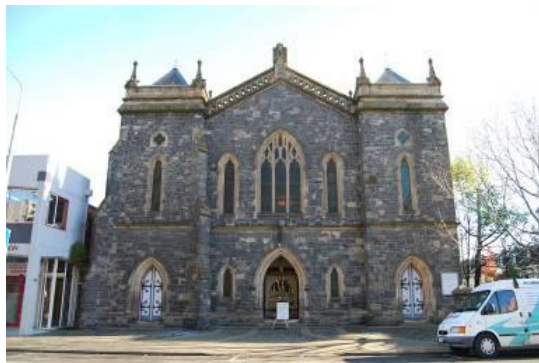
Significance: The Durham Street Methodist Church opened on Christmas Day 1864. Built of stone it was the first church to be erected in permanent materials on the Canterbury Plains and was Gothic Revival in style. It was designed by the Melbourne architectural firm, Crouch and Wilson, who won the 1863 competition for the design of the new church. The church was a significant example of early ecclesiastical architecture in Christchurch.

Condition prior to September 2010: Good

Strengthening history: While historical bracing and ties of walls, floor and roofs was observed following earthquake damage,⁴⁰ there is no record of strengthening works on the NZHPT's file. Alterations occurred in 1986 and 1994, including fire safety work.

Level of Damage: September-December 2010: Moderate-severe damage.

NZHPT post-earthquake response: On 28 September 2010, the NZHPT supported Engineer's recommendations that the site be made safe by removing gable stonework, strapping of towers and construction of supporting frame with recording of deconstruction. Later on 15 February 2011, the NZHPT recommended to Christchurch City Council that all risks of collapse should be addressed. After the 22 February 2011 earthquake, the NZHPT did not oppose demolition as the building had collapsed.

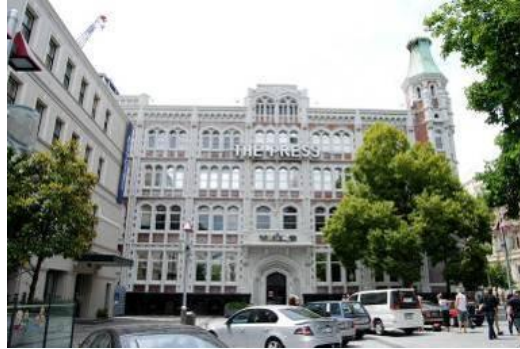
Significance: The Press Building (1903) was a distinctive feature of Cathedral Square and, in conjunction with the Lyttelton Times building, illustrates the history of the two main Canterbury newspapers. The Press Building was a noted example of the work of Armson, Collins and Harman in the ‘Perpendicular Gothic style’ and was technically important as one of the earliest reinforced concrete buildings in Christchurch.

Condition prior to September 2010: Unknown

Level of Damage: September-December 2010: Moderate damage (damage to corner tower).

January-June 2011: Major damage (collapse of top floor, damage to façade).

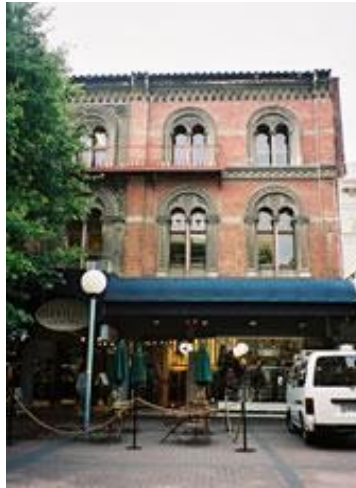
Significance: This building was originally erected to house shops and offices for John Anderson (1820-1897), whose iron foundry was situated at the rear. Anderson arrived on one of the first four ships, served as the city's mayor and his foundry firm constructed many bridges in the 1870s. The three storey façade of this building by architect WB Armson was a fine example of the Venetian Renaissance style.

Condition prior to September 2010: Unknown

Strengthening history: Strengthening of ground floor was observed following earthquake damage.
