## **Collapse of the CTV Building in Christchurch During the Seismic Event on 22 February, 2011**

Observations and Opinions by Graham Frost, CPEng - who spent 5 days assisting with the rescue and recovery efforts as a USAR Support Engineer.

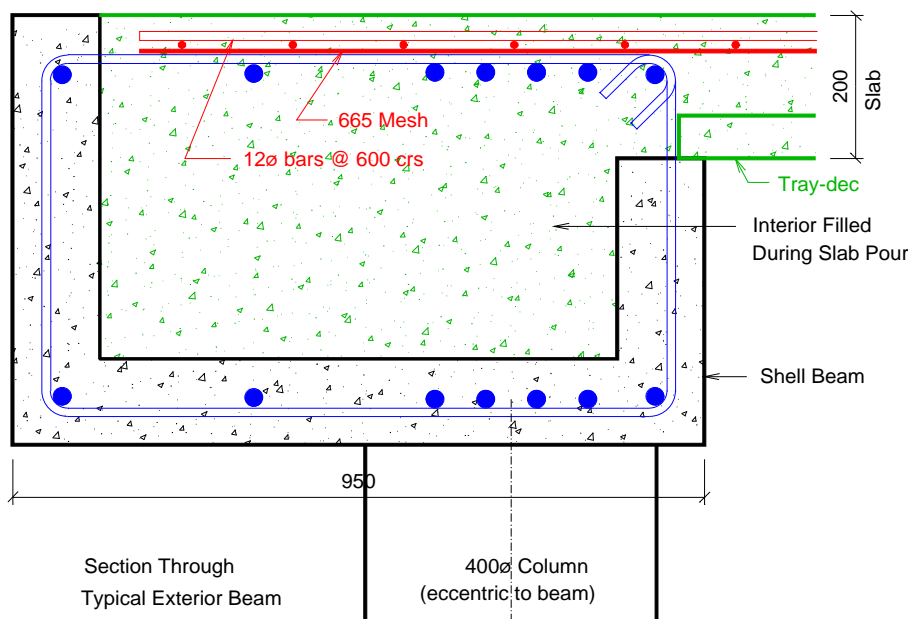
1. Apart from the two main structural elements discussed above, the only other load bearing elements appeared to be 400 $\phi$  columns at approximately 7.5m centres in both directions on all levels
2. The confining steel for these columns appeared to be just an R6 spiral with a pitch of at least 250mm – again, on all levels. (Does this even meet code requirements?)
3. The typical external beams are precast shell beams approx 950 wide by about 600 deep
4. The R12 stirrups to these beams typically stopped 300mm from the column centreline

5. The formed surfaces to the inside of the shell beams are smooth.
6. There was no reinforcing added to the interior of the shell beams.
7. Formed block-outs at the end of the shell beams and interior 'half-beams' are also smooth.

8. When adjacent beams butt together above a column, these semicircular blockouts for a 300 $\phi$  hole through which the column starter bars pass.
9. With the **TINY** R6 spiral in the columns omitted through the depth of the beam and with the beam stirrups stopping 300mm from column centreline, there is now confining steel through the beam column joint.
