**ROYAL COMMISSION OF INQUIRY INTO
BUILDING FAILURE CAUSED BY CANTERBURY
EARTHQUAKES**

THE CTV BUILDING COLLAPSE

**STATEMENT OF EVIDENCE OF RONALD WILLIAM GODKIN
IN RELATION TO THE CTV BUILDING**

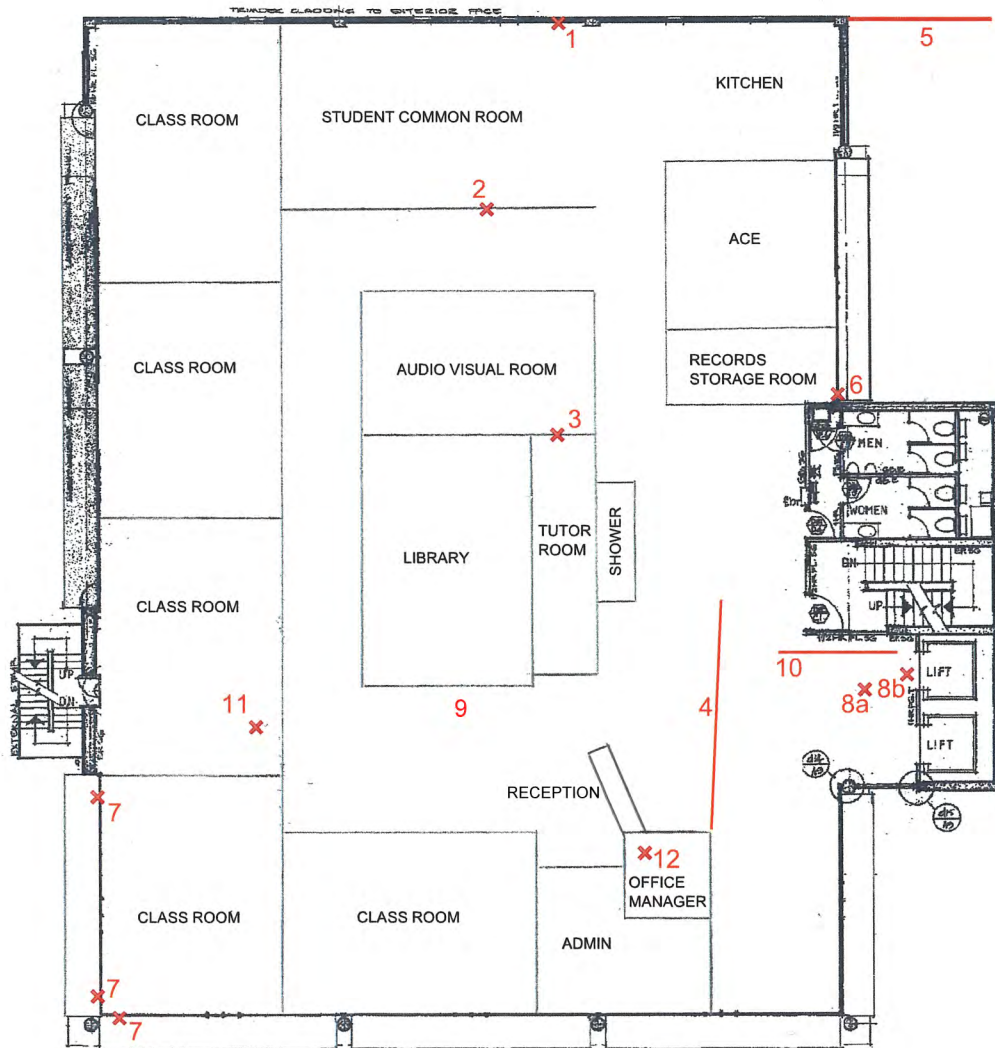
249 MADRAS ST - LEVEL 4

5. Following the September earthquake there were a number of cracks that appeared on the 3rd floor. Attached is a floor plan of the Building I have prepared (marked "A"). The positions of the rooms and internal walls have not been drawn to scale and their placement is approximate only. The cracks and other issues of concern that I refer to in my evidence are marked on this plan.

6. There was a horizontal plaster crack under a window on the western side. I have marked the approximate position of this as “1” on the plan. It was only visible as a crack in the plaster. On the eastern wall of the student common room there was a big glass wall and a very large crack had developed about the middle. I have marked the approximate position of this as “2” on the plan. It had gone from the top to the bottom. I got black tape to tape it because I didn’t want it to break in another aftershock. There was also a big crack which ran from ceiling to floor in an internal partitioning wall between the Tutor’s Room and the Audio Visual room. I have marked the approximate position of this as “3” on the plan. This had a width of about 50 millimetres. Finally, there was a “hump” in the floor which I will refer to in more detail later in my evidence. I have marked the approximate position of this as “4” on the plan. I now realise that each of these areas of damage ran together, effectively in a straight line, between the east and west walls of the building, but I did not realise this at the time.

11. The "hump" I have referred to ran east to west across the foyer of the Building at the point marked "4" on the plan. It first appeared following the September earthquake but as we experienced more earthquakes the hump appeared to get bigger and become more and more noticeable. It was a matter of particular concern to me and to other staff. The effect of this hump was sufficient to cause a pencil to roll across the receptionist's desk, which did not happen before the September earthquake. As far as I am aware the vinyl floor coverings in the foyer were not lifted during either of the two inspections in order to examine the "hump", although I pointed it out to John Drew and the engineer on their second inspection and expressed the concern both my colleagues and I had about it. The engineer said that all concrete buildings "hump" between the supporting beams that hold the floors up when the concrete dries over the support. The engineer told me the Building was doing what it was meant to do following an earthquake and it was not a problem.

before the 22 February earthquake and during the course of the demolition. Both of these areas of damage were at ground level and could be seen from the ground floor car park. They have been marked “5” and “6” on the attached plan. The damage noted as “5” involved a concrete non supporting wall at the end of the car park area that had completely collapsed eastwards. The wall marked “6” was between two supporting pillars. It had dropped and separated from the roof above it by about 20 millimetres or so, but did not collapse. Neither of these walls were load bearing. After this occurred I checked the whole of the western wall, but I saw no other movement or cracking.

17. Areas of cracked glass developed along the southern wall, these are marked “7” on the plan. The majority of damage occurred to the windows nearer to the eastern end. Some of this was post September, but before the demolition commenced. Some of it was after the demolition commenced. The repair work for the glass was done by Cranfield Glass. Following Boxing Day I did not observe any additional glass damage.

- 1. Horizontal plaster crack
- 2. Crack in glass wall
- 3. Crack in internal partitioning wall
- 4. "Hump" in the floor
- 5. Collapsed wall (ground floor)
- 6. Gap between wall and roof (ground floor)
- 7. Cracked glass
- 8a Location of Ronald Godkin
- 8b. Location of David Horsley
- 9. Filing cabinets
- 10. Fallen concrete
- 11. Position of individual who dropped from view
- 12. Location of survivors
