**ROYAL COMMISSION OF INQUIRY INTO  
BUILDING FAILURE CAUSED BY  
CANTERBURY EARTHQUAKES**

**THE CTV BUILDING COLLAPSE**

**STATEMENT OF EVIDENCE OF SIMON LEE THOMAS  
IN RELATION TO THE CTV BUILDING**

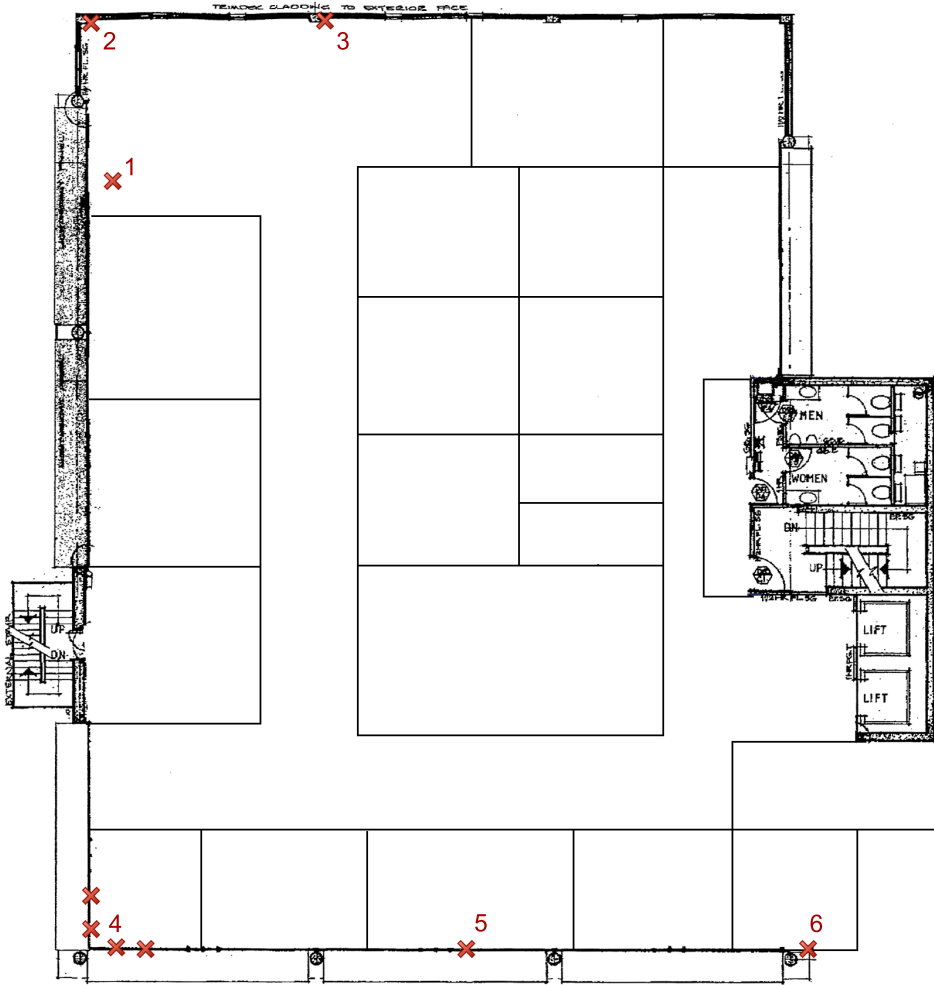
"A"

4. I sat beside the window in the south-western corner of Level 2. I have marked this position as "1" on the plan. From my desk I could see two major cracks in the wall. I would describe these as major because they were very large and got bigger as the earthquakes continued.

5. One of the cracks was on the western wall in the southern corner. I have marked this as "2" on the plan. The second crack was near the middle of the room on the western wall. I have marked this as "3" on the plan. This was right above Amanda (Mandy) Uraio's desk. They ran from close to the roof to around the middle of the wall. Over time these cracks slowly got bigger and bigger. By the time I left CTV

they ran from the roof nearly to the floor. I thought the cracks looked very bad and was very concerned about them. It looked as though the wall was falling to pieces.

6. There was also damage to the windows along the eastern wall of Level 2. I have marked these as "4-6" on the plan. The worse cracks could be seen in south-eastern corner. This is the area marked as "4". There was no pillar in the corner and the glass went right around. Tape had been put on the window. I think this was to stop the cracks spreading. It looked very bad. I don't think it was ever replaced. The crack marked as "5" kept getting worse and worse and was eventually replaced. The crack marked as "6" was also taped, but I don't think it was replaced.

- 1. Location of Simon Thomas
- 2. Crack in southwest corner
- 3. Crack along western wall
- 4-6 Damage to windows

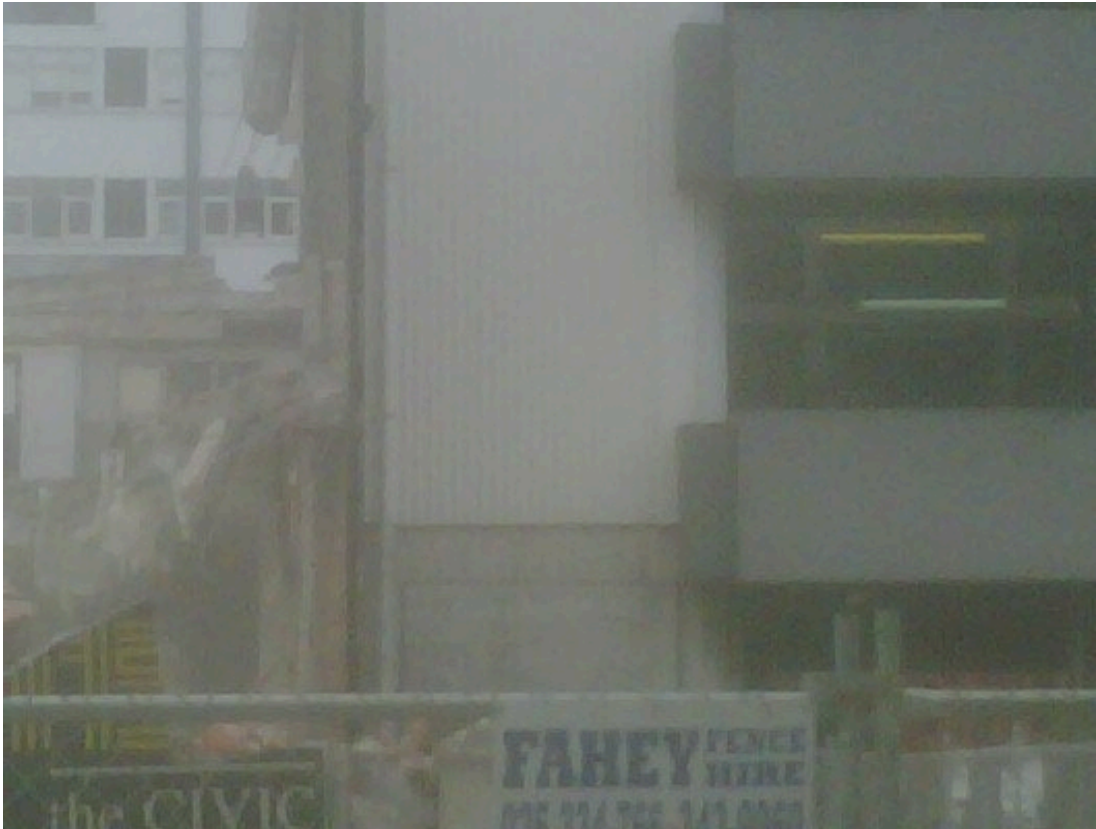
BUI.MAD249.0241.1

13. I took two photographs sometime in December. These are attached and marked **"B" (BUI.MAD249.0241)**. I was prompted to take the photos because of the distance between where the CTV Building and the demolition. I was in wonderment at what was going on because we were so close. The photos help show the distance between the two buildings. The walls were about 4 inches apart. I don't think they were connected in any way.
