**BEFORE THE CANTERBURY EARTHQUAKES ROYAL COMMISSION**

**STATEMENT OF JOHN MAXWELL DREW IN RELATION TO THE CTV BUILDING**

# 249 Madras Street Earthquake Damage Report

Following a telephone discussion with John Drew, Building Manager, on 24 September 2010, CPG NZ Ltd was invited to inspect the building at 249 Madras Street and to report on damage sustained during the 4 September Christchurch earthquake and subsequent aftershocks.

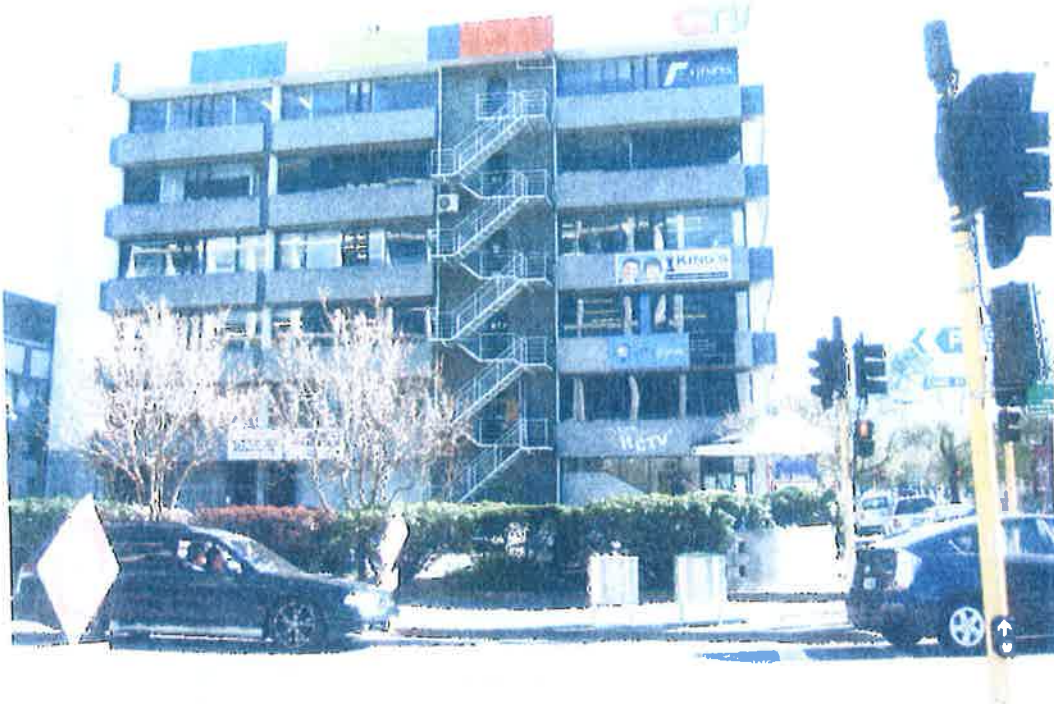
Photo 1 South Elevation of Building

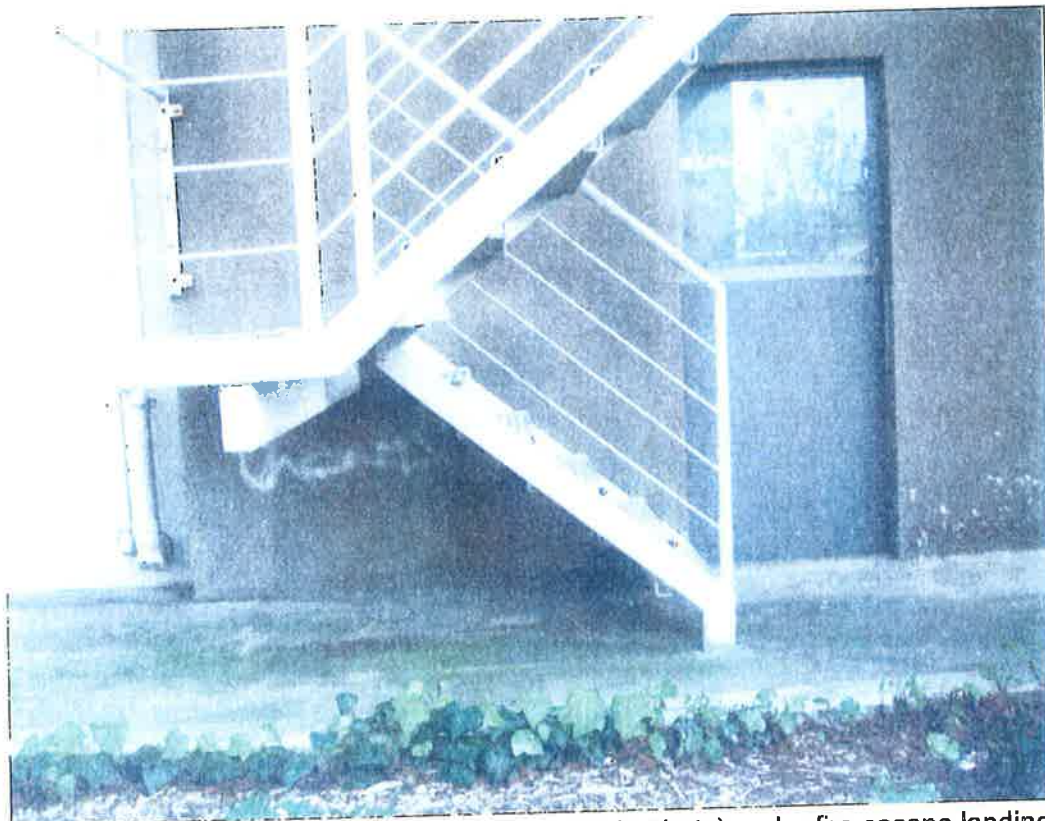
This wall is in fact what is termed a coupled shear wall. It has door holes in the middle of the wall at each storey providing access to the external fire escape. Beams across the door heads couple the walls, each side of the doors, together. The exterior of this wall is coated with a plaster splash coat. The rough texture of the finish on the wall makes it difficult to detect any cracking on the outside face, but there is one diagonal crack visible on the outside ground storey just below the fire escape landing. Photo 2.

No cracking was observed in the gypsum plaster lining of this wall at levels above the second floor. It seems likely that cracking is present in the ground storey portion of the wall, similar to that of the first storey. We would expect that any cracks present are relatively fine and similar in width to those on the first storey. We recommend that the internal ground storey strapping and plaster board lining be removed to view the structure behind. The lining is damaged and would have to be replaced anyway. Cracks greater than 0.2mm in width should be repaired with epoxy injection. The external surface of the wall should be protected against the ingress of water in any fine cracks with the application of a silicon sealer or similar.

Photo 2 Cracking in south shear wall (not visible in photo) under fire escape landing

We have not attempted for the purpose of this report to investigate or recommend restoration systems. However, diagonal shear cracking and cracking of construction joints has occurred in the shear walls, as reported below. We believe that there has been no yielding of the reinforcement in these walls and that structurally their integrity is still sound. However we would recommend repair of those cracks with a width of more than 0.2mm with epoxy injection. The damaged linings and finishings should also be repaired.

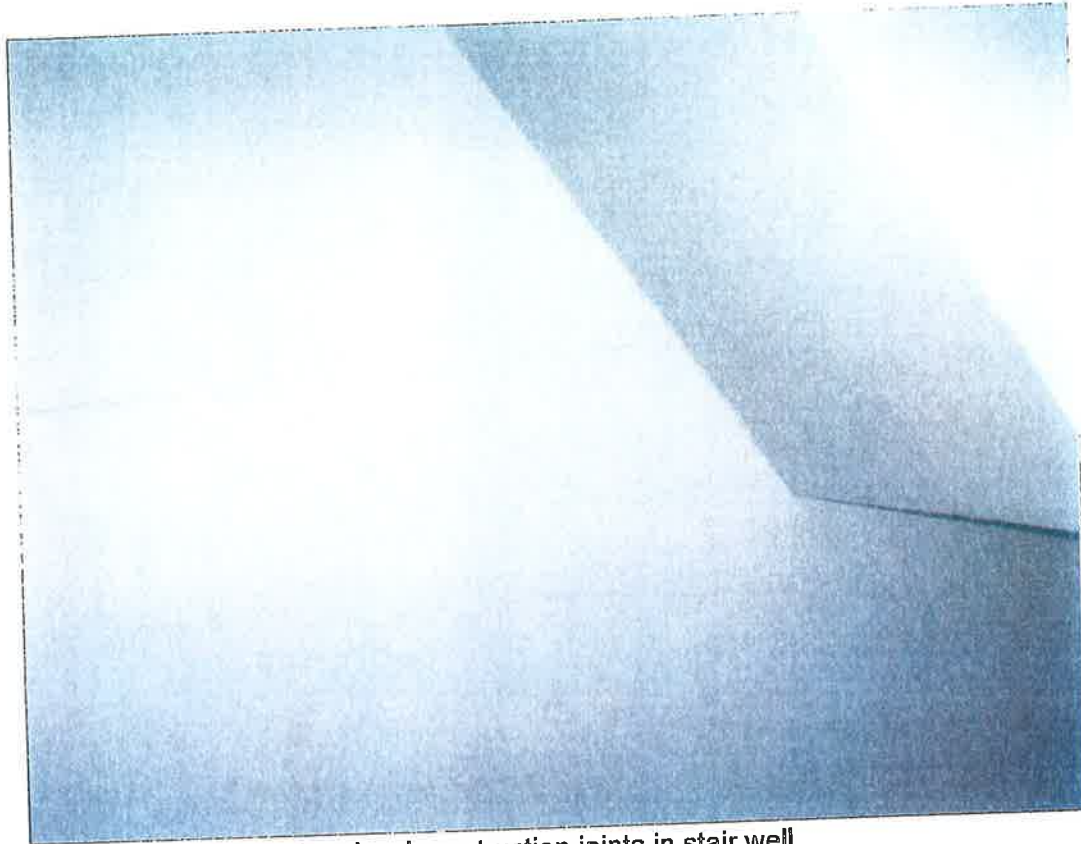
As visible in the stair well, there are construction joints in the walls immediately below and above each floor level. This is a normal construction practice. At almost all floor levels, cracking has occurred along part of the length of these construction joints and these cracks measure generally in the order of 0.2mm in width but with a few up to possibly 0.35mm in width. Photo 3. Again the cracks larger than 0.2mm in width should be repaired with epoxy injection and the external surface weather proofed.

Photo 3 Cracking in floor level construction joints in stair well

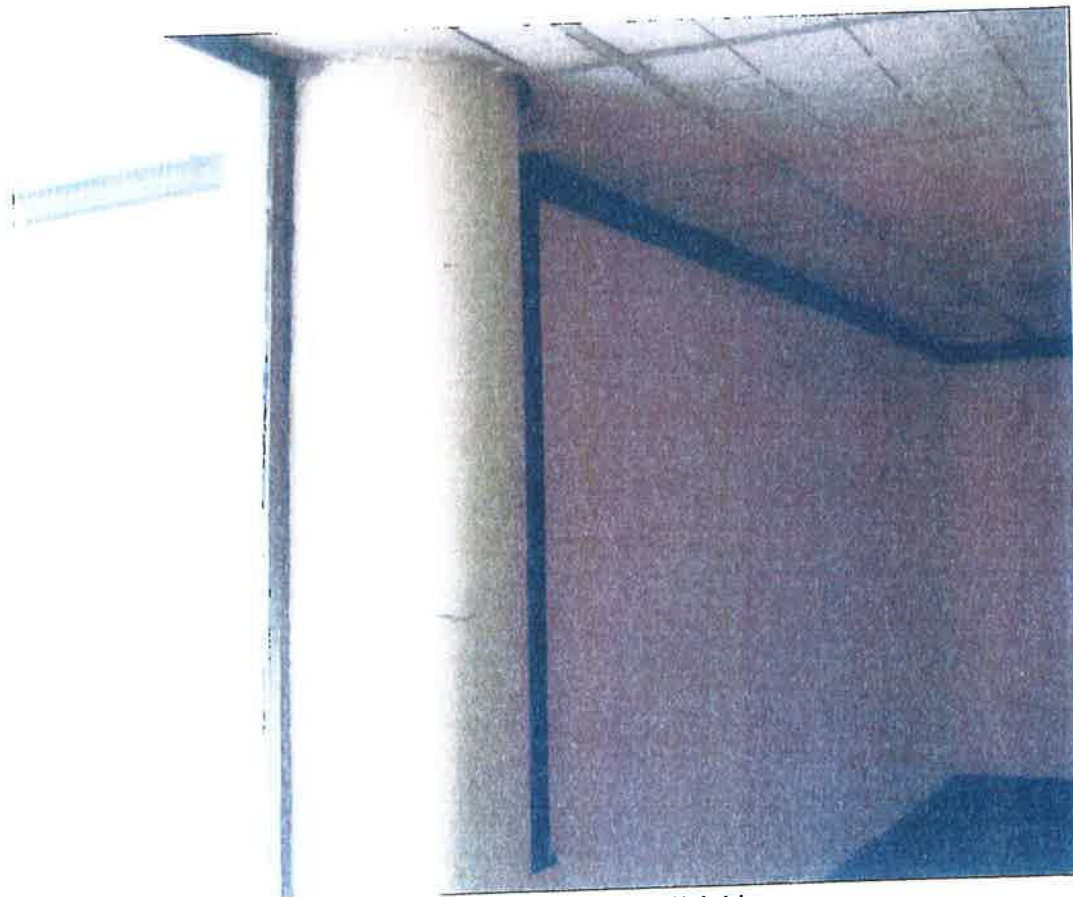
north-east corner of the building also exhibits some cracking. The appearance of the cracking is accentuated because the paint has chipped off at the cracks (photos 4). One of the south side columns at the top storey also exhibits some fine cracking. We recommend that the cracks in these upper storey columns be injected with epoxy resin.

Photo 4 Cracking in top storey column adjacent to lift lobby.

In addition to the epoxy injection requirement the 5<sup>th</sup> Floor overhead beam is likely to require minor breakout of defective concrete and reinstatement with a structural mortar.

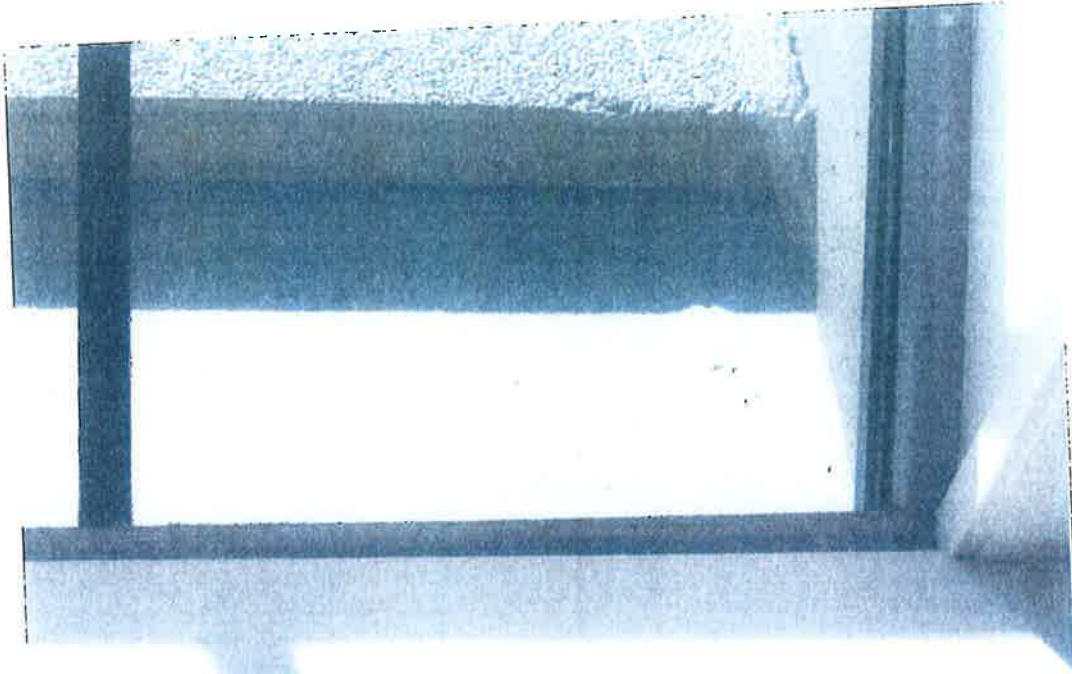
The first floor beam on the north face of the building in the span between the north-east corner of the building and the adjacent column to the west has some fine diagonal cracking (Photo 5). We recommend that this crack be injected with epoxy resin. We did not see any signs of distress in beam column joints.

Photo 5 Cracking in first floor beam north elevation over entry.

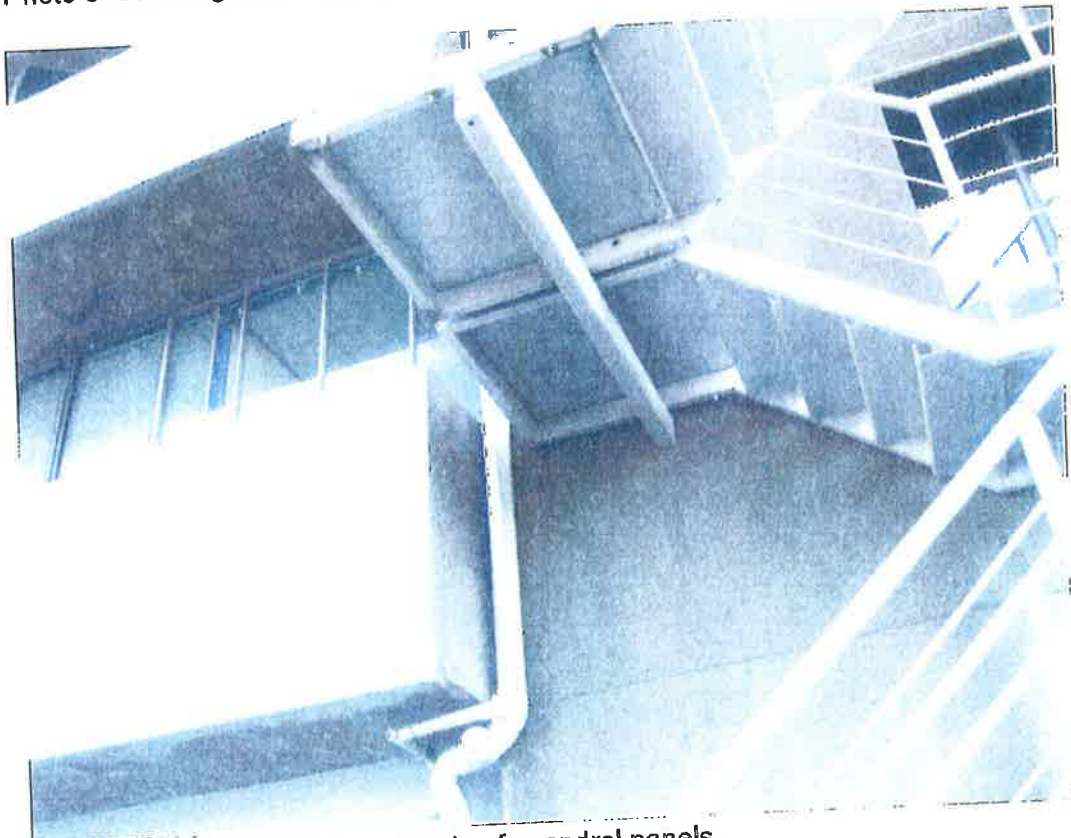
The precast concrete spandrel panels appear to have sustained very little damage. However, each side of the south side shear wall, the ends of the spandrels have been plastered. This plaster is spalling off at most levels as a result of differential movement caused by the earthquake. It is a hazard to people below. It should be removed, the concrete surface properly prepared and a strong bonding epoxy plaster re-applied. (Photo 6).

Photo 6 Spalling of plaster off ends of spandrel panels.

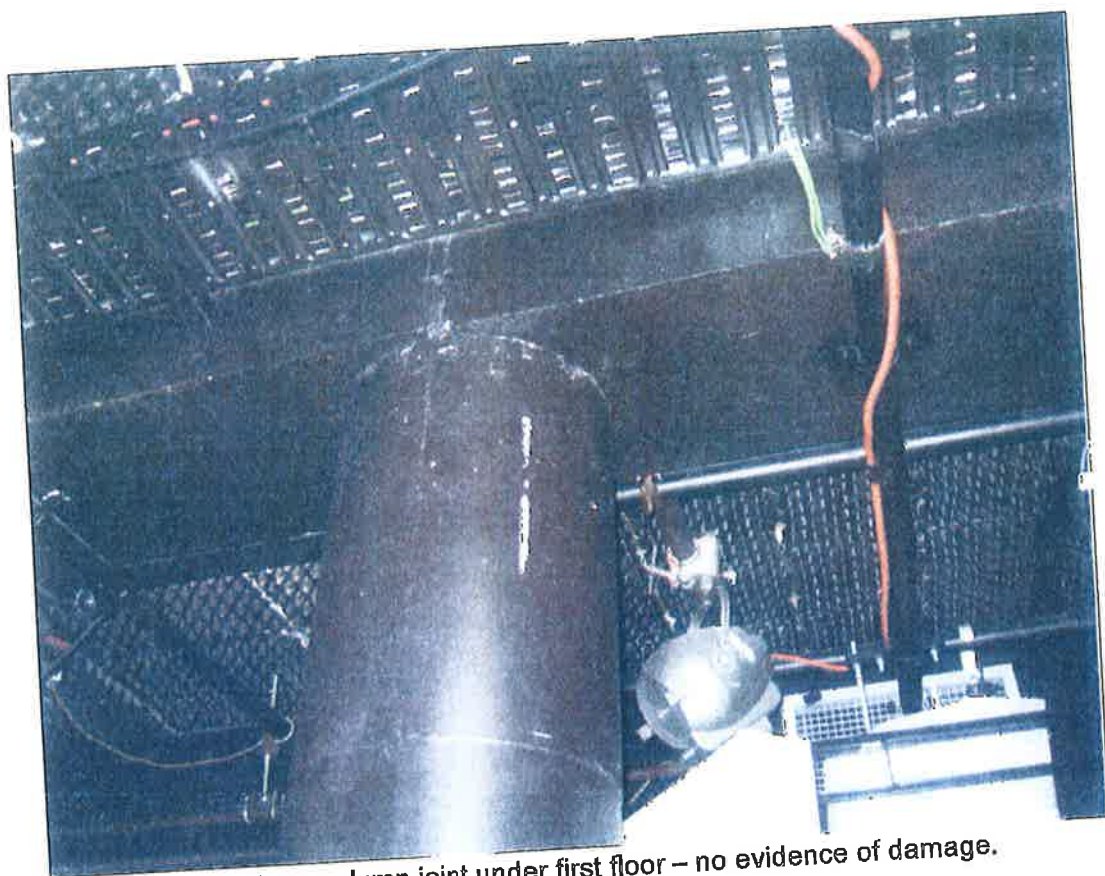
In the limited number of locations where we removed ceiling tiles and observed the floor to beam connections we did not see any signs of distress. (Photo 7).

Photo 7 Internal beam column joint under first floor – no evidence of damage.

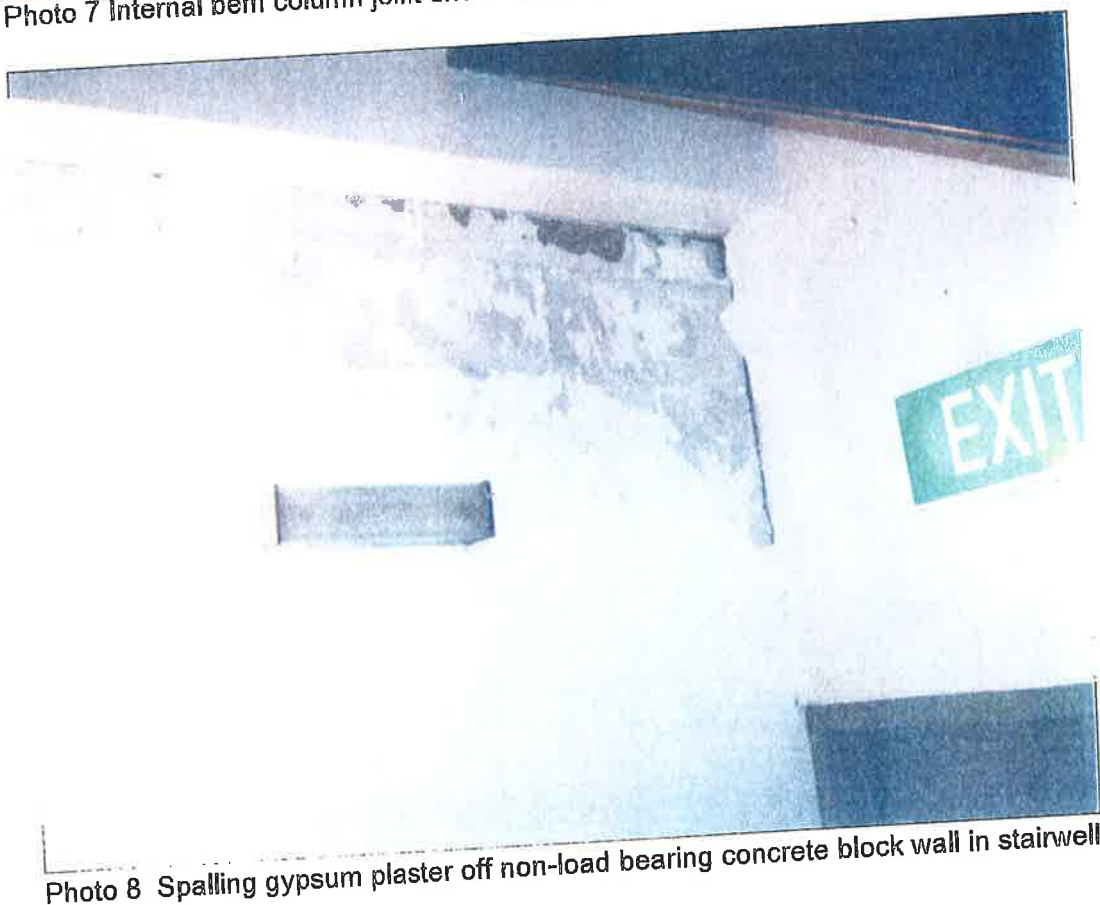
At ground storey, there is a concrete block wall parallel to the north side shear wall but on the opposite side of the stair well. This wall has a thin gypsum plaster coating in the stair well. At the top of the wall the plaster coating has been peeled off. It appears that it was touching one of the stair well structural walls and the differential movement has damaged the plaster. There may also be some minor cracking of the top block course which should be repaired. However, this is not a structural component and does not contribute to the integrity of the building. Photo 8.

Photo 8 Spalling gypsum plaster off non-load bearing concrete block wall in stairwell.

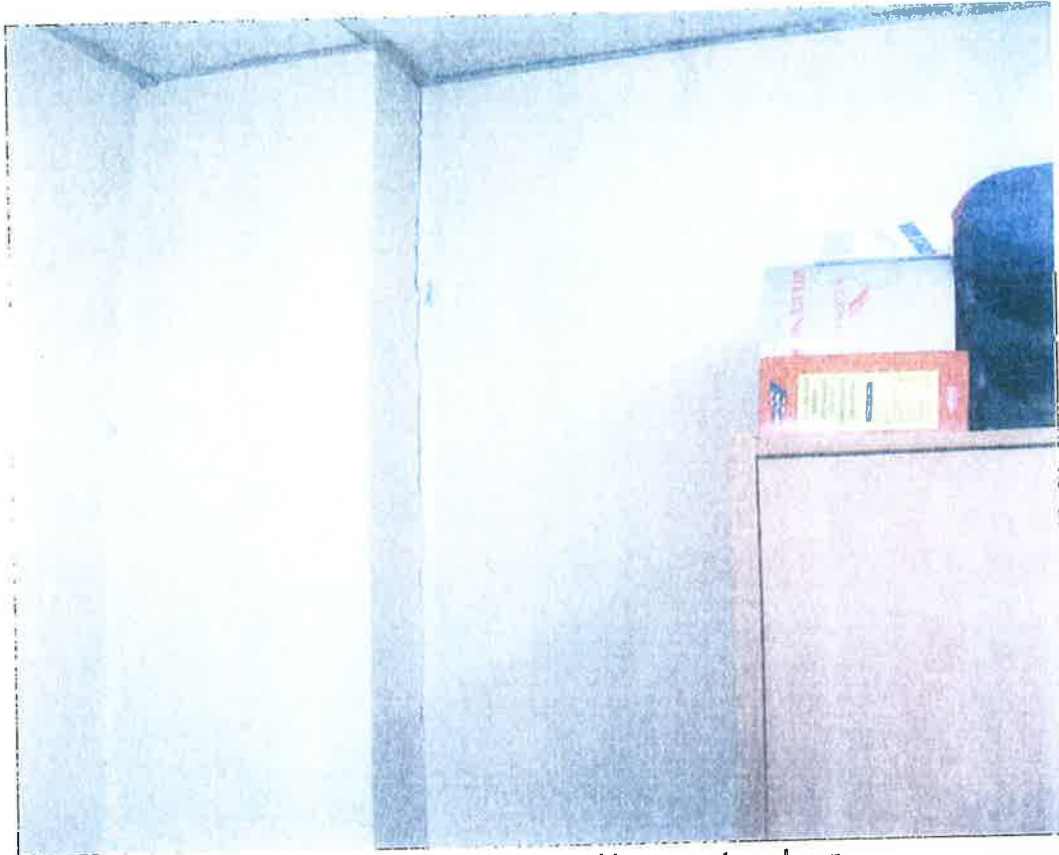
Photo 9 Partition lining damaged at junction with concrete column.

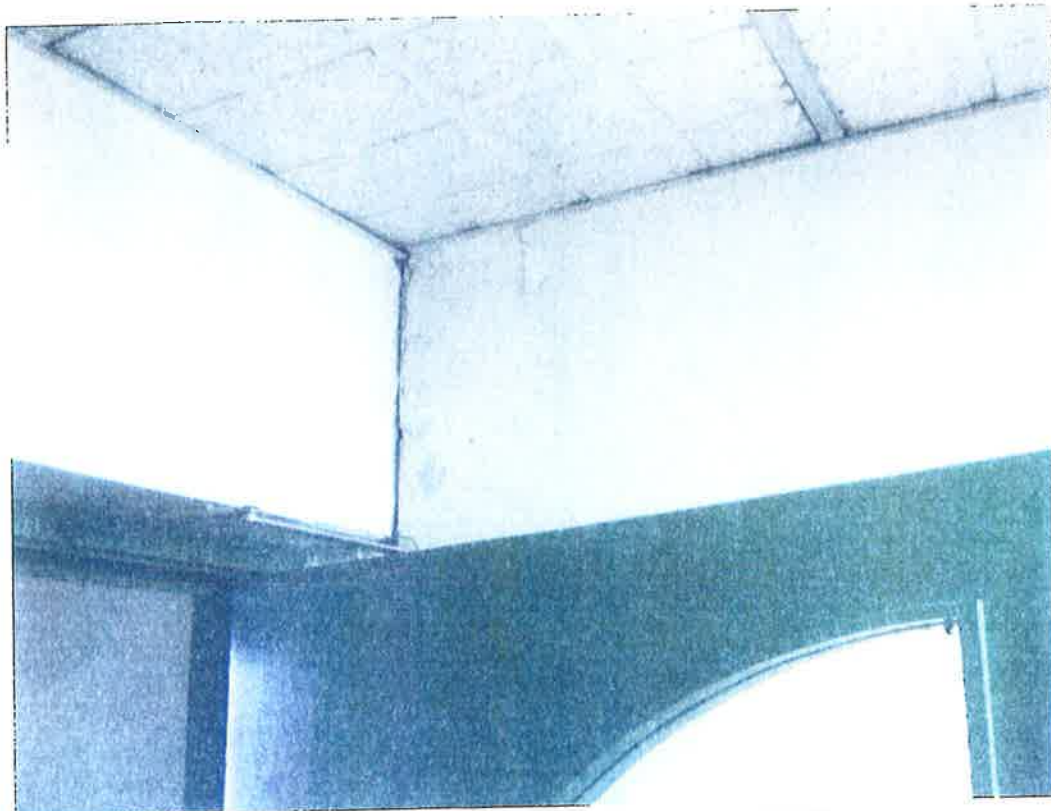
Photo 10 Partition lining damaged at junction with concrete beam.

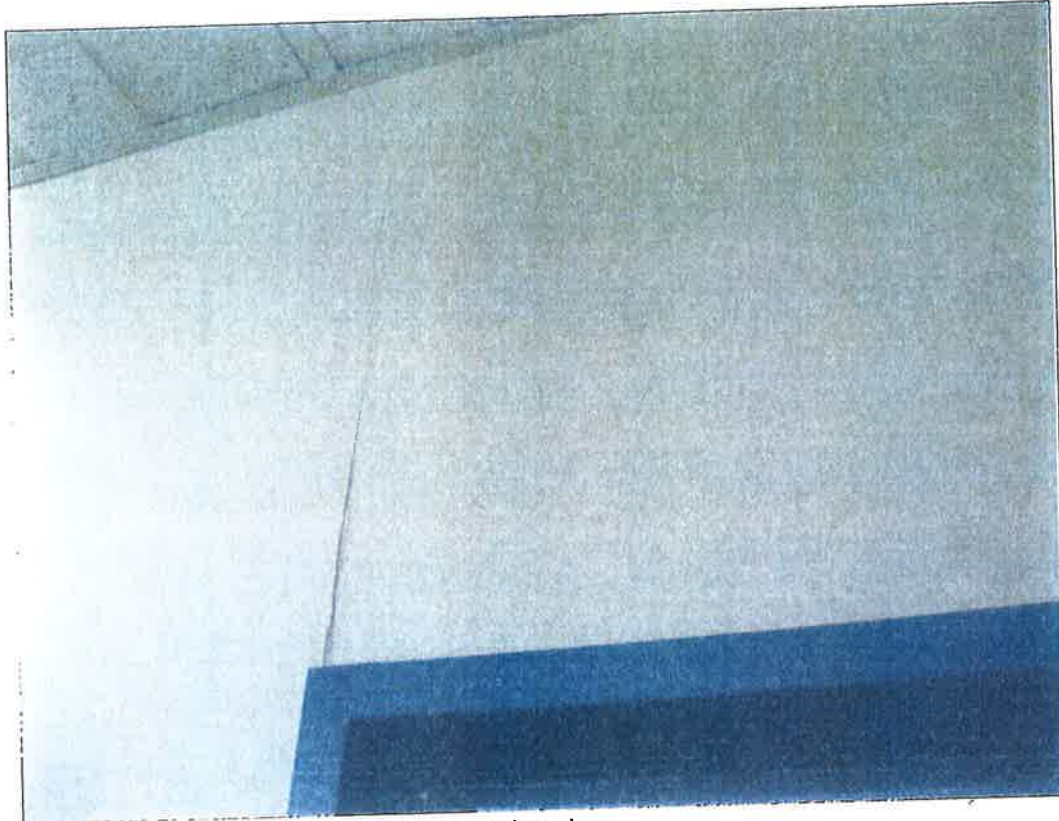
Photo 11 Cracking in linings over door head

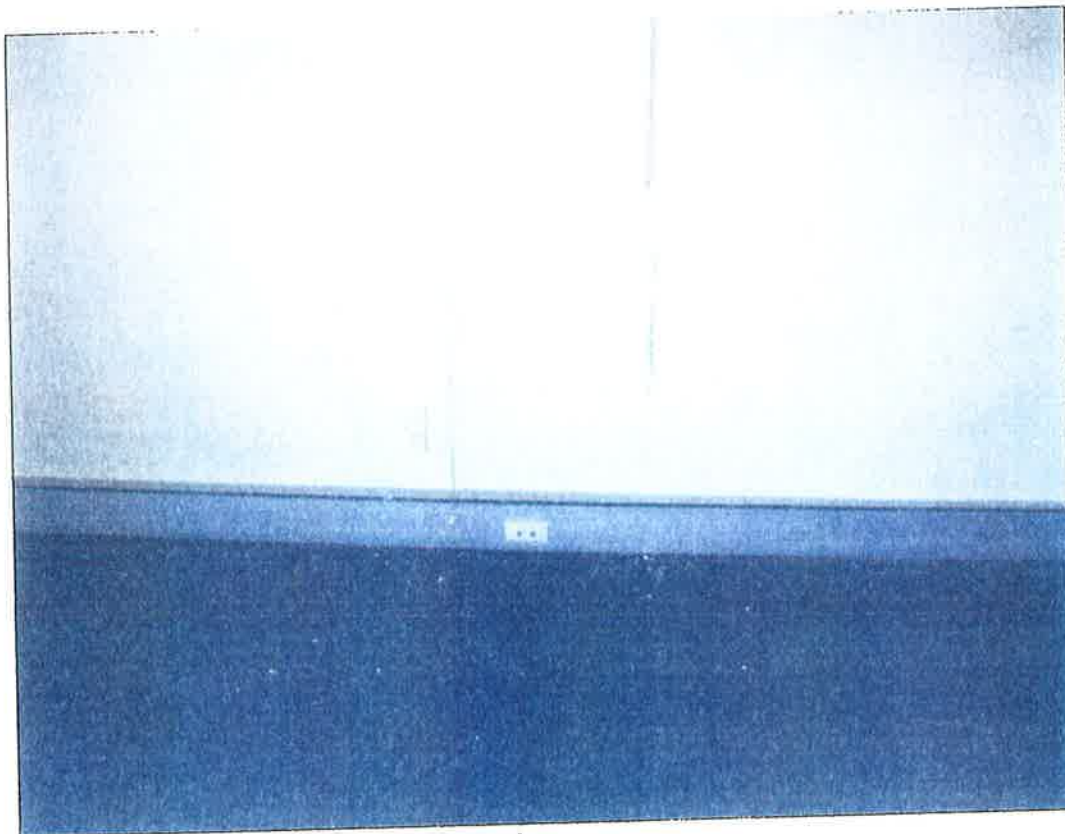
Photo 12 Crackling in linings under window.

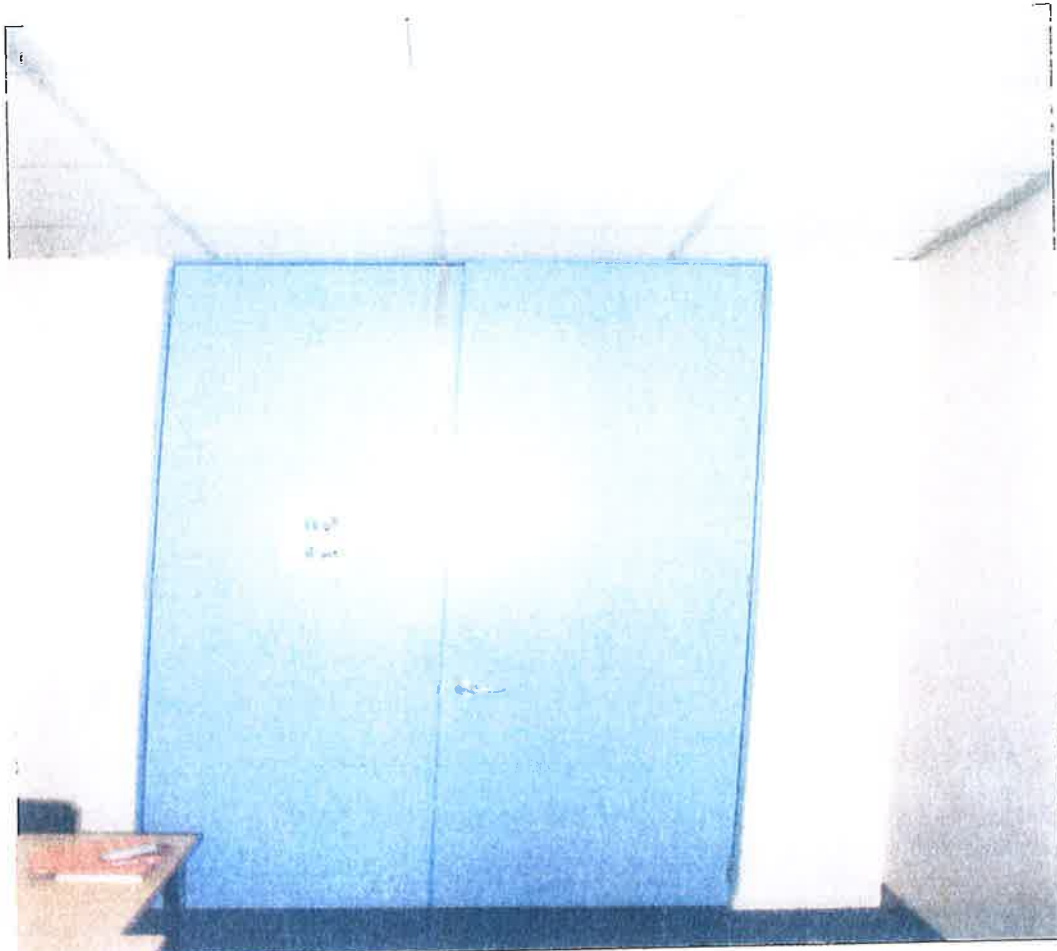
At numerous locations at all levels, there is damage to internal framing and linings. Commonly, internal walls and their linings have been finished hard against structural walls and columns. With movement of the building during the earthquake(s), the structural components have applied in-plane loads to the stiff plaster board lined walls. There are many instances where the plaster board linings have been damaged where they adjoin the structural components. Sometimes, the plaster board has buckled some distance away from the structural wall or column. Photos 9 and 10. There are also numerous instances of plaster board cracking over door heads and under windows and elsewhere. Photos 11 and 12. Ceiling covings and skirting boards have also been damaged. At the south end of one internal north south wall on the second floor, the partition wall has racked sufficient for the double doors contained in the wall to be binding. Photo 13.

Photo 13 Racked second floor partition wall and binding double doors.

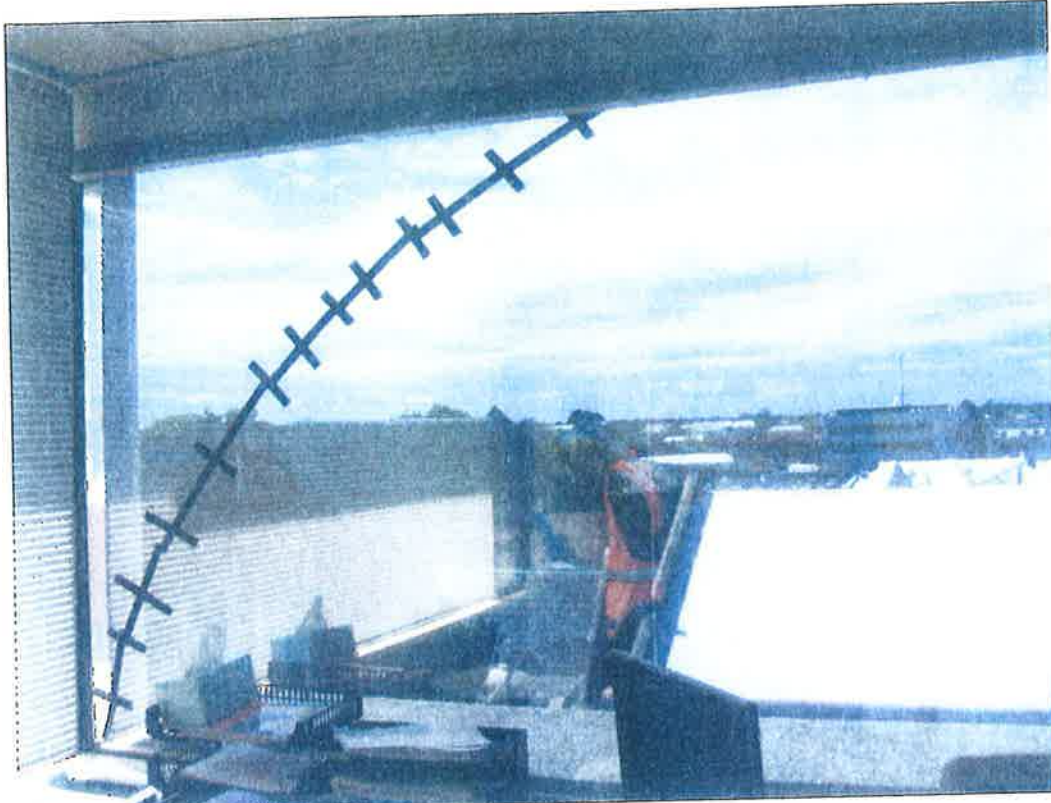
A few windows, particularly in the east elevation have been broken. Photo 15. This may also reflect greater movement of the building in the north-south direction. There are no windows in the opposite west wall but the damage to interior linings on that west wall is significant.

Photo 15 Broken window.
