Plan Section at Typical Interior Column
(thru Bottom of Precast Log Beams)

SK GF 20120501

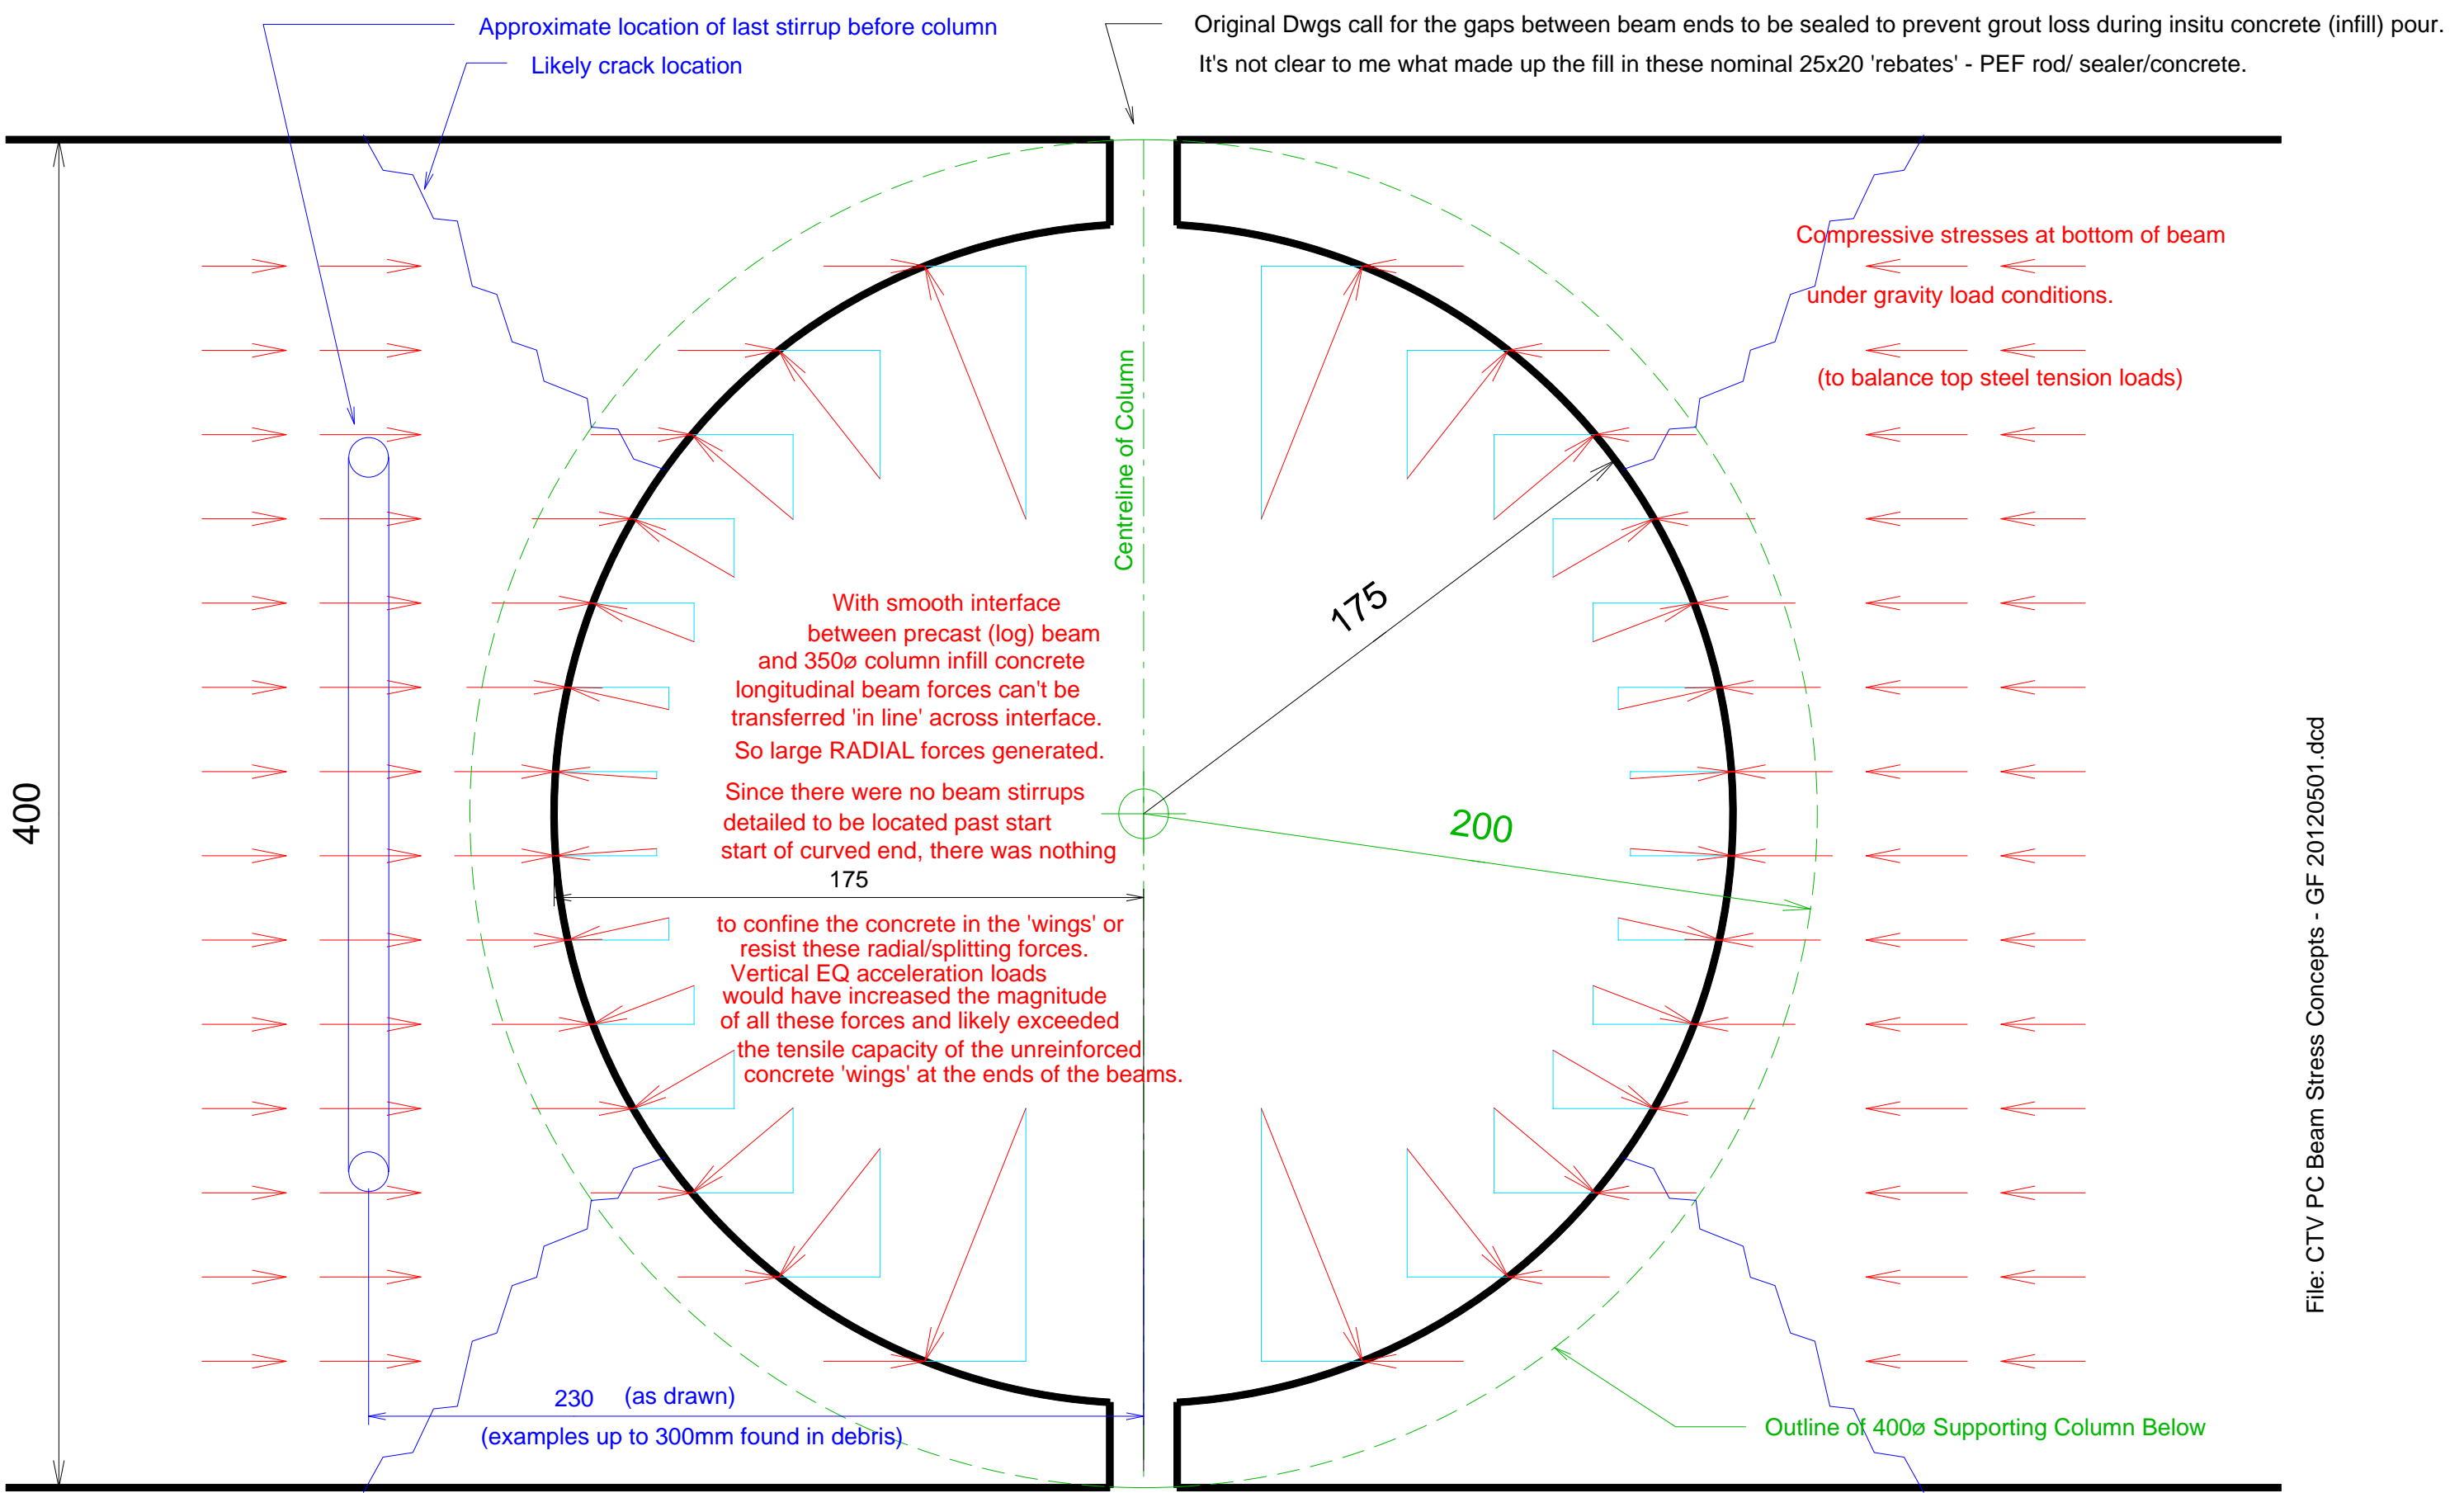
Original Dwgs call for the gaps between beam ends to be sealed to prevent grout loss during insitu concrete (infill) pour. It's not clear to me what made up the fill in these nominal 25x20 'rebates' - PEF rod/ sealer/concrete.

Approximate location of last stirrup before column
Likely crack location

Compressive stresses at bottom of beam
under gravity load conditions.
(to balance top steel tension loads)

With smooth interface between precast (log) beam and 350ø column infill concrete longitudinal beam forces can't be transferred 'in line' across interface. So large RADIAL forces generated. Since there were no beam stirrups detailed to be located past start of curved end, there was nothing

to confine the concrete in the 'wings' or resist these radial/splitting forces. Vertical EQ acceleration loads would have increased the magnitude of all these forces and likely exceeded the tensile capacity of the unreinforced concrete 'wings' at the ends of the beams.

230 (as drawn)
(examples up to 300mm found in debris)

generate large RADIAL forces in at the interface.
