**ROYAL COMMISSION OF INQUIRY INTO
BUILDING FAILURE CAUSED BY CANTERBURY
EARTHQUAKES**

THE CTV BUILDING COLLAPSE

**STATEMENT OF EVIDENCE OF NILGUN ELIZABETH KULPE
IN RELATION TO THE CTV BUILDING**

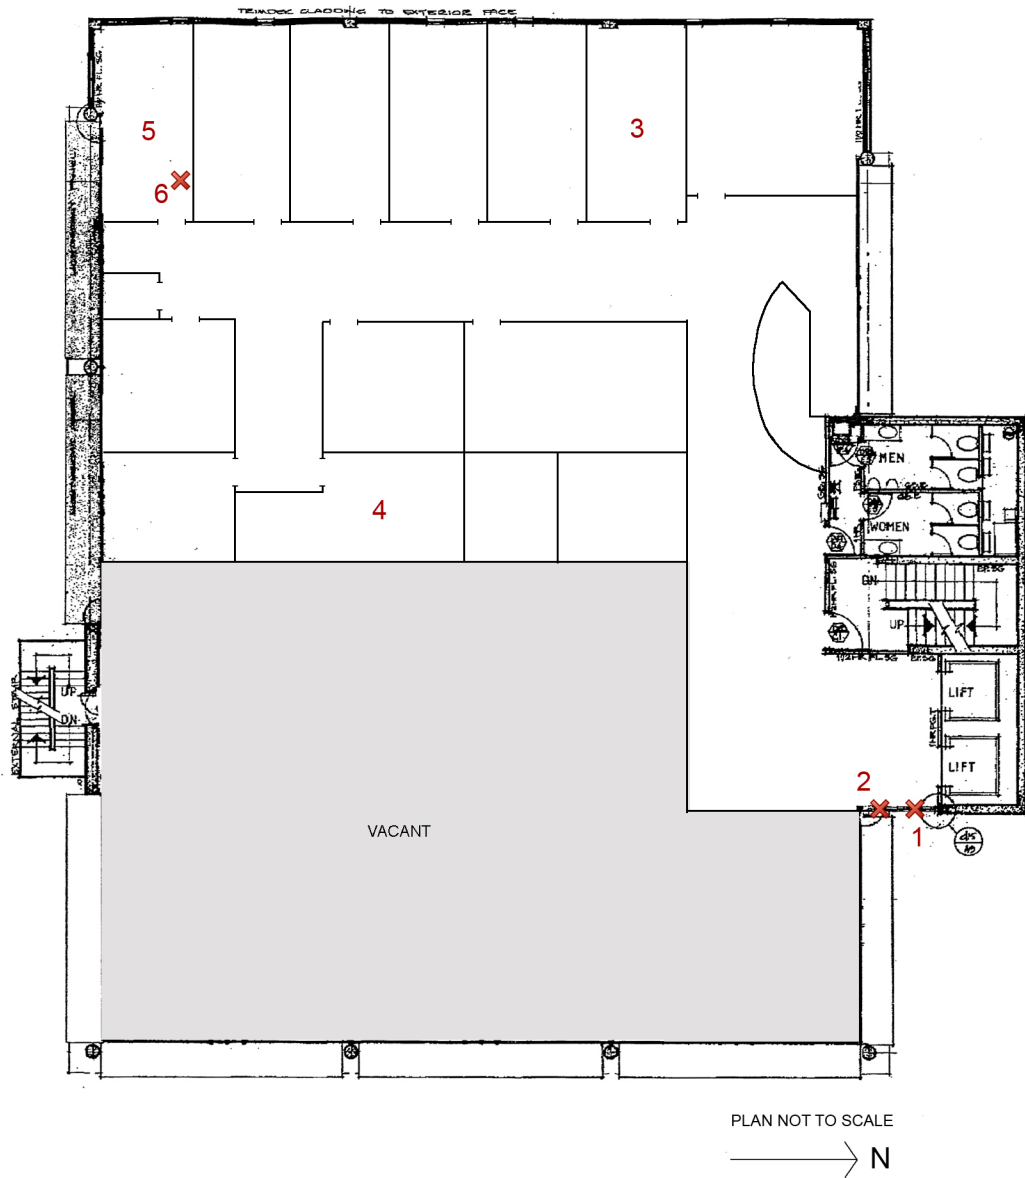
"A"

8. I noticed a small crack in the foyer by the lifts. I have marked this as "1" on the plan. It ran vertically on a slight diagonal. From memory I would say it was approximately 1.5 metres in length. It ran above the window and underneath the window as well.

15. After the Boxing Day earthquake I noticed that one of the pillars was cracked. This was outside the lifts. I have marked this as "2" on the plan. I can't be sure it was a result of the Boxing Day earthquake, but I didn't notice it before then. I noticed it about two or three weeks before the 22 February earthquake. I remember telling my husband about it when he picked me up one day. I pointed it out to him and told him that it was new.

1. Crack along the wall
2. Crack in the pillar
3. My room
4. Meeting room
5. Meeting room
6. Filing cabinet
