**ROYAL COMMISSION OF INQUIRY INTO
BUILDING FAILURE CAUSED BY
CANTERBURY EARTHQUAKES**

THE CTV BUILDING COLLAPSE

**STATEMENT OF EVIDENCE OF ELIZABETH MARY CAMMOCK
IN RELATION TO THE CTV BUILDING**

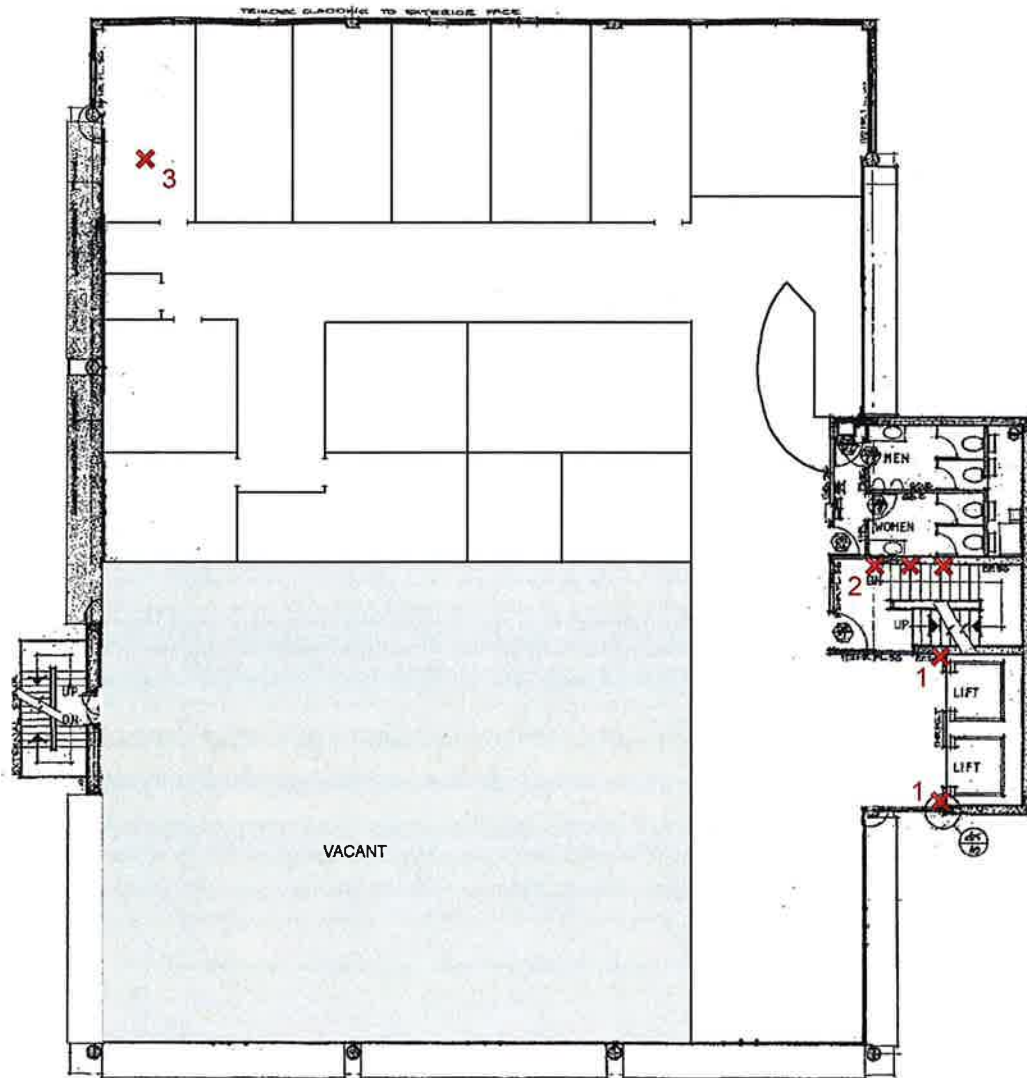
249 MADRAS ST - LEVEL 6

5. A number of areas of damage had appeared on the 5th floor. Attached is a floor plan of the Building I have prepared (marked "A"). The positions of the rooms and internal walls have not been drawn to scale and their placement is approximate only. The issues of concern that I refer to in my evidence are marked on this plan.

6. Two cracks had appeared on either side of the elevators. I have marked these cracks as "1" on the plan. I can't be sure when these cracks first appeared because the elevator was not something I used often, but I know they were more pronounced following the Boxing Day earthquake. We talked about the damage by the elevators at staff meetings. Moira Underdown, the Upper South Area Manager, assured us that the Building had been inspected and it was safe.

17. There were cracks that had appeared up the stair well in the north core. I have marked the area of cracking as “2” on the plan. I biked into work and used to carry my bike up the stairs. I only noticed cracking around the 4th and 5th floors. I remember feeling really uncomfortable walking up the stairs and feeling unsafe.

19. I remember the cracks by the elevator were more pronounced after the Christmas break. I can't remember how wide they were but you could see them very easily, even from a distance of approximately ten metres away. I remember they ran from floor to ceiling and were very distinctive. It looked like someone had slightly pulled the wall apart. I wondered how the Building could be safe with these cracks in both corners.
