## EXECUTIVE SUMMARY

This report covers the structural damage sustained by the Canterbury District Health Board's Christchurch Women's Hospital, as a result of the series of Earthquakes that includes the Darfield Earthquake that struck at 4:36am on 4<sup>th</sup> September 2010, the Lyttelton Earthquake at 12.51 pm on the 22<sup>nd</sup> of February 2011, the June 13<sup>th</sup> 2011 (2:20pm) earthquake and December 23<sup>rd</sup> 2011 (1:58pm) event. The Darfield Earthquake produced force demands in the isolator system equal to Maximum Considered Earthquake (MCE for an IL2 building), or ultimate limit state (ULS), conditions for an Importance Level 4 building. The Lyttelton Earthquake by comparison did not induce such large horizontal forces, but likely took the structure through larger displacement demands at the isolator level. Consequently it is important that a full evaluation is performed.

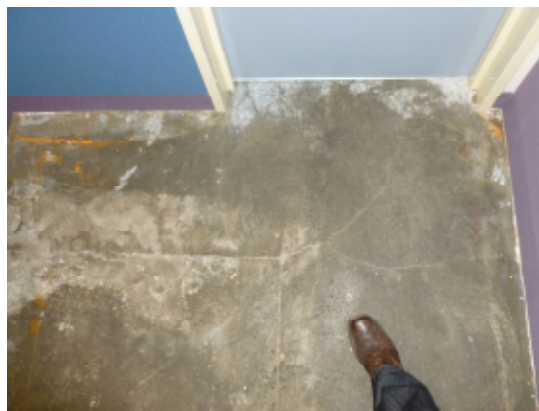
1.2. Cracking up to 0.6mm in topping slab + Inspection	LEVEL 3: Cracking in topping slab parallel to beams on GL 3 & 6. Cracks observed on north and south sides of beams.	Remove carpet/vinyl to inspect the top of the slab along full length of GL 3 & 6, both sides of beam below. Epoxy inject all cracks that are greater than 0.3mm in width. Refer to HCG Specification

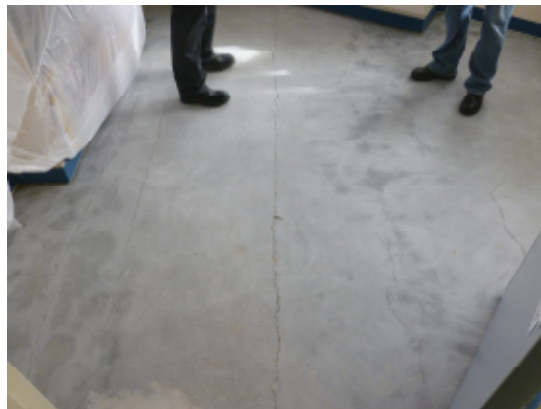
1.3. Cracking up to 0.6mm in topping slab + Inspection	LEVEL 4: Cracking in topping slab parallel to beams on GL 3 & 6. Cracks observed on north and south	Some locations have been epoxy injected already. Where not already remediated remove carpet/vinyl to inspect slab along full length of GL	See above

Damage	Locations	Recommendation	Example
	sides of beams.	3 & 6, both sides of beam below. Epoxy inject all cracks that are greater than 0.3mm in width. Refer to HCG Specification	
1.4. Cracking up to 1.2mm in topping slab + Inspection	LEVEL 4:	Multiple rooms between Grid A and C showing extensive cracks, some linear/parallel and others diagonal and intersecting. Epoxy inject all cracks that are greater than 0.3mm in width. Refer to HCG Specification, however do not inject before reinforcement testing is complete. Further strengthening may be required once all analysis and testing has been completed.

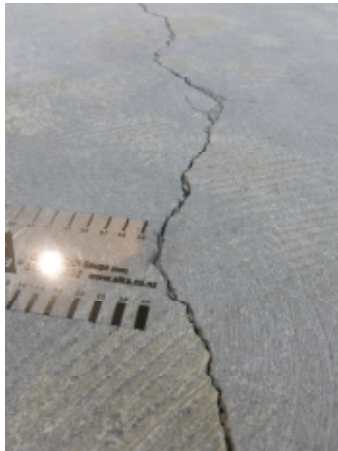
1.5. Inspection	LEVEL 5:	Room 5080 observed floor cracks similar to L4 and L5. Further inspection of rooms required to confirm full extent of cracks.

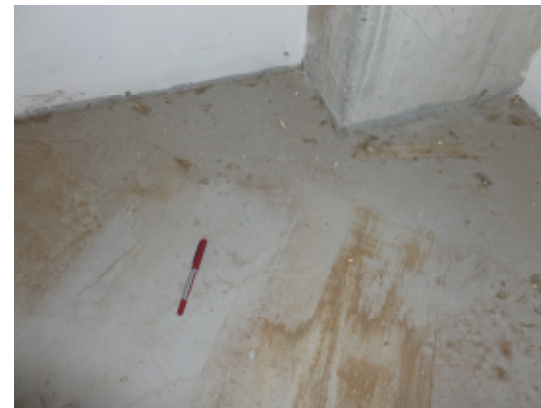
Damage	Locations	Recommendation	Example
1.6. Inspection	LEVEL 5: Possible cracking in topping slab parallel to beams on GL 3 & 6 per Level 3 and 4. Cracks observed on north and south sides of beams.	Remove carpet/vinyl to inspect the slab along full length of GL 3 & 6, both sides of beam below. Epoxy inject all cracks that are greater than 0.3mm in width. Refer to HCG Specification	See above
1.7. Slab cracks radiating from column	LEVEL 6: South-west corner column	Epoxy inject cracks greater than 0.2 mm in width. Refer to HCG Specification

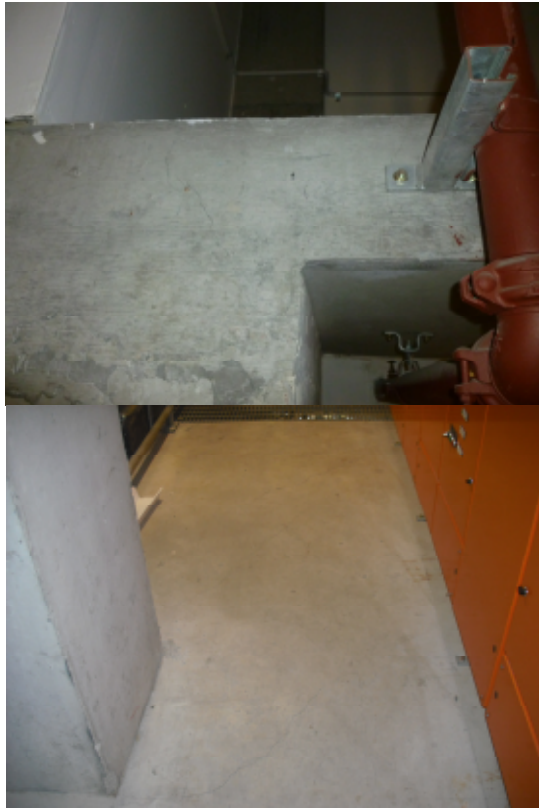
Damage	Locations	Recommendation	Example
1.8. Slab cracks up to 0.7 mm	LEVEL 6 MEZZANINE: Cracks in slab observed in soffit of landing, cantilevered slab and radiating from columns	Epoxy inject cracks greater than 0.2 mm in width. Refer to HCG Specification

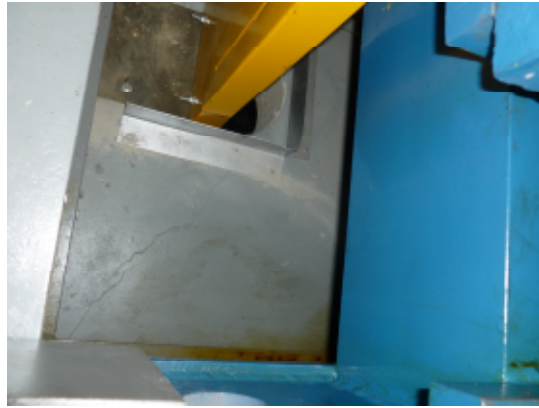
Damage	Locations	Recommendation	Example
1.10. Slab cracks up to 0.8 mm	LIFT MACHINE ROOM: Full slab depth cracks observed around/beneath lift machines and central area of floor.	Epoxy inject cracks greater than 0.2 mm in width. Refer to HCG Specification

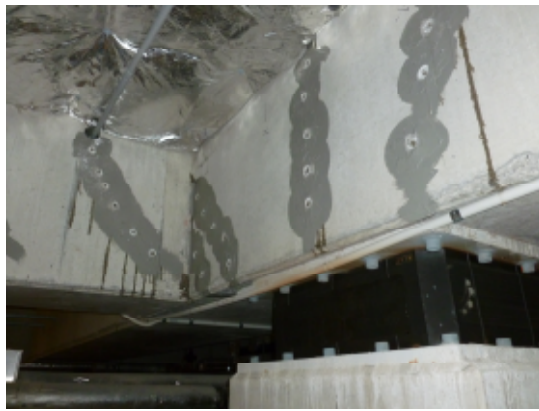
Some diagonal cracking has been observed in the transfer beams (forming part of the stiff grid of the Lower Ground floor) that support the elevator pit and span back to adjacent isolator bearings. Given that cracks were not extensively observed in other transfer beams, it is possible that this cracking has occurred as a result of the elevator shaft mass being vertically accelerated during the February 22<sup>nd</sup> earthquake.

2. Beams and Precast Floor Ribs			
2.1. Flexure and shear cracks up to 0.4 mm + Inspection	BASEMENT: Cracks in transfer beams spanning around the elevator pits GLs C, 6 & E. Also at locations where post-tensioned tie-downs are anchored around perimeter of building	Epoxy inject cracks greater than 0.2 mm in width. Inspect beams with tie-down anchors passing through at east end of building. Refer to HCG Specification

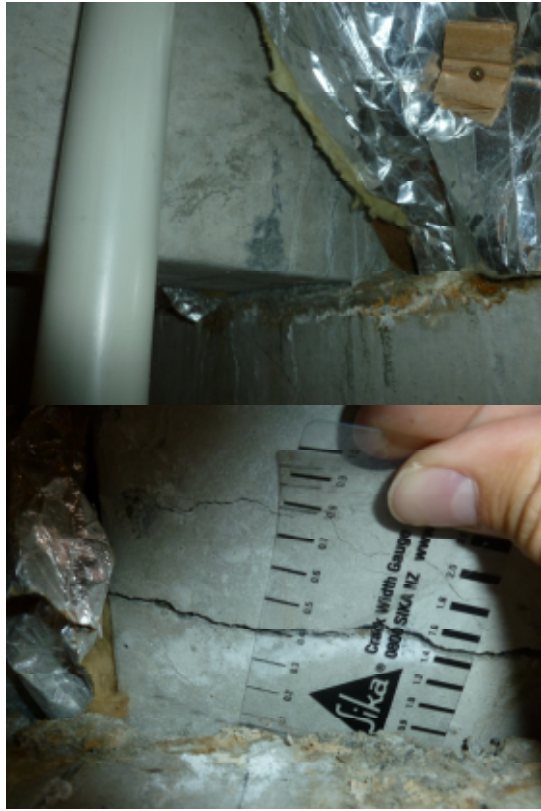
The precast concrete floor ribs that make up the Lower Ground floor and are observable from the basement have shown a consistent amount of damage in the western half of the building. Single cracks have developed in a number of the units near the seating with cracks widths ranging up to 1.5 mm in size. A remediation Site Instruction and detail has been issued for the locations considered to be critical, where epoxy injection will not be sufficient to ensure the units perform with their original strength. In locations at other floor levels where such damage is observed with crack widths of 0.8 mm or more, it is suggested that temporary propping be installed to support the damaged ends of these units until full repairs can be finished.

Damage	Locations	Recommendation	Example
2.2. Shear cracks in precast concrete rib joists up to 1.5 mm wide	BASEMENT:  Cracks in precast ribs near seating at multiple locations as indicated on plan provided Appendix B	Epoxy inject cracks greater than 0.2 mm in width. Where cracks are wider than 0.8 mm provide steel seating detail. See concept sketch SKS-C1 in App. C. Refer to HCG Specification

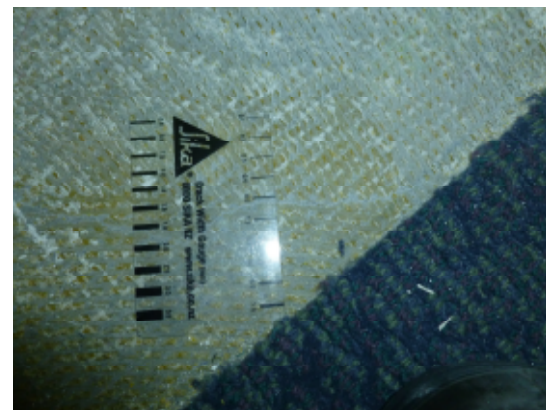
Damage	Locations	Recommendation	Example
2.3. Cracks up to 0.5 mm wide + Inspection	LEVEL 3: Crack noted in slab/top of beam in Rm 3094 on SW side of column	Further inspection required on beams around perimeter of building. Suggest beams are exposed at every 2 <sup>nd</sup> column by lifting flooring, and removing ceiling tiles. If cracks are consistently noted then similar for Level 4 and 5. Epoxy inject cracks greater than 0.3 mm. Refer to HCG Specification

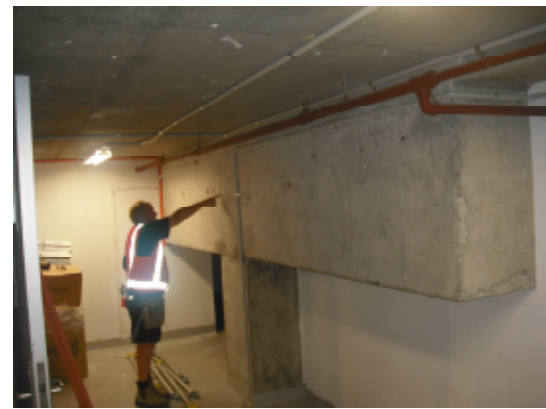
2.4. Precast rib joists	LEVEL 3, 4 & 5: Possible cracks near supports of precast floor ribs.	Investigation of precast floor ribs supporting L3, L4 and L5 required to confirm if similar cracks near the supports is present (as seen in basement)	No photo
2.5. Cracks up to 0.6 mm wide	LEVEL 6: Support beam to mezzanine above as seen at L6 landing.	Epoxy inject cracks greater than 0.2 mm in width. Refer to HCG Specification

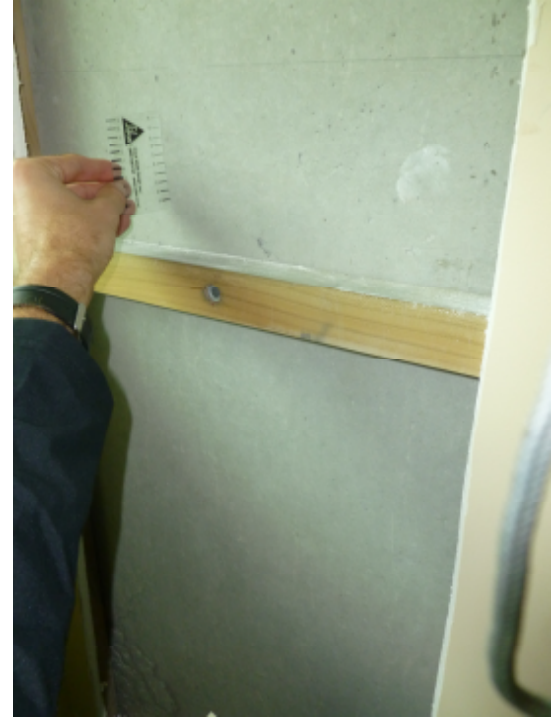
Damage	Locations	Recommendation	Example
2.6. Cracks up to 0.4 mm wide	LEVEL 6 MEZZANINE: Beams supporting Level 7 have diagonal cracks	Epoxy inject cracks greater than 0.2 mm in width. Refer to HCG Specification	No Photo
3. Columns			
3.1. Cracks <0.2 mm. + Inspection	LEVEL 3: Columns inspected in three locations Rm 3009, 3094 & 3096. Minor cracks at mid-height observed.	See item 2.3. Further inspection of every 2 <sup>nd</sup> column required. Epoxy inject cracks greater than 0.2 mm Refer to HCG Specification

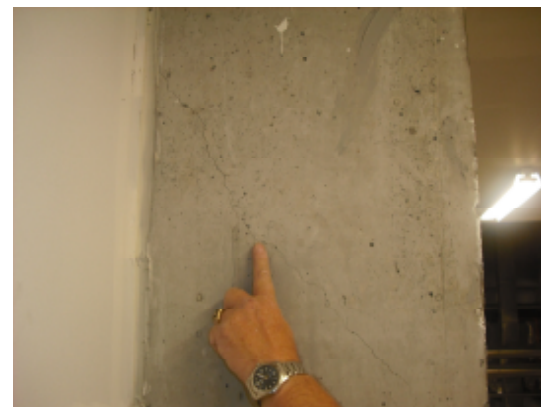
Damage	Locations	Recommendation	Example
3.2. Diagonal cracks up to 0.4 mm	LEVEL 6 MEZZANINE: Crack all way through column at landing GL D/3	Epoxy inject cracks greater than 0.3 mm Refer to HCG Specification

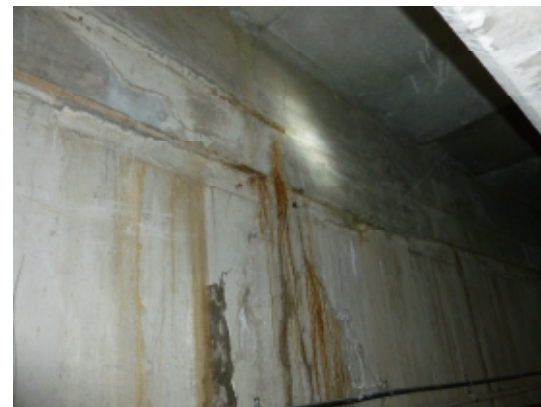
4. Basement Walls			
4.1. Cracks in perimeter walls + Inspection	Some locations already noted/repared. Confirm locations with Fletcher.	Inspect all walls around basement including tunnel through to Parkside and epoxy inject all cracks that are greater than 0.2mm in width. Refer to HCG specification.

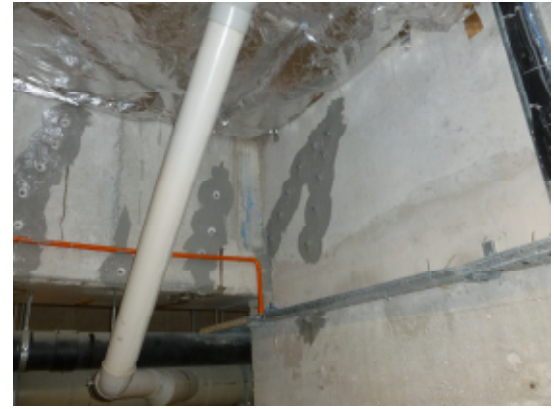
Damage	Locations	Recommendation	Example
4.2. Diagonal cracks up to 1.2 mm wide	Elevator shaft pit walls	Epoxy inject cracks greater than 0.2 mm. Refer to HCG Specification

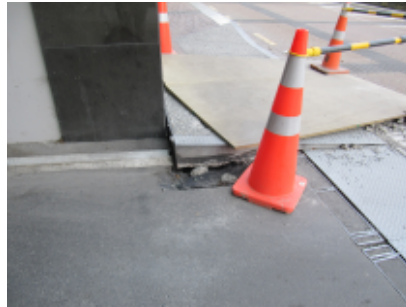
Damage	Locations	Recommendation	Example
5.2. Exterior covers have pounded perimeter wall	Perimeter “moat” around exterior of building at Lower Ground floor	Contact locations to be repaired per original specifications. See revised details issued previously.

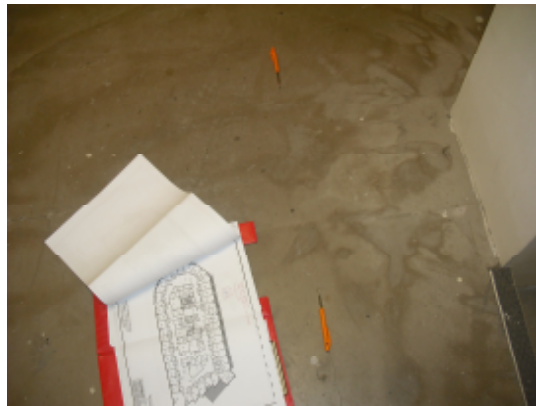
6. Staircases			
6.1. Damage to landings noted in west service stair with cracks up to 0.8 mm + Inspection	L3 mid-landing & L5 mid-landing. Confirm if present at other levels as vinyl may be hiding cracks.	Remediation of stair connections similar to concept sketch SKS-C2 App C. Epoxy inject all cracks that are greater than 0.3mm in width. Refer to HCG specification

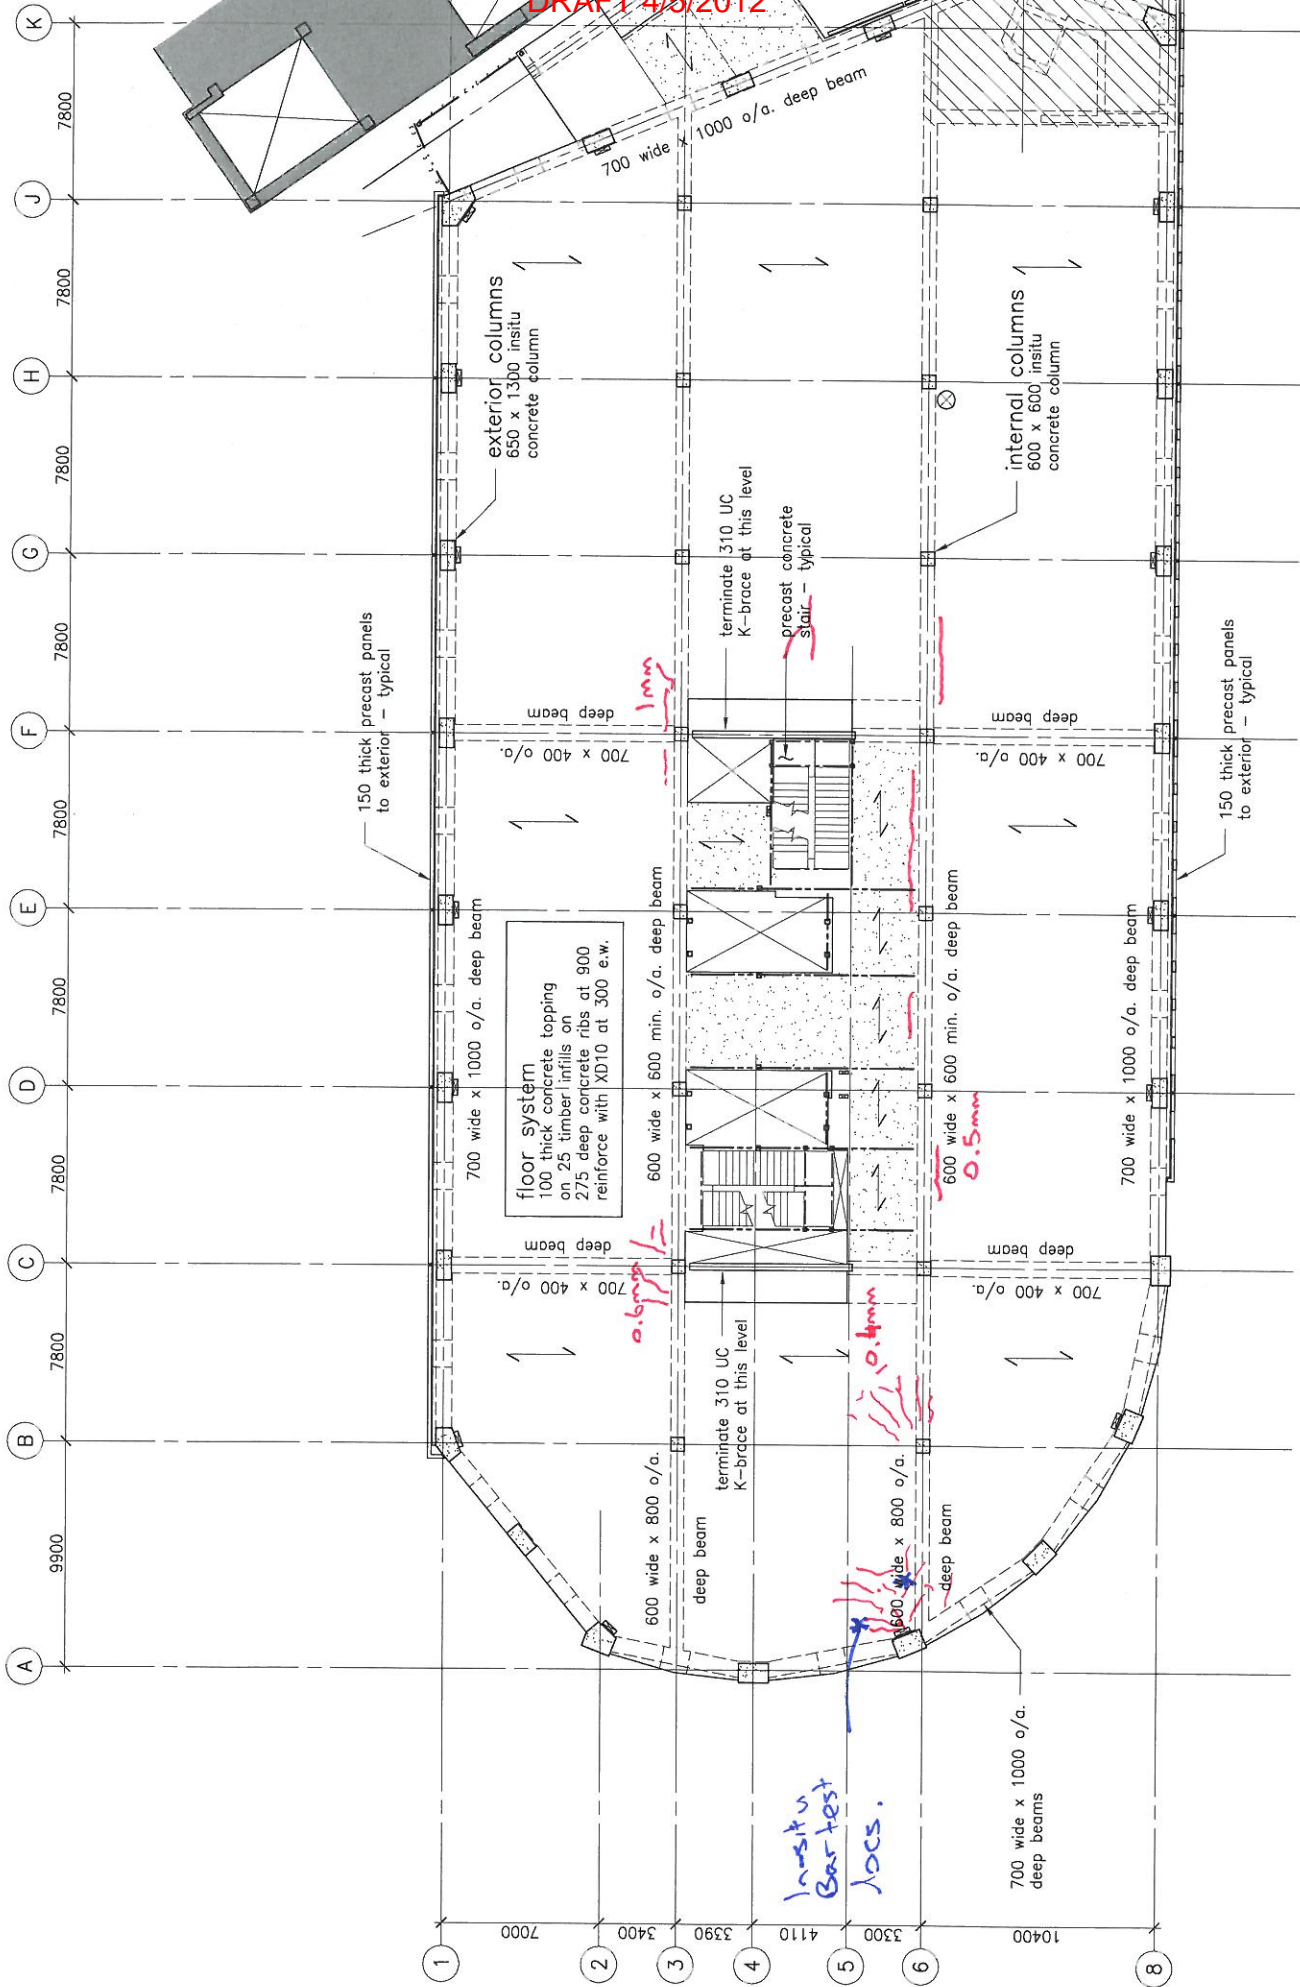
THIRD FLOOR PLAN: APPROX CRACK MAP FOR AREAS  
INSPECTED UP TO 1/5/2012

At Levels Three and Four a series of cracks have been found parallel to the beam edges along Grids 3 and 6 in the vicinity of the stair and lift shafts (see Appendix D). In some cases these cracks have already been epoxy injected and finished off, while others are yet to be remediated. The consistent observation of these cracks and their size indicates that further investigation is required to confirm their full extent across the length of the building. The locations of these cracks, and observed cracking in other areas of the slabs suggest they are likely to be pre-existing shrinkage cracks that have been worked open by the earthquake movements. Although no carpet or vinyl finishing damage was observed, this further investigation should include Level Five as it is likely that similar cracks exist at this level and further investigation is required to confirm and possibly remediate these.

Further cracking of the slabs at Levels Three, Four and Five has been observed at the west end of the building between grids A to C (see Appendix D). The crack patterns are consistent in width and extents from one location to another, and in some cases are considered to be significant enough that the slab reinforcement may have yielded. At this stage representative locations at Level Three and Four have been marked for in-situ testing of the reinforcement to assess the residual steel capacity. A computer model of the Level Four perimeter moment frame has been developed to investigate the extent of frame deformation and hence potential for slab damage under earthquake loading. Combined with the reinforcement testing, the information from the computer model and visual observations will provide indications as to whether the cracks have developed solely under earthquake loading or whether they were existing shrinkage cracks that have opened further under the earthquake demands, thus being damage due to the shaking response of the building.
