**ROYAL COMMISSION OF INQUIRY INTO  
BUILDING FAILURE CAUSED BY CANTERBURY  
EARTHQUAKES  
KOMIHANA A TE KARAUNA HEI TIROTIRO I  
NGA WHARE I HORO I NGA RUWHENUA O  
WAITAHA**

**STATEMENT OF EVIDENCE OF THOMAS RICHARD HAWKER  
IN RESPECT OF THE CTV BUILDING**

**DATE OF HEARING: COMMENCING 25 JUNE 2012**

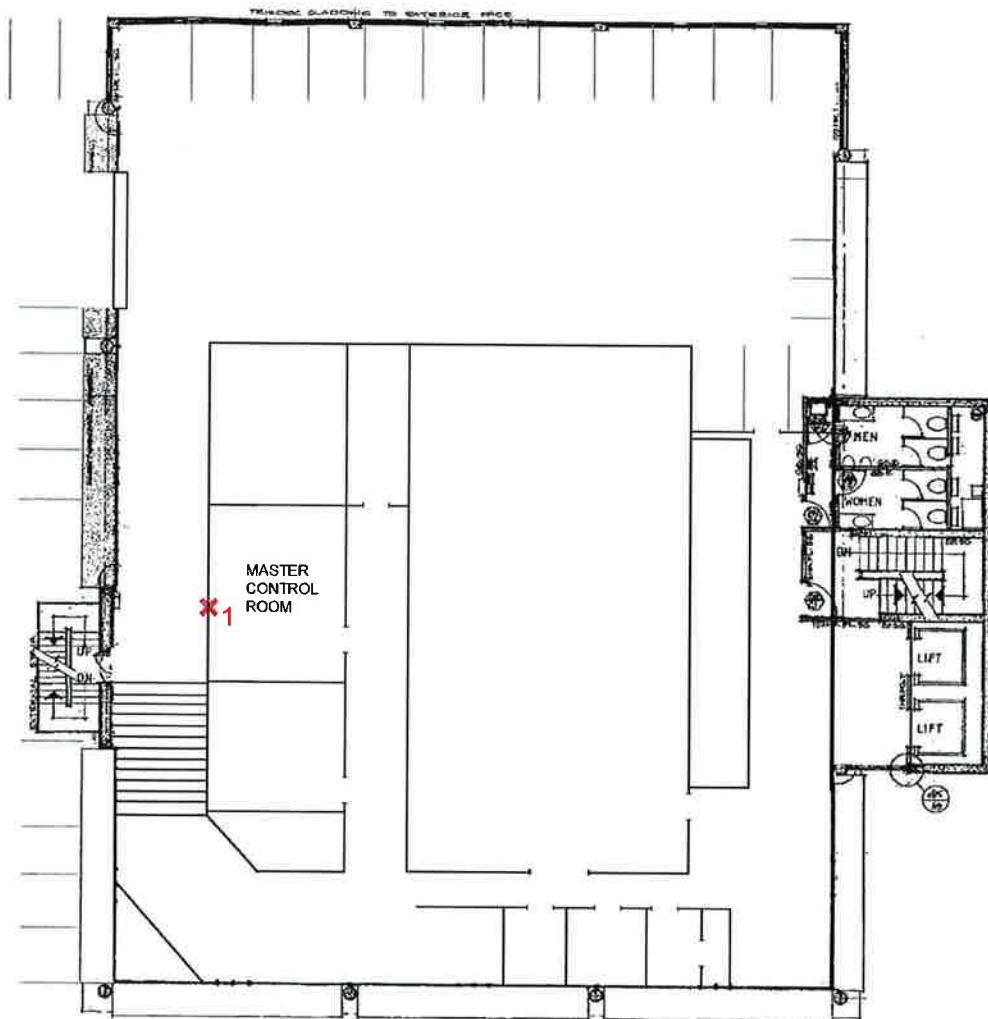
## CTV BUILDING LEVEL 1 (GROUND FLOOR)

- 5 After the September 2010 earthquake I noticed internal cracking in the Master Control Room situated on Level 1. This jagged crack went up on a diagonal and was about 1 metre long. I have marked this area with the number "1" on Plan 1. I recall either 2 or 3 people inspecting this crack and taking photos of it after the September 2010 earthquake. I do not know where they were from.

1. Cracking on wall of master control room
2. Cracking in Archives Room
3. Approximate location of other cracks on west wall

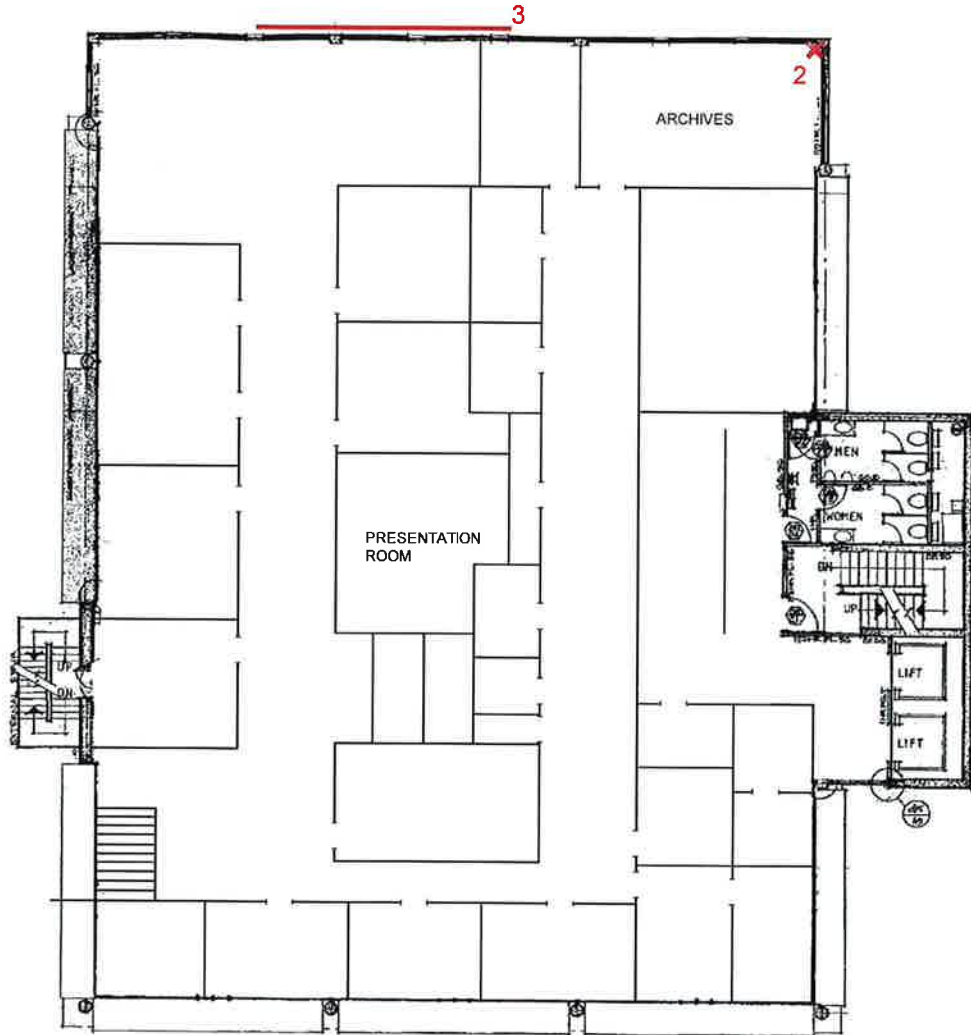
CTV BUILDING  
LEVEL 2

- 10 I occasionally worked in Archives in the north-west corner of Level 2. After the Boxing Day earthquake there were cracks in the corners of the walls in that area. You could see little holes, about pinhole size, with daylight coming through them. I have marked this area with the number "2" on Plan 1. I remember there were also cracks in the internal plaster walls and gaps in the brick further along the west wall where daylight shone through, but I am unsure of the exact locations of these. I have marked the approximate location on the west wall with the number "3" on Plan 1.

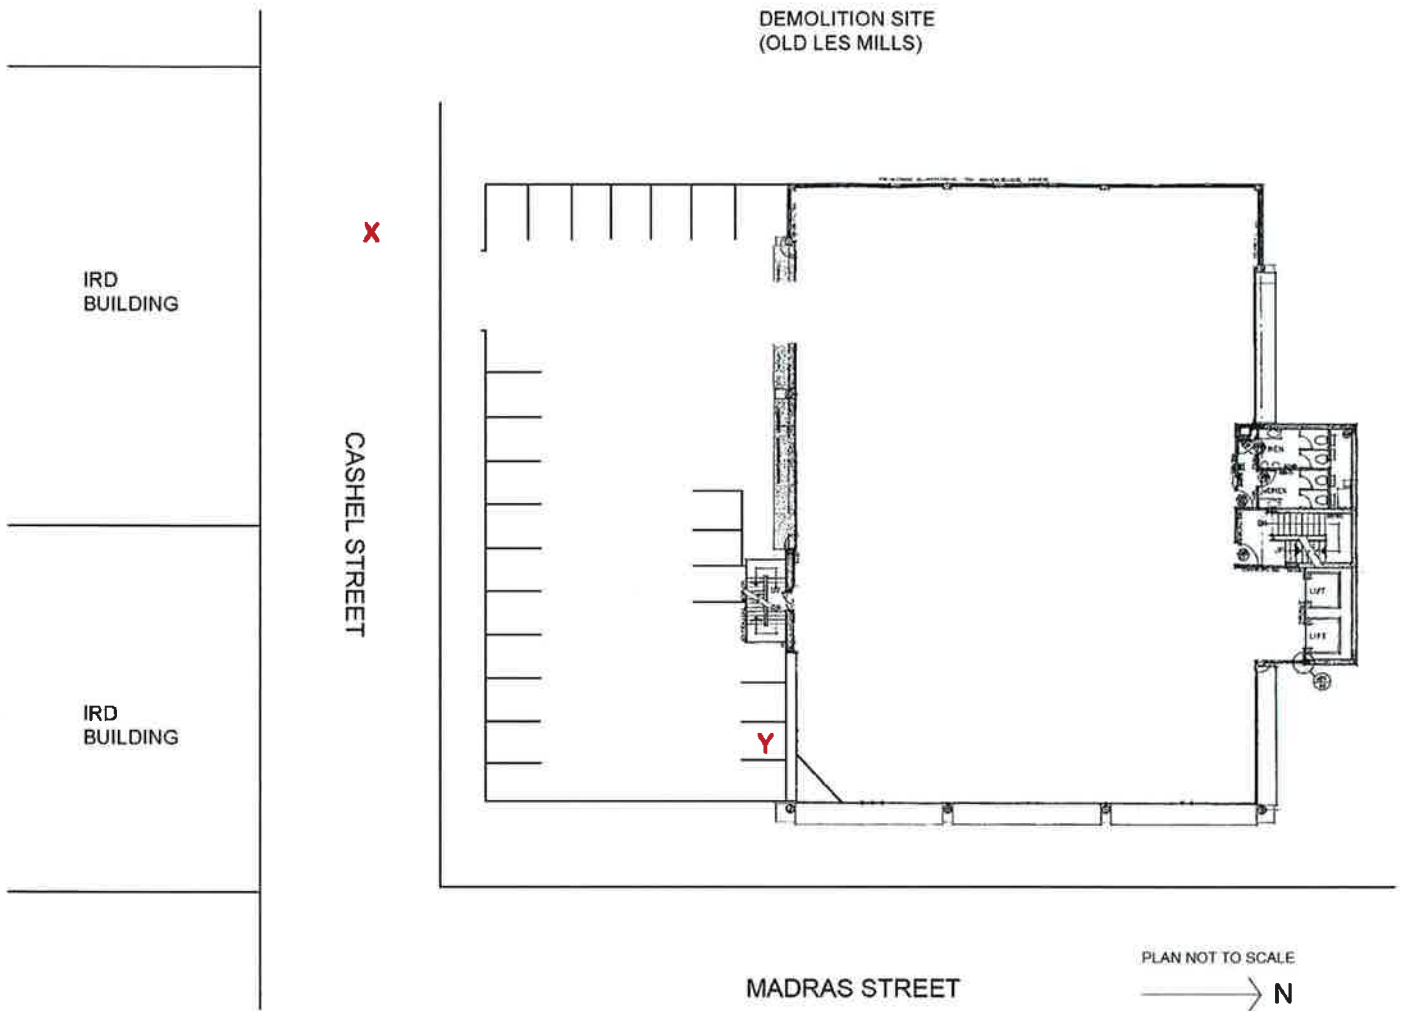
## 249 MADRAS STREET SITE PLAN

- 18 The Building was directly in front of me. I have drawn another Plan (Plan 2) of the outside of the Building. Annexed hereto and referenced WIT.HAWKER.0001.8 is a copy of Plan 2. I have marked with an "X" to indicate where I was standing on Cashel Street. I could see the entire south side and the south west corner of the Building.

- 19 I watched the Building shake violently for about 5 seconds. I saw cracking appear on Level 5 and then this Level collapsed first and sort of pancaked down, which in turn pancaked the rest of the floors below. Level 6 fell as a whole, it stayed intact as it fell and did not collapse until it hit the rubble at the bottom. The sound was horrific.

- 21 I had thought because of the way the Building was swaying it might fall towards us but it fell straight down. I know this because my car was parked right beside the south wall of the Building and I have marked its location with the letter "Y" on Plan 2. Only my bonnet, bumper and windscreen were damaged. A photograph of my car showing the damage was taken after it had been removed from the Building site. A copy of that photograph is annexed hereto and referenced WIT.HAWKER.0001.9.
