**ROYAL COMMISSION OF INQUIRY INTO
BUILDING FAILURE CAUSED BY CANTERBURY
EARTHQUAKES**

THE CTV BUILDING COLLAPSE

**STATEMENT OF EVIDENCE OF LEONARD FORTUNE
IN RELATION TO THE CTV BUILDING**

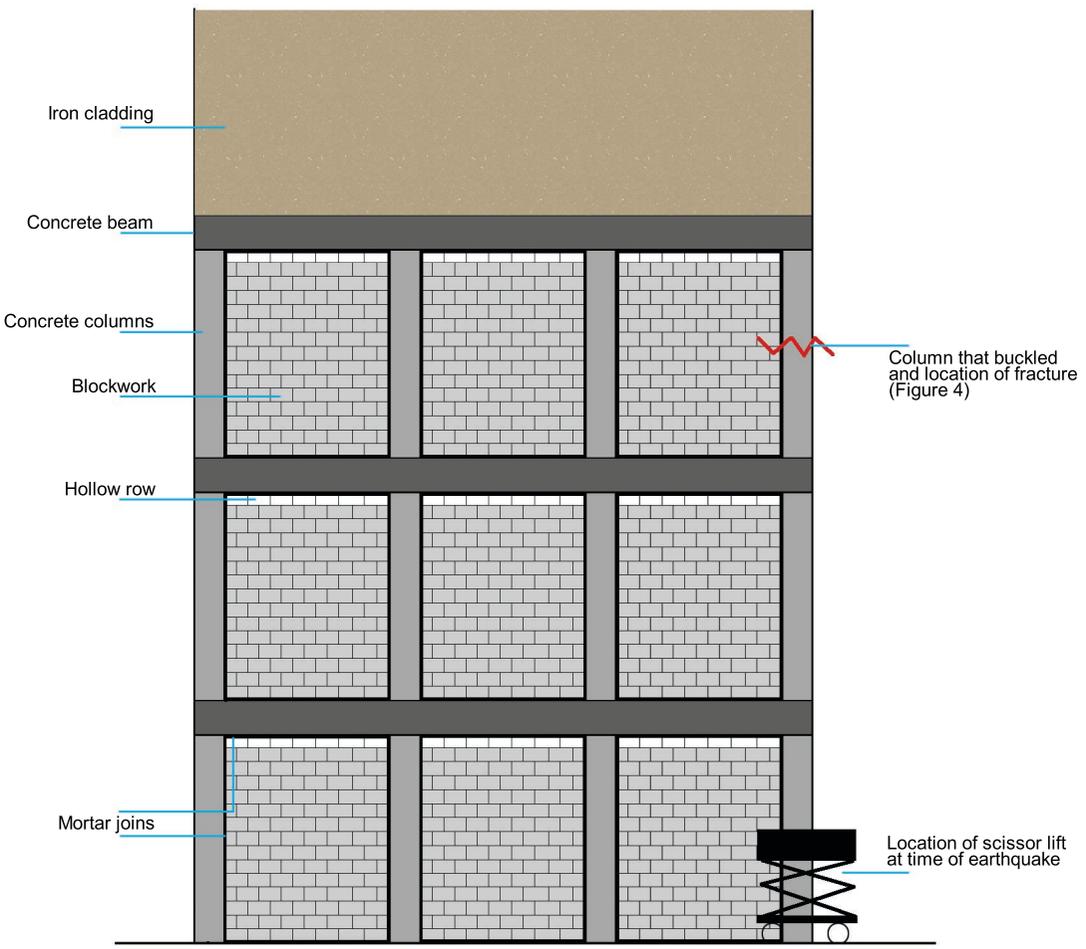
Figure 1
Western wall

involved recladding the first three storeys of the Building to meet up with the existing iron cladding on the western side (Figure 1). The work began on Monday, 21 February and was expected to take a couple of days to complete. Working on the wall with me were Bruce Campbell, director of the company, and James Askew, a labourer.

12. I remember the horizontal beam was one single structure. The columns were then fused to it with concrete. There were no gaps in the joins (Figure 1).

21. I then looked back at the Building to make sure nothing was coming down. It was then that I saw a column on the southwest corner of the Building, between Levels 3 and 4, that had cracked in the middle. This column - and the location of the fracture - is shown in Figure 1 (“**B**”). It appeared to me like the two bits held together by the steel had fractured outwards and the whole column was buckling under the weight. This is shown in Figure 4. It looked like the fractured sections were sticking out towards the west by about 300 millimetres.

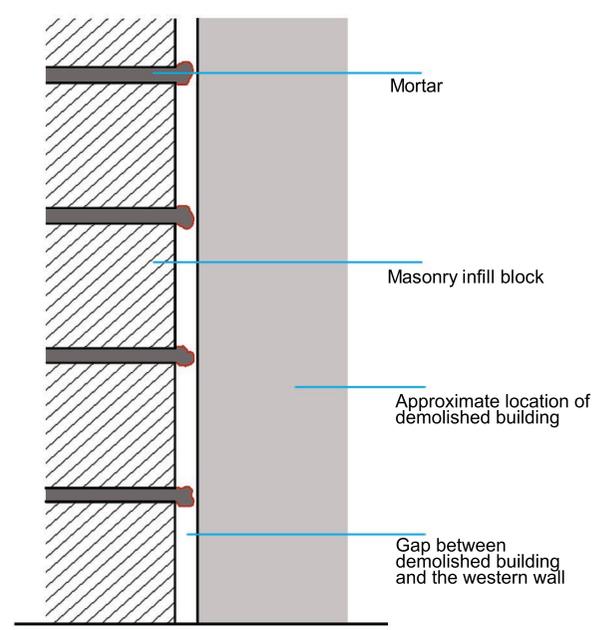
Figure 3
Western Wall Cross Section

9. The masonry infill blocks (masonry blocks) had been laid in a brick bond formation held together by mortar (Figure 3). Mortar was used to join the blockwork to the columns and horizontal beam. There were no gaps in the joints (Figure 1).
10. The top rows of masonry blocks in each section of blockwork were hollow (Figure 1). It may be that these masonry blocks could not be filled with concrete with the beam in the way.
11. I noticed other hollow masonry blocks too, but these seemed to exist in the blockwork at random. It seemed to me like the concrete hadn't filled all of the masonry blocks properly when it was poured, perhaps due to the masonry blocks not being lined up correctly.
