**ROYAL COMMISSION OF INQUIRY INTO
BUILDING FAILURE CAUSED BY CANTERBURY
EARTHQUAKES
KOMIHANA A TE KARAUNA HEI TIROTIRO I
NGA WHARE I HORO I NGA RUWHENUA O
WAITAHA**

**BRIEF OF EVIDENCE OF ROBERT JAMES HEYWOOD
IN RELATION TO THE CTV BUILDING**

BRIEF OF EVIDENCE OF ROBERT JAMES HEYWOOD IN RELATION TO THE CTV BUILDING

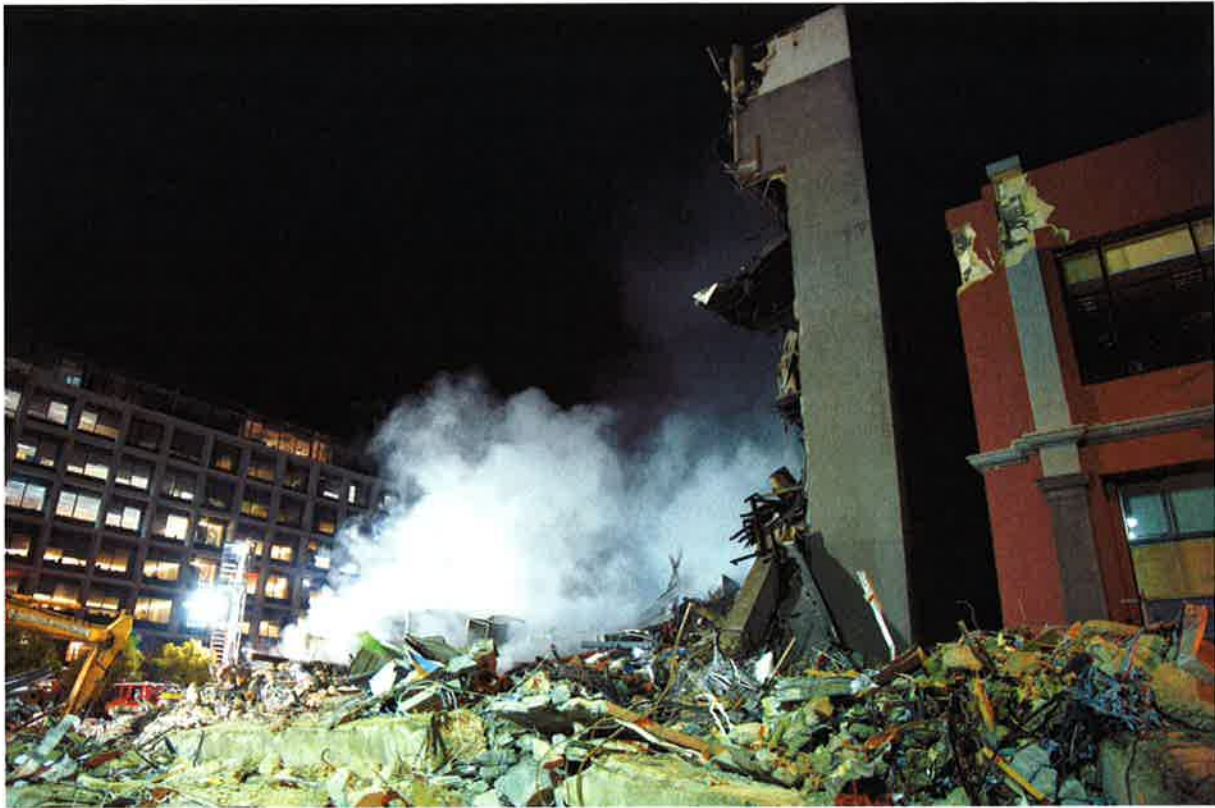
Figure 4

My initial observation of the CTV Building from Madras Street looking southwest. Some remnants of the floor slabs were hanging from the North Core on Level 6. Concrete beams and precast panels were on top of the pile of debris adjacent to the North Core. An excavator was stockpiling debris on Madras Street. (4:00 AM 24 Feb 2011)

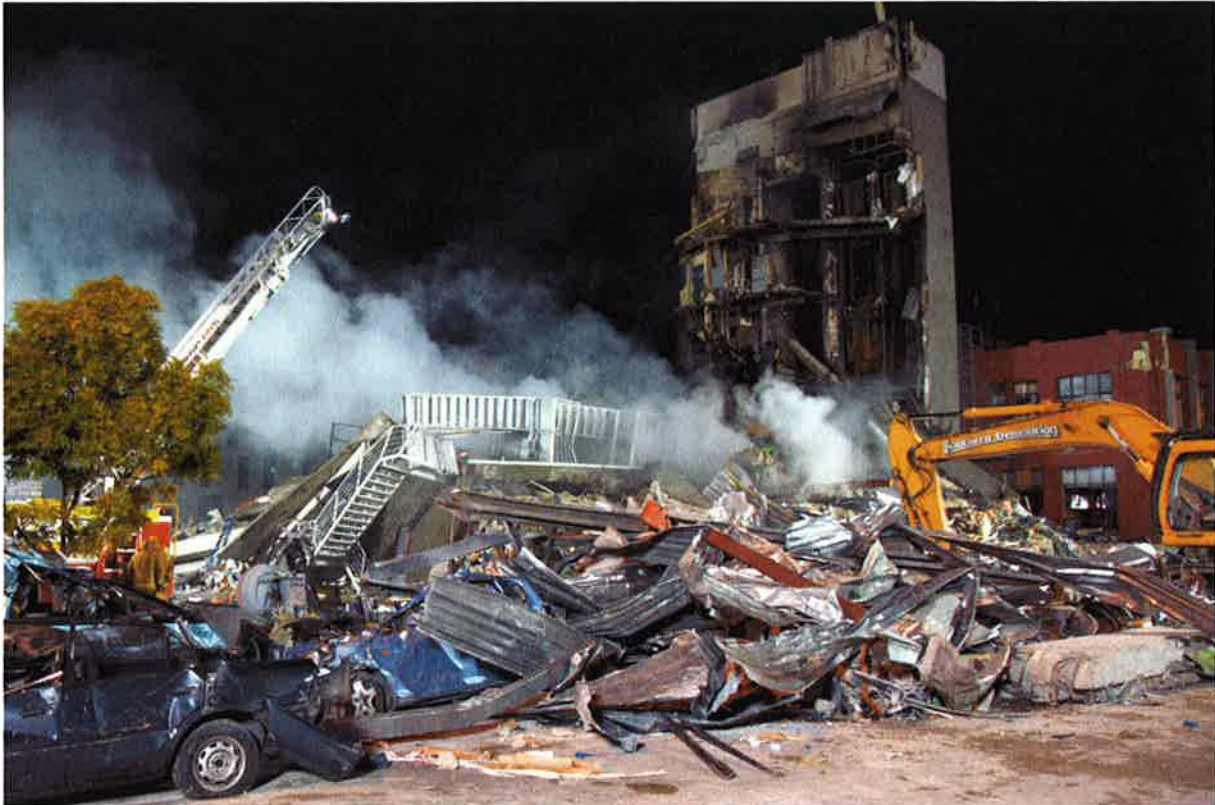
Figure 5

The CTV Building seen from the corner of Cashel and Madras Streets on arrival. The burnt North Core remained standing and smoke was rising from the Building rubble with the fire brigade in attendance. An excavator was working removing rubble and stockpiling it in Madras Street. The external stairs and their supporting South Wall had collapsed onto the Building. Most of the material in the foreground appeared to have been relocated (4:00 AM 24 Feb 2011).

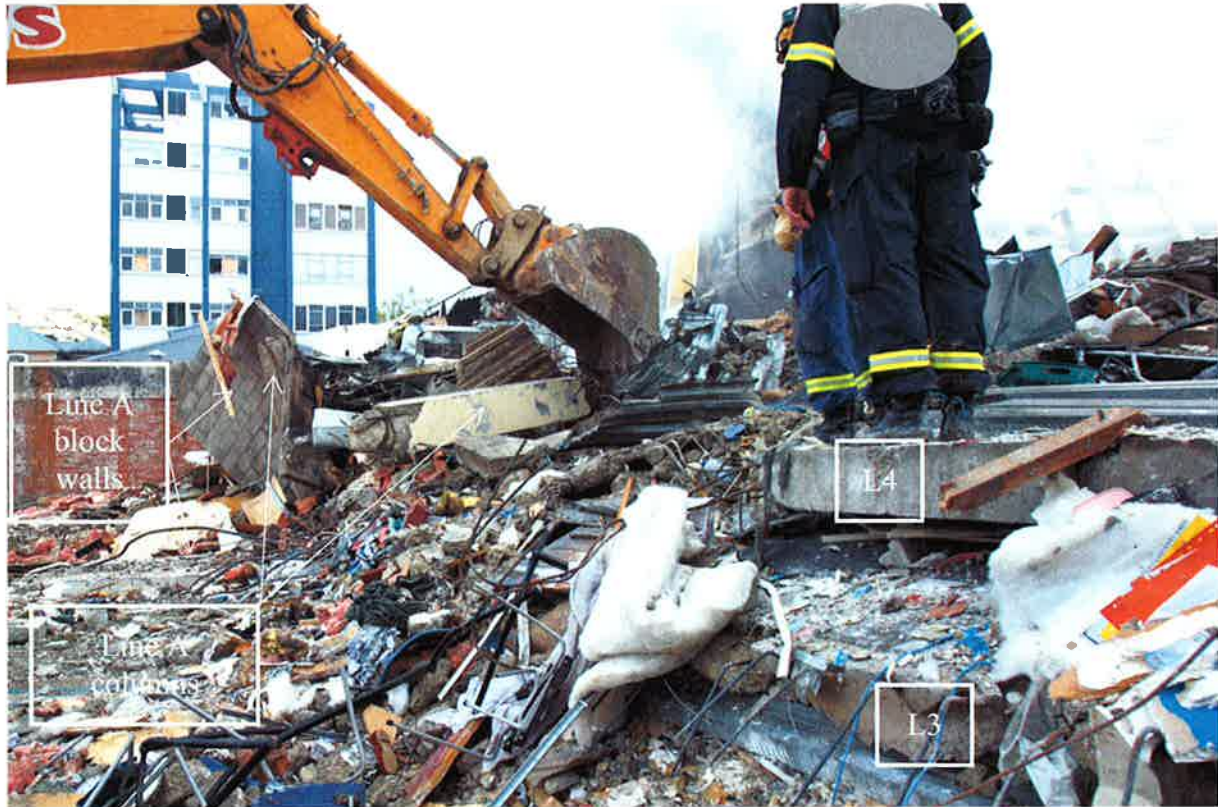
Figure 6

An excavator removing a column from the western face (Line A) of the CTV Building viewed from midway between Line 1 and 2 towards the north. There is one segment of the block wall standing in the background and one other segment on the ground. The “smooth” edges of two floor slabs (Line A) are evident with the Hi Bond metal decking separated from the underside of the lower slab (6:30 AM 24 Feb 2011).

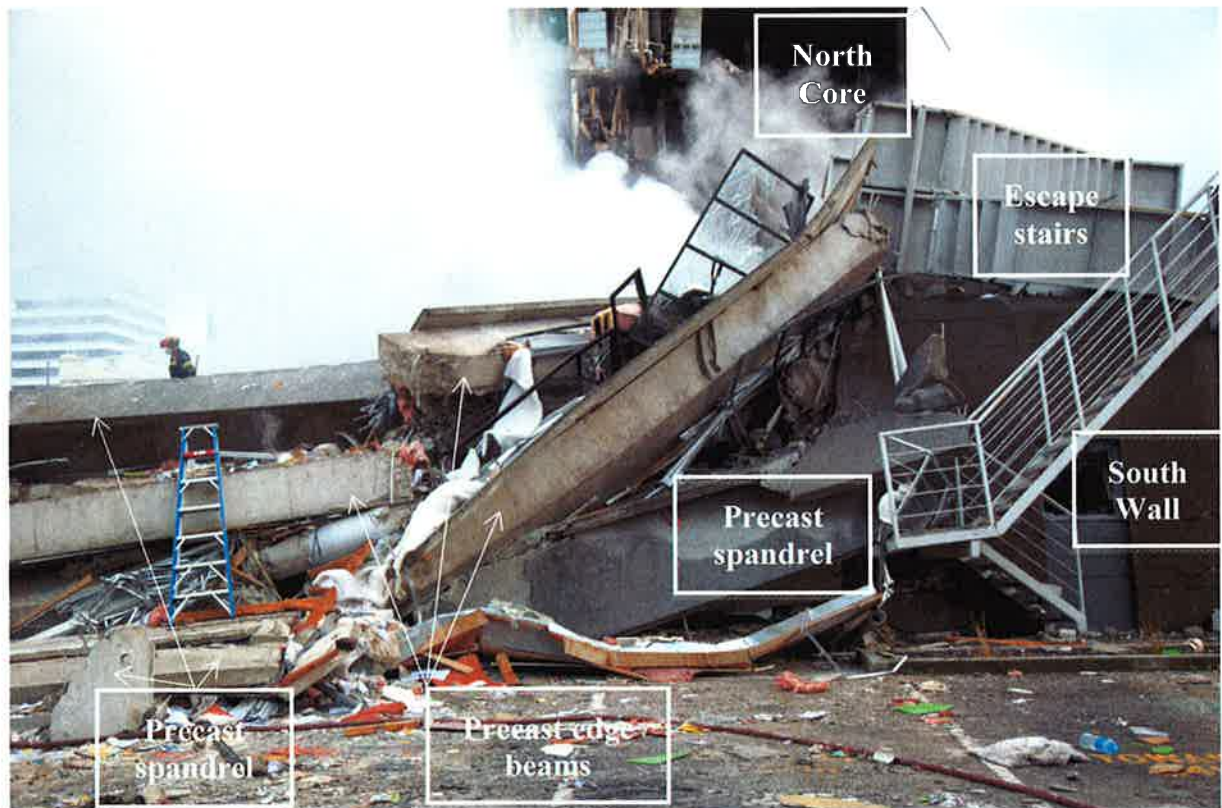
90. The west, south and east perimeter, including the exterior columns, of the Building had been substantially altered before my arrival.
91. The circular columns on the eastern elevation of the Building had been removed before my arrival. Some segments of the circular columns (C2 and C3) were on site. These had broken into pieces that were a storey length or less (refer Figure 7 [WIT.HEYWOOD.0001.36]).

Southern elevation of the Building to the west of the South Wall showing precast spandrel beams and their supporting edge beams, and an external circular column (6:20 AM 24 Feb 2011).

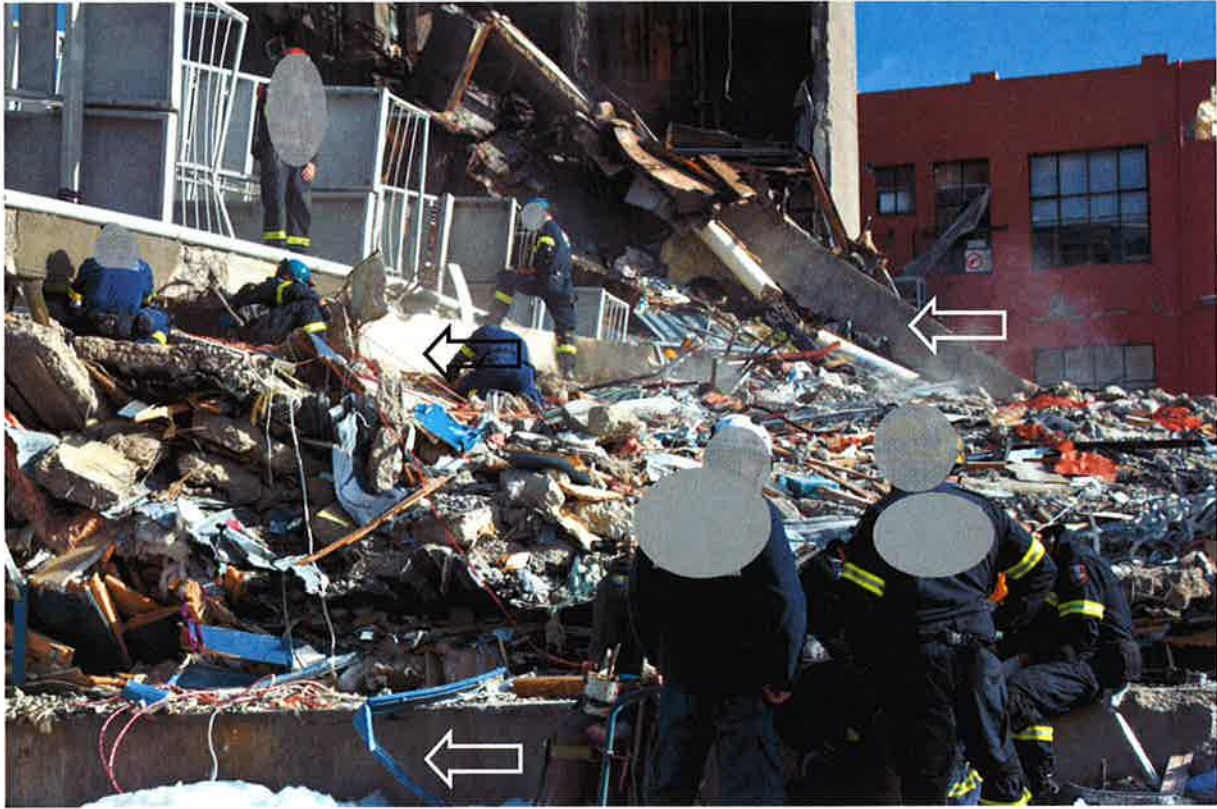
Figure 8

The collapsed South Wall lies on top of the debris. A Line 1 edge beam is in the foreground. A second line 1 edge beam lies on top of the debris almost parallel to the collapsed South Wall. A Line 4 edge beam lies on the rubble in front of the North Core and beside Column C18. The arrows indicate the edge beams (8.30 AM 24 Feb 2011).

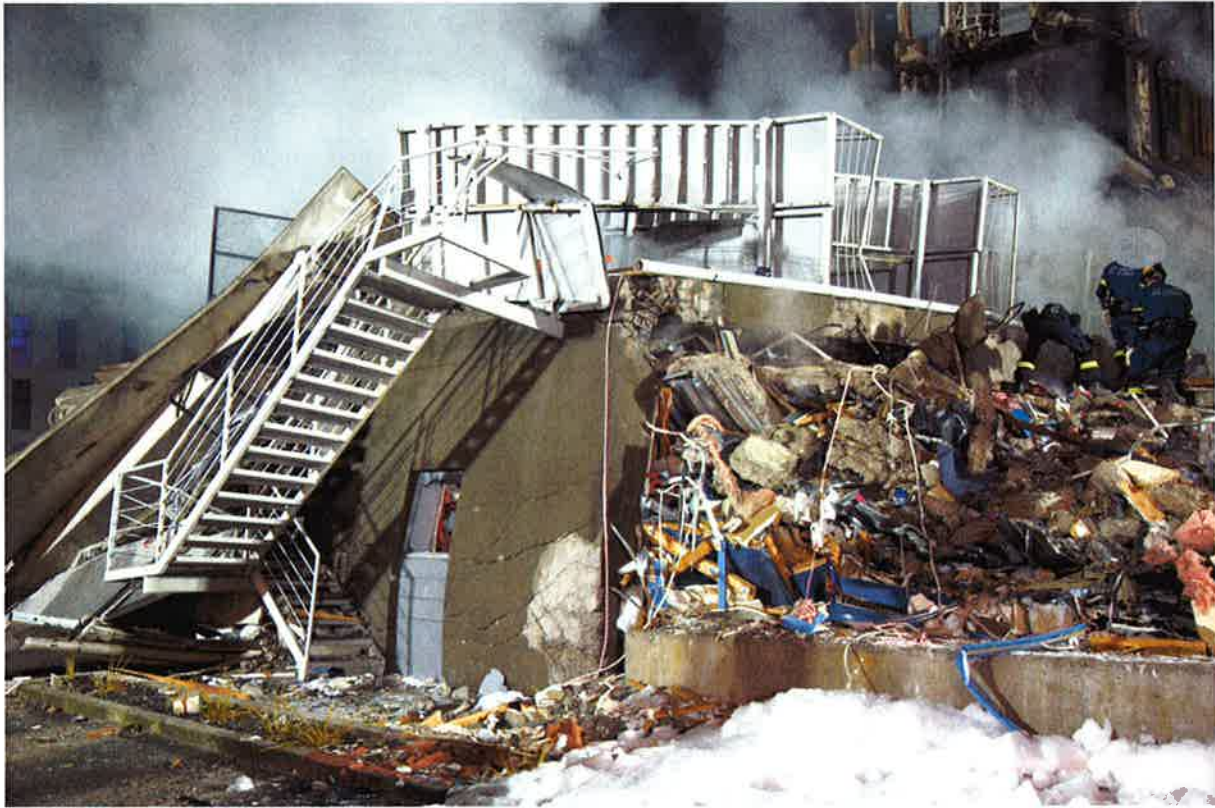
Figure 9

View of South Wall and fire escape stair collapsed onto the Building. The wall “hinged” about a line parallel to its base at about Level 2. The edge beams are no longer attached to the lower levels on the eastern side of the South Wall (4:30 AM 24 Apr 2011).

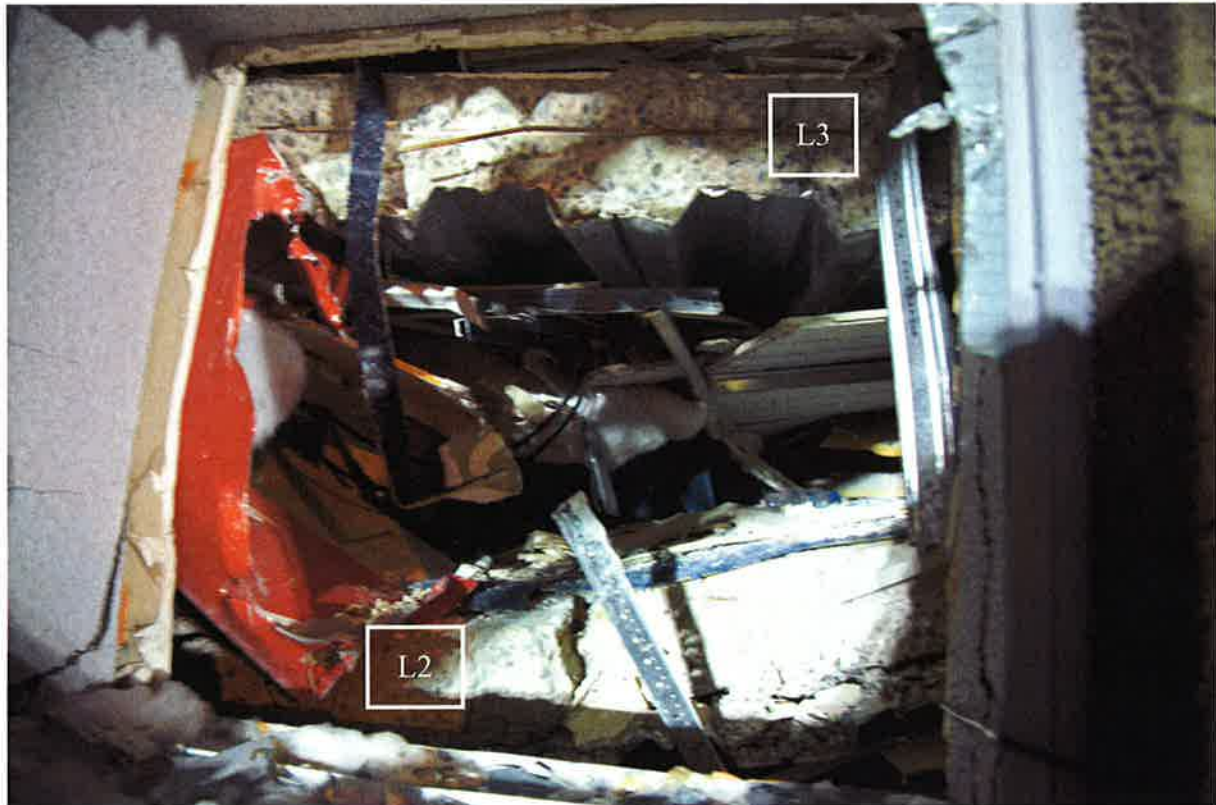
35. Figure 10 [WIT.HEYWOOD.0001.39] and Figure 11 [WIT.HEYWOOD.0001.40] is the view inside the Building through the broken window in the South Wall that can be seen in Figure 9 [WIT.HEYWOOD.0001.38]. The severed edges of two floor slabs are visible through the broken window. Their position suggests that the floor slabs are from Level 2 and Level 3. This is consistent with the observations that follow. The carpet varied from floor to floor and this may assist in identifying the levels of the floor slabs. The "664 mesh" used as reinforcement in the top of the slab consists of 6 millimetres (1/4 inch) diameter wires welded together at 150 millimetres (6 inch) centres to form a square grid. The Hi Bond metal decking used as formwork and reinforcement for the concrete floor slabs is visible on the outside of the floor slabs.

Two slabs were visible through the opening in the South Wall immediately below the escape stair landing at Level 2. The Hi Bond metal decking is visible below the two levels of slab.

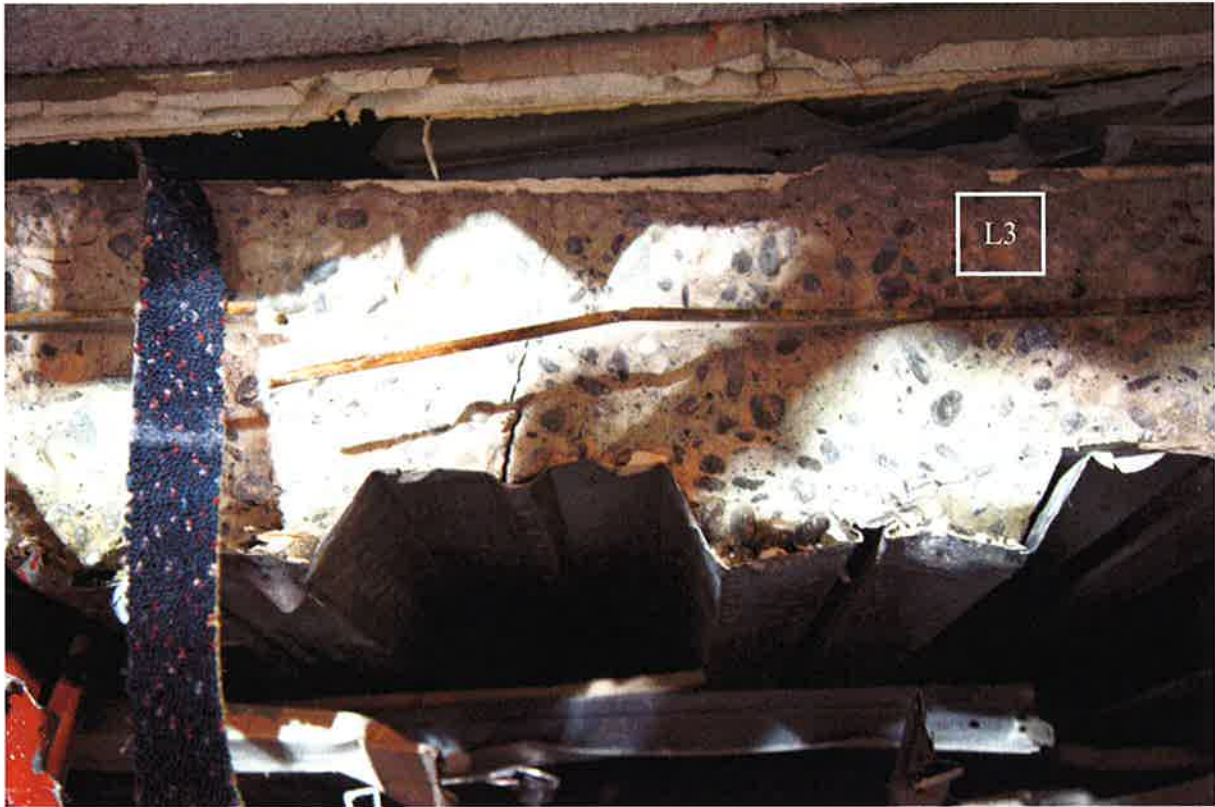
Figure 11

A close-up of the upper slab showing fracture surface through the concrete, the “664” mesh reinforcement and the Hi Bond metal decking.

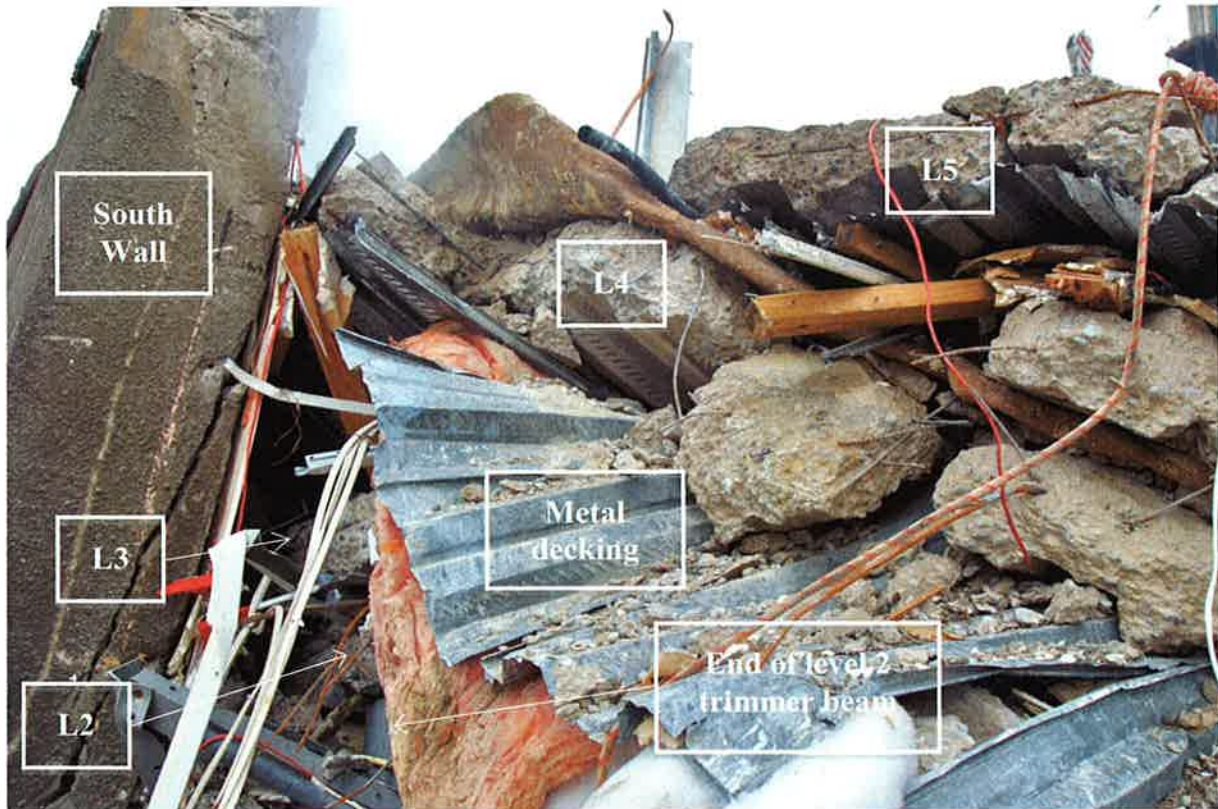
Figure 12

Southern edges of floor slabs from Levels 2 (L2), 3 (L3), 4 (L4) and 5 (L5) immediately to the east of the South Wall on Line 1 (7:20 AM 25 Feb 2011).

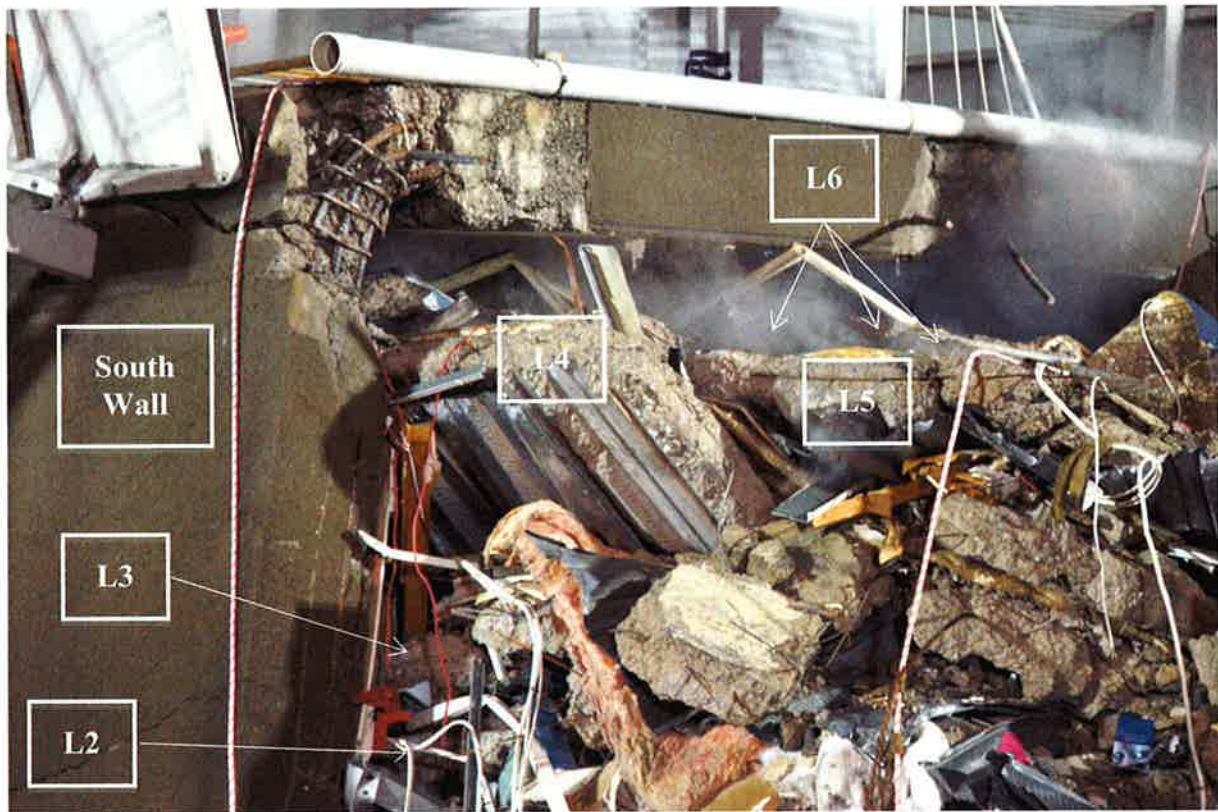
Figure 13

Southern edges of L2, L3, L4, L5 and L6 floor slabs immediately to the east of the South Wall on Line 1 (4:30 AM 24 Feb 2011).

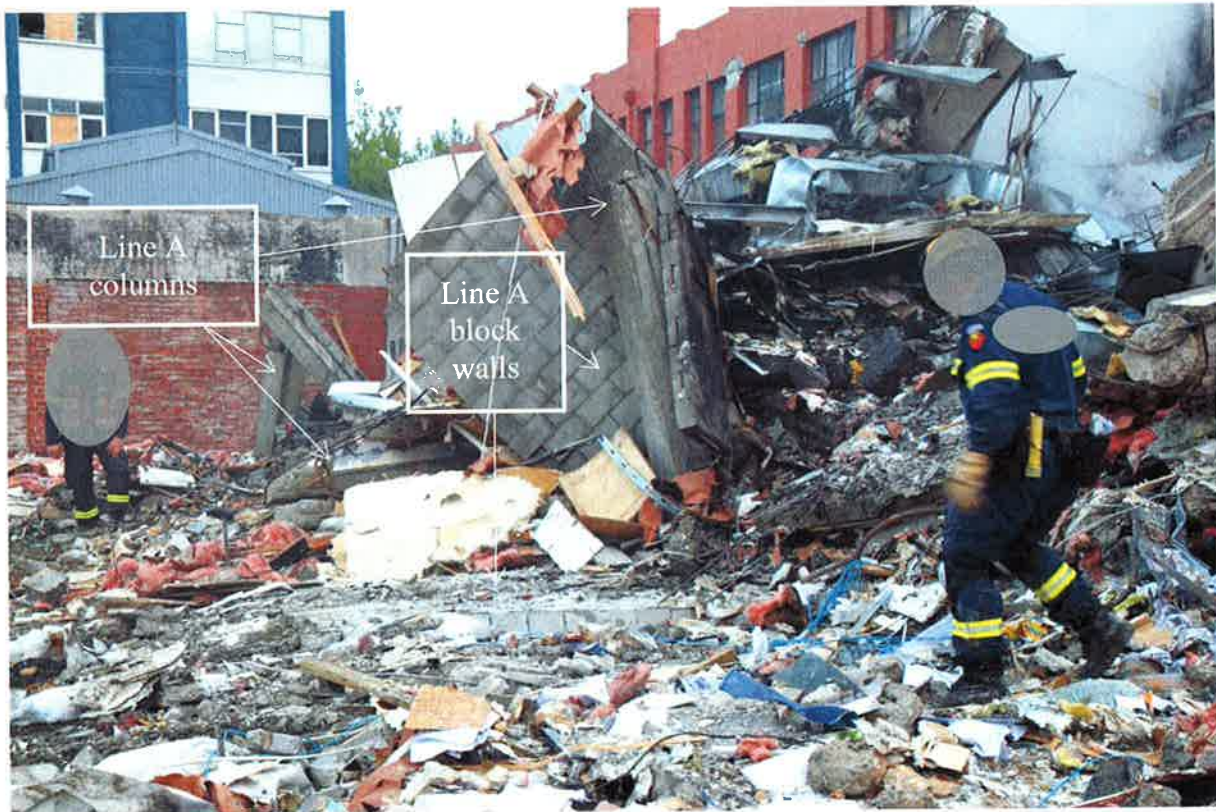
Figure 14

Segments of Line A columns connected by exposed steel column reinforcement (6:30 AM 24 February 2012).

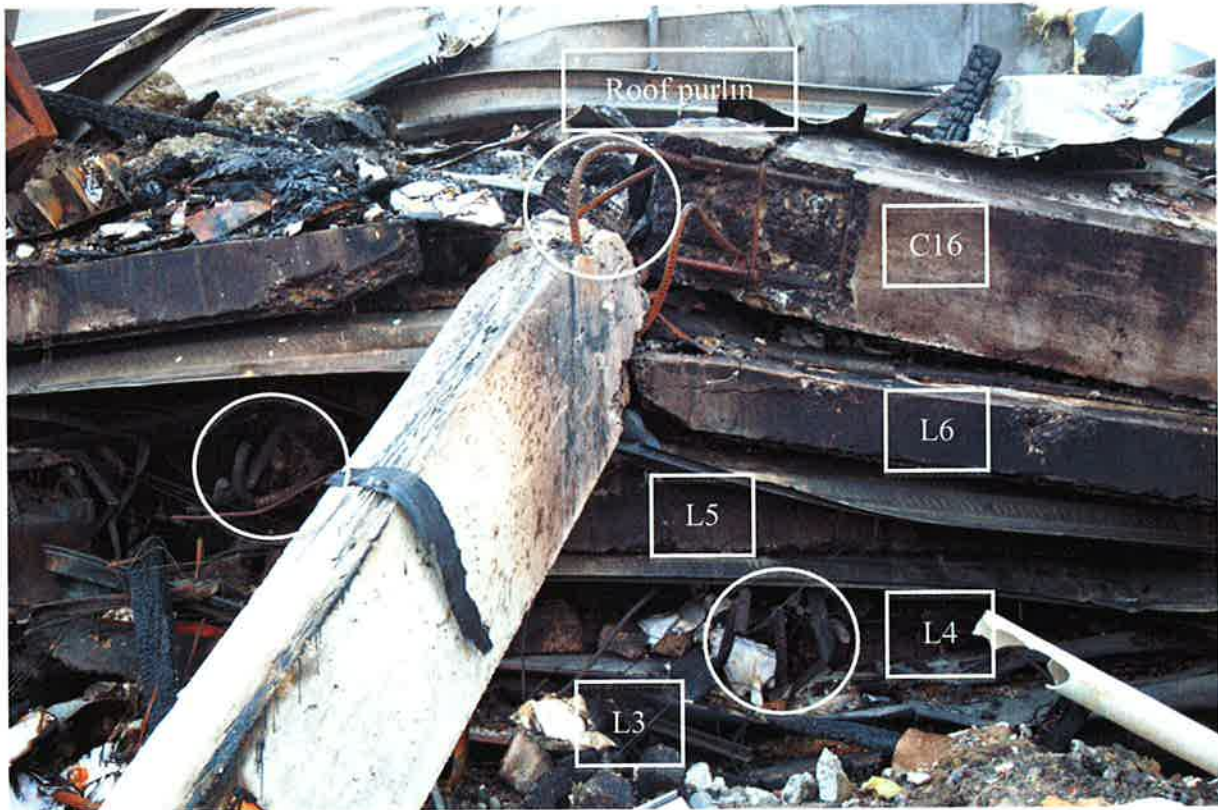
Figure 15

43. The ends of the internal floor beams that were once connected to the rectangular columns are circled in Figure 15. The concrete at the ends of the internal floor beams was missing, revealing the bent ends of the beam reinforcement. These bars were specified on the drawings to be bent up and down by 90 degrees (refer Details 1 and 2 of Drawing S19, and B05 and B10 on Drawing S20). The 90 degree bends specified on the drawings are still obvious, but there has been some additional deformation, likely attributable to the collapse.

Collapsed slabs lie on top of each along Line A. The ends of the Line 3 internal beam reinforcement have been circled and floor levels of the slabs labelled.

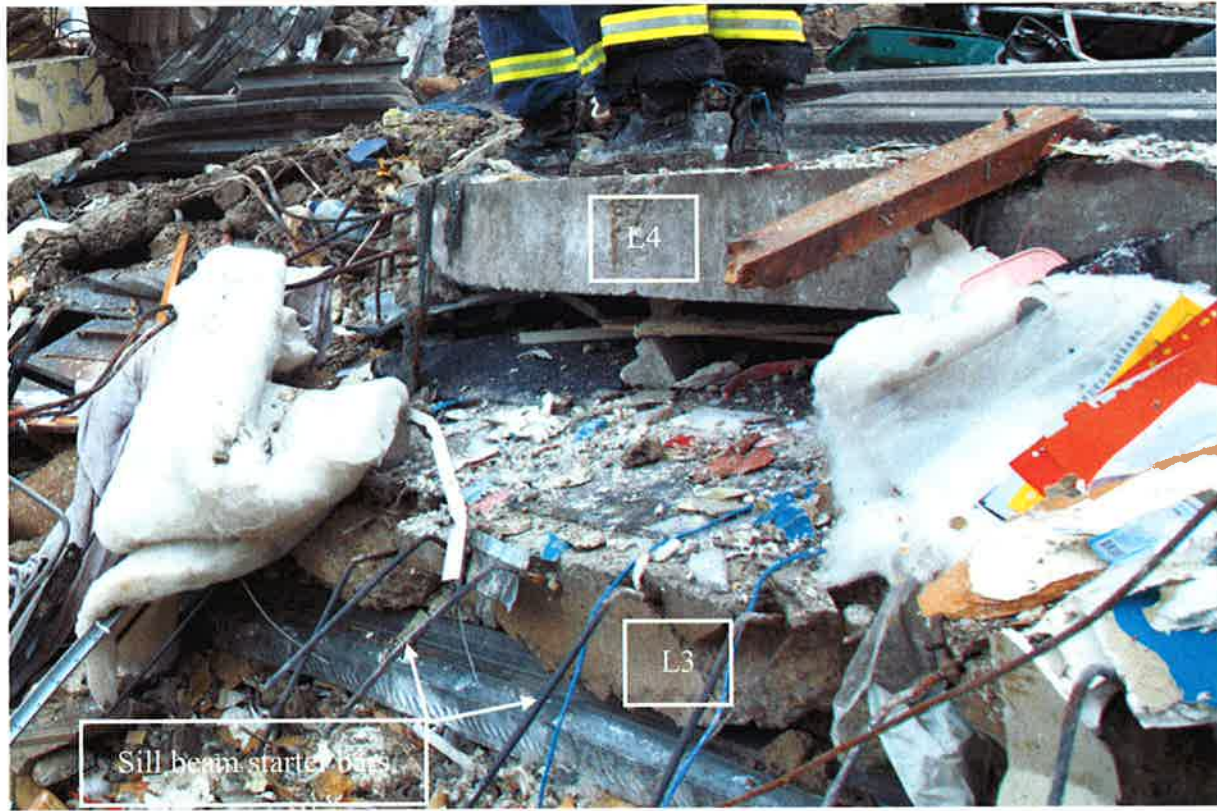
Figure 16

Sill beam starter bars in the edges of the Level 3 floor slab on Line A (6:30 AM 24 February 2011).

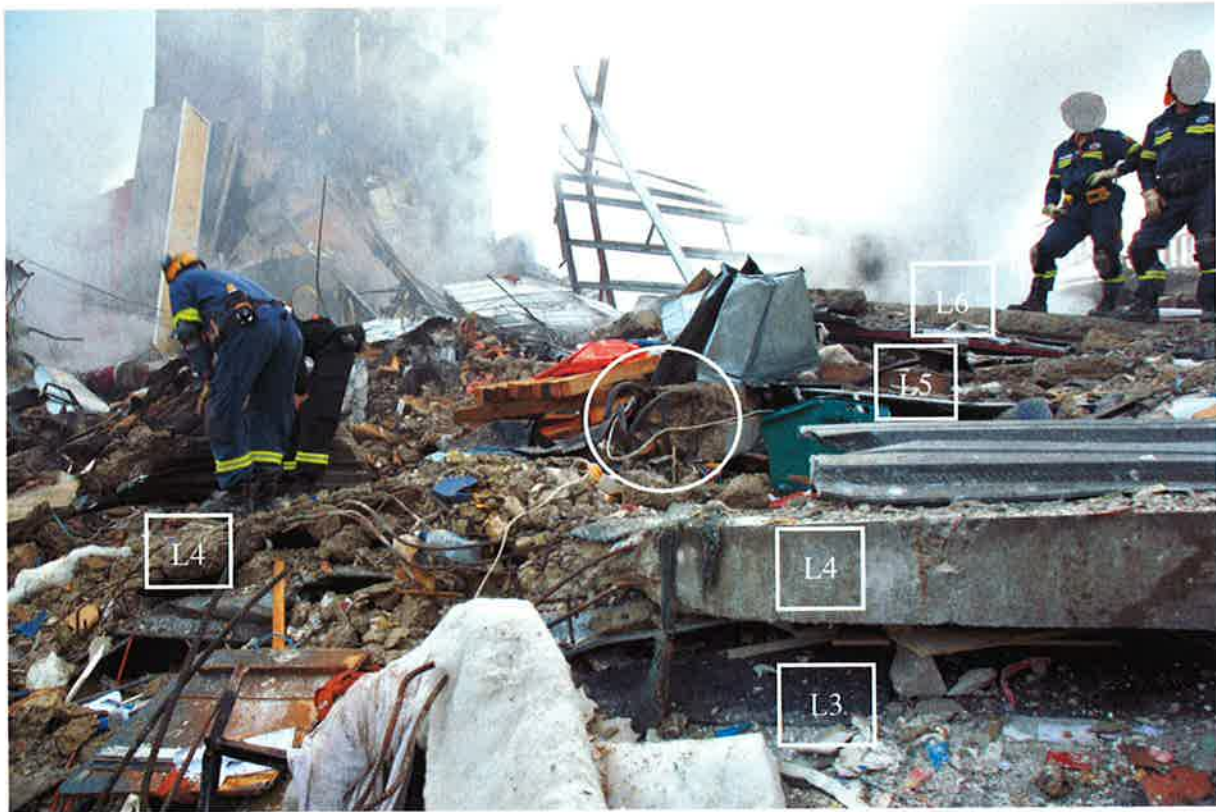
47. It is not possible to observe where the edges to the Level 5 and Level 6 floor slabs fell in relation to Line A as their edges are broken, possibly from search and rescue operations (Figure 17 [WIT.HEYWOOD.0001.46]). The position end of the Level 5 floor beam circled in Figure 17 suggests that Level 5 came to rest some distance (1.5 metres say) to the east of the Level 4 slab edge.

125. Other examples that show the internal beams separated from the floor slabs are presented in Figure 17 [WIT.HEYWOOD.0001.46] and Figure 26 [WIT.HEYWOOD.0001.55]. The failure surface can be seen on an internal beam after its removal from the rubble in Figure 49 [WIT.HEYWOOD.0001.78].

View of the edges of the slabs near Line A looking towards the North Core from near the southwest corner of the Building (6:30 AM 24 February 2011).

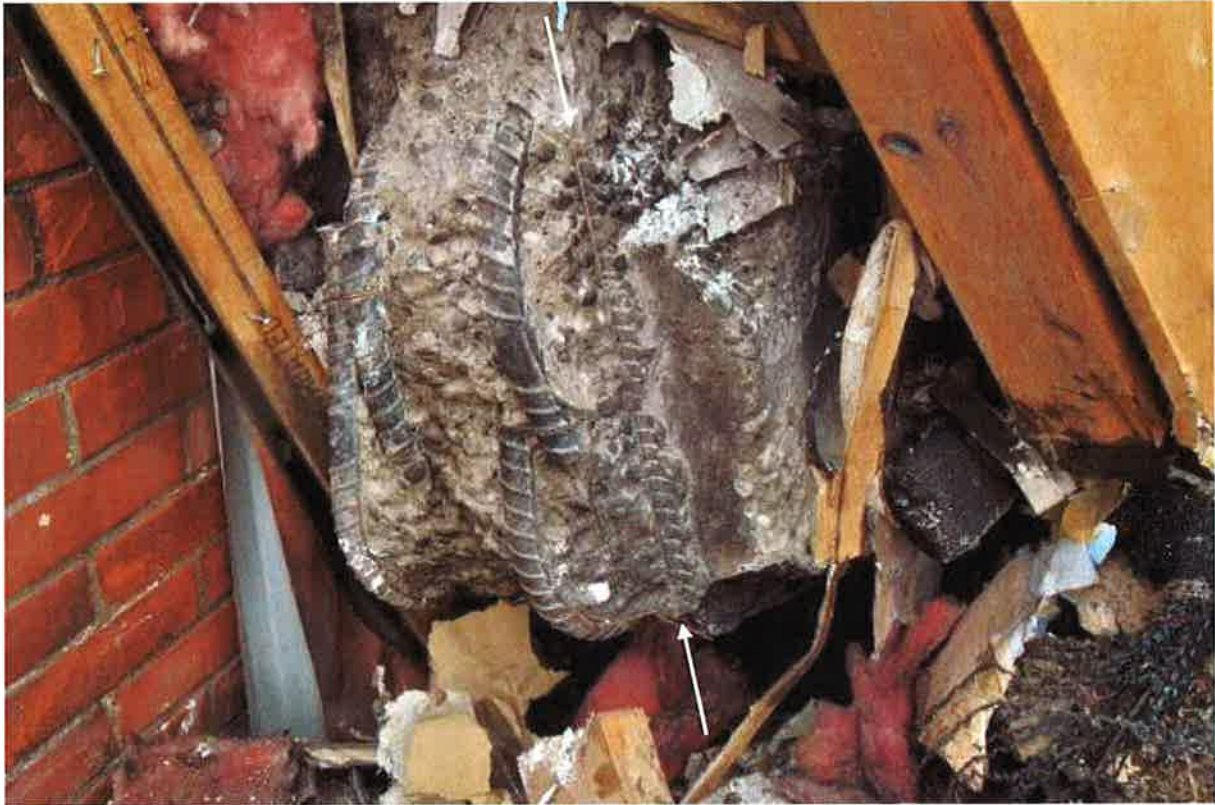
Figure 20

This western end of a northern narrow edge beam (Line 4) came to rest at the base of the brick wall to the adjacent covered car park.

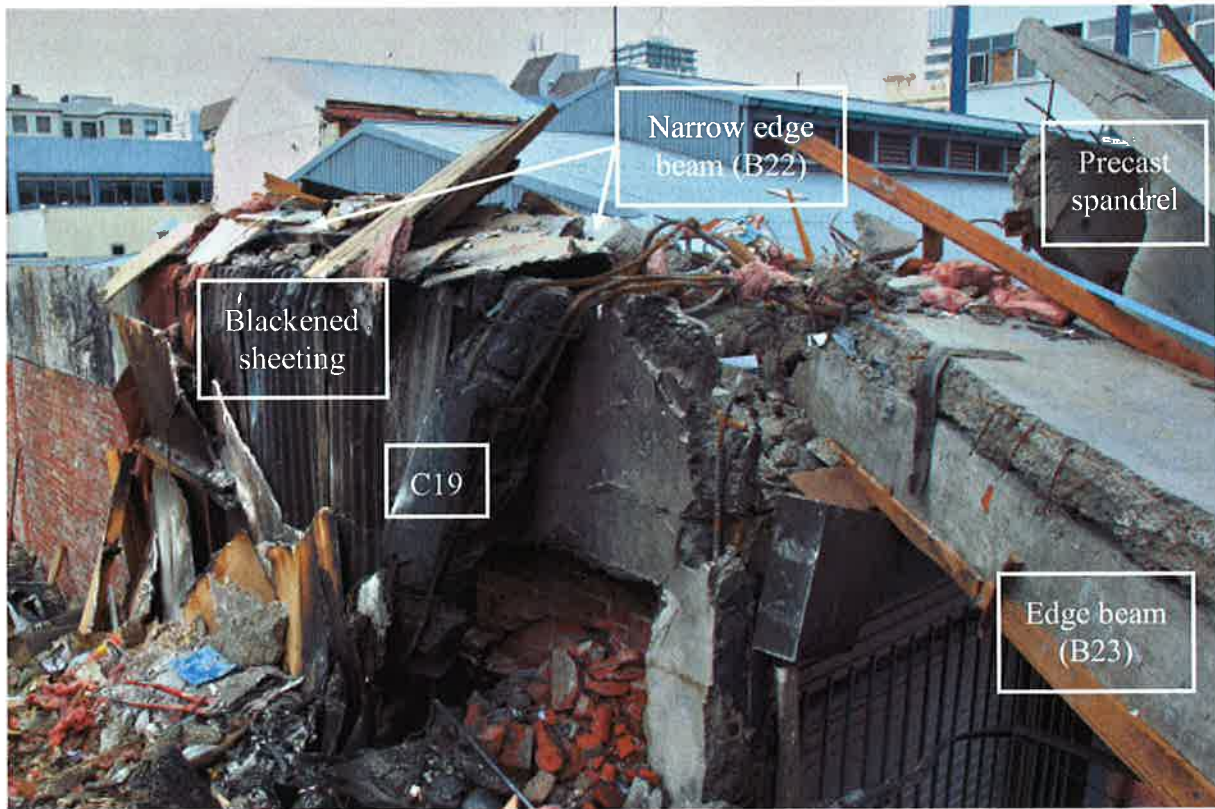
57. Figure 22 shows the edge and spandrel beam B23 and column C19, when viewed from near the lift core looking northwest. The narrow edge beam (B22) to the west of C19 lodged on the car park roof an estimated 5 to 6 metres north of its “as built” position. The concrete in the junction between C19, B22 and B23 has disappeared – only the reinforcement remains. The connections between the edge beams and the slabs they supported have been severed – the concrete has broken, the reinforcement has failed in tension and the Hi Bond metal decking is no longer attached.

112. Examples of the vertical failure surface indicated by the solid line in Figure 43 are shown in Figure 22 [WIT.HEYWOOD.0001.51], and Figure 40 [WIT.HEYWOOD.0001.69]. In these cases, both the mesh reinforcement and the supplementary reinforcement have failed in tension.

View of the northwest corner of the Building viewed from the collapsed Building looking to the northwest over the undercover car park (12:00 noon 25 Feb 2011).

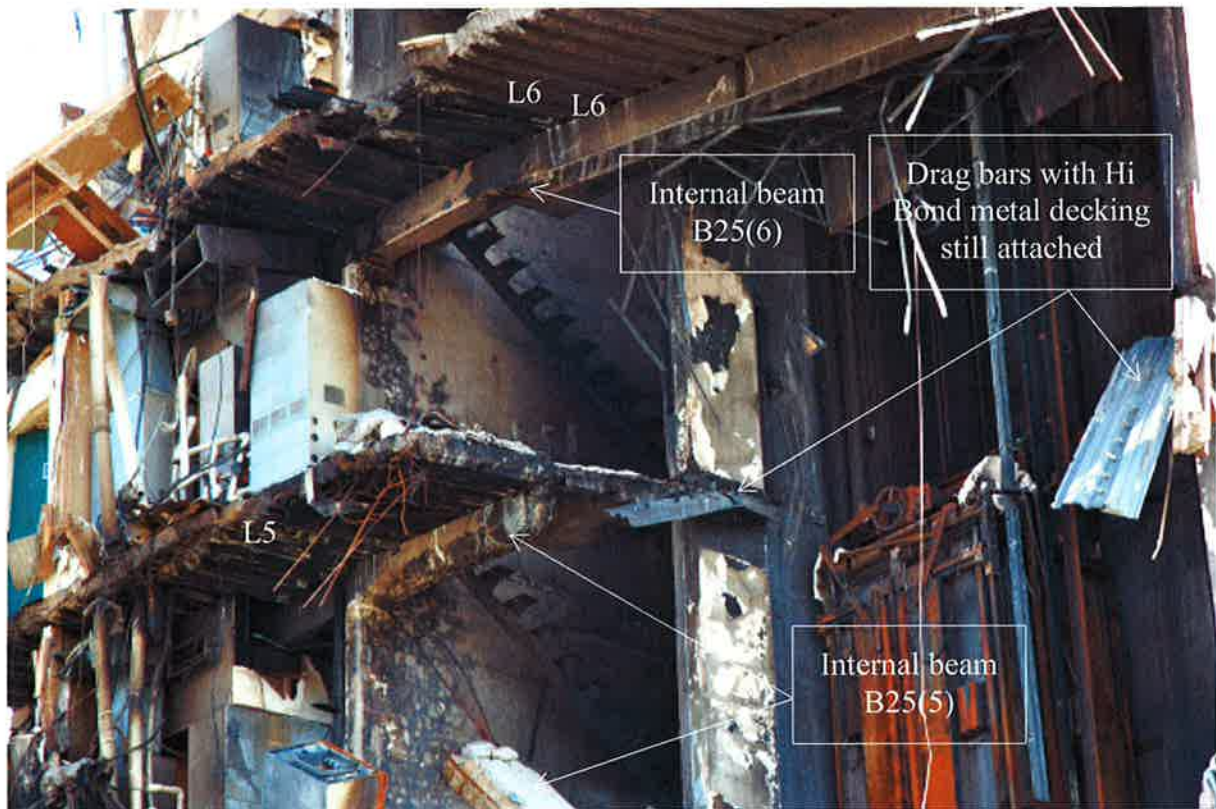
74. Drag bars were installed on Levels 4, 5 and 6 on both sides of the lift well walls of the North Core to provide an earthquake resistant connection between the North Core and the floor slabs. As illustrated in Figure 25 [WIT.HEYWOOD.0001.54], the drag bars did not prevent the slab from detaching from the North Core as either the slab failed around the drag bars (e.g. Level 6) or the slab pulled away from the drag bars (e.g. Level 5).

View of North Core showing lift, remnants of Level 5 and 6 floor slabs, supporting internal beams and Level 5 drag bars (10:30 AM 24 Feb 2011).

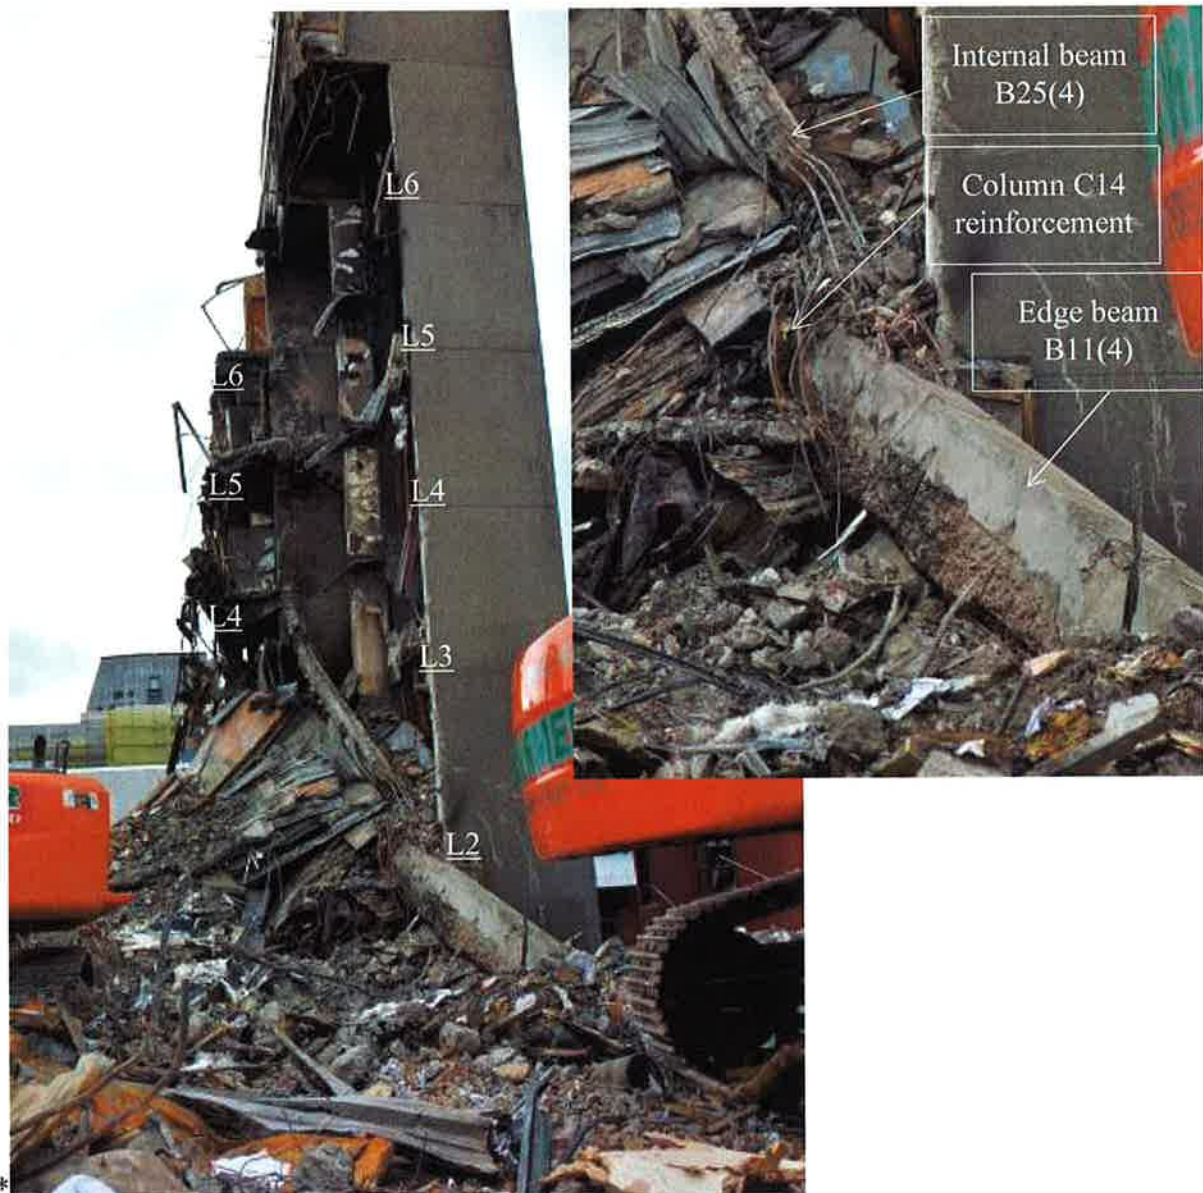
64. Both edge beam B11(5) and B11(4) had been detached from the floor slab. The slab reinforcement had torn out of the concrete on top of the beam B11(4), as indicated by the spall and the reinforcement imprints in Figure 26. The discolouration of the concrete spall suggests that the floor slab had separated from B11(4) before the fire and before the partial removal of the rubble under which it was buried.

113. An example of the vertical and horizontal failure surface, indicated by the dashed line in Figure 43 [WIT.HEYWOOD.0001.72], is shown in Figure 26 [WIT.HEYWOOD.0001.55]. In these cases, both the mesh reinforcement and the supplementary reinforcement have torn from the top surface of the beam, possibly promoted by low concrete cover.

View of North Core looking west after partial removal of rubble (11:45 AM 25 Feb 2011).

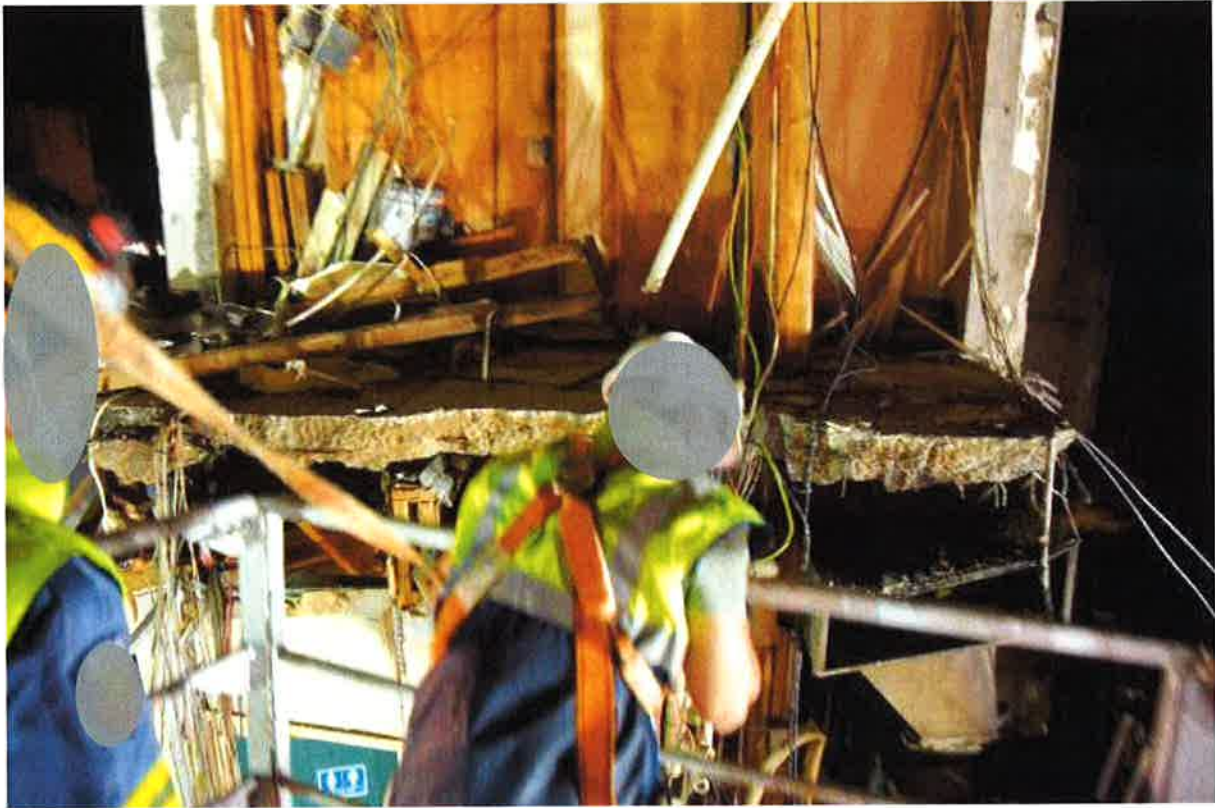
the North Core (refer Figure 25 [WIT.HEYWOOD.0001.54]). The 664 mesh was observed to have failed in tension in the Level 6 failure surface (refer Figure 27 [WIT.HEYWOOD.0001.56]). The downward angle of the exposed mesh and the spalling of the underside of the slab on the left are consistent with some vertical relative movement during failure. The top cover to the 664 mesh appears to be greater than the 30 mm specified on Drawing S15;

View of the edge of the severed Level 6 slab to the south of the amenities in the North Core after the slab had been removed from in front of the stair well and the lift well (1:20 AM 26 Feb 2011).

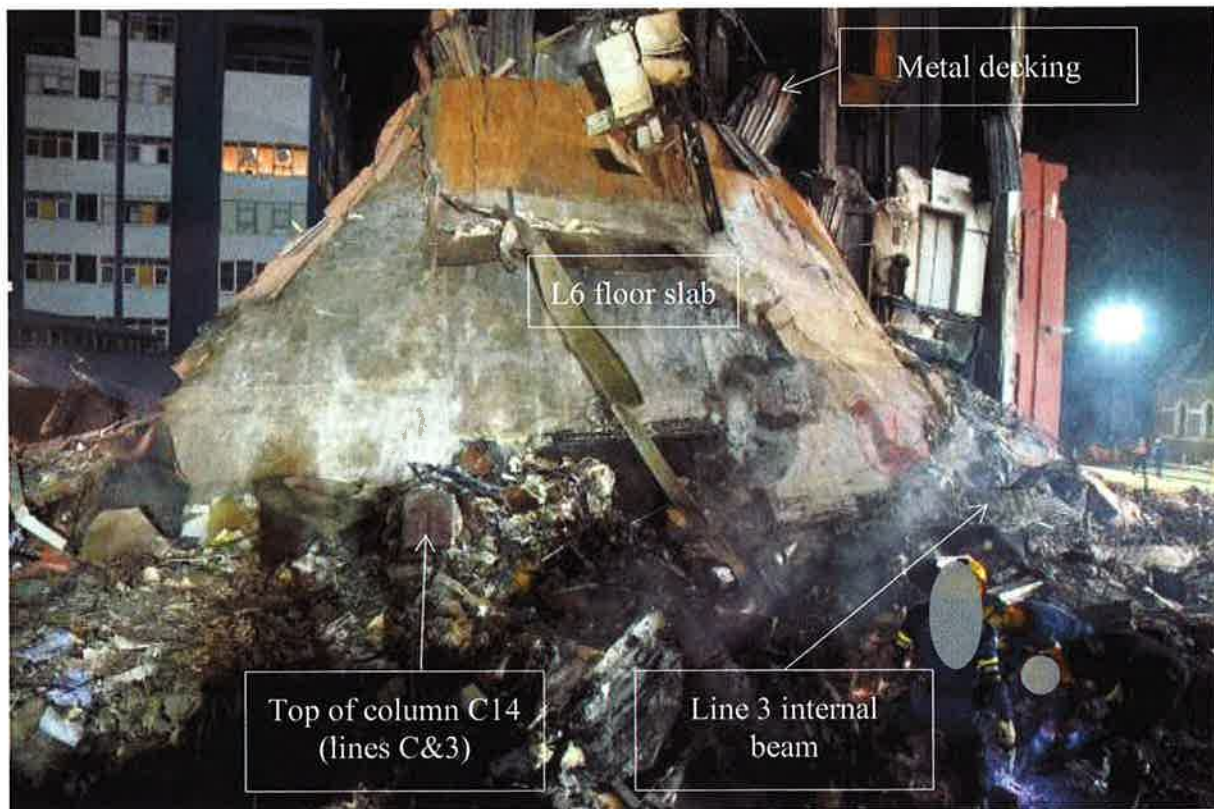
Figure 29

View looking north of the floors leaning against the North Core showing the Level 6 slab and the top of column C14 (Lines C and 3) still connected to the slab (11:55 PM 25 Feb 2011).
