**ROYAL COMMISSION OF INQUIRY INTO
BUILDING FAILURE CAUSED BY CANTERBURY
EARTHQUAKES
KOMIHANA A TE KARAUNA HEI TIROTIRO I
NGA WHARE I HORO I NGA RUWHENUA O
WAITAHA**

**BRIEF OF EVIDENCE OF ROBERT JAMES HEYWOOD
IN RELATION TO THE CTV BUILDING**

BRIEF OF EVIDENCE OF ROBERT JAMES HEYWOOD IN RELATION TO THE CTV BUILDING

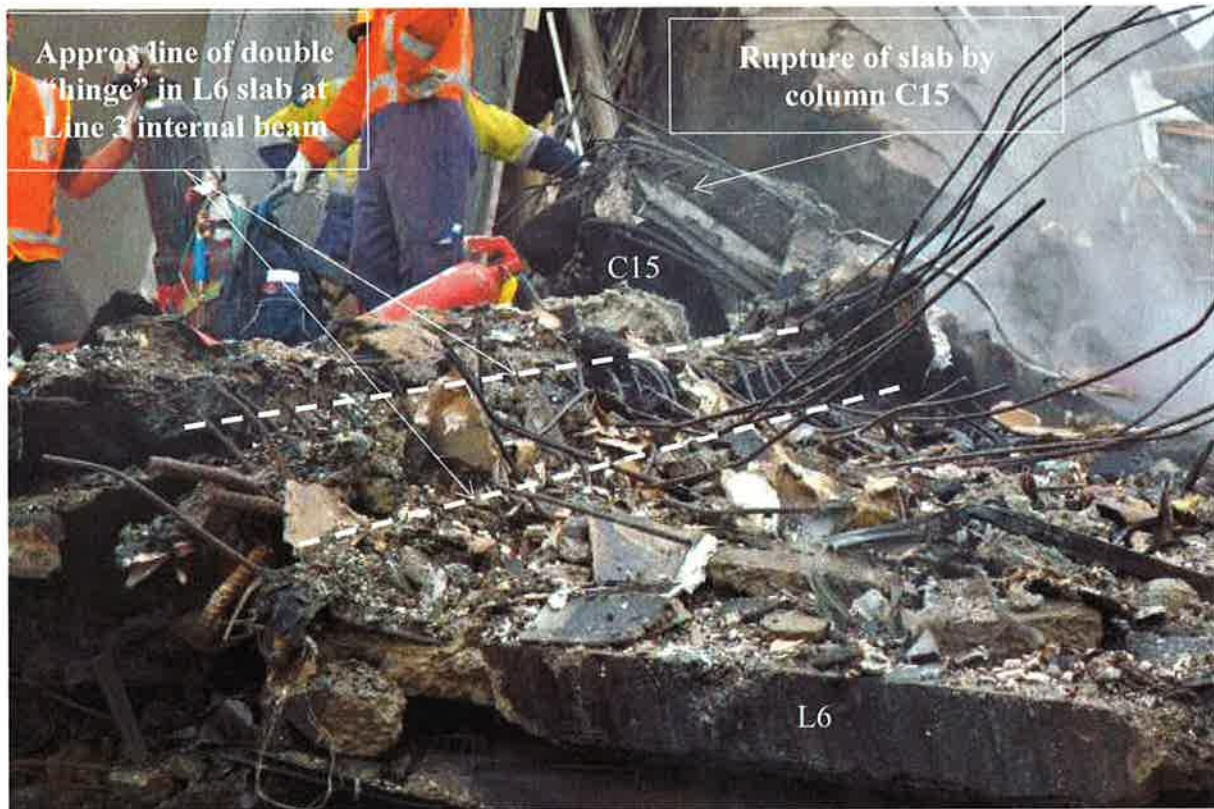
80. The Level 6 floor slab appears to have been ruptured by column C15, as indicated in Figure 33 [WIT.HEYWOOD.0001.62]. The two reinforcing bars circled are from the column, which has separated from the internal beam by 1 to 2 metres.

124. The internal beams separated from the floor slabs during the collapse with very few exceptions. The observed failure surface is shown in cross-section in Figure 47 [WIT.HEYWOOD.0001.76]. Often the beam had rotated so it was no longer perpendicular to the floor slab, as illustrated in Figure 48 [WIT.HEYWOOD.0001.77]. “Hinges” also formed in the thin residual slab (refer Figure 33 [WIT.HEYWOOD.0001.62]).

View of a slab double “hinge” in the Level 6 slab viewed from the western elevation looking northeast towards the North Core (8:20 AM 25 March 2011).

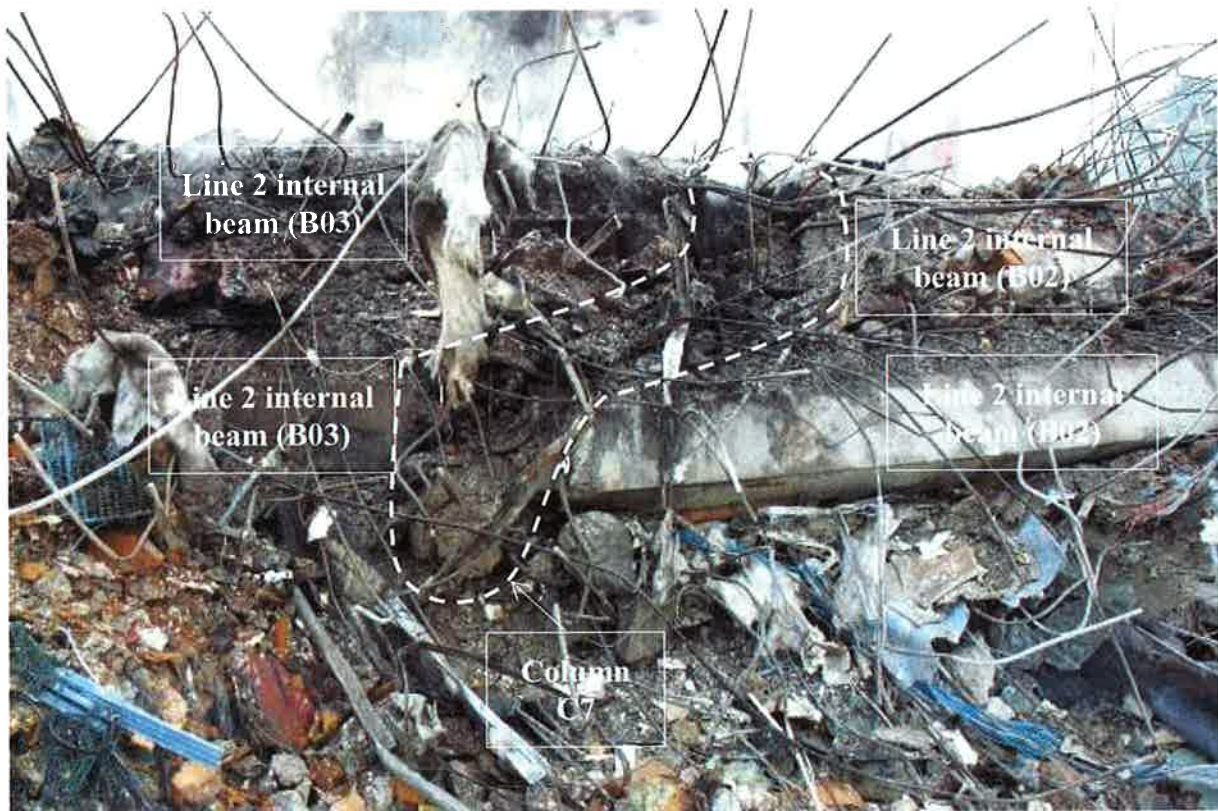
Figure 35

83. The precast portions of the internal beams appear in sound condition (refer Figure 35). They appear to have rotated in an anticlockwise direction when looking east with possibly a larger rotation evident in the eastern beams (B02) compared to the western beams (B03).

Junction between Line 2 internal beams and column C7 looking north towards the North Core. Refer to Figure 34 for a wider view (7:00 AM 26 Feb 2011).

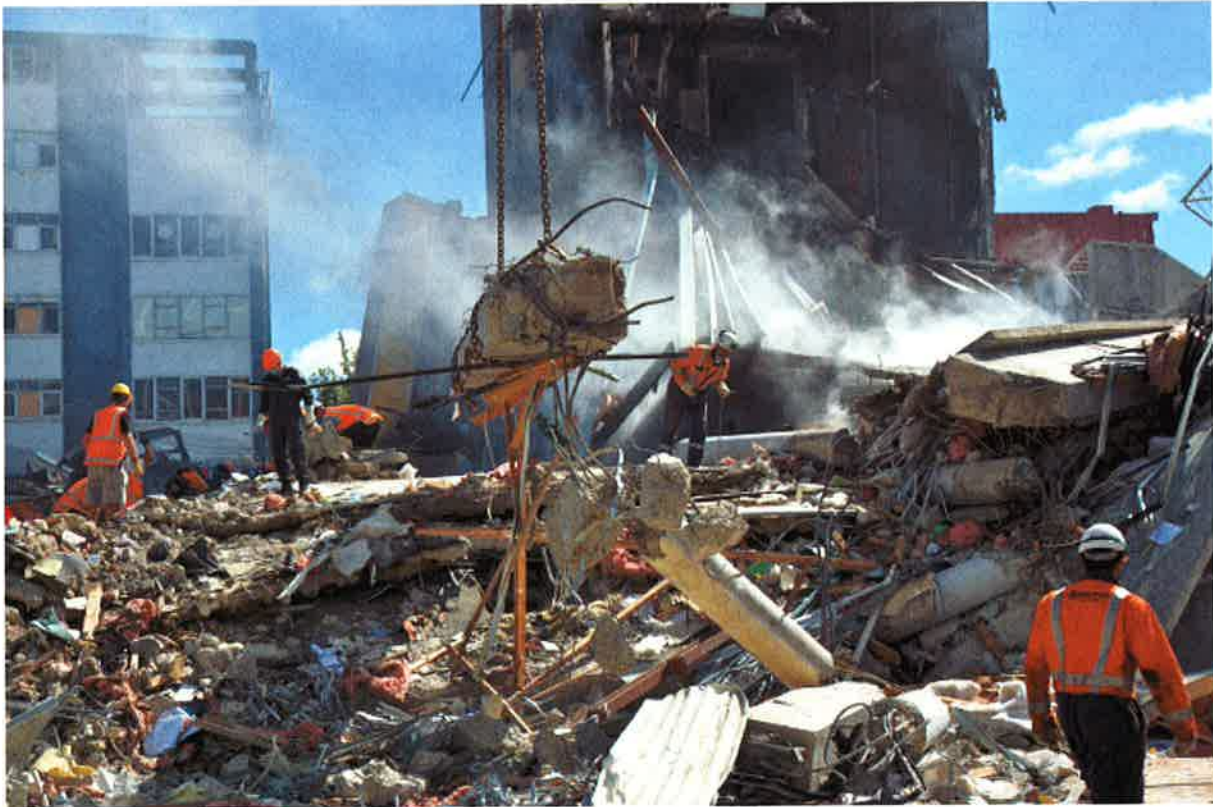
114. The edge beams were typically extracted from the rubble in one piece with little sign of structural damage to the precast elements except at their ends (refer Figure 26 and Figure 37 [WIT.HEYWOOD.0001.66]).

View of an edge beam and a segment of a circular column being removed from the west of the South Wall on Line 1 (10:30 AM 24/ Feb 2011).

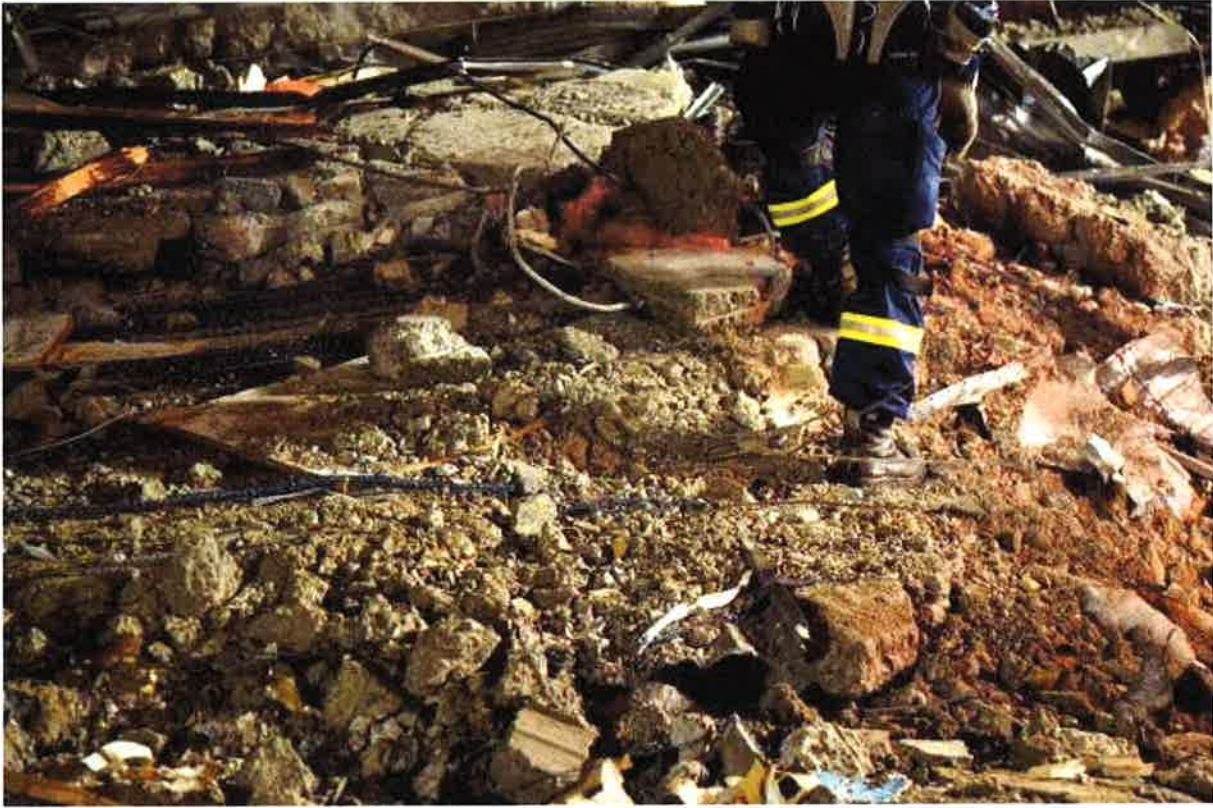
102. With respect to the concrete in the Building, I observed that the concrete disintegrated into rubble more readily than I would have expected (refer Figure 38 [WIT.HEYWOOD.0001.67] and Figure 42 [WIT.HEYWOOD.0001.71]). Many people at the Building site noted how readily the concrete turned to rubble. It was surprisingly difficult for a machine to lift any substantial piece of concrete slab without it breaking into pieces and rubble. This made the concrete challenging to remove. This was true in all areas – those that had been and had not been affected by the fire.

View of the concrete breaking down into rubble on the southeast corner of the Building (4:45 AM 24 Feb 2011).

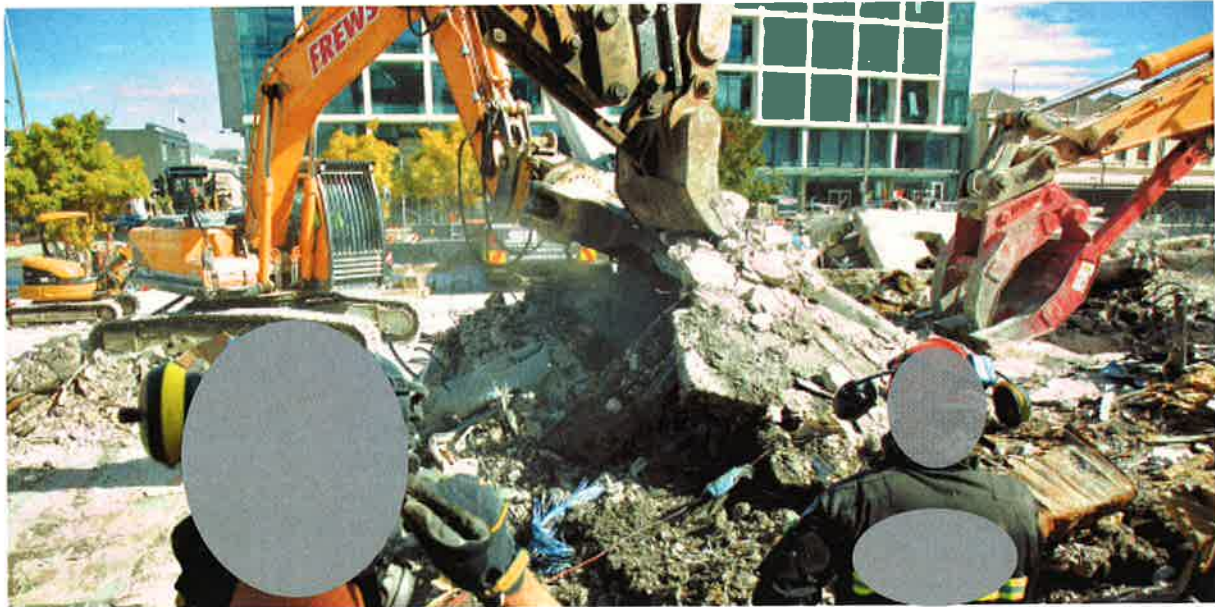
103. Towards the end of the search and rescue operation, all of the rubble was being sifted and tested as part of the search for human remains. Consequently it was desirable to remove concrete without it turning into rubble. I observed three machines operating in unison in an attempt to load one slab of concrete at a time onto trucks so as to minimise its disintegration into rubble (refer Figure 39 [WIT.HEYWOOD.0001.68]). I

Three concrete demolition machines working in unison to remove a concrete floor slab from the Building while minimising rubble generation.

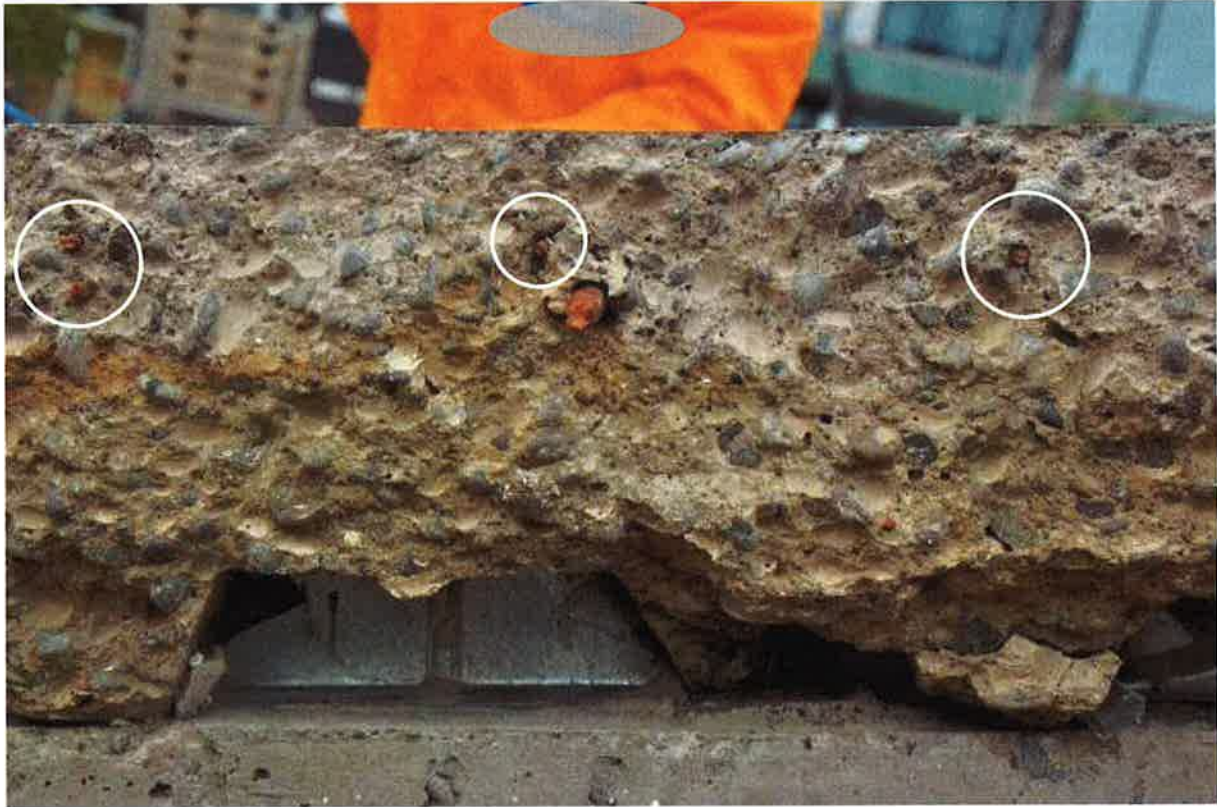
104. The coarse concrete aggregates were rounded gravel up to about 20 millimetres in size. The aggregates were observed in the rubble or in any of the surfaces where the concrete had failed. Figure 40 [WIT.HEYWOOD.0001.69] and Figure 41 [WIT.HEYWOOD.0001.70] show typical failure surfaces, which are characterised by the rounded aggregate projecting from the surface or the rounded impressions of aggregate. Almost all the coarse aggregates had pulled from the matrix rather than the pieces of coarse aggregate breaking. This indicates that increasing the bond between the matrix and the coarse aggregate would have increased the concrete's tensile strength.

112. Examples of the vertical failure surface indicated by the solid line in Figure 43 are shown in Figure 22 [WIT.HEYWOOD.0001.51], and Figure 40 [WIT.HEYWOOD.0001.69]. In these cases, both the mesh reinforcement and the supplementary reinforcement have failed in tension.

View of the failure surface where the 200 mm thick floor slab was severed from a north wall edge beam showing the broken wires from the 664 mesh (circled), a broken H12 reinforcing bar and the metal stop used to seal the ends of the Hi Bond metal decking during concreting.

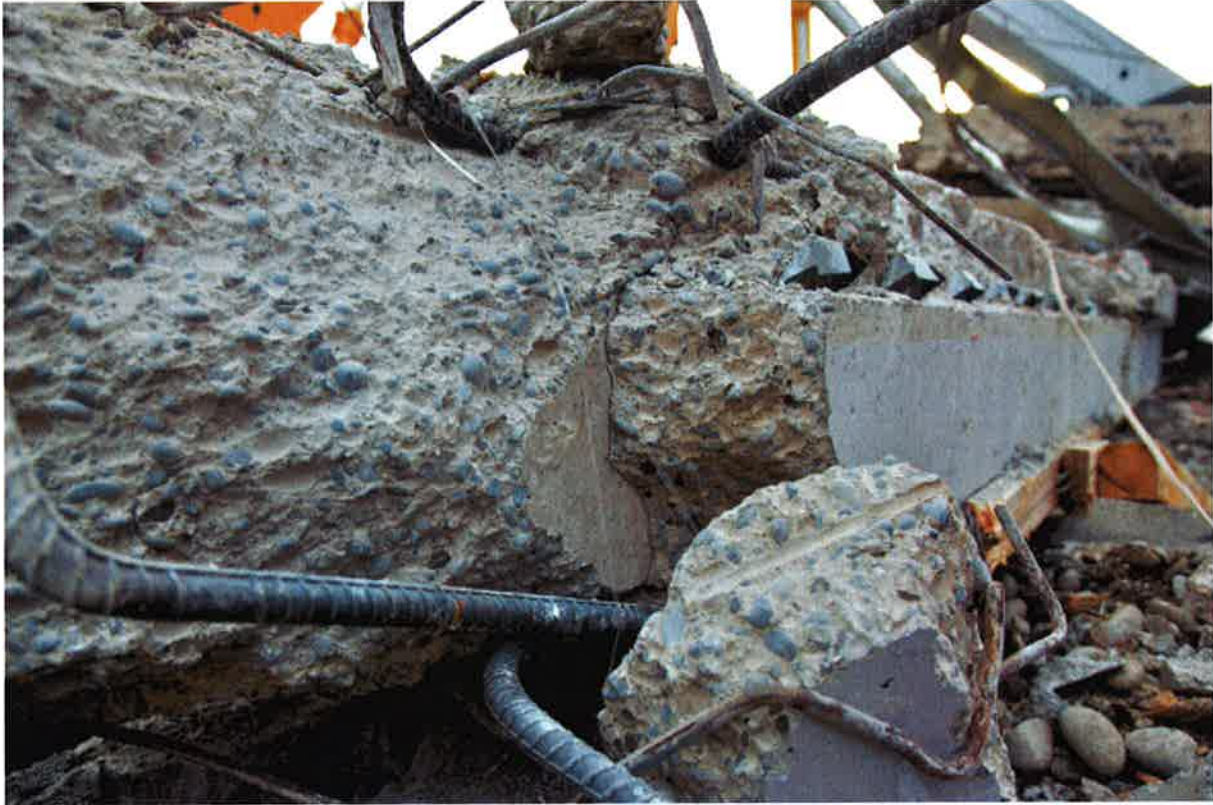
Figure 41

An edge beam after removal from the Building showing the “shell” beam construction, the shelf and seal plates for the Hi Bond metal decking, and the failure surfaces characterised by the aggregate pulling out of the concrete matrix (6:50 AM 25 Feb 2011).

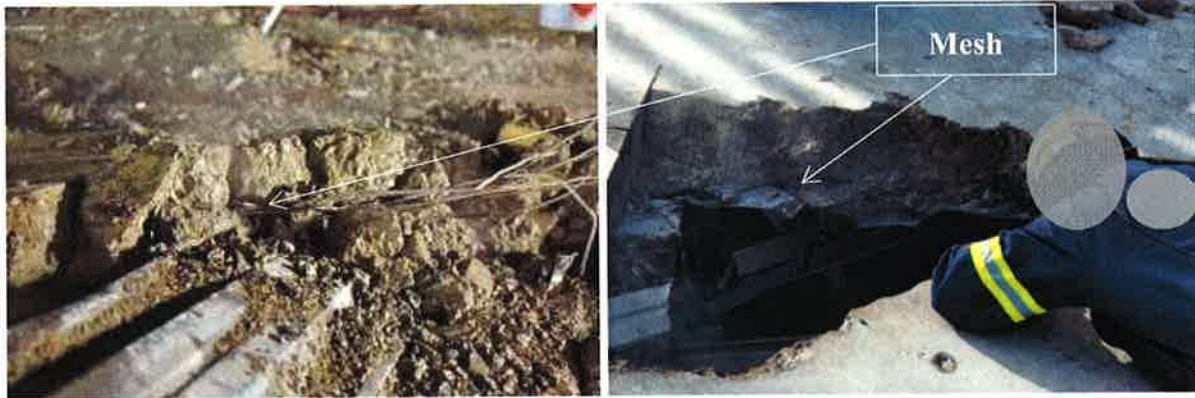
Figure 42

Two examples of concrete floor slabs where the 664 mesh is close to the bottom of the floor slabs and the Hi Bond metal decking.

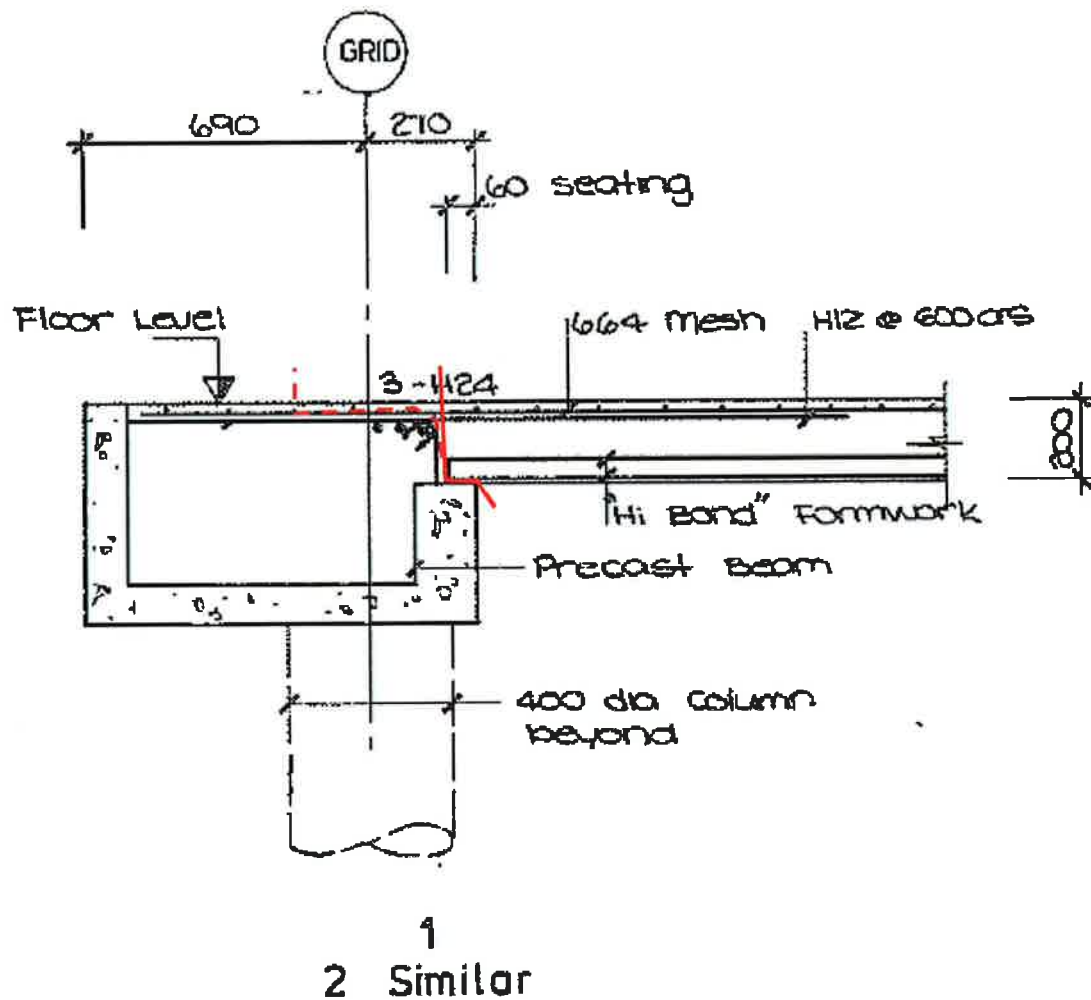
111. All observed connections between the edge beams and the floor slab were severed during the collapse with the two observed failure surfaces illustrated in Figure 43 [WIT.HEYWOOD.0001.72]. Both failure surfaces went around the end of the Hi Bond metal decking.

Precast edge beam to slab connection for perimeter beams except spanning between Lines A and B on Lines 1 and 4 (extract from Dwg S 15). The two failure paths observed are indicated. The "Hi Bond Formwork" noted is referred to in this Brief of Evidence as "Hi Bond metal decking".

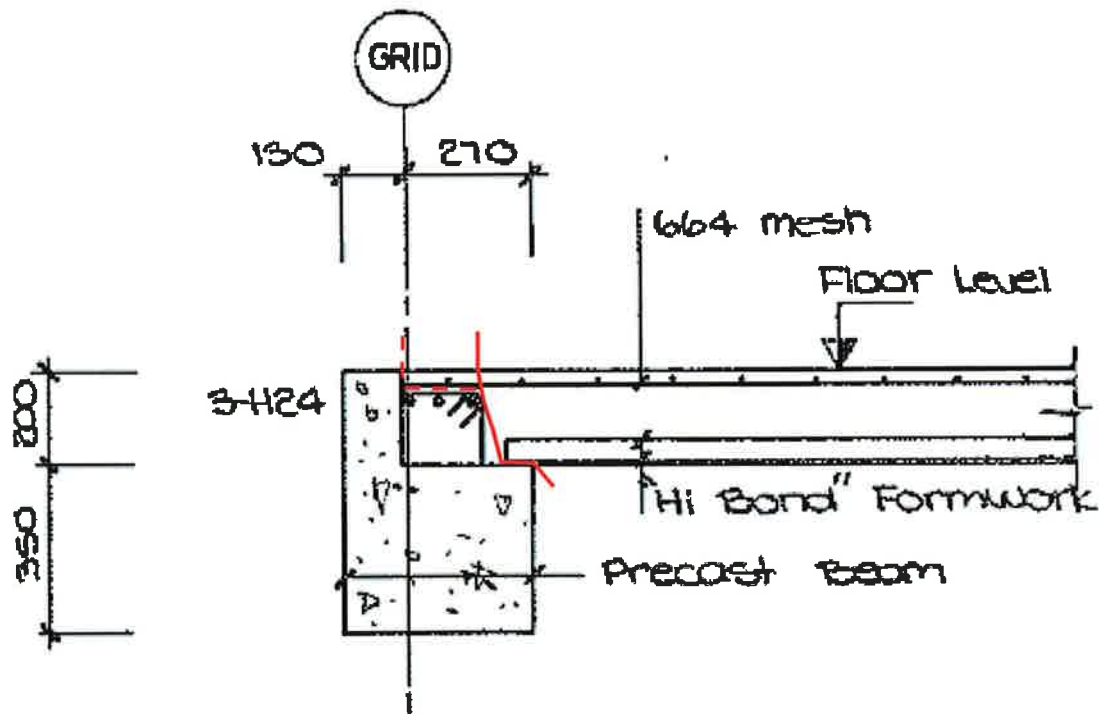
118. All observed connections between the narrow edge beams and the floor slabs were severed during the collapse with the two observed failure surfaces illustrated in Figure 44 [WIT.HEYWOOD.0001.73].

Narrow precast edge beam to slab connection for beams spanning between Lines A and B on Lines 1 and 4 (extract from Dwg S 15). The two failure paths observed are indicated.

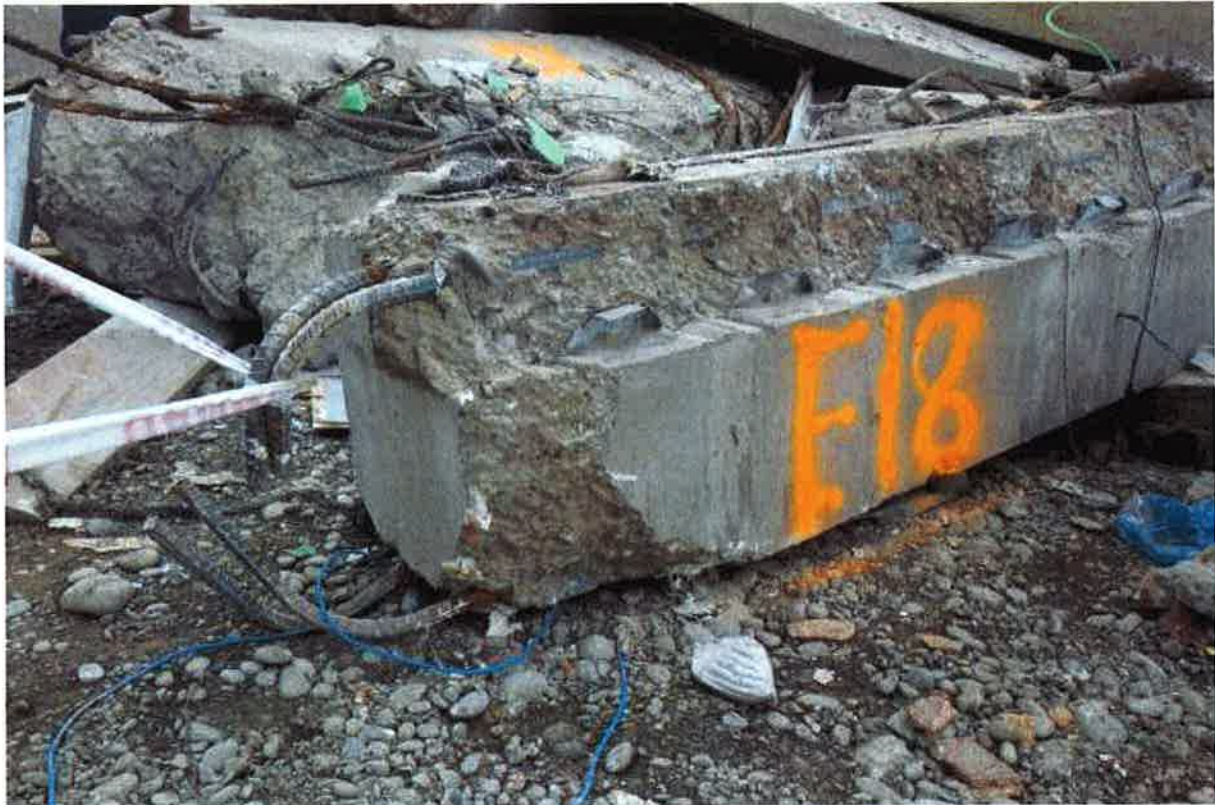
119. An example of the vertical failure surface illustrated in Figure 44 (solid line) is shown in Figure 45 [WIT.HEYWOOD.0001.74]. In this case, only one wire from the mesh crossed the failure plane. This suggests the mesh had practically zero overlap of the reinforcement cage.

121. The narrow edge beams were typically extracted from the rubble in one piece with little sign of structural damage to the precast elements except at their ends (refer Figure 45 [WIT.HEYWOOD.0001.74]).

Narrow edge beam from Line 4 between Lines A & B showing failure of the slab to beam connection along a nominally vertical plane (Exhibit E18 with black brown carpet).

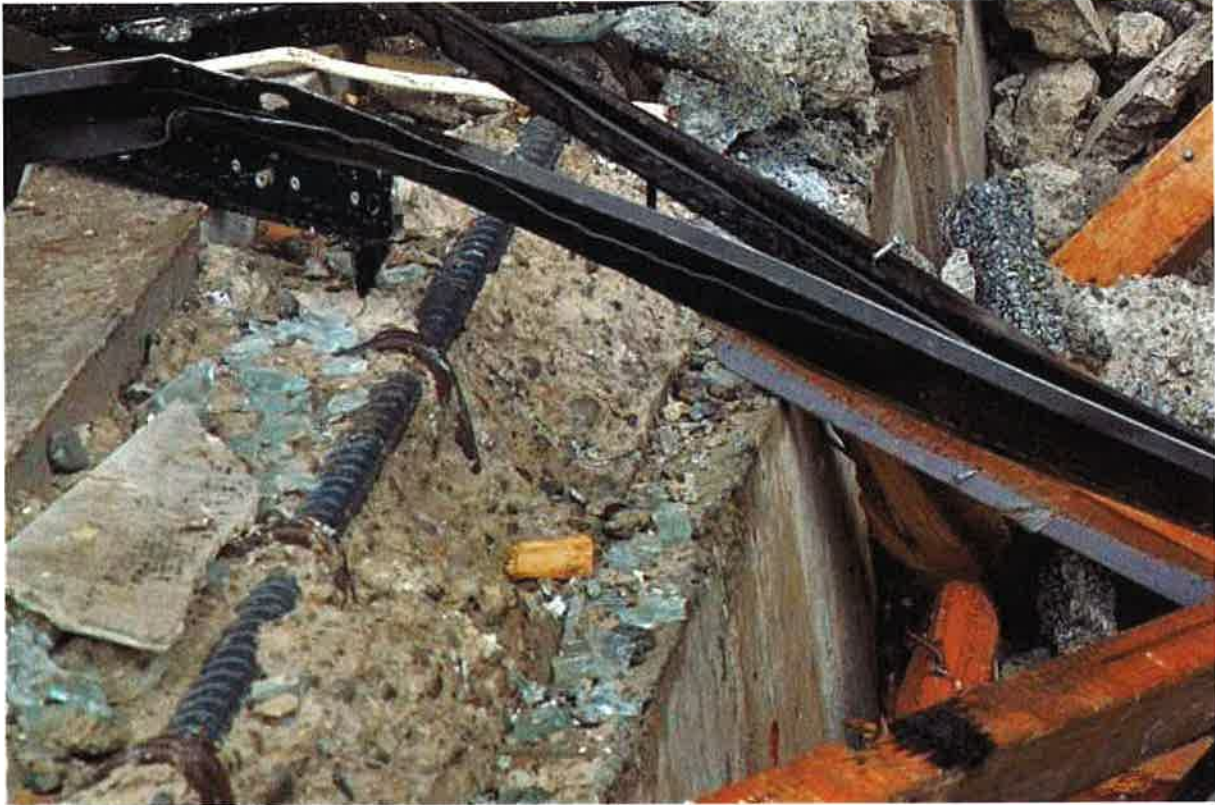
120. An example of the vertical and horizontal failure surface, indicated by the dashed line in Figure 44 [WIT.HEYWOOD.0001.73], is shown in Figure 46 [WIT.HEYWOOD.0001.75]. In this case, the failure surface includes a horizontal surface between the mesh and the top of the beam reinforcement cage, indicating that even if the overlap were sufficient, the structure may fail around the reinforcement.

Narrow edge beam from Line 4 between Lines A & B showing the concrete broken away from both the front and the top of the reinforcement cage.

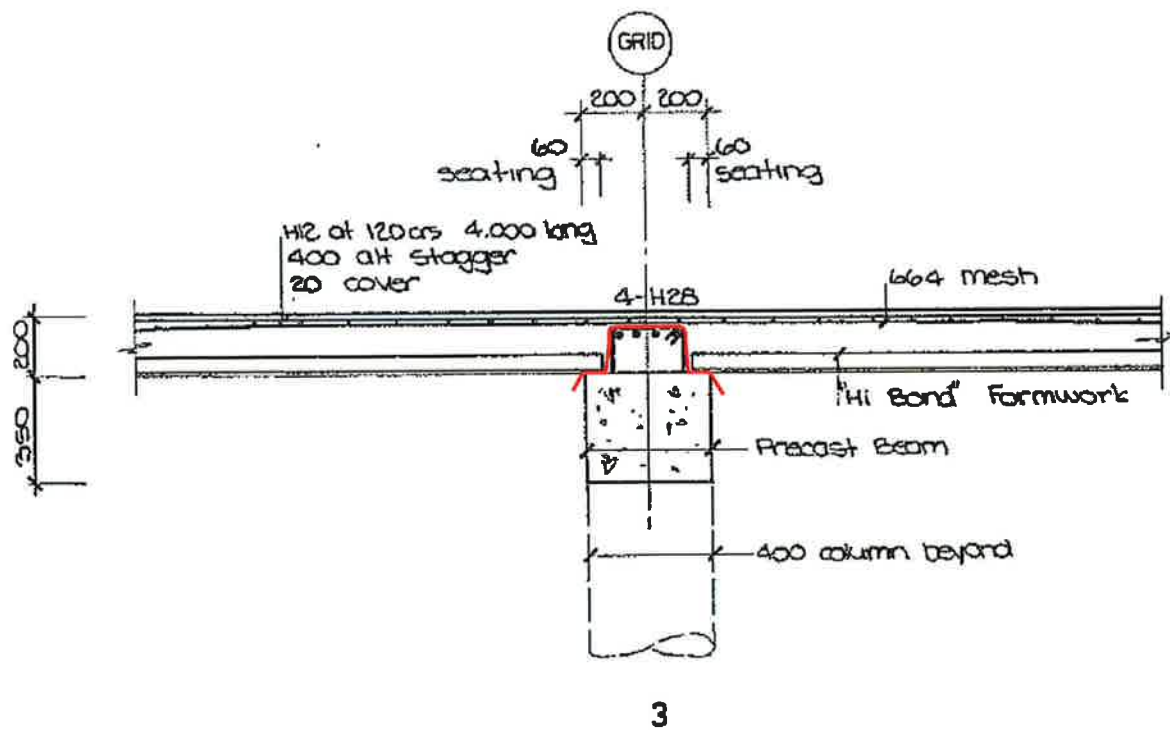
Figure 47

Section through precast internal beam to slab (extract from Dwg S 15). The typical failure surface observed is indicated.

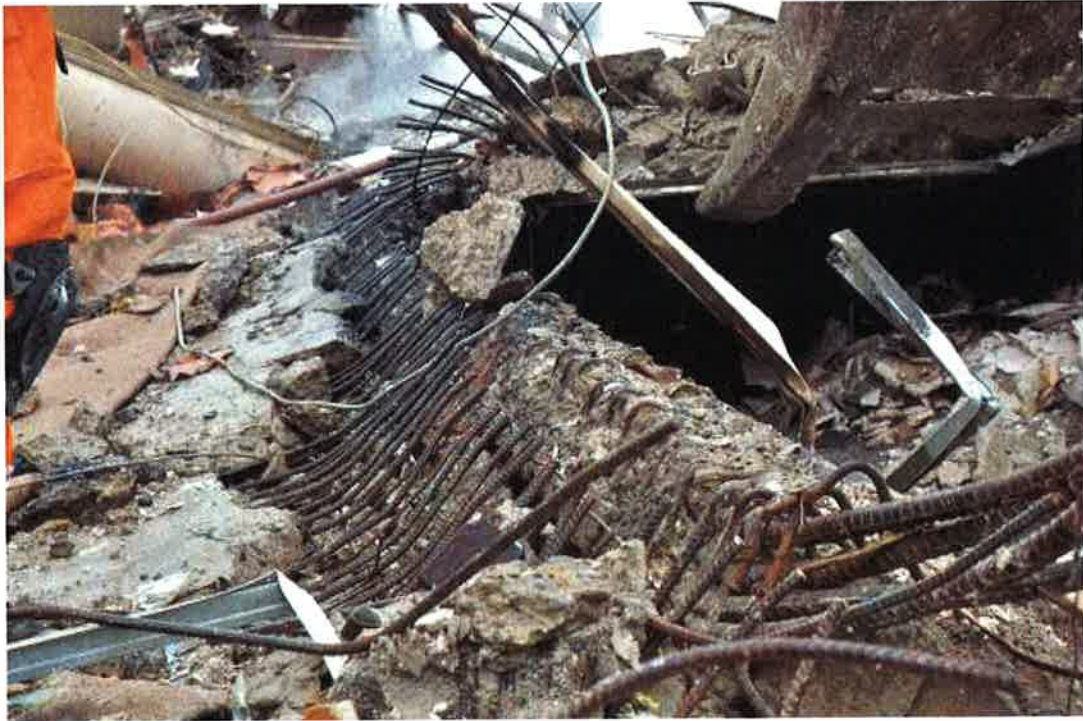
and Figure 32. A double “hinge” can also be observed in Figure 48 [WIT.HEYWOOD.0001.77].

Demolition equipment lifting a slab that had separated from a precast internal beam. The top reinforcement (D12 @120 and 664 mesh) has been cut along the centre of the precast internal beam to facilitate the removal of the slab (8:30 AM 25 Feb 2011).

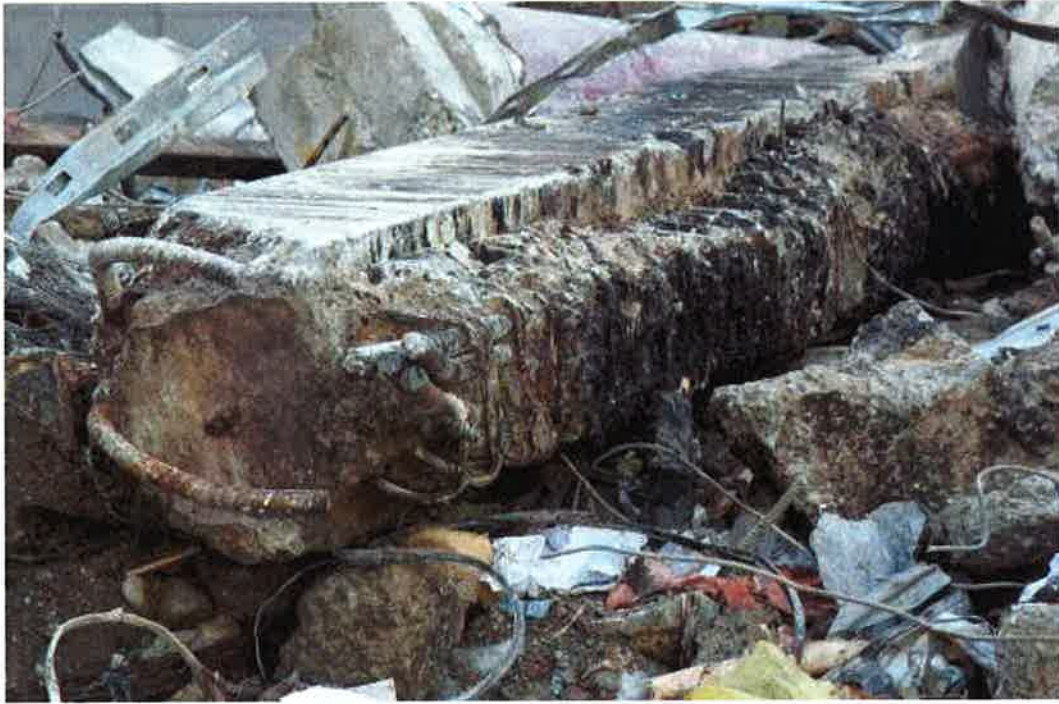
125. Other examples that show the internal beams separated from the floor slabs are presented in Figure 17 [WIT.HEYWOOD.0001.46] and Figure 26 [WIT.HEYWOOD.0001.55]. The failure surface can be seen on an internal beam after its removal from the rubble in Figure 49 [WIT.HEYWOOD.0001.78].

126. The internal beams were typically extracted from the rubble in one piece with little sign of structural damage to the precast elements except at their ends (refer Figure 49).

A precast internal beam lying on its side after extraction from the Building. The beam had completely separated from the slab during the collapse as indicated by the fire blackened concrete on the failure surface. The bent bars protruding from the end, the cylindrical surface on the end of the beam and the oxy-cut top reinforcing bars indicate that the end of the beam to the left of the photograph was supported on a round internal column.

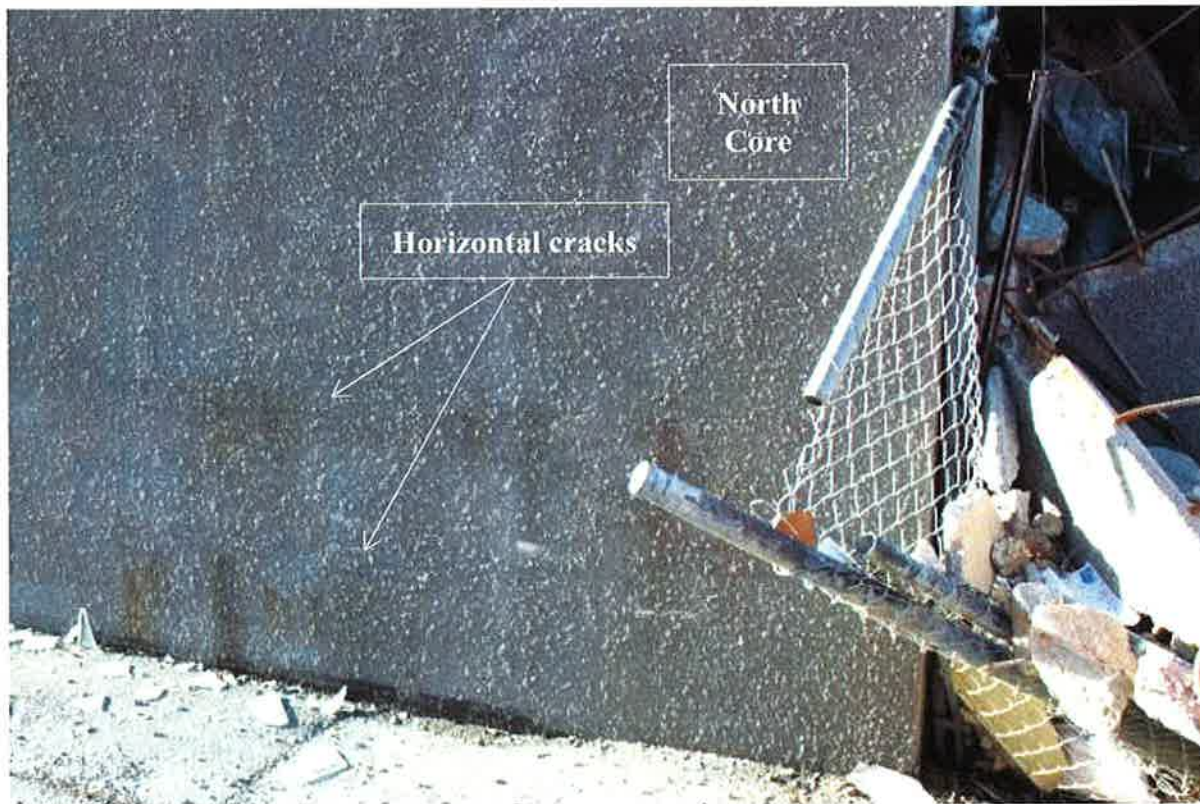
128. On arrival, I observed the visible portions of the North Core were still in good condition other than where damage had occurred from the edge beams detaching from the walls. A closer inspection of the northern face of the North Core revealed two horizontal cracks in the rendered concrete within 1 metre of ground level (refer Figure 50 [WIT.HEYWOOD.0001.79]). The cracks indicated that either the North Core may have been bent towards the south so as to crack the concrete or that this was a pre-existing crack. The staining below the crack supports the view that the crack was a pre-existing

crack. In either case, the North Core appeared to have performed well during the earthquake. I did not inspect the tower closely after the debris was removed.

Crack in northern face of the North Core near the western end (7:30 AM 24 Feb 2011).
