Madras Equities Ltd

249 Madras Street

Damage Report

4 September 2010 Earthquake

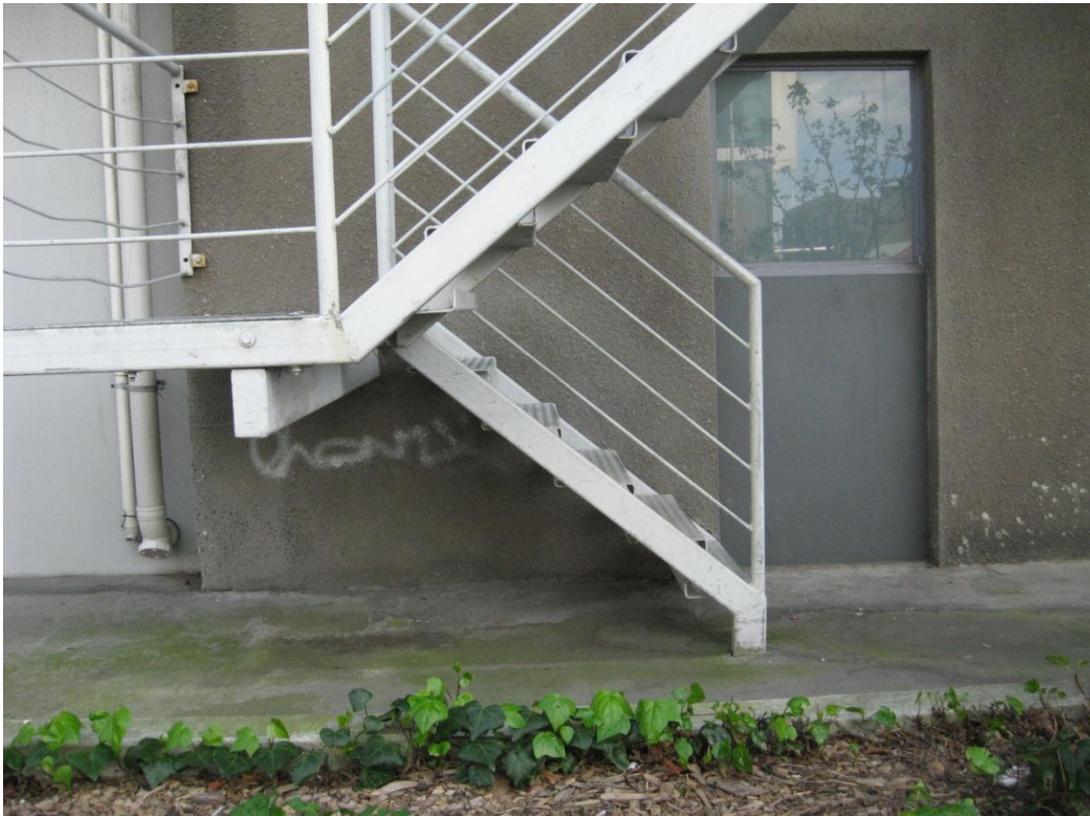
This wall is in fact what is termed a coupled shear wall. It has door holes in the middle of the wall at each storey providing access to the external fire escape. Beams across the door heads couple the walls, each side of the doors, together. The exterior of this wall is coated with a plaster splash coat. The rough texture of the finish on the wall makes it difficult to detect any cracking on the outside face, but there is one diagonal crack visible on the outside ground storey just below the fire escape landing. Photo 2.

Photo 2 Cracking in south shear wall (not visible in photo) under fire escape landing

We have not attempted for the purpose of this report to investigate or recommend restoration systems. However, diagonal shear cracking and cracking of construction joints has occurred in the shear walls, as reported below. We believe that there has been no yielding of the reinforcement in these walls and that structurally their integrity is still sound. However we would recommend repair of those cracks with a width of more than 0.2mm with epoxy injection. The damaged linings and finishings should also be repaired.

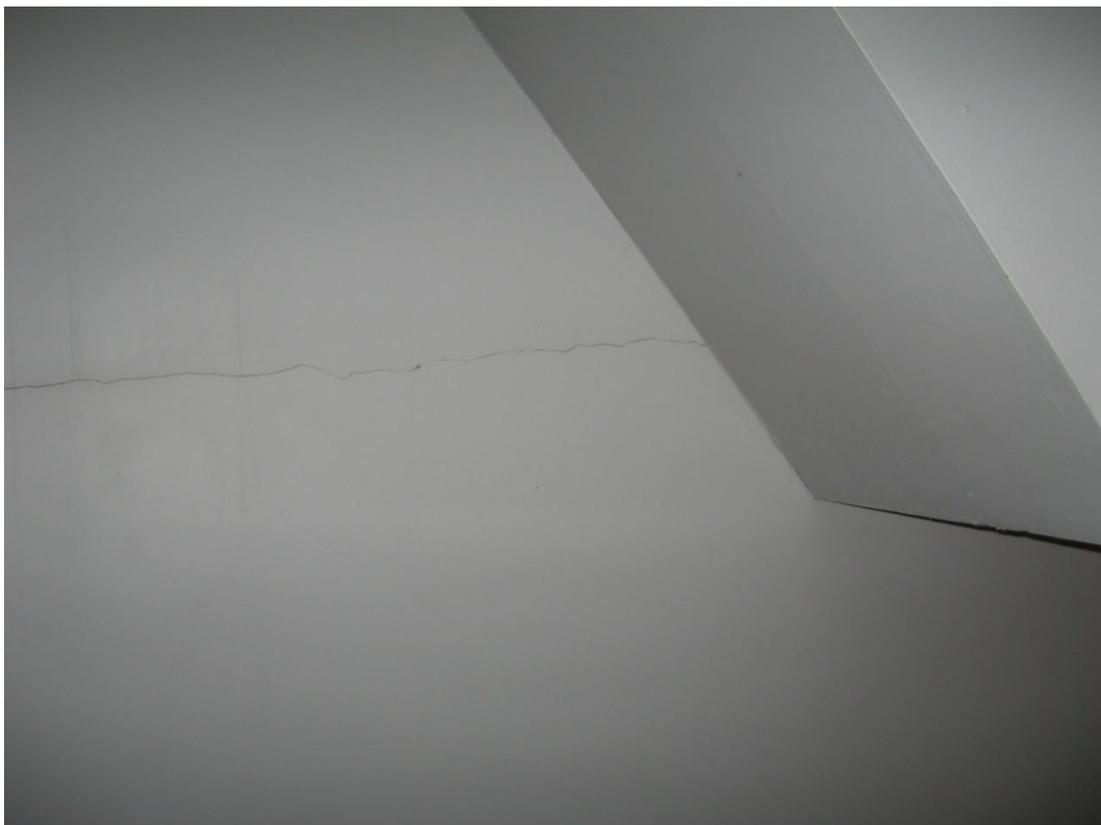
As visible in the stair well, there are construction joints in the walls immediately below and above each floor level. This is a normal construction practice. At almost all floor levels, cracking has occurred along part of the length of these construction joints and these cracks measure generally in the order of 0.2mm in width but with a few up to possibly 0.35mm in width. Photo 3. Again the cracks larger than 0.2mm in width should be repaired with epoxy injection and the external surface weather proofed.

Photo 3 Cracking in floor level construction joints in stair well

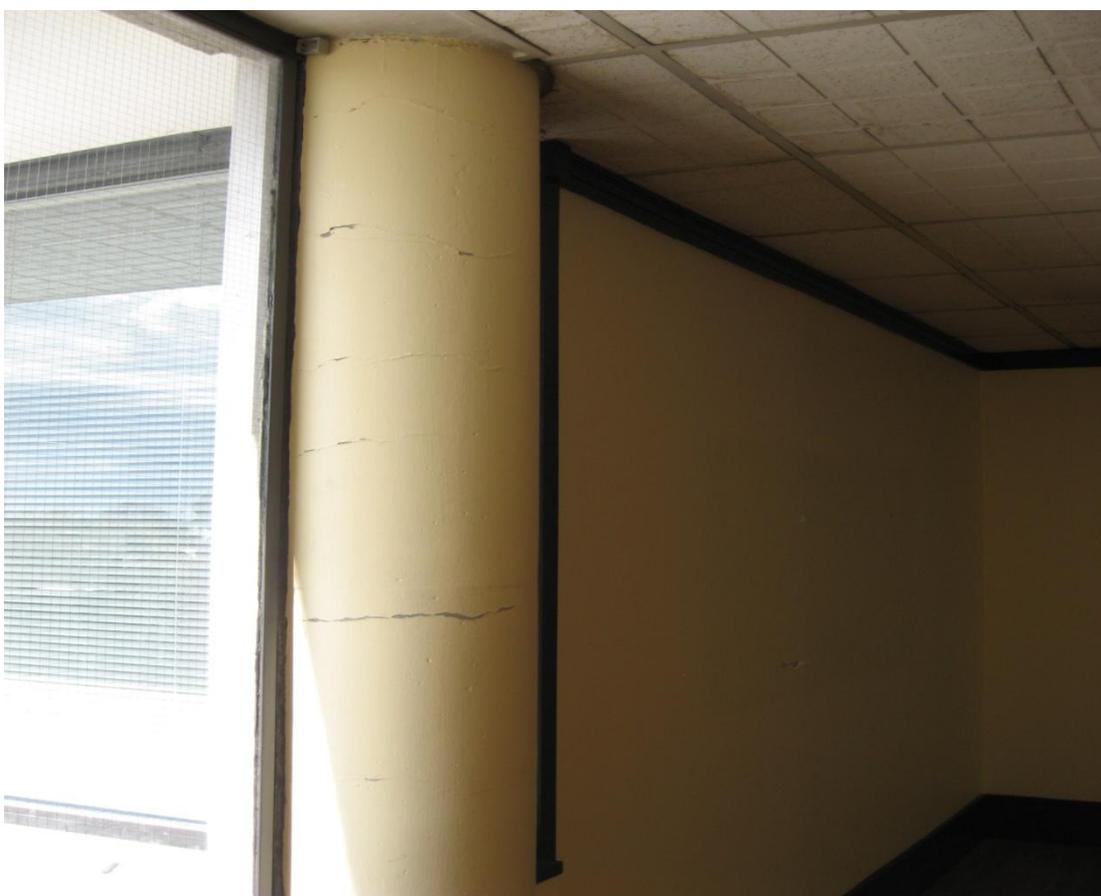
As stated above, we believe that the columns and beams provide gravity support only and have not been designed to resist lateral loads. However, they do have some stiffness and when the building moves in an earthquake and they do attract some load. Generally we observed very little damage to beams and columns. However there are a few exceptions. The north-east corner column immediately above the third floor spandrel exhibits some minor cracking which is very fine and in our opinion requires no treatment. At the top storey, the first column west of the north-east corner of the building also exhibits some cracking. The appearance of the cracking is accentuated because the paint has chipped off at the cracks (photos 4). One of the south side columns at the top storey also exhibits some fine cracking. We recommend that the cracks in these upper storey columns be injected with epoxy resin.

Photo 4 Cracking in top storey column adjacent to lift lobby.

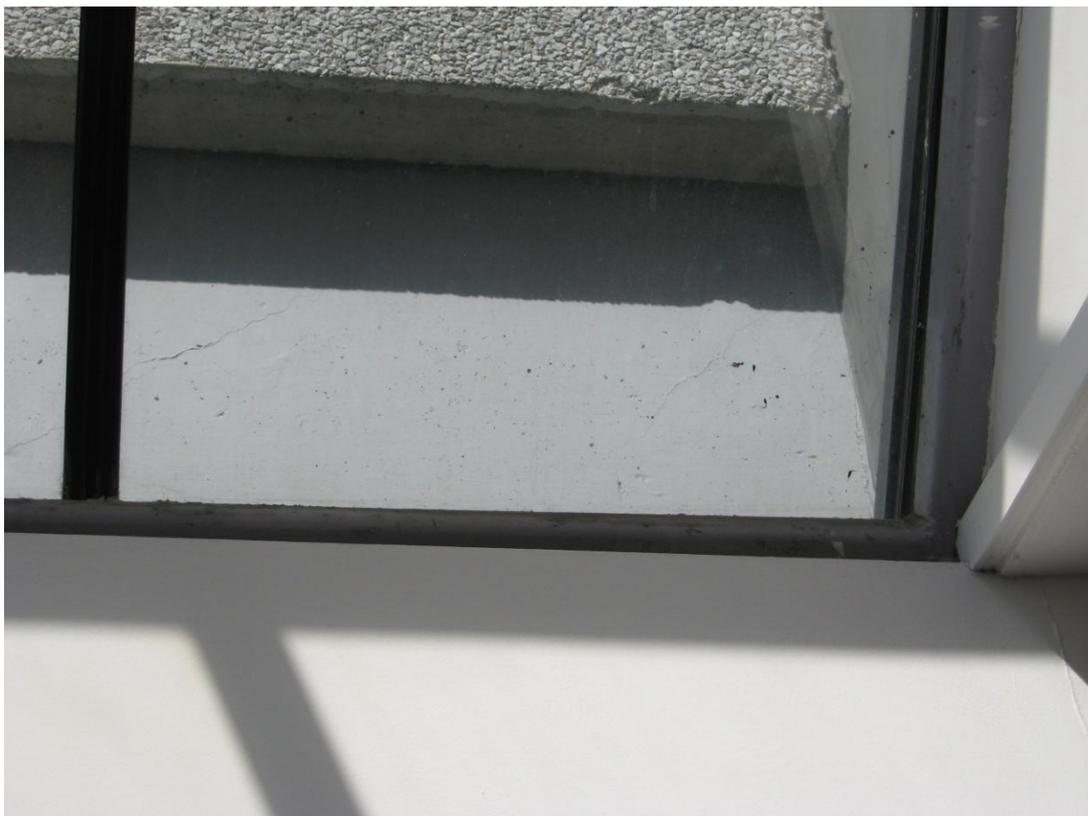
The first floor beam on the north face of the building in the span between the north-east corner of the building and the adjacent column to the west has some fine diagonal cracking (Photo 5). We recommend that this crack be injected with epoxy resin. We did not see any signs of distress in beam column joints.

Photo 5 Cracking in first floor beam north elevation over entry.

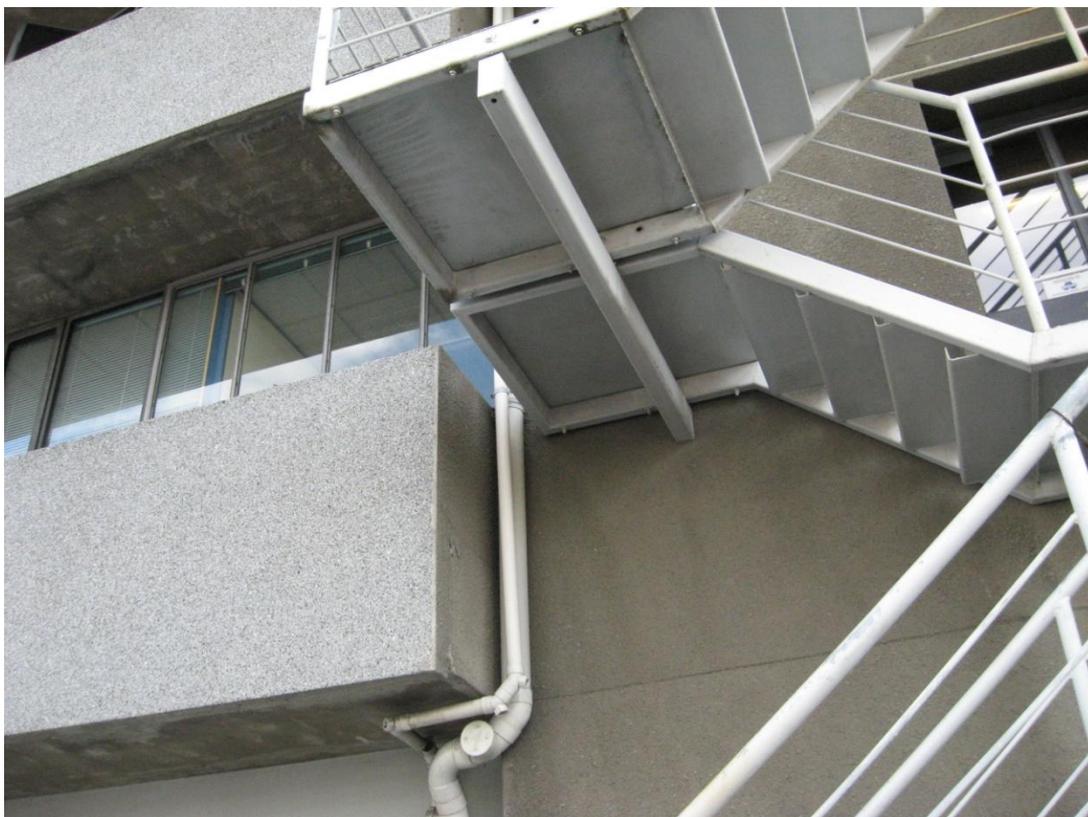
The precast concrete spandrel panels appear to have sustained very little damage. However, each side of the south side shear wall, the ends of the spandrels have been plastered. This plaster is spalling off at most levels as a result of differential movement caused by the earthquake. It is a hazard to people below. It should be removed, the concrete surface properly prepared and a strong bonding epoxy plaster re-applied. (Photo 6).

Photo 6 Spalling of plaster off ends of spandrel panels.

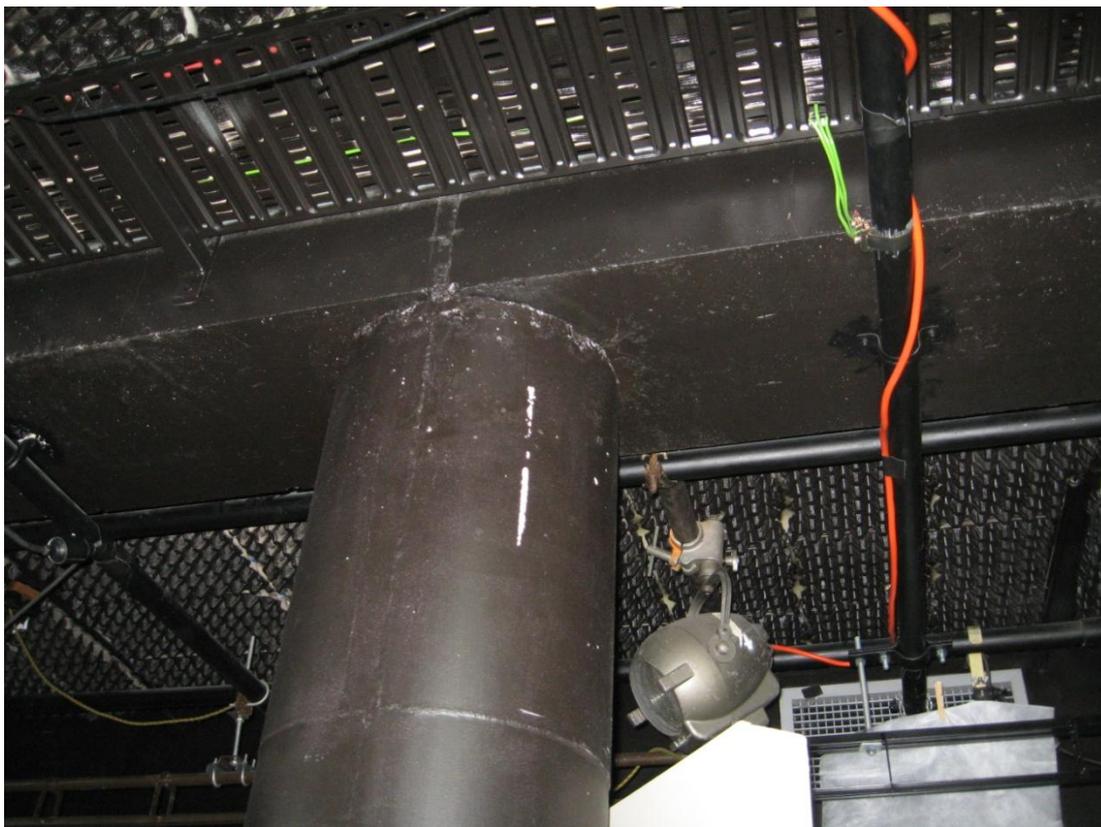
In the limited number of locations where we removed ceiling tiles and observed the floor to beam connections we did not see any signs of distress. (Photo 7).

Photo 7 Internal beam column joint under first floor – no evidence of damage.

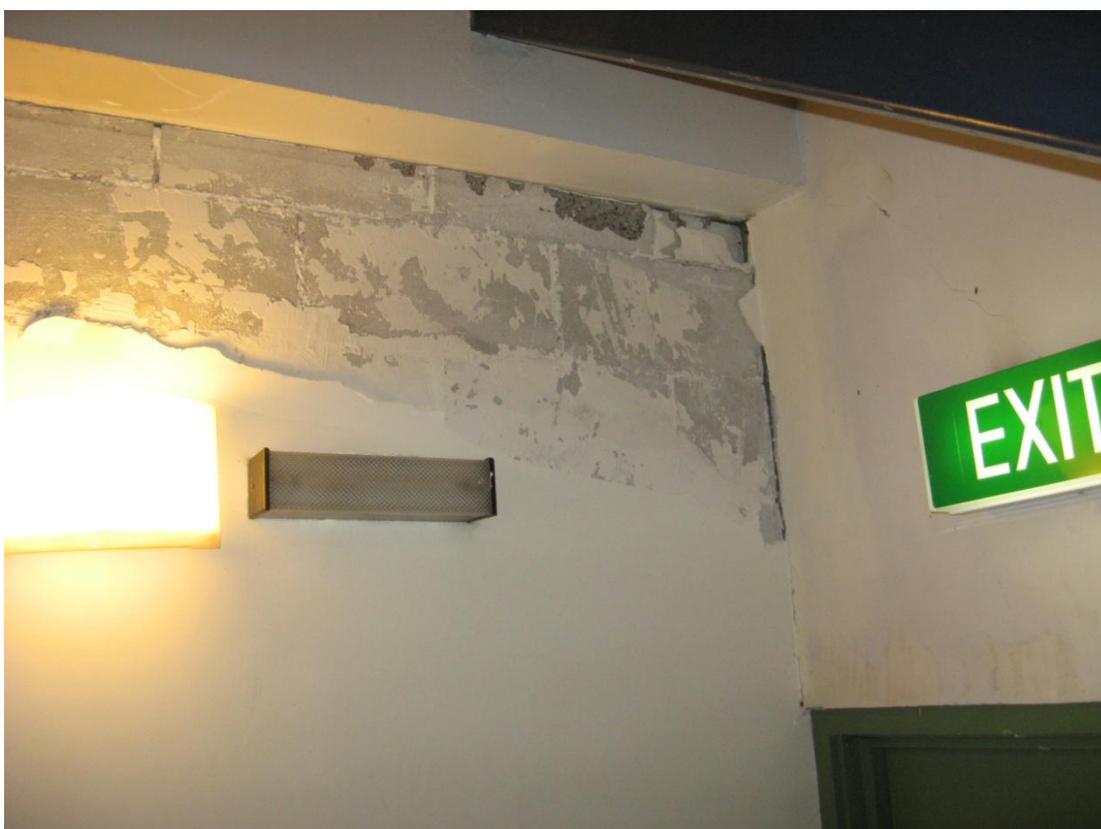
At ground storey, there is a concrete block wall parallel to the north side shear wall but on the opposite side of the stair well. This wall has a thin gypsum plaster coating in the stair well. At the top of the wall the plaster coating has been peeled off. It appears that it was touching one of the stair well structural walls and the differential movement has damaged the plaster. There may also be some minor cracking of the top block course which should be repaired. However, this is not a structural component and does not contribute to the integrity of the building. Photo 8.

Photo 8 Spalling gypsum plaster off non-load bearing concrete block wall in stairwell.

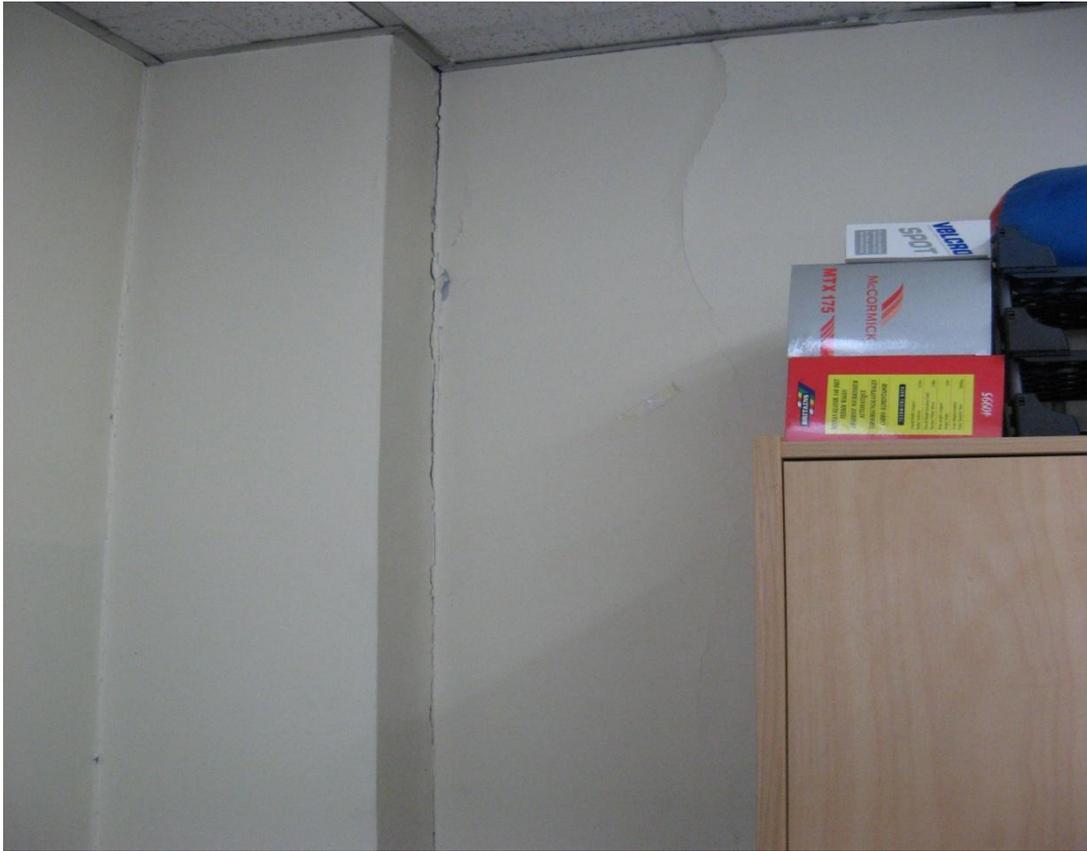
Photo 9 Partition lining damaged at junction with concrete column.

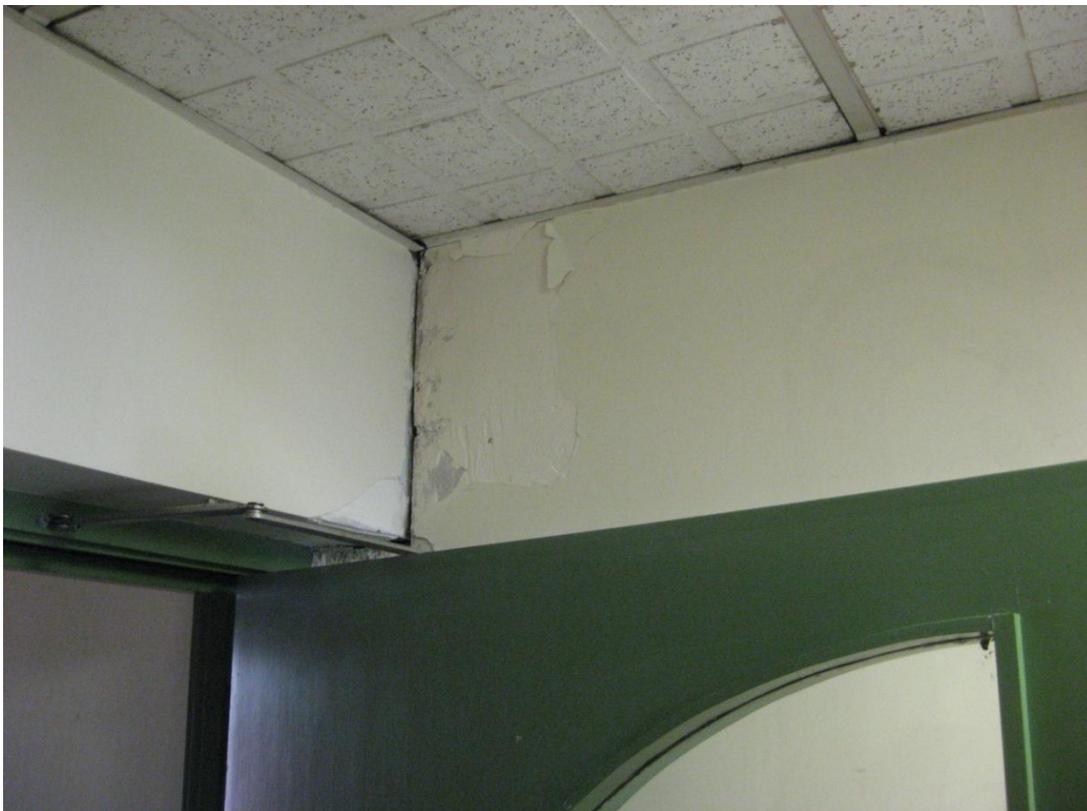
Photo 10 Partition lining damaged at junction with concrete beam.

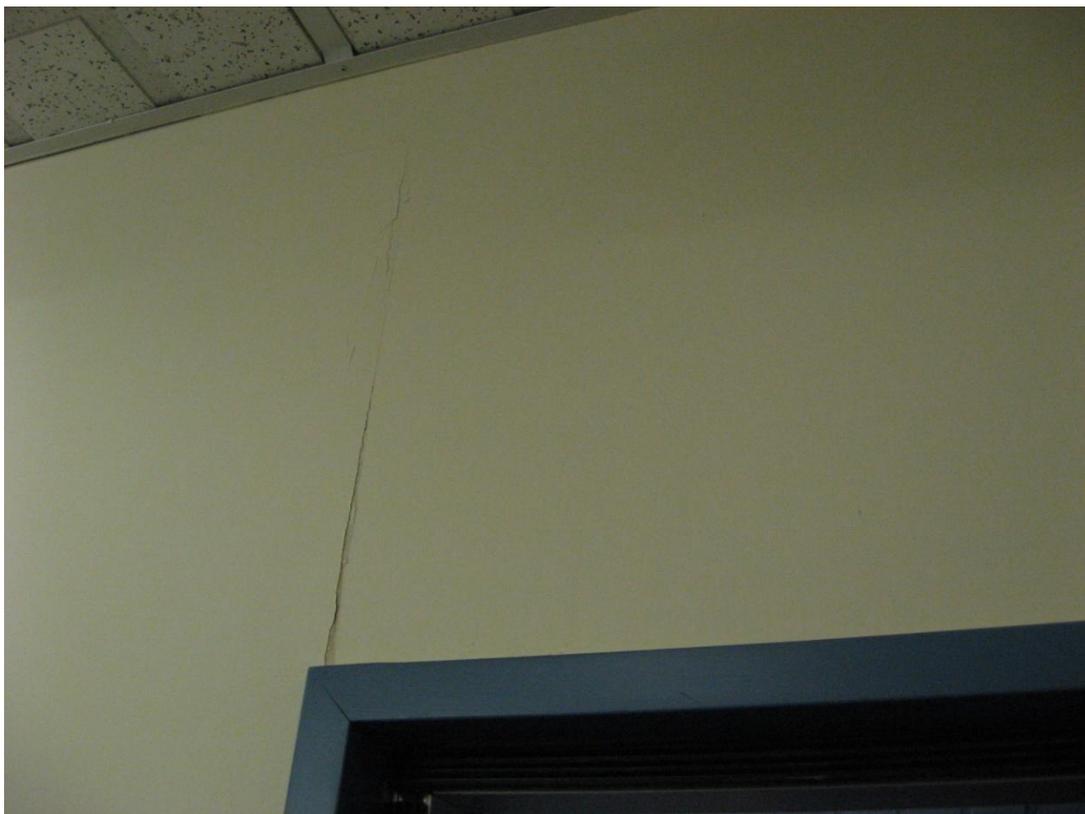
Photo 11 Cracking in linings over door head

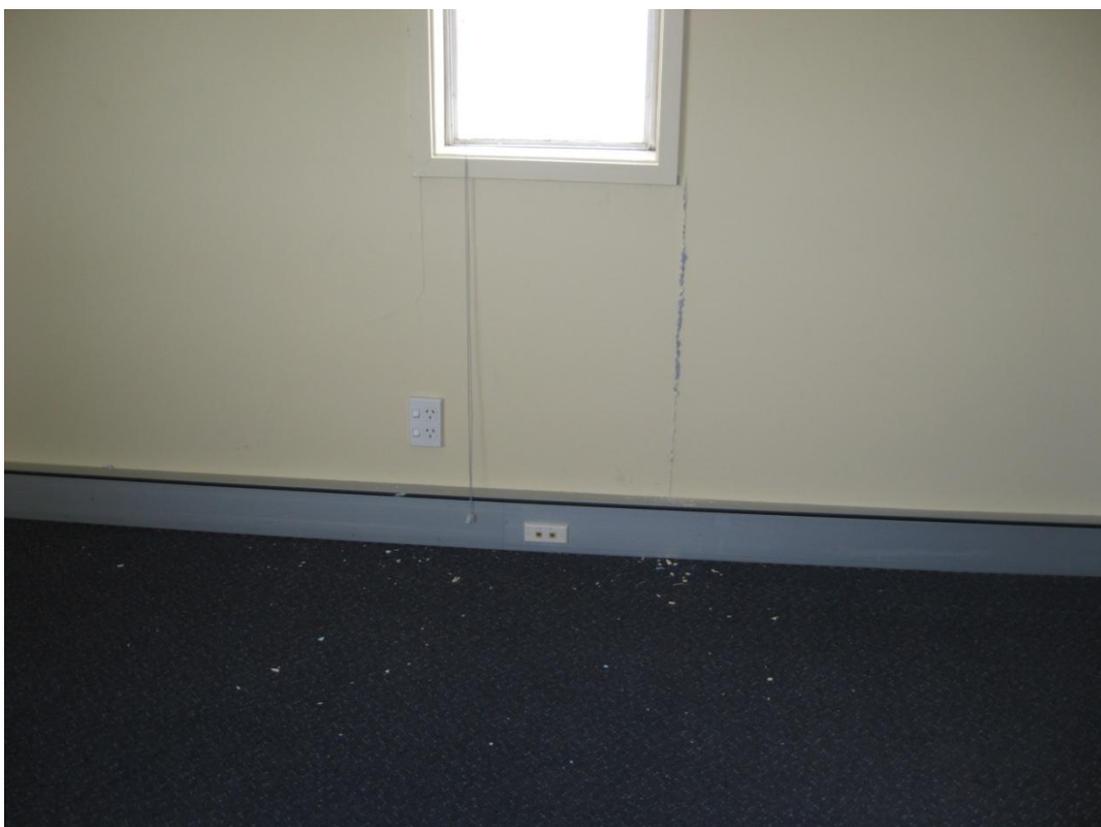
Photo 12 Crackling in linings under window.

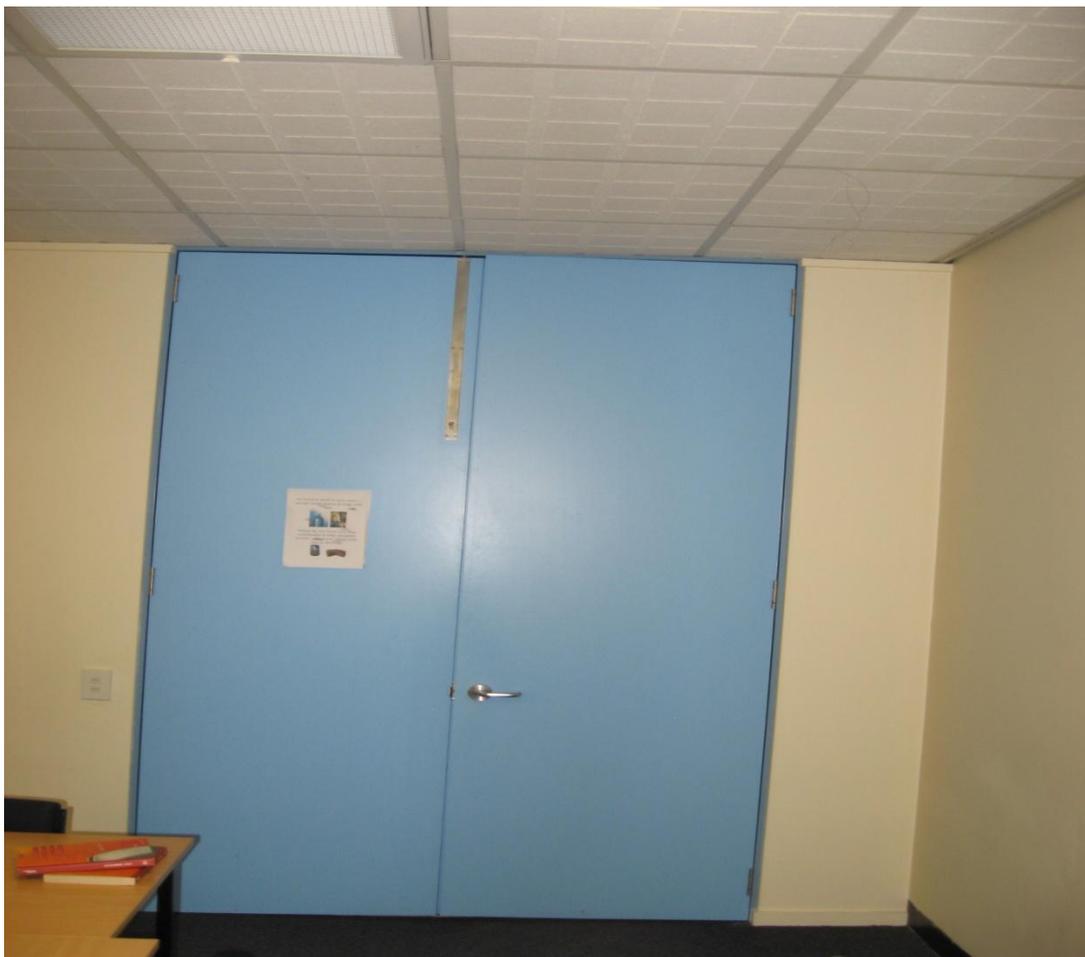
At numerous locations at all levels, there is damage to internal framing and linings. Commonly, internal walls and their linings have been finished hard against structural walls and columns. With movement of the building during the earthquake(s), the structural components have applied in-plane loads to the stiff plaster board lined walls. There are many instances where the plaster board linings have been damaged where they adjoin the structural components. Sometimes, the plaster board has buckled some distance away from the structural wall or column. Photos 9 and 10. There are also numerous instances of plaster board cracking over door heads and under windows and elsewhere. Photos 11 and 12. Ceiling covings and skirting boards have also been damaged. At the south end of one internal north south wall on the second floor, the partition wall has racked sufficient for the double doors contained in the wall to be binding. Photo 13.

Photo 13 Racked second floor partition wall and binding double doors.

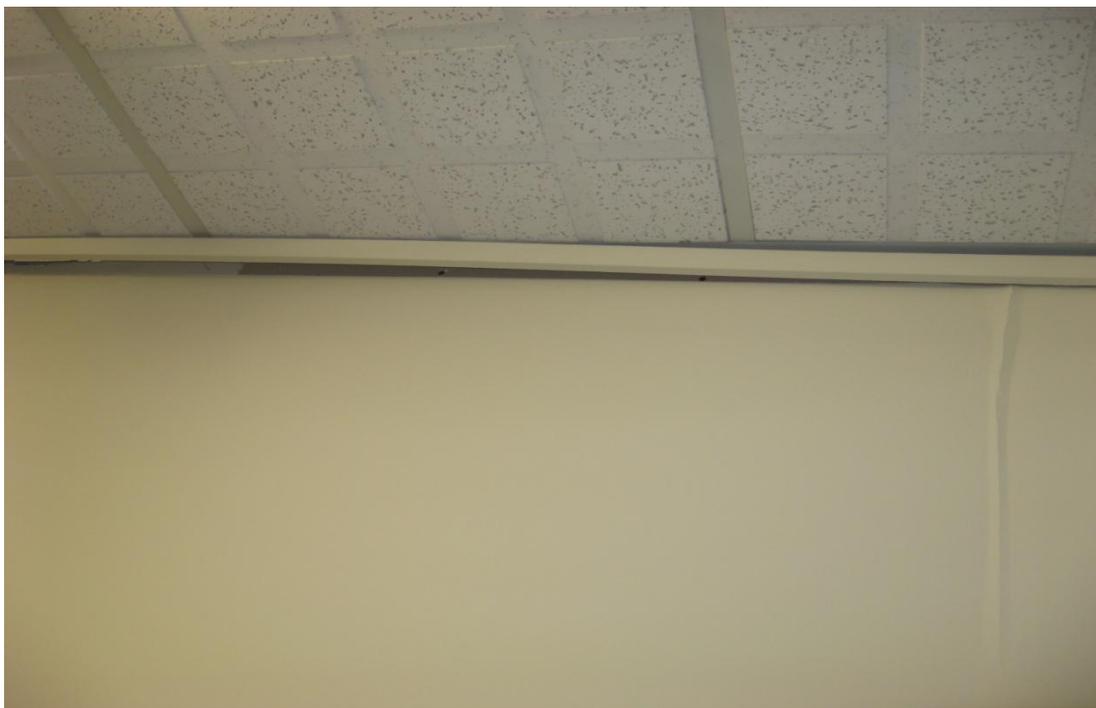
Where ceiling linings adjoin concrete columns, the plaster linings have been damaged. In some cases the rails for the suspended tiled ceilings have been buckled. Photo 14.

Photo 14 Cracked wall lining and damaged ceiling coving.

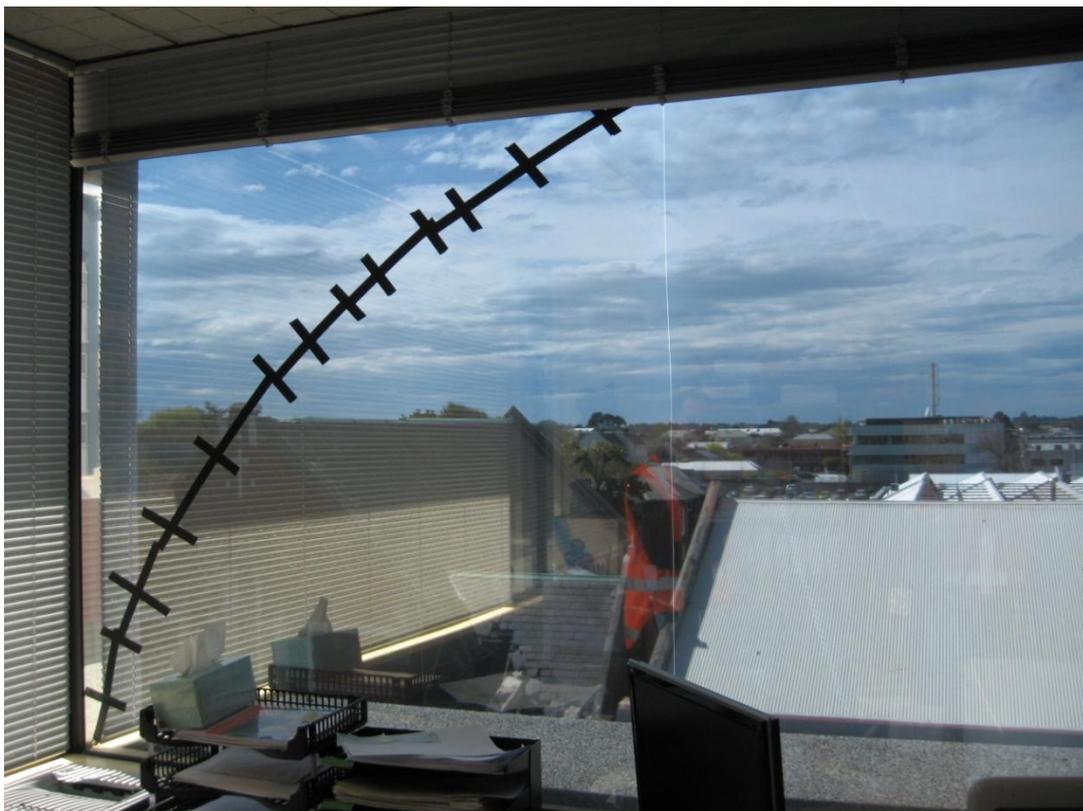
A few windows, particularly in the east elevation have been broken. Photo 15. This may also reflect greater movement of the building in the north-south direction. There are no windows in the opposite west wall but the damage to interior linings on that west wall is significant.

Photo 15 Broken window.

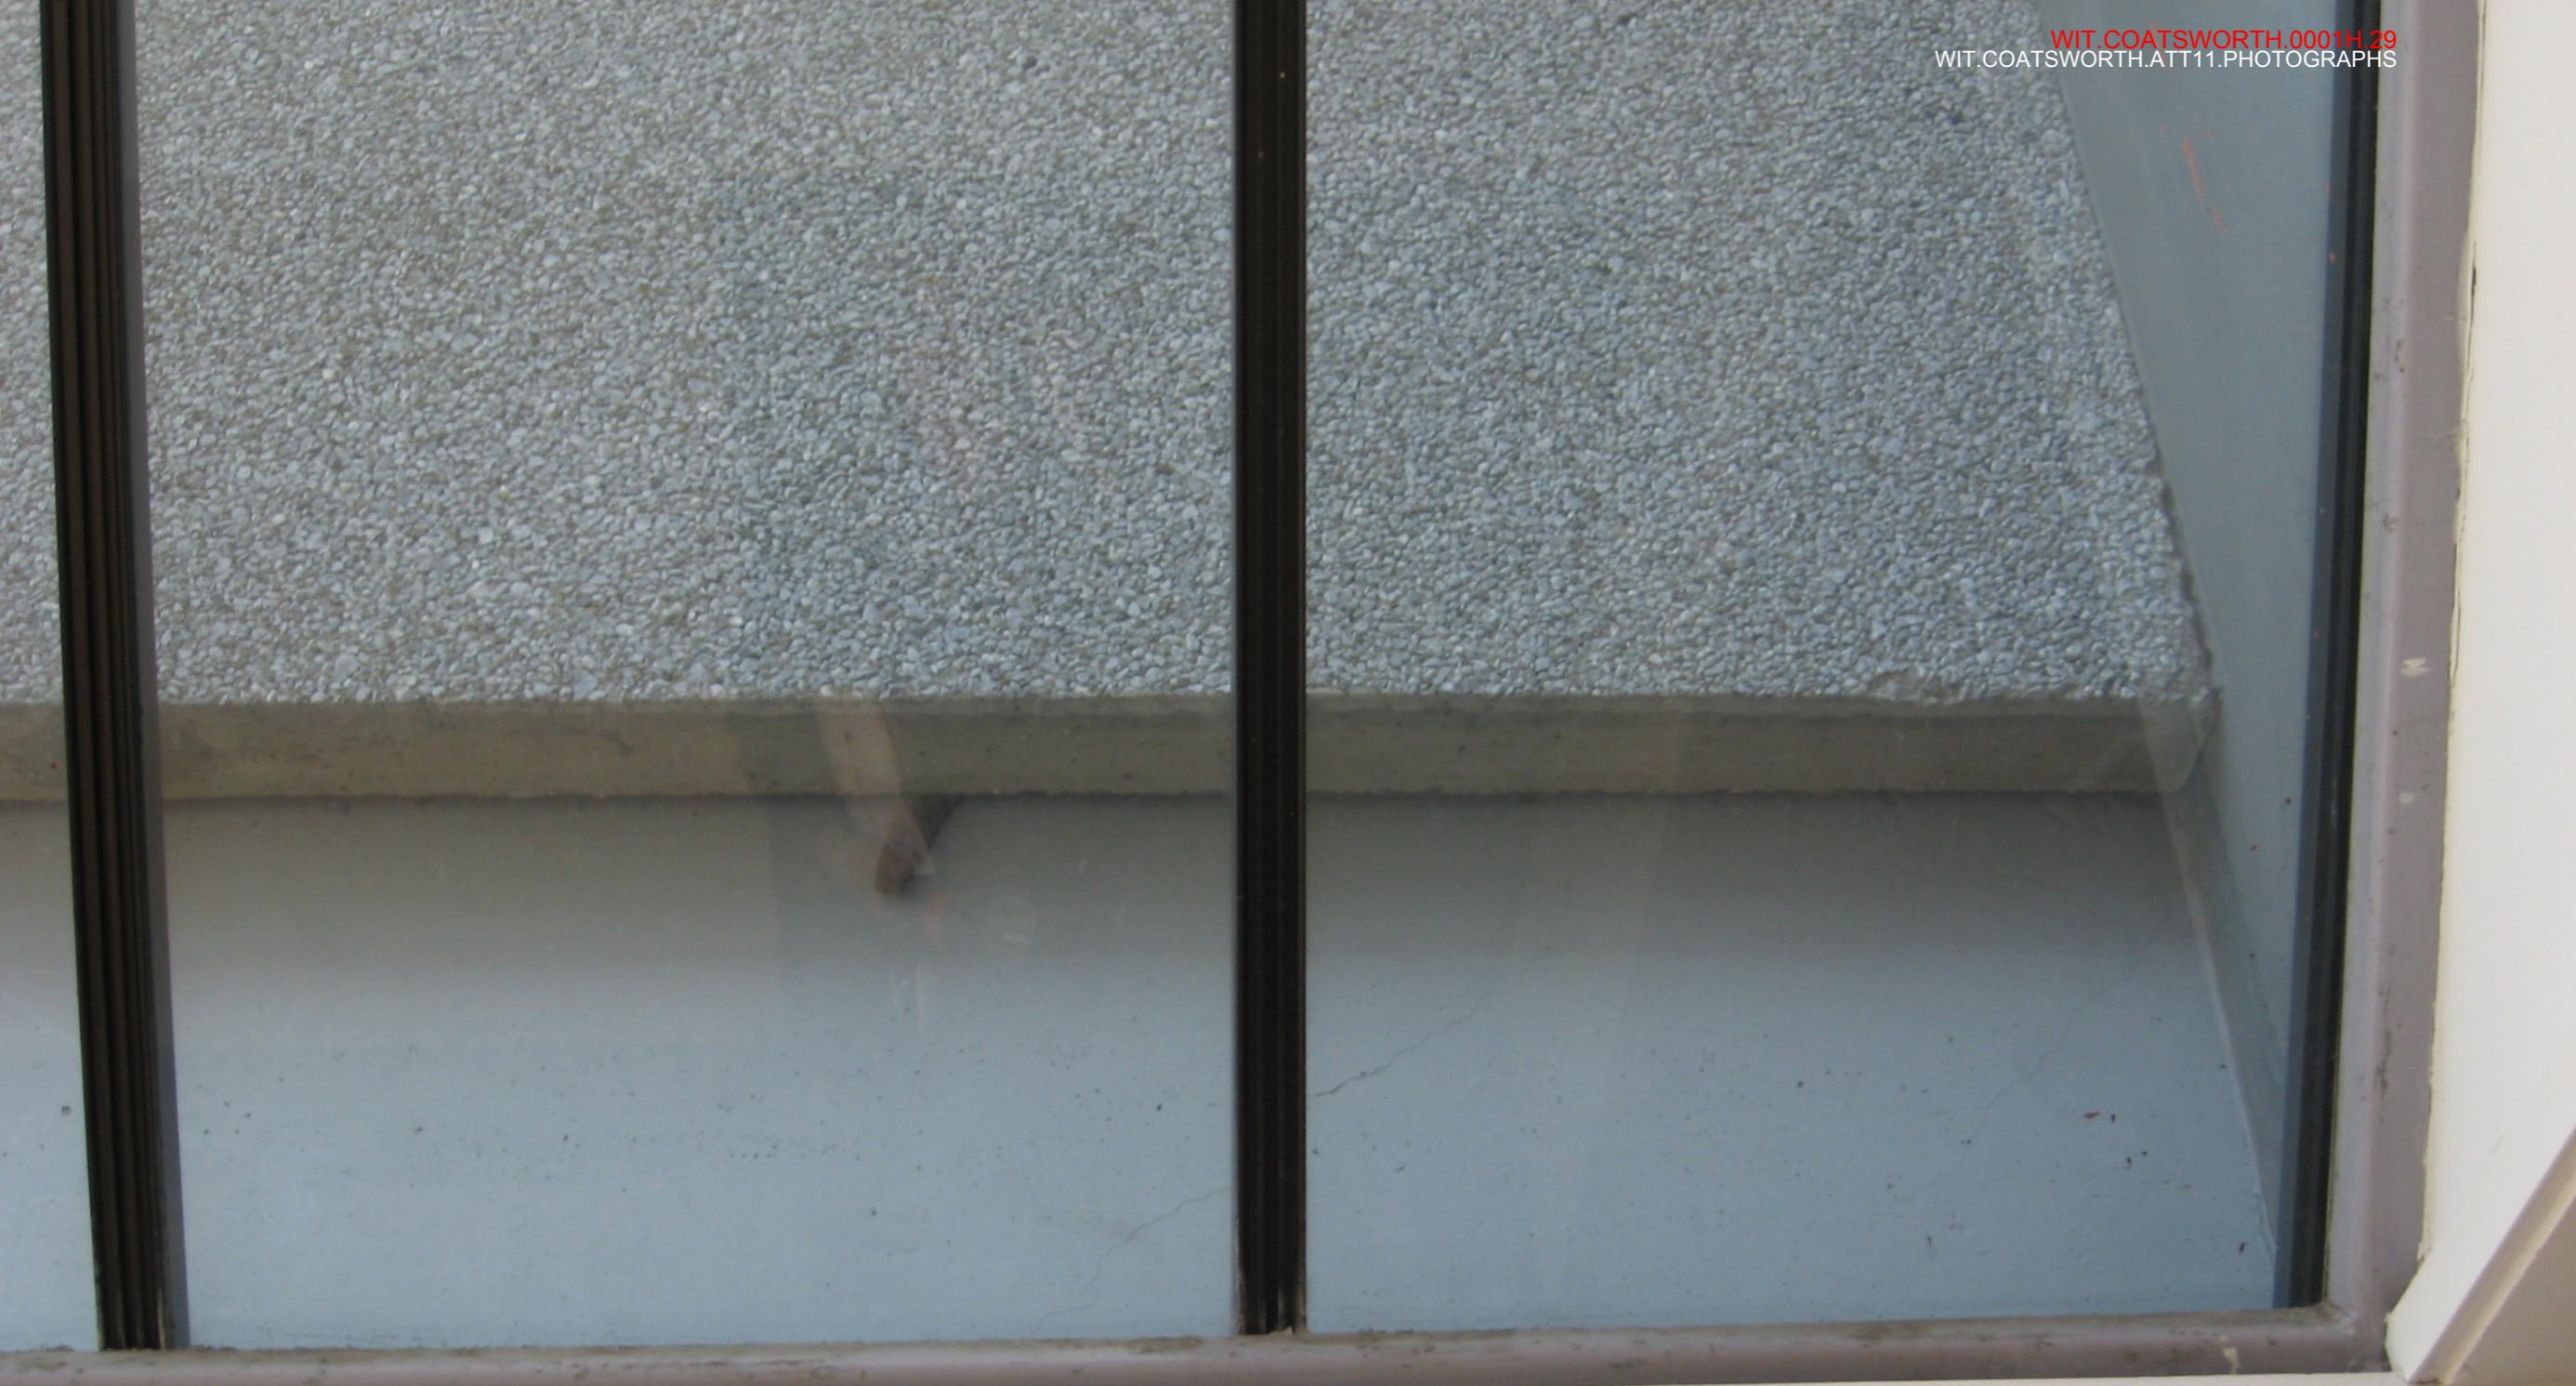
001 1st Fl beam crack Nth elev, east of lift lobby, similar to 29Sep10 Photo 045

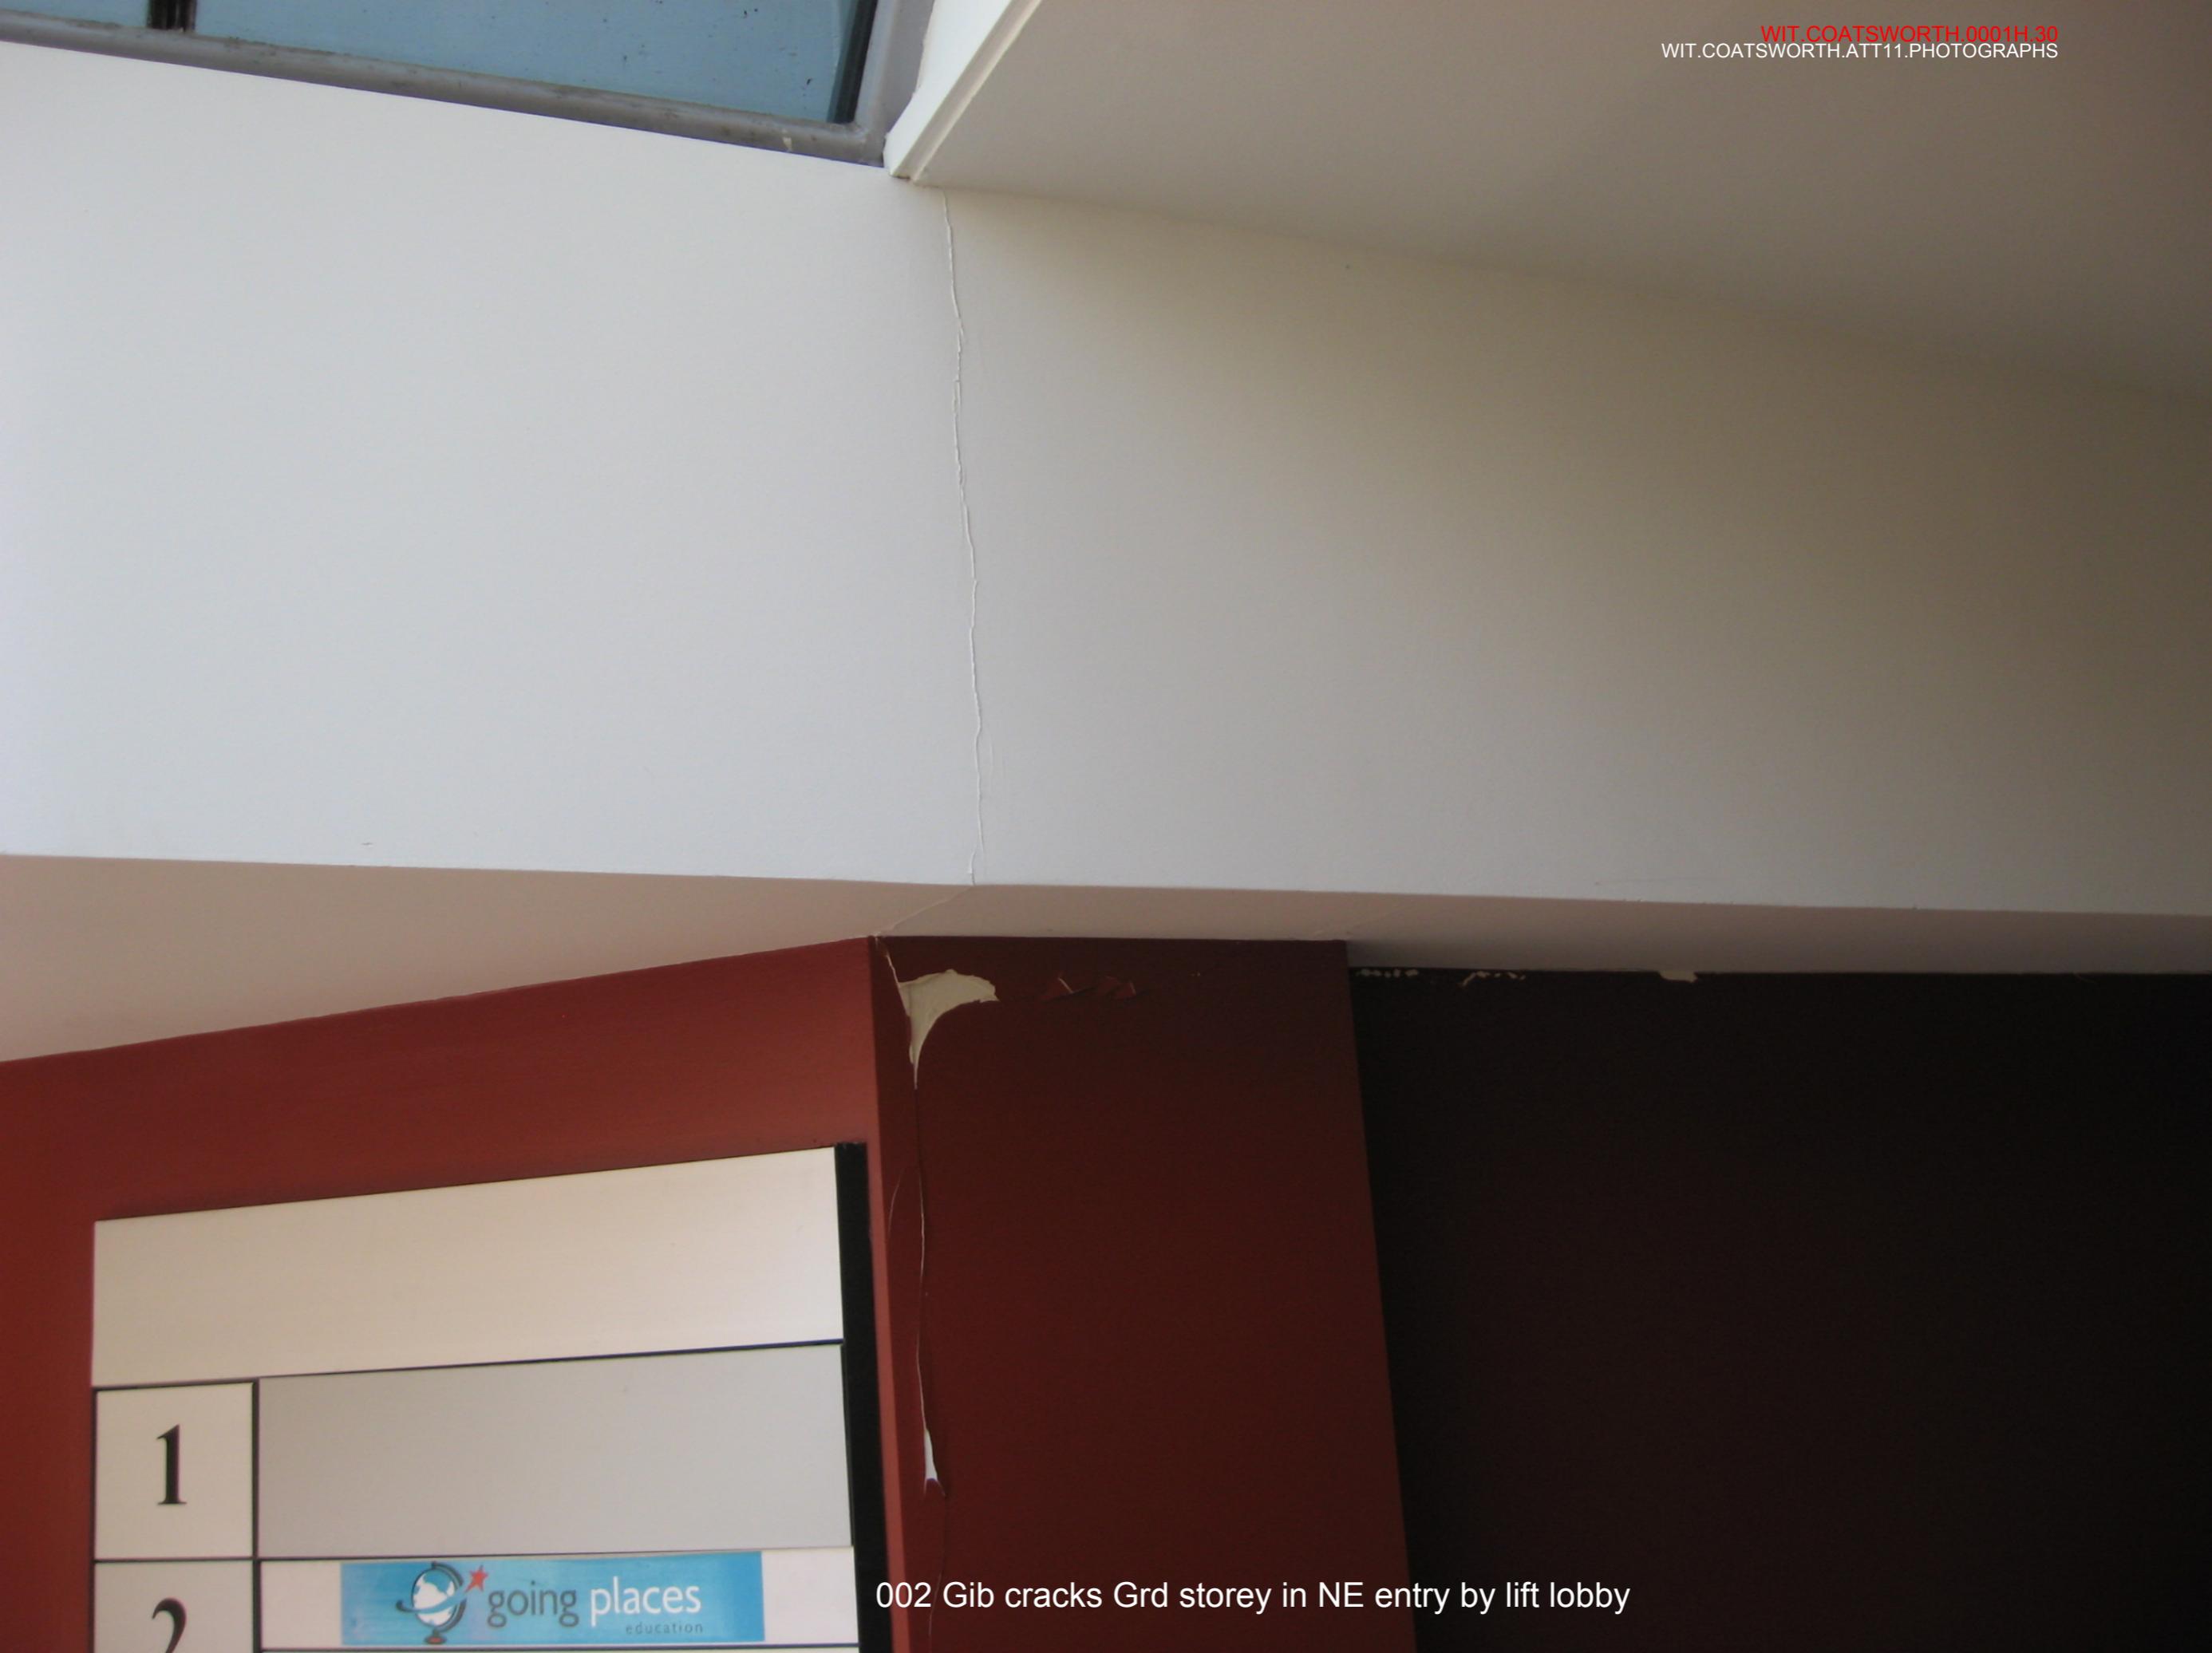
002 Gib cracks Grd storey in NE entry by lift lobby
