Madras Equities Ltd

249 Madras Street

Damage Report

4 September 2010 Earthquake

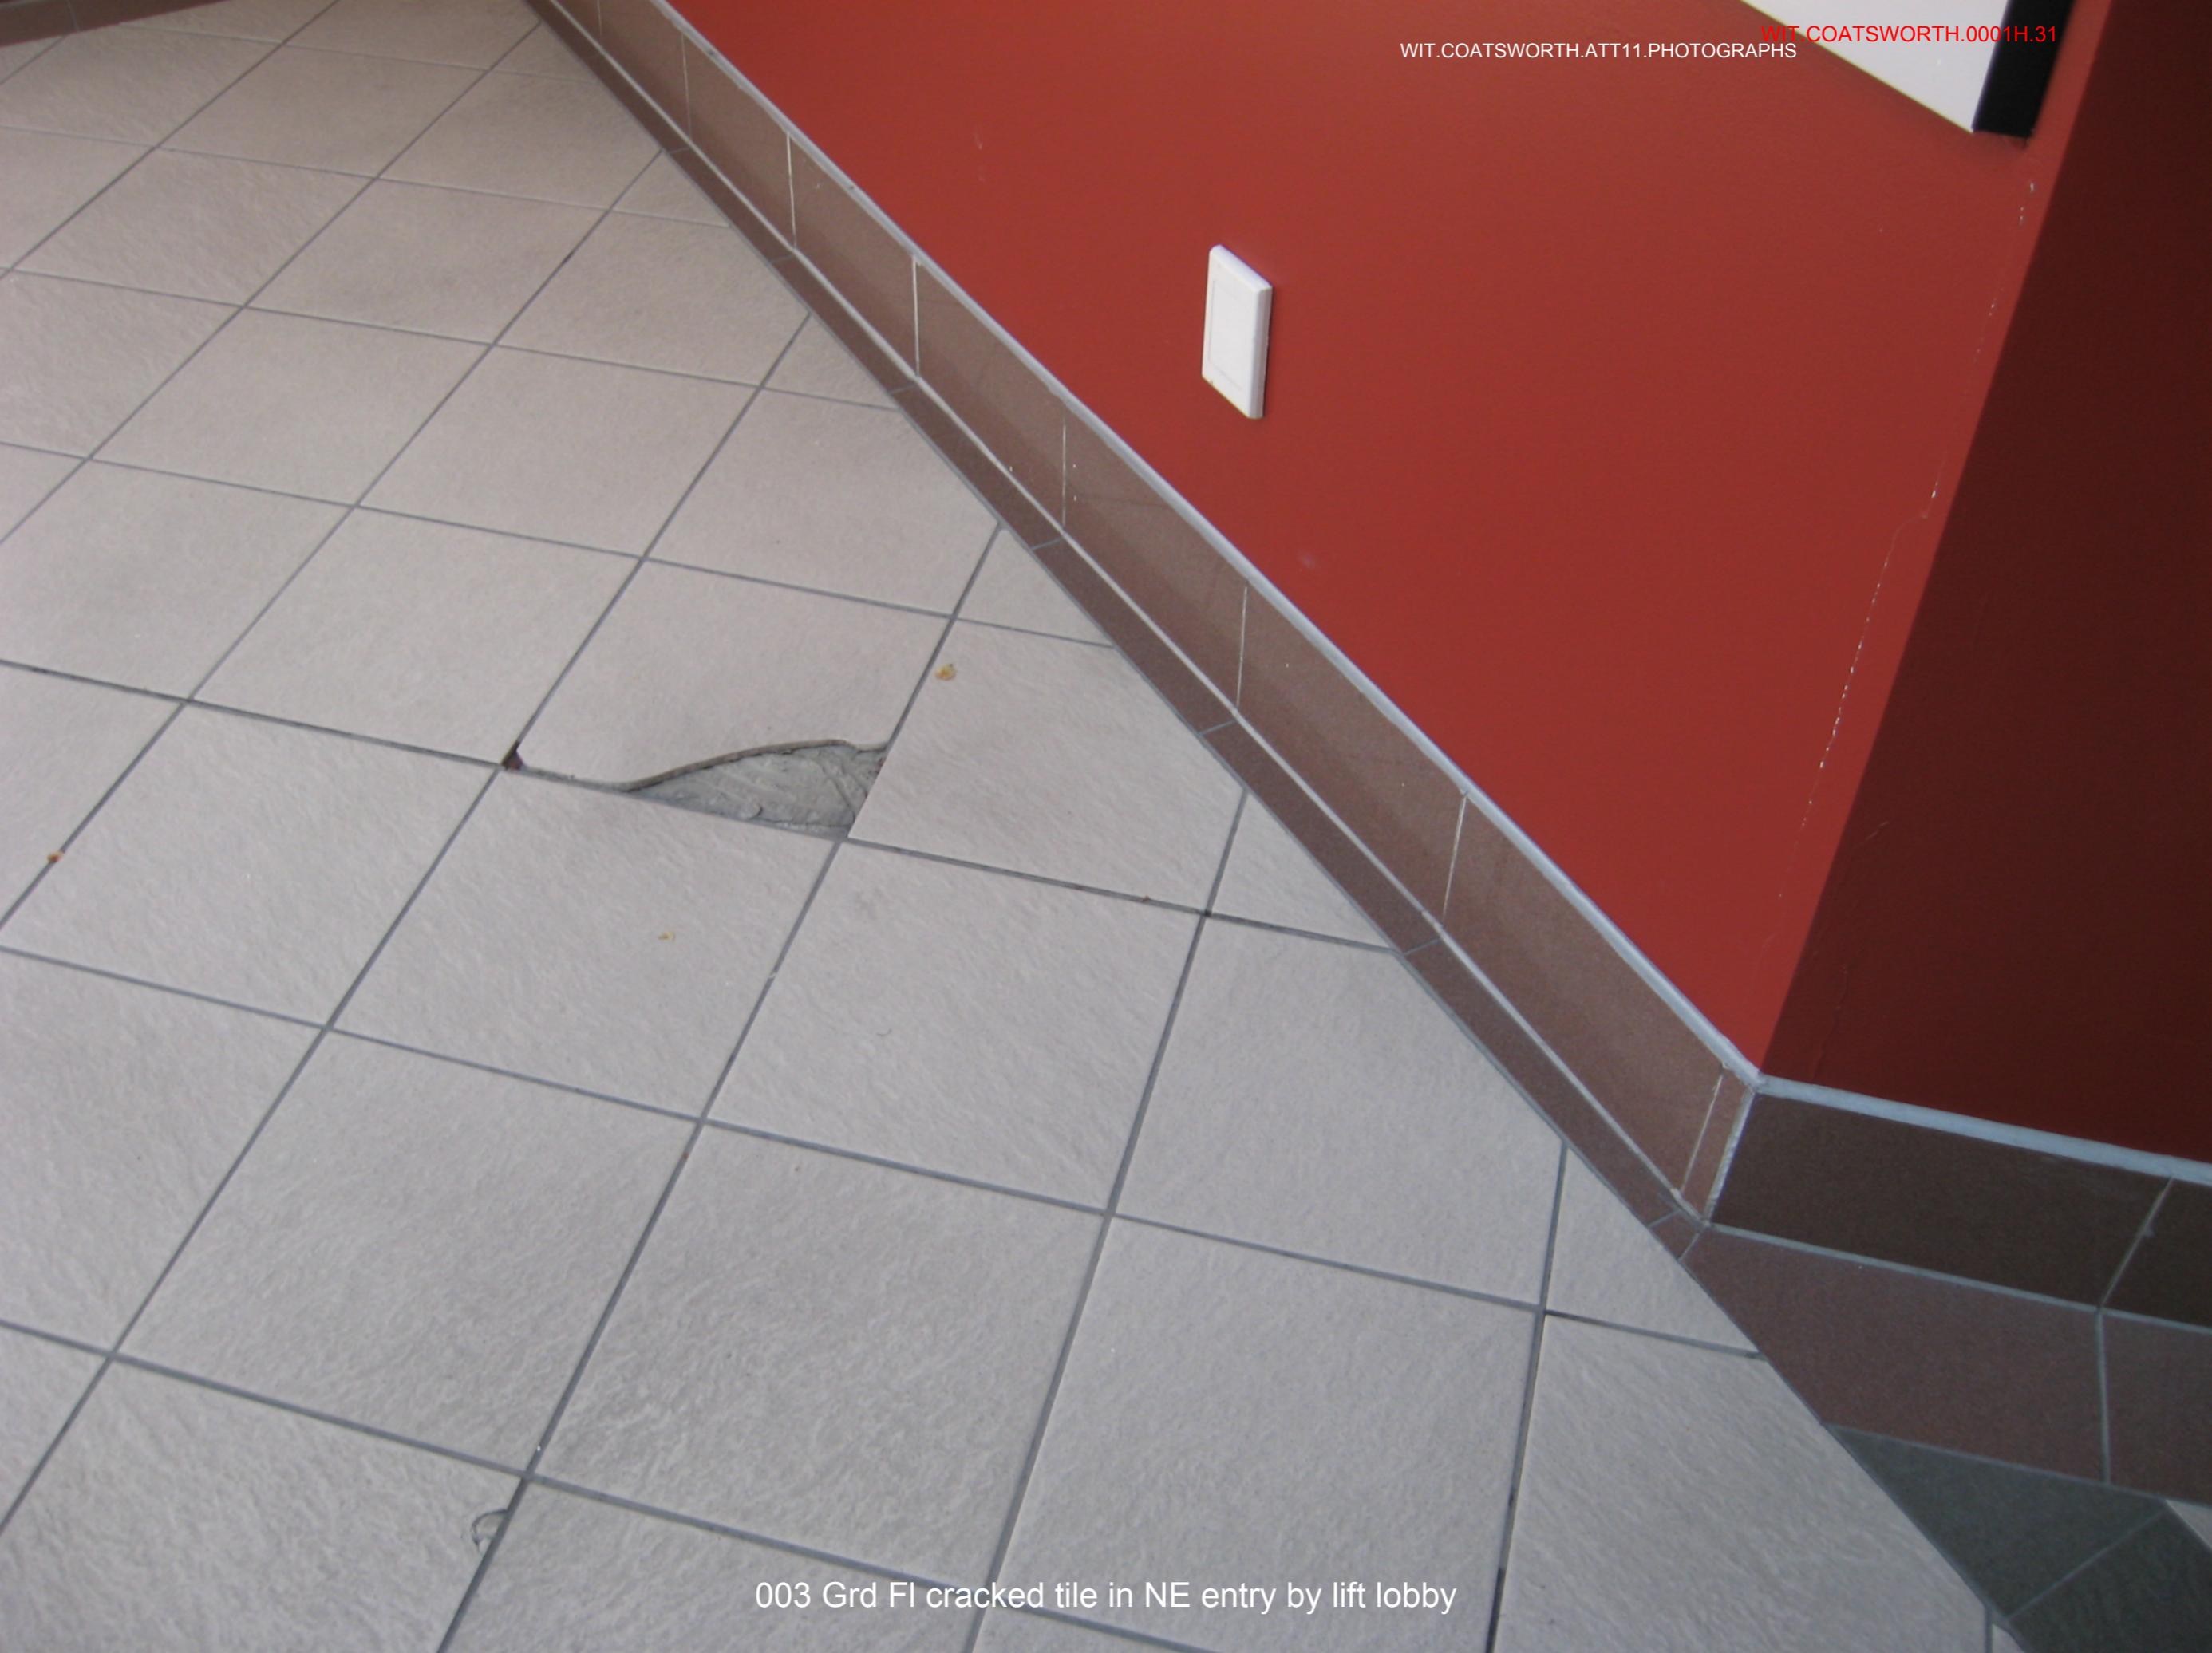
003 Grd Fl cracked tile in NE entry by lift lobby

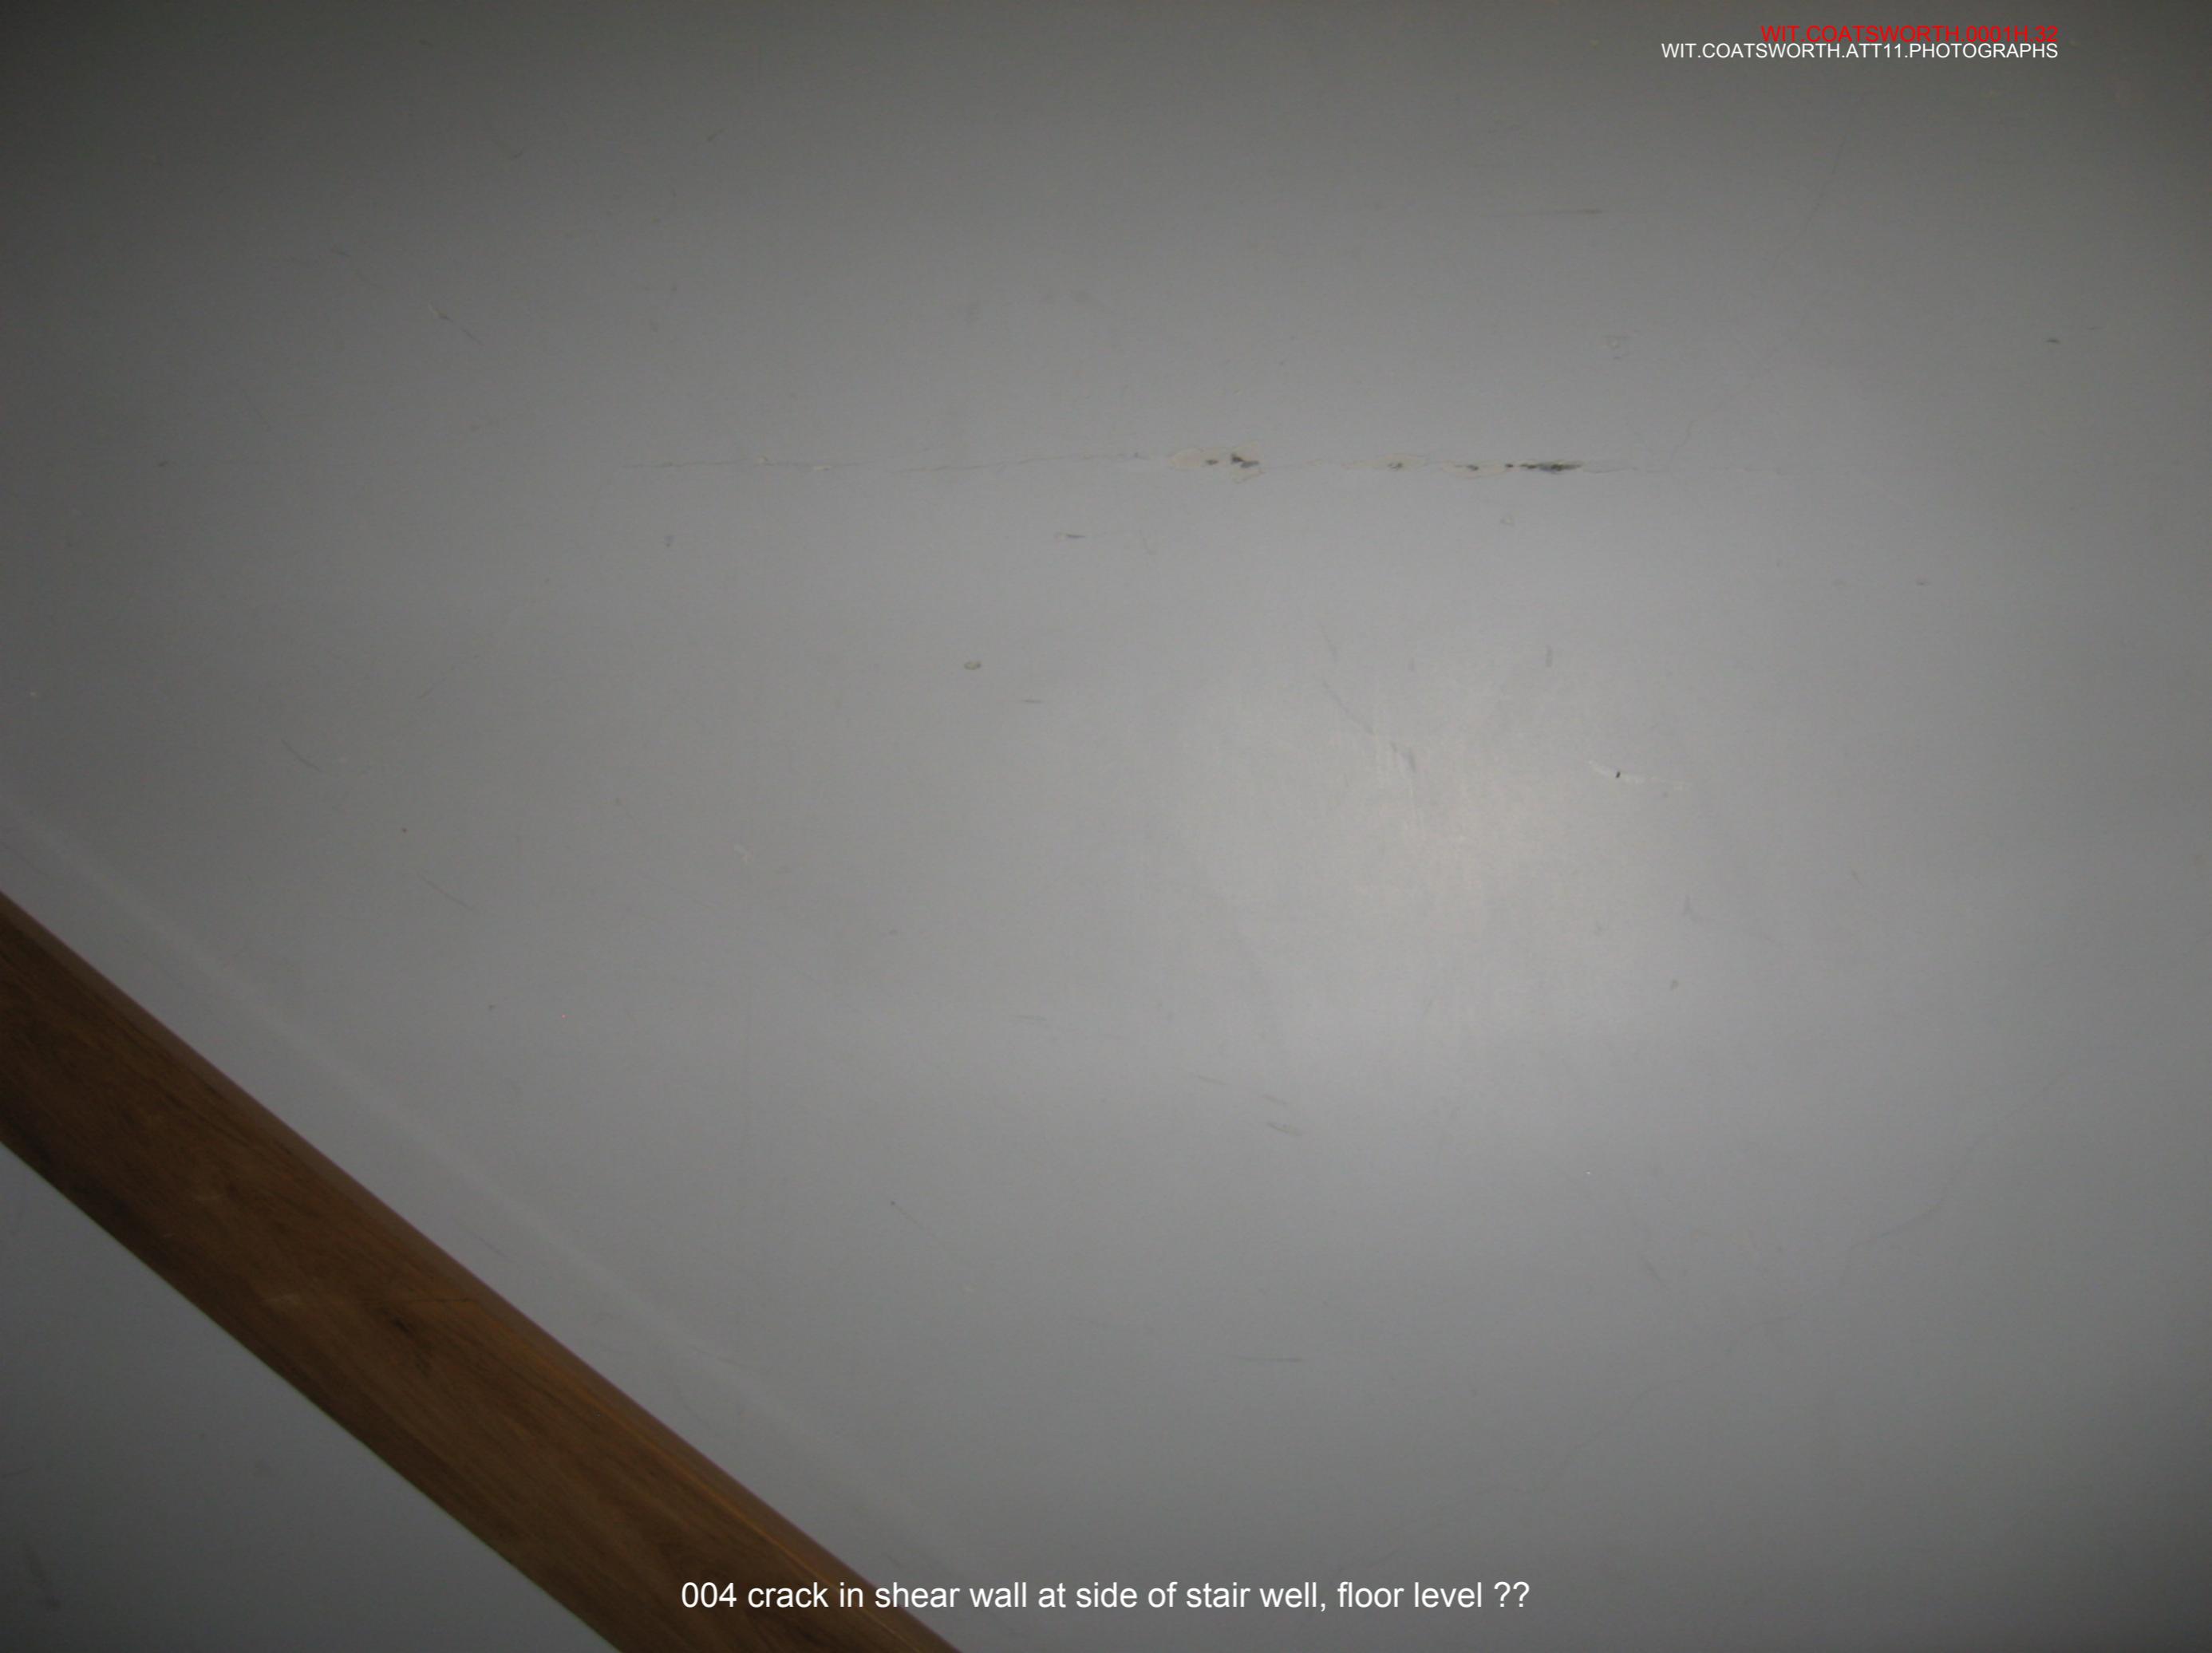
004 crack in shear wall at side of stair well, floor level ??

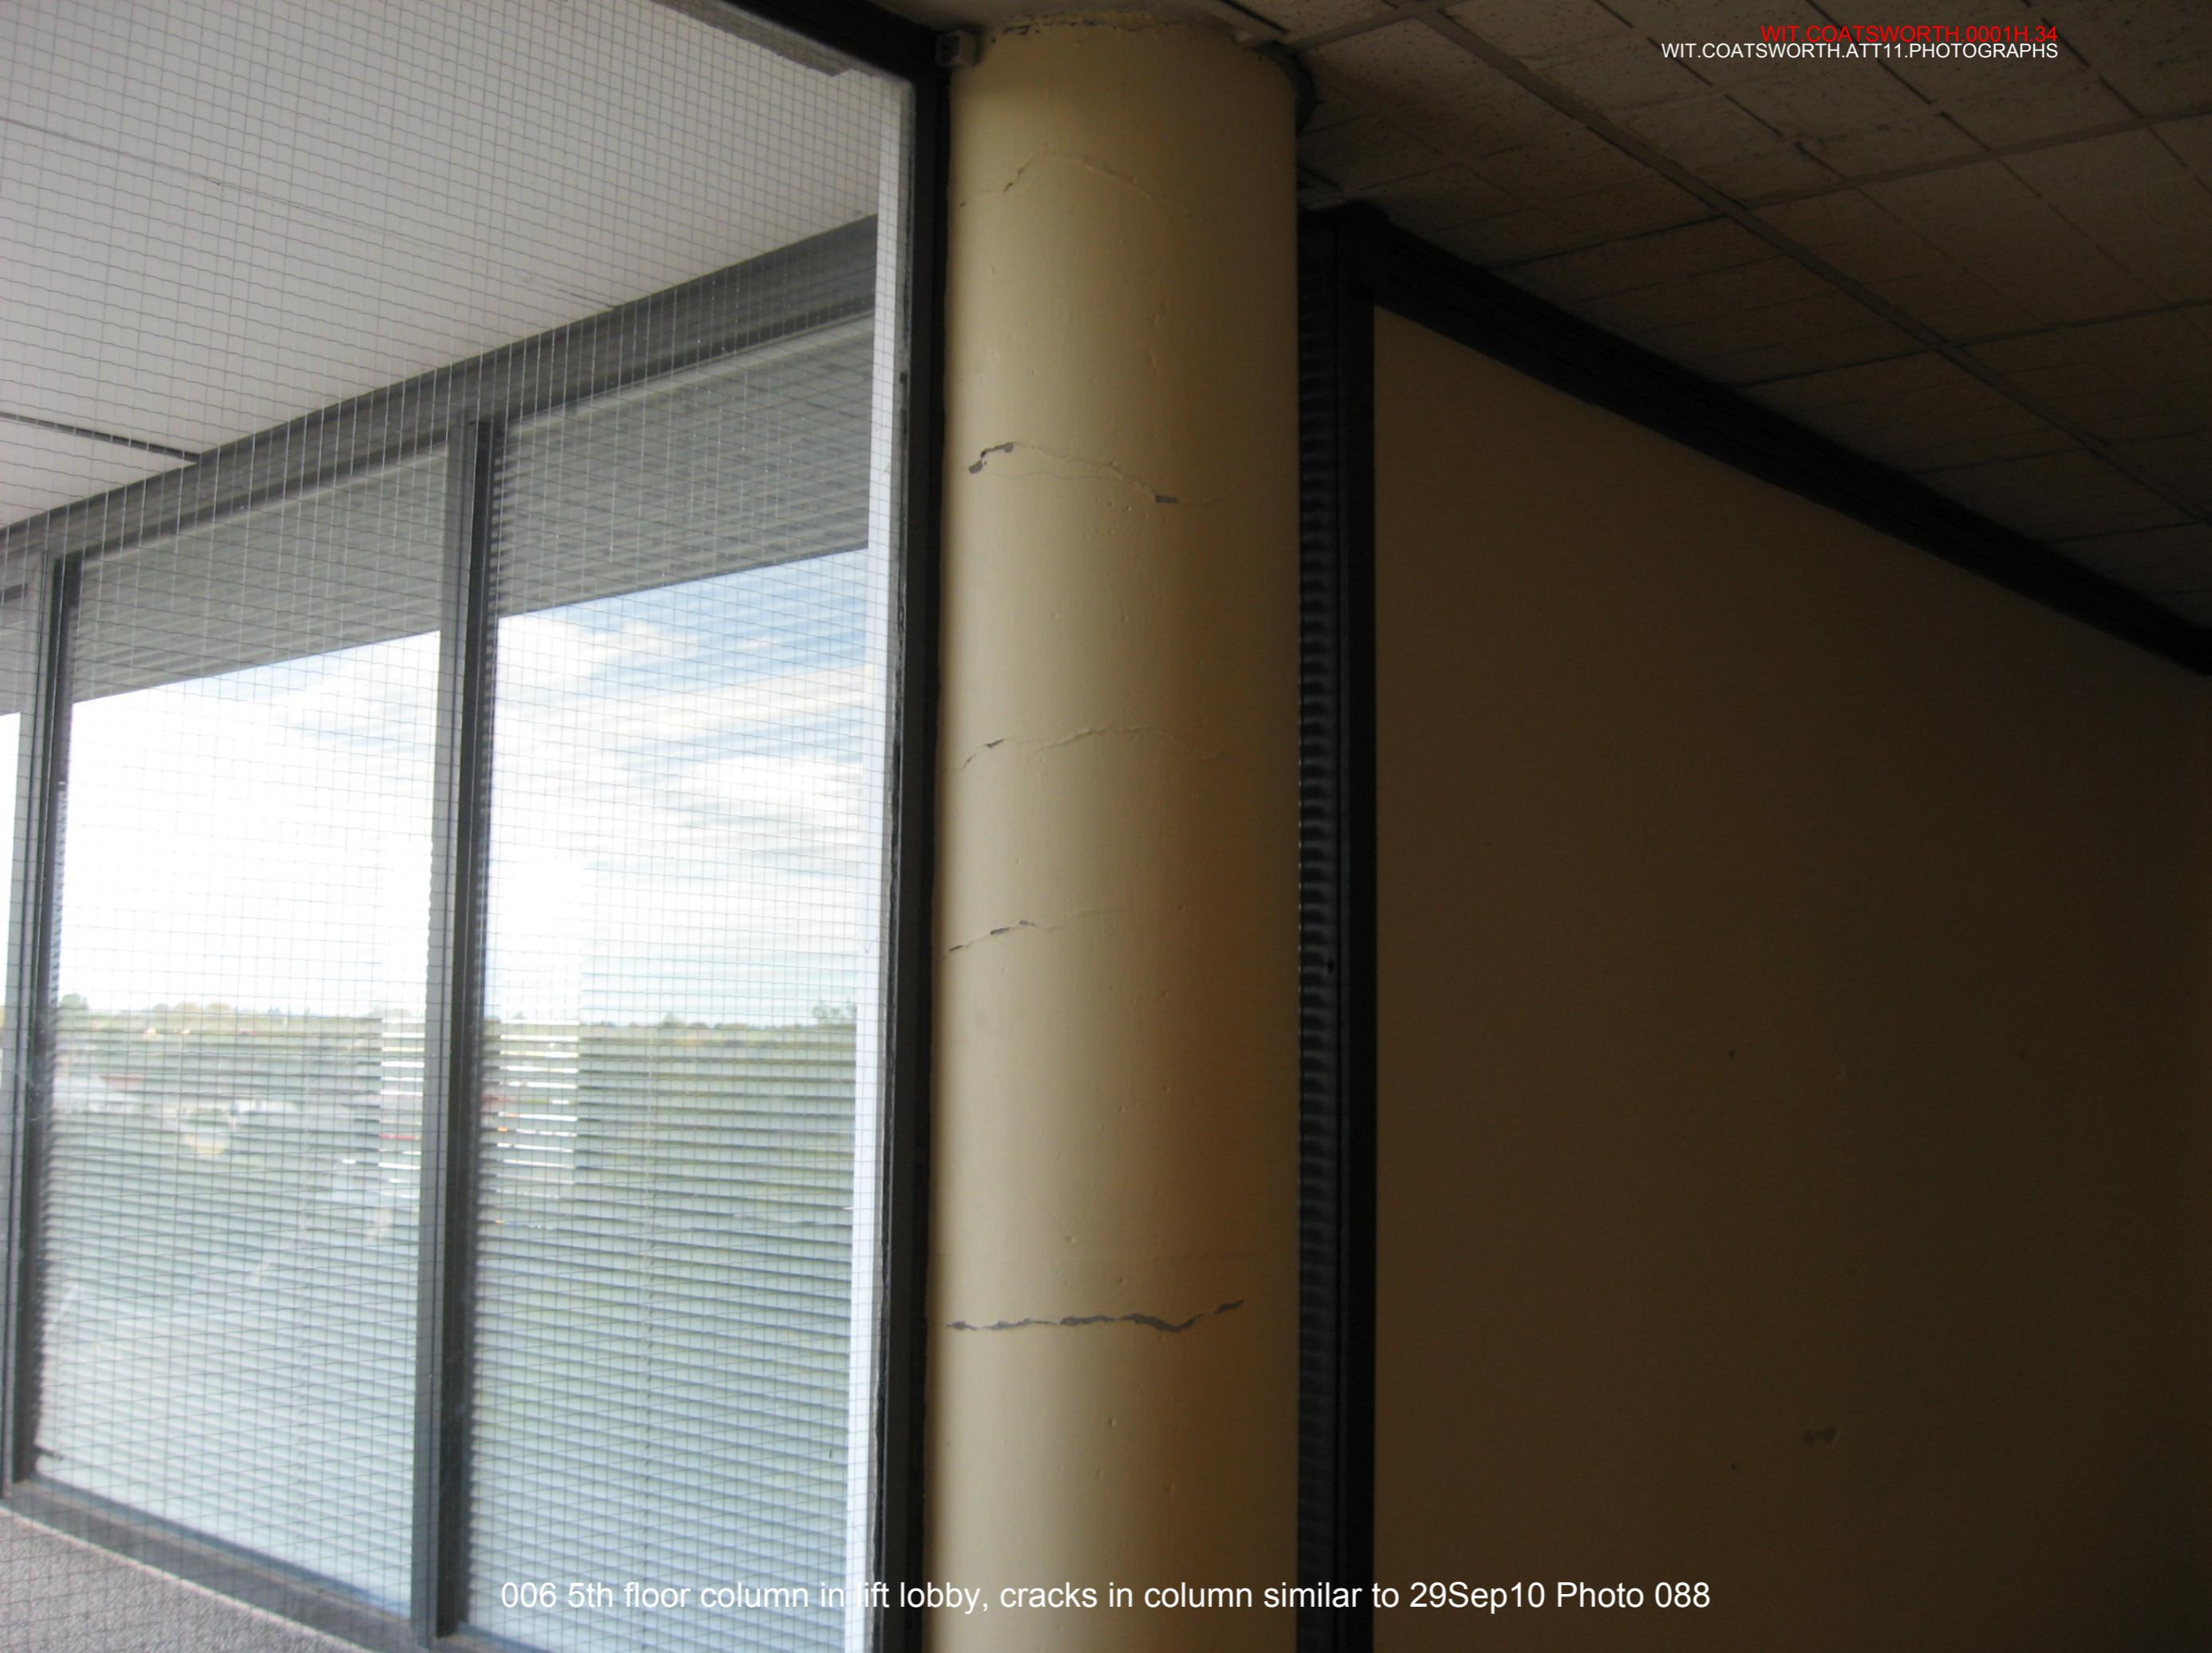
006 5th floor column in lift lobby, cracks in column similar to 29Sep10 Photo 088

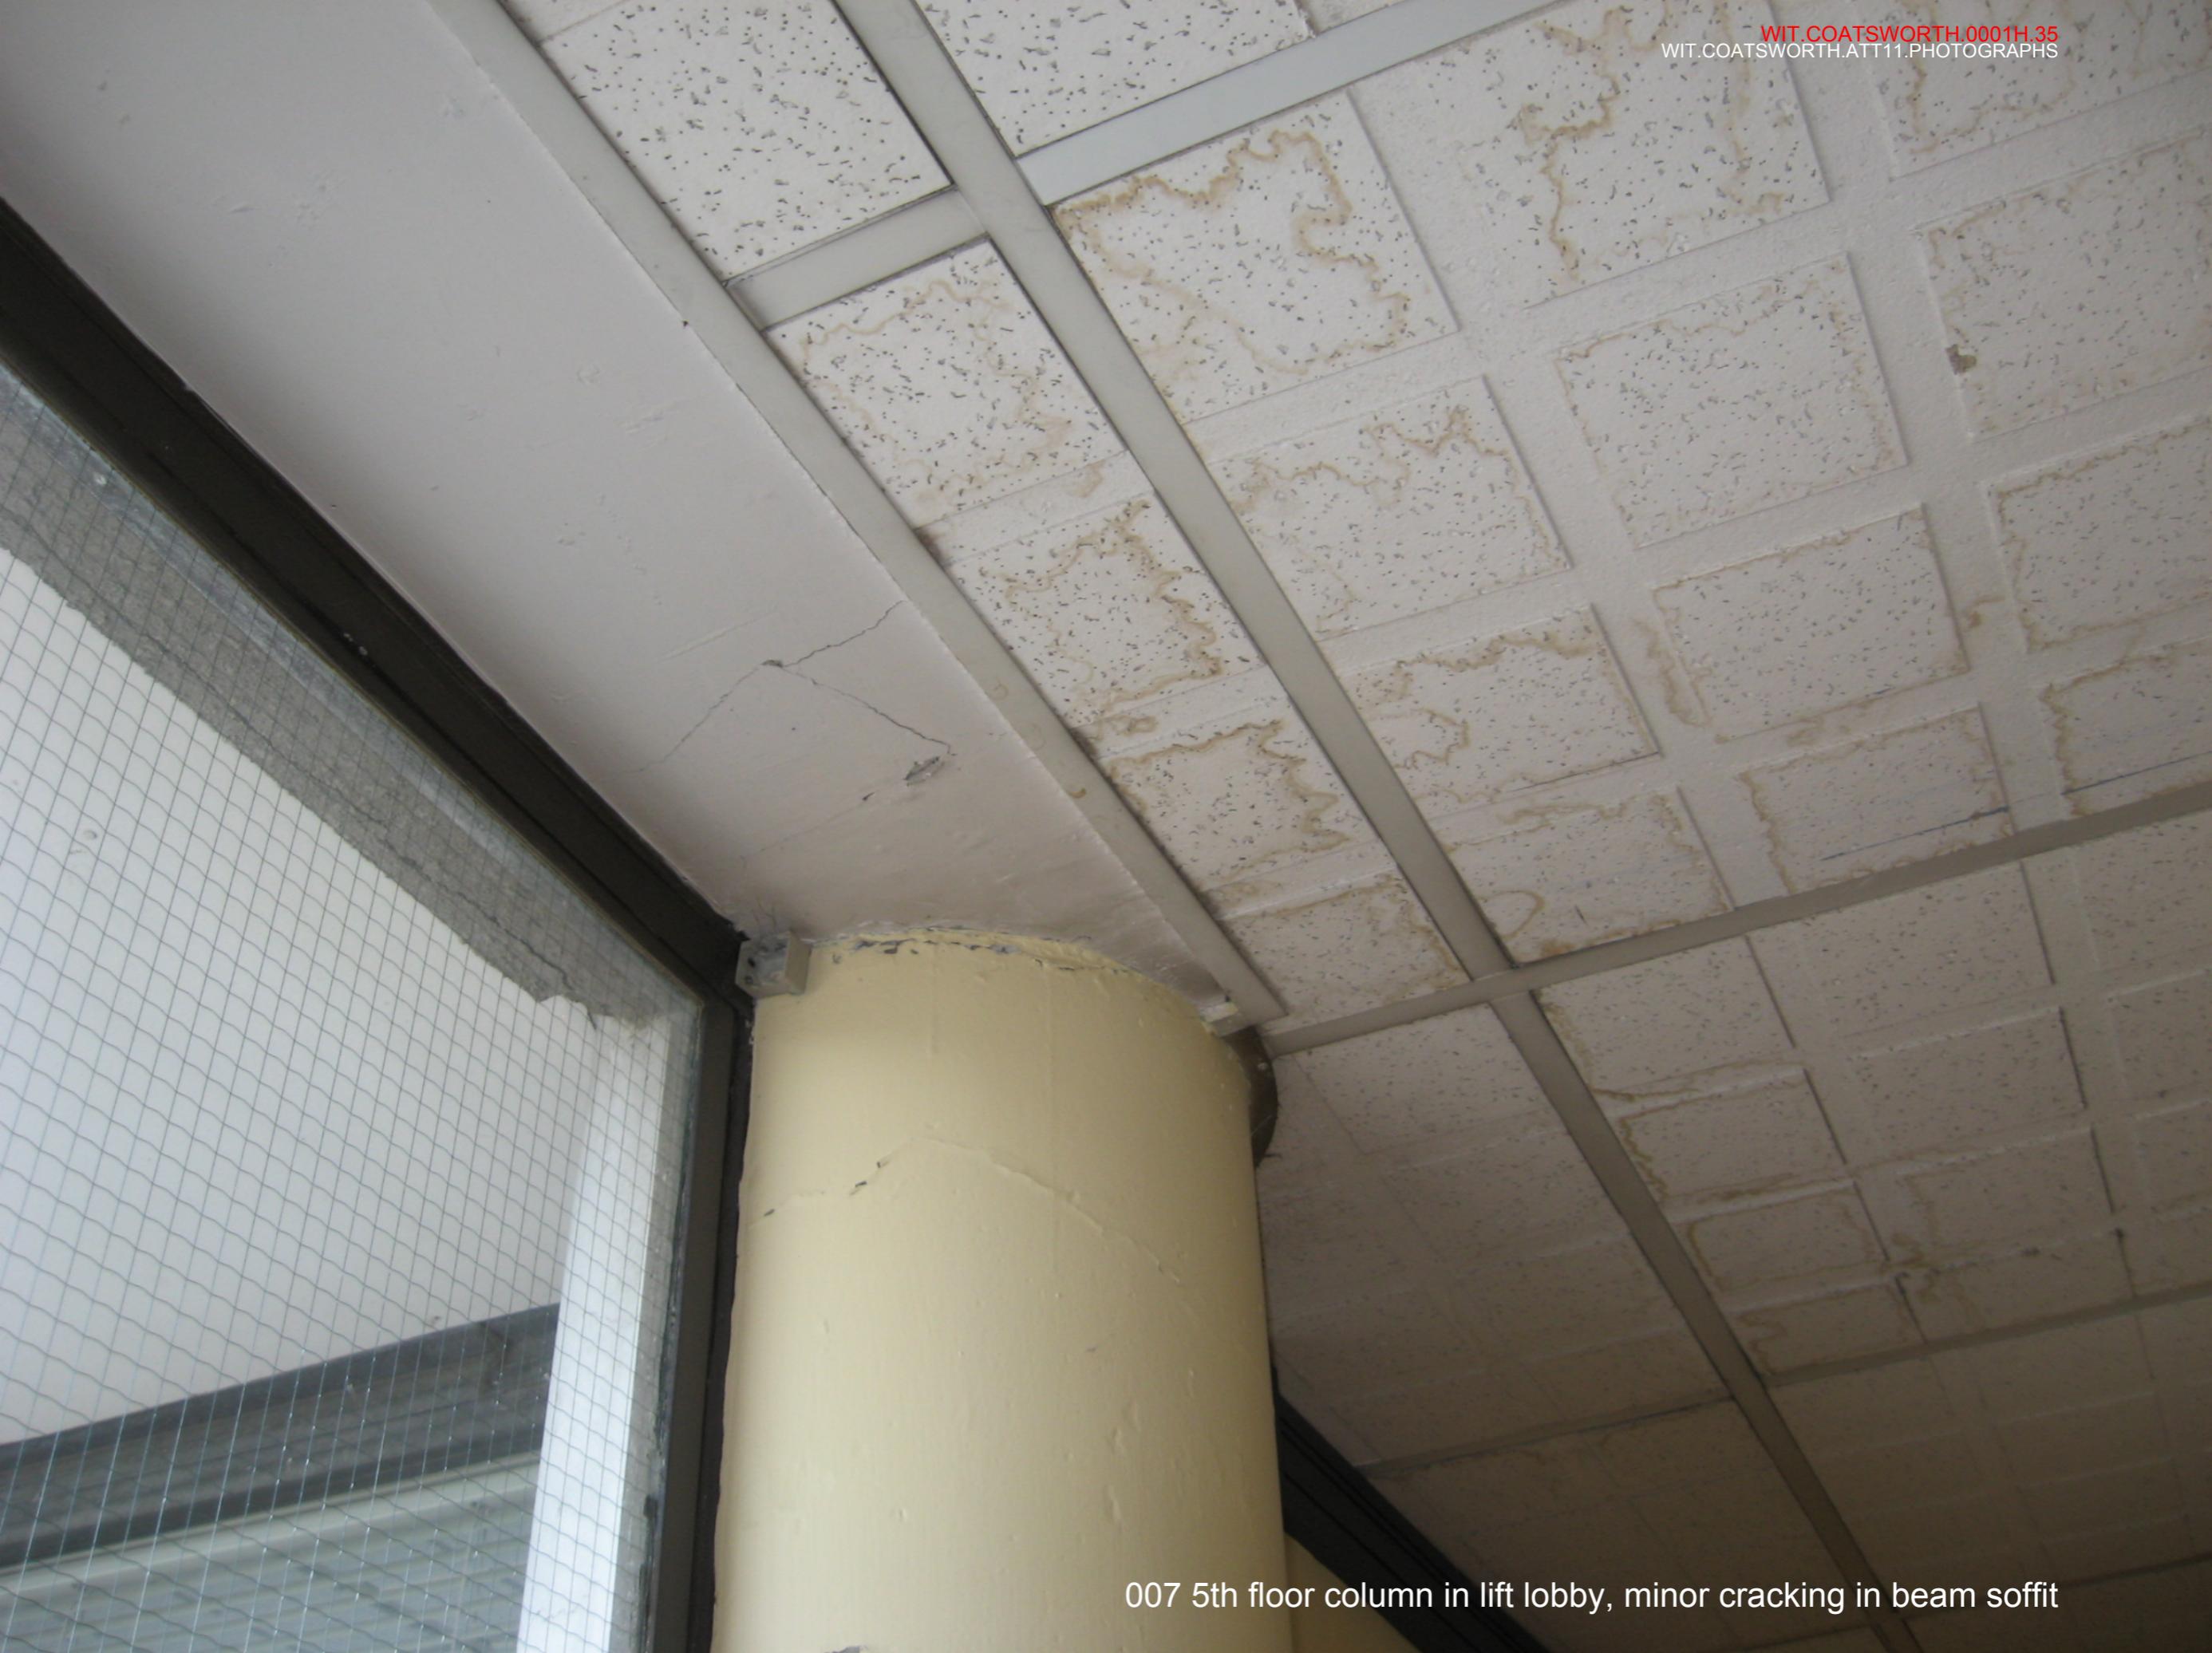
007 5th floor column in lift lobby, minor cracking in beam soffit

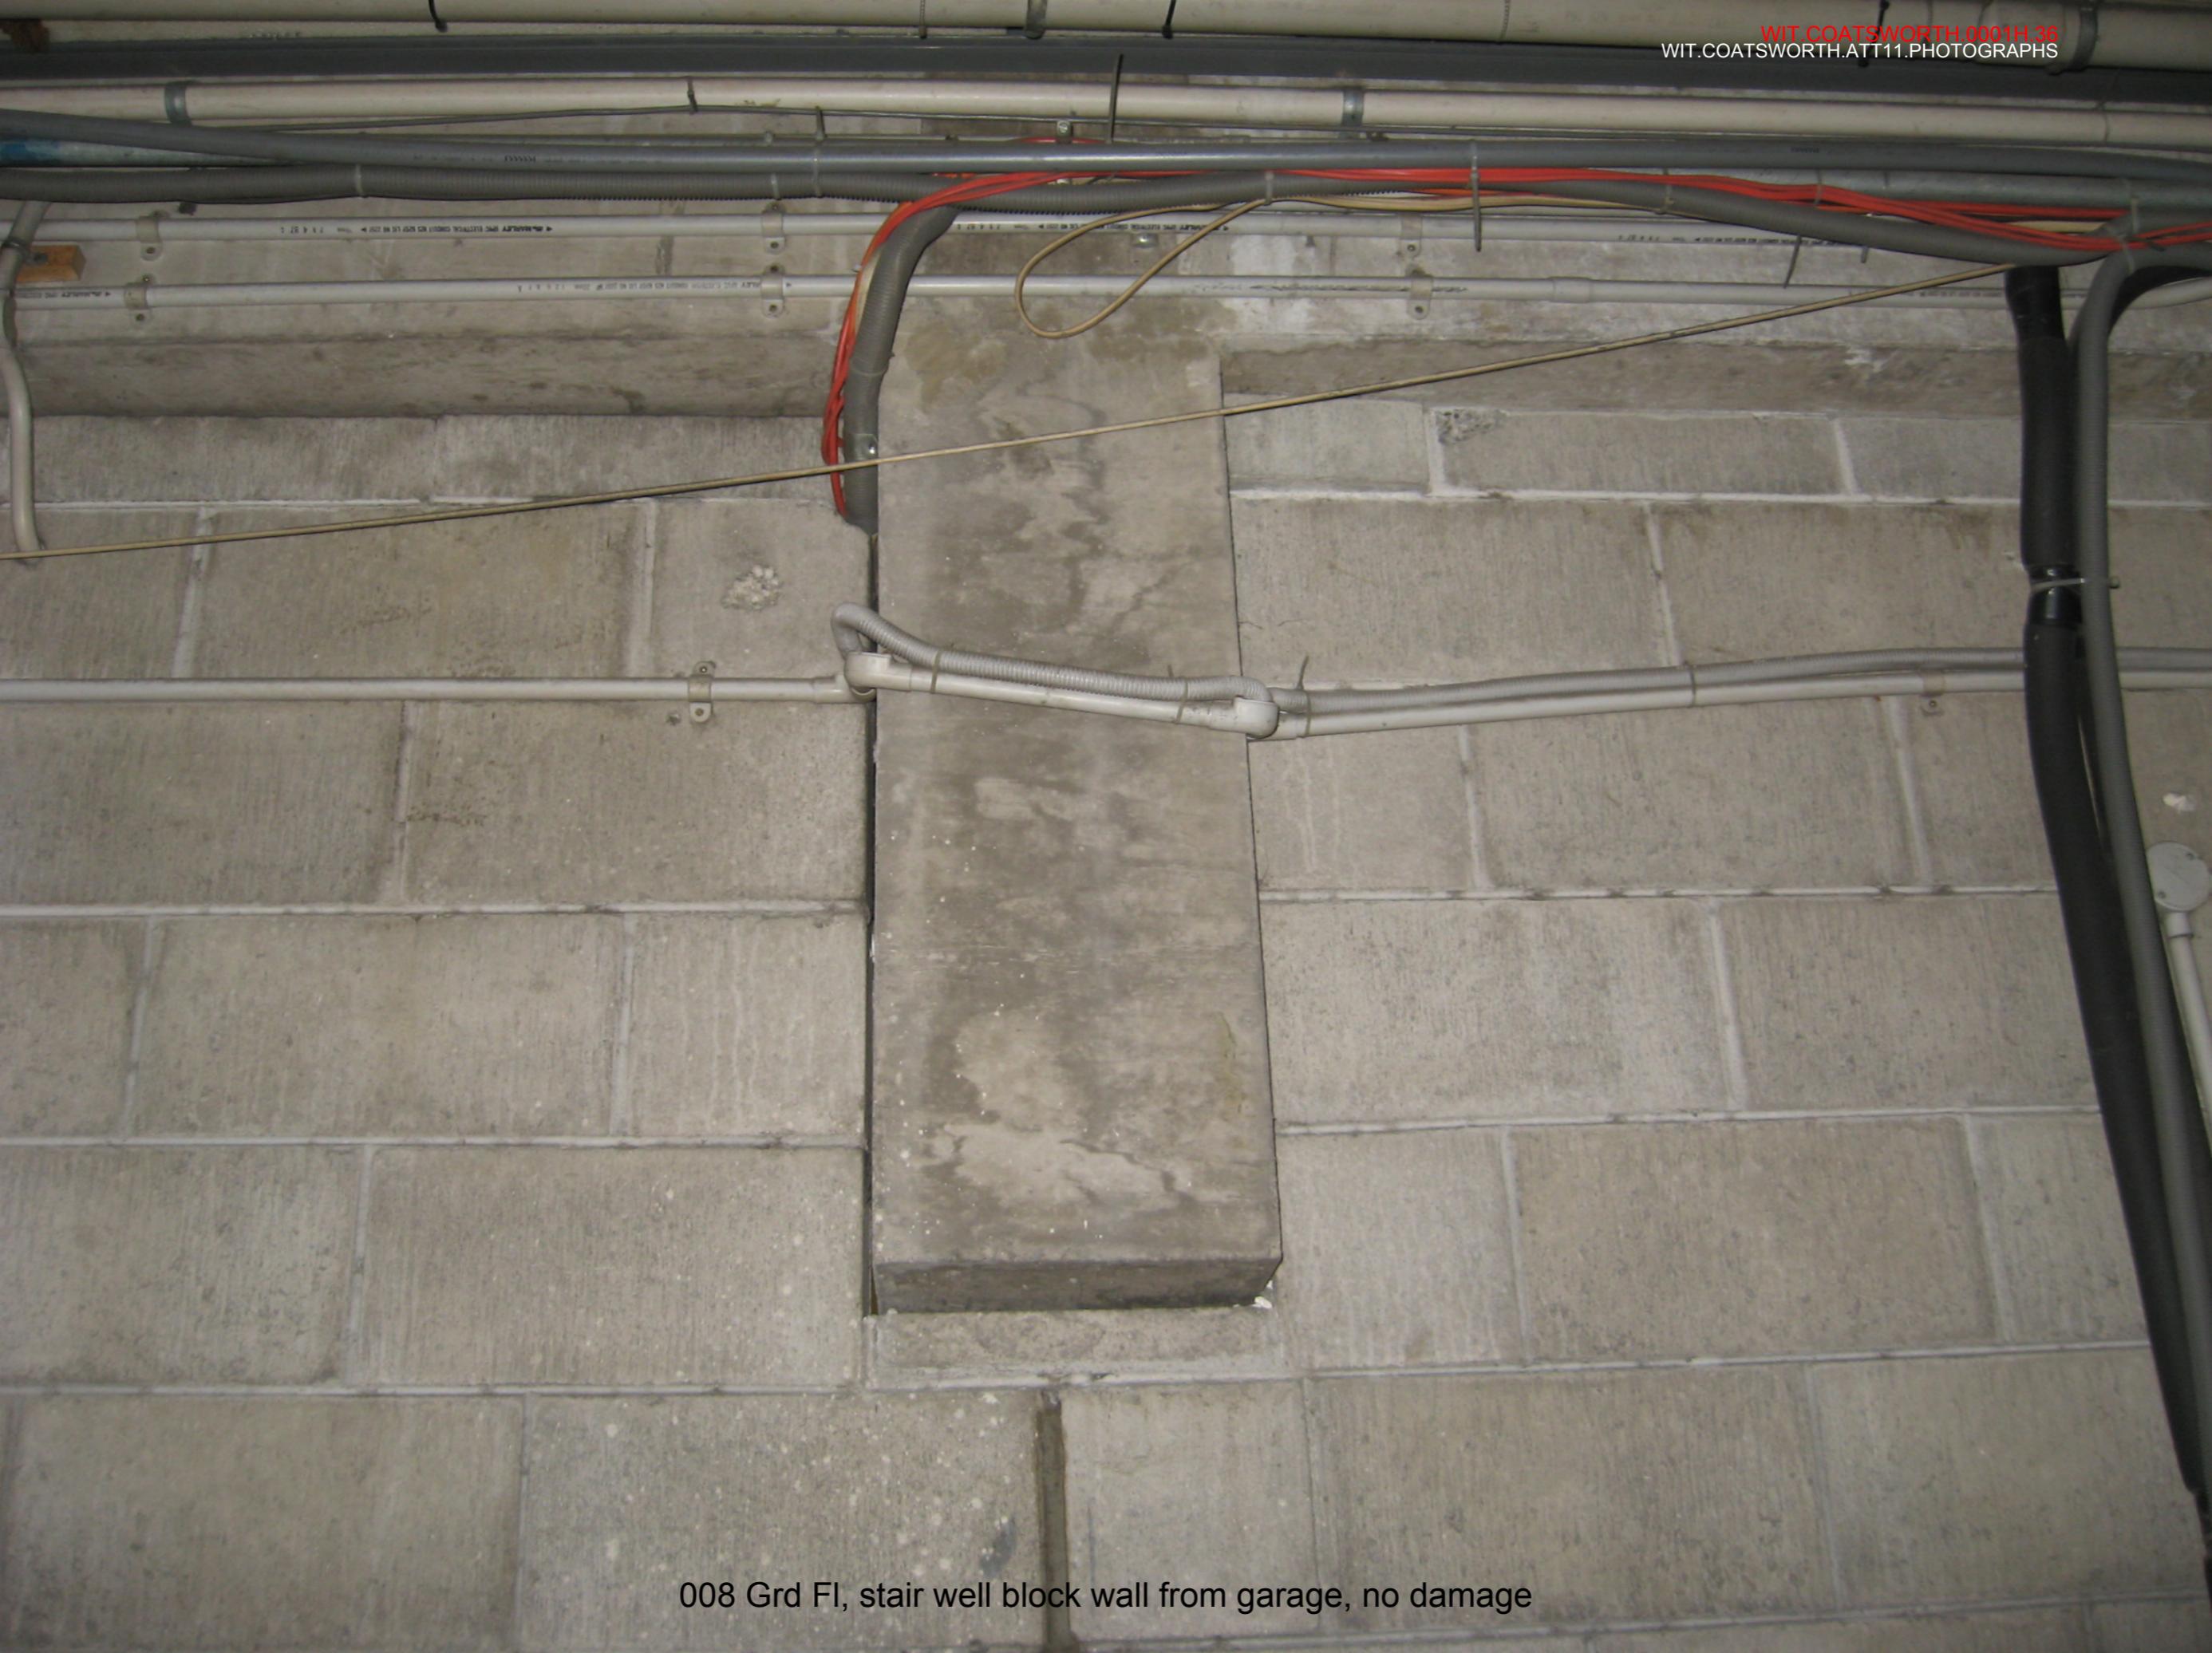
008 Grd Fl, stair well block wall from garage, no damage

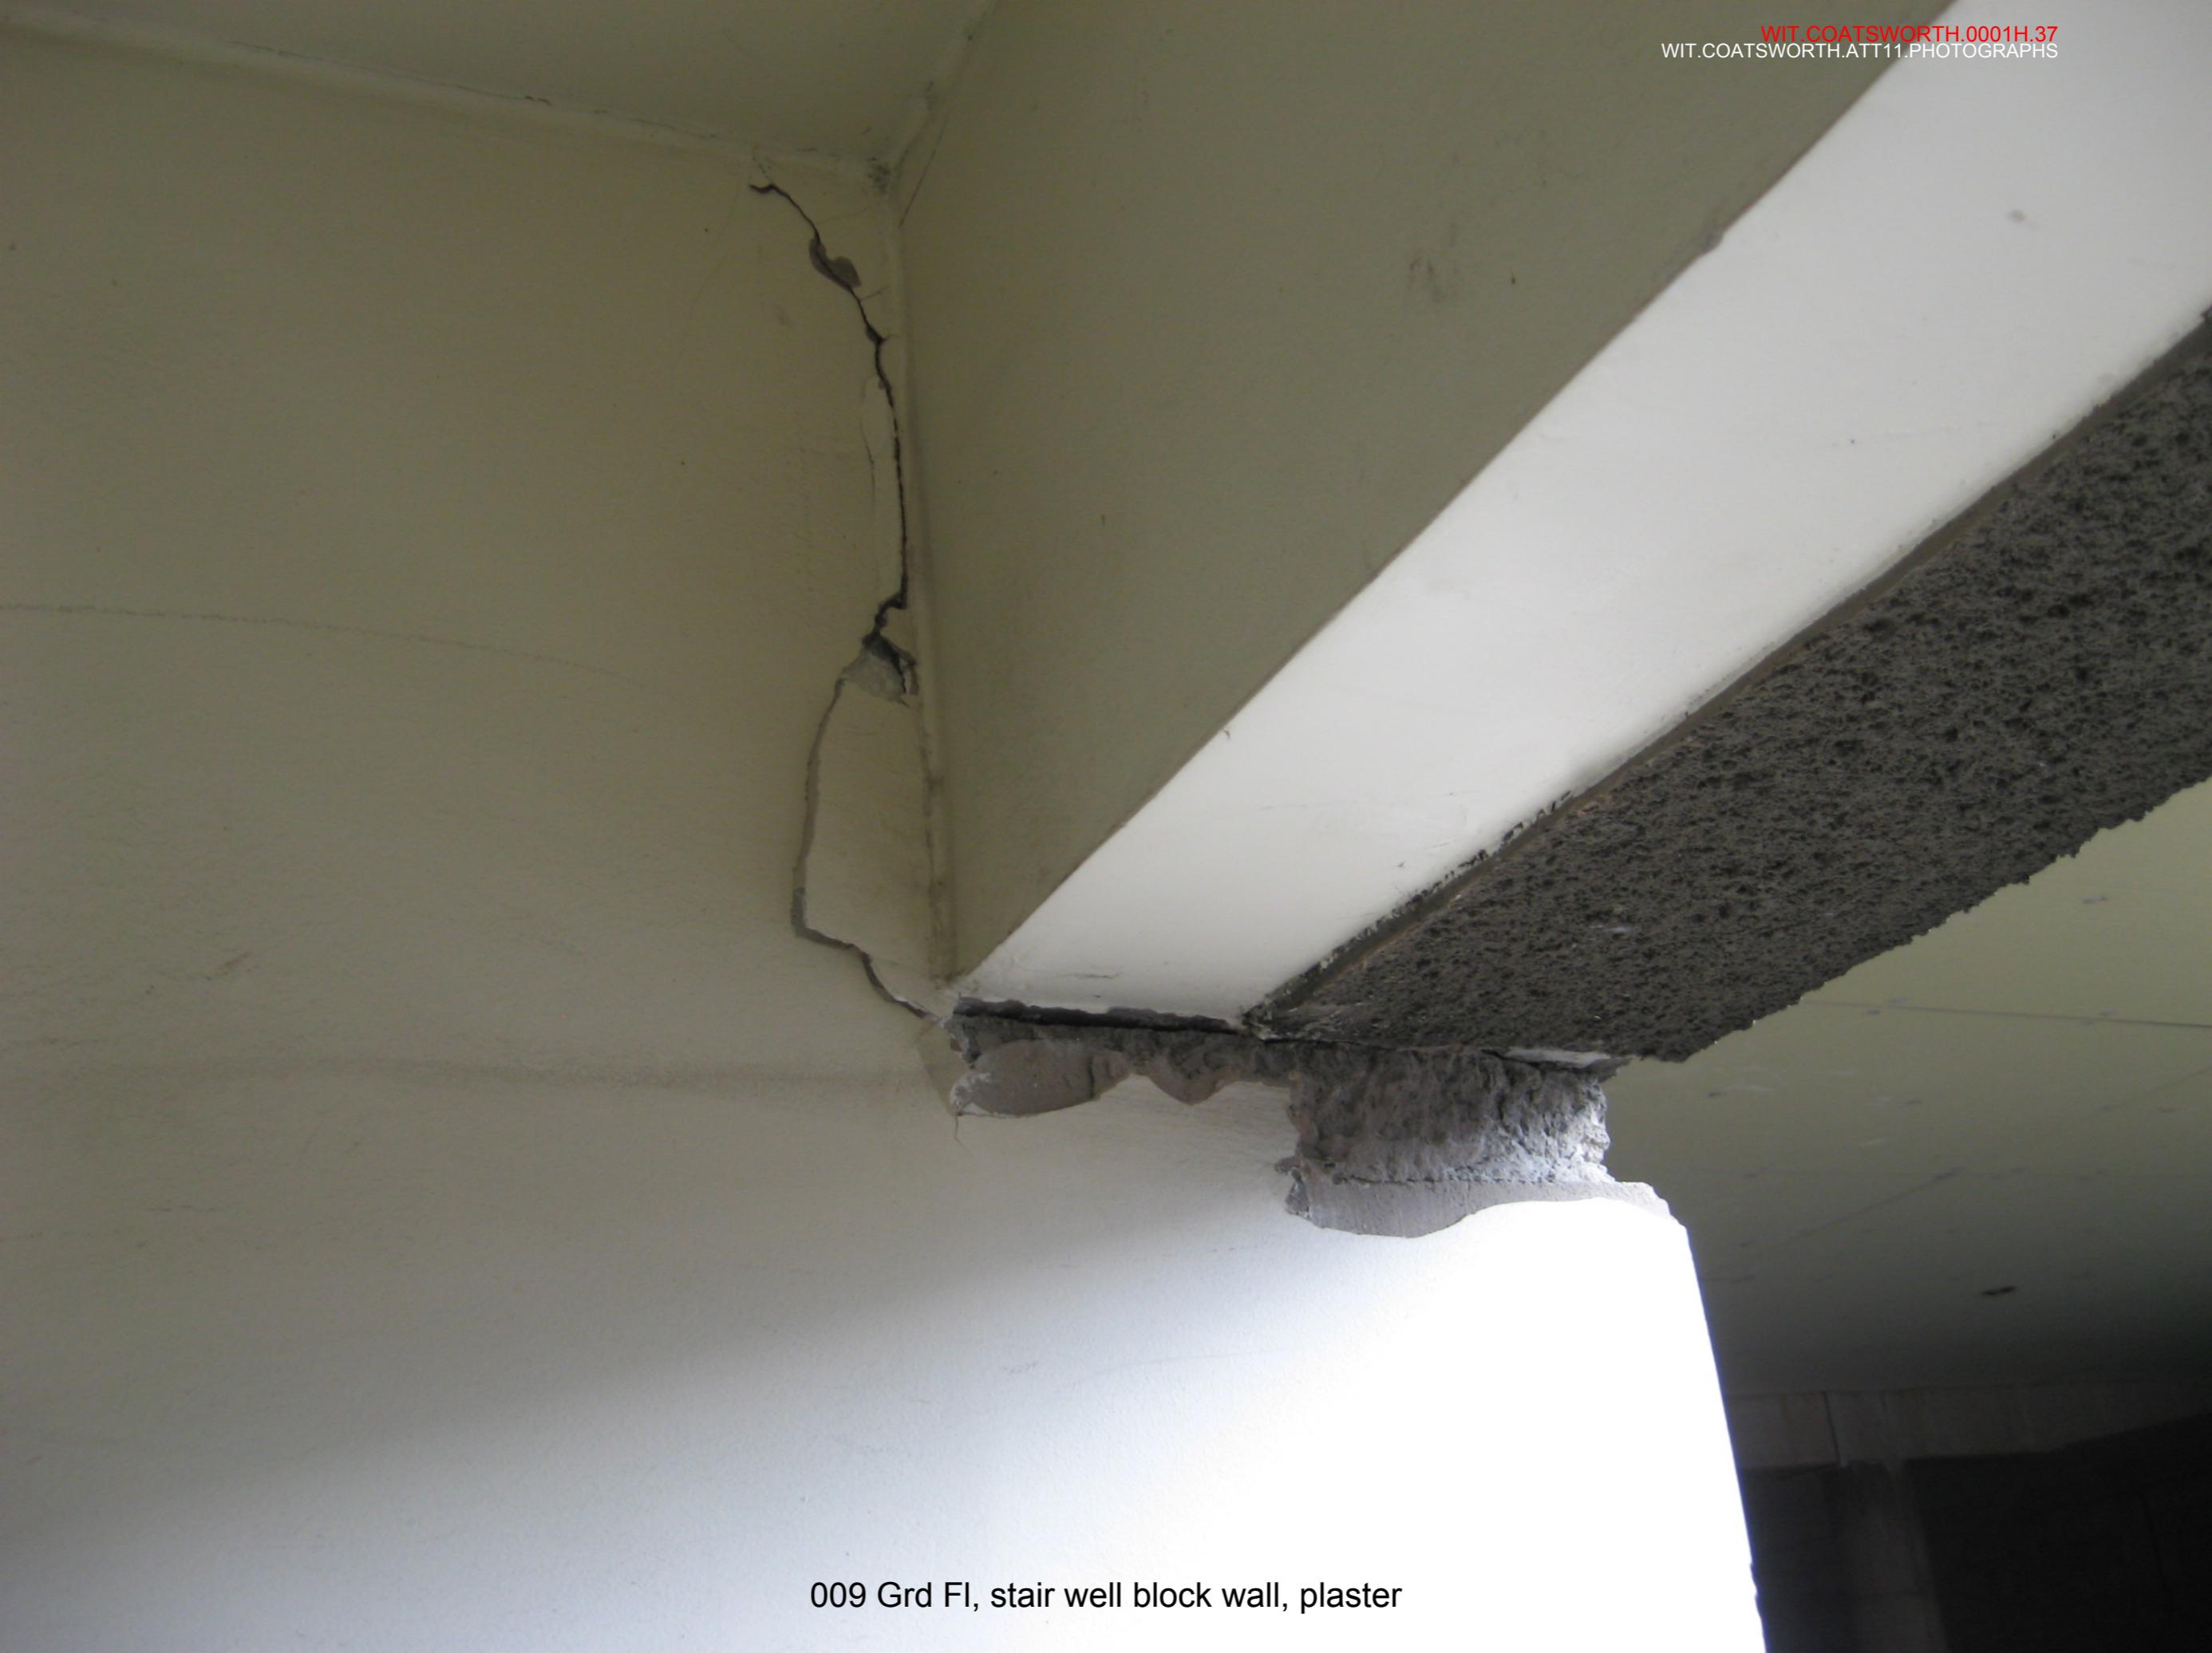
009 Grd Fl, stair well block wall, plaster
