CTV Building Collapse Investigation

Peer Review
William T. Holmes
Structural Engineer
San Francisco, CA

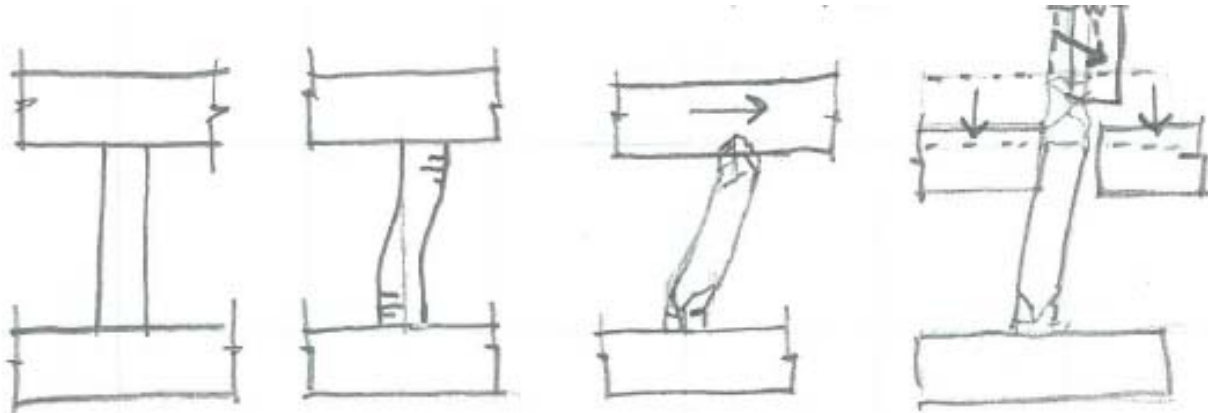
- Sidesway not evident
- Column “failure” extending into beam-column joints would create significant local instability, loss of overall structural integrity, and loss of vertical support of at least some of the beams, and a mostly vertical collapse.

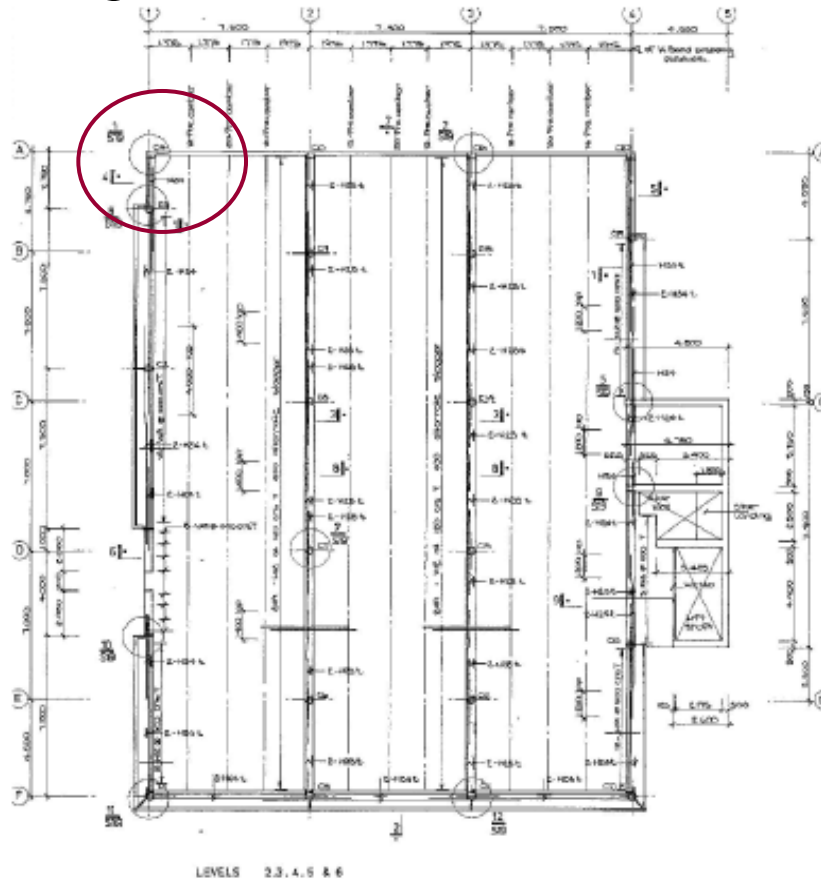
- Eyewitness 16 from Appendix A of Report: On the outside of the building, at the lower level at the corner A-1.

He described seeing the column fracture. “It buckled out. It had cracked and the two bits held still by the steel had spat out, and obviously as the weight got too much, it broke and came down. This was in the middle of the column, between floors. It ‘kicked out’ in the direction of Les Mills. I

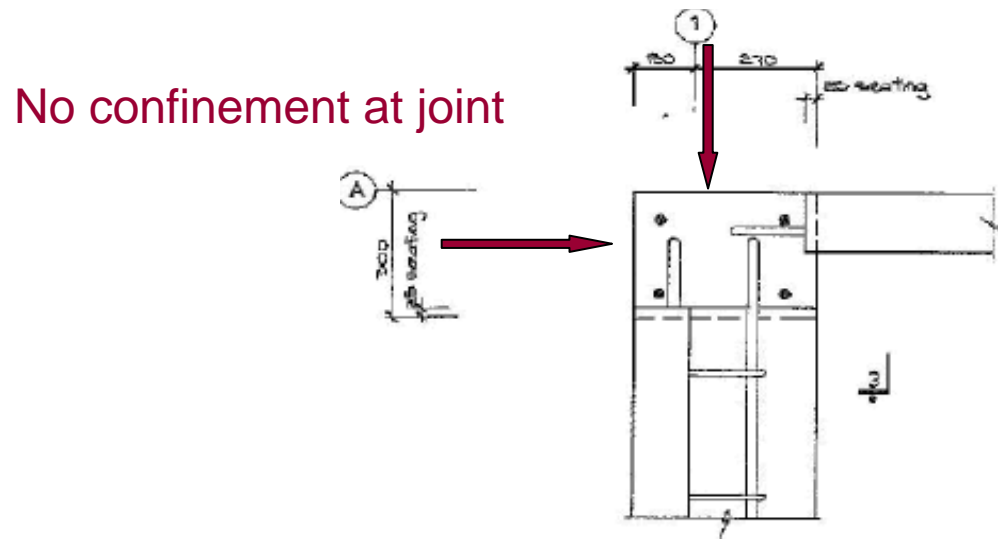
Two story buckling of corner column?

I believe that his description of the buckling, "...the two bits held still by the steel had spat out...This was in the middle of the column, between floors." was actually a two story buckling of the column at 1A when the joint at level 4 had broken up and released the column outward. There was no reason for the column to buckle between floors, particularly here because the axial loading was low and there was no possible spandrel interaction on either face of this column. But the description of the two bits held together by the steel sounds exactly like other columns at the site with rebar exposed in the joint region. This particular column was unique in the building (see Detail 1 on Sheet S19). It

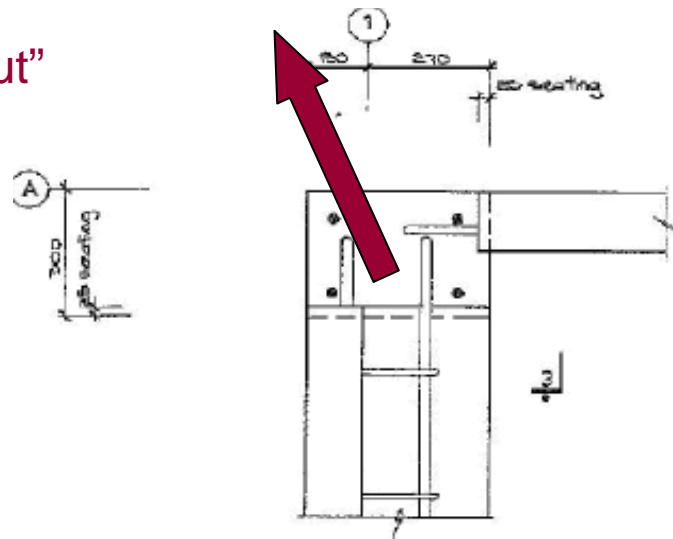
Joint "kicked out"

I believe that his description of the buckling, "...the two bits held still by the steel had spat out...This was in the middle of the column, between floors." was actually a two story buckling of the column at 1A when the joint at level 4 had broken up and released the column outward. There was no reason for the column to buckle between floors, particularly here because the axial loading was low and there was no possible spandrel interaction on either face of this column. But the description of the two bits held together by the steel sounds exactly like other columns at the site with rebar exposed in the joint region. This particular column was unique in the building (see Detail 1 on Sheet S19). It

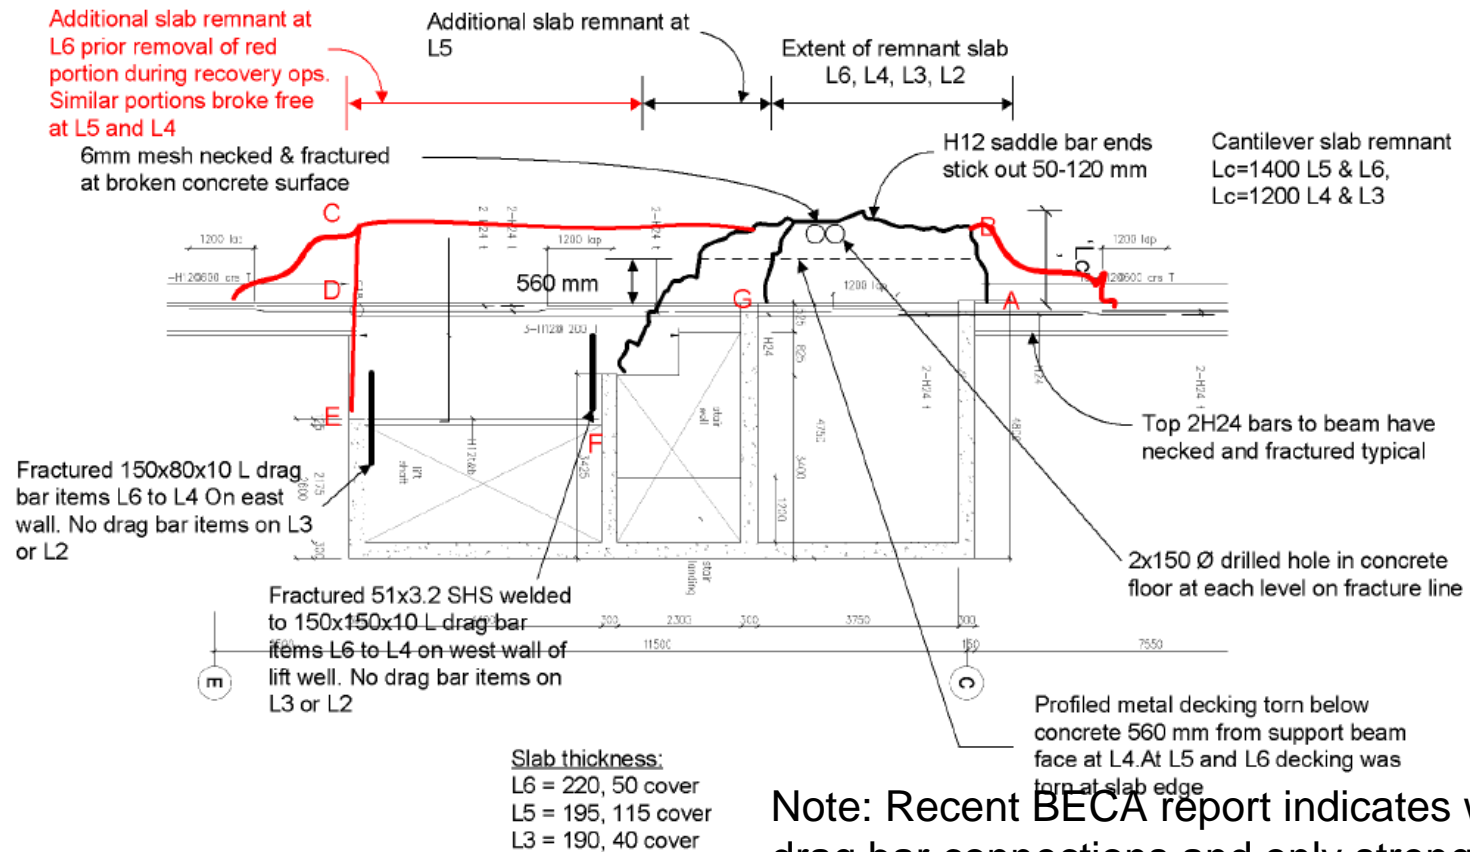
- Report suggests that upper level slabs failed from vertical movement, not tension, indicating interior collapse prior to disconnection:

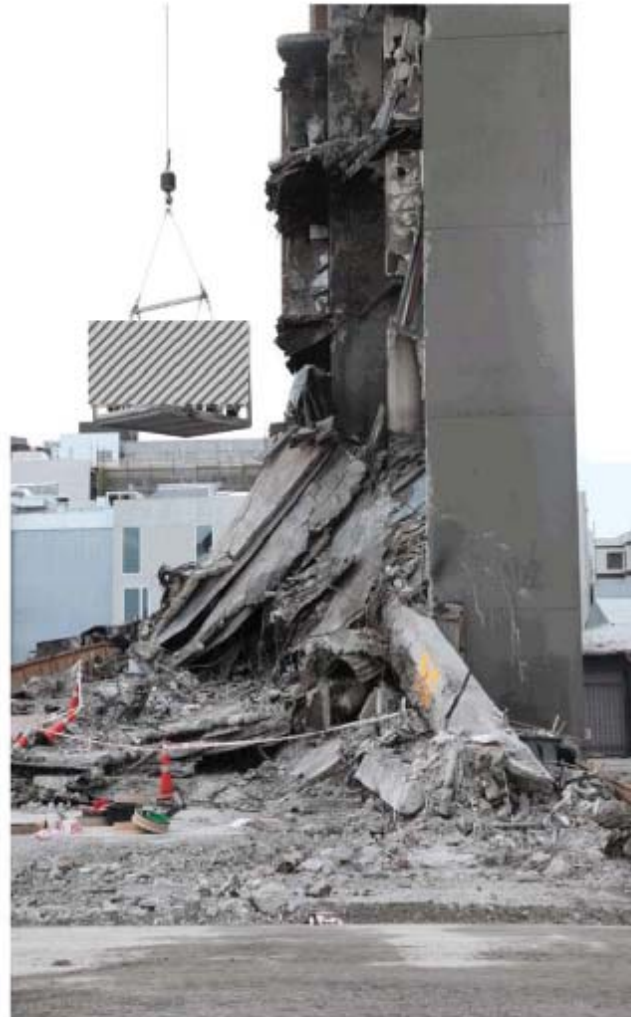
- Report suggests that upper level slabs failed from vertical movement, not tension, indication interior collapse prior to disconnection:
- Disconnection at lower levels considered unlikely due to slab positions in Figure 165, again indicating collapse away from the face of the tower at line 4

Figure 165 - North Core slabs leaning against the North Core showing that their collapse occurred after collapse of the Line 3 frame
