ROYAL COMMISSION OF INQUIRY INTO
BUILDING FAILURES CAUSED BY CANTERBURY
EARTHQUAKES

BRIEF OF EVIDENCE OF CLARK WILLIAM KEITH HYLAND
IN RELATION TO THE CTV BUILDING

DATE OF HEARING: COMMENCING 25 JUNE 2012

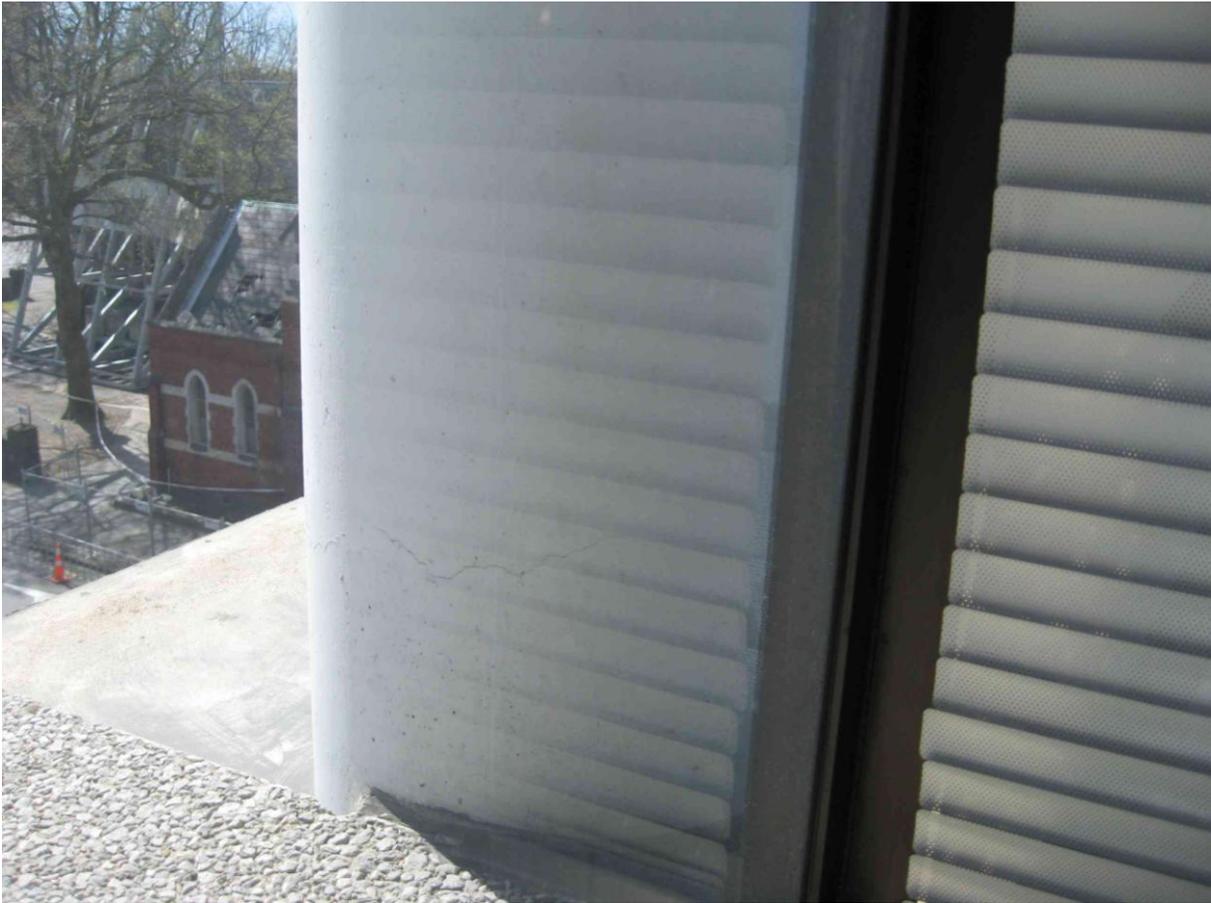
Figure 5 - Photo of Column F4 (249 Madras Street 068C.jpg) at the northeast corner of the CTV Building at Level 4 taken by David Coatsworth during his inspection after the September Earthquake. It is the only column that was found to be cracked below Level 6. See review of Statement of Evidence by damage observer Pagan on page 53. See also the review of the Statement of Evidence by eyewitness Smith on page 55.

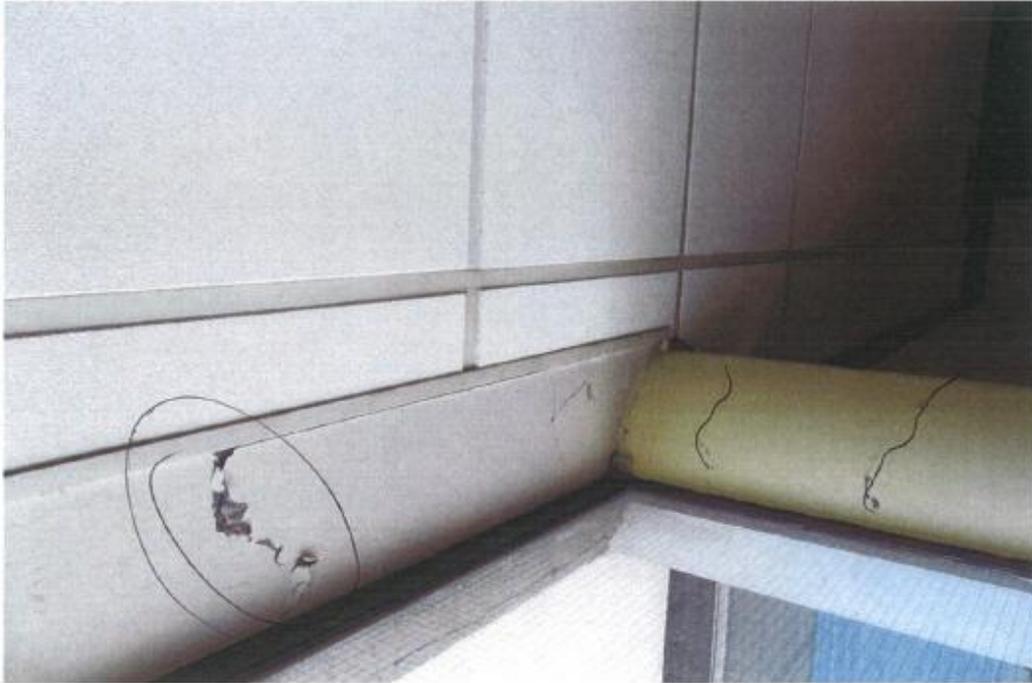
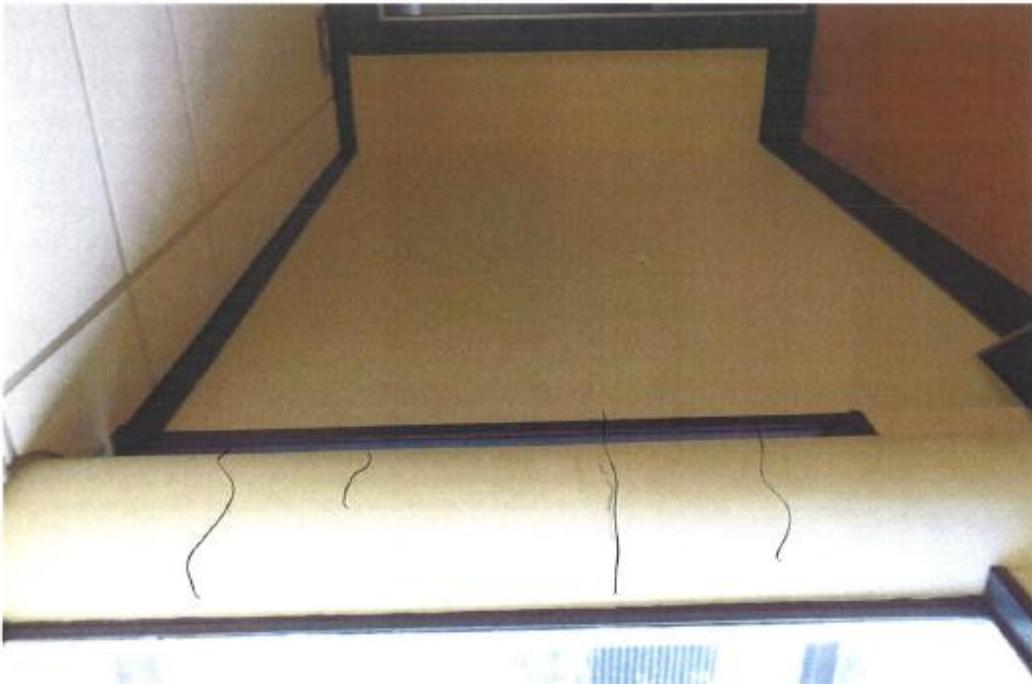
David Bainbridge observed concrete blowouts on this column indicating some level of compressive damage had occurred. The six evenly spaced cracks along the column observed by Peter Higgins indicate tensile flexural damage. Those inspecting the C18 column in the absence of structural drawings or reference back to the original design engineer assumed it connected into a lintel beam. David Bainbridge observed water damage through this area.

The cracking seen in the photos by Peter Higgins and Leonard Pagan in conjunction with the brownish coloured water damage to the attached ceiling indicates that severe damage had occurred to the connection of the column into the North Core. I was not previously aware of this damage.

This damage may have contributed to increased flexibility in the building after the September Earthquake as the column was part of the North Core wall system and therefore contributed to the performance of the North Core. However the Core had significant redundancy of strength and did not collapse in the February Aftershock. If the connection of the C18 column head to the North Core had been stronger and the column had been detailed to match the ductility of the North Core it is possible that column C18 and the floor area tributary to it may not have collapsed but it would not have prevented the collapse of the building as a whole.

L5. Approx 500 lb x 6 cracks circumferential.
Been lintel overhead.

Figure 21 - Photos from Peter Higgins (BUI.MAD249.0454) showing damage to column C18 and connection to overhead North Core wing wall on Line D/E.

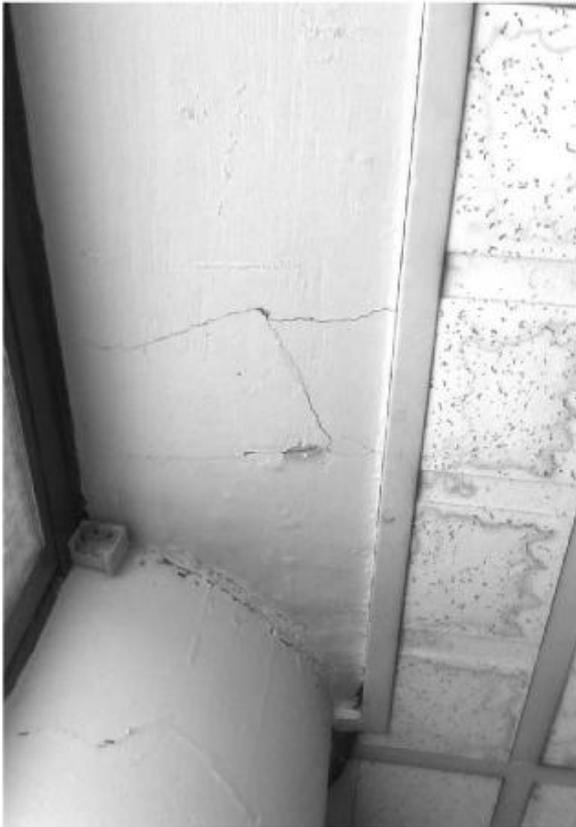
Column C18 was different in that it was connected into the North Core walls and so participated as a member of the North Core. The head of the column attachment to the North Core shows cracking occurred at the attachment in photo by Leonard Pagan and also Peter Higgins. The column was found to have broken away from the North Core in the February Aftershock at that location (BCR Fig 116). The connection also appeared to not have the specified amount of reinforcing steel.

C9	He thought the column had performed to its maximum capacity and would fail in future events	Not sure of what basis was used for his structural assessment. However the damage to the connection into the North Core as seen in photo 037 WIT.PAGAN.0001.45 seems to be a precursor to its pull out in the February Aftershock.
C11	Cracks also in a column at 3B	This column would not have been affected by Spandrel Panel interaction indicating cantilever effects. Not mentioned by David Coatsworth, Leonard Pagan or Graeme Smith. Column 1B cracks not mentioned but may not have seen that column.
C12 & 13	Water damage in ceiling around connection of column C18 to North Core overhead wind wall on Line D/E.	<p>The water damage may indicate that water was coming through the cracked concrete of the connection of the column to the North Core. This appears to be what was also seen in wit.pagan 0001.45 photo 037.</p> <p>The damage indicates distress to the connection of the column to the North Core that may have led to increased flexibility of the building.</p>

Figure 22 - Collection as photographed by Pagan. Photo 37 shows the damage to the connection of the Column C18 into the North Core overhead wing wall on Line D/E.
