**ROYAL COMMISSION OF INQUIRY INTO BUILDING
FAILURE CAUSED BY CANTERBURY
EARTHQUAKES**

**SECOND STATEMENT OF EVIDENCE OF ROBERT HEYWOOD IN RELATION TO THE
CTV BUILDING**

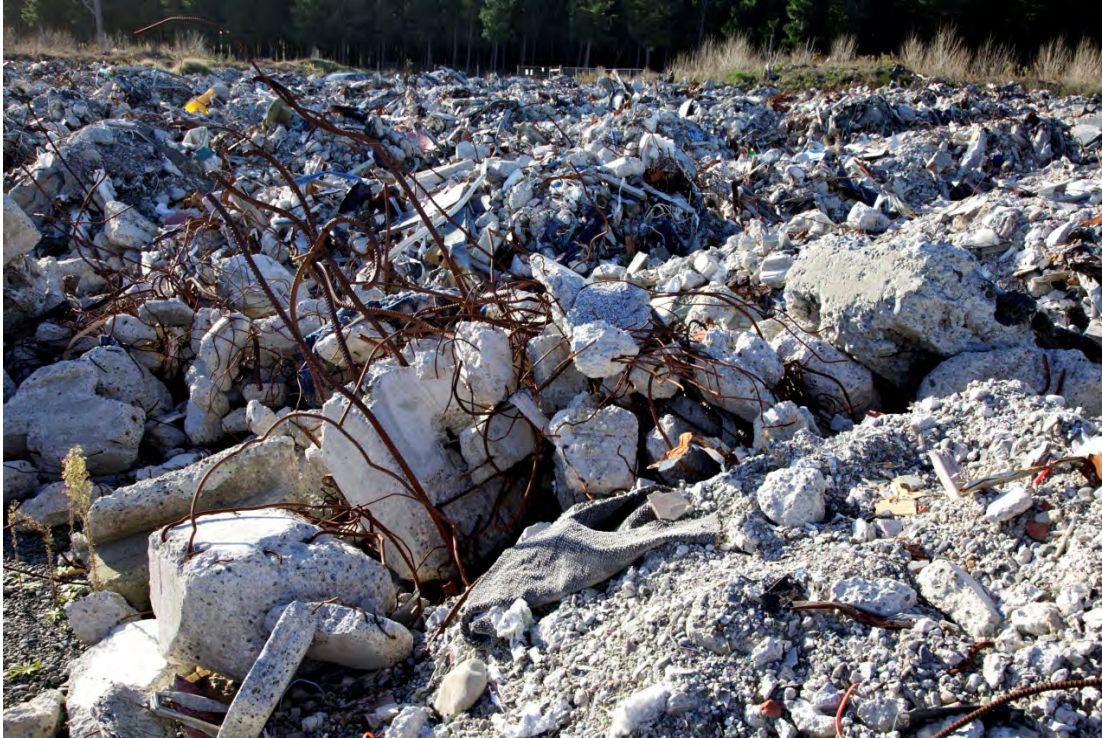
4. I was not able to sight the exhibits that Graham and I had set aside at the CTV site in the days after the collapse, at Burwood.
5. The remnants of the CTV building had been dumped in a series of closely spaced piles at Burwood (refer Figure 1 [BUI.MAD249.0520.1]). Only the surface of these piles was visible. In one location the piles had been flattened by the passage of a tracked vehicle.

Figure 1 Remains of CTV Building at Burwood

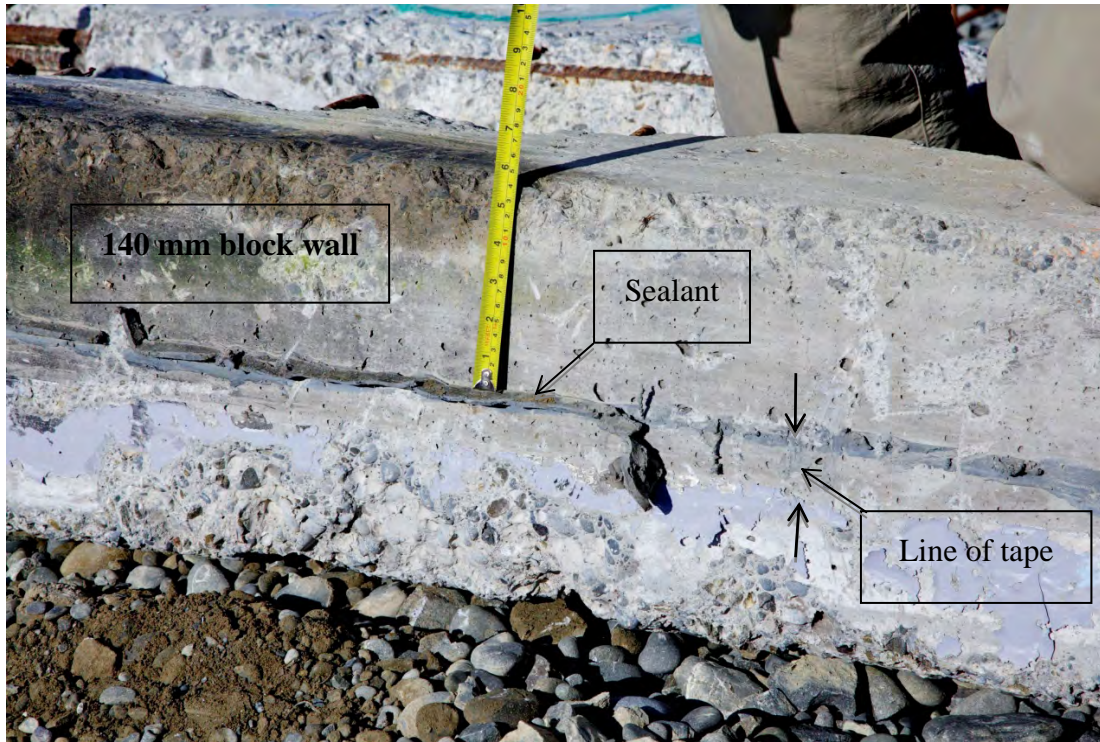
6. I observed sealant on the side faces of some rectangular columns from Level 4 and below as detailed on Section 3 of drawing S17 [BUI.MAD249.0284.18]. This was in a position consistent with the 140mm blockwork. I also observed a segment of blockwork with sealant attached (refer Figure 2 [BUI.MAD249.0520.2])
7. S17 Section 3 also specifies a backing strip and asbestos tape. There was no sign of the backing strip but the markings in the paint suggested that there had been some form of tape over the joint (refer Figure 2(a) [BUI.MAD249.0520.2]).
8. There was no sign of ties or reinforcement connecting the rectangular column and the blockwork in columns identified to be from Level 4 or below (e.g., refer Figure 2(a) [BUI.MAD249.0520.2]).

a) Remnant of sealant on face of rectangular column

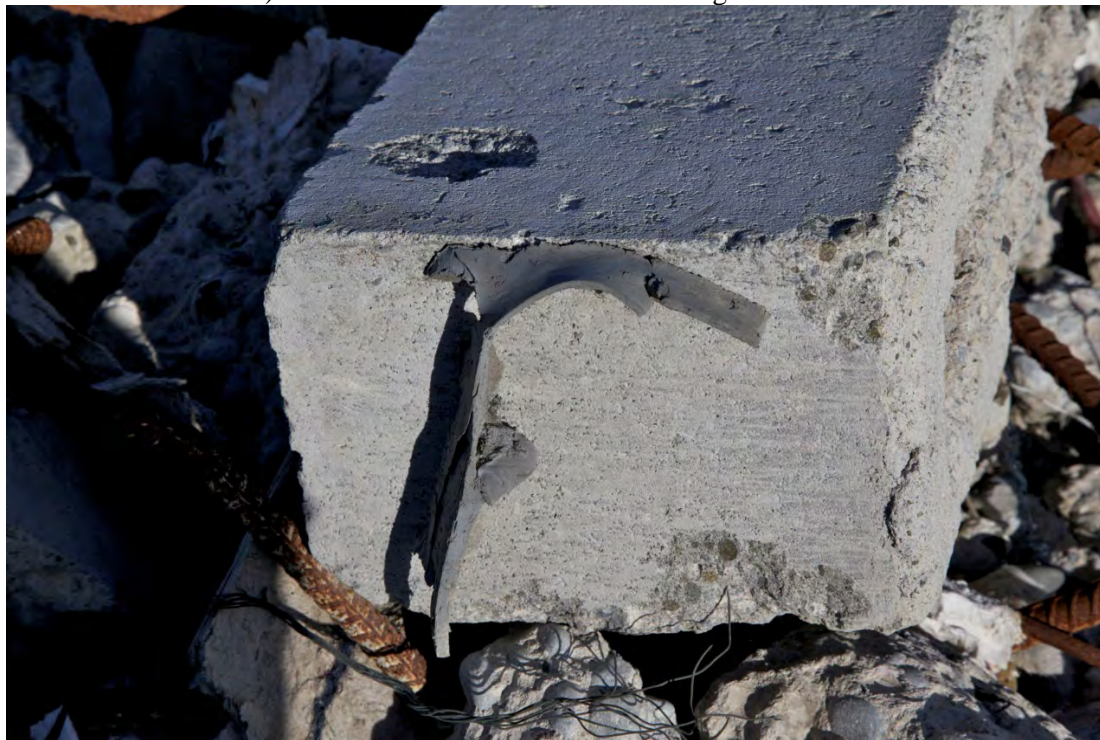
b) Remnant of sealant on reinforced core filled blocks

Figure 2 Remnant of sealant between the rectangular columns and western the block wall

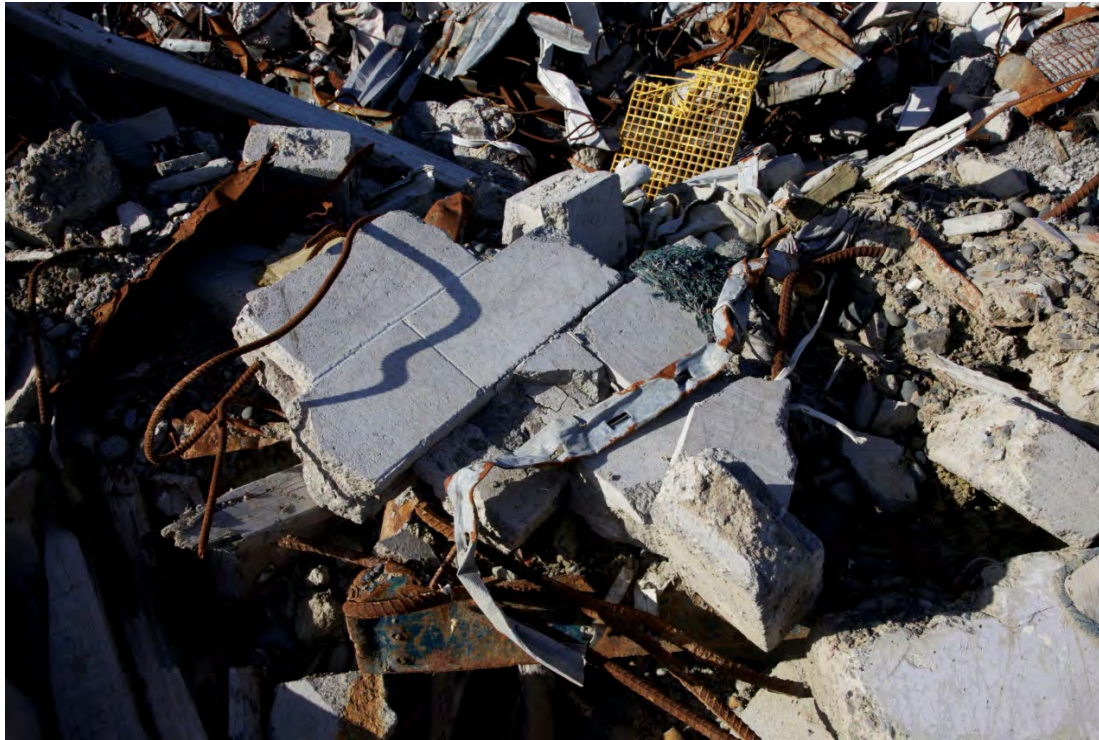
9. A number of small segments of 140mm blockwork were observed. These were core filled and contained vertical and horizontal D12 reinforcement. I observed no segments of blockwork that did not have the cores filled. (e.g., refer Figure 3 [BUI.MAD249.0520.3])

Figure 3 Remnant of 140 mm block wall

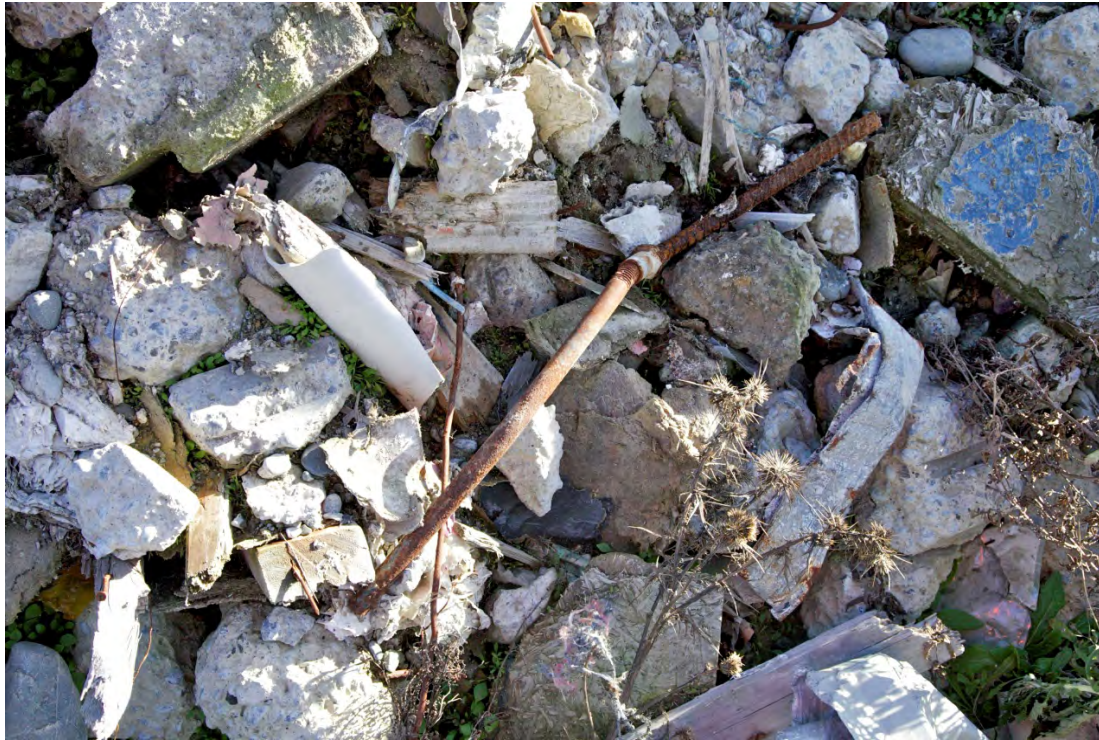
10. I did not see any remnants of the sill beams that supported the western block walls at Burwood.
11. One complete and one part sample of what appeared to be Fixing A on drawing S39 was found at Burwood and this was provided to the Royal Commission (refer Figure 4(a) [BUI.MAD249.0520.4]). Fixing A (refer Fixing 4(c) [BUI.MAD249.0520.4]) was intended to connect the precast sill beams to the top of the blockwall, as detailed in Section 1 on drawing S23 (refer Figure 4(b)) [BUI.MAD249.0520.4]

(a) Fixing A at Burwood

Figure 4 A deformed assembly consistent with Fixing A

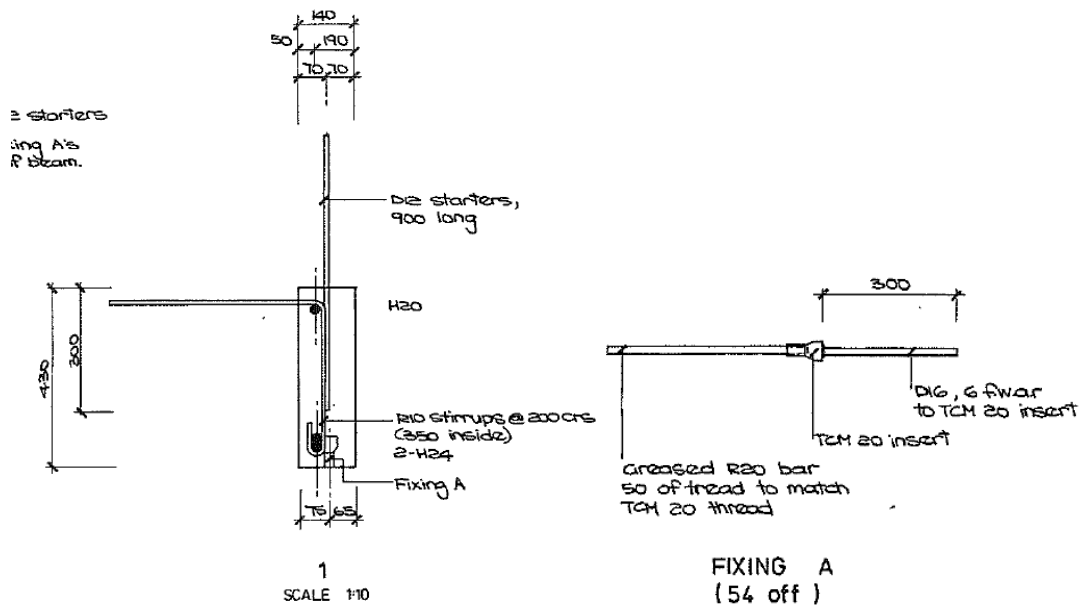
(b) Dwg S23 Section 1

12. Section 1 on drawing S23 shows R10 stirrups @ 200 centres (refer Figure 4(b)). These bars were protruding from a floor slab in Figure 16 ([WIT.HEYWOOD.0001.45]) of my previous brief of evidence. Section 1 shows an 180 degree hook around the bottom bar whereas the ends of the bars evident in Figure 16 are straight.

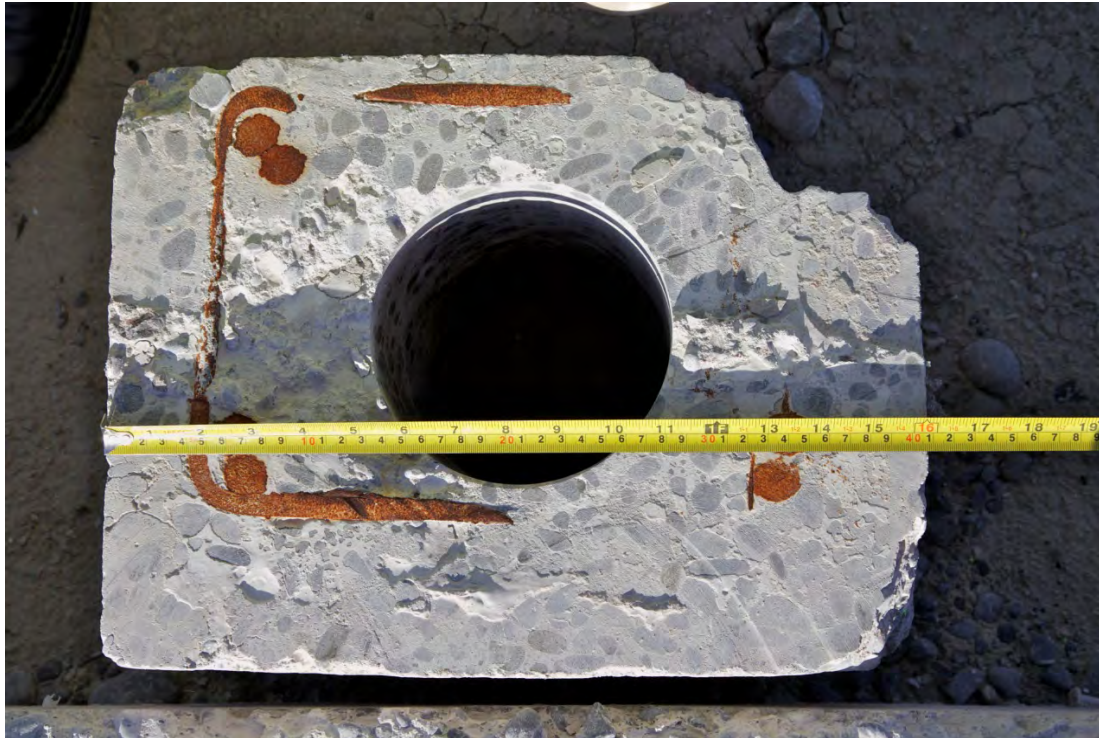
13. I observed sliced circular and rectangular columns which revealed some sections with the reinforcement cage eccentric to the column, i.e. low cover on one side and high cover on the other side (refer Figure 5 [BUI.MAD249.0520.5]).
14. I also observed a column which was oval in shape (refer Figure 5(b)).

(a) Cross-section of a rectangular column with cored hole

Figure 5 Examples of columns with low and high cover

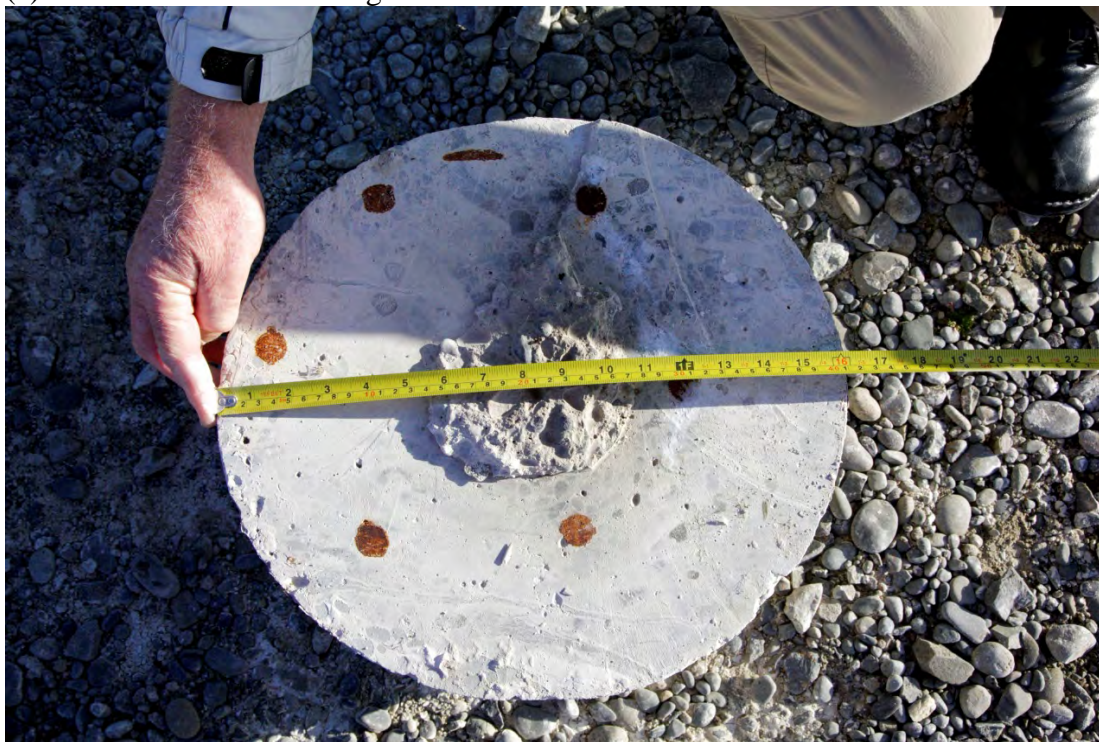
(b) Slightly oval cross-section of a circular column

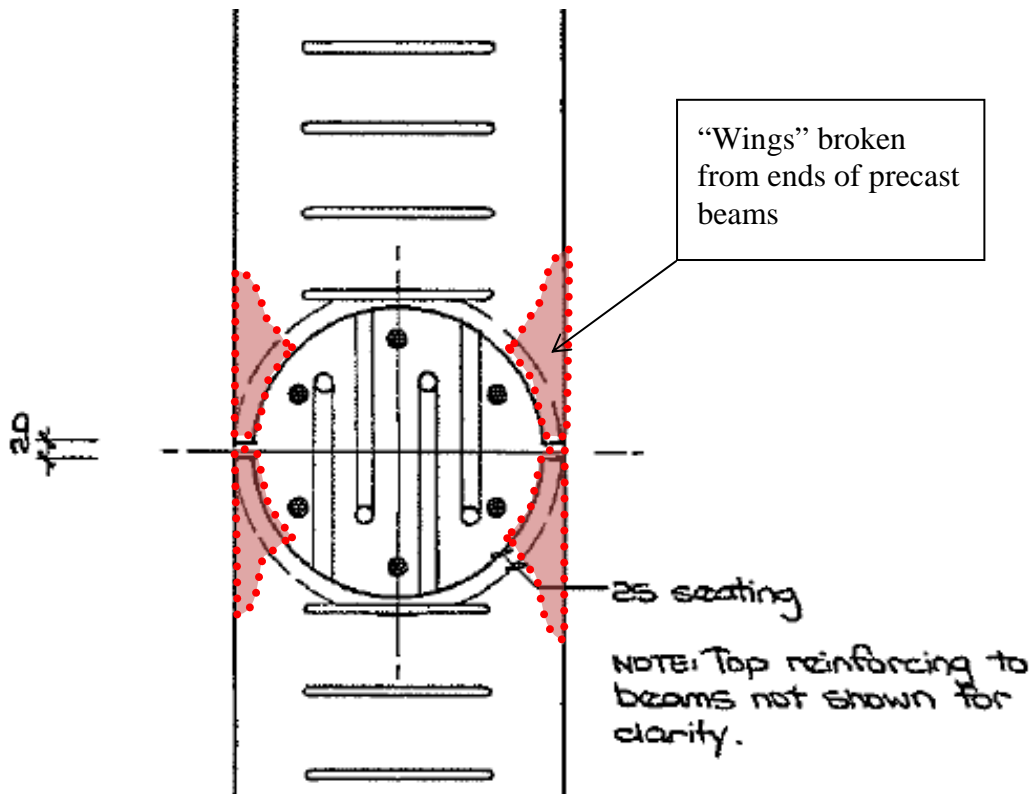
(a) Plan of a typical connection between a precast internal beam and an internal circular column showing "wings" (Dwg S18 Detail 7)

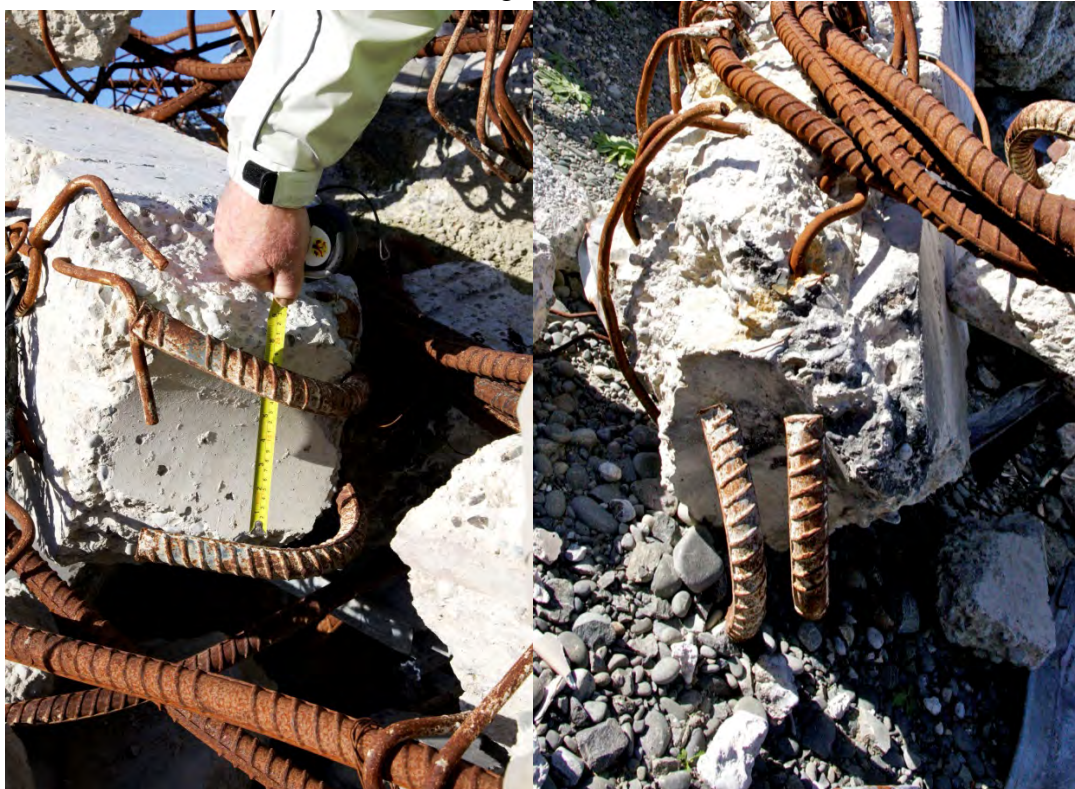
15. I observed a number of internal and edge beams in the rubble. The "wings" of these beams were broken at the ends of the beams where the beams provided the formwork for the internal circular columns (refer Figure 6(a) [BUI.MAD249.0520.6]). The remaining semi-circular faces at the ends of the beams were essentially as formed – there was no surface roughening and no evidence of substantial bond between the semi-circular faces and the column concrete (refer Figure 6(b)). The loss of these "wings" was also observed during the USAR operations.
16. I did not observe any internal or edge beams with cored holes through the beams. The number of internal beams where the vertical faces were observed during USAR

(b) Examples of internal beams with broken "wings"

Figure 6 Broken "wings" on internal beams.

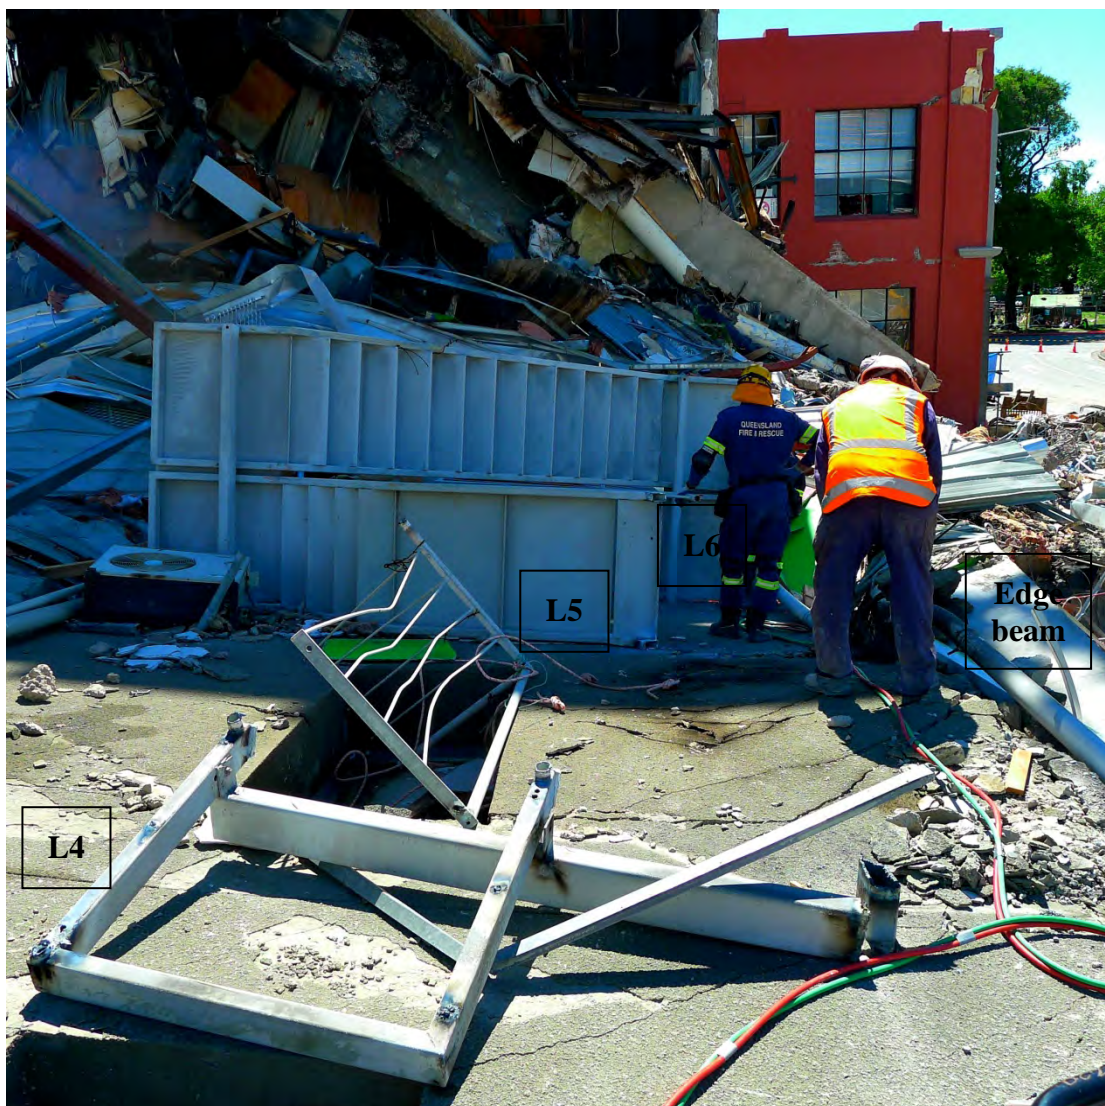
18. Figure 8 [BUI.MAD249.0520.8] is a view of the South Wall looking towards the North Core during USAR operations to remove the steel escape stair and before the South Wall was broken up for removal. Steel roof framing and roof sheeting is visible between the end of the South Wall and the North Core. An edge beam is evident lying parallel to the right (east) of the South Wall. It appears that there is only one flight of stairs remaining to be removed, indicating the photograph was taken from around Level 3 with levels as indicated on Figure 8. The cracking in the South Wall appears to be more severe on the eastern side.

Figure 8 View of South Wall during operations to remove escape stair (Photo by John Reid)

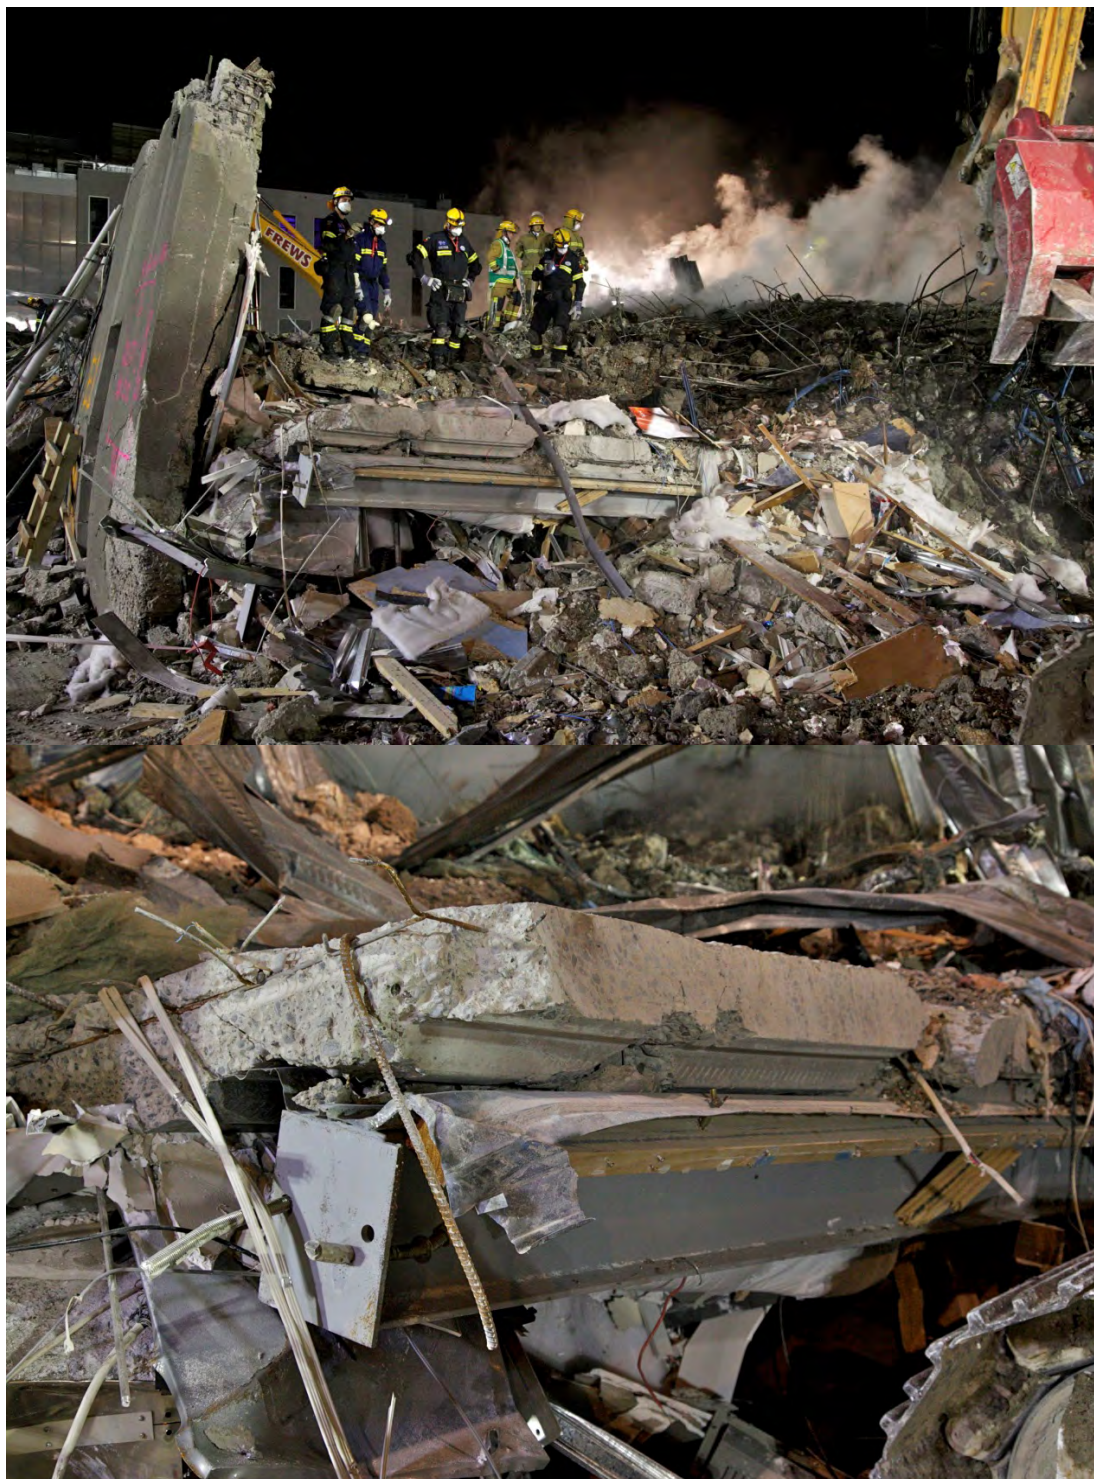
19. The Steel trimmer beam installed around the hole cut through the Level 2 slab for the stairwell in the south-east corner of the building was in relatively sound condition (Figure 9 [BUI.MAD249.0520.9]). The masonry anchors that connected the steel trimmer beam to the concrete structure had pulled from the concrete.
20. The D12 reinforcement and "664" mesh is evident in the broken edge of the slab. The imprint of the top reinforcement of an edge beam is visible immediately below the "664" reinforcement. The two D12 reinforcing bars evident have pulled from the edge beam infill concrete rather than broken.

Figure 9 Steel trimming beam: Level 2, south-east corner of the Building
