**ROYAL COMMISSION OF INQUIRY INTO BUILDING
FAILURE CAUSED BY CANTERBURY
EARTHQUAKES**

THE CTV BUILDING COLLAPSE

**STATEMENT OF EVIDENCE OF WILLIAM HOLMES
IN RELATION TO THE CTV BUILDING**

Review of Structural Alterations in 2000 to Add New Stair from Level 1 to Level 2 by William T. Holmes

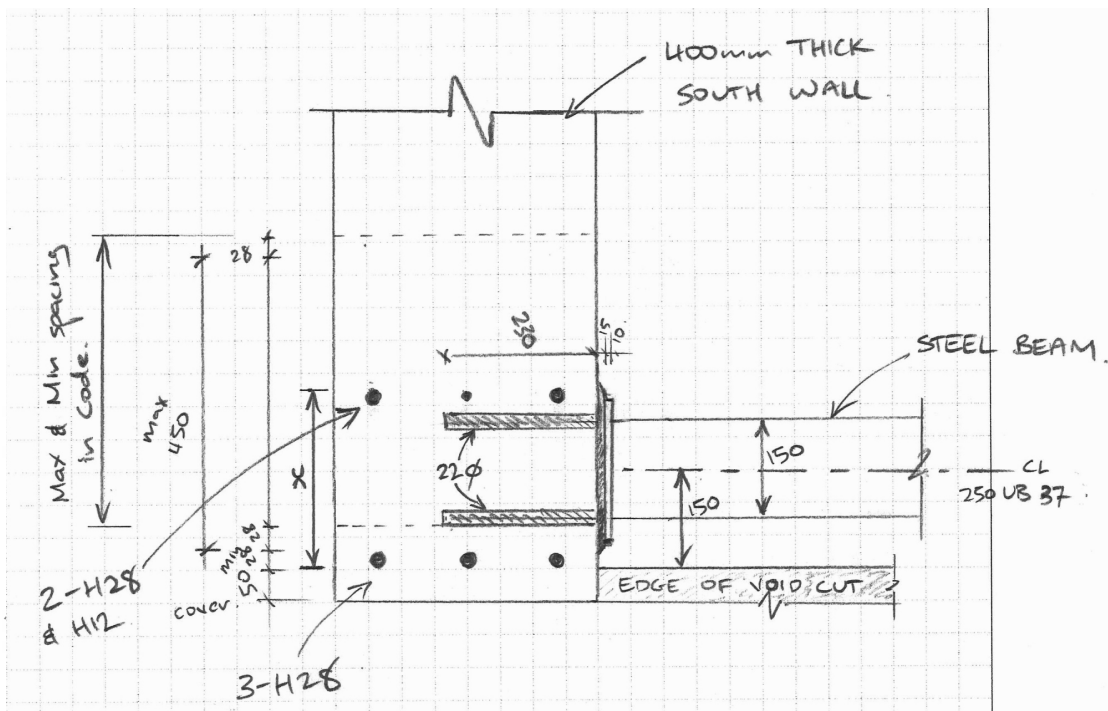
19. The locations of the drilled holes for the beam connection bolts shown in Details 4 and 6 of the Falloon and Wilson drawing are placed to avoid top and bottom steel of the beams and can be assumed to be unaffected by the drilled holes.
20. The potential effect on the vertical bars is less clear, as shown in Figure 1 (below). The holes for the trimmer beam connection bolts would apparently miss the outer 2-H28 vertical bars. As sketched, the inner bolt will also miss the inner set of 2-H28 and 1-H12 bar. However, the dimension X on the sketch is not specified on the structural drawings and was drawn in Figure 1 to scale as shown on the drawings. Therefore, depending on the exact location of the shear wall reinforcing bars, the holes for installation of the trimmer beam connection bolts could have hit the shear wall vertical bars.

Figure 1 Showing plan of vertical bars in end of south wall and drilled holes from trimmer beam

26. It should be noted that the connection of a trimmer beam with drilled-in dowels at the end of a major shear wall should have included a note to carefully monitor drilling and avoid cutting of bars.

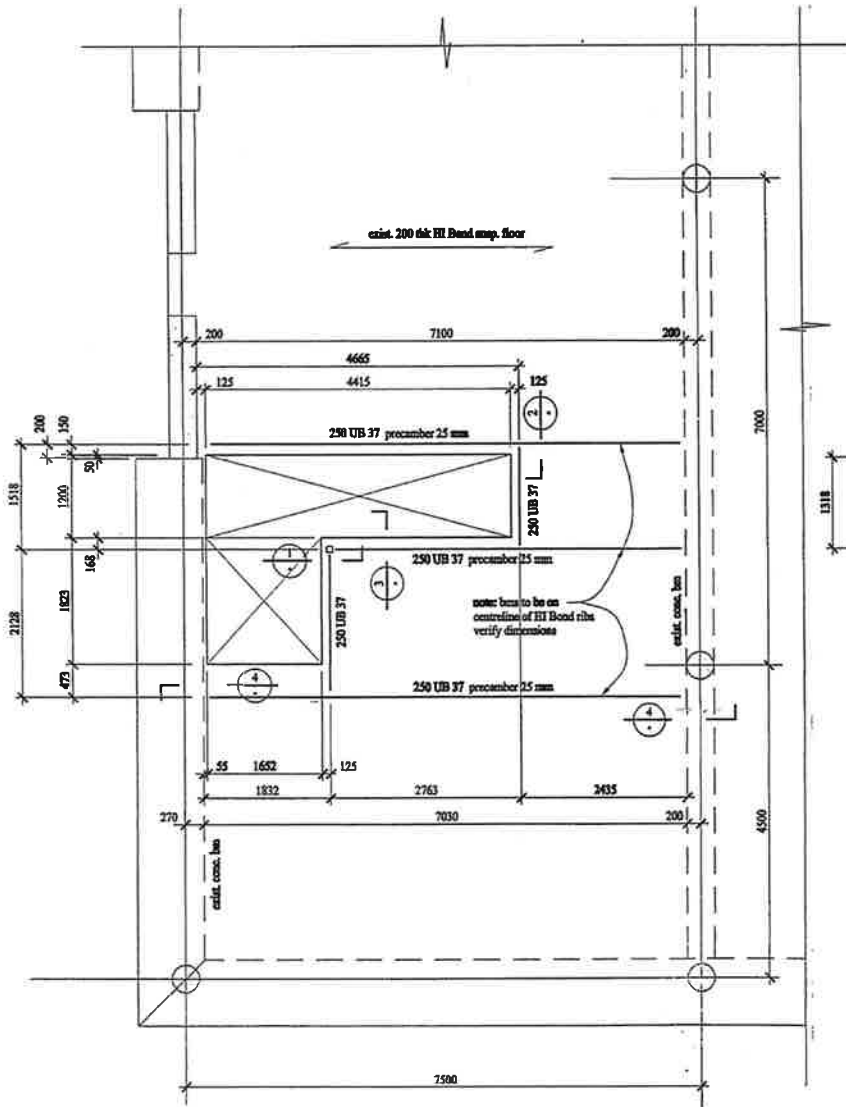
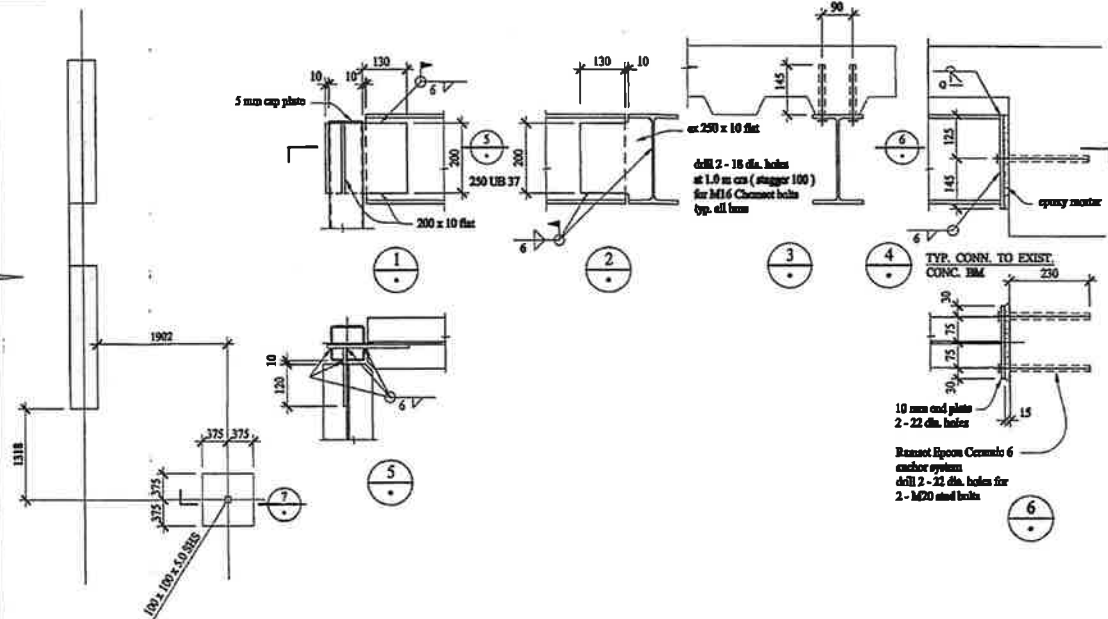
**PARTIAL FIRST FLOOR FRAMING PLAN
AT NEW STAIR OPENING**

2. In preparing this review have referred to the drawing submitted to the Christchurch City Council for this work by Falloon and Wilson [**BUI.MAD249.0151B.2**]. I have also referred to the original structural drawings and calculations for the Building.

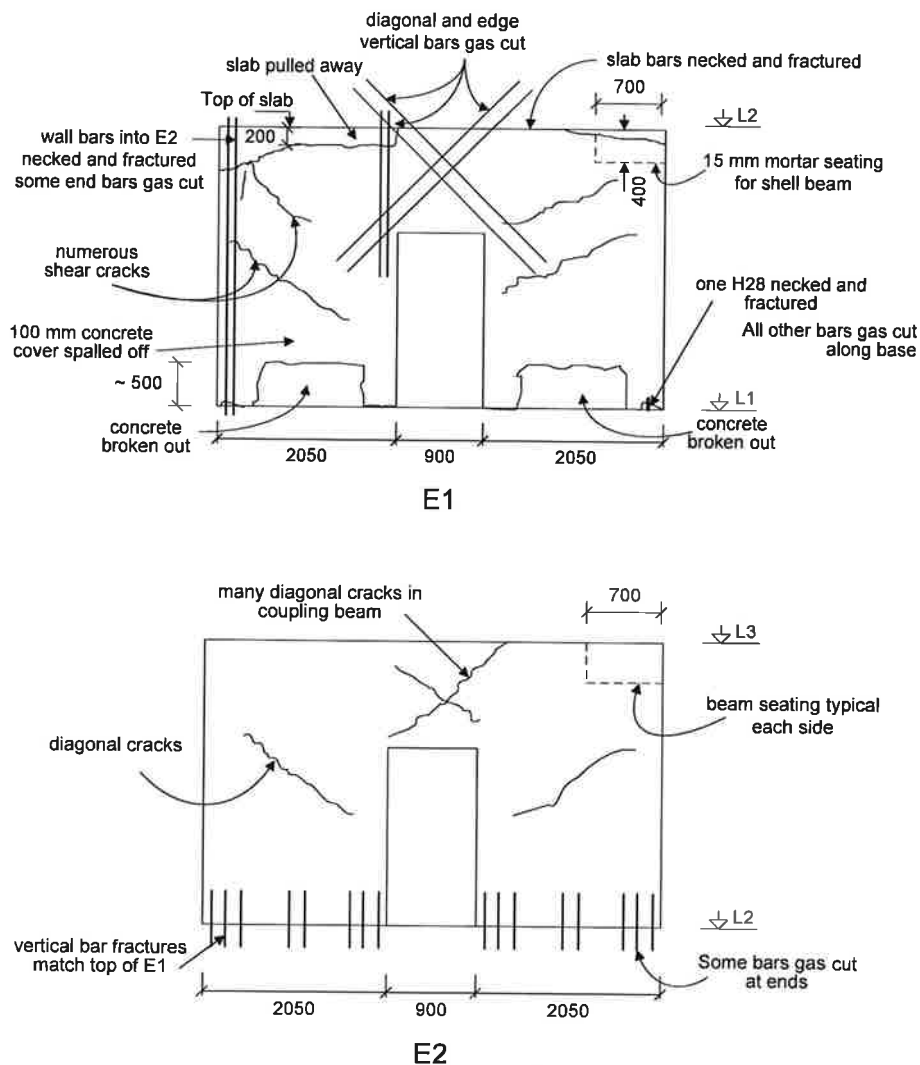
21. However, sketches of the south wall remnants in appendix C of the Hyland report do not show any indication of heavy cracking or premature yielding of the wall at the location where a cut would have been located (top right of the bottom figure in Figure 109 [BUI.MAD249.0189.213]). In fact, the sketches of the south wall indicate that the south wall was not heavily loaded in the east-west direction, either due to failure of one or more levels of drag beams on line 1, or due to early initiation of collapse elsewhere.

This panel showed flexural cracking patterns typical of cantilever shear walls rather than coupled shear walls (Figure 109). This was likely due to the effect of the Level 1 doorway having been in-filled with reinforced concrete masonry.

Reinforcing steel taken from the east end of the wall was found to have yielded and elongated prior to the collapse of the building.

Figure 109 - Line 1 South Wall remnants (top) E1 Level 1 to 2; (Bot) E2 Level 2 to 3.

This panel had diagonal cracking in the piers consistent with cantilever wall behaviour and two way diagonal cracking in the door head coupling beam (Figure 109).

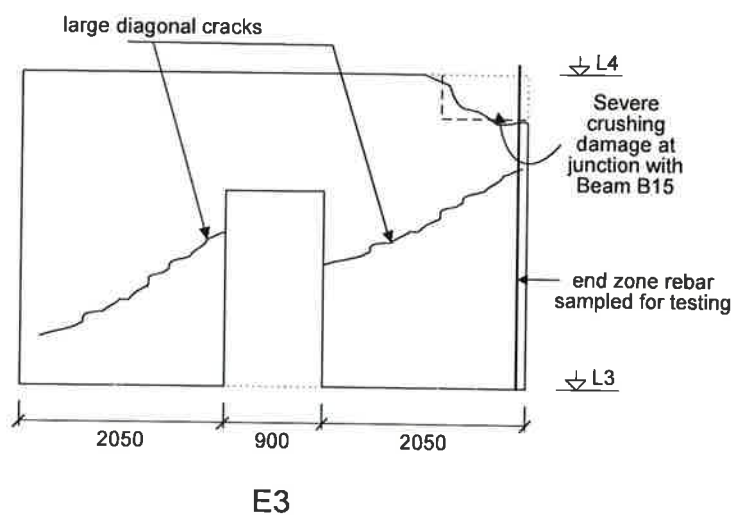
This panel had dominant uni-directional diagonal cracking running from the bottom west corner to the top east end (Figure 110).

Figure 110 - Line 1 South Wall remnant E3, Level 3 to 4.

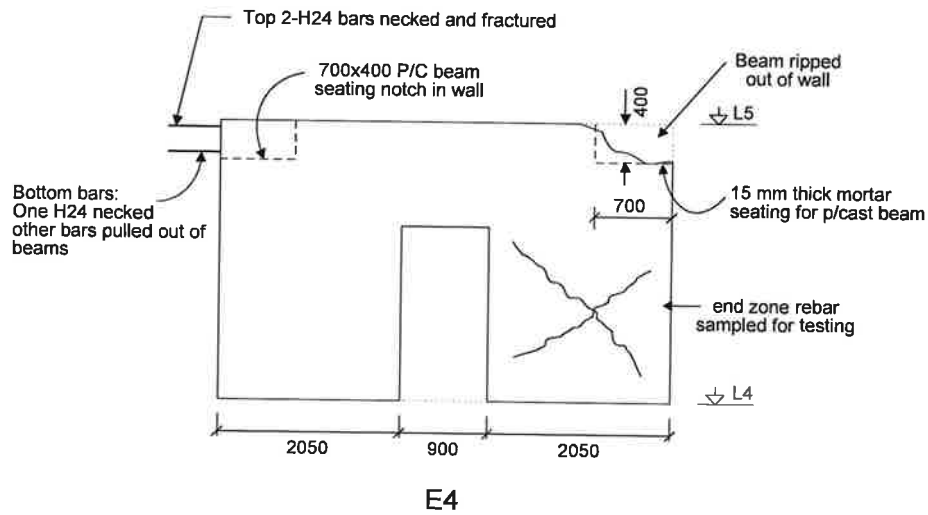
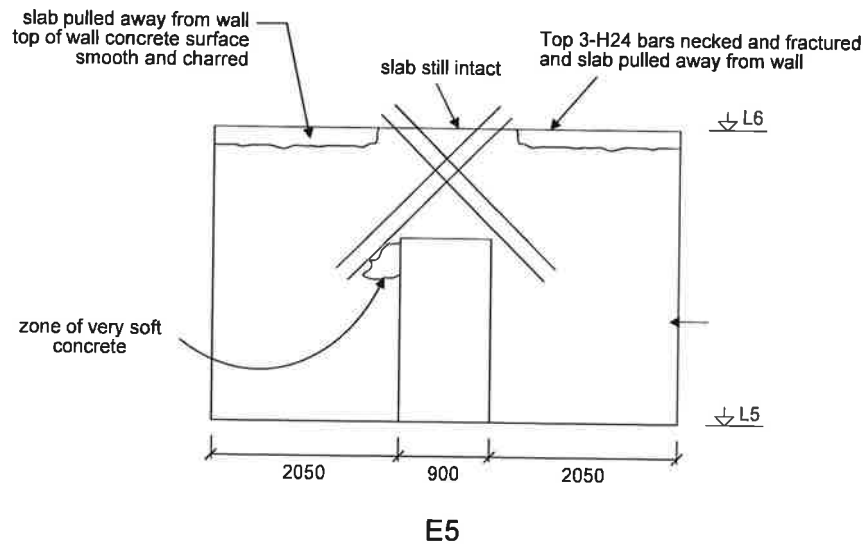
Severe two-way diagonal cracking in east pier and loss of cover to vertical reinforcing steel on east edge.

Smooth mortar construction joints rather than roughened at junctions with pre-cast shell beams B15 and B16 (Figure 111).

The cracking may have been caused on impact with the ground during the collapse.

Weak concrete in west pier adjacent to top of doorway that was able to be dislodged by boot (Figure 111).

The top surface of wall was smooth rather than a roughened construction joint for slab seating.

This may have led to slippage on these joints potentially contributing to greater than intended inter-storey drifts.

Figure 111 - Line 1 South Wall remnants E4 Level 4 to 5 and E4 level 5 to 6.

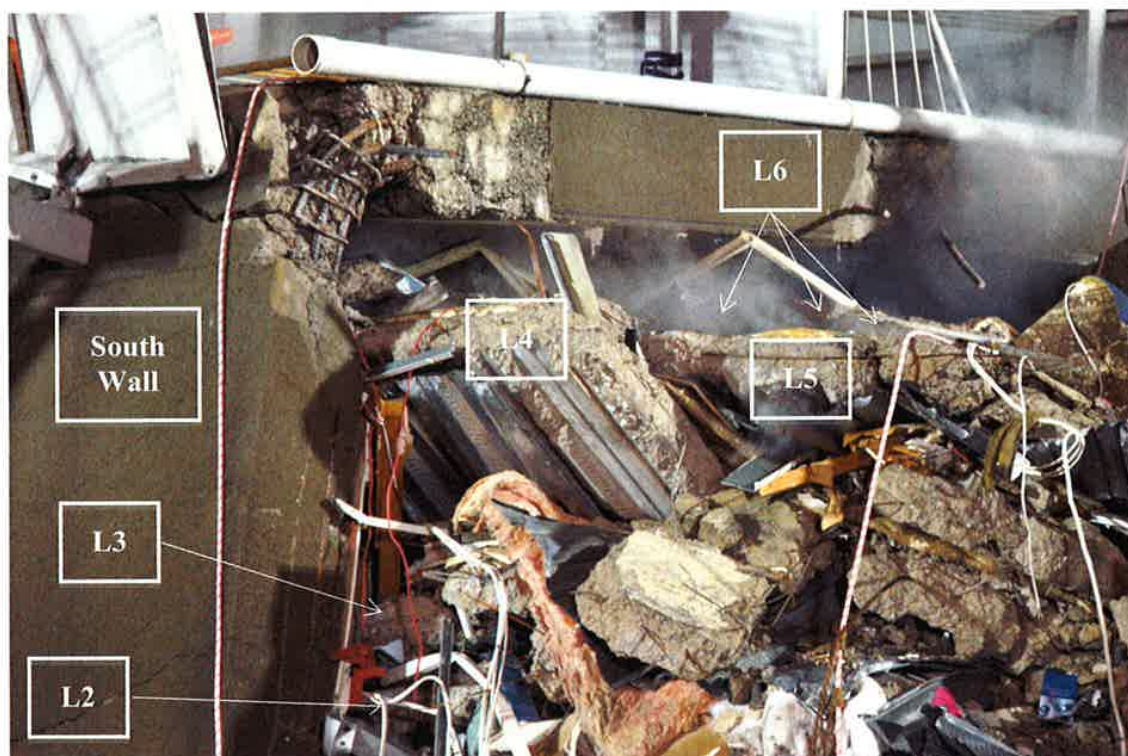
22. Figure 13 of the (First) Statement of Evidence of Robert Heywood evidence shows almost the exact location of the connection of the trimmer beam connection to the South Wall and the bars are intact [WIT.HEYWOOD.0001.42]. Unfortunately, the inner 2 bars cannot be seen.

Southern edges of L2, L3, L4, L5 and L6 floor slabs immediately to the east of the South Wall on Line 1 (4:30 AM 24 Feb 2011).

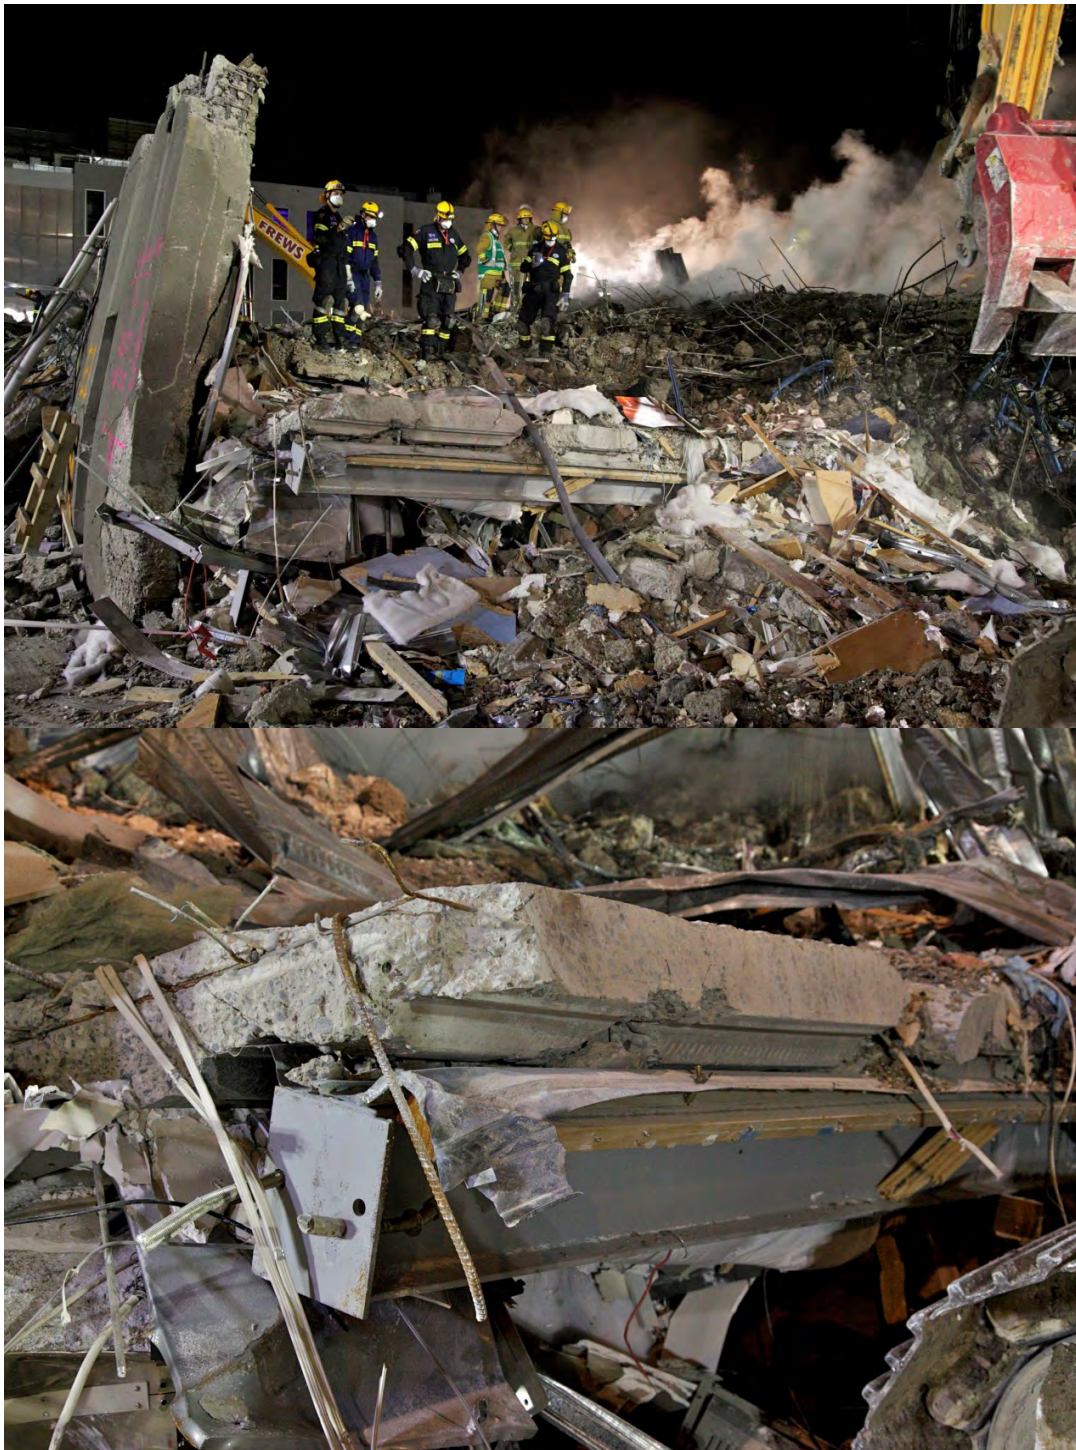
23. Most significantly, Figure 9 of the Second Statement of Evidence by Robert Heywood [WIT.HEYWOOD.0002.13] clearly shows the western trimmer beam and its connection after the collapse. The trimmer beam had pulled out of the wall. The eastern bolt, nearest the camera in the bottom photograph, has been moved from its original location and installed slightly to the west and below the original position that is identified by the hole in the mounting plate. This indicates to me that the original hole in fact hit reinforcing and the hole was moved and the bolt installed in the alternate position, free of the reinforcing. Such changing of the hole location to miss reinforcing is common practice among knowledgeable contractors.

Figure 9 Steel trimming beam: Level 2, south-east corner of the Building
