Submission to the Canterbury Earthquakes Royal Commission, on the role of professional societies in the engineering sector

A Sordid Saga of Corruption and Incompetence within the New Zealand Marine Industry and the Engineering Profession

Appendix 1 (Silver Wing)

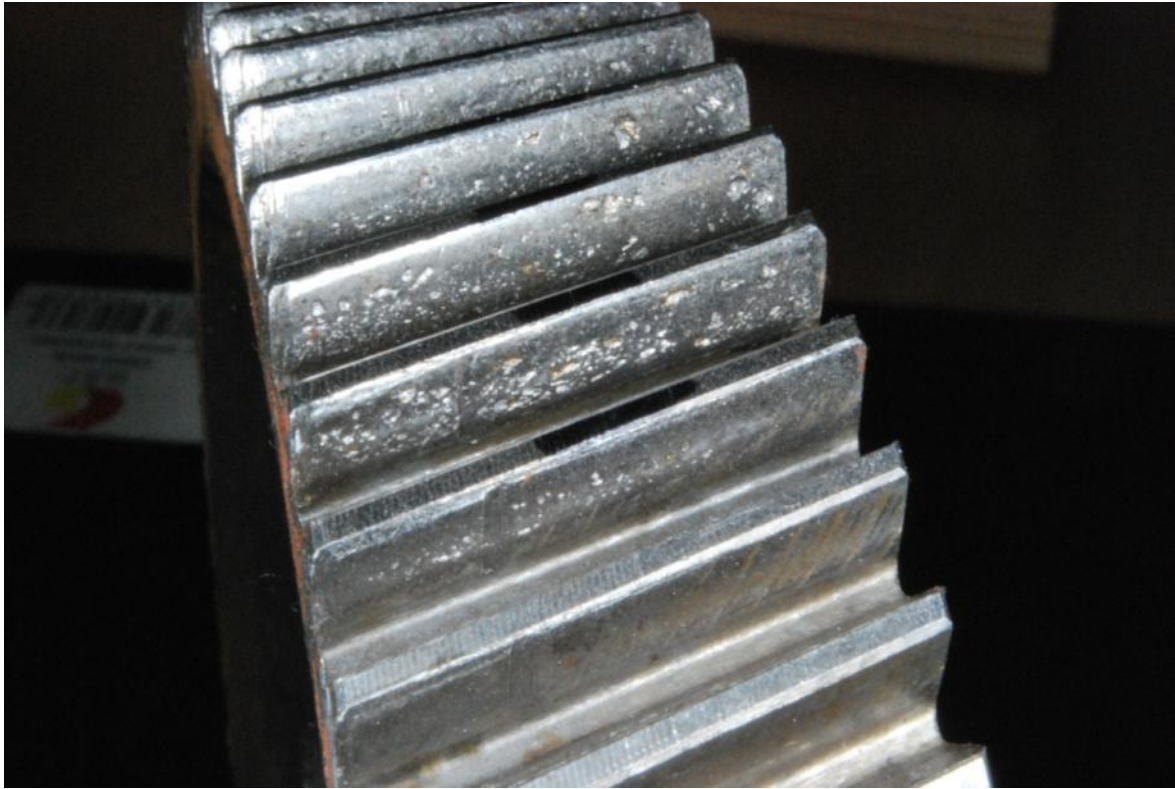
Figure 1: Silver Wing - On the non-driving side of the teeth on the camshaft timing gear, examination showed the presence of pitting and spalling. Damage is non-uniform and localised in bands of teeth.

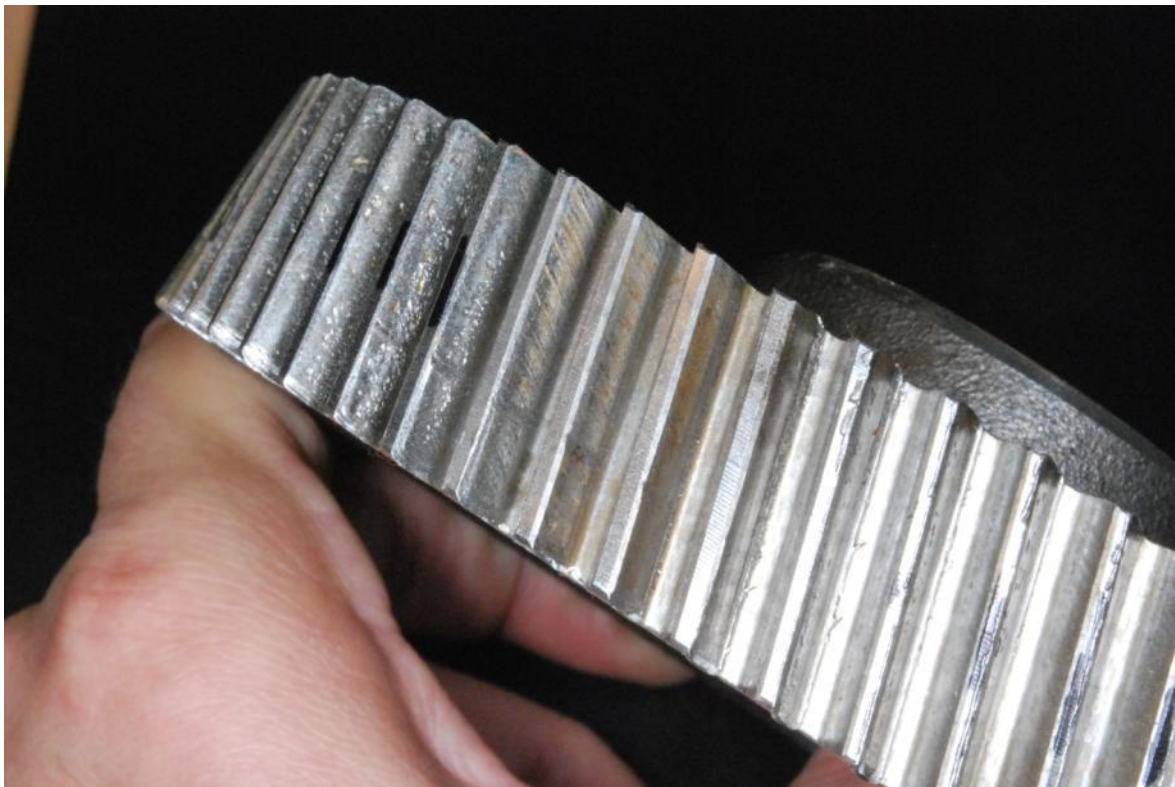
Figure 2: Silver Wing - On the camshaft timing gear there are six equi-spaced groups of damaged teeth, 60° apart.

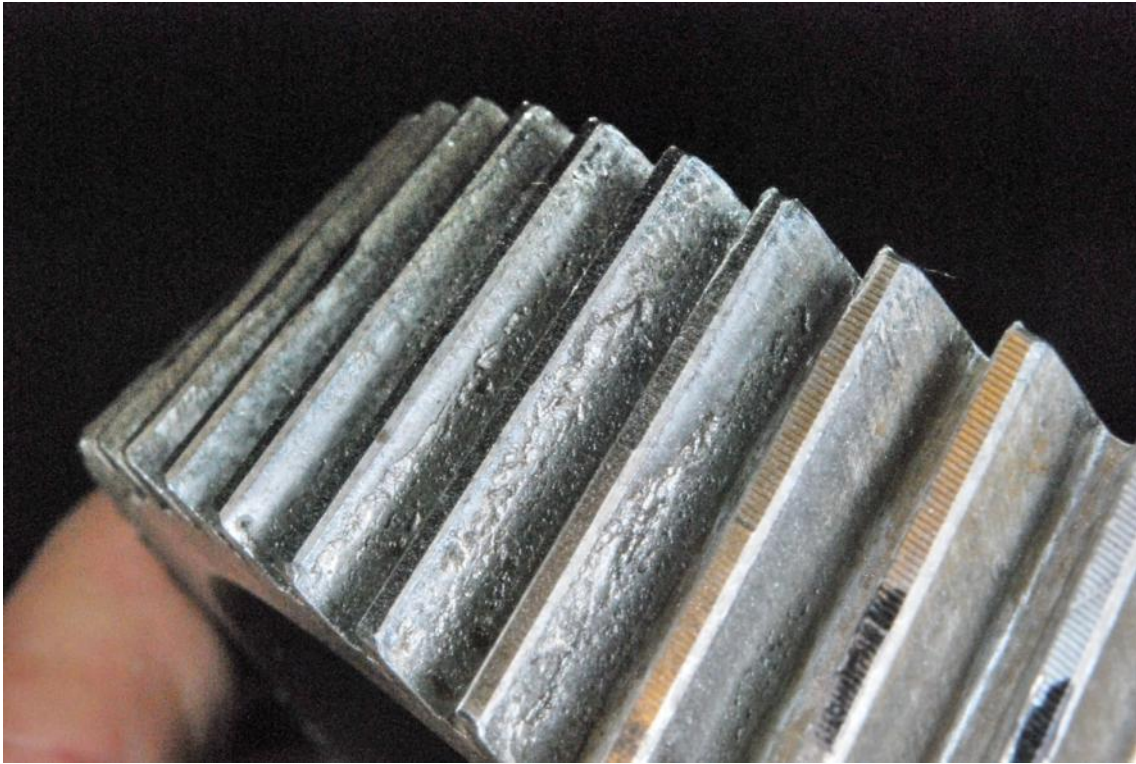
Figure 3: Silver Wing - On the driving side of the camshaft timing gear teeth, severe plastic yielding (peening / rolling) damage is present along with pitting and spalling.

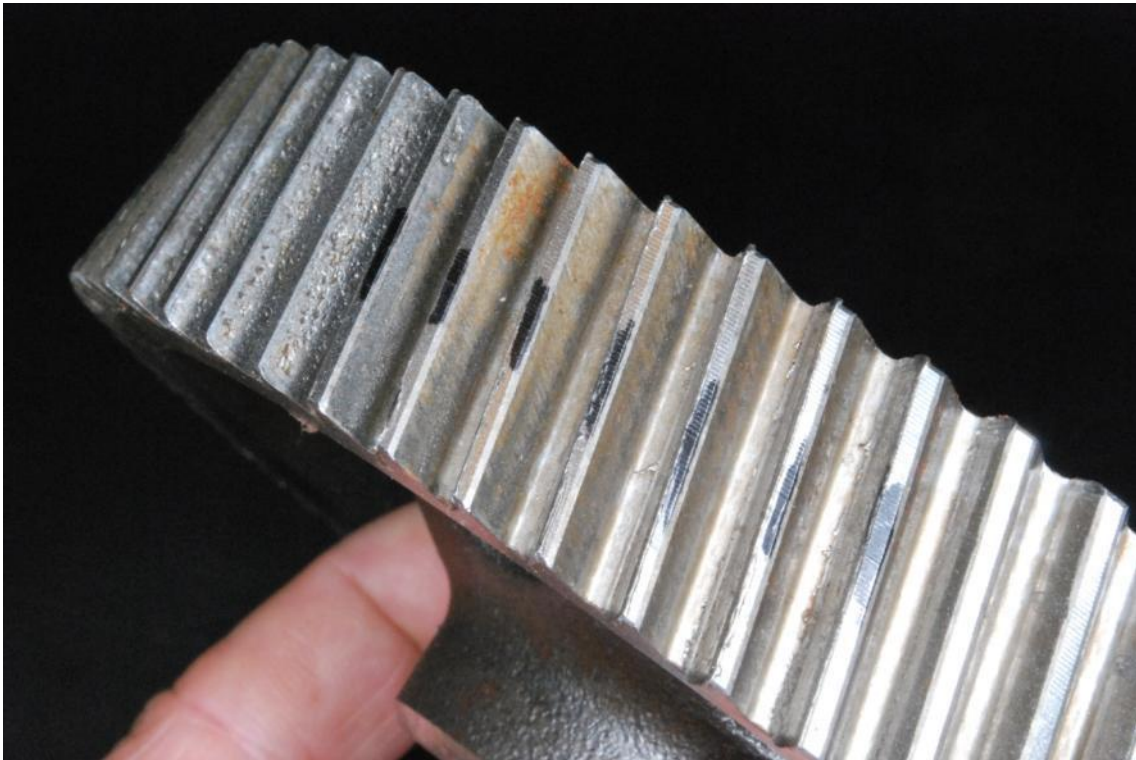
Figure 4: Silver Wing - On the non-driving side of the camshaft timing gear teeth, there are also six equi-spaced groups of severely (plastic yielded, pitted and spalled) damaged teeth (six teeth in each group) between each group of slightly pitted teeth.

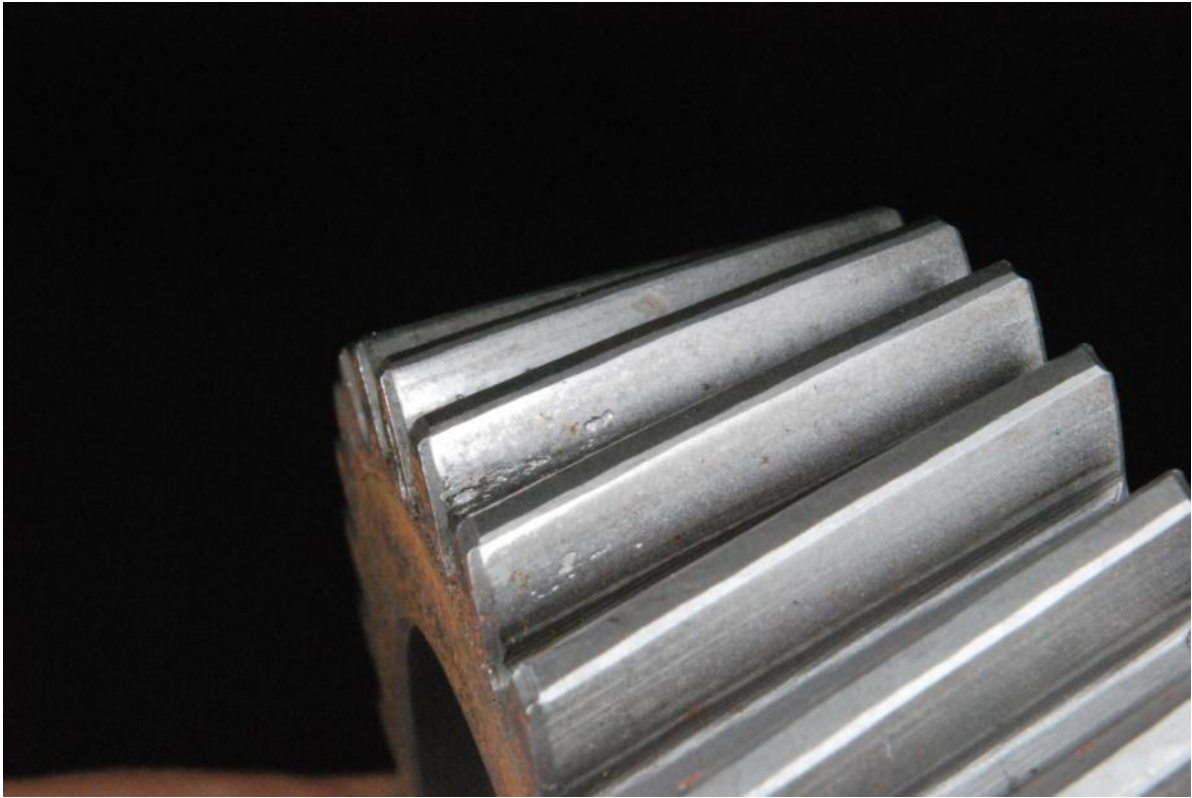
Figure 5: Silver Wing - On the driving side of the camshaft timing gear teeth, there is minor pitting present just under the pitch line of the tooth face.

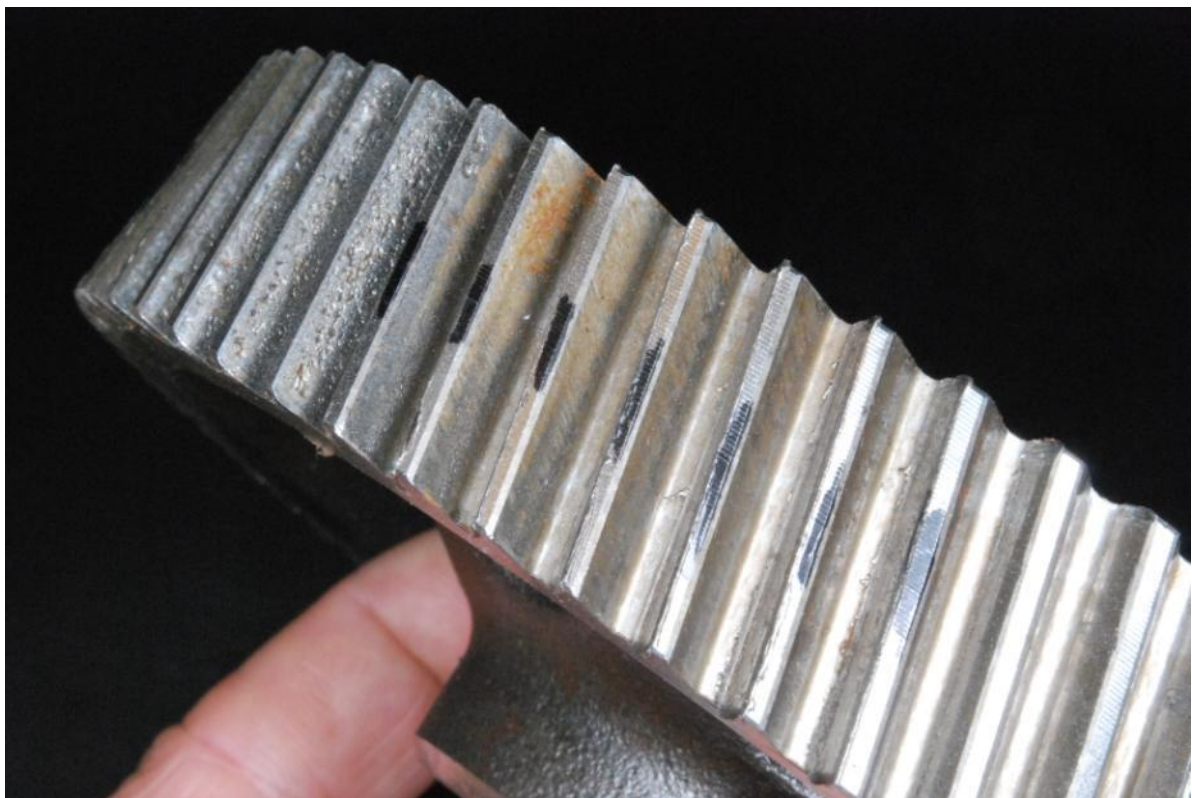
Figure 6: Silver Wing - On the camshaft timing gear, the damage is localised at three equi-spaced groups of damaged teeth (three teeth in each group), the groups being 120° apart.

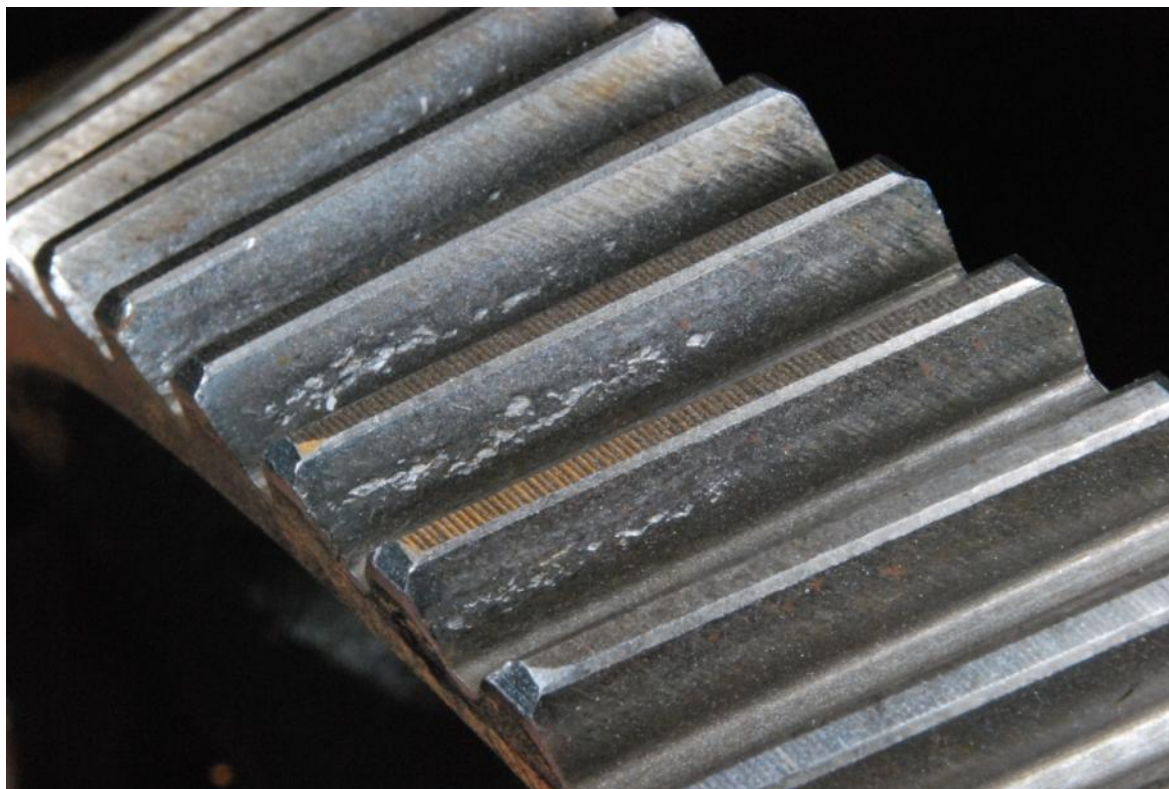
Figure 7: Silver Wing - Pitting and scoring are present on the non-driving side of the fuel injection pump timing gear teeth.

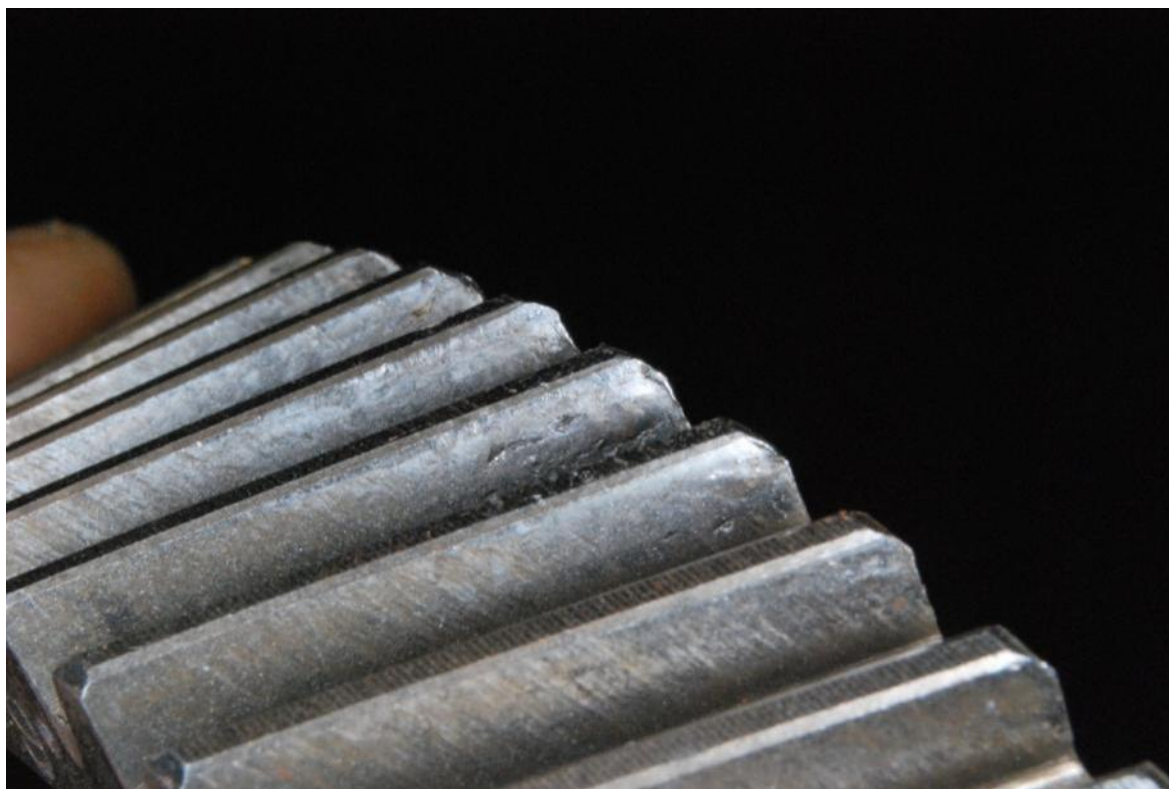
Figure 8: Silver Wing - Pitting and scoring were present on the driving side of the fuel injection pump timing gear teeth.

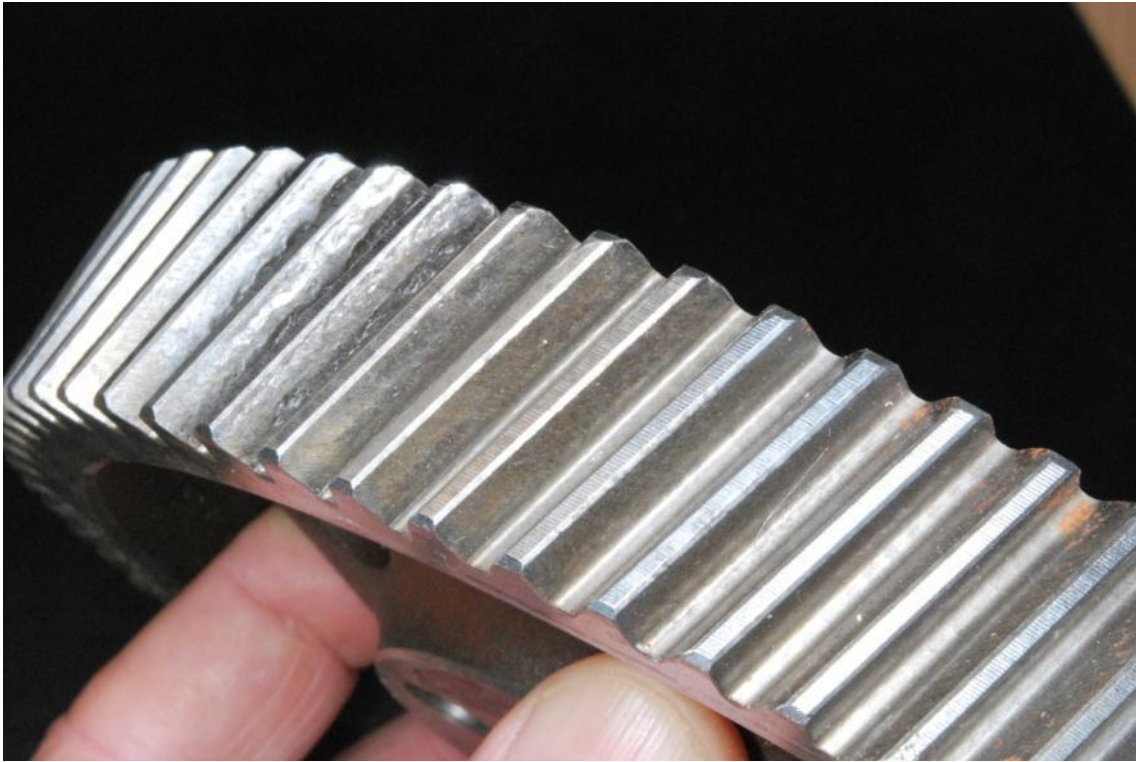
Figure 9: Silver Wing - On the fuel injection pump timing gear, there are six equi-spaced groups of damaged teeth which are in alignment with the severely (plastic yielded, pitted and spalled) damaged teeth on the camshaft gear on the driving side

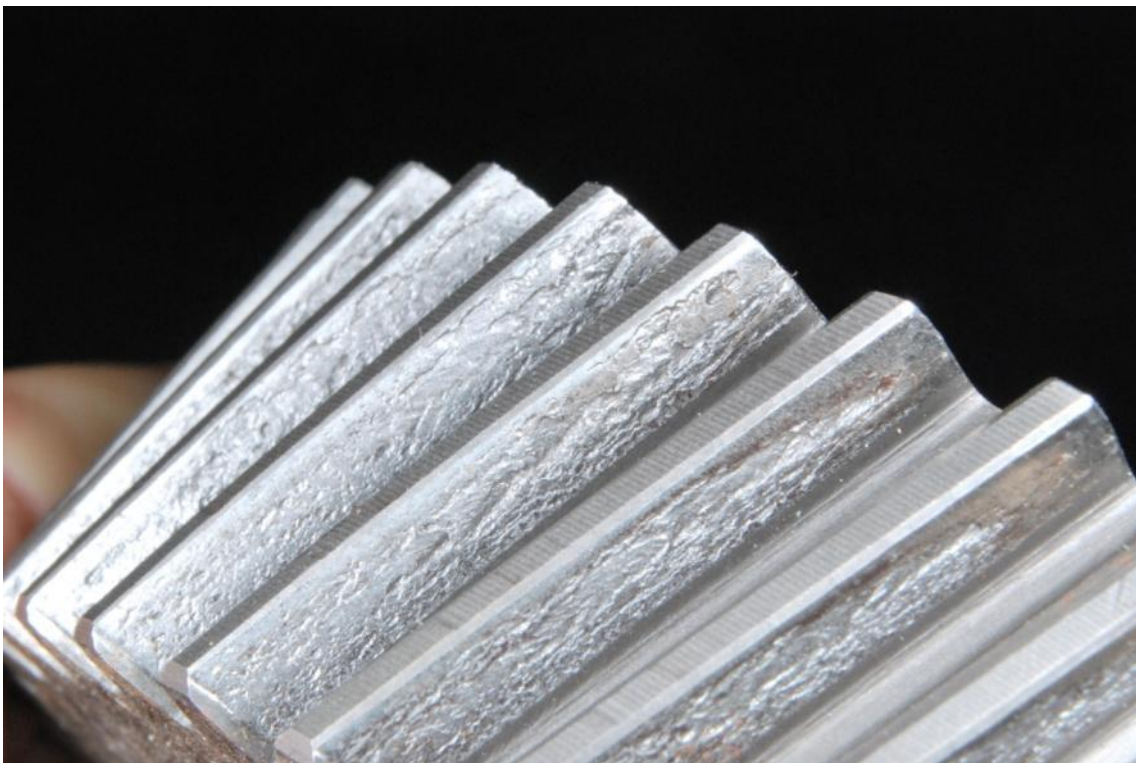
Figure 10: Silver Wing - Severe spalling has occurred over the entire surface of every single tooth on the driving side of the idler timing gear.

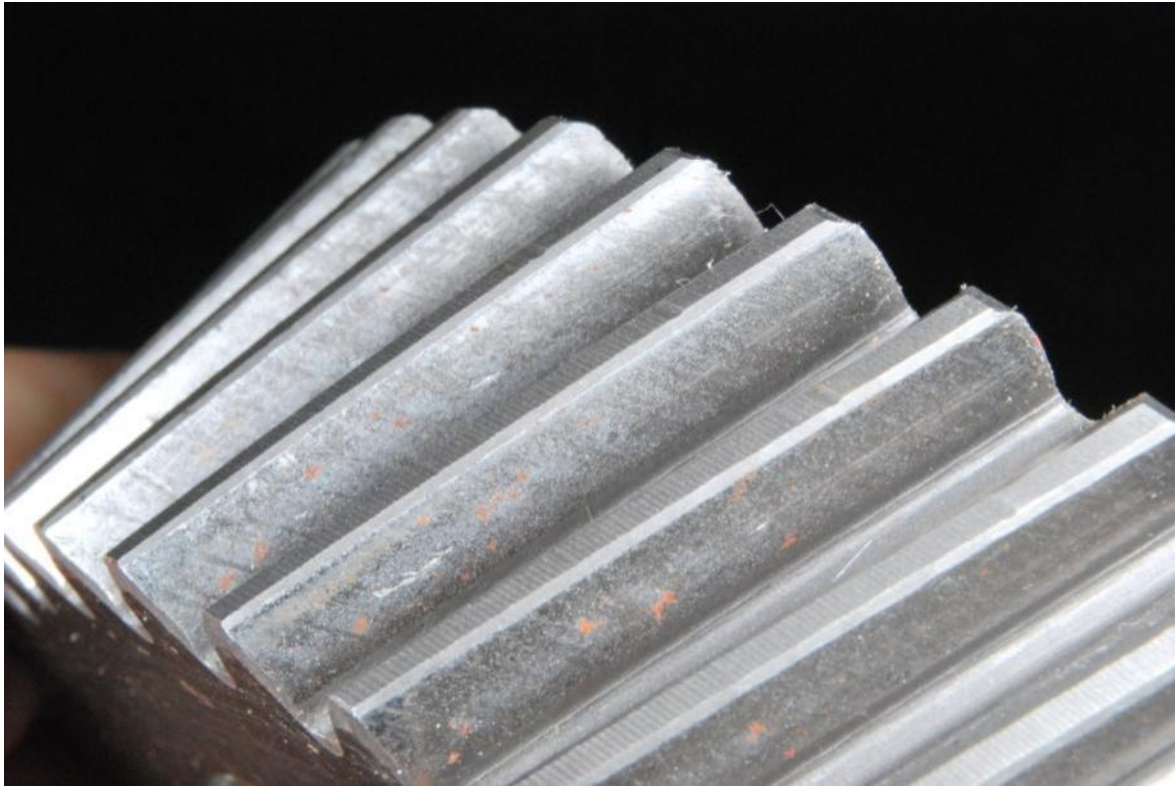
Figure 11: Silver Wing - There is no damage on the non-driving side of the idler gear teeth.

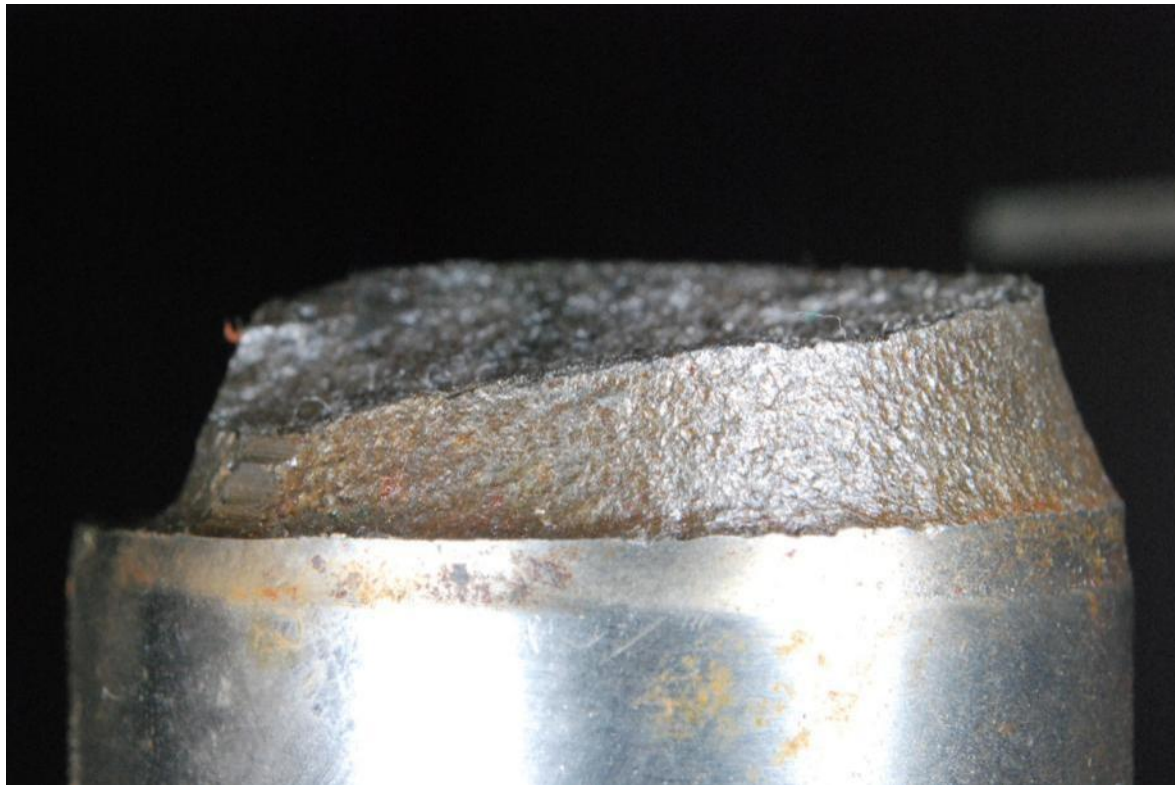
Figure 12: Silver Wing port engine's failed camshaft. The angle of fracture shows that the predominant loading at point of initiation was torsional.

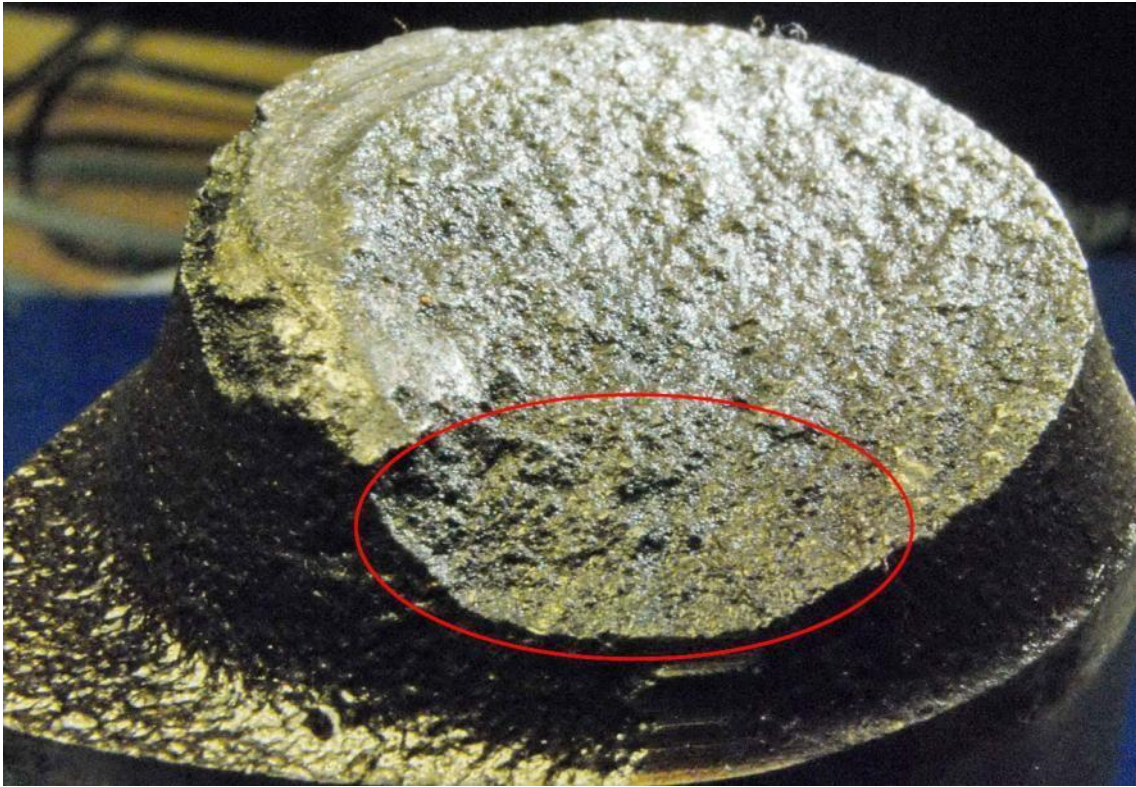
Figure 13: Silver Wing's failed camshaft. The crack initiation area is marked.

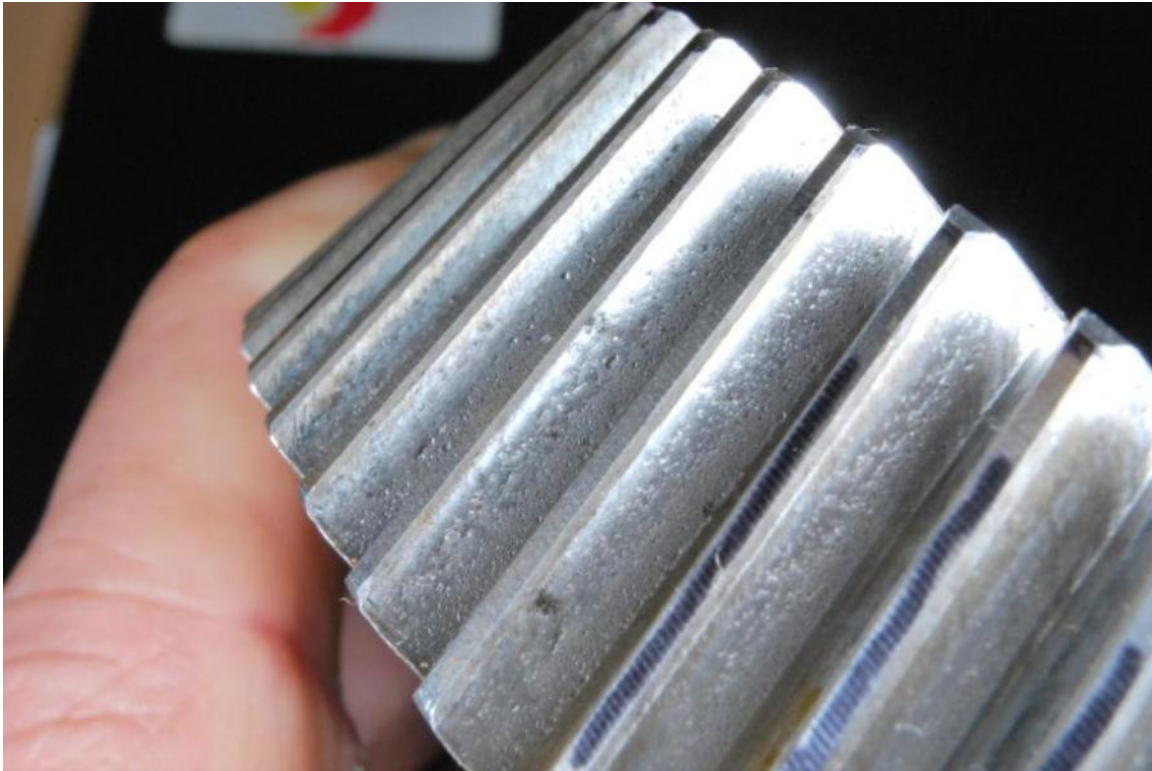
Figure 14: Callagher - On the non-driving side of the camshaft timing gear teeth, examination showed the presence of pitting and spalling.

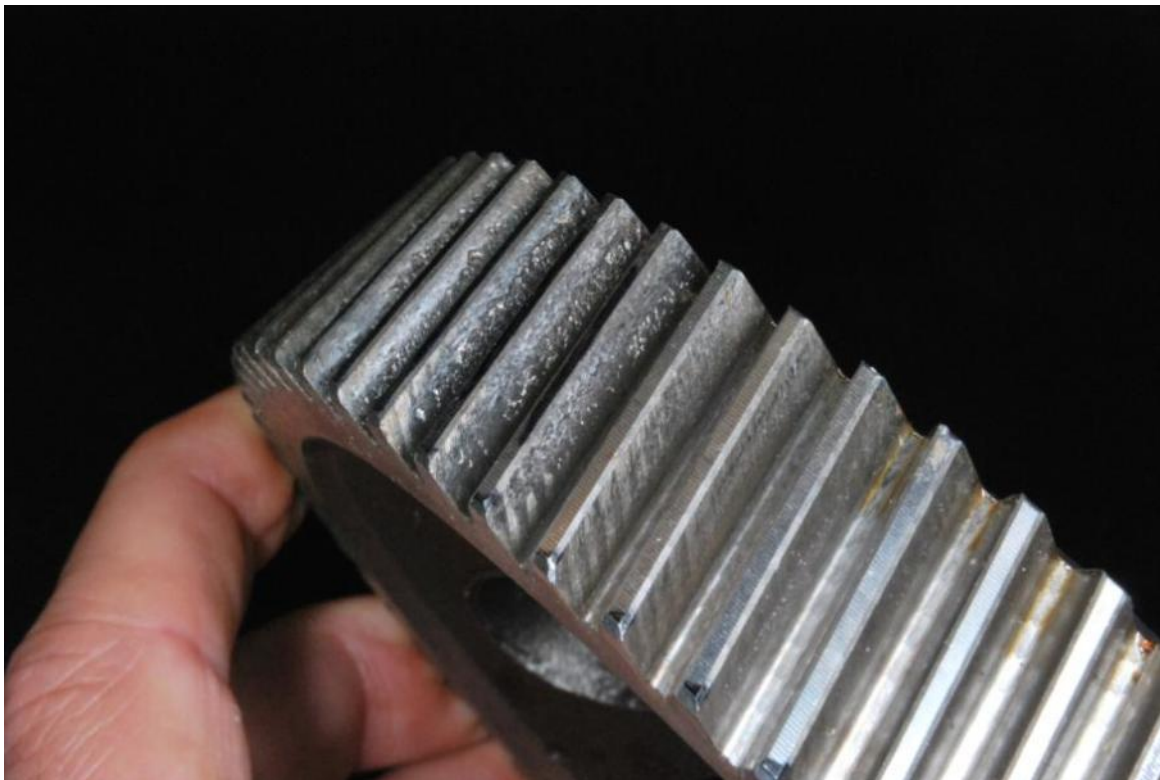
Figure 15: Callagher - The non-driving side of the camshaft timing gear. The distribution of damage is similar to that found on the non-driving side of the Silver Wing port engine's camshaft timing gear.

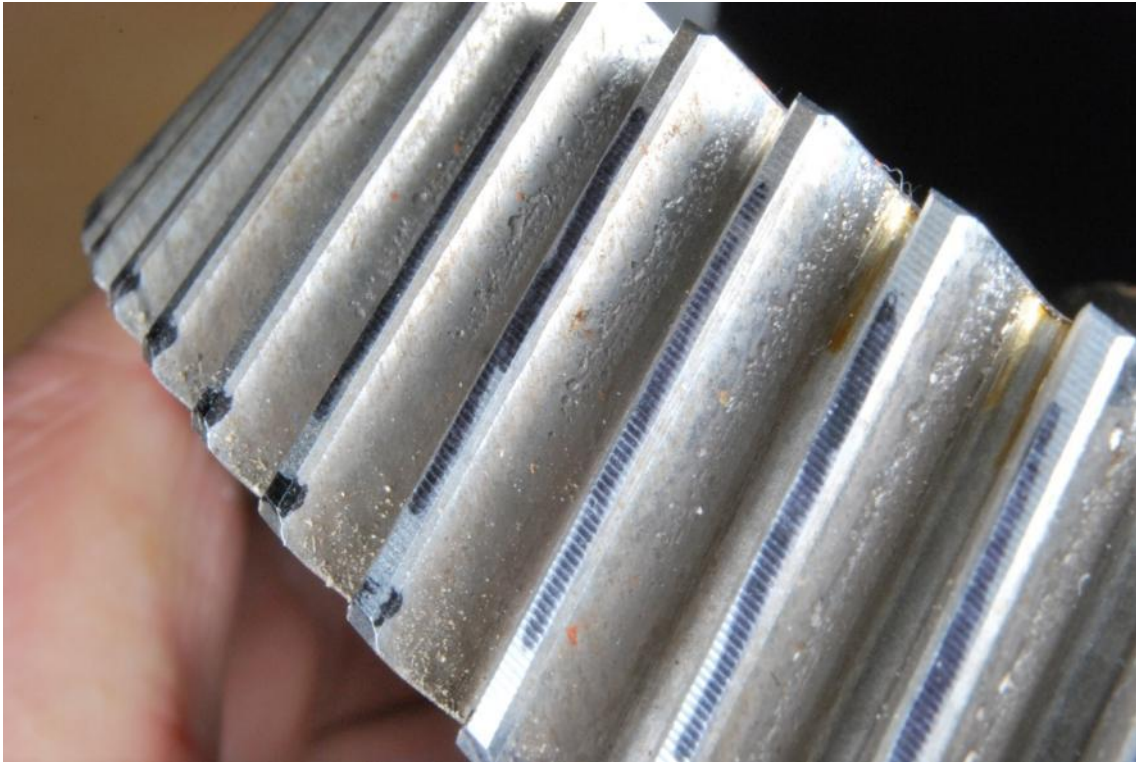
Figure 16: Callagher - On the driving side of the camshaft timing gear teeth, severe plastic yielding (peening/ rolling) damage is present, along with pitting and spalling.

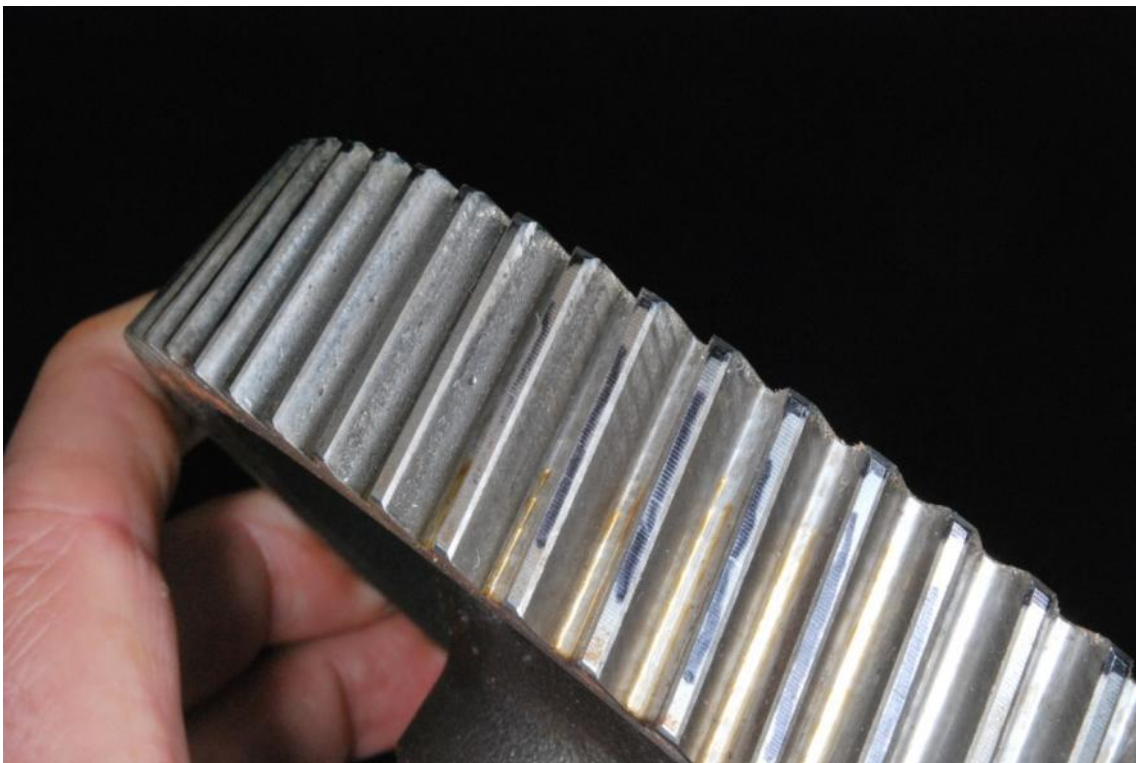
Figure 17: Callagher - On the non-driving side of the camshaft timing gear, there are also six equi-spaced groups of severely (plastic yielded, pitted and spalled) damaged teeth (six teeth in each group) between each group of slightly pitted teeth. The groups are approximately 60° apart.

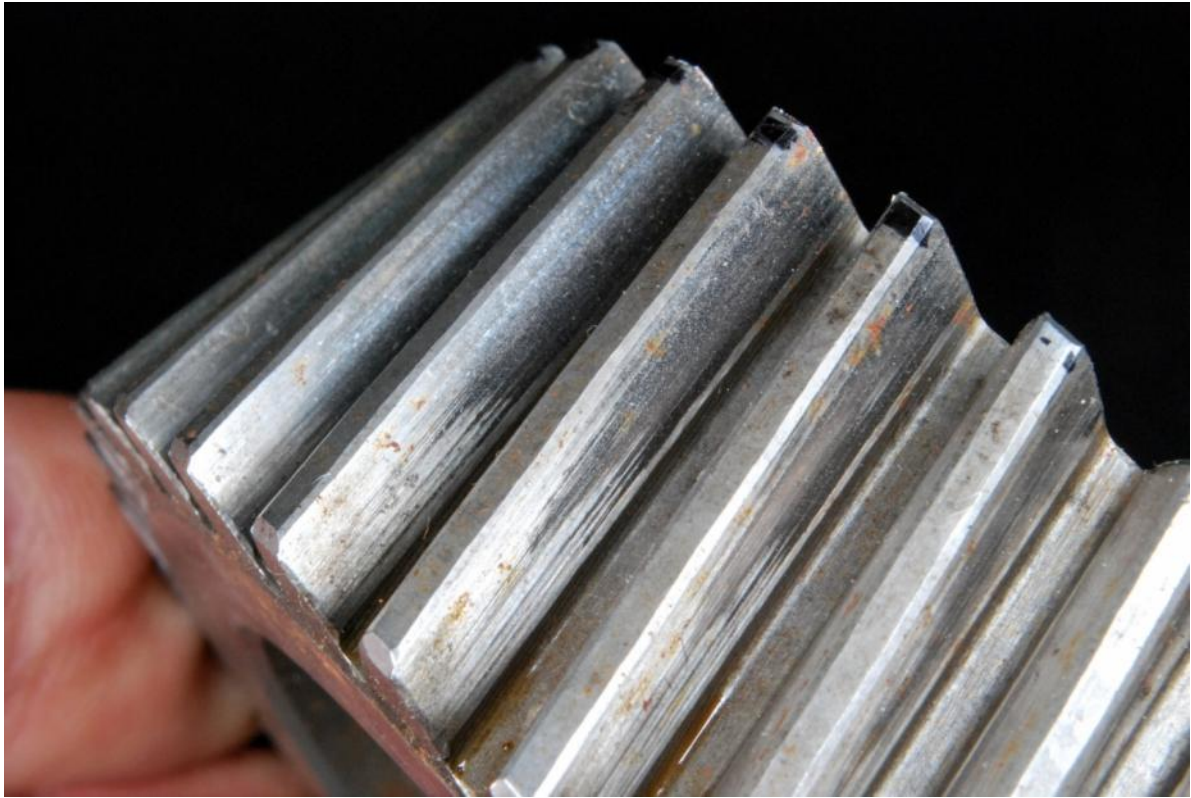
Figure 18: Callagher - The driving side of the crankshaft timing gear teeth are in good condition, with only minor pitting present.

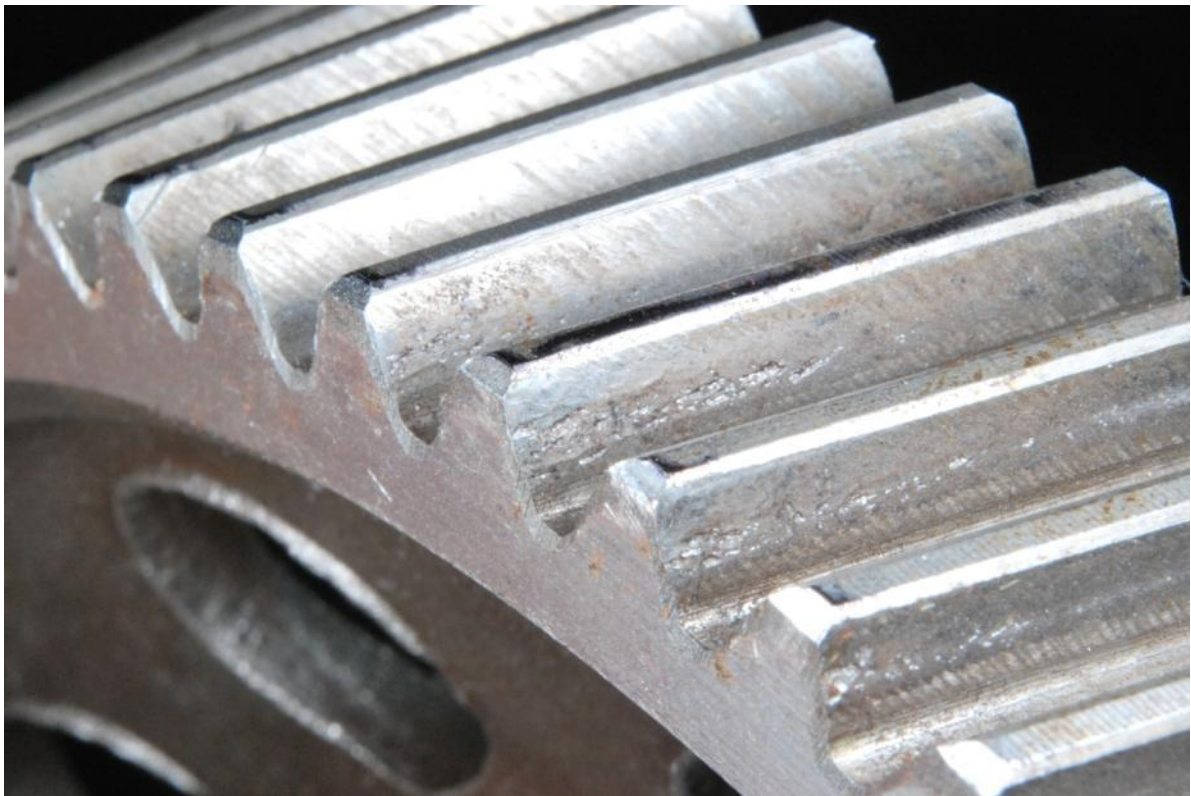
Figure 19: Callagher - Pitting and scoring on the non-driving side of the teeth on the fuel injection pump gear.

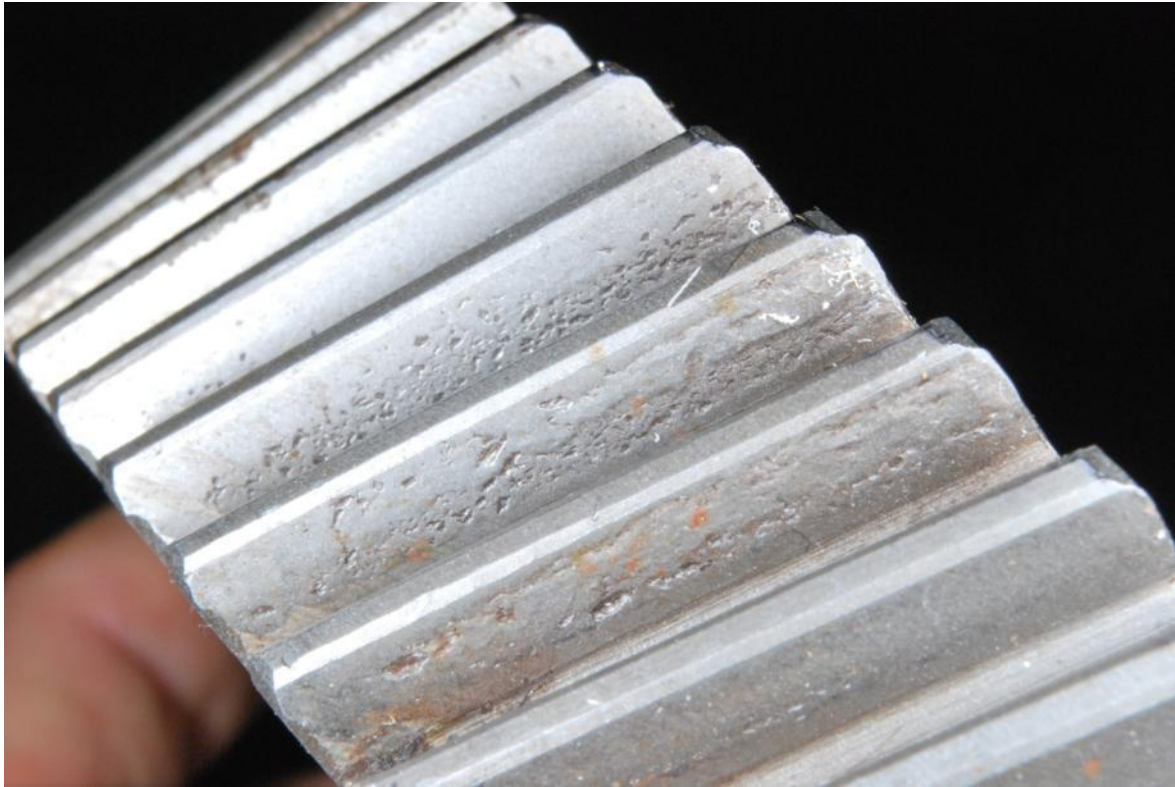
Figure 20: Callagher - Pitting and scoring are present on the driving side of the fuel injection pump timing gear teeth.

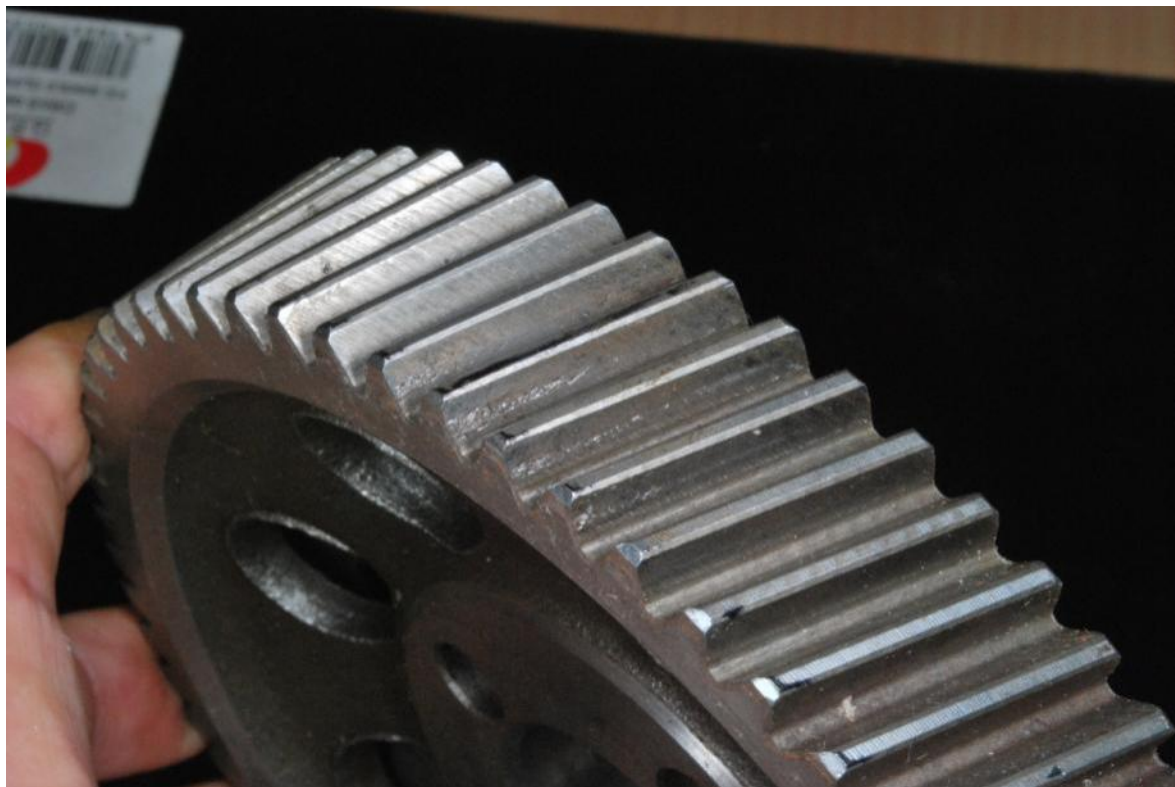
Figure 21: Callagher - The driving side of the fuel injection pump timing gear teeth. The damage distribution pattern is similar to that on the camshaft timing gear, but to a lesser extent.

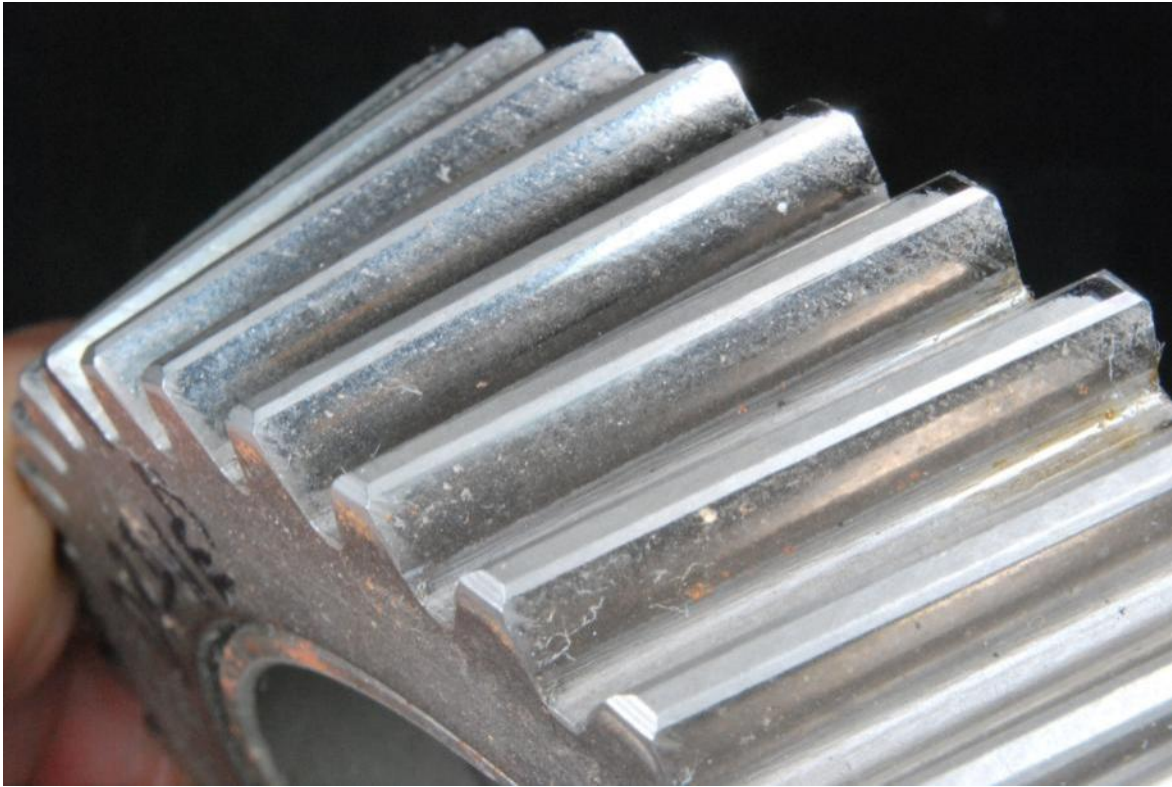
Figure 22: Callagher - There is no damage showing on the teeth on the idler timing gear.

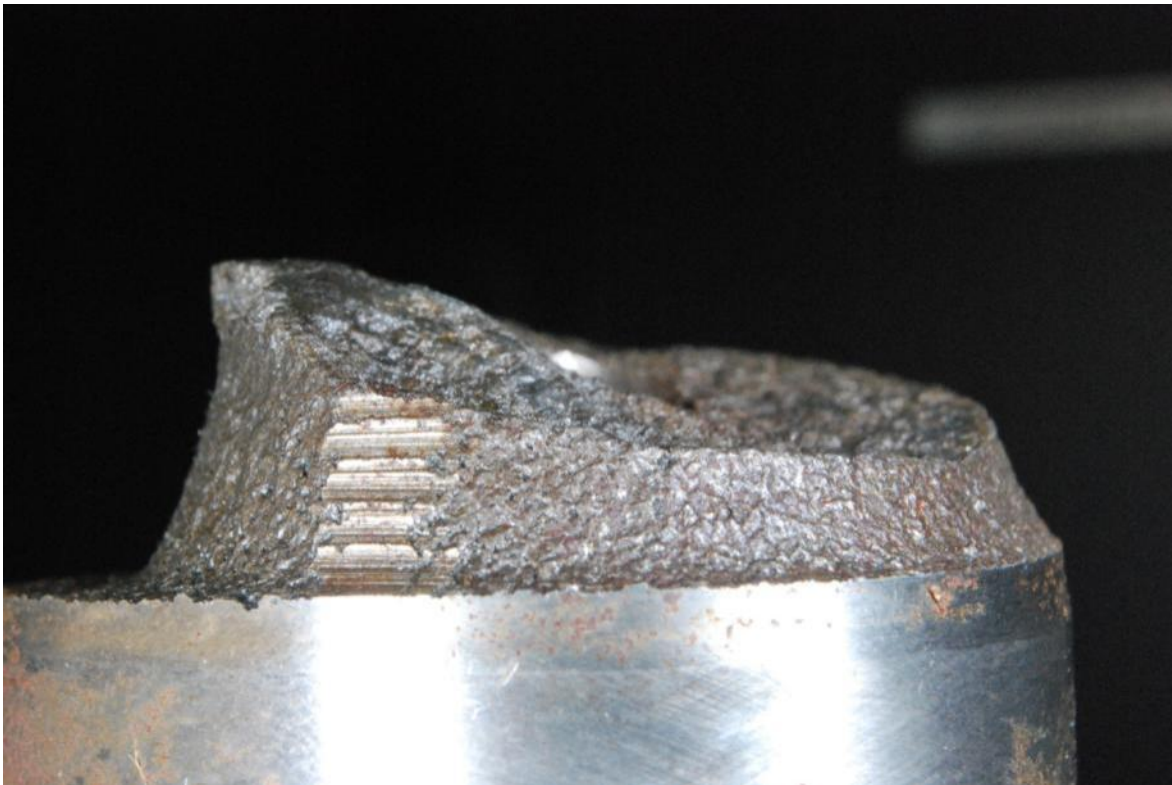
Figure 23: Callagher - Failed camshaft. The angle of fracture shows that the predominant loading was torsional.

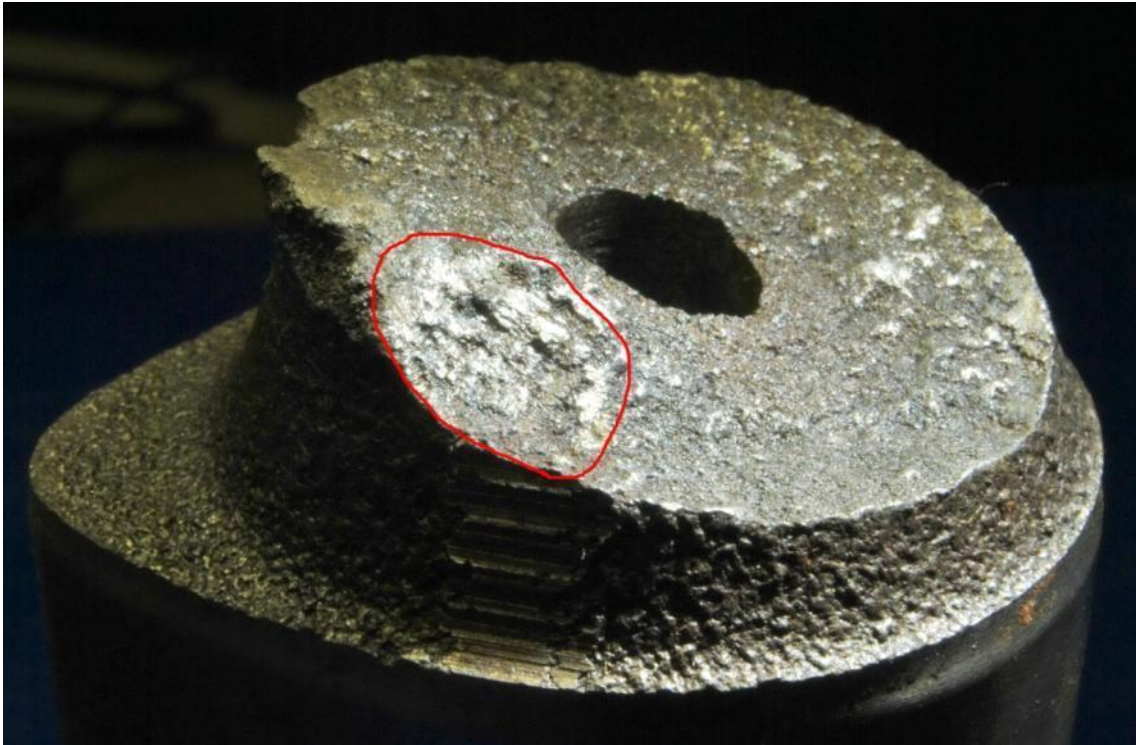
Figure 24: Failed camshaft from the Callagher engine. The crack initiation area is marked.
