Under **THE COMMISSIONS OF INQUIRY ACT 1908**  
In the matter of the **CANTERBURY EARTHQUAKES ROYAL COMMISSION  
OF INQUIRY INTO THE COLLAPSE OF THE CTV  
BUILDING**

**CLOSING SUBMISSIONS  
FOR ALAN REAY CONSULTANTS LIMITED AND DR REAY**

**Dated 3 September 2012**

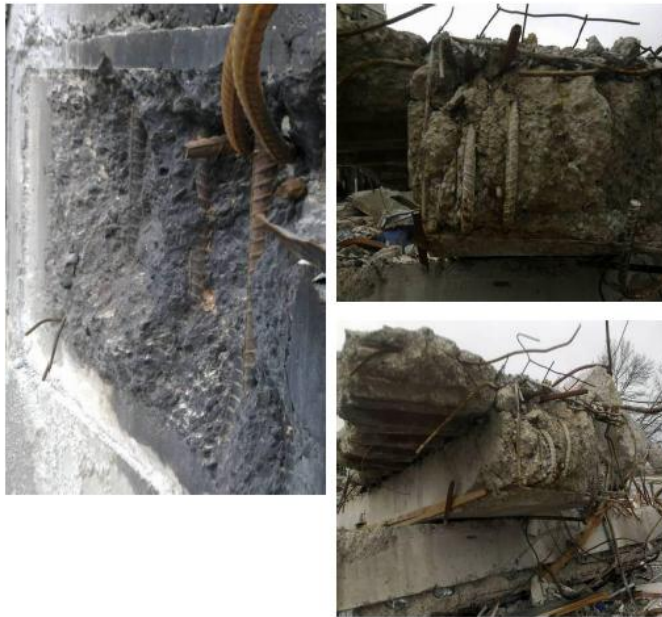
Figure 44, BUI.MAD249.0189.109

82. Mr Brooks' evidence on this issue was that the bars could not have been bent that way on site.<sup>130</sup> It therefore seems more likely to have been a defect in the pre-cast beam as supplied. Regardless, it should not have been installed in that form and this represents another construction fault, with the result that the connection was considerably less robust than it should have been. This issue was also identified in the DBH report and is supported by photographs.<sup>131</sup>

<sup>131</sup> BUI.MAD249.0189.110, figure 44 at BUI.MAD249.0189.109

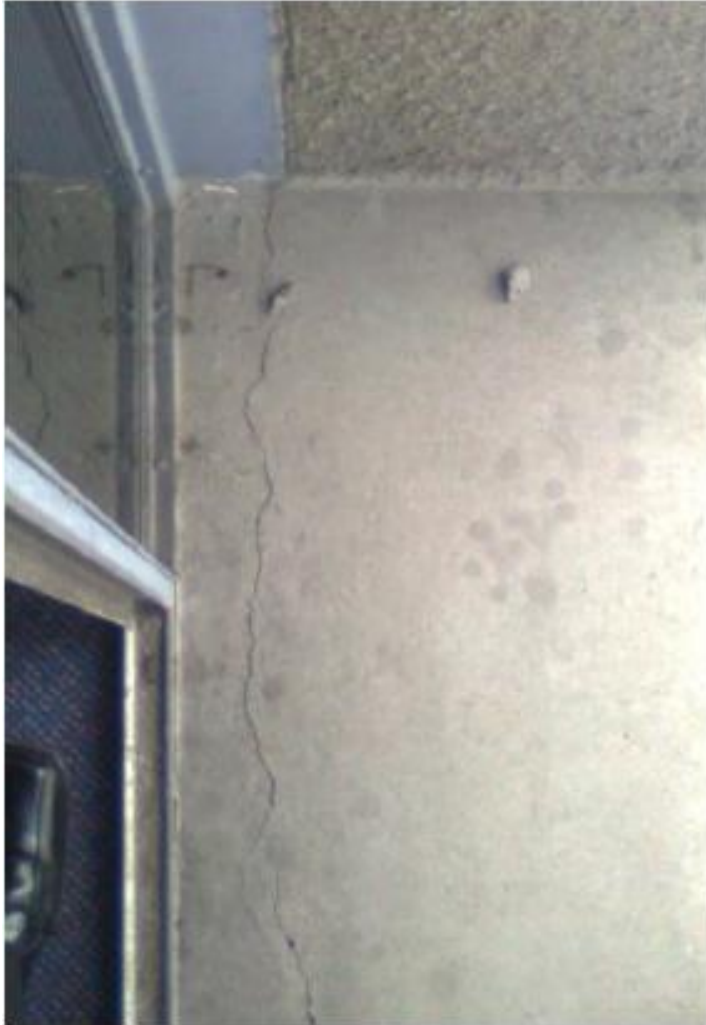
BUI.MAD249.0386B.8 [32]

222. Additionally, there are many indicators of some damage. It seems likely that there was some slab separation from the north shear wall. It is also likely that there was south shear separation.<sup>242</sup> This inference is from analysis, however such insight is important because visually such damage is unlikely to have been directly observable.

<sup>242</sup> See for example the photographs at BUI.MAD249.0386B.8 [photograph [32]] and, on a different floor, BUI.MAD249.0386.10 [photograph [40]] – adjacent to the black shoe shown in the photograph annexed to the evidence of Mr Pagan

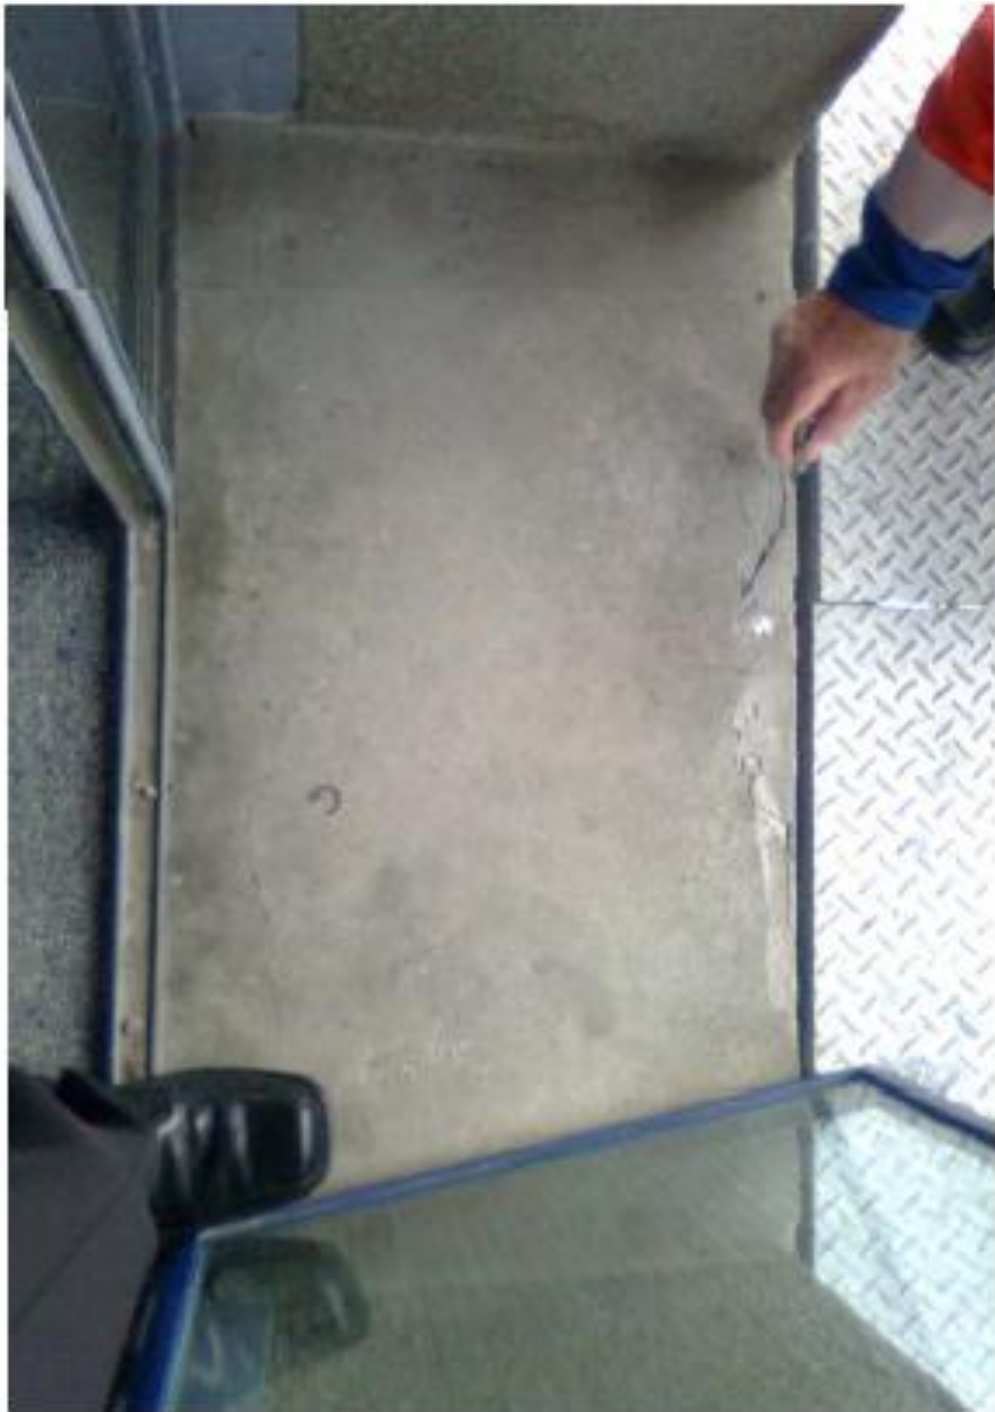
BUI.MAD249.0386.10 [40]

223. It is also quite possible that in parts the slab delaminated from the Hi-bond during or as a result of the September earthquake, but this could not be seen without pulling up carpets, which did not occur. Observed from the floor below, Mr Coatsworth considered the Hi-bond looked satisfactory, but this would not identify any delamination above the Hi-bond. Professor

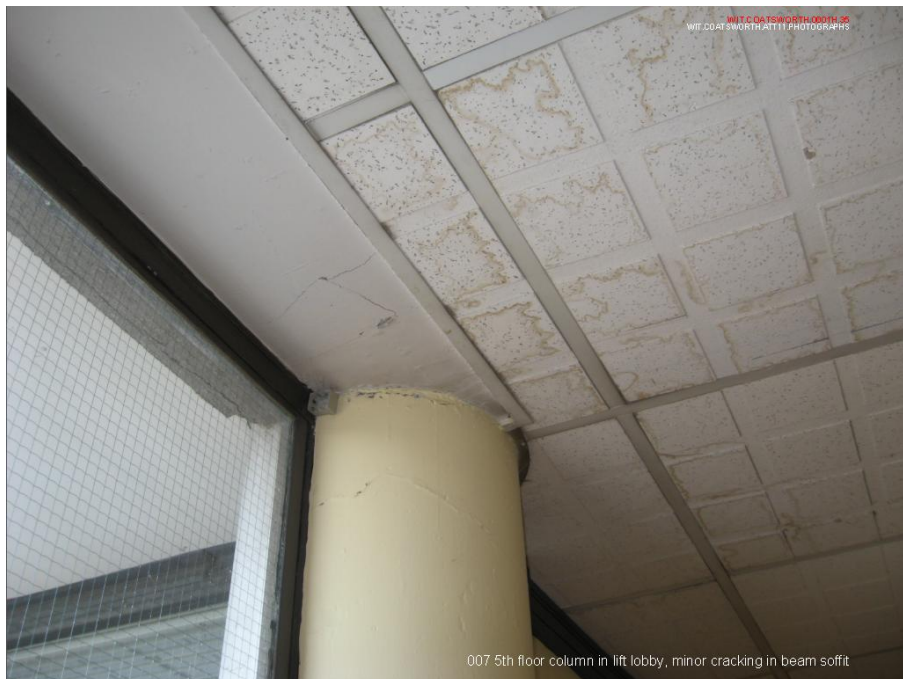
WIT.COATSWORTH.0001H.35 (October 2010)

235. The second important new evidence is that of Mr Higgins, confirmed in a photograph he took in February 2011.<sup>256</sup> When compared with photographs of the same area taken by Mr Coatsworth in October 2010,<sup>257</sup> a marked change in the level of damage can be observed. Mr Coatsworth confirmed that he would have taken a photo of this damage if it had been there when he visited the building.<sup>258</sup>

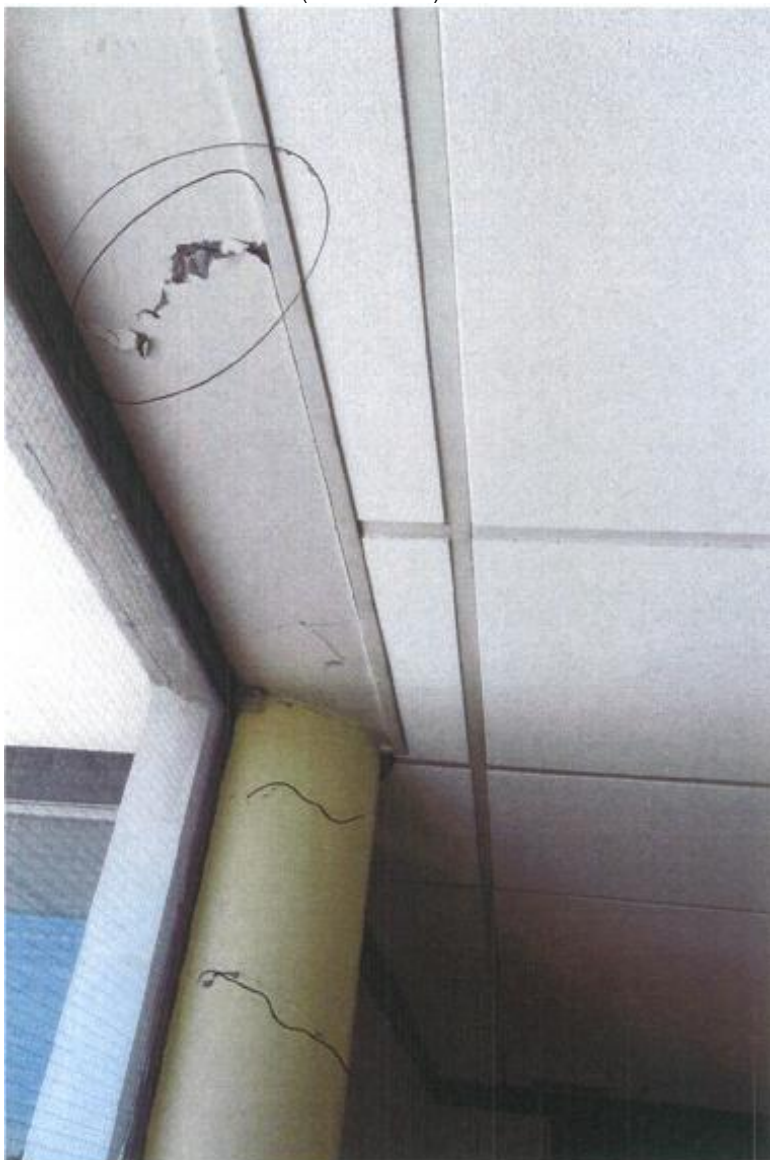
BUI.MAD249.0454.1 (February 2011)

236. The CTV Building had now been through a design-level earthquake, many aftershocks including a major aftershock,<sup>259</sup> and was damaged. Its remaining resilience in the face of a further major aftershock cannot now be assessed but was clearly significantly reduced from design levels.

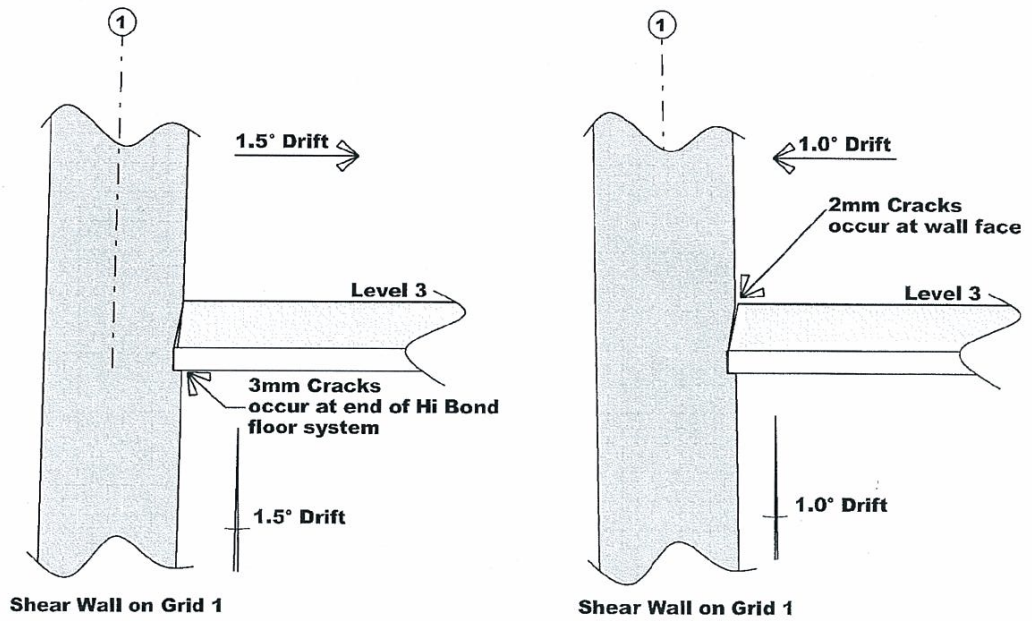
**Level 3 - Wall / Floor Connection**  
**September 4th Earthquake**

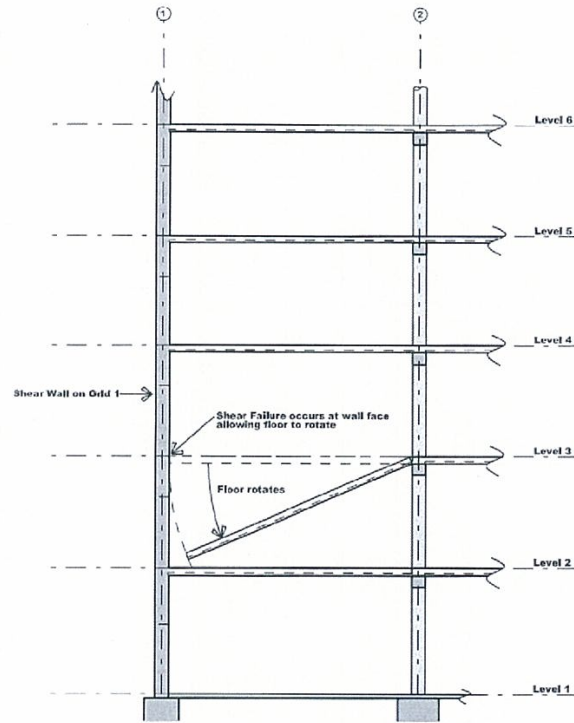
Probable Collapse Mechanism - Stage 1  
February 22nd Earthquake

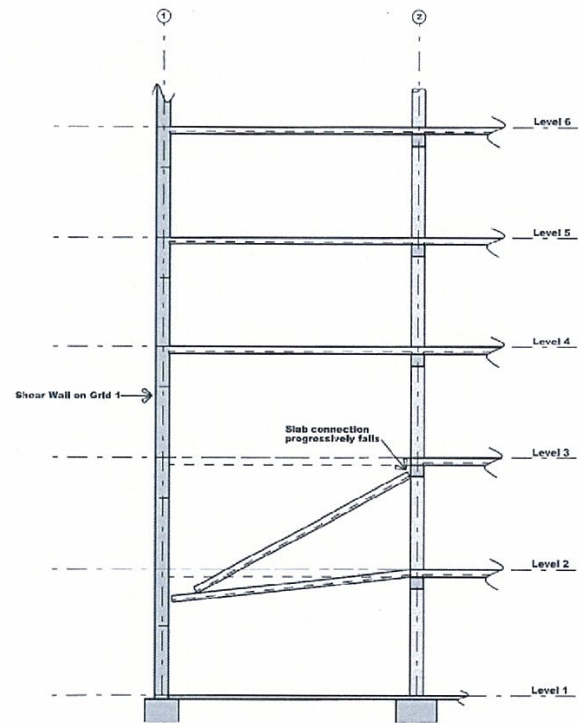
Probable Collapse Mechanism - Stage 2a  
February 22nd Earthquake

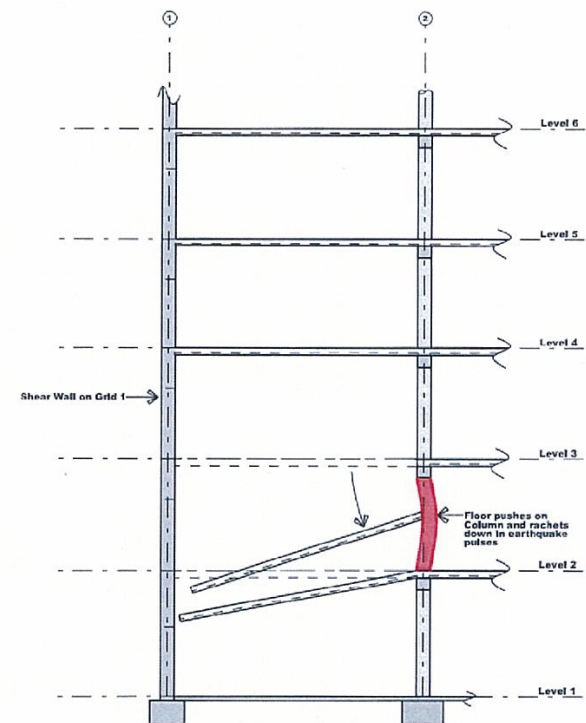
Probable Collapse Mechanism - Stage 2b  
February 22nd Earthquake

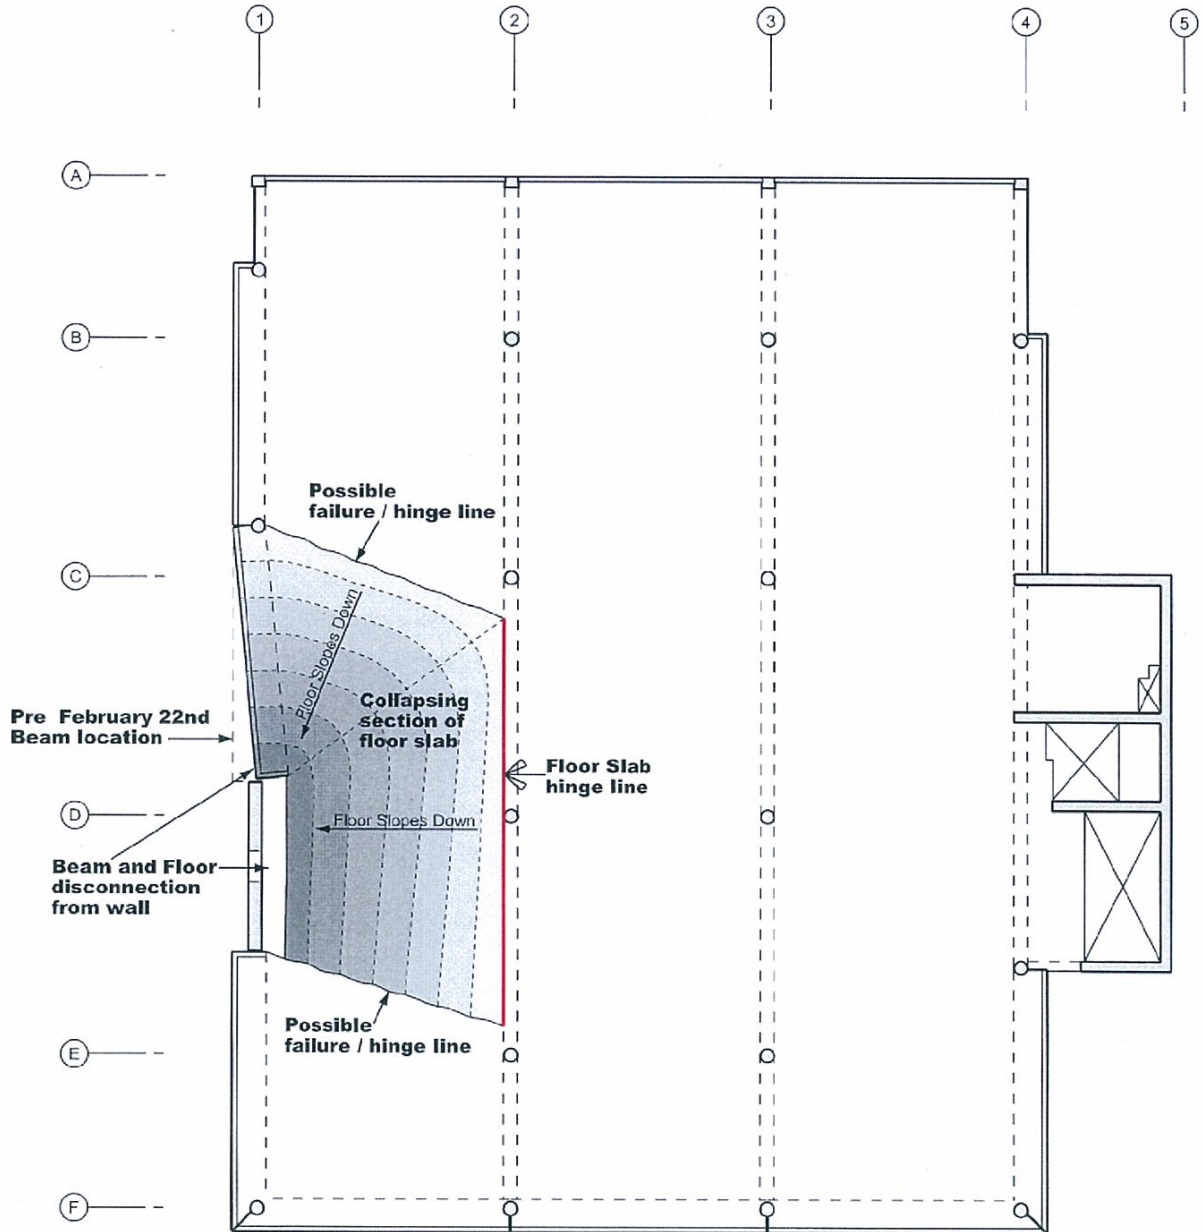
D3

**Probable Collapse Mechanism - Stage 1**

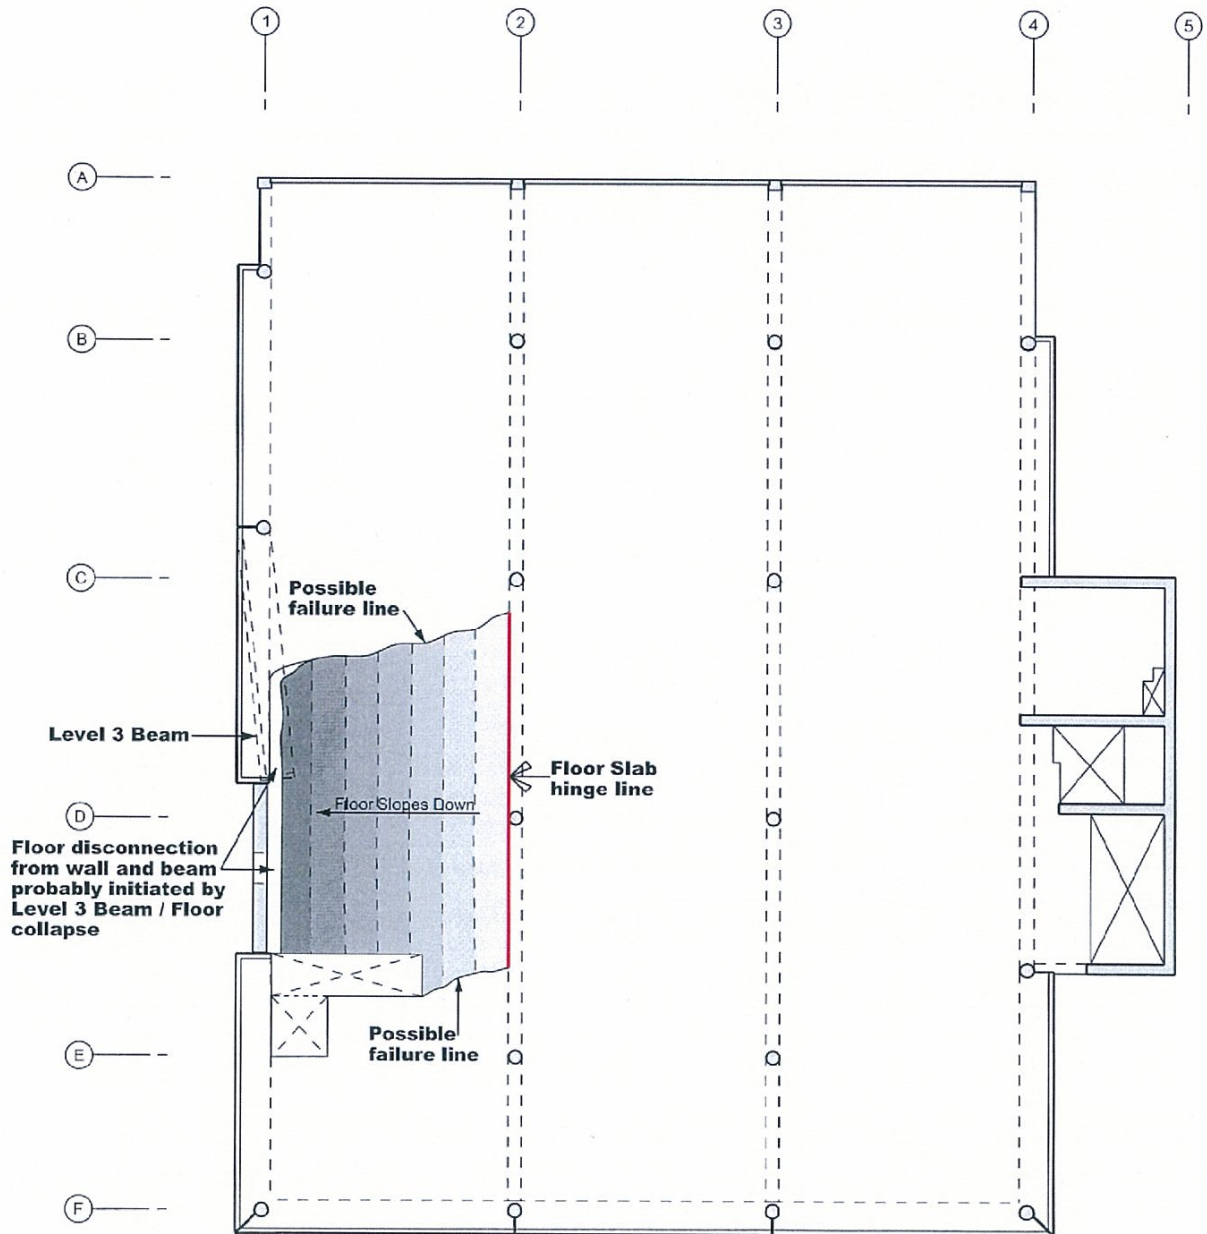
D4

**Probable Collapse Mechanism - Stage 2**

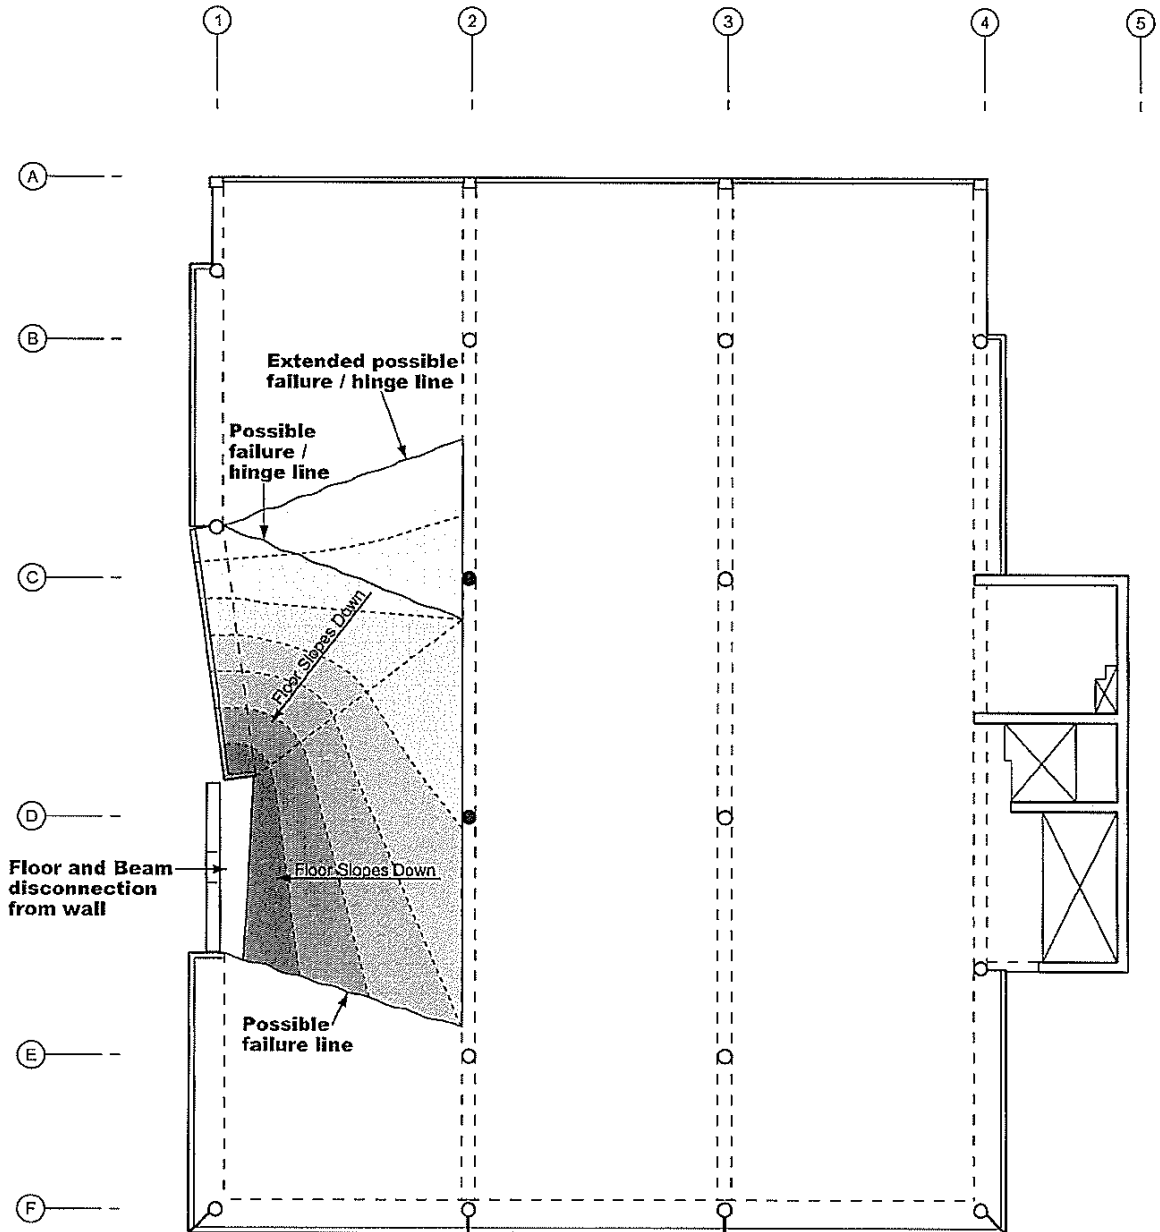
D5

**Probable Collapse Mechanism - Stage 3**  
**Possible extended collapse of Level 3 floor**

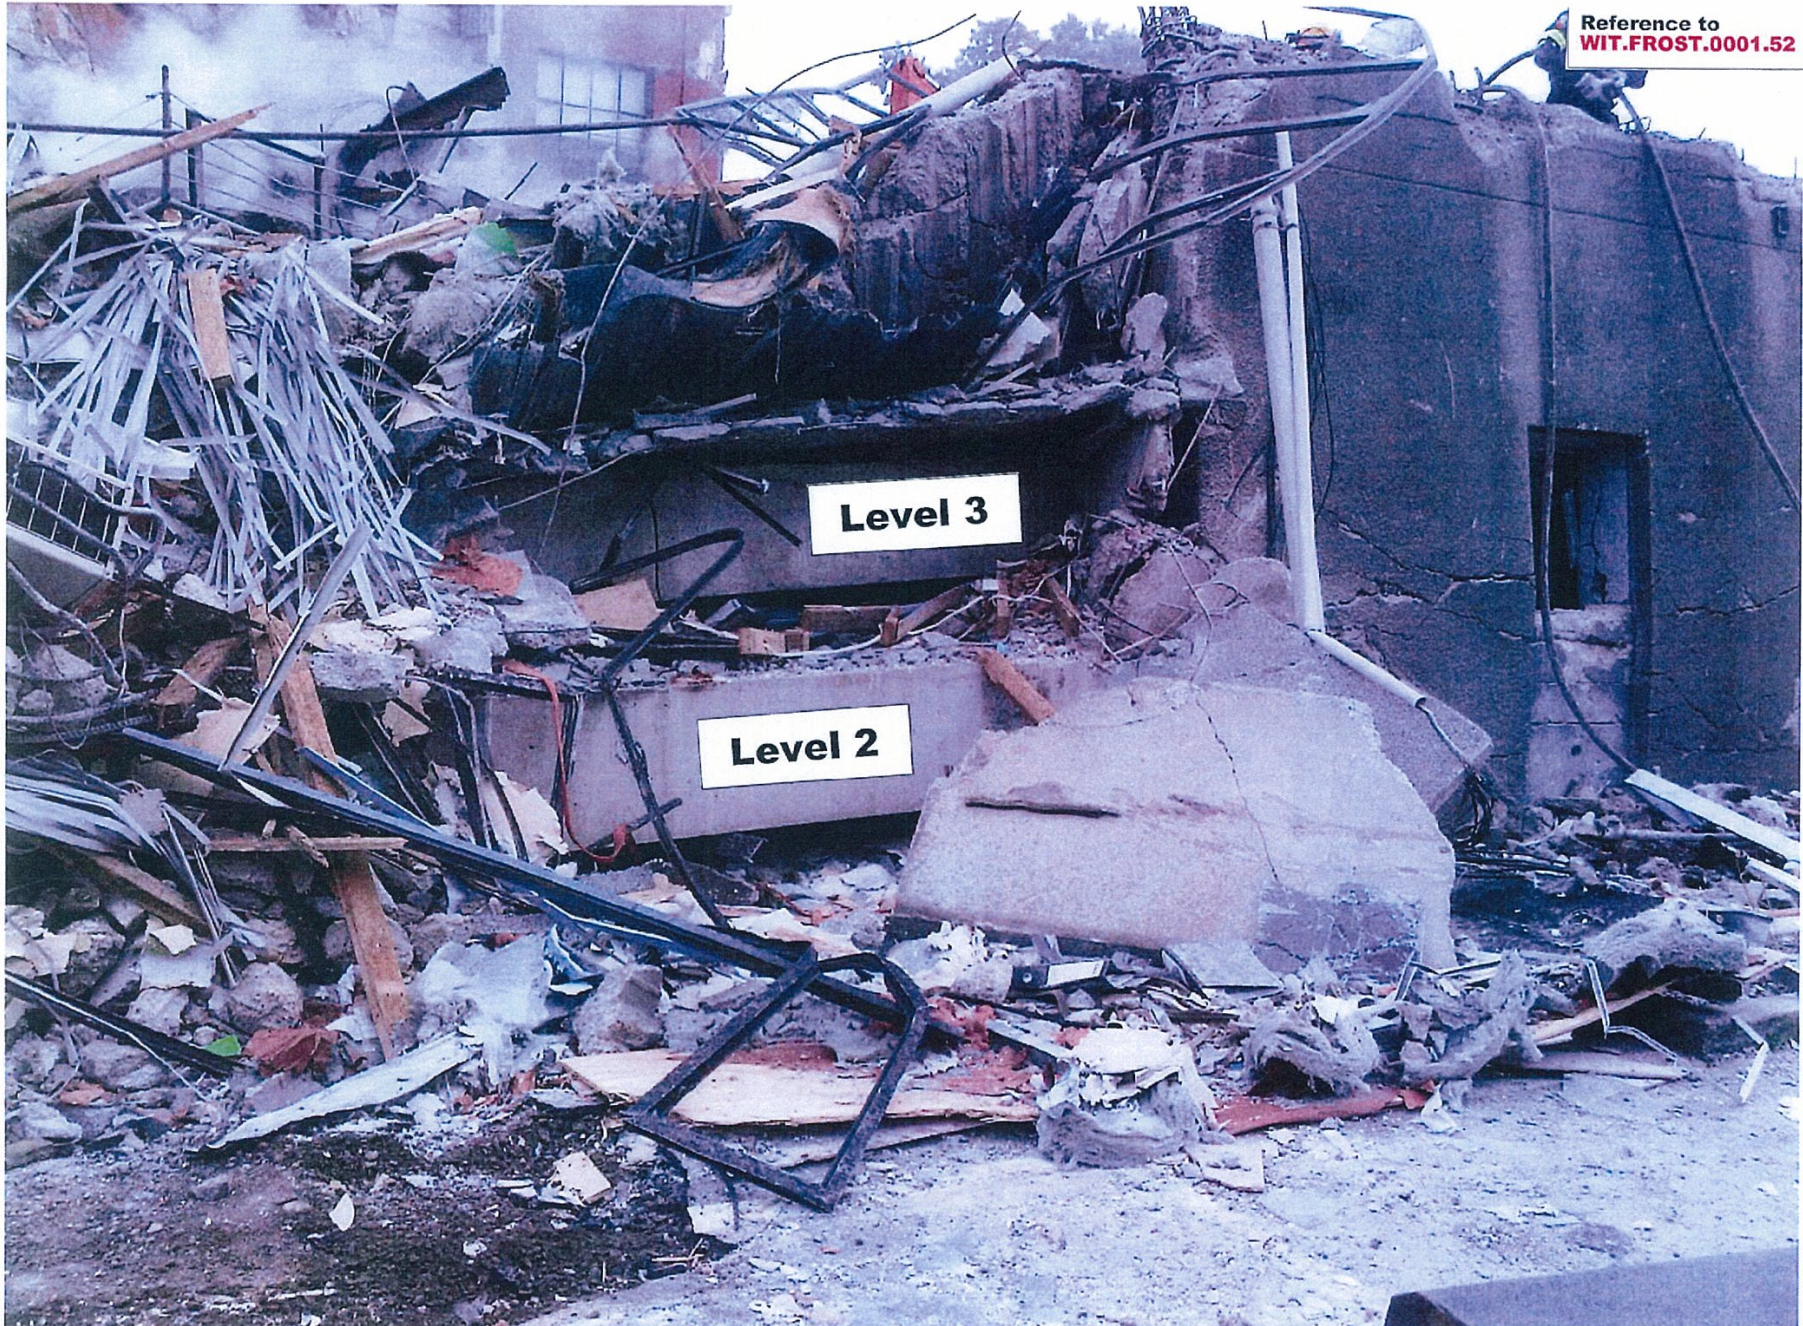
Figure 12

Southern edges of floor slabs from Levels 2 (L2), 3 (L3), 4 (L4) and 5 (L5) immediately to the east of the South Wall on Line 1 (7:20 AM 25 Feb 2011).
