#### earthquake damage report

project	Pacific Tower, 166 Gloucester Street	project no	5631
date	19 <sup>th</sup> May 2011	from	Sean Gardiner
client	Pacific Tower Body Corporate

#### 1 Scope of this Report

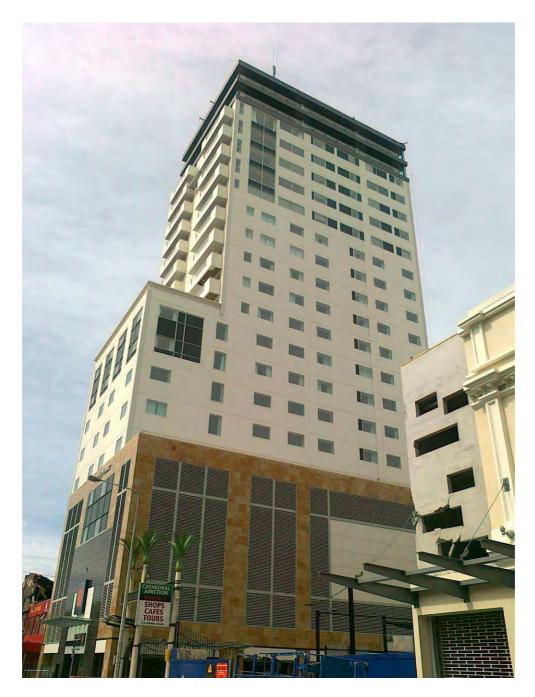
Pacific Tower 2 March 2011 (some damage to north balcony soffits visible).

- The cross-bracing in many of the car stackers has unhooked at midway along its length. These will require repair/reinstatement prior to carstacker operation. (We suggest "D" shaped shackles be used to prevent this happening again). Inspection of

the carstacker restraints at the top of the carstackers by Kiwi Sparky (electrical contractor) have identified two fractured SHS restraints and some cleat connections that have pulled out, which will require repair.

Fractured carstacker top lateral restraints

- Reinstate carstacker cross braces and top lateral restraints. Re-weld fractured restraints with FPBW, examine other restraints for signs of damage and

repair/reinforce welds as required. Replace and re-fix anchors which have pulled out of the blockwork masonry.
