**79 CAMBRIDGE TERRACE
CHRISTCHURCH**

SITE INVESTIGATION REPORT

Reference Number: 3984

Date: 29 November 2011

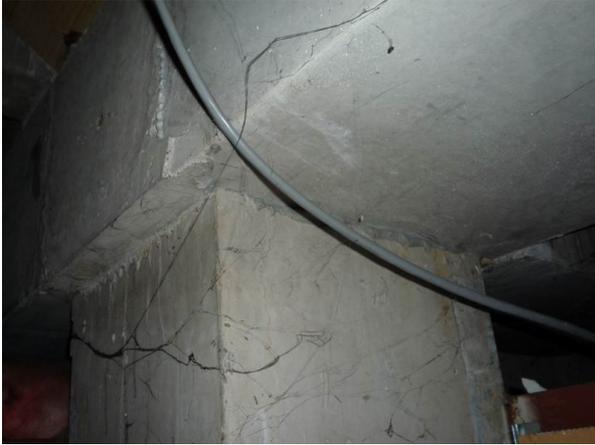
PHOTO A
Minor cracking at top of ground floor column

- Column B2 has cracked cover concrete at the top and leans 25mm to the north. There is no damage at the base of the column.
 - Column B3 is undamaged.
 - Column B4 has cracked cover concrete at the top and leans 20mm to the west. There is no damage at the base of the column.
 - Column B5 has cracked cover concrete at the top which extends into the line 5 beam above. One of the prestressed Stahlton planks has cracked at the beam.
 - Column C3 has minor cracking to cover concrete at its corners at both top and bottom.
 - Column C4 has no obvious damage.
- *See Photo A for typical cracking at top of column.*

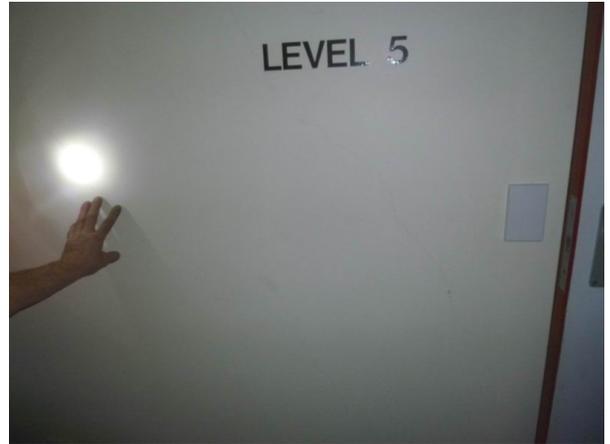
PHOTO B
Diagonal cracking in line 3 wall at level 5

The east/west shearwalls show an extensive pattern of diagonal cracking at the lower levels with cracks in each direction at about 300mm centres. There is also cracking at the upper levels, but this is more widely spaced. Where checked, the cracks run right through the walls.

Generally damage to the line 3 wall is more significant than damage to the line 4 wall.

Crack widths are difficult to estimate because of the plaster coating on the walls, but we estimate them to be up to 0.5mm at the lower levels reducing to 0.2mm near the top of the building.

- *See Photo B showing diagonal cracks in the line 3 wall.*

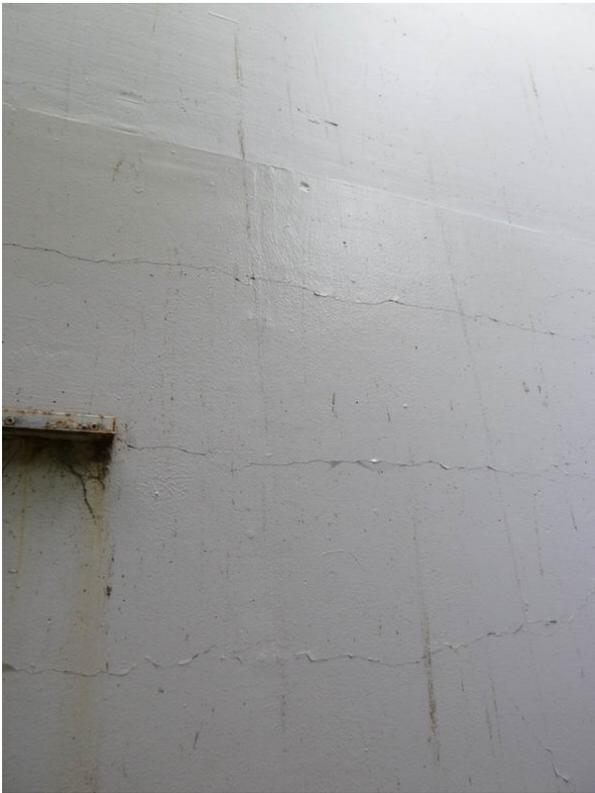
PHOTO C
Horizontal cracking in line F shearwall between ground and first floors

This is the west exterior wall of the building. From the outside, multiple horizontal cracks are visible for at least 3 levels above ground. These appear to be regularly spaced, at about 300mm centres. Because this wall is extensively lined on the inside, it wasn't possible to check whether the cracks run right through the wall. There is a minor diagonal crack visible on the inside of the wall from within a cleaner's cupboard on level 5.

- *See Photo C showing horizontal cracks from outside.*

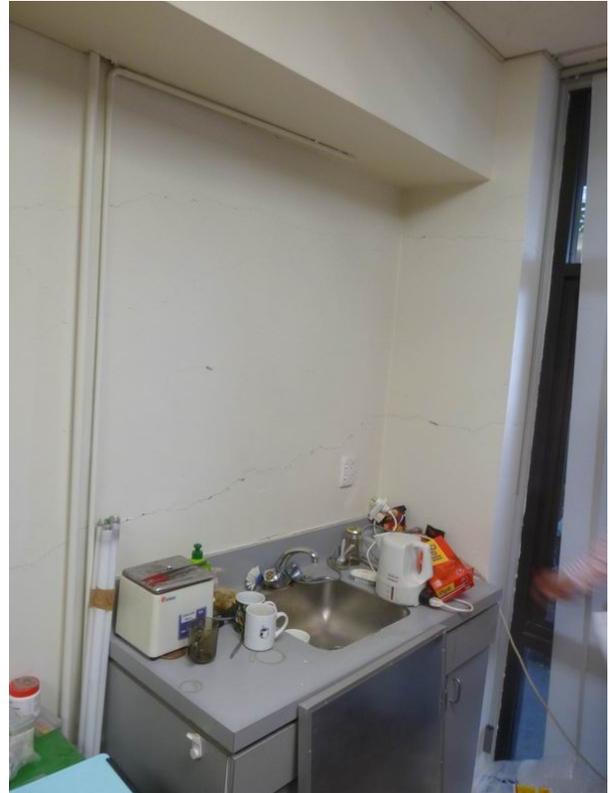
PHOTO D
Damage at junction of line 3 and F shearwalls, ground floor

At this location there is a door opening in the line F wall adjacent to line 3. There is significant horizontal cracking in the line 3 wall, which connects to the short length of line F wall to the north of the door opening. Cover concrete has spalled off the north end of the line F wall at its base.

Cracks in the line 3 wall here are horizontal rather than diagonal.

Crack widths in this location are up to 0.7mm.

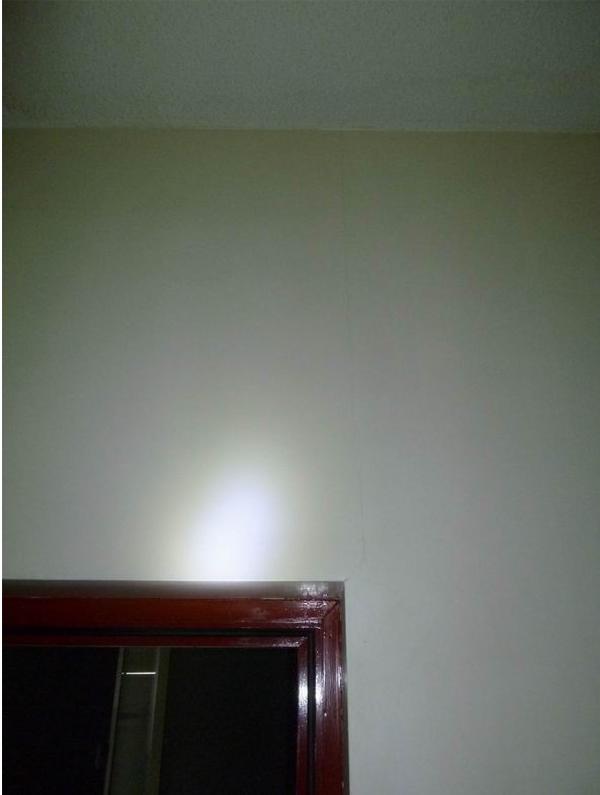
PHOTO E

No cracks were noted in the line E wall itself, but there are vertical cracks visible at the joint between the coupling beams and the main wall at most levels. These vary in width from an estimated 1.0mm at level 1 down to 0.1mm at level 6. At grid D3 on level 3 we noted diagonal cracking in the coupling beam itself as well as a vertical crack at the beam to wall junction.

- *Refer Photo E showing a typical vertical crack.*

Vertical crack between precast coupling beam and main shearwall on line F

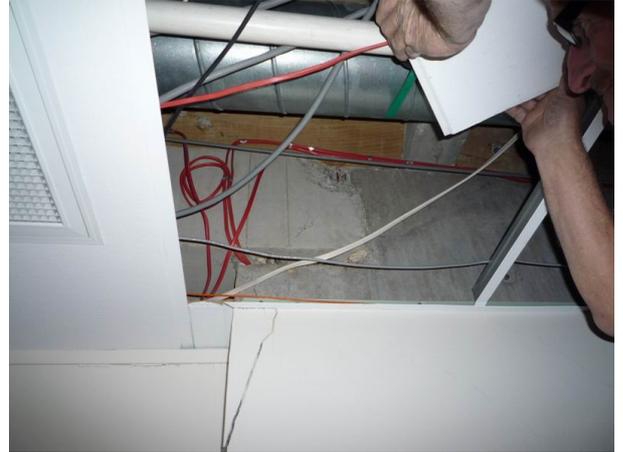
PHOTO F

- At 3D/E there is moderate damage to the beam to shearwall junction with some spalling of the end of the shearwall. There are hairline vertical cracks in the beam itself.
- At 4D/E there is cracking in both the beam and the column, but no spalling.

Damage to top of column and beam above at junction of line 3 beam and end of line 3 shearwall, at level 2 floor

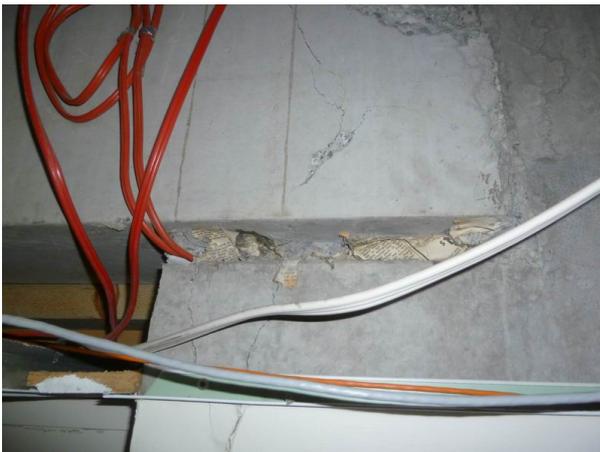
PHOTO G

Close-up of damage to beam in Photo F

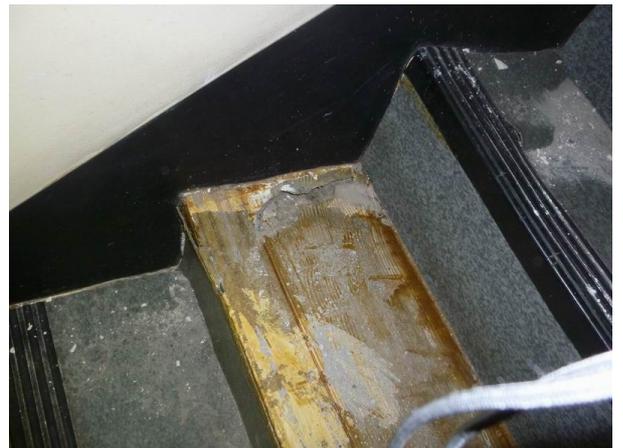
PHOTO H

Several stair flights have bowed downwards, with the maximum bow estimated at 20mm. Where the “Whisper” soffit lining has been removed from beneath 2 stair flights, cracks are visible in the stair soffits. The cracks run across the stair flights.

Bowed down stair unit

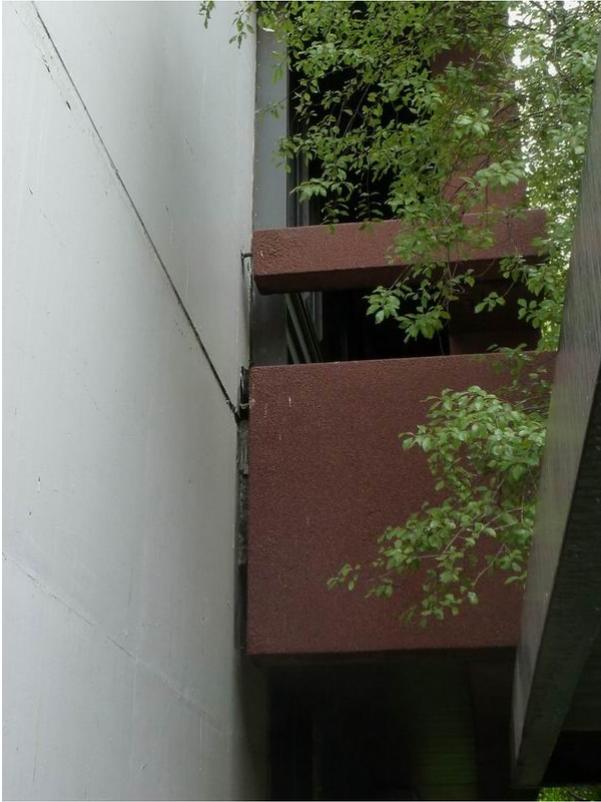
PHOTO I

**Separation of precast cladding panels
from line F shearwall, at first floor level**
