Section 5: Post-collapse investigations

5.1 Post-collapse examinations of building debris

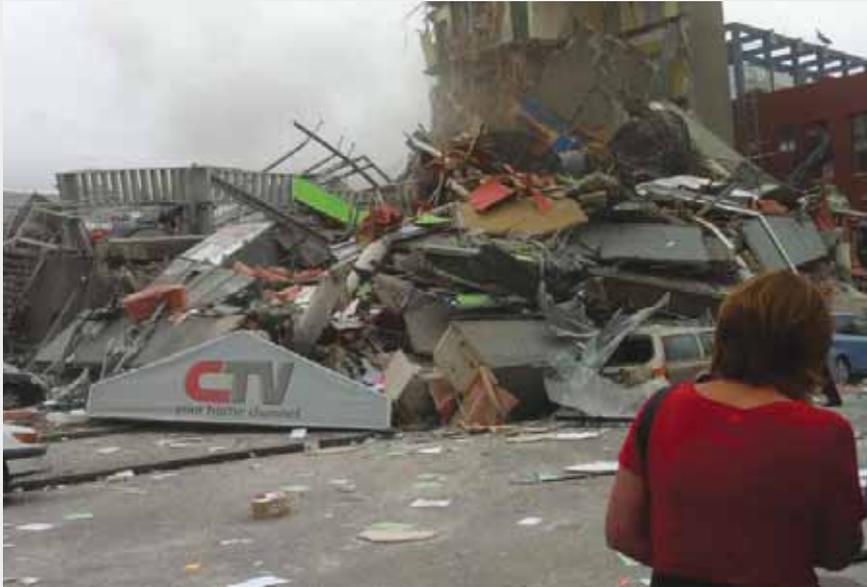
Mr Trowsdale arrived at the site at around 7.30pm on 22 February. Mr Frost arrived on the evening of 23 February, about 30 hours after the building collapsed. The original structural form was not clearly discernible to him (see Figure 58(a)), however he identified the main seismic resisting elements as the wall complex to the north which was still standing and the south shear wall at the southern end of the site.

(a) Immediately following collapse (source: Graham Frost)

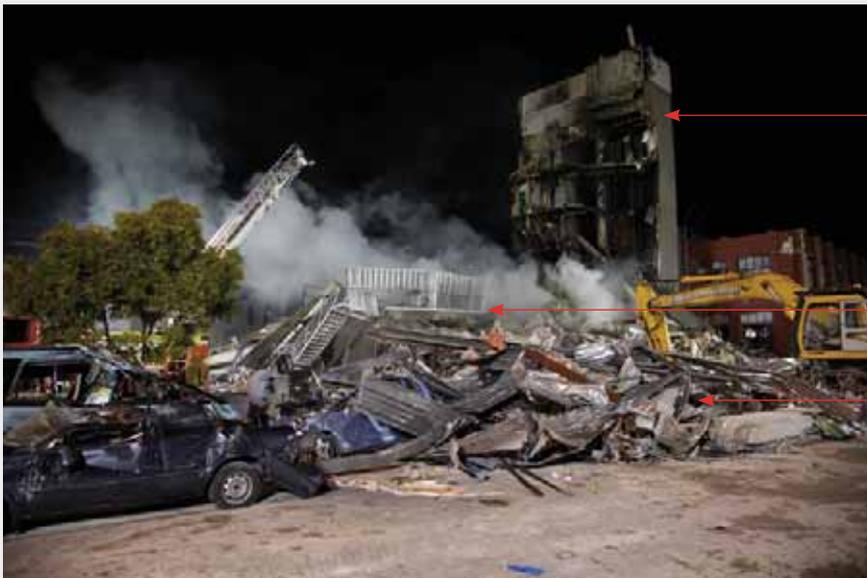
Dr Heywood started working on the CTV building site at 4:00am on 24 February 2011. Figure 58(b) is a photograph of the building taken by him at this time. Substantial quantities of material, particularly on the eastern side, had been shifted or removed before Dr Heywood's arrival. This consisted of the spandrels and edge beams that spilled out on to the cars parked on Madras Street, as shown in Figure 58(a). Dr Heywood explained that the building had fallen mainly within its own footprint and only the north wall complex remained standing. Remnants of floor slabs leant against the north wall complex and the south shear wall had fallen inwards on top of the debris. The external steel staircase attached to the side of the south shear wall can be used to identify its location in the debris (see Figure 58(b)). The south shear wall lay horizontally with the top section sloping down relative to the rest of the wall.

(b) North wall complex and collapsed south shear wall with relocated material in the foreground at 4am on 24 February 2011 (source: Robert Heywood)

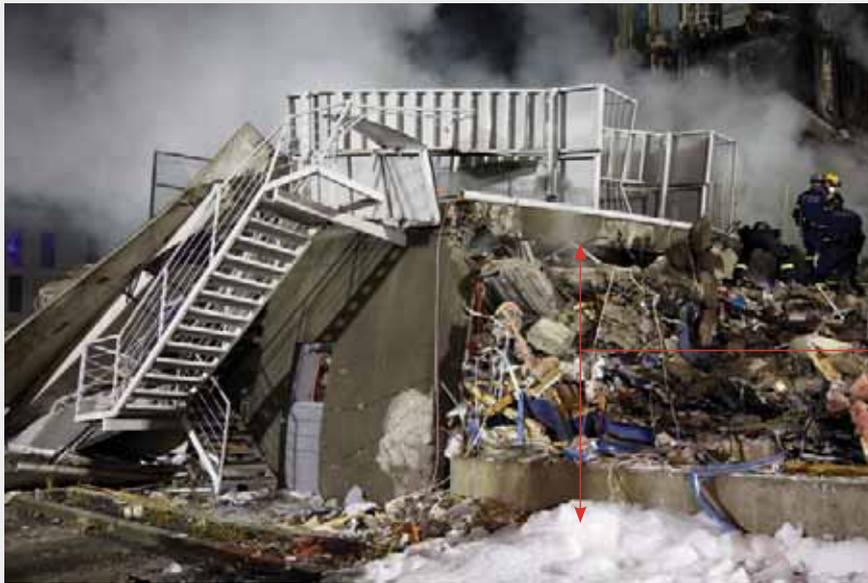
There was little debris south of the base of the south shear wall. This indicated that the southern half of the building had collapsed vertically with little horizontal displacement. All six levels had compressed into a pile of rubble approximately 3.7 metres high, as shown in Figure 59(a), which was equivalent to the height of level 1 prior to the earthquake. Figure 59(b) identifies some edge beams that detached from the south shear wall. Dr Heywood explained that not all edge beams detached, with some edge beams from

Figure 59(a): South shear wall bent over at the height of level 1 with all floors slabs compacted beneath (source: Graham Frost)

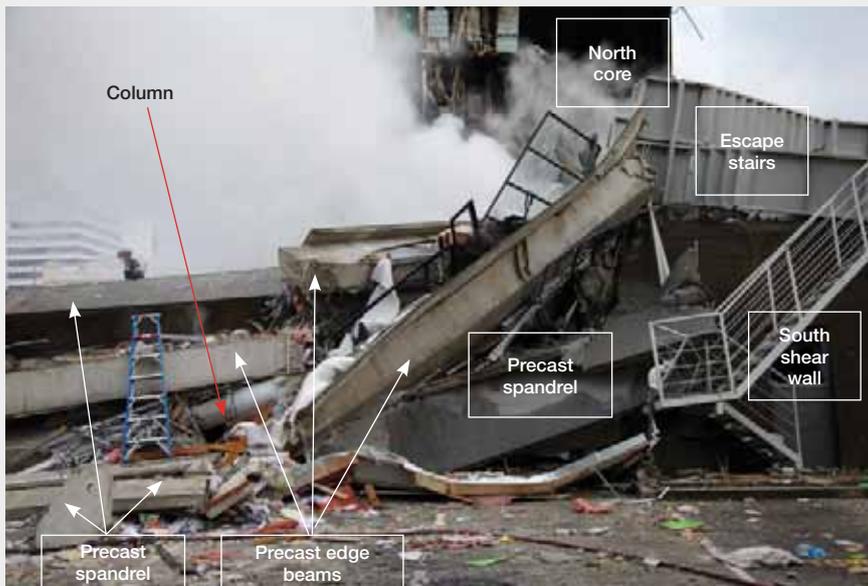
Figure 59(b): Spandrel panels and edge beams to the west of the south shear wall (source: Robert Heywood)

building, had been substantially altered before he arrived. The circular columns on the eastern side had been removed before he arrived, although he saw and photographed segments of the circular column C2 (see Figure 59(b)).

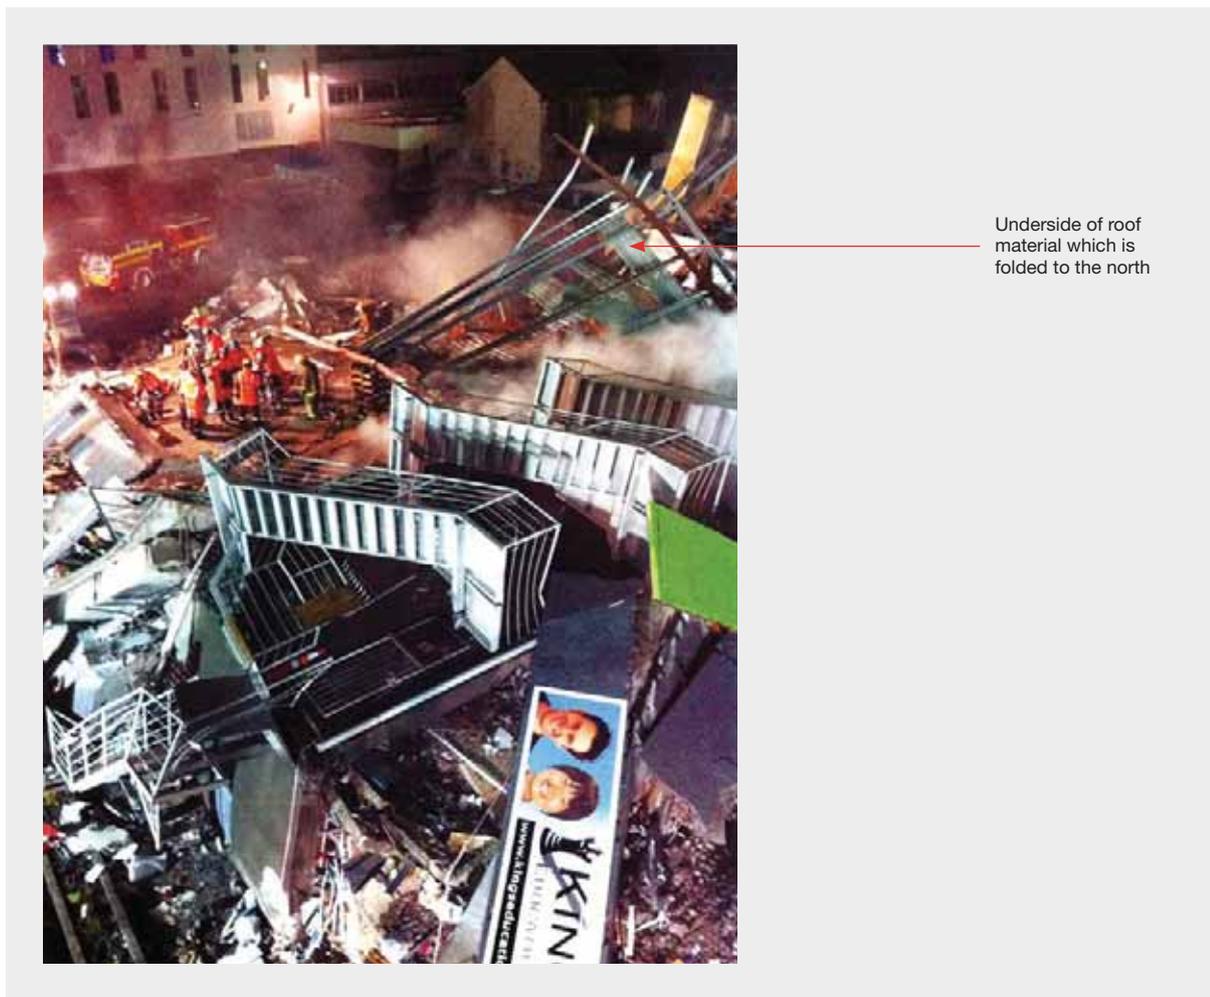
Figure 59(c): View of debris from a New Zealand Fire Service snorkel basket (source: John Trowsdale)

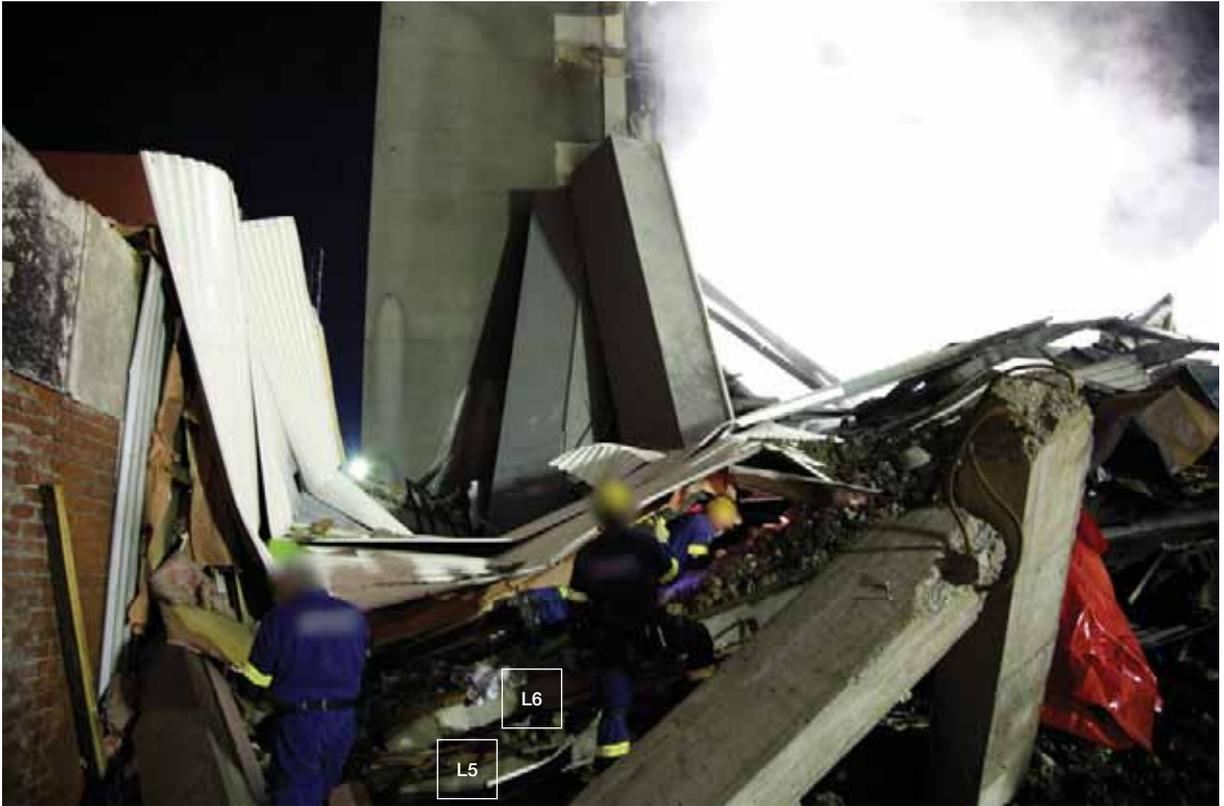
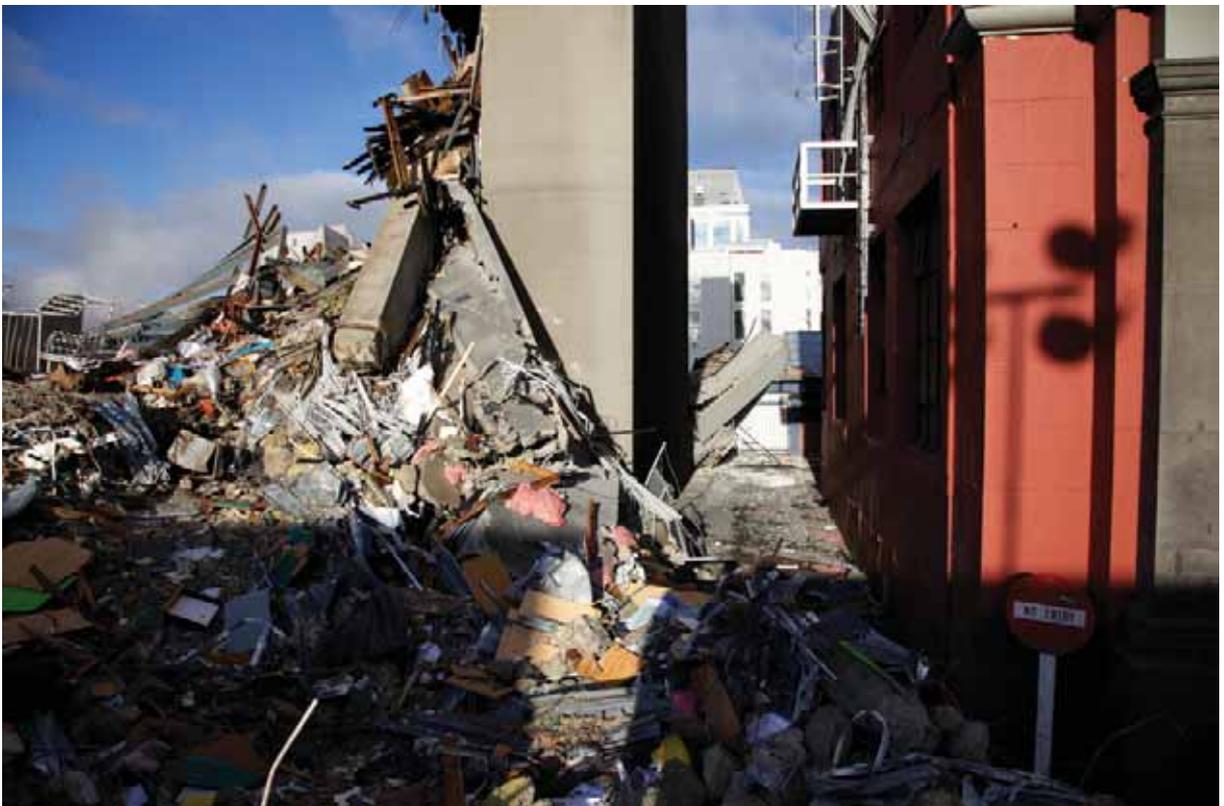
Figure 60: Debris located north of north wall complex

Mr Frost said that some slabs and beams in the northern half of the building had moved several metres to the north relative to their original position. The debris to the north-east and north-west of the north wall complex had spilled out northwards, as shown in Figure 60(a) and (b). He stated that the slabs, beams and spandrel panels in the northern half of the building had been thrown northwards due to a “pendulum effect”. He considered this was caused by a combination of support being lost near the centre of the building and the building elements remaining attached to the north wall complex. As the building elements swung down they detached and were thrown northwards.

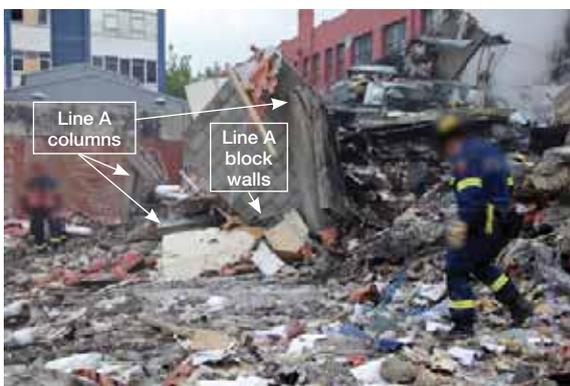
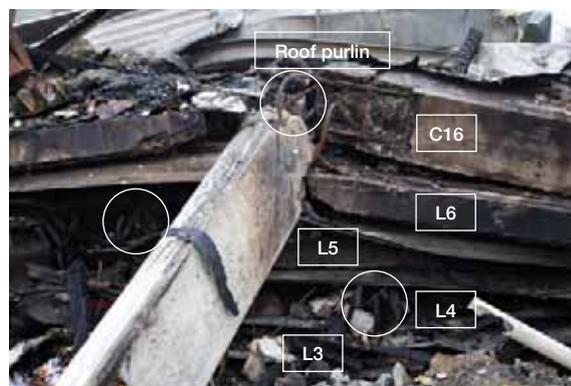
Figure 61: Western elevation of building

Dr Heywood described debris on the western side of the building being more defined than other sides (see Figure 61(b)). Most floor slabs lay with their ends vertically above each other, although not all slabs fell directly on top of each other. Most of the block wall had been removed before Dr Heywood arrived at the site with only a single section partially upright, as can be seen in Figure 61(a). The ends of the internal floor beams are circled in Figure 61(b). These are approximately in a vertical plane but have some relative displacement in the north-south direction. The 90° bent bars protruding from the beam ends have pulled out of the rectangular columns.

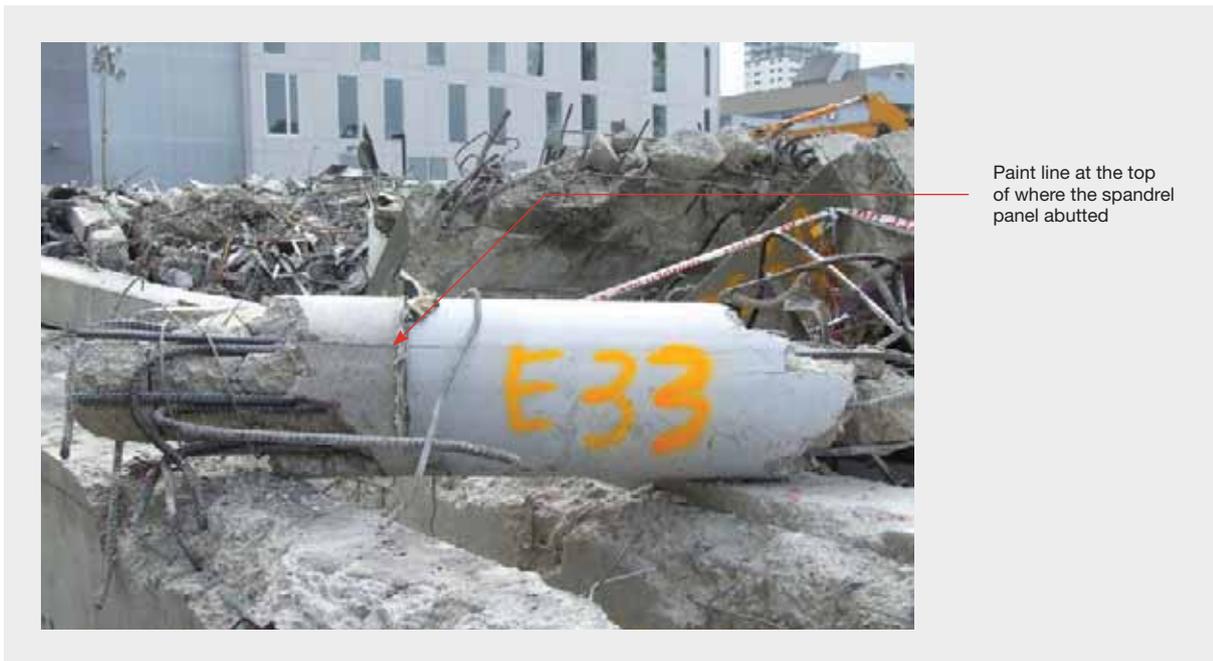
Mr Frost gave evidence that the only real damage that he saw to columns was at their ends. The central sections of the columns he saw were largely intact. Figure 62(b) shows where a precast spandrel panel adjoined a column. The unpainted area on the left of the column was covered by the spandrel panel. There was no damage to this column at the level adjacent to the top of the spandrel and Mr Frost saw no evidence of column hinging caused by spandrel panel interaction. Figure 62(c) shows the vertical and spiral reinforcement within a typical column.

Figure 62(b): Exterior column (source: Graham Frost)

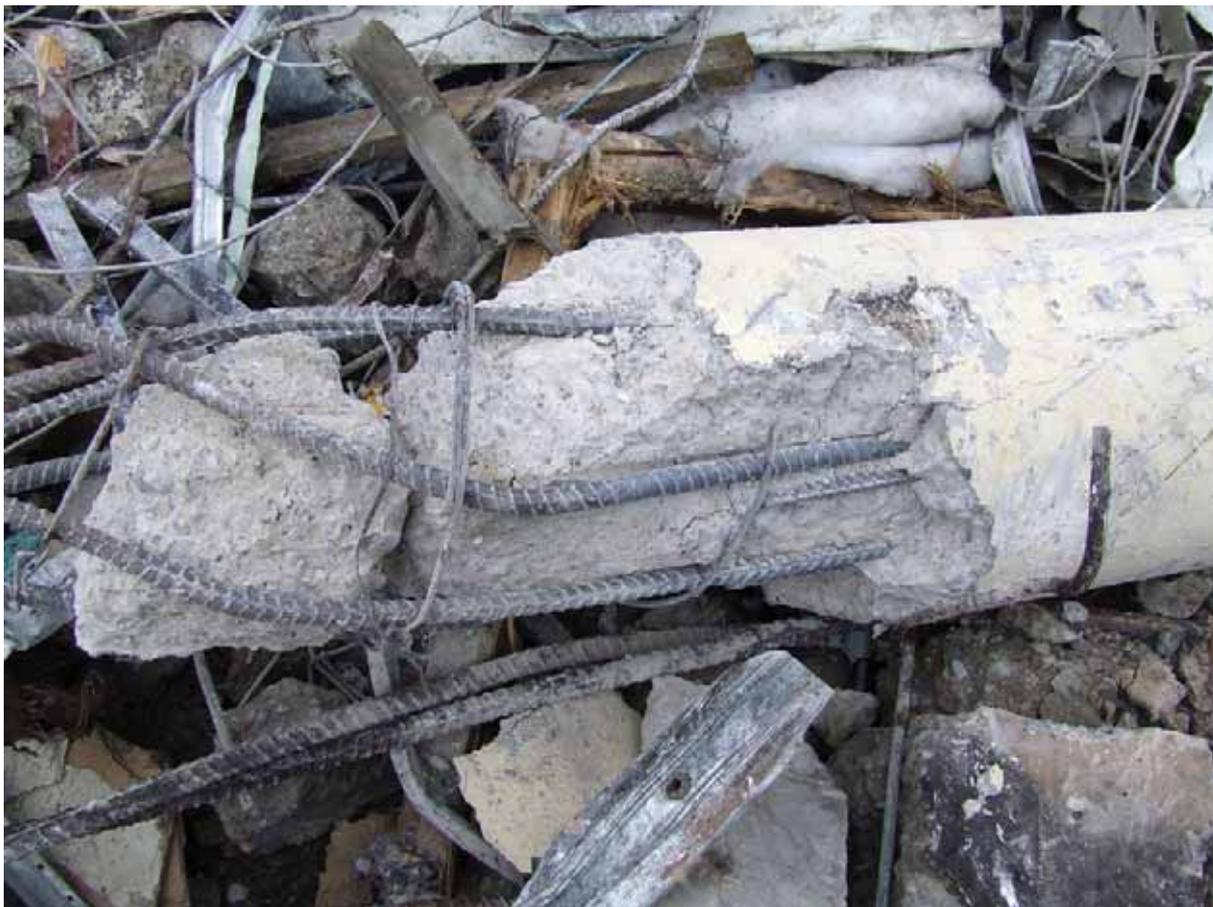
Figure 62(c): Column of unknown location showing vertical reinforcing bars and spiral transverse reinforcement. Concrete has spalled off from outside the reinforcement and fractured inside (source: Graham Frost)

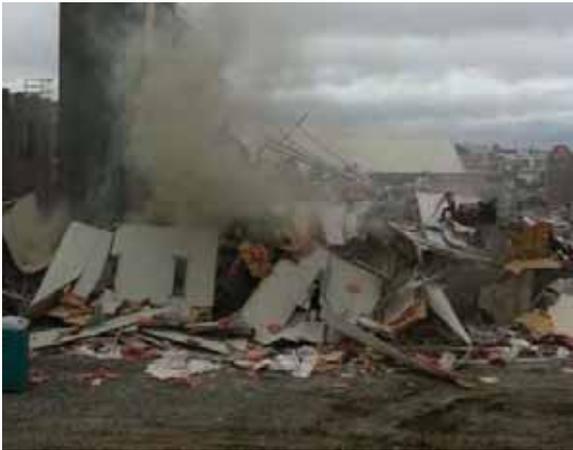
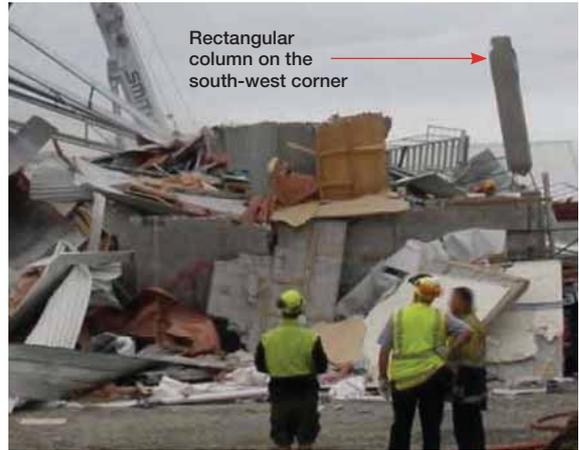
Dr Heywood referred to photographs from the Hyland/Smith report (see Figures 62(d) and (e)) which show the column on the south-west corner visible. A part of column C4 (about one storey in length) (see the column location diagram in Figure 62(a)) remained vertical after the collapse although concrete was missing at its base. The rectangular columns on the western elevation were detached from the building as continuous lengths but the concrete in the vicinity of the beam-column joints had been lost. The segments of columns between the floors appeared to be sound with the segments connected by the column reinforcement.

Figures 62(d) and (e): The western elevation with the column on the south-west corner visible (source: Hyland/Smith¹ report)

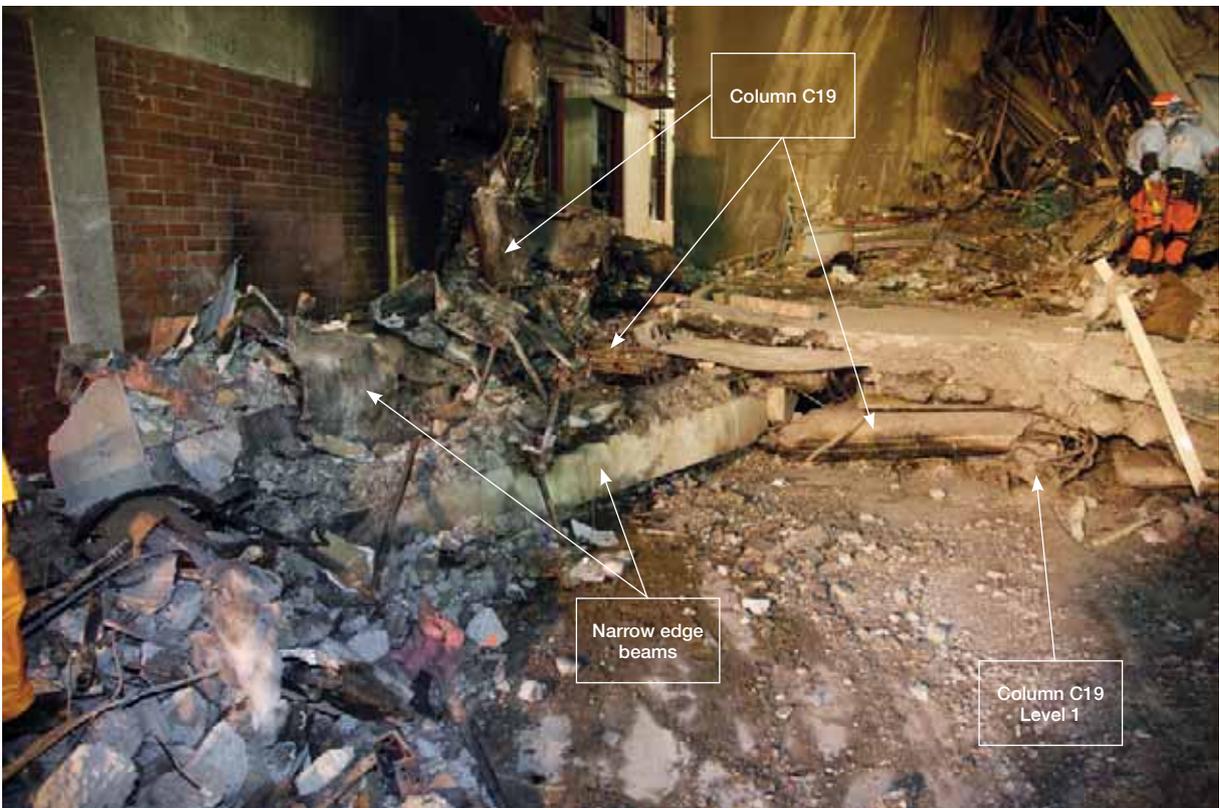
Dr Heywood said that column C19 (see Figure 62(a)) collapsed against the brick wall of the adjacent undercover car park (see Figure 62(f)). He said that this column appeared to have moved with the collapsing edge beams. The ends of the edge beams attached

Figure 62(f): View of the north-west corner looking towards the north wall complex (source: Robert Heywood)

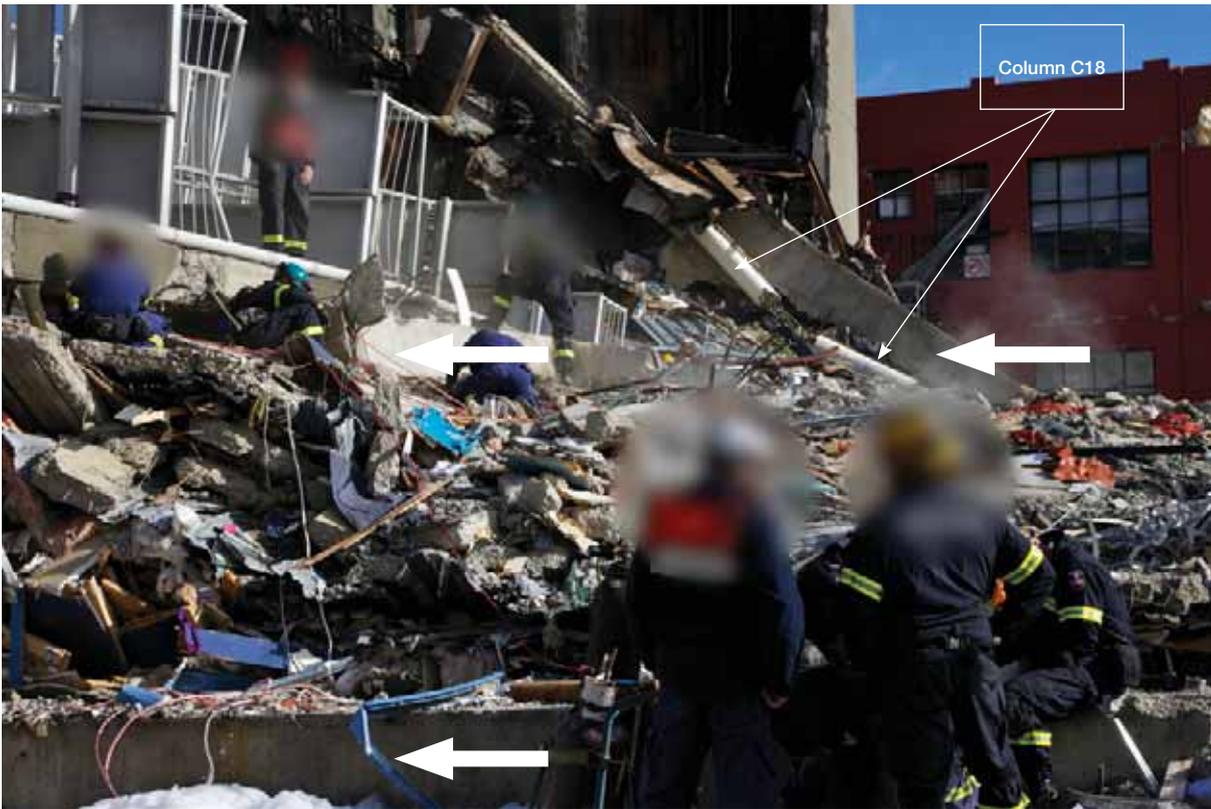
to C19 came to rest near the base of the north wall complex at one end and on top of the roof of an adjacent building at the other end. He also described two storey-long segments of column C18 which remained intact and joined by column reinforcement (see Figure 62(g)). Column C18 was unique since it connected to the top of the north wall complex. This meant it could continue to support some loads even if the columns below it had gone.

Figure 62(g): View towards the north wall complex from the south-east showing two storey-long segments of column C18 (source: Robert Heywood)

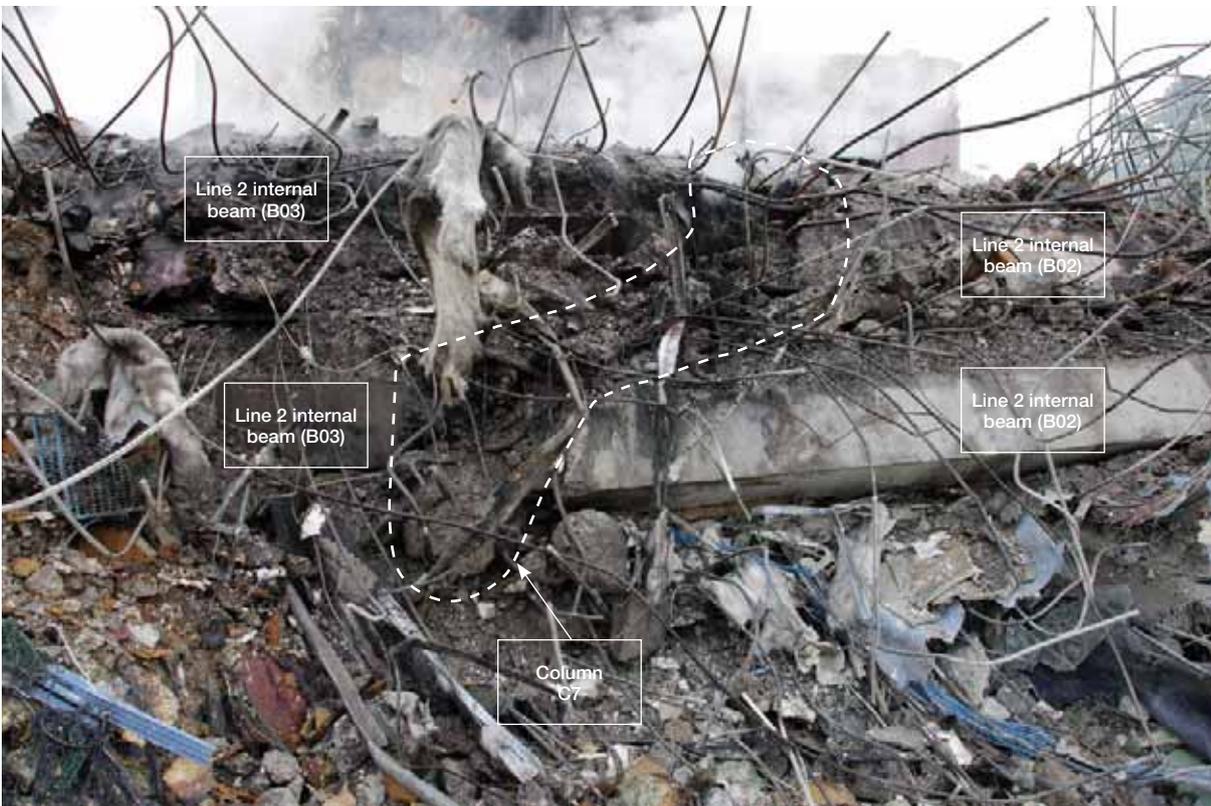
Dr Heywood said that a number of interior columns above level 6 remained intact, with some maintaining their connection with the level 6 floor slab and interior beams. However, below level 6 his overall impression was that interior columns were largely reduced to reinforcement and rubble with the occasional short length of column (see Figure 62(h)).

Figure 62(h): The junction between line 2 and column C7 looking north towards the north wall complex. The remains of column C7 are in the centre (source: Robert Heywood)

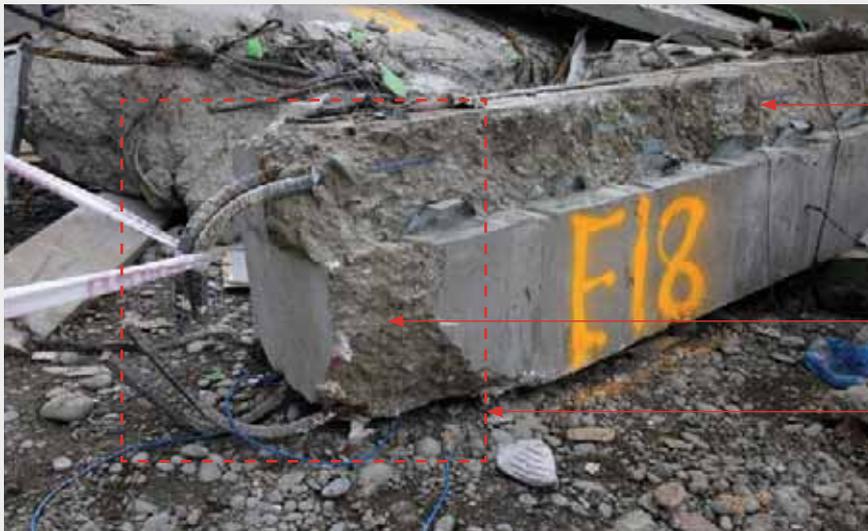
The beams were largely intact with the damage typically at the ends and on the top where the floor slab had detached. Most of the beams Mr Frost saw had the end corners broken off with little damage along the beam length, as shown in Figure 63(a).

Figure 63(a): Edge beam from line 4 between lines A and B (source: Robert Heywood)

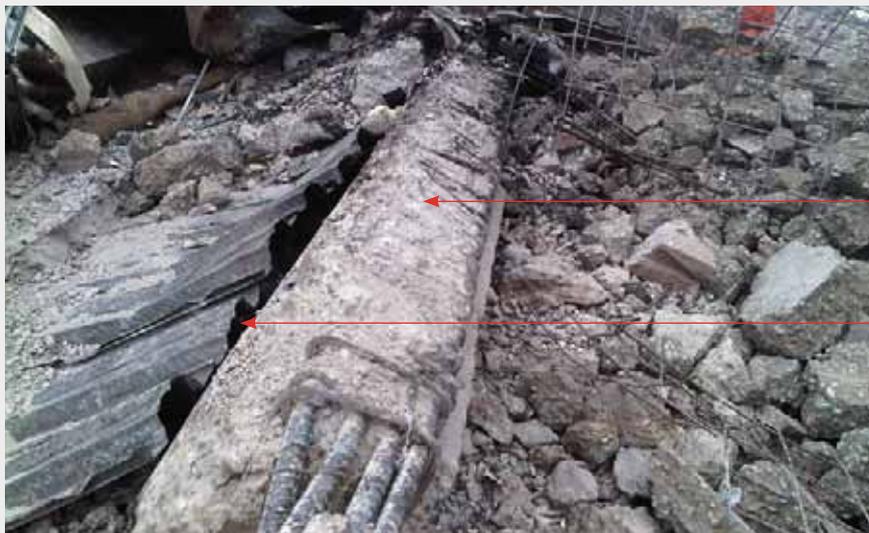
Mr Frost said that no interior beams were found with the concrete slabs still attached, as illustrated by Figure 63(b). The internal beam to floor connection is illustrated by the structural drawing section in Figure 63(c). The steel Hi-Bond flooring is discontinuous at the beams with a 60mm seating and the slab mesh passes over the top of the beam stirrups and longitudinal reinforcement. Dr Heywood indicated in red where the failure surface was typically observed. He also observed that all connections between the edge beams and floor slabs were severed. In every case the mesh and supplementary H12 reinforcement was torn from the top surface of the beam. The structural drawings specified that slab reinforcing should be placed above the beam steel. Mr Frost's opinion was that this detailing provided poor connectivity. He would have placed some slab reinforcing underneath the top longitudinal steel to increase the connectivity between the beam and the slab.

Figure 63(b): Interior beam from the western side of the building (source: Graham Frost)

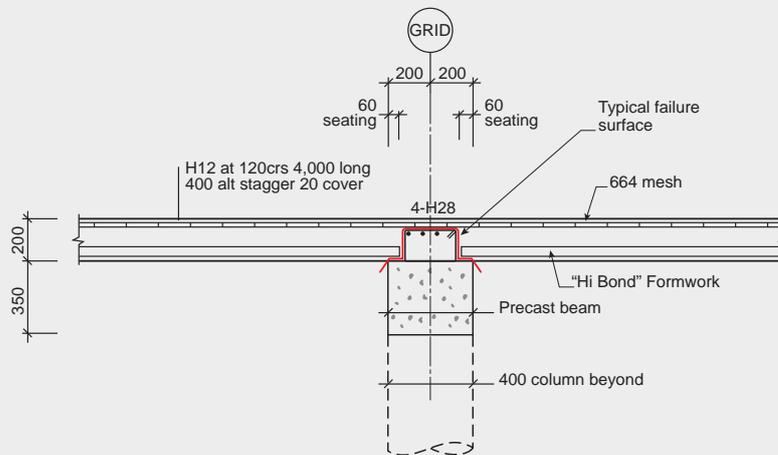
Figure 63(c): Section through precast internal beam to slab with typical observed failure surface indicated in red

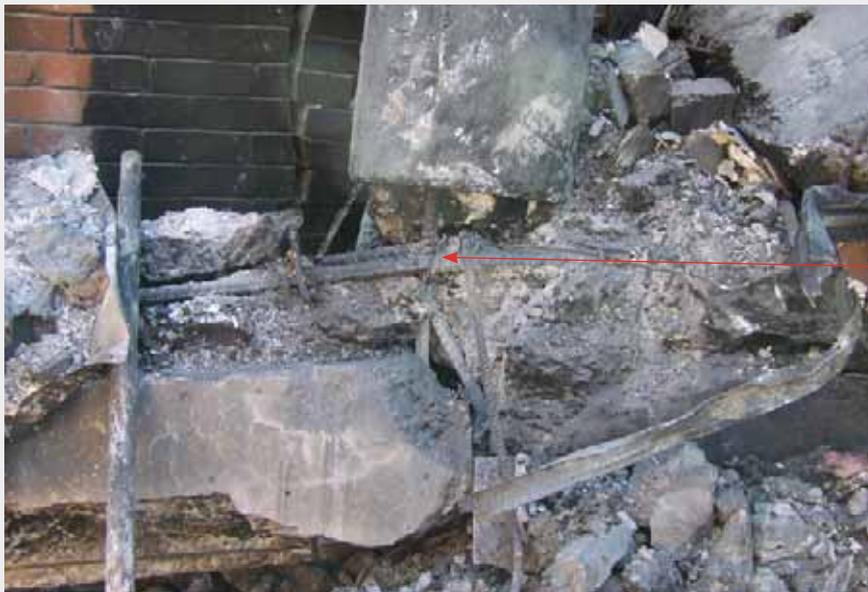
Neither Mr Trowsdale nor Mr Frost saw any beam-column joints intact. Mr Frost stated that the joint regions had fallen apart as there was no steel to confine the concrete, as illustrated in Figure 64(a). Dr Heywood did not observe any interior beam-column joint where the concrete in the joint had not been lost or rendered ineffective, other than at level 6 where the columns supported the roof. The precast beam in Figure 64(b) has pulled away from the beam-column joint and is lying on its side. The photograph illustrates the smooth formed circular surface and broken off corners (or “wings”) that were a common observation with these beams.

Figure 64(a): Disintegrated beam-column joint (source: Graham Frost)

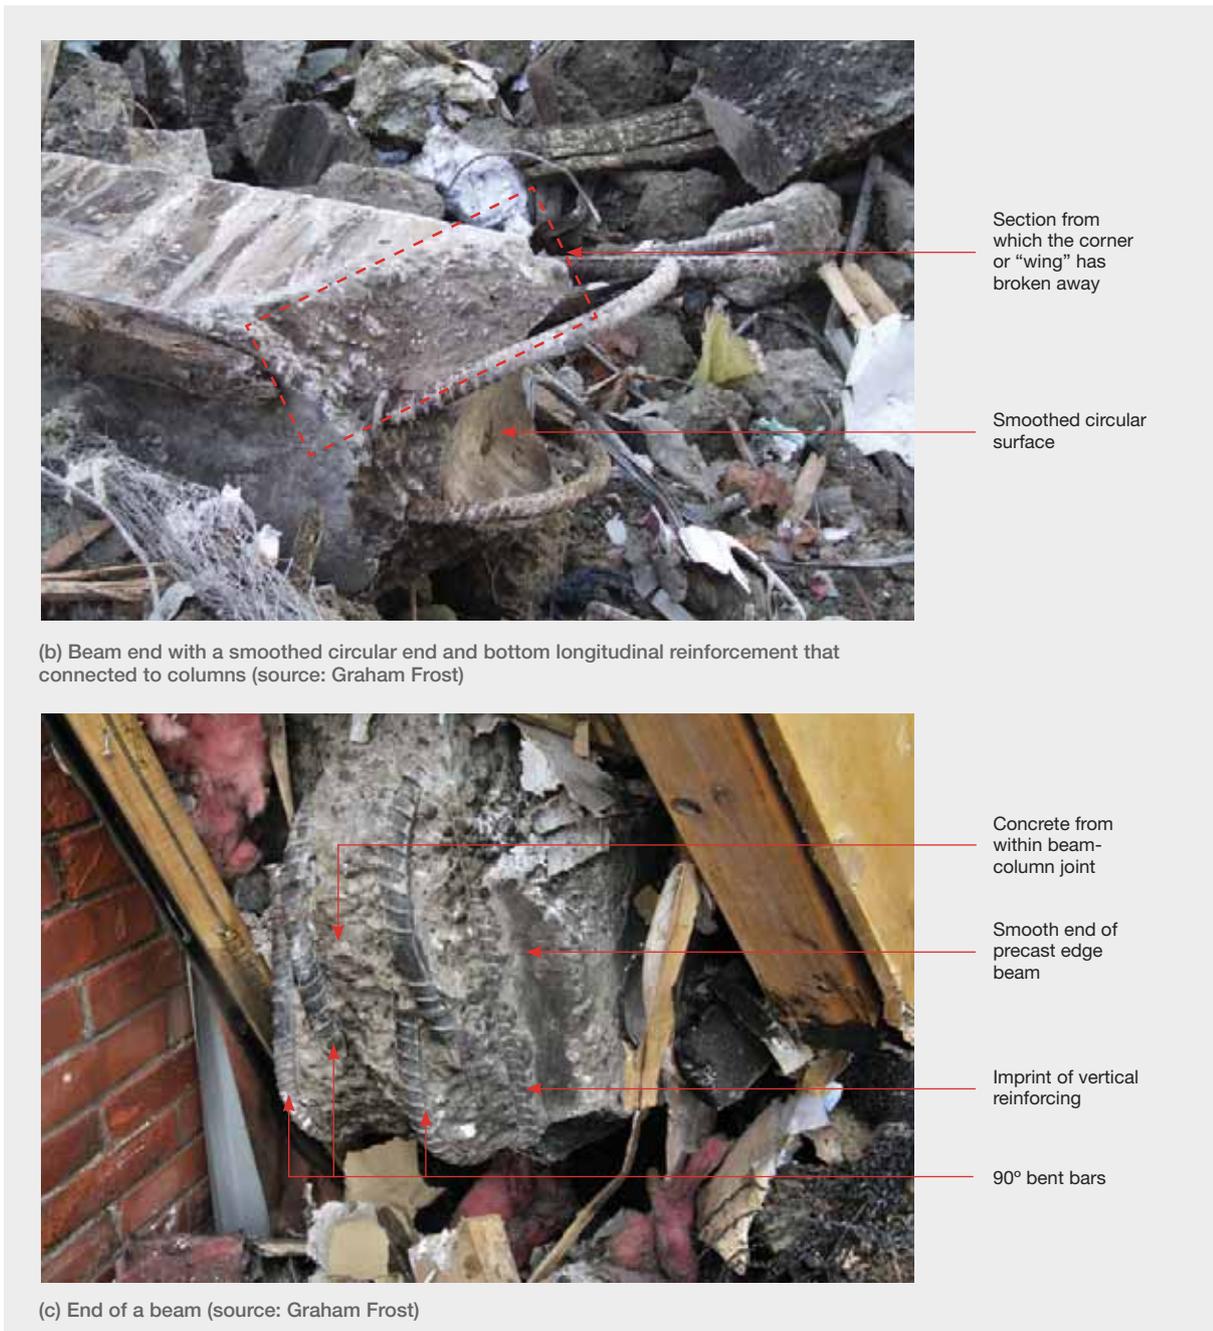
Figure 64: Beam-column joint details

When examining the remnants of the CTV building at the Burwood landfill on 28 June 2012, Dr Heywood observed a number of internal and edge beams in the rubble. All of the “wings” at the end of these beams had broken away. These wings acted as a mould for the column concrete which was cast in situ (see Figures 64(b) and 65). The semi-circular surface at the beam ends had no surface roughening and there was no evidence of any substantial bond between the beam and column concrete.

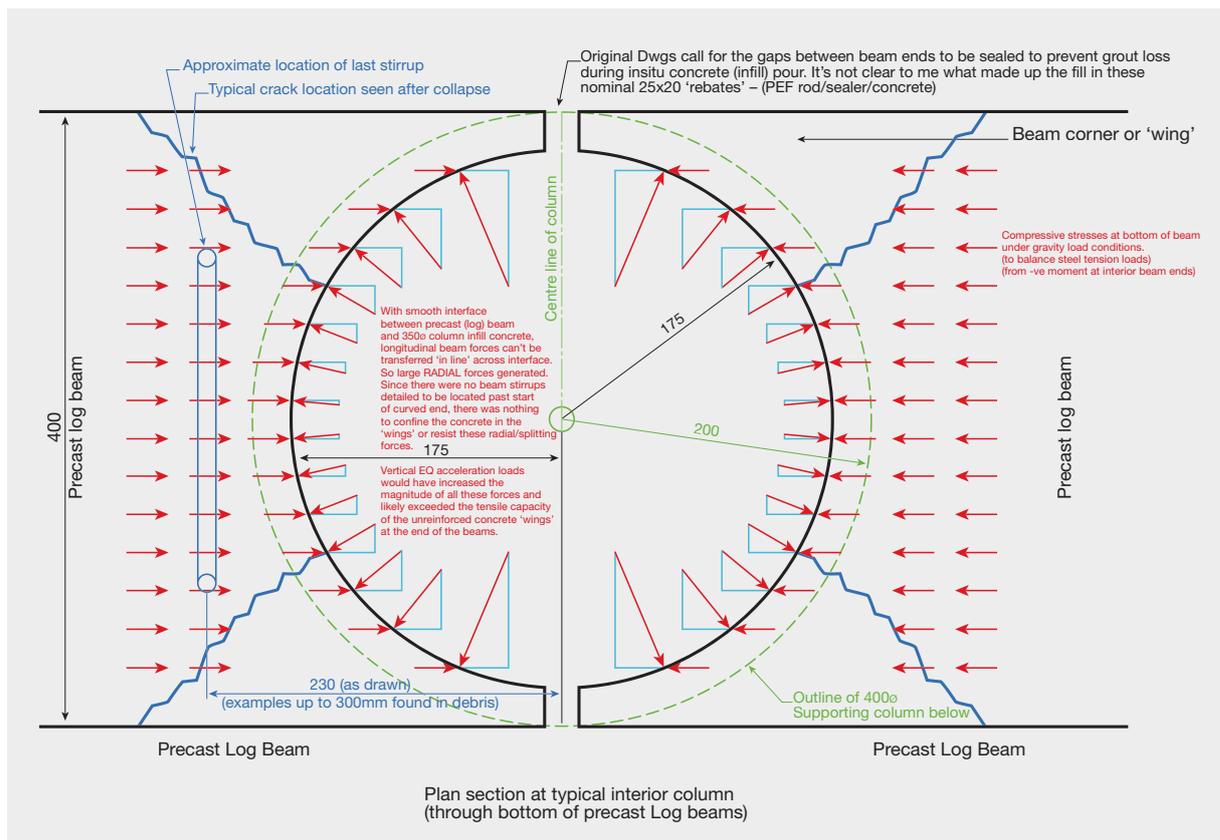
Figure 65 is a diagram of the interior beam-column joint prepared by Mr Frost. This diagram illustrates the forces that could lead to the beam wings breaking off. The red arrows indicate the direction of the compression forces

from gravity loading at the bottom of the beam. The very smooth interface between the beam and column means that forces cannot be effectively transferred straight across the joint. This, together with the curved surface, generates radial forces from the column which tend to split the beam wing sections off. Since there is no reinforcing acting to confine these wings, a crack may develop as illustrated in Figure 65. Mr Frost thought it was a very strong possibility that a pulse from vertical acceleration created a force sufficient to break the wings off. He stated that, after these wings were lost, the joint would have little capacity left. The gravity and seismic shear loads on the beams would then have to be transferred through the slab, dowel action and the much reduced bearing area at the bottom of the beam. Mr Frost considered that this bearing area was a vulnerable region at the top of the column. The beam sat on the cover concrete of the column which would spall and fall away when the column was exposed to high drifts.

Figure 65: Plan view of beam-column joint prepared by Graham Frost

These observations led Mr Frost to conclude that a possible building failure mechanism was the failure of one or more beam-column joints due to a lack of confining steel in the beam ends and beam-column joints, exacerbated by the transfer of beam

compression stresses across smooth formed surfaces that were not perpendicular to the line of action of those forces.
