# Section 6:

## Technical discussions on structure

### 6.1 Design earthquake loading and analysis of the CTV building

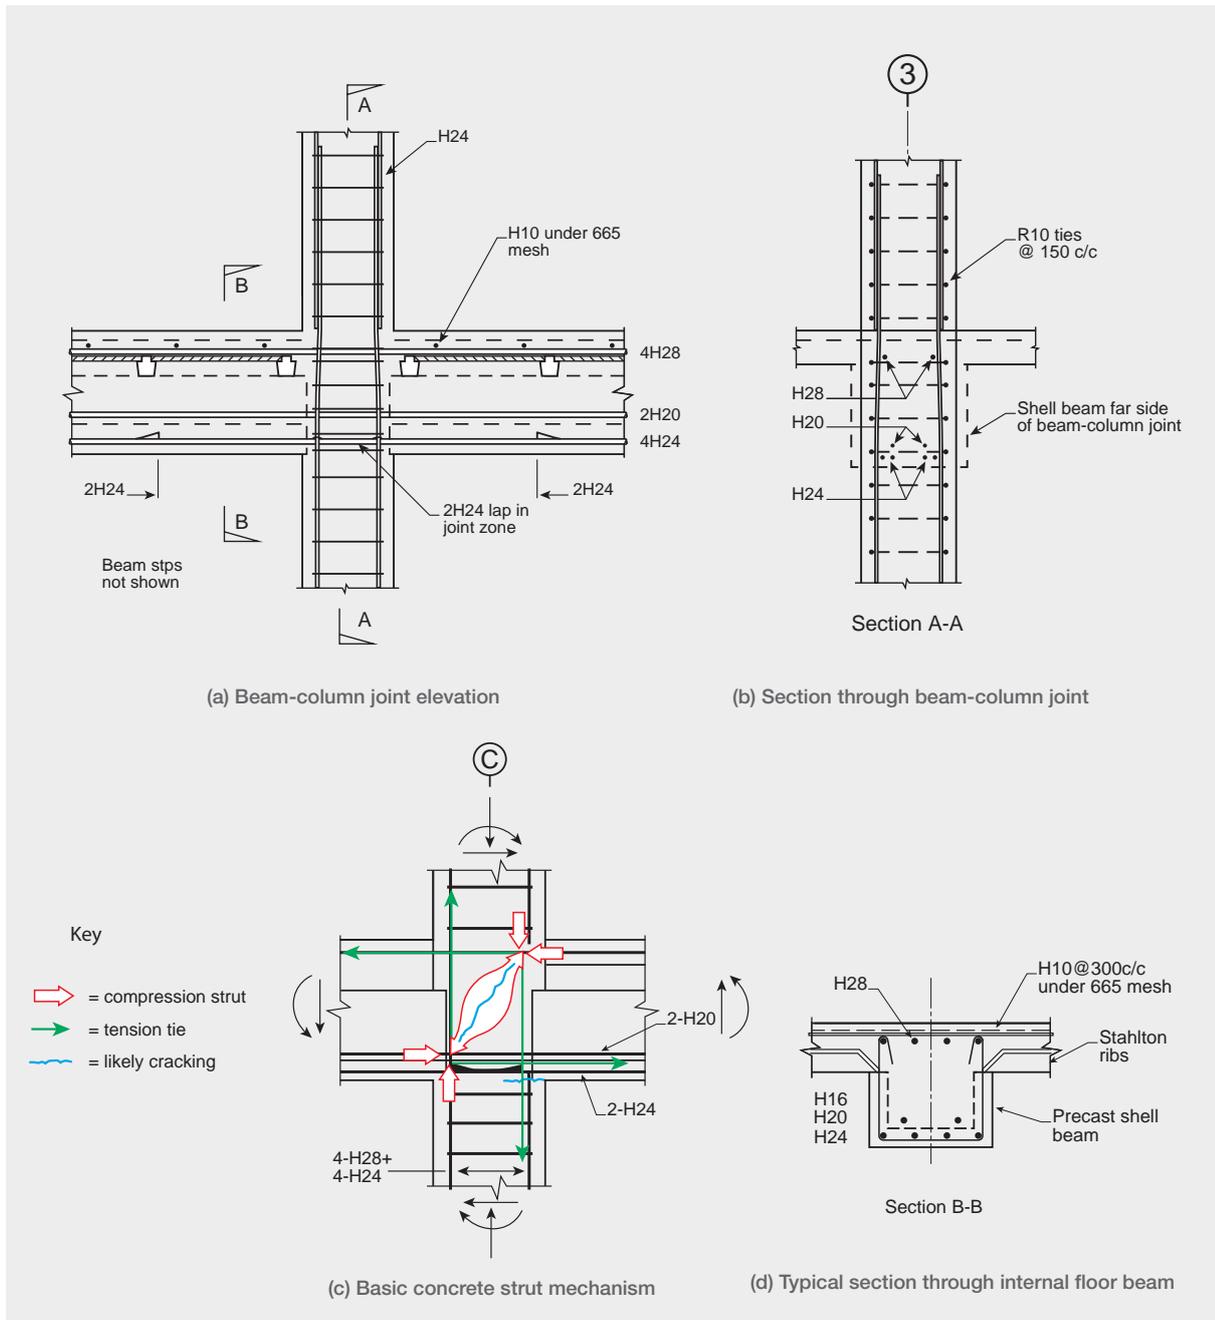
Figure 74: Beam-column joint detailing

The columns for the CTV building were reinforced with a 6mm diameter spiral at a 250mm pitch. The structural drawings show this spiral going through the beam-column joints. However evidence given at the hearing by Mr Graham Frost and Dr Robert Heywood suggests that no spiral reinforcement was installed in the joint zones. The CTV building typically had two 28mm bottom bars bent up and anchored in the middle of the connection zone with effectively no beam-column joint zone shear reinforcement. In comparison, the Landsborough House joint detailing would give better performance in an earthquake. The CTV joints would quickly degrade in strength with the hooked bottom bars vulnerable to pull out as described in section 6.3. The basic mechanism of shear transfer in the Landsborough House beam-column joints is shown in Figure 74(c). The shear forces lead to diagonal compression and tension stresses in the joint core, with the latter giving diagonal cracking. To prevent shear failure by diagonal tension under cyclic loading, usually along a potential corner-to-corner failure plane, both horizontal and vertical shear reinforcement is required. In Landsborough House the continuous beam bars allowed a diagonal compression strut to be mobilised across the full width of the joints. The progressive cracking along with some slip of the beam bars would have led to a loss in joint strength if there was significant cyclic inelastic demand placed on the beam or column reinforcement. However, the high stiffness of the shear core in Landsborough House protected the beam-column joints from this inelastic deformation. In contrast to this, the CTV joint zones were sensitive to strength degradation in situations where the bottom bars were subjected to tension. In this situation, due to the lack of continuous reinforcement through the joint zone, its performance was dependent on the tensile strength of the concrete, which was unreliable and, once it cracked in tension, strength degradation would occur rapidly under cyclic loading conditions.

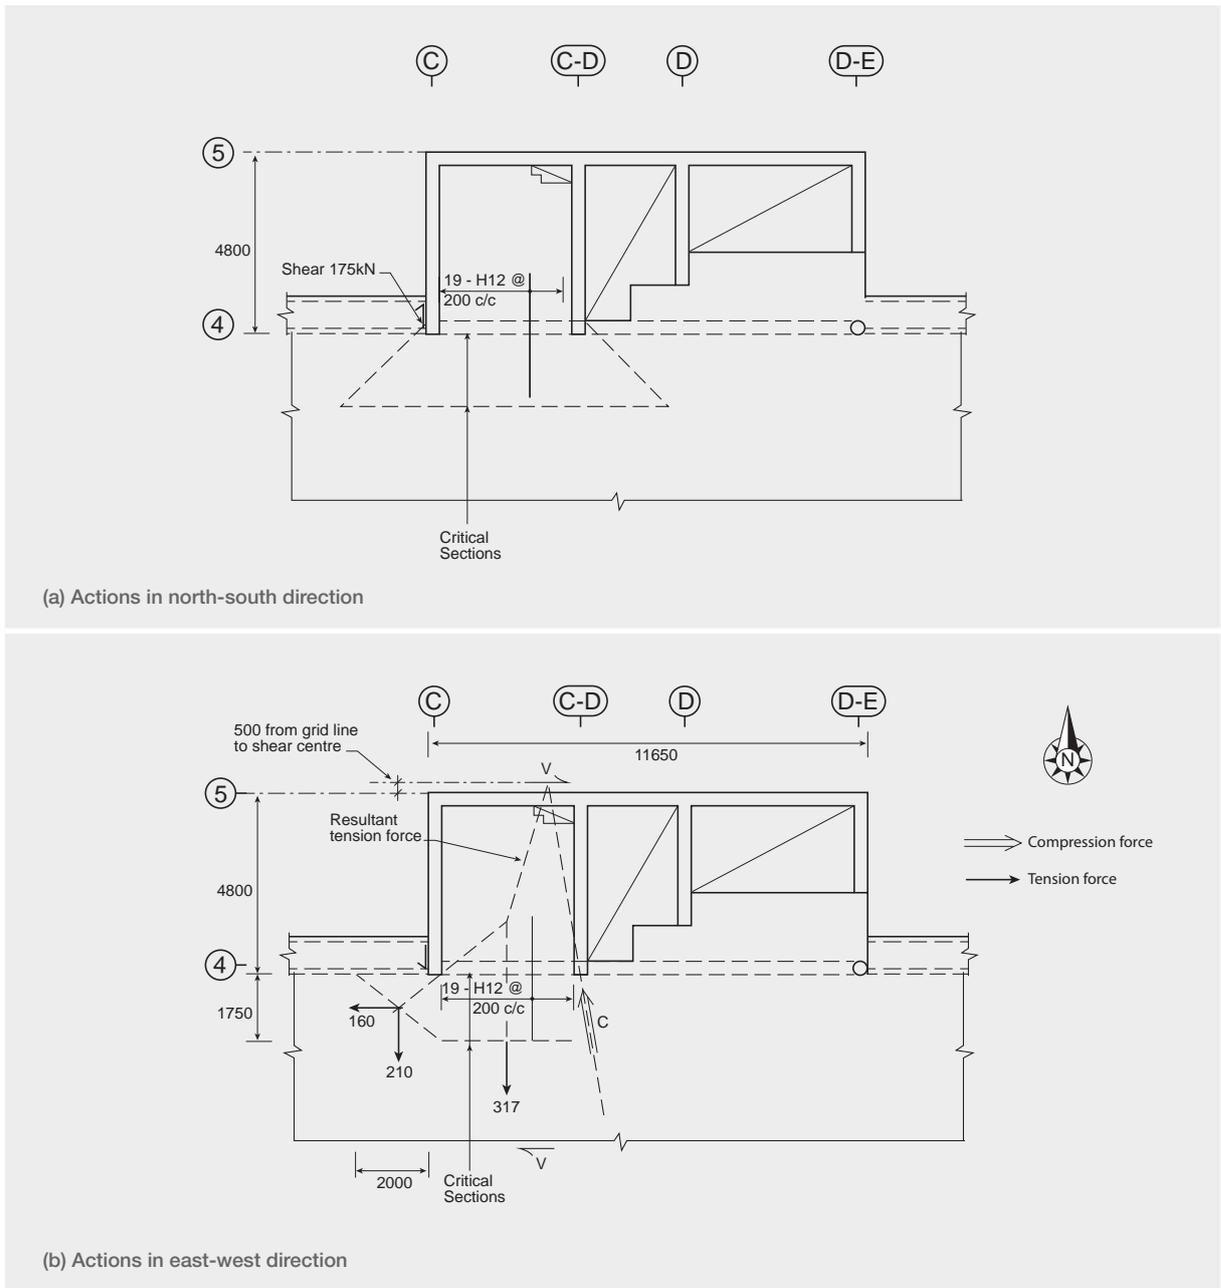
Figure 76: Connection of the floor at level 6 to the north wall complex

As with the forces in the north-south direction the voids in the floors adjacent to the north wall complex prevent any significant transfer of force from the floor to the wall on line 5 in the zone between the walls C-D and D-E. Consequently the shear transfer between lines 4 and 5 is restricted to the floor slab between walls C and C-D. Allowing for the offset of 0.1b between the centre of mass and the assumed location of the resultant lateral force gives a design shear force at line 4 between the floor on level 6 and the north wall complex of close to 600kN (where b is the width of the building normal to the direction of seismic forces). We have again assessed this force using the parts and portions clauses in NZS 4203:1984. This shear induces bending moments acting in the plane of the slab. Consequently, the floor slab in the location close to line 4 and the walls C and C-D needs to be capable of resisting simultaneously a shear force of 600kN and the associated bending moment (equal to the shear force times the distance from line 4 to the shear centre of the north wall complex). The situation, and a method of assessing the capacity of the floor slab to resist these actions, is illustrated in Figure 76(b).

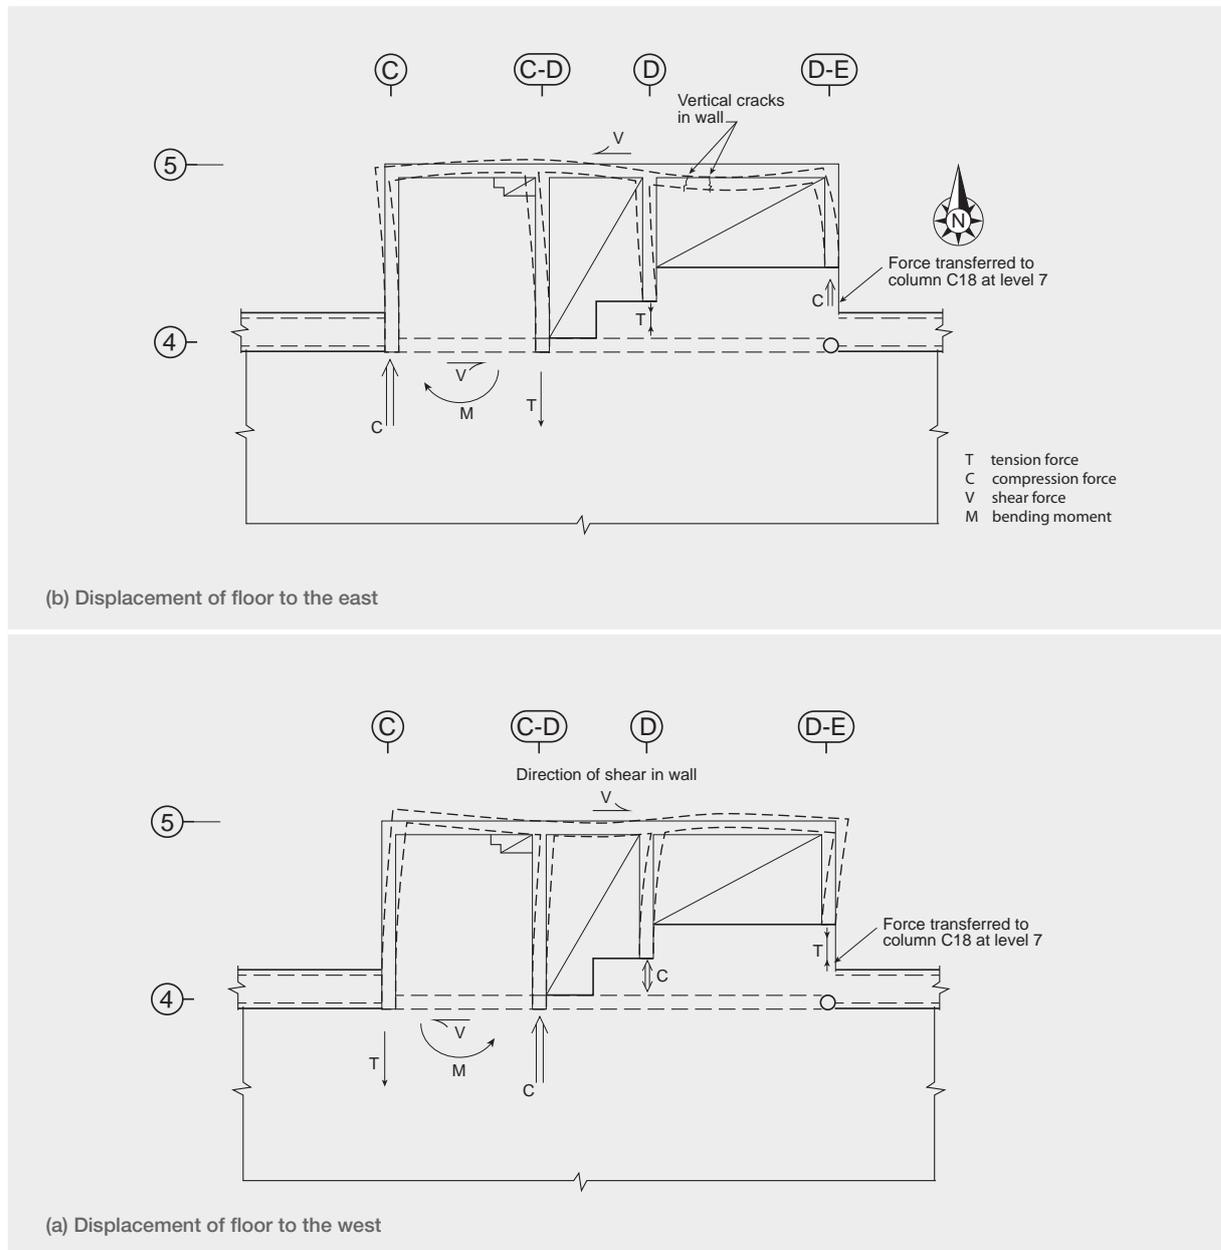
Figure 79: Warping of north wall complex

The bending moments induced in the floor due to seismic forces acting in the east-west direction cause the wall on line 5 to rotate relative to line 4. This rotation results in warping of the wall, which is illustrated in Figure 79. This action induces out-of-plane bending moments in the wall on line 5. Lateral forces are also induced in the finger walls D and D-E and in the connections between these walls and the floors. The out-of-plane bending moments in wall 5 account for the

vertical cracks which were found by Mr Graeme Smith in the wall on line 5 in the lift shaft.

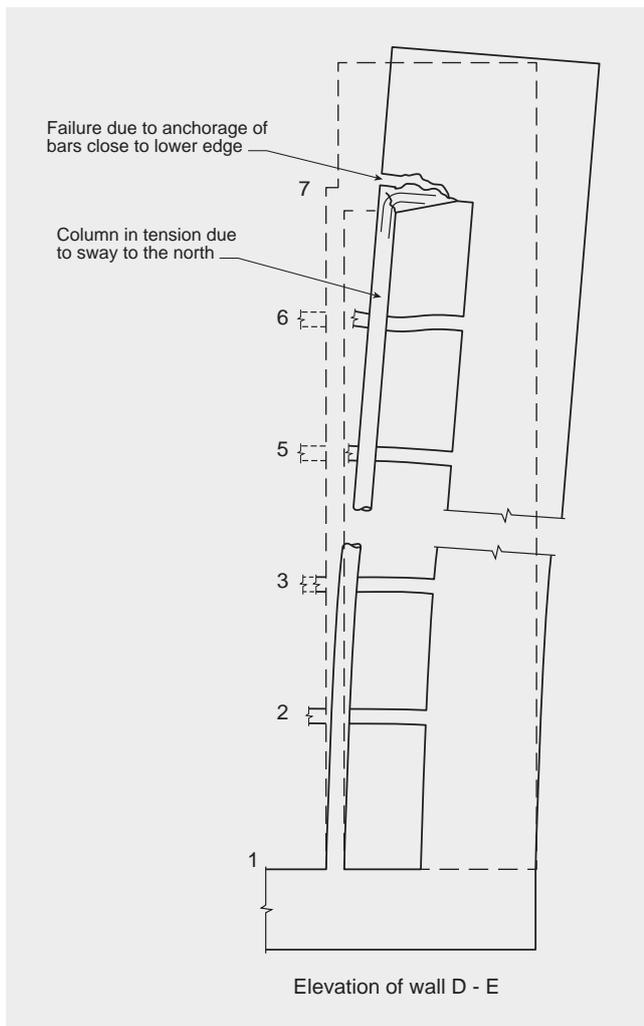
**Figure 80: Deflected shape of wall D-E**

The wall D-E is tied into the column C18, as shown in Figure 80. Bending of the wall D-E due to seismic actions in the north-south direction would induce axial forces in the column which, combined with the warping action described in the previous paragraph, accounts for the observed cracking in the column C18 on level 6.

The connection between the column C18 and the wall D-E was poorly detailed with the bars from the column being bent into the wall close to the lower surface of the wall at level 7 (see Figure 80). Any appreciable tension in these bars would result in the portion of wall shown in the figure being pulled out of the wall. It is likely that this was the source of the damage observed by Mr Coatsworth and Mr Leonard Pagan after the September earthquake and by Mr Peter Higgins after the Boxing day earthquake. This damage can be seen in Figures 50(a) and (b) in section 3.6.7.2 of this Volume.

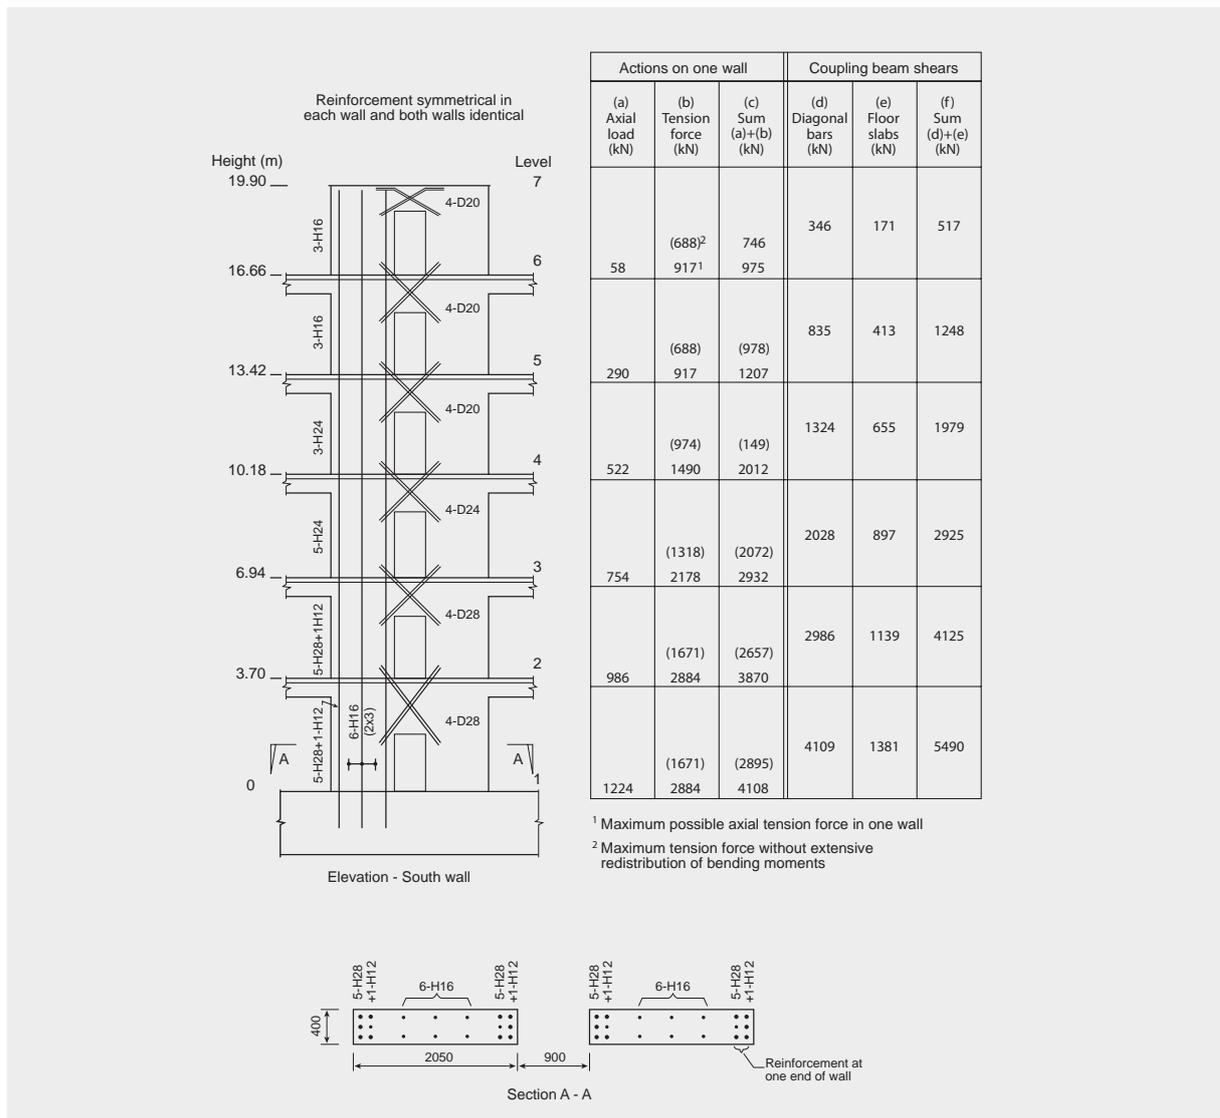
Figure 81: The coupled shear wall on line 1

Coupled structural walls are intended to dissipate seismic energy by forming plastic hinges at the base of each wall and by plastic deformation in the coupling beams. However, photographs and sketches in the Hyland materials report<sup>5</sup> of the wall show less damage to the coupling beams occurred than would be anticipated given that the non-linear time history analyses<sup>2</sup> predicted inter-storey drifts in excess of 2.5 per cent. From the Hyland materials report it is apparent that extensive yielding occurred at the base of the wall, where at least one 28mm bar necked and fractured. In addition there were significant diagonal cracks in the walls close to the base. There were also diagonal cracks in the coupling beam immediately below level 3 and in the walls between levels 2 and 3. There was little apparent damage to the coupling beams above level 3, though there were a few flexural shear cracks in the walls.

The Hyland materials report indicates that many of the beams on line 1 separated from the wall with either the bars anchoring the beam to the coupled wall being necked and fractured, or the beam and bars being pulled out completely from the wall.

indicated that below level 2 the coupled wall would act as a single unit. The damage at this level is consistent with this prediction. However, when the criterion was applied at level 2 and above it indicated that coupling beams might yield, but only if extensive redistribution of bending moment occurred.

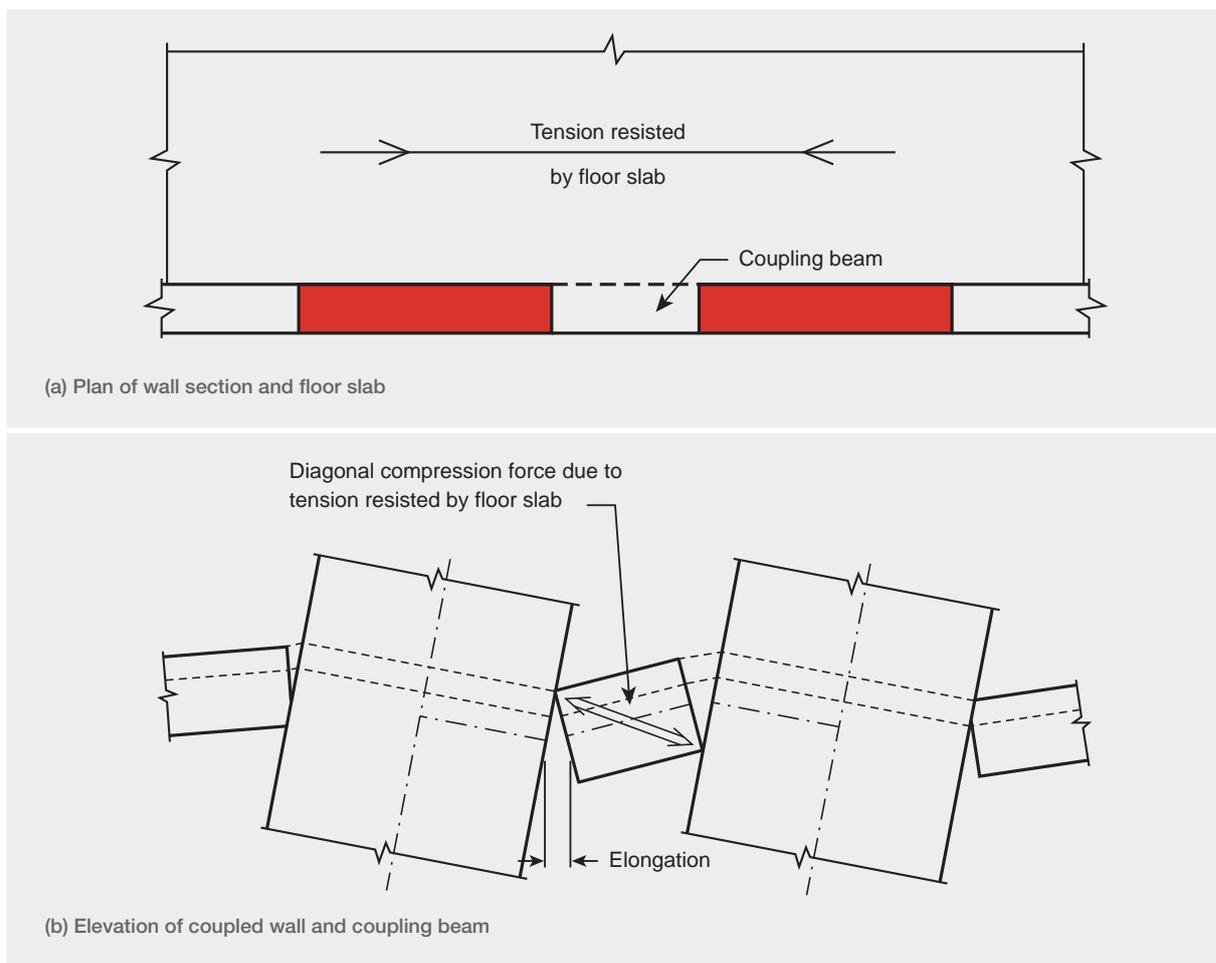
**Figure 82: Elongation of coupling beam and interaction with floor slabs**

As shown in Figure 82, once flexural cracks form in the coupling beam elongation occurs. If floors are connected directly or indirectly to the coupled walls they apply lateral restraint to the walls. The restraining tension force induced in each floor applies a corresponding compression force in the coupling beam. Professor Mander agreed that this action would occur. As illustrated in Figure 82(b), this increases the shear capacity of the coupling beam, with the axial force increasing the diagonal compression force in the coupling beam.

The slab in the east-west direction was reinforced by 664 mesh. Due to this low reinforcement content, when the floor was subjected to axial tension, cracking would have been limited to a single crack, with the reinforcement yielding at this one section. Consequently, due to tension stiffening of the concrete the floor would have acted as a stiff tie with a lateral tie force limited by the yield capacity of the 664 mesh. To assess the significance of the restraint force on the coupled wall it has been assumed that the tie force in the slab is limited to the tension capacity of the mesh in half of the 7.5m span of the slab between lines 1 and 2 (a distance of 3.75m) stressed to its 0.2 per cent proof stress of 485MPa. Using this force, the added shear capacity of the coupling beams can be assessed by assuming that the diagonal force due to axial load forms at the same angle as the diagonal compression force in the coupling beams.

Our previous Recommendation 47 in Volume 2 is for structural designers to develop a greater awareness of the interaction between elements due to elongation, and for guidance on these matters to be given in the commentary to the Standard. We note that the potential restraining effect of floor slabs on coupled shear walls, as described above, is an example of such an interaction.

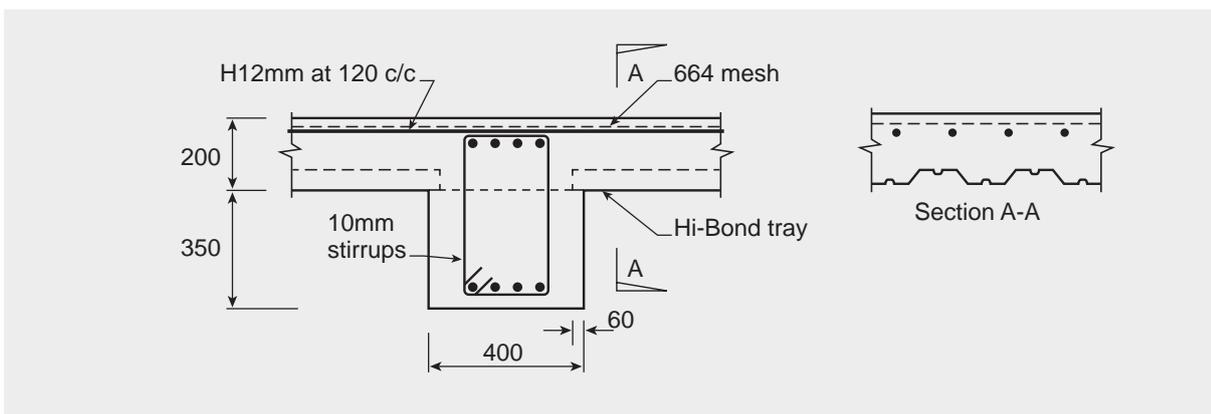
Figure 84: Typical details of floor slab and support beams

Typical details of the beams and floor slab (which was constructed by casting 200mm of concrete reinforced with 664 mesh on a Dimond Hi-Bond metal tray) are shown in Figure 84. The clear span of the floors was 7.1m, which, as we have earlier noted, was approximately 500mm in excess of the recommended maximum span (Dimond Hi-Bond technical literature). To compensate for the extra 500mm, 12mm high strength bars were placed over the beams at 120mm centres. There was no direct reinforcement tie between the beams and the floor slab and consequently, in the event of partial loss of support, the beam and associated floor could separate. This detail is not robust and it is possible that this contributed to the progressive collapse of the building.

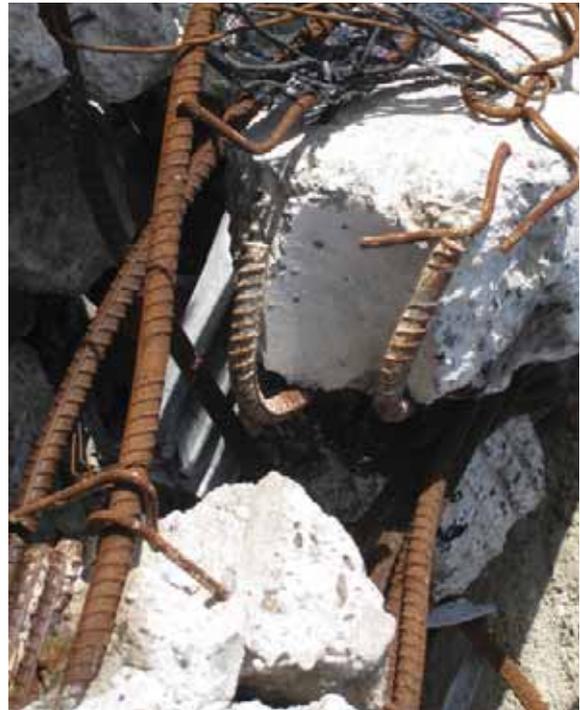
Figure 86: Photo of end of beam

Photographs show that typically when the beam wings had fallen off, the remaining interface between the column and beam had a width of about 200mm.

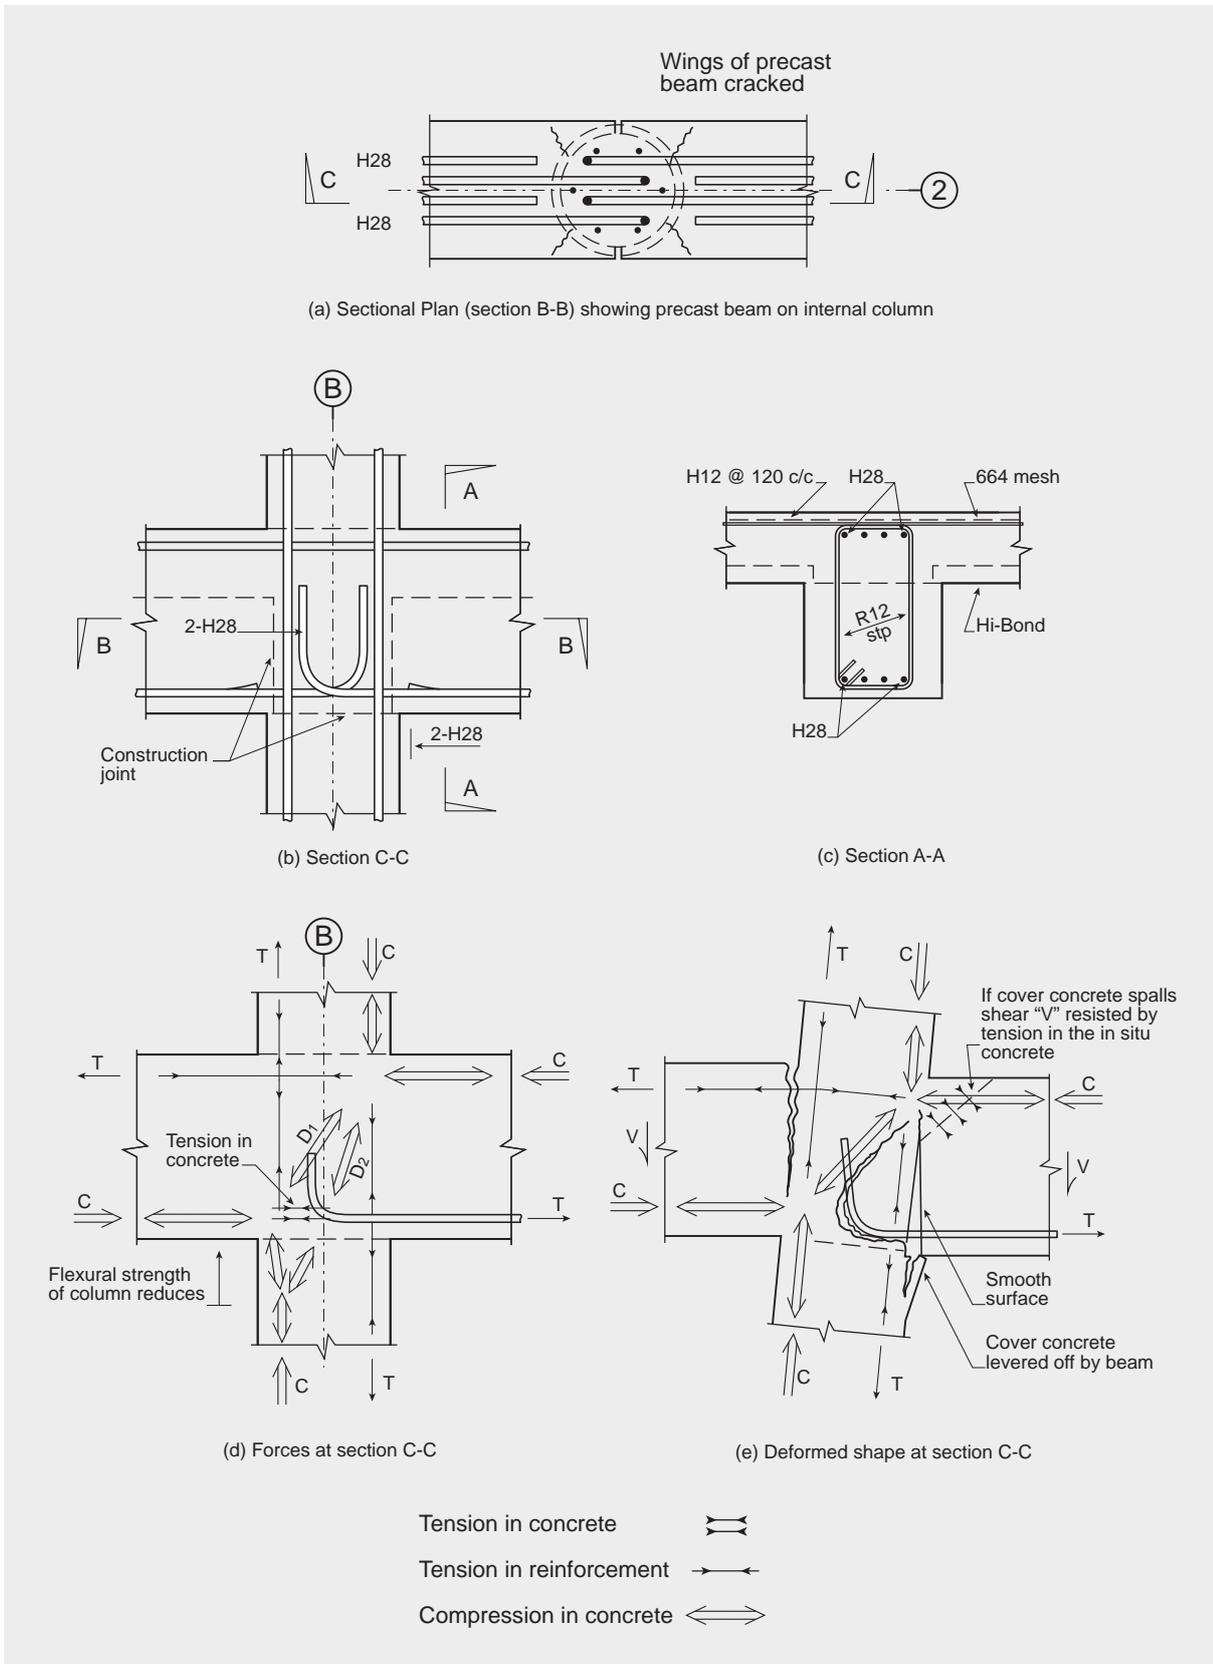
Figure 87: Junction of internal beams and column

Figure 87 shows the structural details and potential failure mechanisms associated with an internal beam column support. Parts (a), (b) and (c) of the figure show a plan view and a sectional elevation of the joint zone and a beam section. Of the four 28mm bars at the bottom of each beam only two extend into the joint zone. This reduction in reinforcement close to the column face concentrates any positive moment flexural tension force into two bars which, as detailed, have just under 60 per cent of the development length required for full strength. With this arrangement any positive moment inelastic deformation in the beam could lead to rapid strength degradation of the joint zone.

cover concrete being levered off from the column, as shown in part (e) of Figure 87. As no shear can be resisted across the smooth crack the shear force is transferred to dowel action of the hooked bars at the bottom of the beam, and to tensile resistance in the in situ slab concrete at the top of the beam. Appreciable deformation is required to develop dowel action and, as one of the bars is relatively close to the free edge of the column, it is unlikely that appreciable dowel action could be sustained. The shear resistance provided by tension in the slab concrete is a brittle action. Consequently, the capacity of dowel action and the tension capacity of the concrete in the slab cannot be added together. The shear force in the beam is resisted by the web, which has a width of 400mm. If the shear force is resisted by tension in the slab an effective width of slab is likely to be of the order of 500mm, which is 100mm wider than the width of the web. Four 28mm top bars pass through this region, reducing the effective width of slab that could resist the tension to about 400mm. Based on this width the diagonal tension stress in the concrete required to resist the gravity load (of 160kN) is of the order of 2MPa. The design direct tensile strength given in NZS 3101:2006 is 1.8MPa for 25MPa concrete and it is used with a strength reduction factor of 0.6. Consequently a direct tensile strength of the order of 2MPa is close to a condition where failure would be expected to occur. If allowance is made for vertical seismic ground motion, the tensile stresses are likely to increase into the range where failure would be expected, and this would result in collapse of the beam. Mr Frost postulated a similar collapse mechanism.

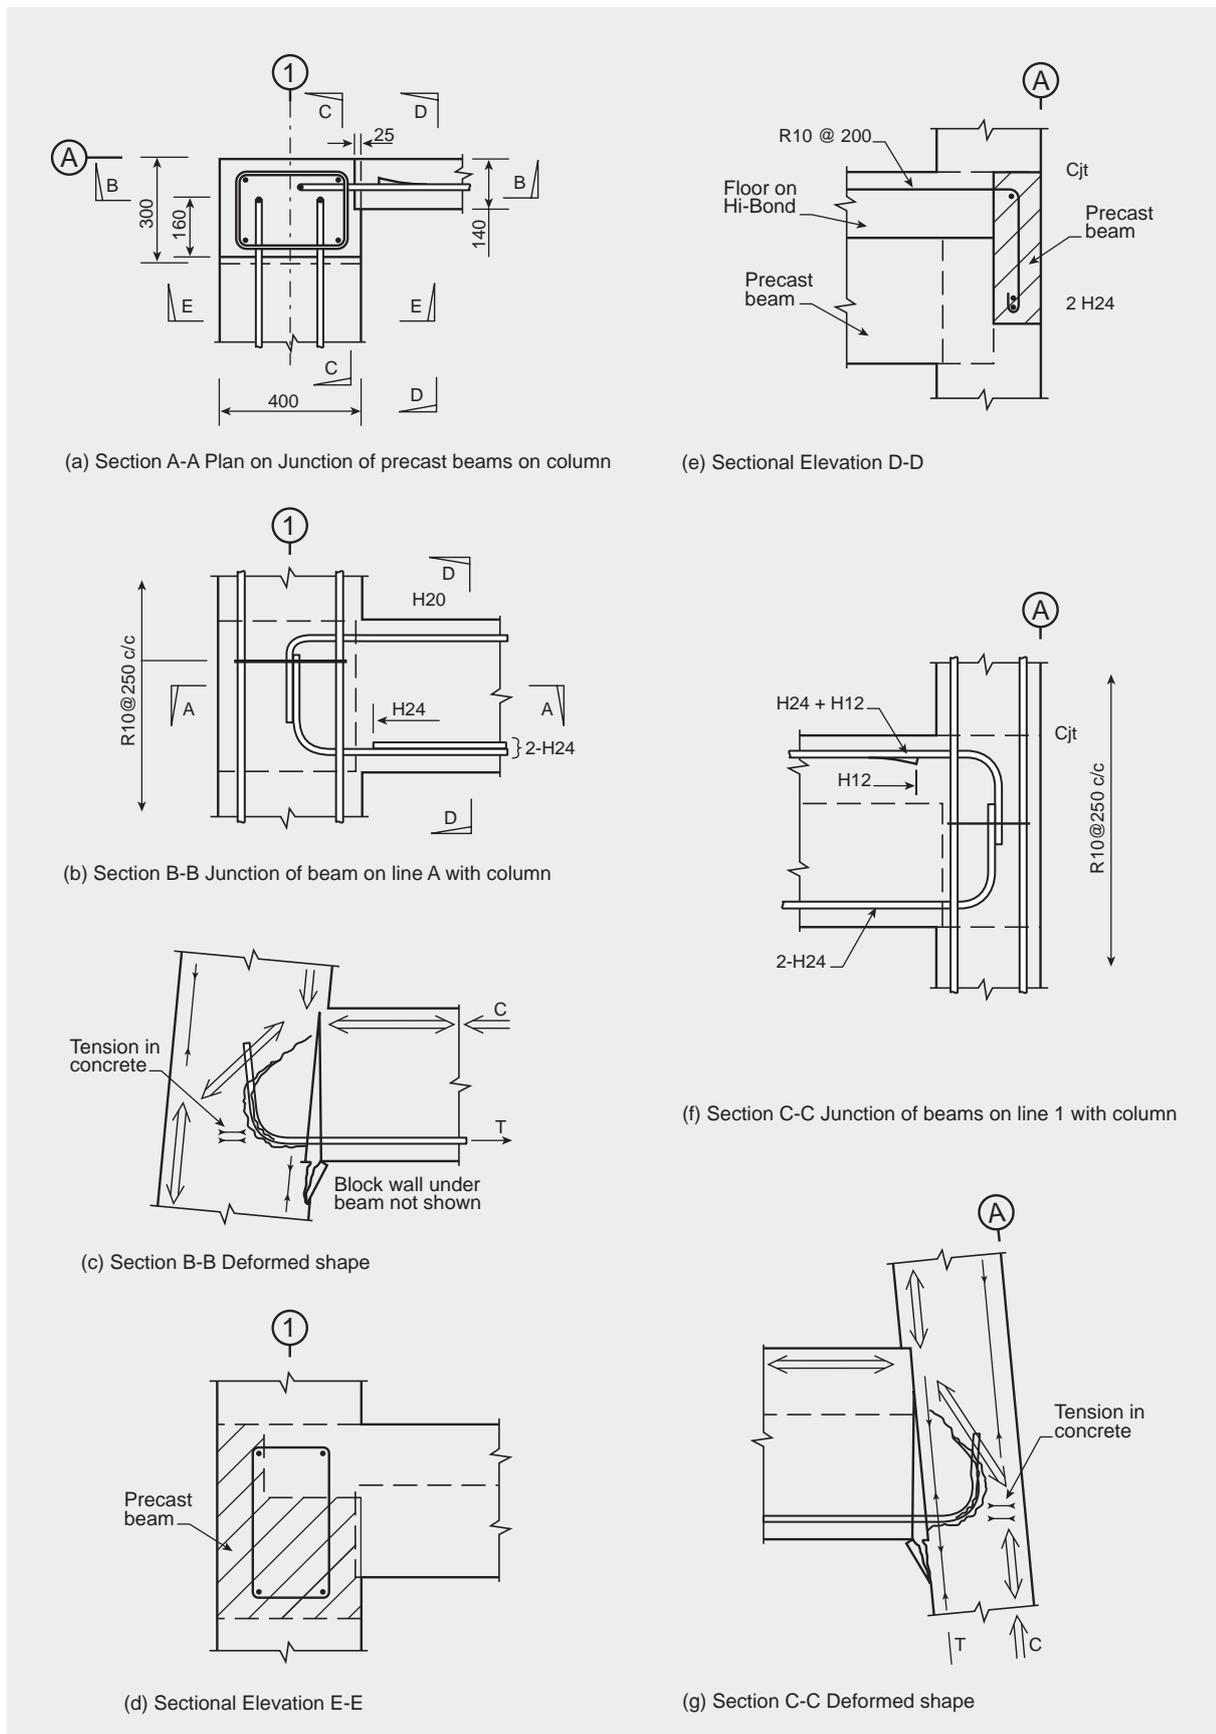
Figure 88: Junction of beam and column at south-east corner of building

Figure 88(b) shows the reinforcement details of the intersection of the precast beams at levels 2 and 3 and the corner column. One high-strength 24mm bar extended from the bottom of the beam into the column where it was anchored by a hook just short of the mid-section of the column. This gave a development length of approaching 60 per cent of that required by NZS 3101:1982. The top reinforcement consisted of one 20mm high-strength bar. In addition there was some limited tensile capacity provided by the mesh reinforcement in the slab, which was tied into the beam by plain round 10mm bars ( $f_y$  275MPa) at 200mm centres. Part (c) of the figure shows the seismic actions and potential failure mode due to drift in the north-south direction. Parts (d) and (e) of the figure show details of the beam sections which are supported by the column. Parts (f) and (g) show the reinforcement details and failure mode at the intersection of the beam in the corner column for seismic actions associated with inter-storey drift in the east-west direction. When significant flexural tension is applied to either the top or bottom reinforcement in the beam, the concrete behind the bar hooks is subjected to tension and it will crack allowing the hooked bar to pull out of the concrete. Clearly there is the potential for either or both of the beams on lines 1 and A to tear the joint zone apart.

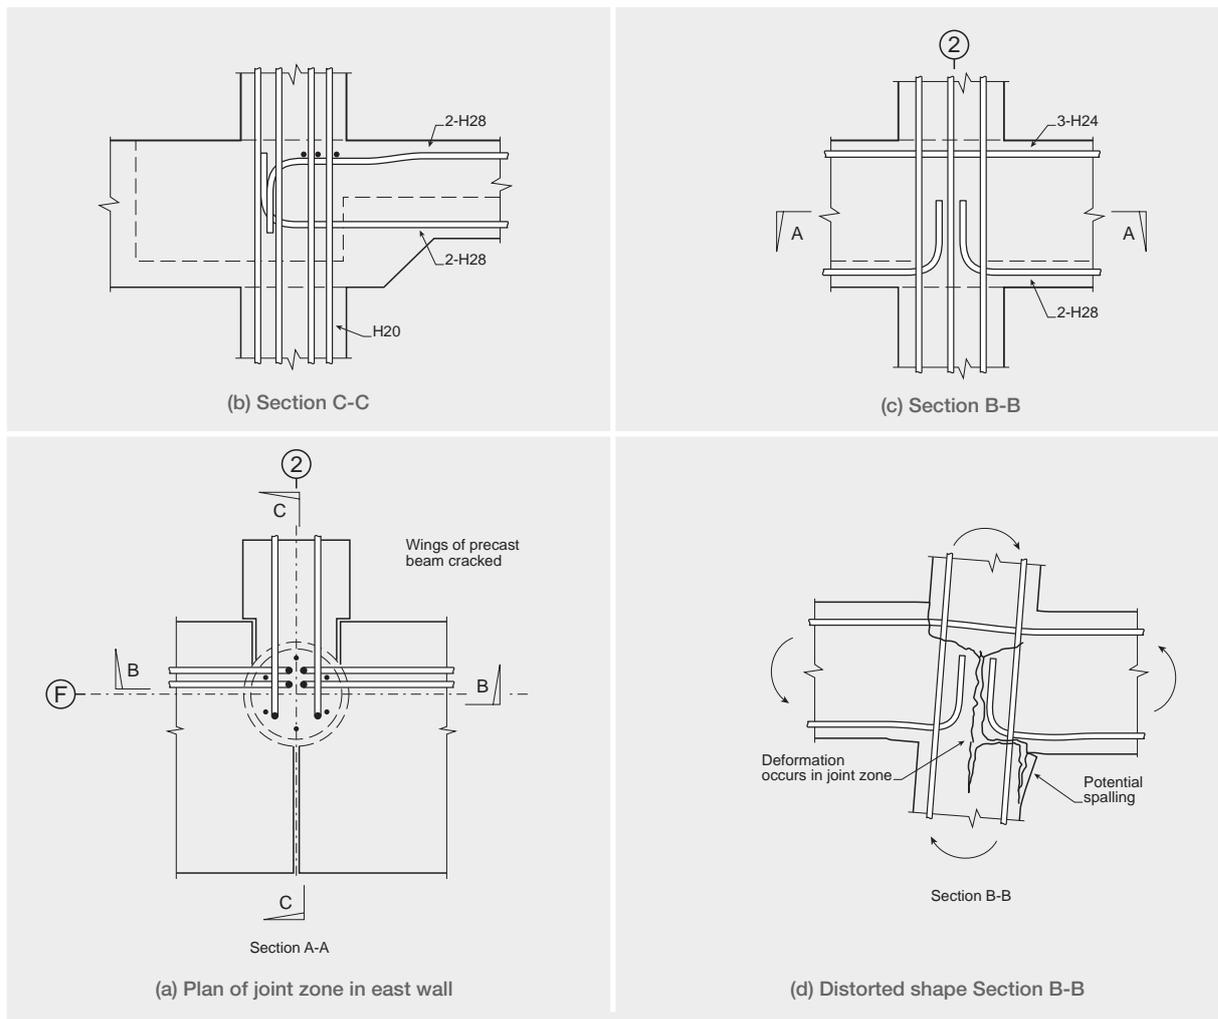
Figure 90: Intermediate beam-column joints on line F

The precast beams on line F were placed so that there was a 20mm gap between the ends of the two beams (see Figure 90(a)). This gap, whether filled with concrete or not, would have acted as a crack initiator, with the crack extending through the column centre-line as shown in part (d) of the figure. Such a crack could be initiated by wind or seismic actions, or it could have been present from shortly after construction due to shrinkage of the concrete due to thermal contraction associated with heat of hydration.

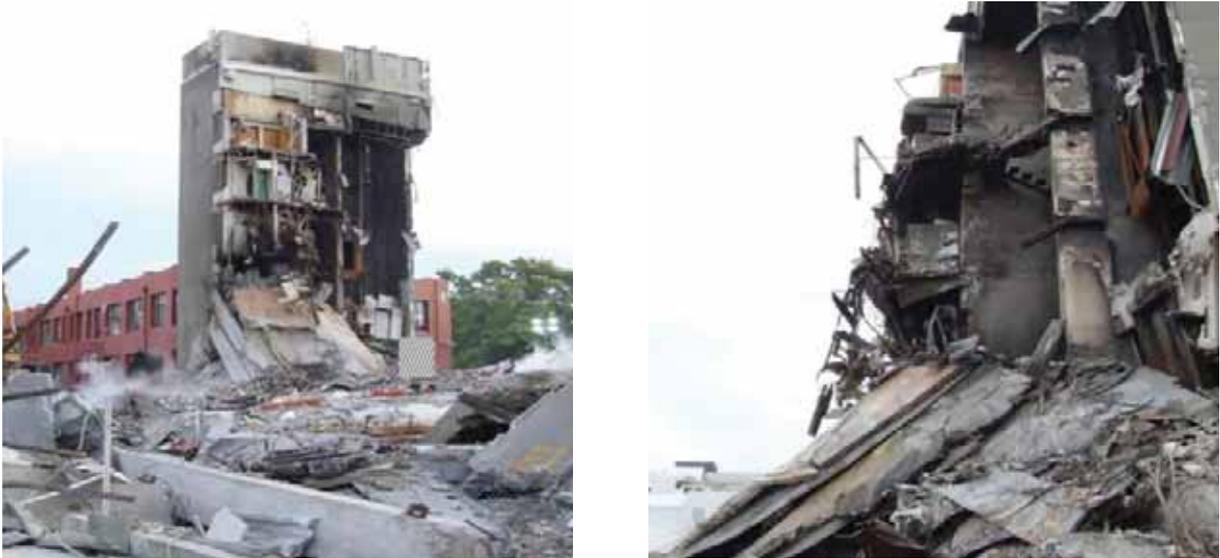
Figure 93: Figure 95 from the Hyland/Smith report showing the slabs lying against the north wall complex

However, Dr Hyland and Mr Smith concluded that diaphragm disconnection at levels 2 and 3 was not entirely consistent with the collapse evidence and less likely than their first two scenarios. They referred to evidence of the floor slab lying against the north wall complex in a manner indicating it had lost support at the line 3 end of the slab rather than at the north wall complex (see Figure 93).

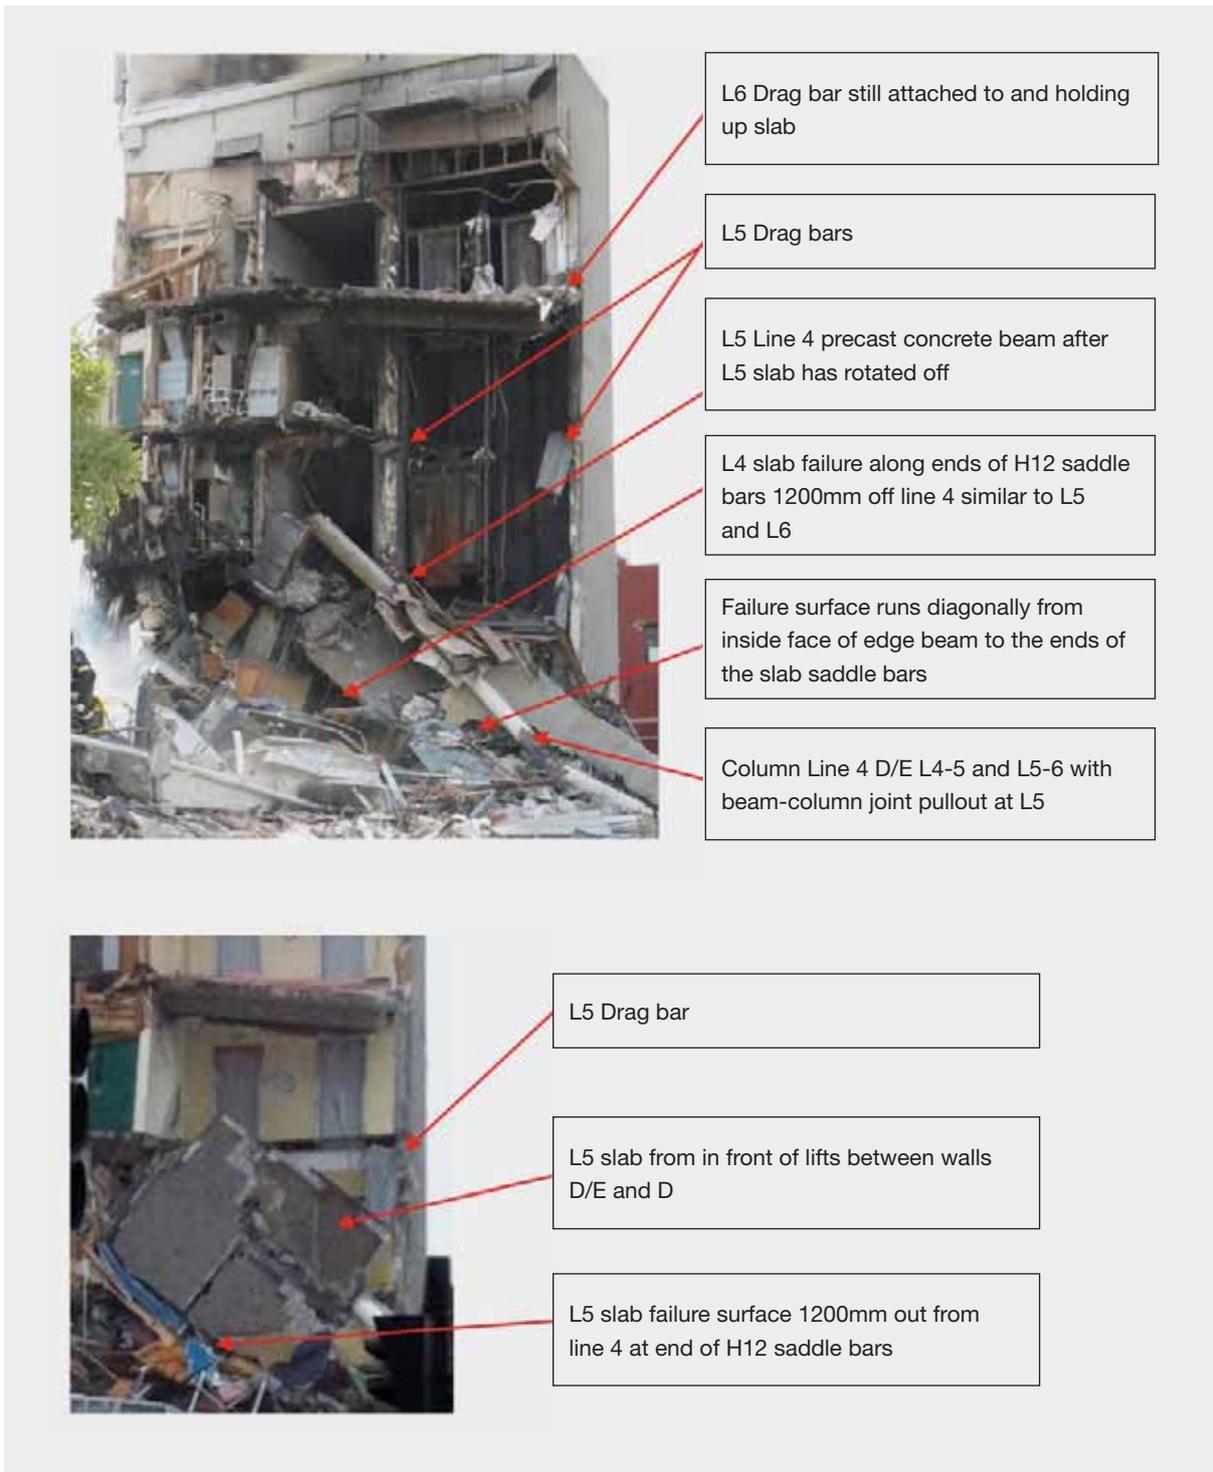
Figure 94: Figures 163 and 164 from the Hyland/Smith report showing diaphragm failure at the north wall complex

Dr Hyland and Mr Smith concluded that this scenario was not entirely consistent with the collapse evidence. Photographs of the north wall complex showed that the levels 4, 5 and 6 slabs may not have failed initially at the drag bars (see Figure 94). For these reasons they believed it was less likely than the previous three scenarios.

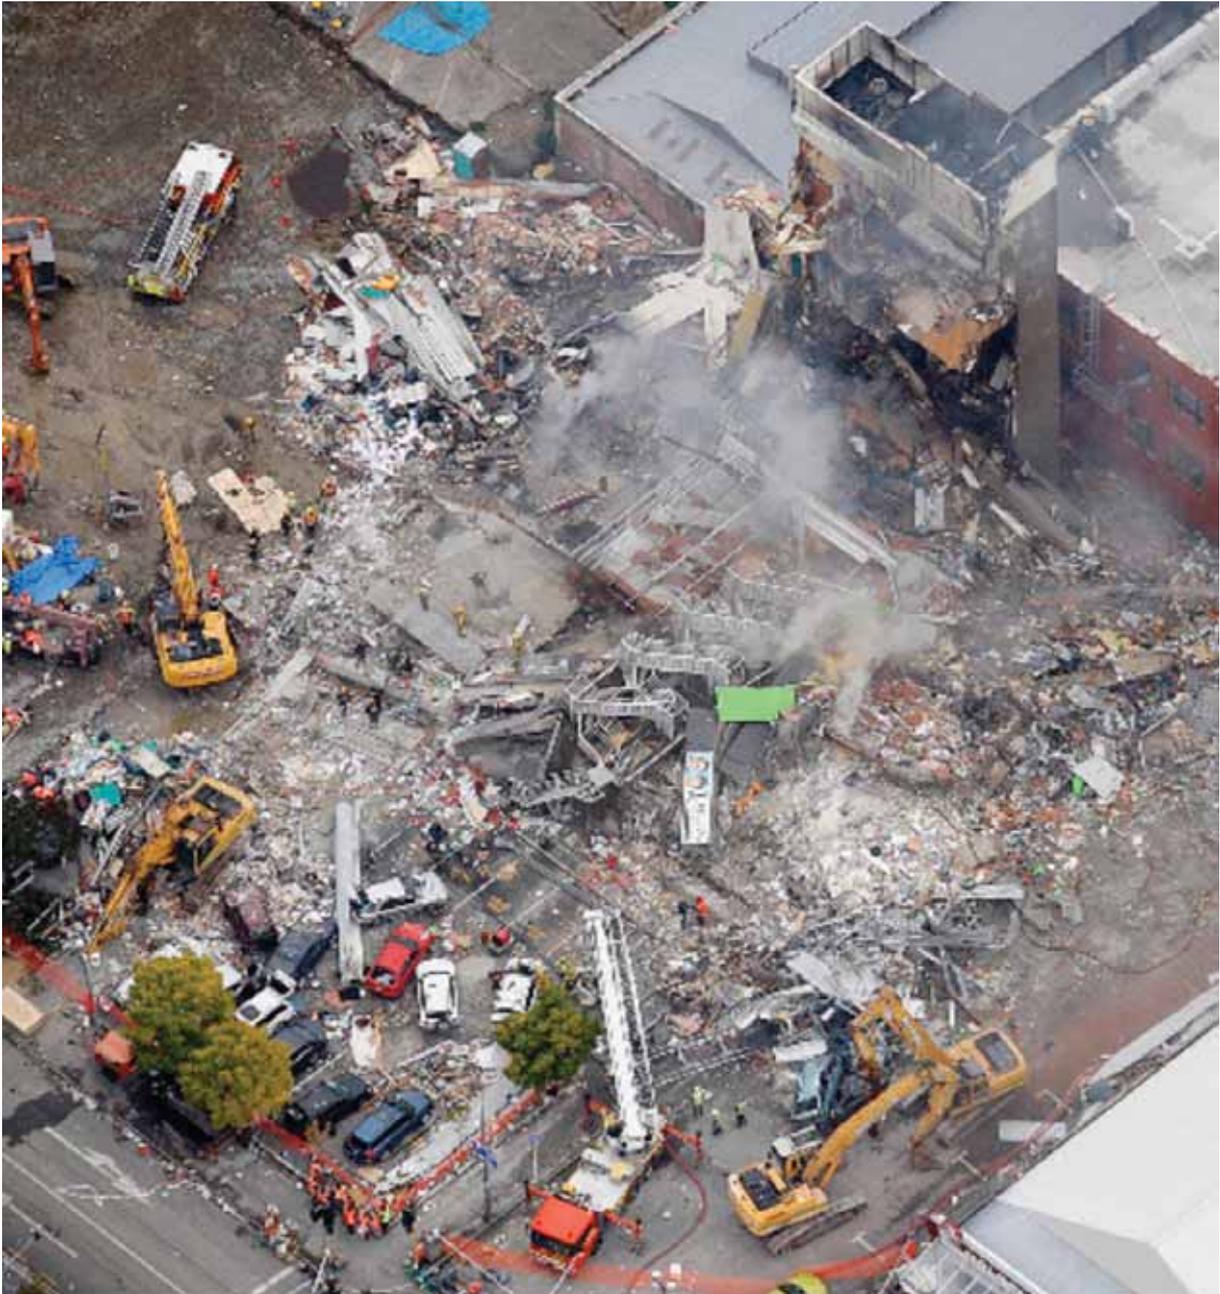
Figure 95: Aerial photograph referred to by Mr Holmes

Mr. Holmes noted that there was a lack of apparent yielding in the north wall and this was not consistent with the predicted drifts of the wall. From this he concluded that partial or complete separation of some of the floors would have occurred at an early stage in the earthquake. This would have led to increased drifts of the columns and greater structural actions on the beam-column joint zones.
