# Section 6:

## Technical discussions on structure

### 6.1 Design earthquake loading and analysis of the CTV building

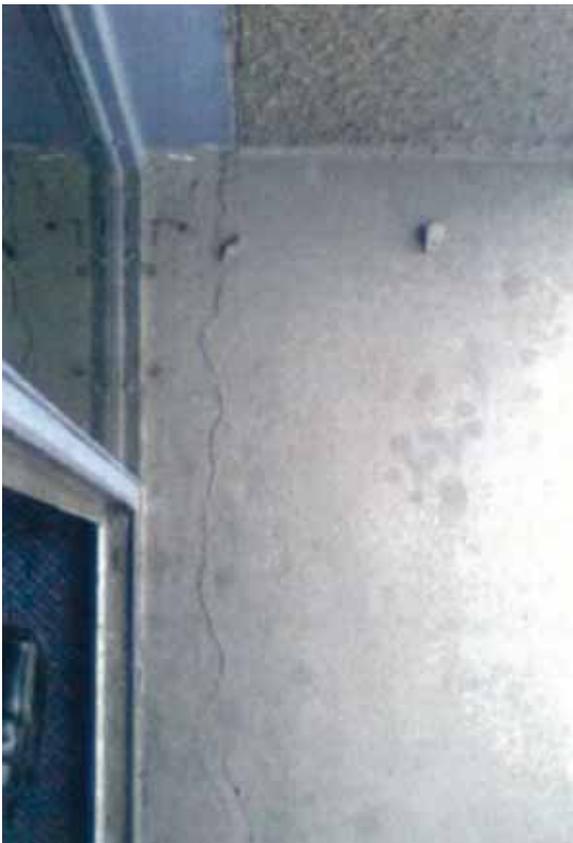
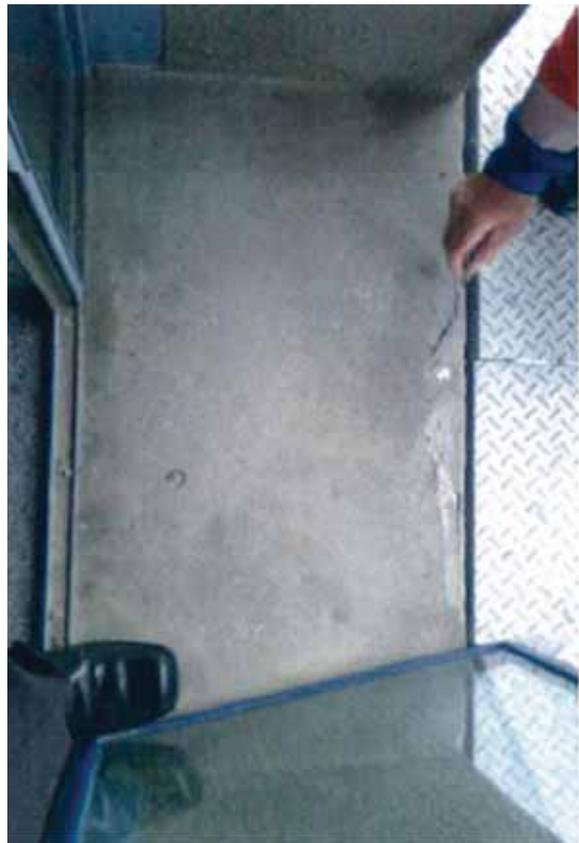
Figure 103: Cracking in south shear wall coupling beams (source: Leonard Pagan)

The text includes a number of photographs of cracks in the coupling beams (see Figure 103) and it was submitted that some of the cracks were 2mm in width. In addition it was noted that Mr Coatsworth identified a few cracks in the south shear wall. It was suggested that the damage represented by these cracks would have contributed to the collapse of the building.
