FINAL REPORT

VOLUME 2

THE PERFORMANCE OF CHRISTCHURCH CBD BUILDINGS

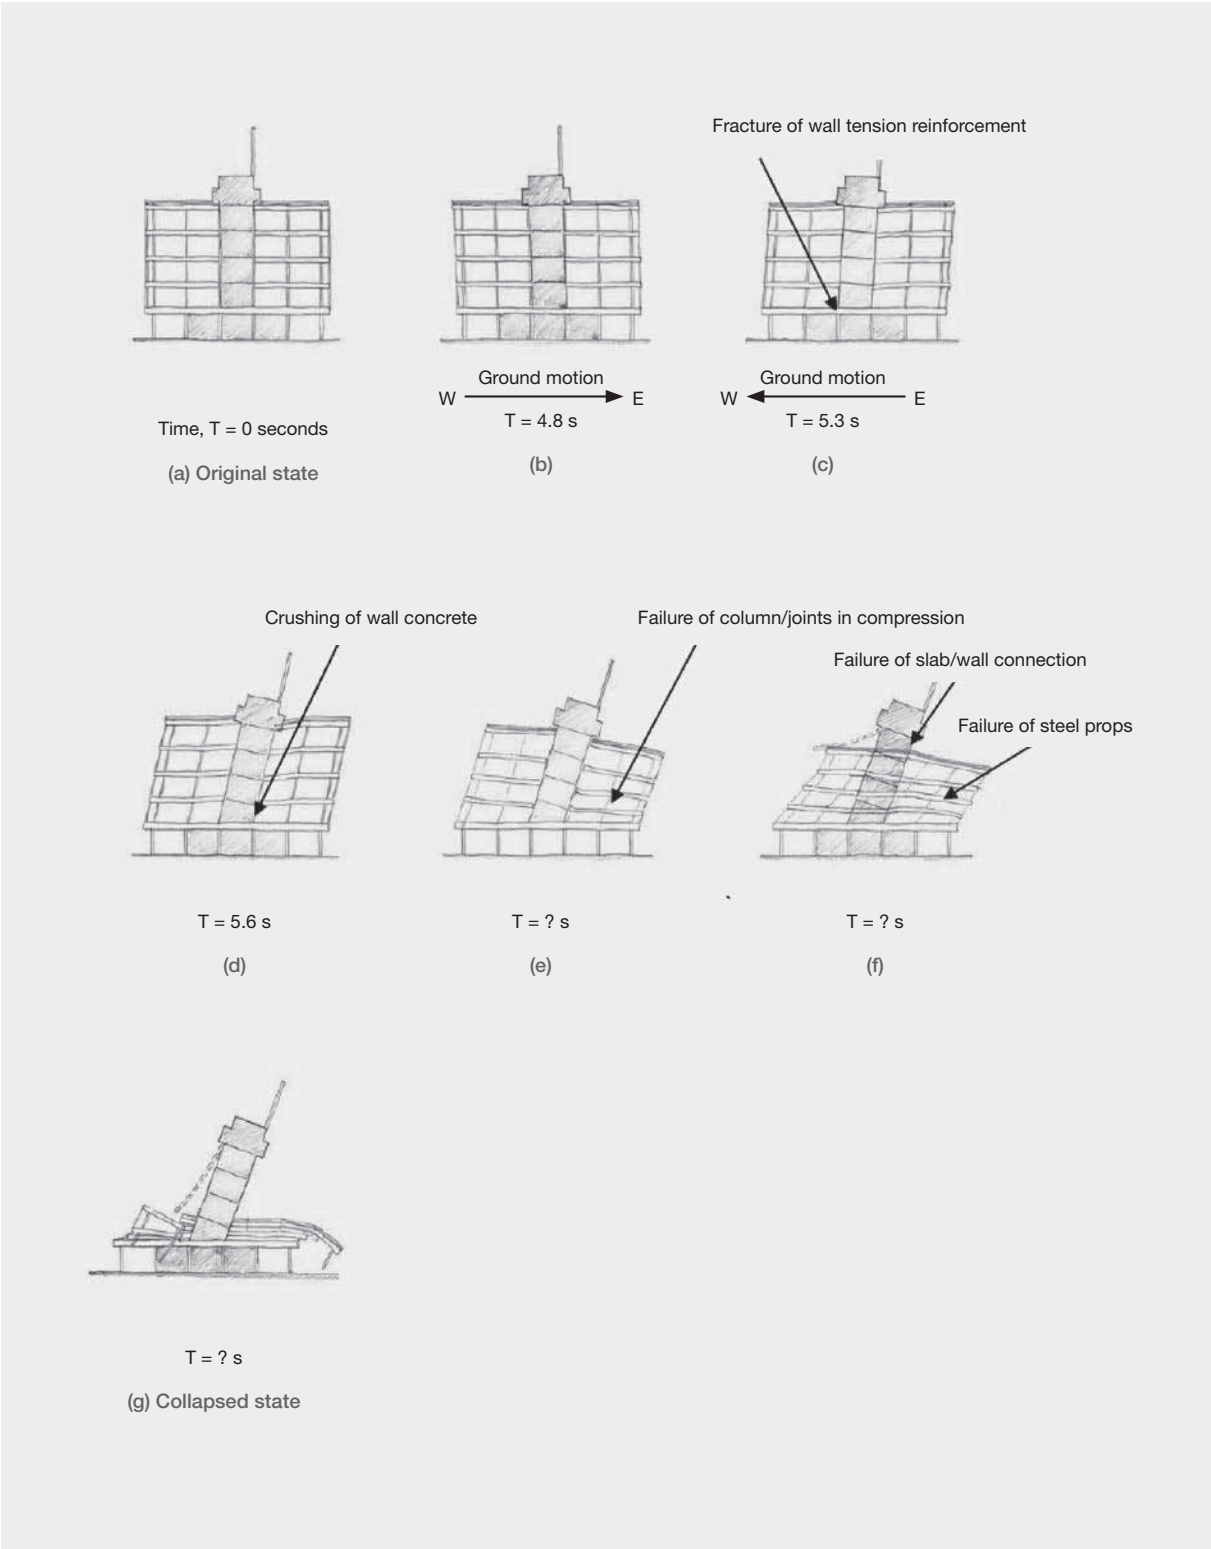
Figure 16: Inferred collapse scenario (source: Beca report)

The collapse scenario that Beca inferred is shown in Figure 16.

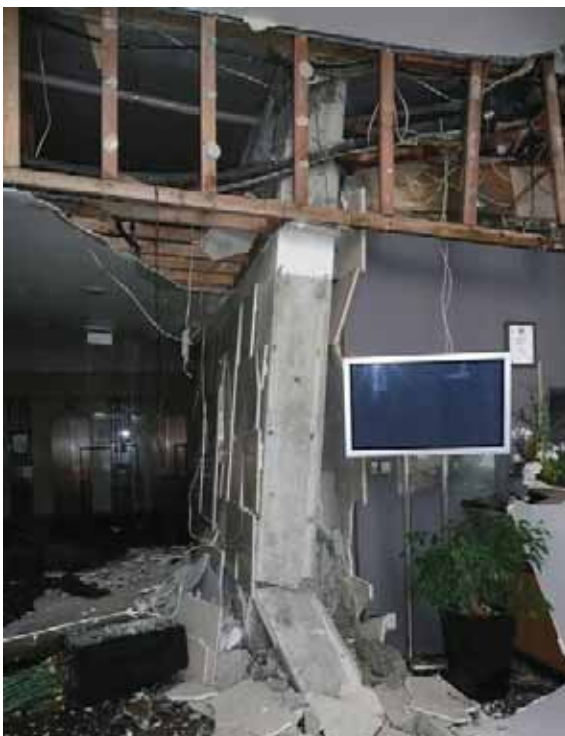
During the February earthquake, a shear wall located on the ground floor of the Hotel Grand Chancellor (HGC) at 161 Cashel Street failed. The failure came close to causing a catastrophic collapse of the building.

Figure 19: Failed wall on ground floor

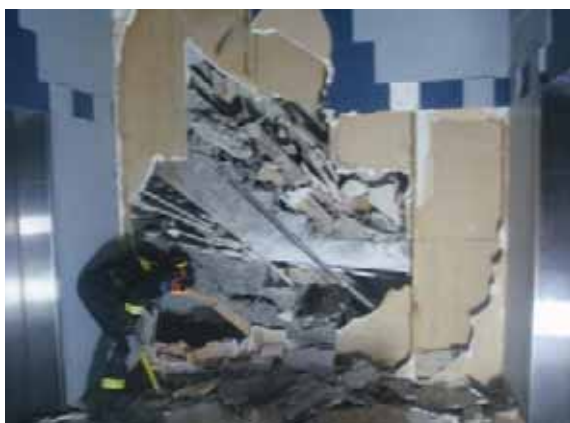
Figure 45: Fallen stair flights at the bottom of the stairwell

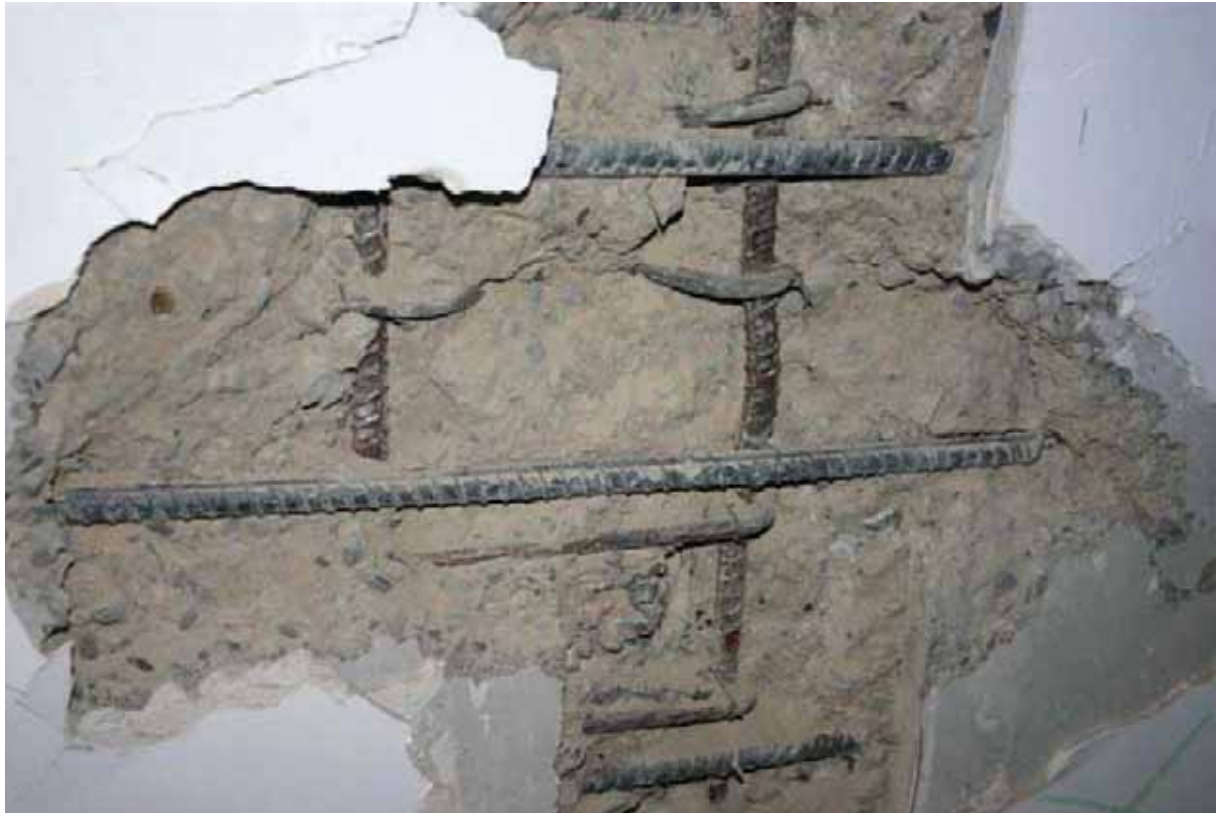
The buckling of the longitudinal reinforcement observed in the wall below level 3 highlights the importance of providing lateral restraint to longitudinal bars in the potential plastic hinge zones (ductile detailing lengths) of walls (refer to Figures 81–83). The extensive spalling of the cover concrete results in the loss of anchorage of the transverse reinforcement, which creates a potential problem that has not been addressed in the current design standards.

Figure 83: Buckling of reinforcement level 2 (source: Spencer Holmes)

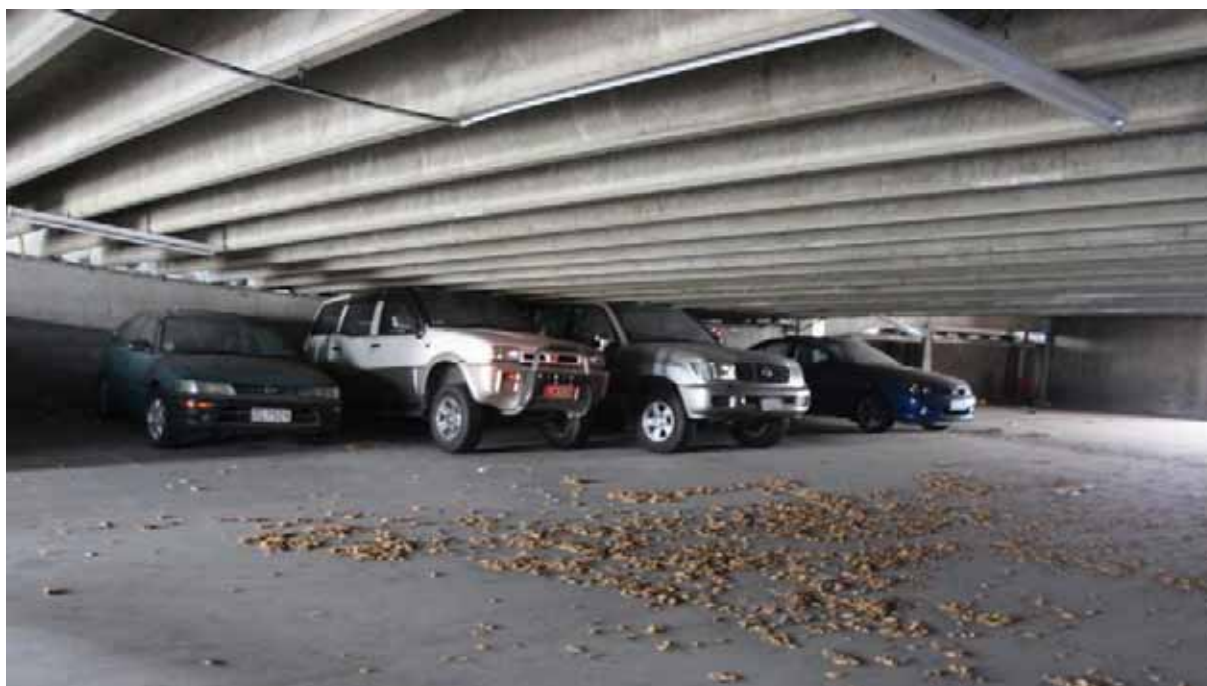
The February earthquake resulted in significant damage to the building and as a result it has now been demolished. The most obvious damage was the failure of the support of one of the precast central beams that supported the double-tee floor system at level 3. The photograph in Figure 96 was taken at level 1 (ground level) and shows that the beam supporting level 3 lost support, resulting in the double-tee units collapsing onto a number of vehicles in the car park at level 1.

Figure 96: Collapse of the double-tee units from level 3

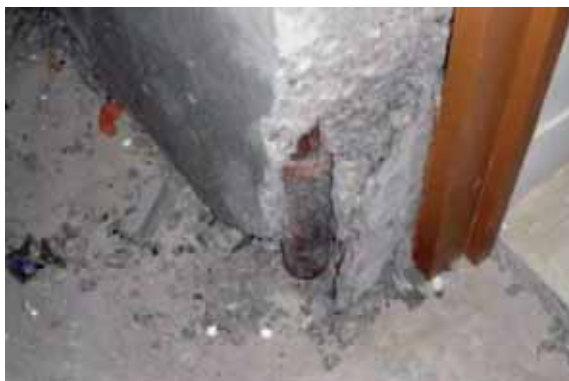
Figure 120: Spalling of concrete exposing the couplers at the bottom of structural walls (source: Spencer Holmes Ltd)

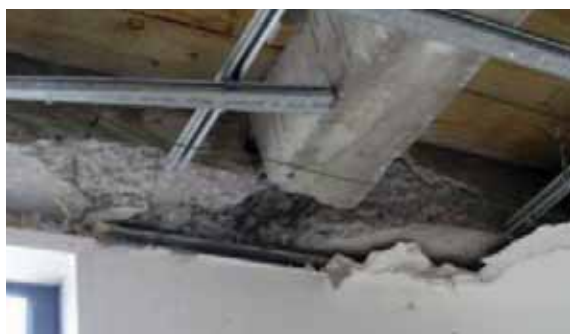
Figure 124: Spalled rib and edge beam (source: Spencer Holmes Ltd)

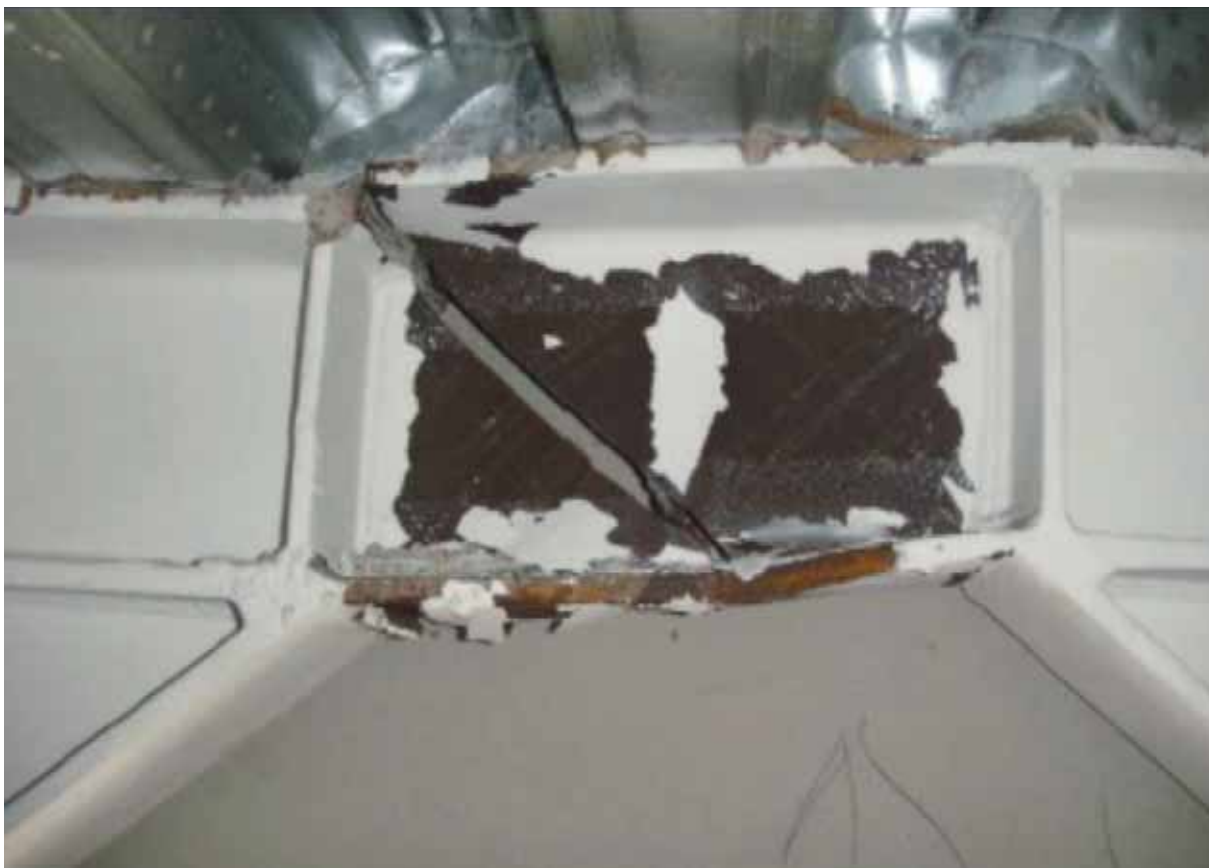
Figure 131: Fractured active link in the Pacific Tower (source: Clifton et al.²⁷)

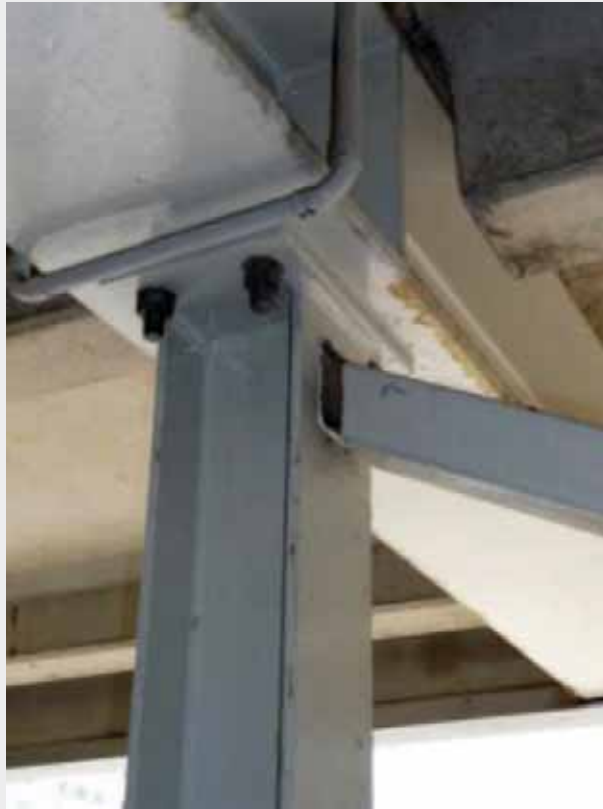
(a) Failed brace (source: Clifton et al., 2011¹⁴)
