204 Manchester Street, Christchurch – Iconic Bar

Re: 204 Manchester Street, Christchurch – Iconic Bar

SITE REPORT

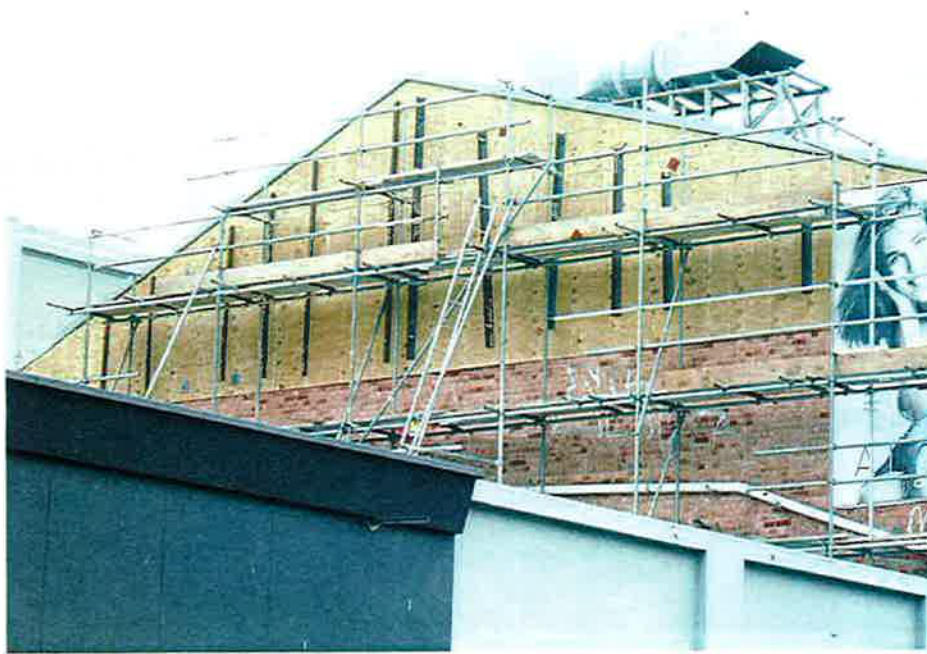
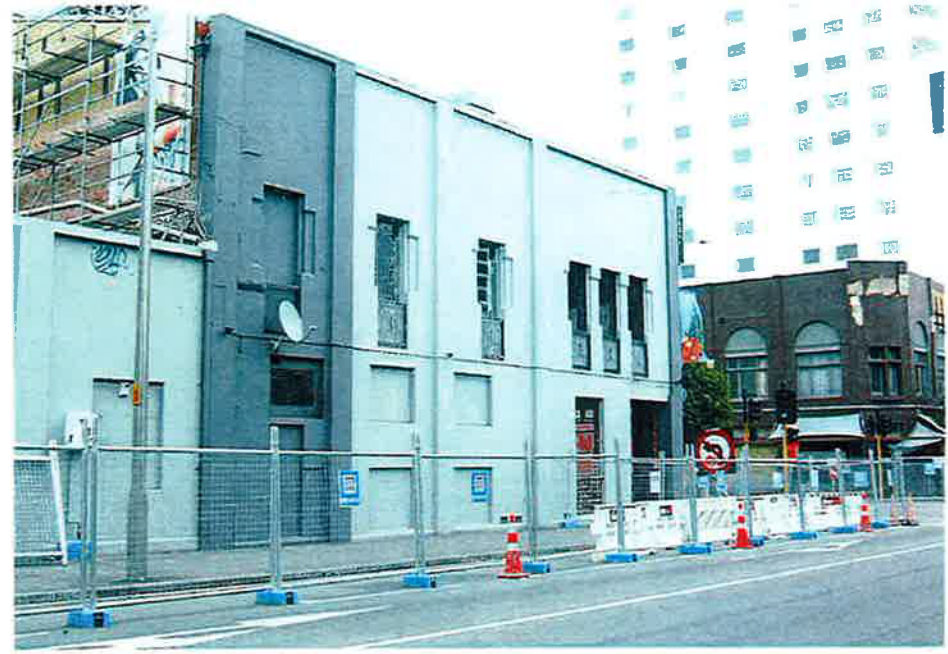
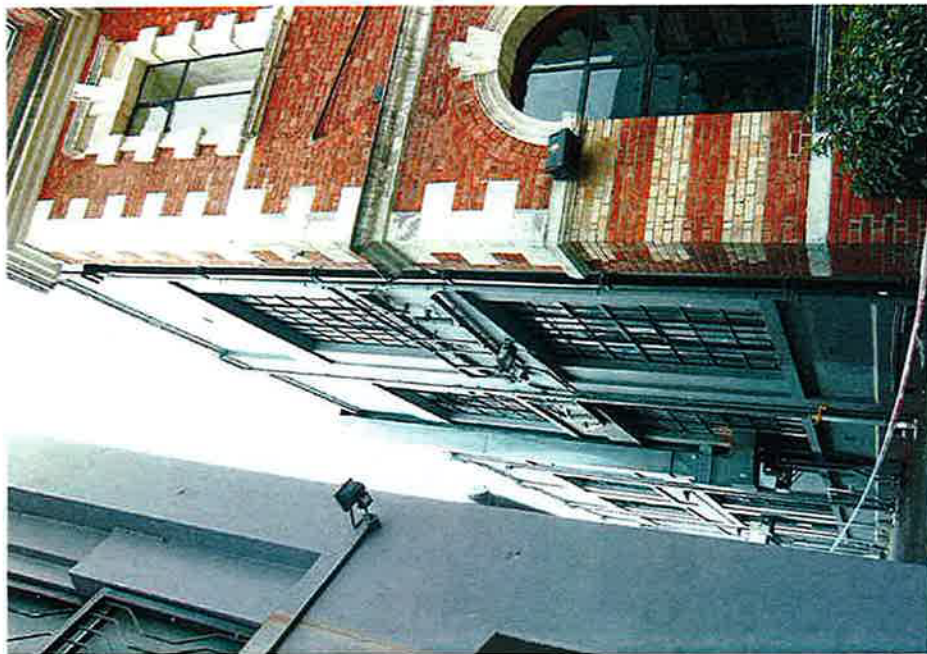
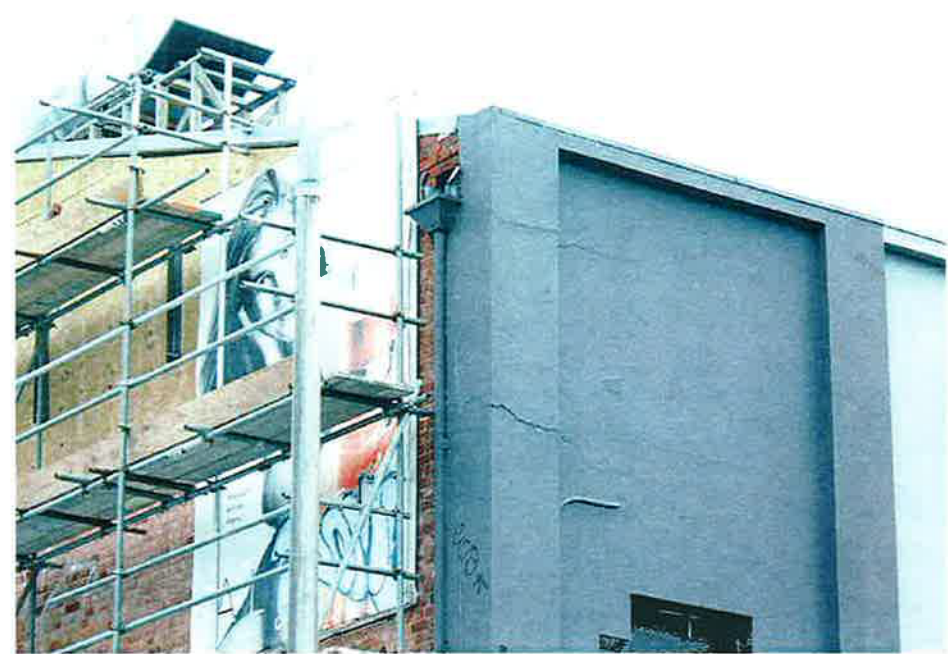
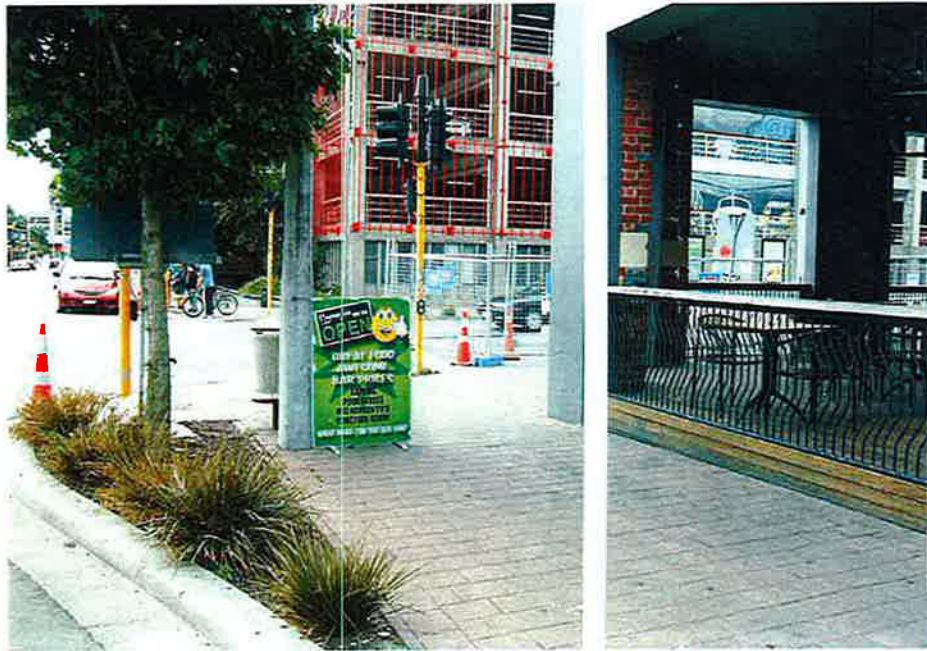
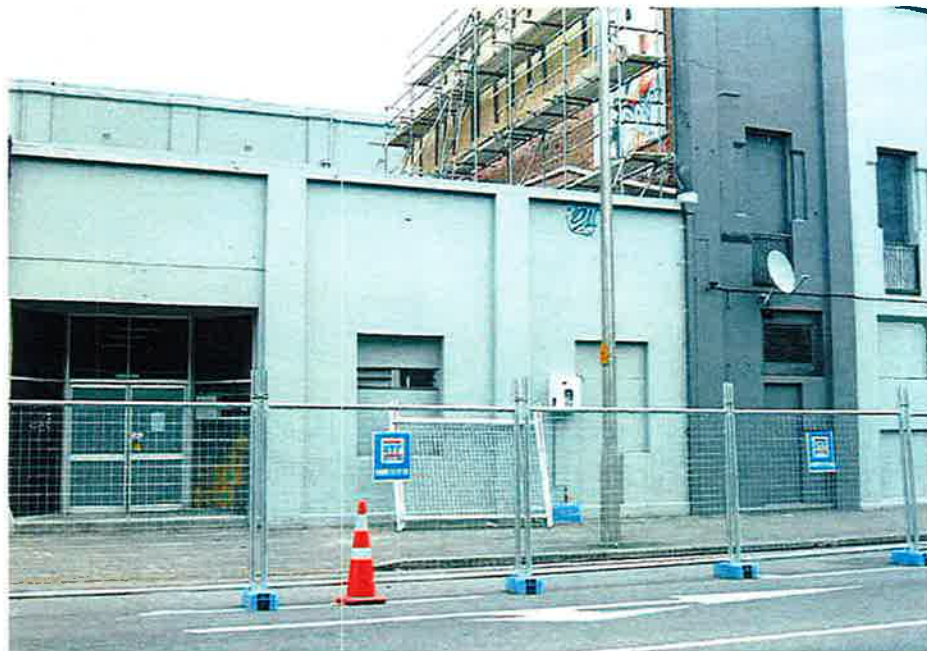
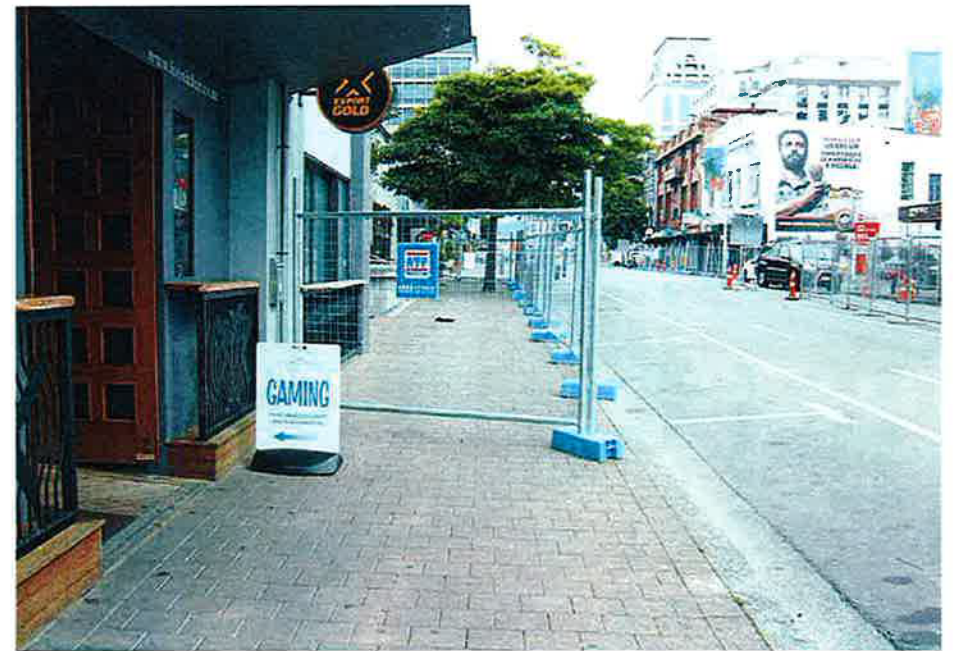
Visual bldg inspection post aftershocks 26 & 27 Dec 2010
Bldg has a red stricker from CCC indicating parapet damage to east wall.
Inspection in roof space shows brick wall from ceiling to roof level to the east wall has bowed out by 50 to 100 mm. The parapet above roof level has collapsed at the apex.

Framing & plywood now in place between end trusses to affected east wall. All well constructed.
Access now available onto adjacent single story roof & scaffolding being placed to give access to damaged face.

- ① Remove all collapsed bricks at the apex parapet area & flash to make water tight.
- ② Provide 20mm HS plywood to the outside face of the east wall from truss bottom chord level to top of parapet. Fix with existing bolts & washers at roof level. Provide M16 bolts at 400 ca into truss bottom chord with 10mm washers to brick & timber. Solid block between brick & truss to prevent clamping. All bolts to be hot dip galv.
- ③ Provide 150x45 joists at 450 ca between truss bottom chords to Z east end trusses. Line over joists with 12mm plywood to prevent any falling bricks coming through suspended ceiling.

Above work is temporary support of damaged wall to make building safe for normal use. Brick wall above truss bottom chord level will need to be removed & rebuilt with suitable structure for long term support.

- ① Provide 100x75x8mm MS L verticals to outside face of wall on top of plywood fixed to existing bolts to rafters at top. At bottom fix to existing bolts to south side of wall & provide new M16 threaded rod to north side of bridle fixed into truss bottom chord 100x100x8mm MS PL washers to brich & timber faces. All steelwork to be prime & top coated.
- ② Provide 200x50 timber placed flat against inside face of brick wall to align with MS L on outside. Provide timber patches between 200x50 & face of truss top & bottom chords. Shear nail in place. Where new bolts are placed from MS L through to truss bottom chord the bolt shall pass through the 200x50 & patches.
