192 MADRAS STREET

CONDITION OF NURSE MAUDE BUILDING: 192 MADRAS STREET

192 Madras Street - Former Nurse Maude District Nursing Building Review of Structural Damage Reports

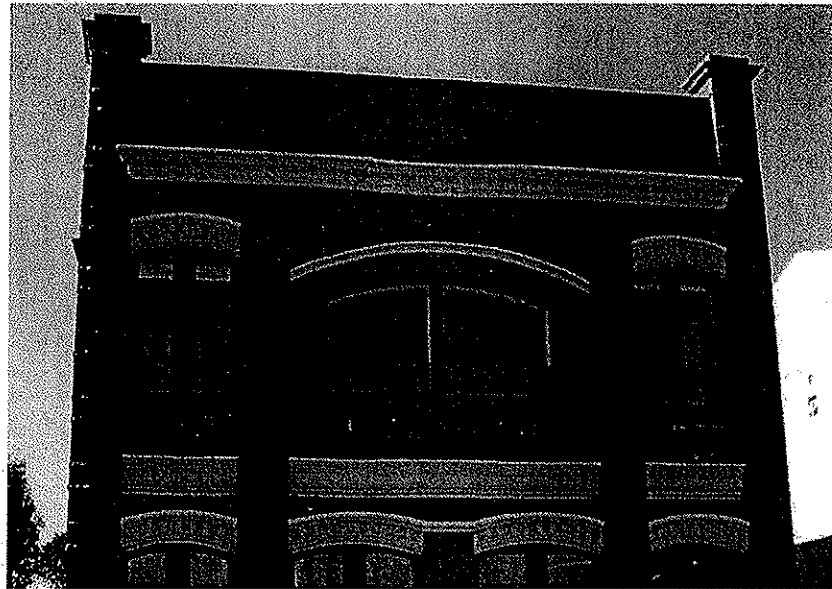
Since the first earthquake and immediate aftershocks, there has been a progressive deterioration of the facade and the north wall at the parapets either side of the facade. This is apparent from Figures 1,2&3, which are essentially the same view of the upper part of the west facade on those three separate dates. There has been some further dropping of sill bricks from the first floor side windows, and the cornice and lettering of the parapet.

Figure 1: 6 September 2010

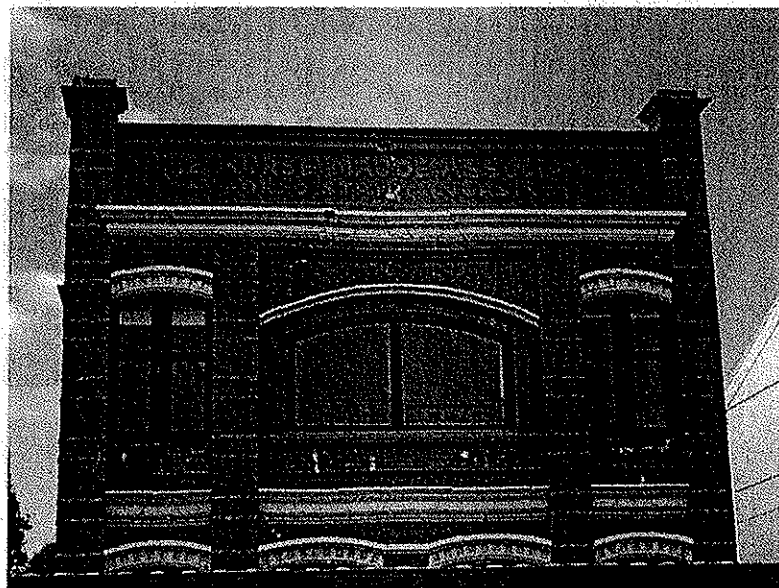
Figure 2: 15 November 2010

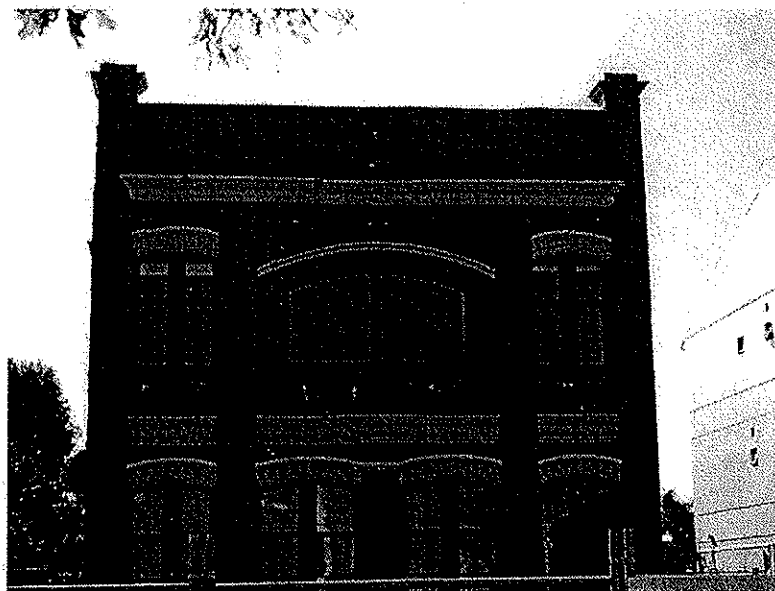
Figure 3: 15 February 2011

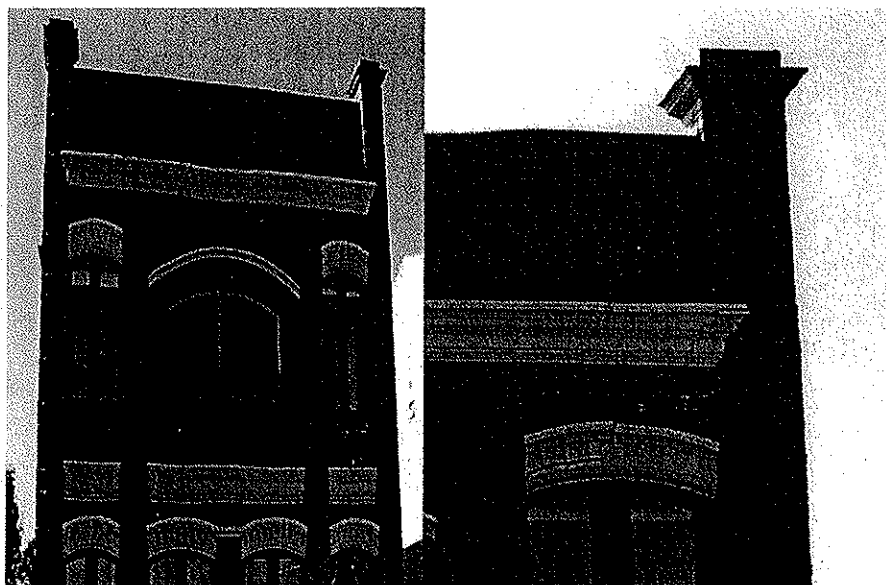
Figure 4: Comparison of south top corner, 6Sept vs 15 Feb

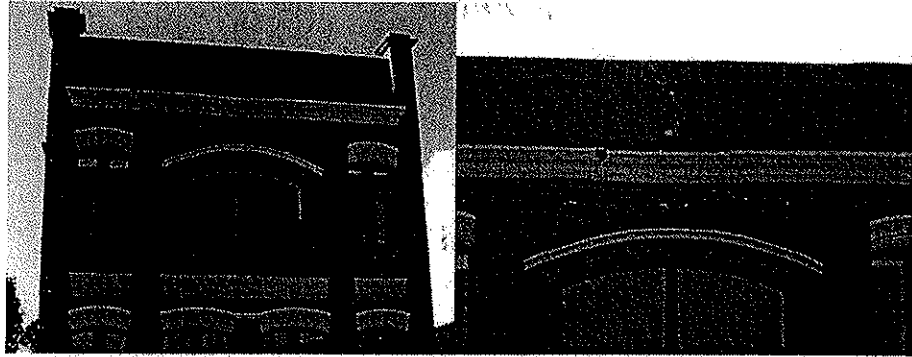
Figure 5: comparison of central lintel, 6 Sept vs 15 Feb

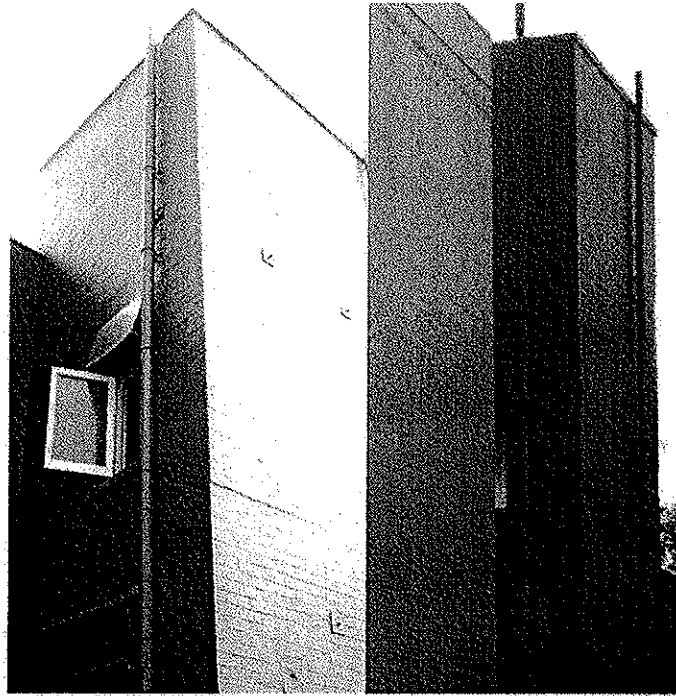
In the prior report, it was noted that the heaviest apparent damage away from the west facade and adjacent side walls was in the east wall of the lightwell adjacent to the first floor window. It appeared that the return shear from the heavy penthouse had kicked out the back of the wall. Figure 7 shows this area – although the quality of the photographs is not great, there appeared to be little further movement in this crack.

Figure 7: South lightwell, 6 Sept to 15 Feb

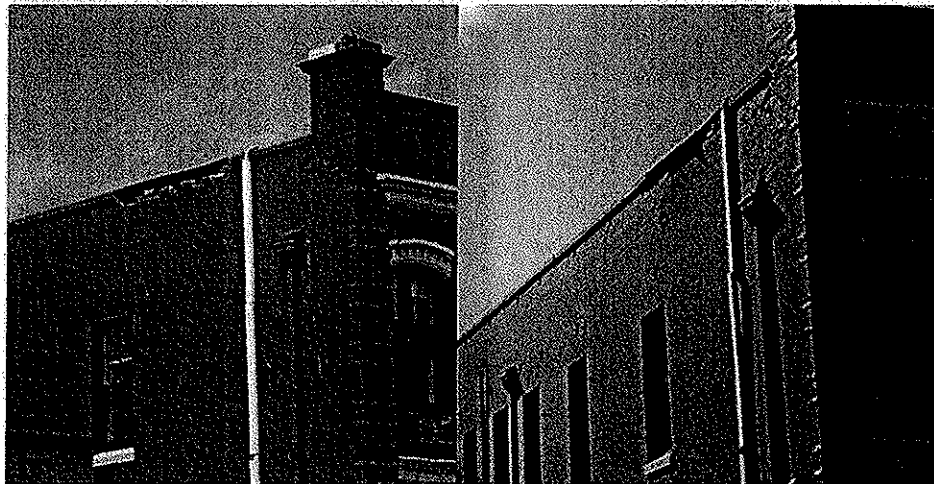
In Figure 8, it can be seen that although there have been no further bricks dropped from the north wall parapet, there is a section of veneer that has separated from the inner wythe and is in imminent danger of falling – this could be removed to make the area safe. It appears that there is now a similar trend in movement at the south face, with some further cracking, but no out-of-plane movement was noted.

Figure 8: North wall 15 Nov to 15 Feb - note out-of-plane offset of veneer at upper level

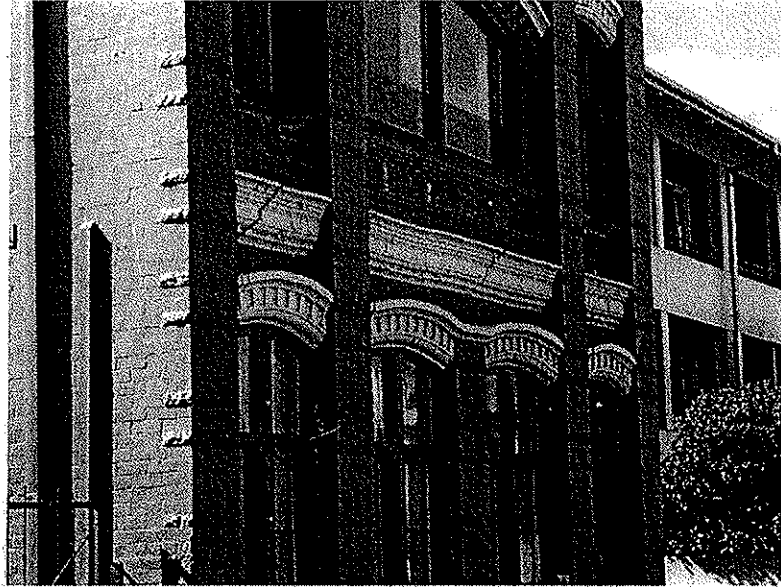
Figures 9 and 10 show the west facade on February 14. It is notable that there is now an out-of-plane offset in the cracks that was not previously evident and is difficult to detect from directly in front. This is reflective of the sharp east-west motion of the Boxing Day earthquake. This offset appeared to be in the region of 20mm in the worst case, but it is not discernable whether this is over the full width of the wall or only the outer course.

Figure 9: West Facade 15 Feb - note out-of-plane offset of near lintel

We recommend that if the facade is to be restored, it must be shored as soon as possible. It is still considered that the building could be saved, but costs would need to be reviewed. Nevertheless, our estimation of the cost of repair is that it would not be significantly more than the cost of full replacement.

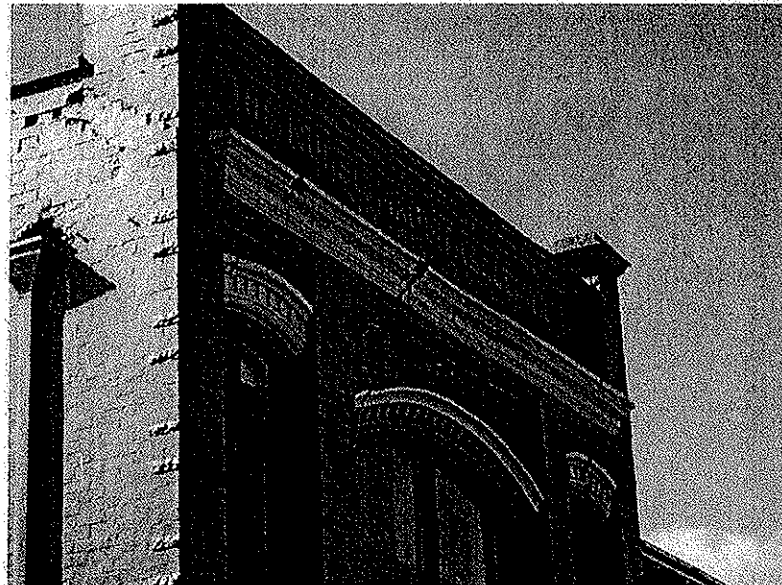
Figure 10: West facade 15 Feb - not out-of-plane offset of central lintel
