Report to the Royal Commission of Inquiry

The Performance of Unreinforced Masonry Buildings in the 2010/2011 Canterbury Earthquake Swarm

Associate Professor Jason M. Ingham The University of Auckland and

> > August, 2011

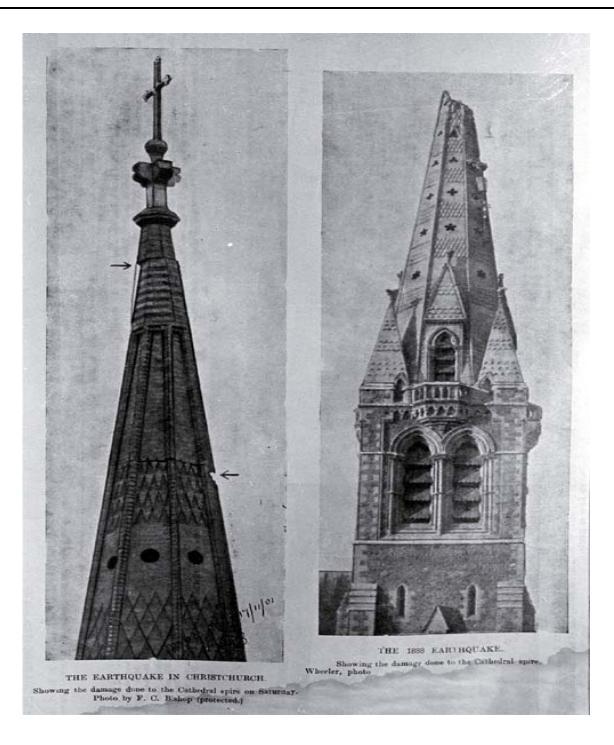
Figure 1.3 Damage to the Cathedral Spire in the 1888 (left) and 1901 (right) earthquakes (Bishop & Wheeler, 1901).

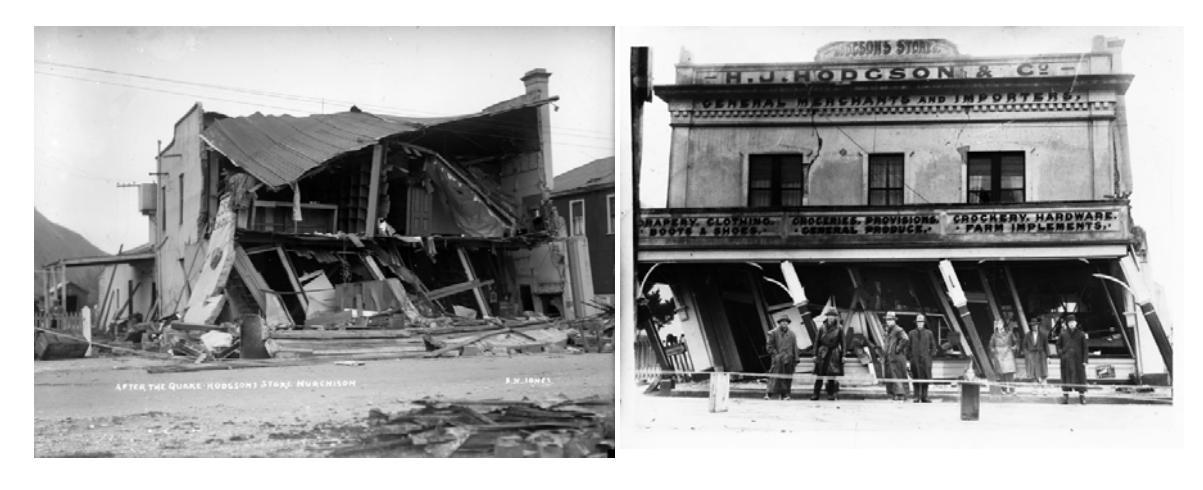
(a) General store damaged by the 1929 Murchison earthquake [Alexander Turnbull Library] (b) Damaged business premises after the earthquake of 17 June 1929 [Alexander Turnbull Library]

Figure 2.5 Damage to masonry buildings in the 1929 Murchison earthquake

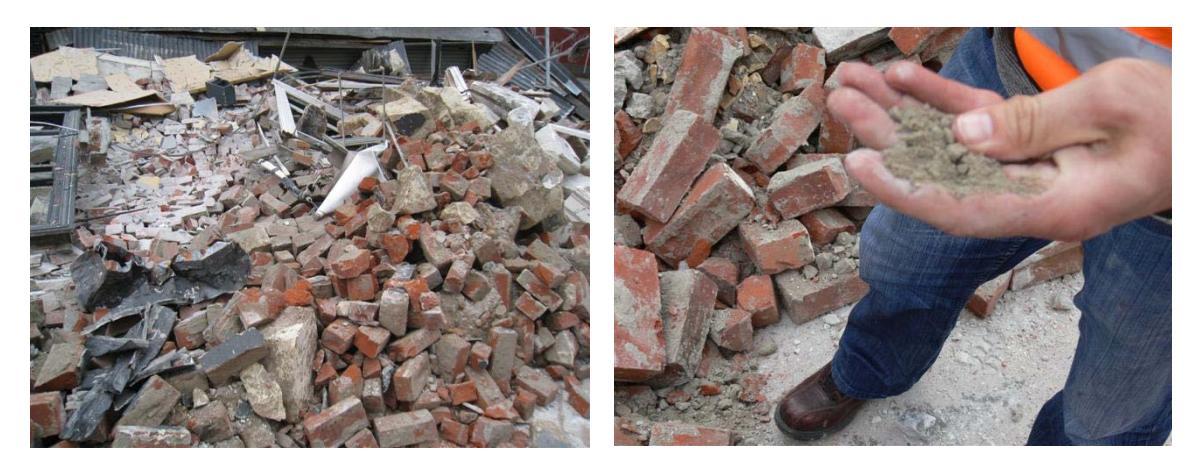
The general observation from the debris of collapsed URM walls was that the kiln fired clay bricks were generally of sound condition, but that the mortar was in poor condition. In most cases the fallen debris had collapsed into individual bricks, rather than as larger chunks of masonry debris (refer to Figure 3.3(a)). When rubbing the mortar that was adhered to bricks it was routinely found that the mortar readily crumbled when subjected to finger pressure (refer Figure 3.3(b)), suggesting that the mortar compression strength was very low. However, it appears that superior mortar was often used in the ornate parapet above the centre of the wall facing the street, as this segment of the collapsed parapet often remained intact as the parapet collapsed (refer Figure 3.4).

(a) Masonry rubble showing 'clean' bricks

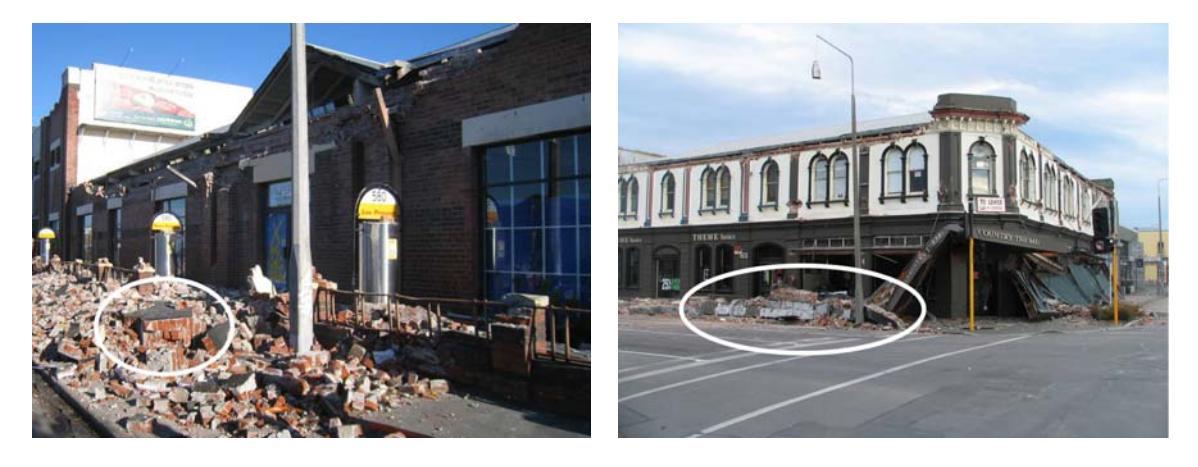
(a) Solid section of masonry gable
(b) Solid section of parapet
Figure 3.4 Large sections of masonry intact after fall from buildings

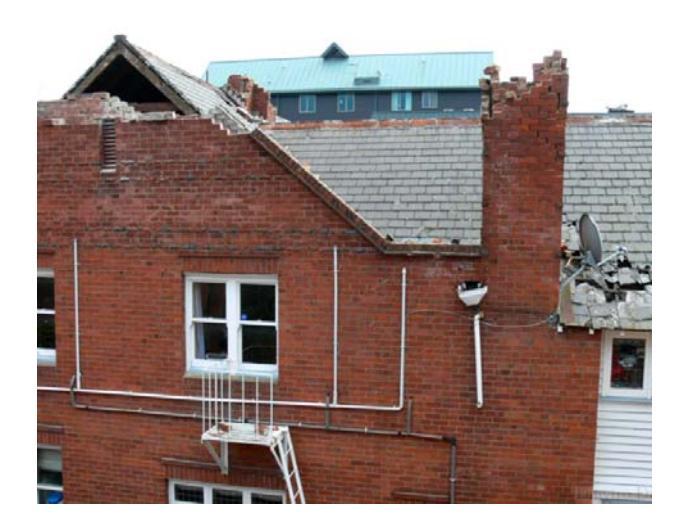
Unsupported or unreinforced brick chimneys performed poorly in the earthquake (Figure 3.6), with numerous chimney collapses occurring in domestic as well as small commercial buildings and some churches. Many examples of badly damaged chimneys that were precariously balanced on rooftops were also seen (Figure 3.6(b)) and it was reported that one week after the earthquake, 14,000 insurance claims involving chimney damage had been received, from a total of 50,000 claims (NewstalkZB, 2010). Emergency services personnel were in significant demand, being deployed to remove damaged chimneys in order to minimize further risk and eliminate these 'falling hazards' (Figure 3.6(c)). In contrast, Figure 3.6(d) shows an example of a braced chimney that performed well. Note that Figure 3.6(b) shows further evidence of the poor performance of mortar during the earthquake.

(a) Two damaged chimneys and gable wall

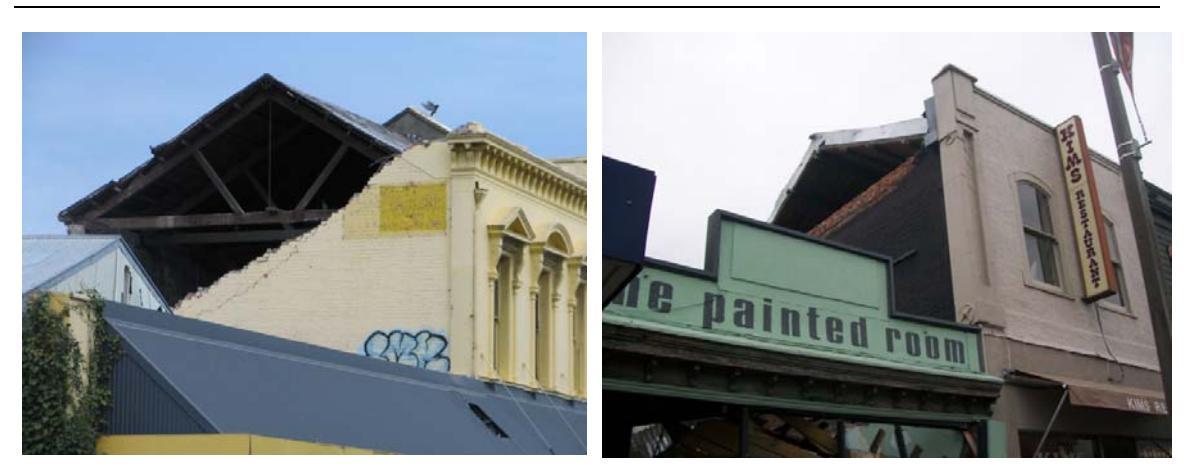
(a) 93 Manchester St

Many gable end wall failures were observed, often collapsing onto or through the roof of an adjacent building (refer to Figure 3.6(a) and Figure 3.7). However, there were also many gable ends that survived; many more than might have been expected, with the majority having some form of visible restraints that tied back to the roof structure. These examples are shown and discussed later (refer Figure 3.14 and Figure 3.15).

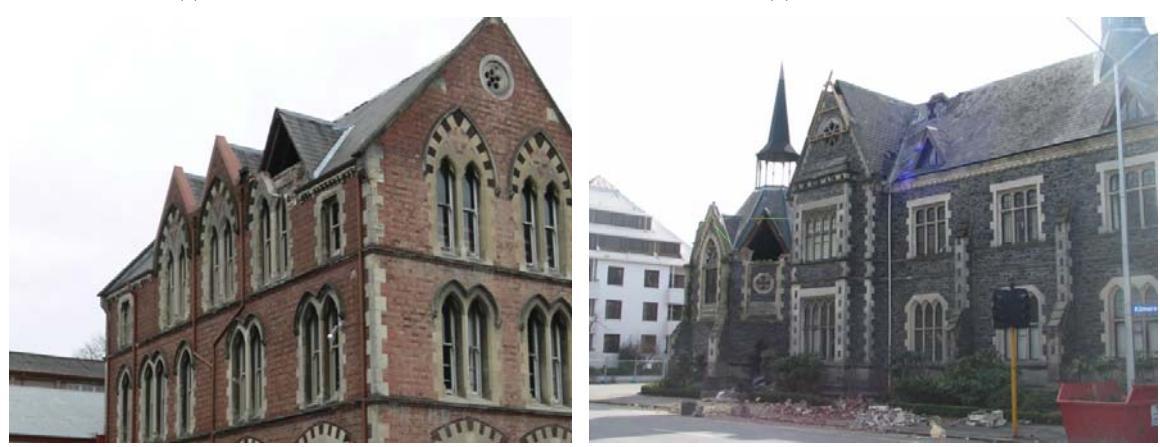
(c) Montreal-Armagh street corner
(d) Kilmore-Montreal street corner
Figure 3.7 Examples of gable end wall failures

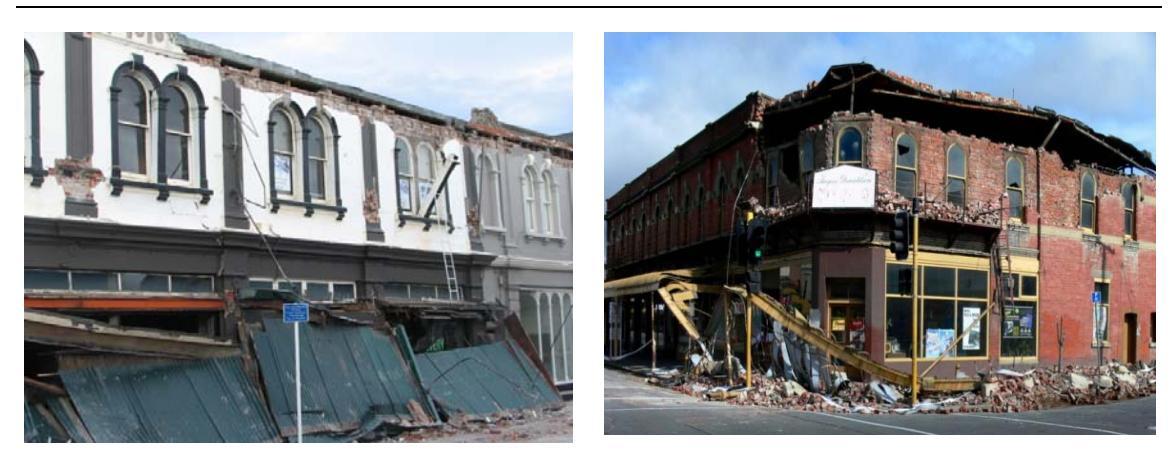
Numerous parapet failures were observed along both the building frontage and along their side walls. For several URM buildings located on the corners of intersections, the parapets collapsed on both perpendicular walls (refer Figure 3.8). Restraint of URM parapets against lateral loads has routinely been implemented since the 1940s, so whilst it is difficult to see these restraints unless roof access is available, it is believed that the majority of parapets that exhibited no damage in the earthquake were provided with suitable lateral restraint. In several cases, it appears that parapets were braced back to the perpendicular parapet, which proved unsuccessful.

(a) Multiple front wall parapet failures

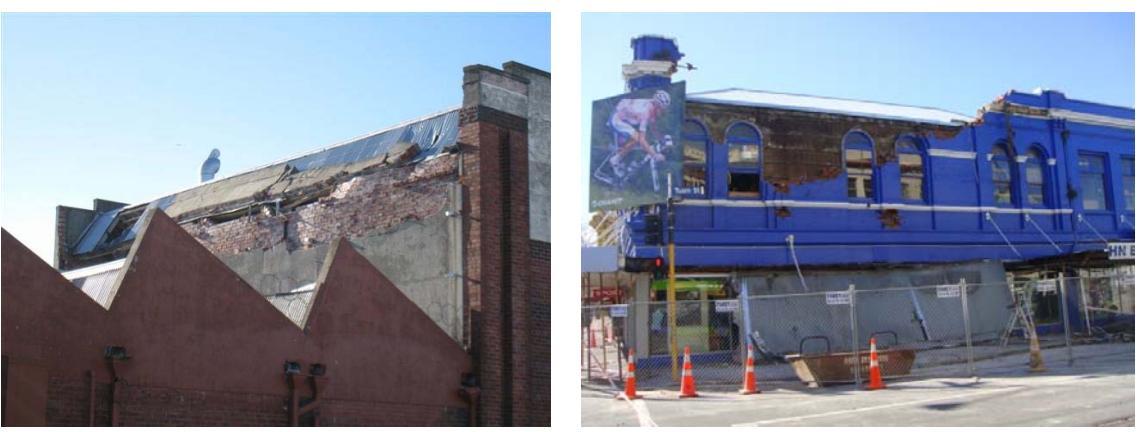
(c) Side wall parapet collapse onto roof.
(d) Corner Columbo and Tuam Street
Figure 3.8 Examples of typical parapet failures

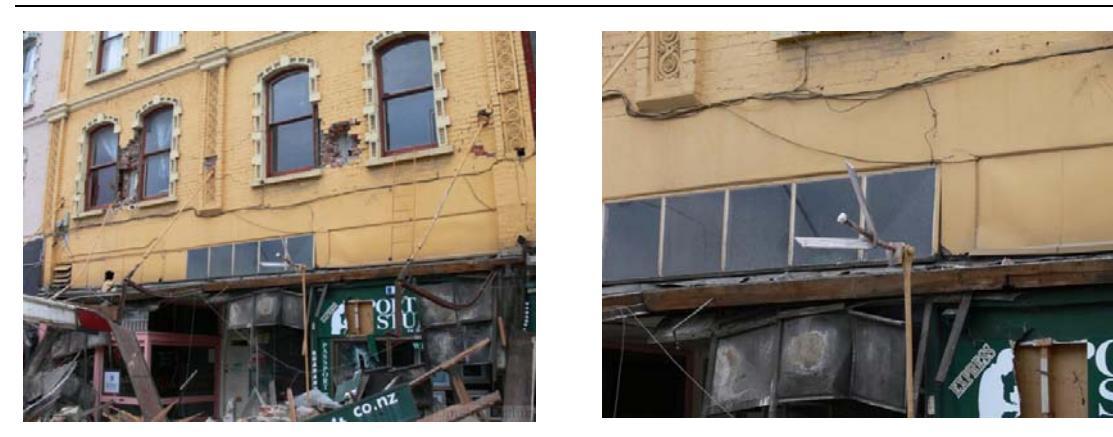
Falling parapets typically landed on awnings, resulting in an overloading of the braces that supported these awnings, leading to collapse. Most awning supports in Christchurch involved a tension rod tied back into the building through the front wall of the building. Many of these connections appear to consist of a long, roughly 25 mm diameter rod, with a rectangular steel plate (about 5 mm thick) at the wall end that is about 50 mm wide x 450 mm long and fastened to the rod and positioned either inside the brick wall or in the centre of a masonry pier or wall. In most cases the force on the rod exceeded the capacity of the masonry wall anchorage, causing a punching shear failure in the masonry wall identified by a crater in the masonry (refer Figure 3.9(a)).

(a) Anchorage failure
(b) Close-up of failed anchorage detail
Figure 3.9 Anchorage failure of awning brace due to parapet collapse

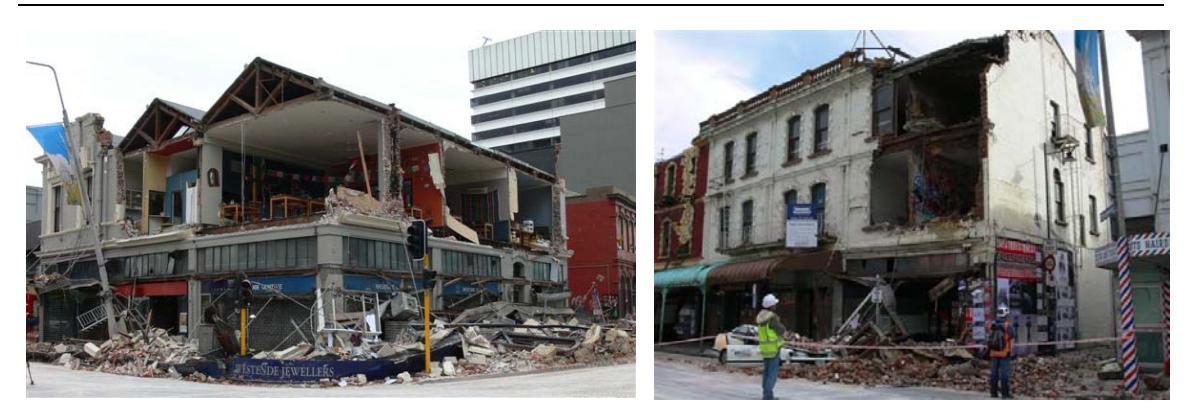
(a) Corner Worcester and Manchester streets

Out-of-plane wall failures were the first images to appear on television directly after the earthquake. Inspection of this damage typically indicated poor or no anchorage of the wall to its supporting timber diaphragm. Several examples of wall failure are shown below. Figure 3.10(a) shows a corner building that had walls fail in the out-of-plane direction in both perpendicular directions, on both sides of the corner. Figure 3.10(b) shows a 3-storey building where walls in the upper two stories suffered out-of-plane failures and Figure 3.10(c) shows similar damage for a 2-storey building. In all three of these instances, it appears that the walls were not carrying significant vertical gravity loads, other than their self weight, due to the fact that the remaining roof structures appeared to be mostly undamaged. In contrast, Figure 3.10(d) shows an out-of-plane failure of a side wall which was supporting the roof trusses prior to failure.

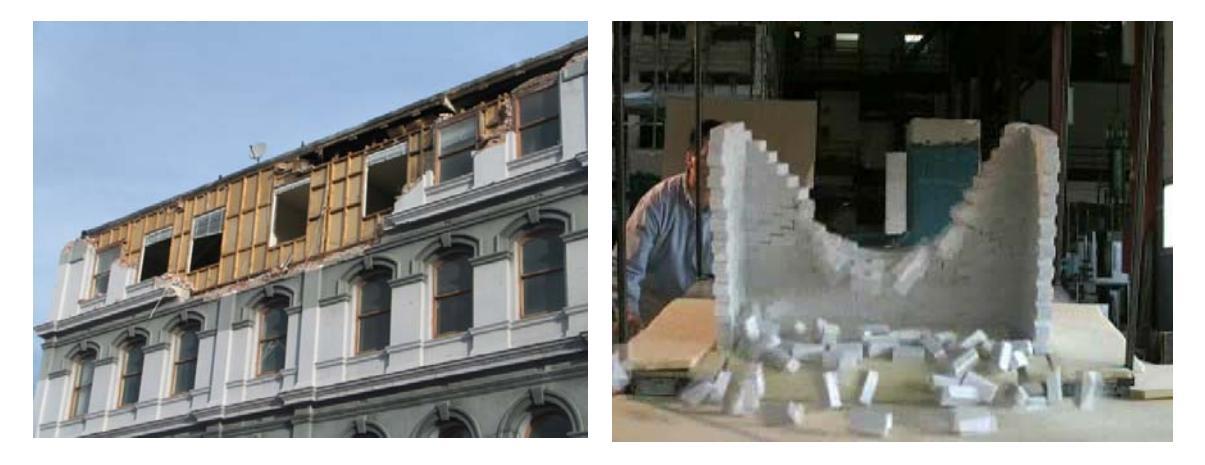
As shown in Figure 3.11, several examples of face load wall failure closely resembled observed damage in dry stack masonry experiments (Restrepo-Velez and Magenes, 2009), providing further support to the supposition that many of the wall failures were partly attributable to poor mortar strength.

(a) Wall damage at 140 Linchfield Street

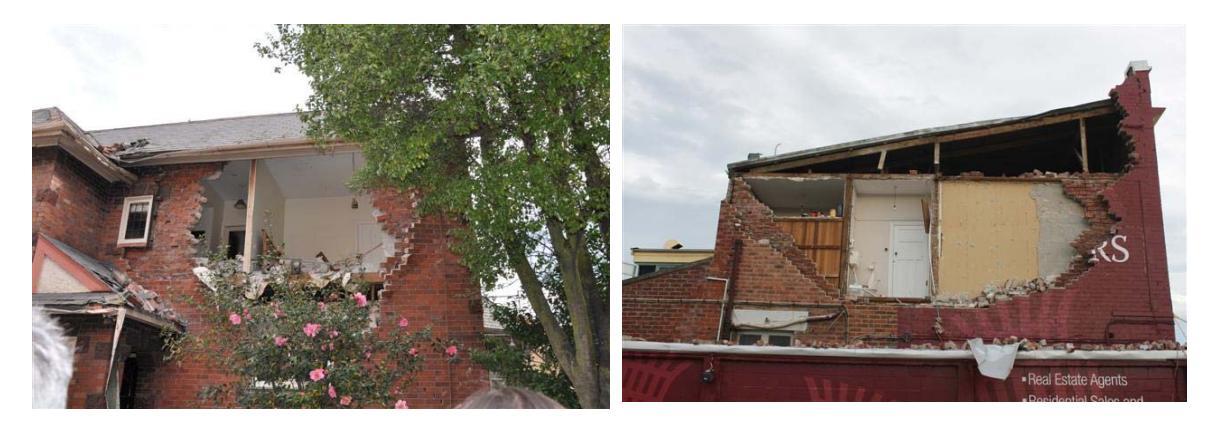
Cavity wall construction is generally believed to be much less common in New Zealand than is solid multi-leaf (or multi-wythe) construction. However, cavity wall construction can be extremely vulnerable to out-of-plane failure in earthquakes in situations where the cavity ties were poorly installed, or more commonly have corroded over time, as the wall is then comparatively slender and less stable than for solid construction. Figure 3.12(a) and (b) show examples of cavity wall buildings that suffered out-of-plane wall failures.

(a) Cavity wall failure in a residential building

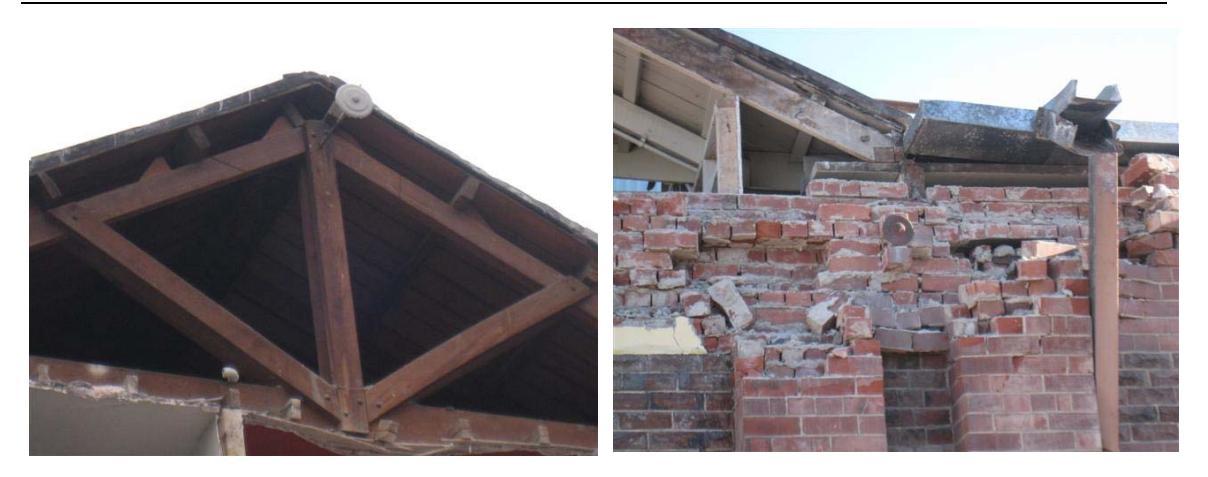
In some cases wall-diaphragm anchors remained visible in the diaphragm after the wall had failed, indicating that failure had occurred due to bed joint shear in the masonry (refer Figure 3.13(a)). Figure 3.13(b) shows a situation where a diaphragm anchor had been embedded within the wall. It can be seen that the anchor successfully prevented the restrained wall from failing, but was not able to prevent toppling of the parapet that was located above the anchor.

(a) Gable end wall failure despite anchor (see also Figure 13a).

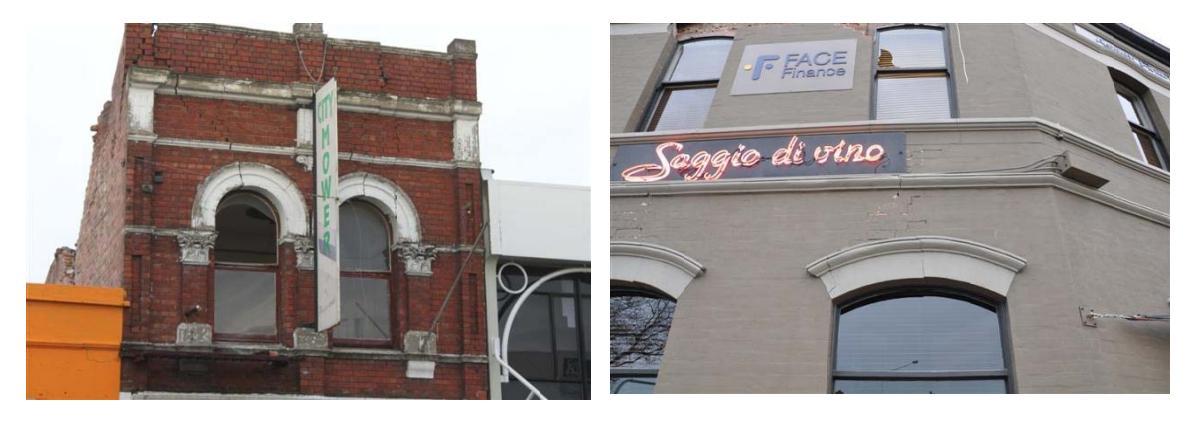
Where walls exhibited some damage to in-plane deformation the cracks were mostly seen to pass vertically through the lintels over door or window openings. Although this type of damage was not widely observed, examples are shown in Figure 3.16.

(a) Extensive vertical cracking above window openings

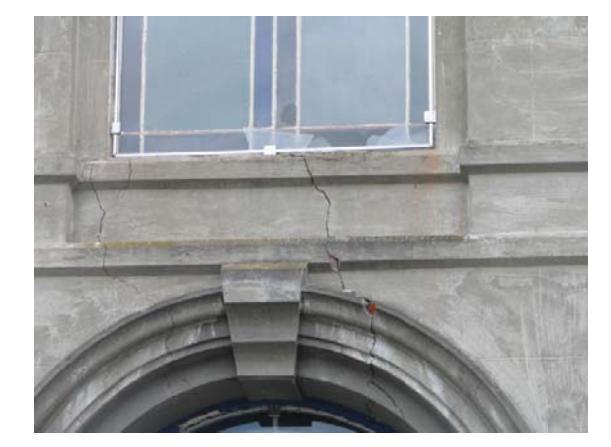
(c) Vertical crack through spandrel

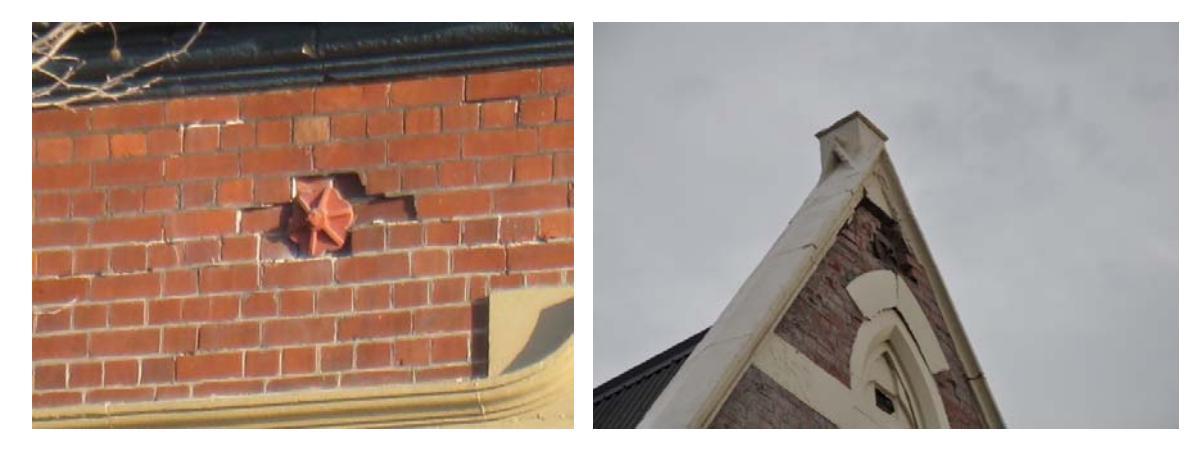
noted that the buildings were not in close proximity to each other. An example of a gable end partial failure is shown in Figure 3.18(b), which can be compared to the comparable anchorage detail shown in Figure 3.13(a) that resulted in complete failure.

(a) Wall-roof anchorage failure

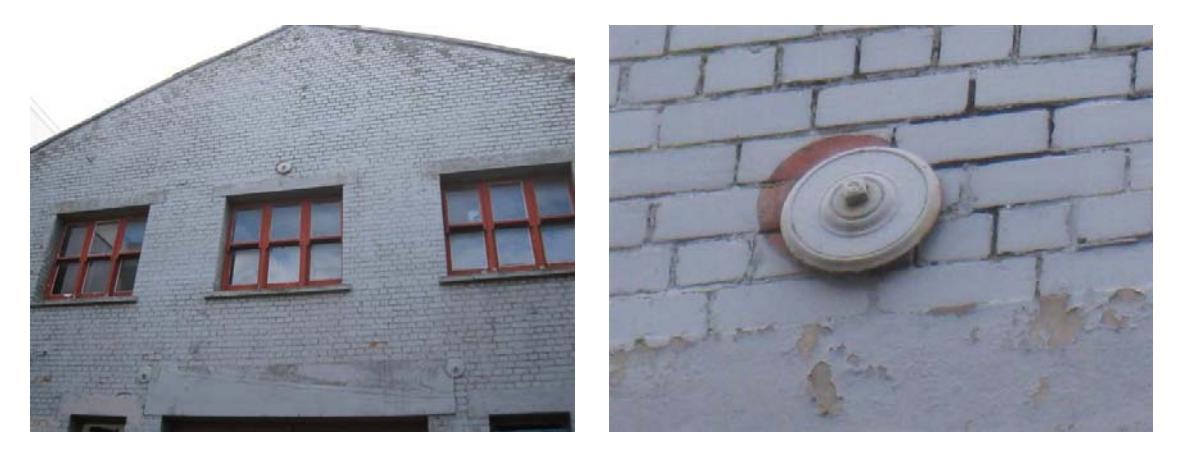
There were frequent examples of wall-diaphragm anchors that had deformed plastically. In these photographs (Figure 3.19), the circular plate can be seen to be slack due to plastic stretching of the anchor rod.

(a) Overview of wall anchors

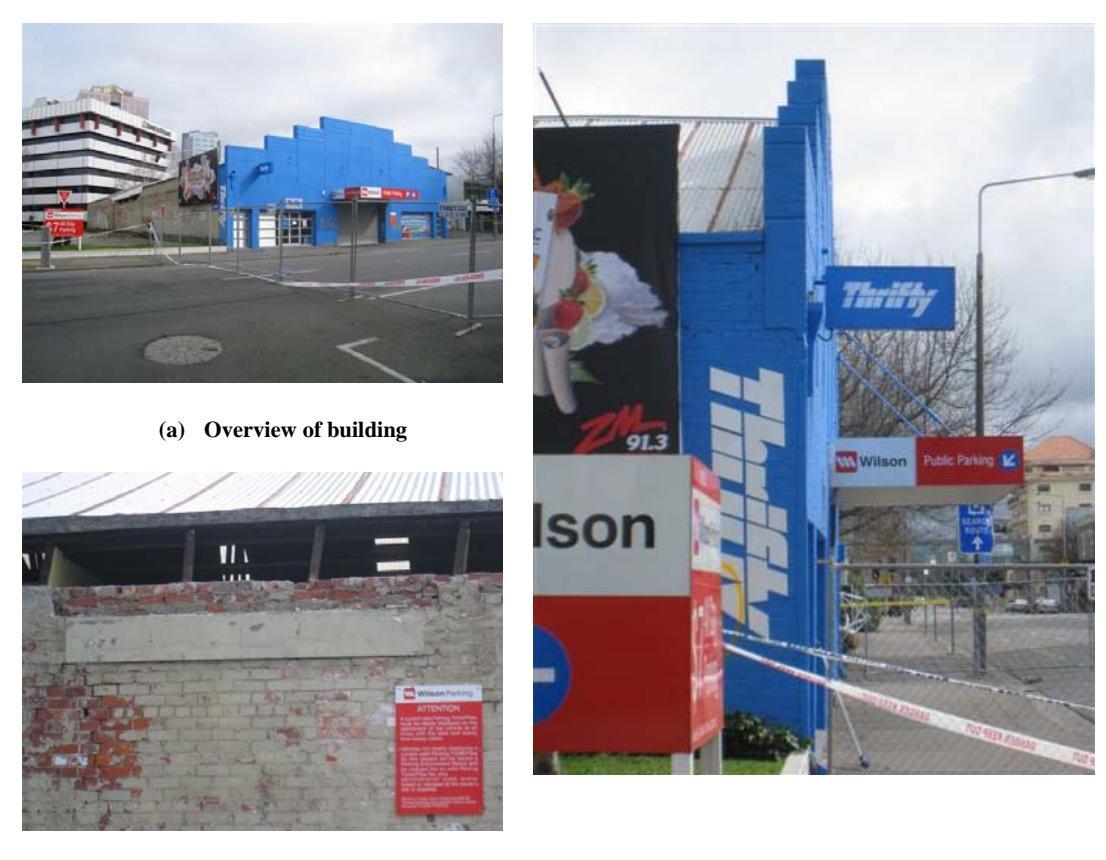
There was one instance where it was clear that diaphragm deformation, relative to the in-plane walls, contributed to partial failure of an out-of-plane wall. Figure 3.20 shows several views of a building which suffered out-of-plane parapet failure along its long, side walls. In Figure 3.20(b) it can be seen that the roof joists have tilted towards the front of the building. This suggested that the front wall of the building was driven forward at its top. Careful inspection of the front wall (Figure 3.20(c)) revealed a substantial outwards curvature which was most pronounced at the top.

(b) Side-view of tilted joists

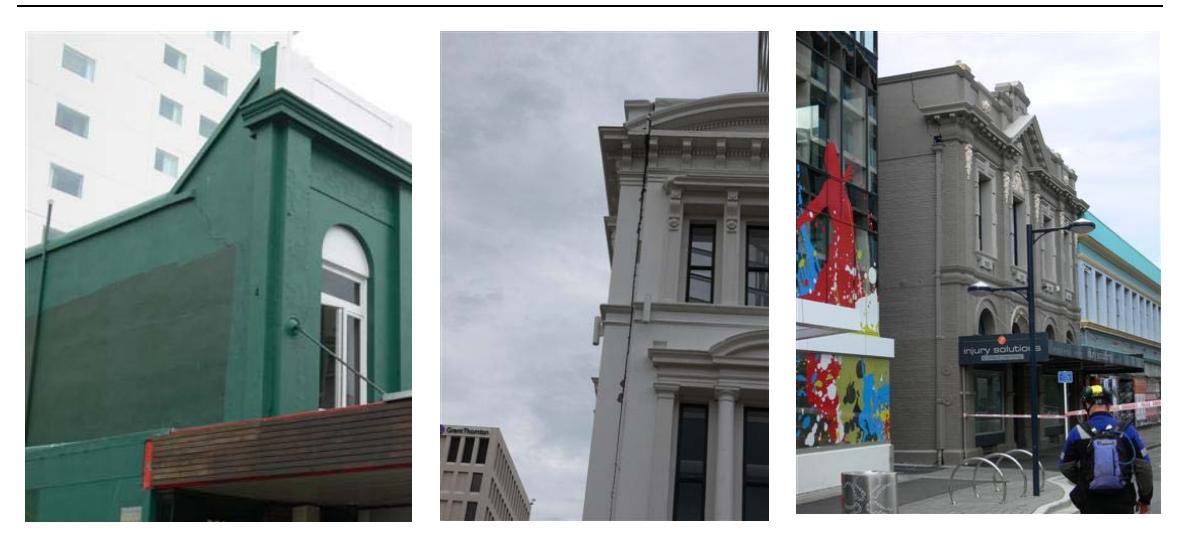
Many buildings exhibited substantial cracking between their front wall and side (return) walls. This damage is not necessarily a catastrophic problem if stiff horizontal diaphragms are well connected to the walls in both directions, but where there is not good diaphragm connectivity, there is the potential for complete out-of-plane collapse of one or both walls. Figure 3.21 shows some examples where major cracking was observed between the side return walls and the front parapet and wall.

Figure 3.21 Examples of wall separation at corners of buildings

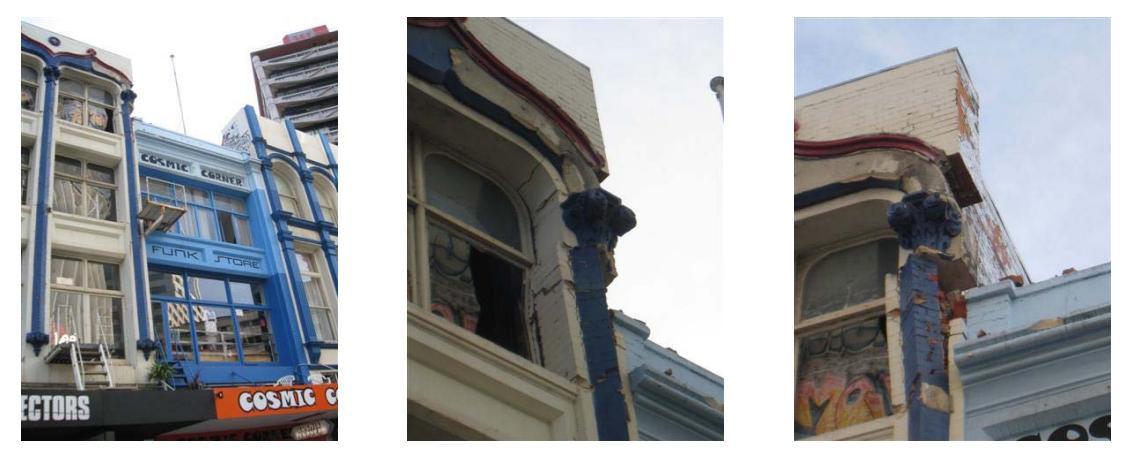
Several instances of damage due to buildings pounding against each other during the earthquake were observed. Figure 3.22 shows how the shorter building in the centre, which has different floor heights than the building to the left, damaged the column of the taller building at its top storey.

```
(a) Building overview
```

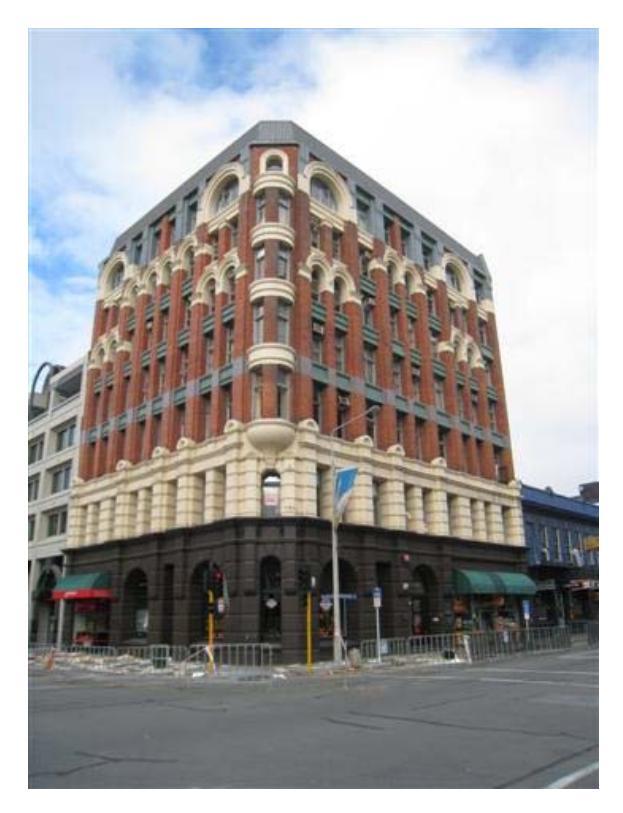
bearing unreinforced masonry piers around the exterior of the building and a steel frame internally (columns spaced roughly at 5 m) with timber floors throughout (New Zealand Historic Places Trust, 2010). The masonry piers, having dimensions of approximately 1200 x 900 mm, were badly cracked at levels 3 and 4 (Figure 3.24). This damage was most likely due to the transition from concrete to masonry at level 3 and the fact that the adjoining 2-storey building located along the southern wall side stopped providing lateral support at that level. It appears that the lift core had received some strengthening previously, as well as the roof, perhaps in the late 1980s as reported by the New Zealand Historic Places Trust (2010). Close up photographs of the masonry piers at levels 3 and 4 show the primary damage that concerned the assessment teams (Figure 3.24). Further inspection by the assessment team exposed the internal face of one pier on the western face of the building to reveal that the external cracking continued through the entire pier thickness.

Figure 3.23 Manchester Courts building (view from NW)

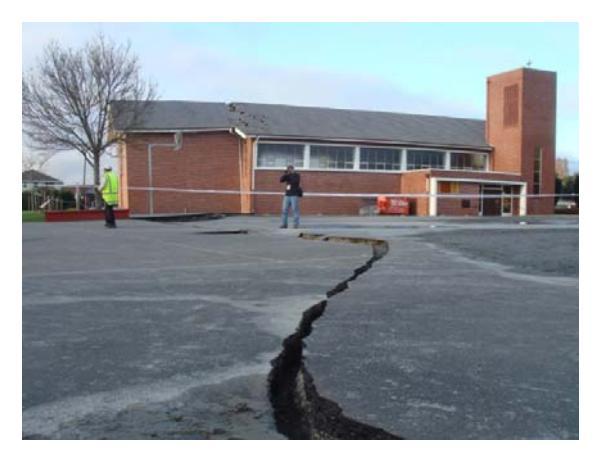
Perhaps the most striking aspect overall of the 2010/2011 Canterbury earthquake swarm was the extensive amount of liquefaction and ground deformation that occurred. These phenomena were not seen to a significant extent in the Christchurch CBD region containing the highest density of URM buildings, but did impact on a number of timber framed structures with masonry veneer. As shown in Figure 3.26, several cases of extreme ground deformation that affected URM buildings were observed outside of the CBD, and there were numerous cases where large crack widths formed in residential timber framed structures having a masonry veneer (Figure 3.26(c)). There were also cases where ground liquefaction had resulted in masonry structures having sunk into the ground (Figure 3.26(d)).

(a) Damage to masonry veneer due to ground deformation

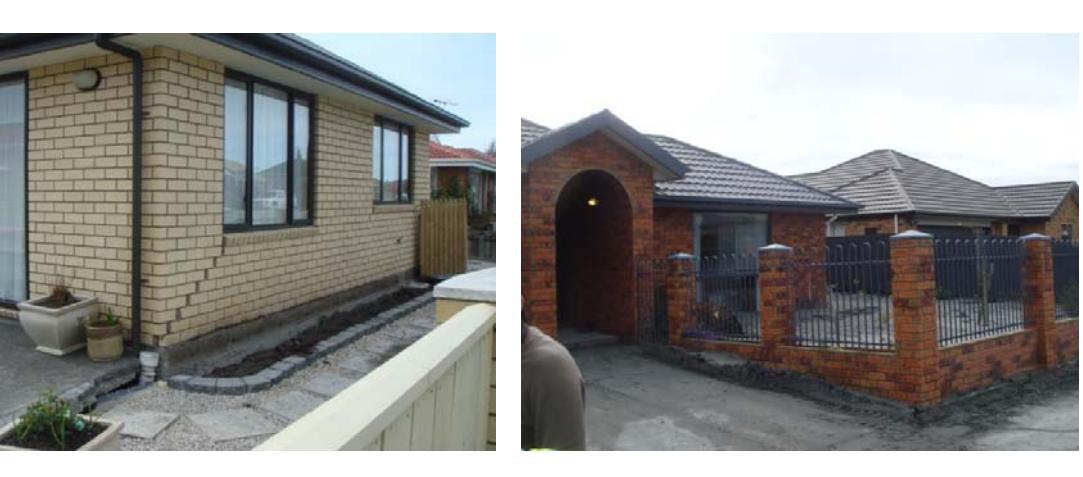
(c) Masonry veneer damage to recently built residence. (d) Damage d

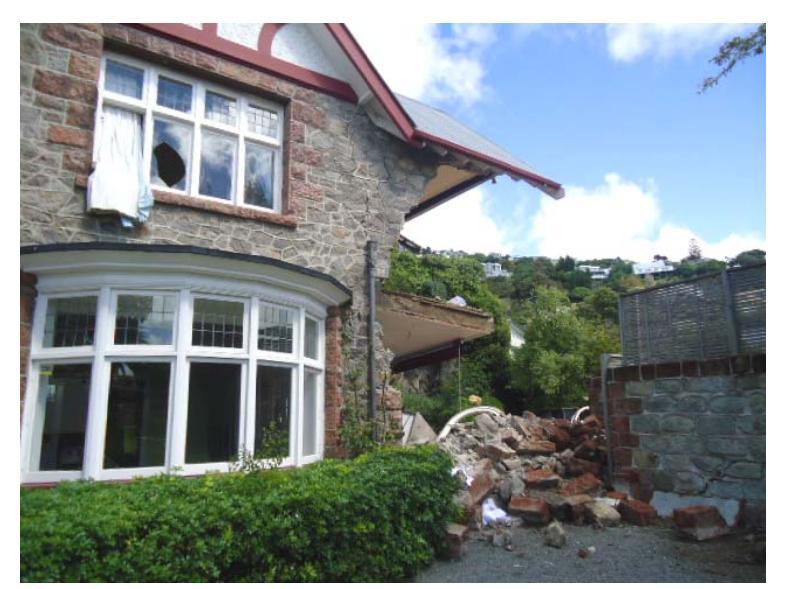
Figure 3.31 Rockvilla dwelling with complete collapse of the north and east façades

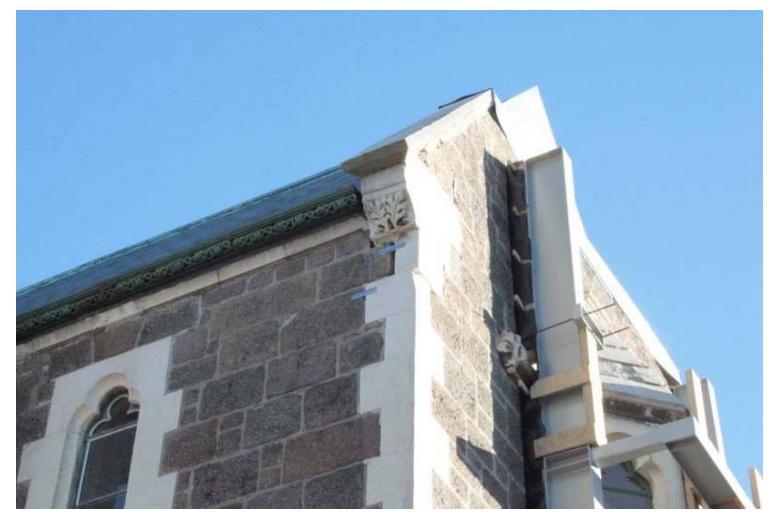
Figure 3.32 Christchurch Arts Centre (former Old Boy's High building), with severe damage due to instability of the façade at the second storey

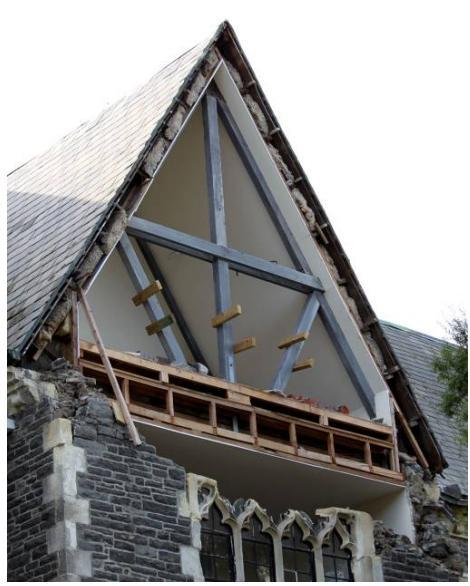
Figure 3.33 Cramner Court, showing complete collapse of a gable

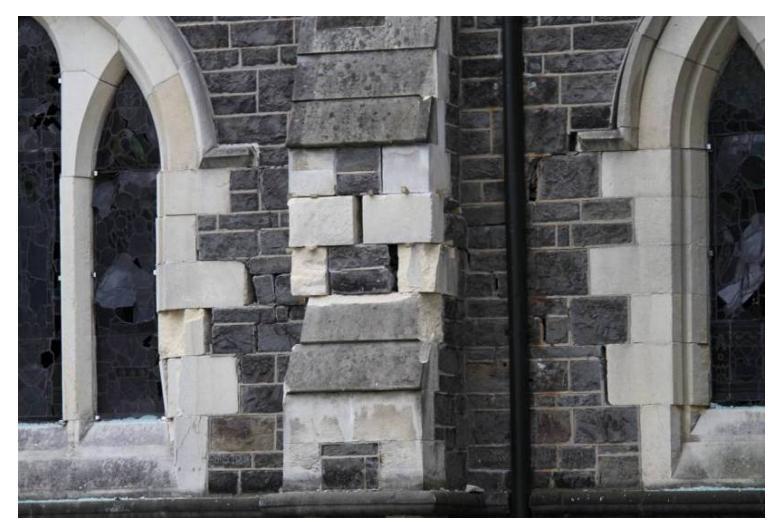
Figure 3.34 Christchurch Anglican Cathedral - diagonal cracks in the south façade piers

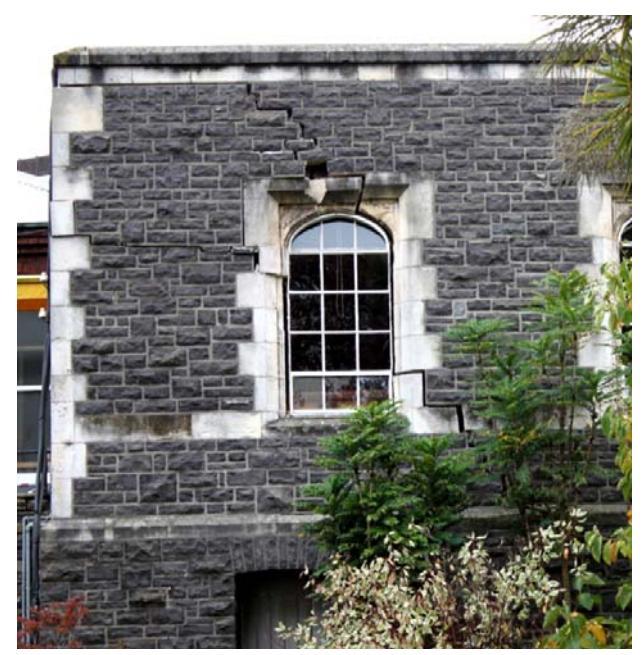
Figure 3.35 Canterbury Provincial Chambers - diagonal crack through entire south façade of the east annex

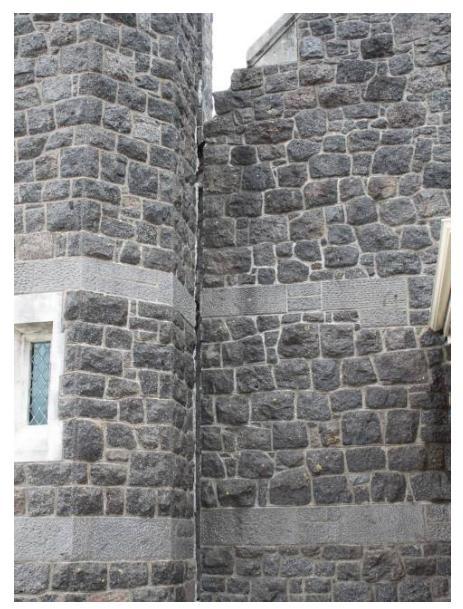
Figure 3.37 St. Mary's Anglican Church - detachment of the bell tower from the nave

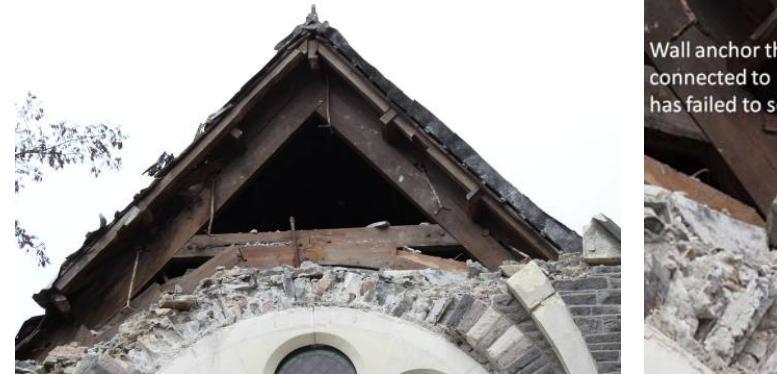
(a) overturning of the front façade gable

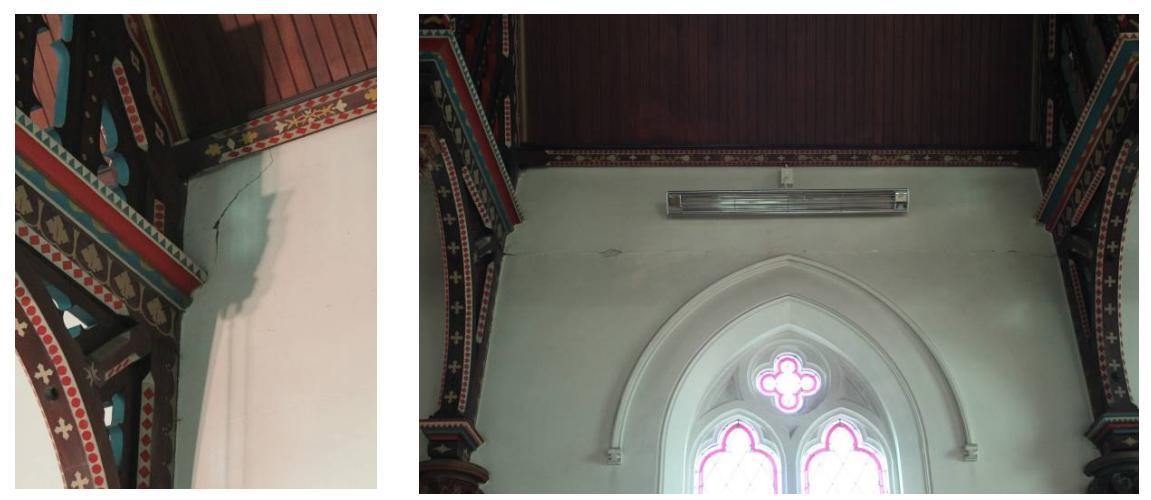
Figure 3.41 St James' Church, hammering of roofing elements on the walls of the nave

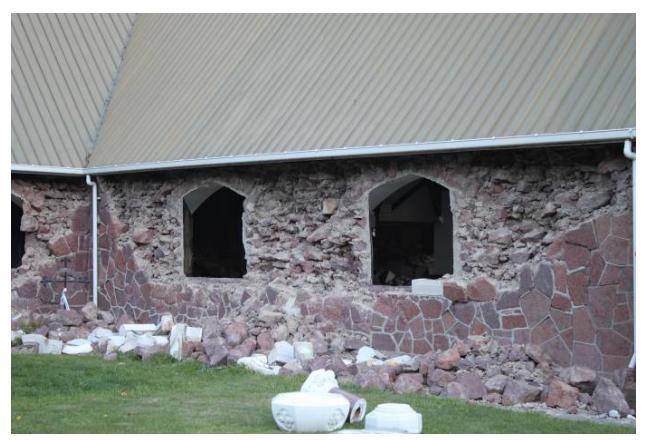
Figure 3.42 Lyttelton Holy Trinity Church. Damage induced by hammering of the roof

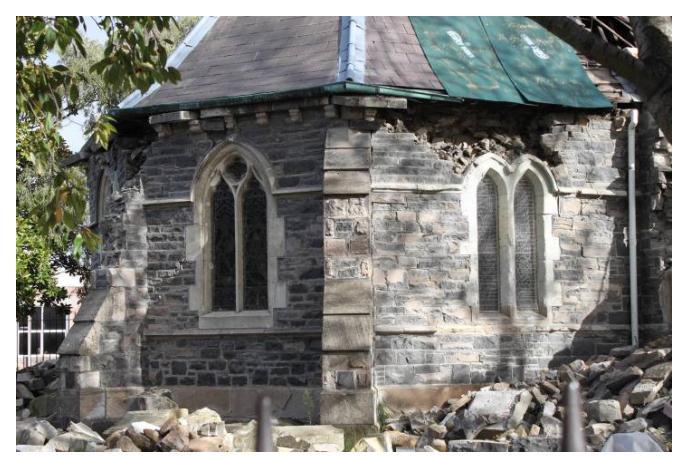
Figure 3.43 St. John's the Baptist Church. Local collapse of material

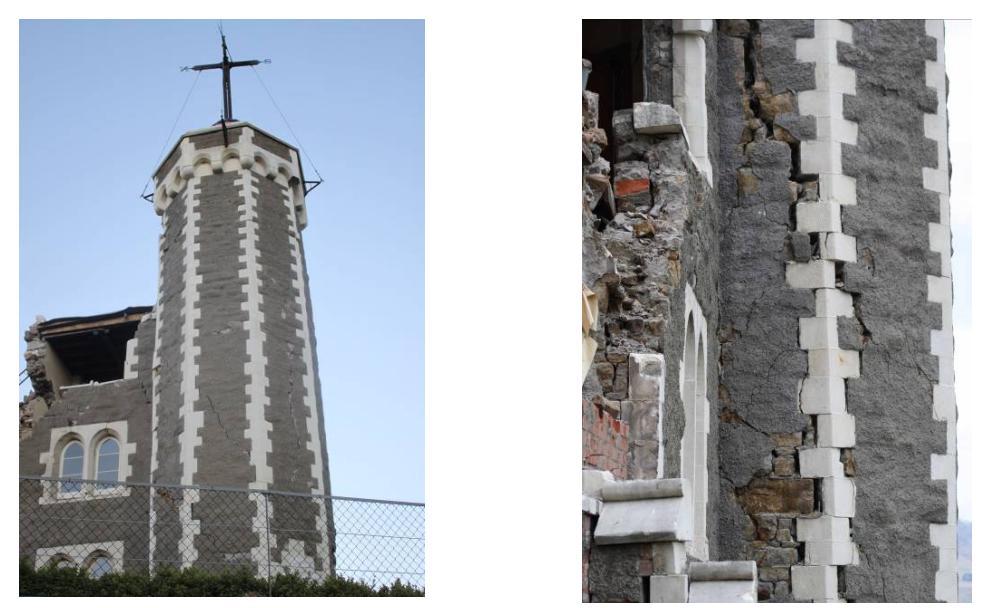
Figure 3.44 Time Ball Station. Damage in the Time Ball tower

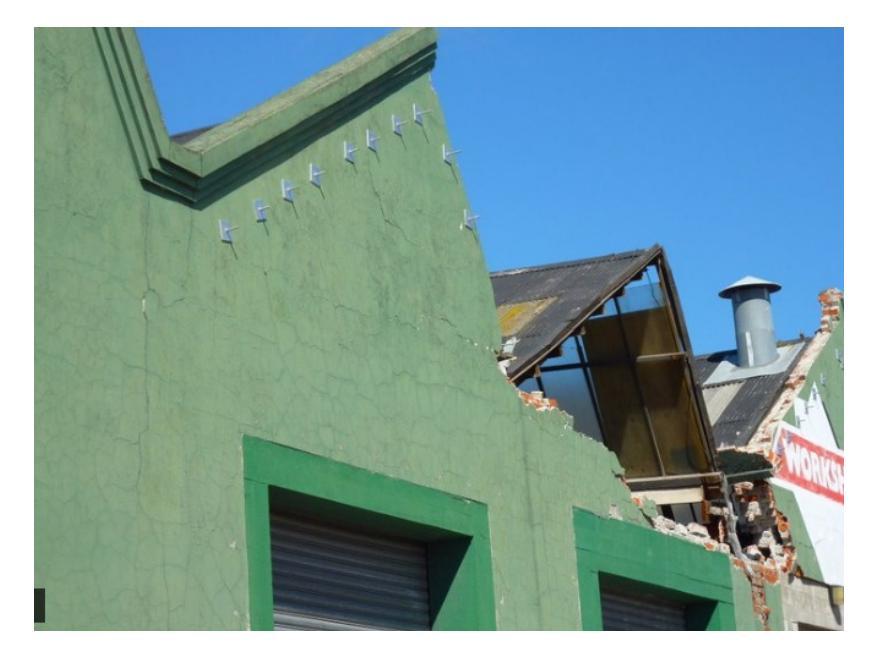
Figure 4.1 Example of a secured gable end that survived earthquake loading and a companion failed gable end that was not secured

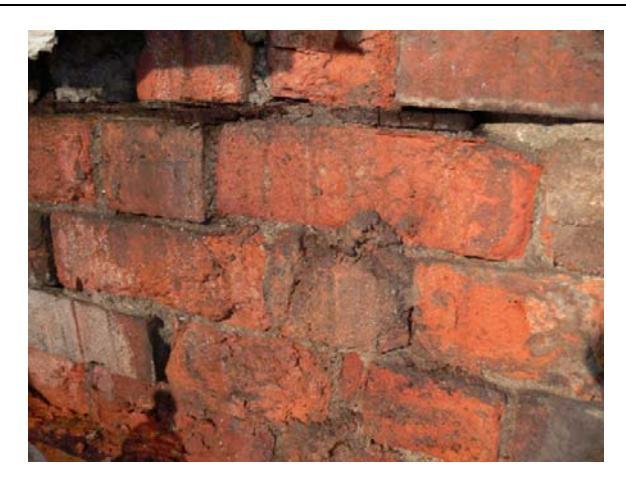
Figure 4.2 Severely degraded bricks and mortar due to moisture ingress

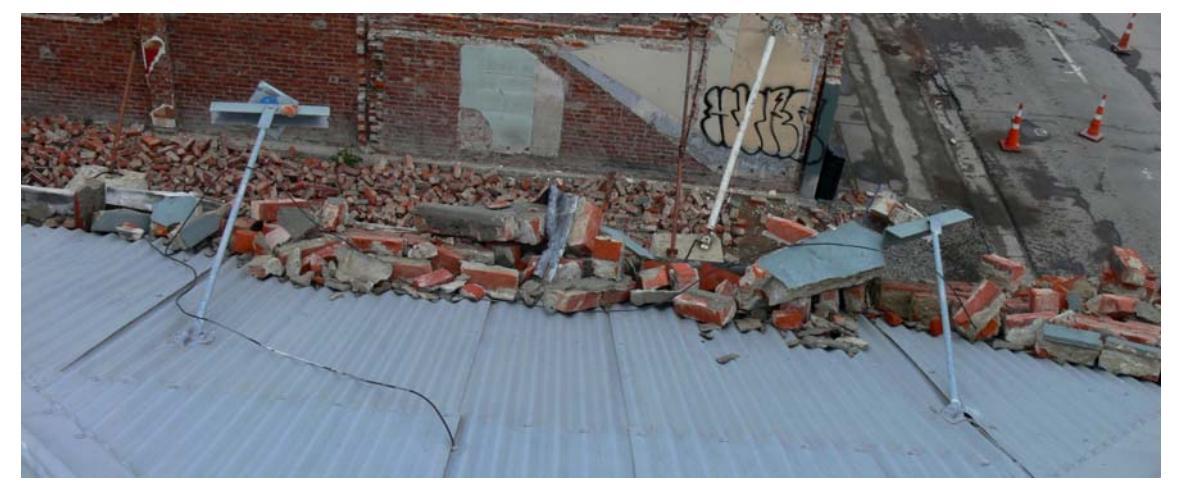
(a) Roof level view of failed parapet restraint

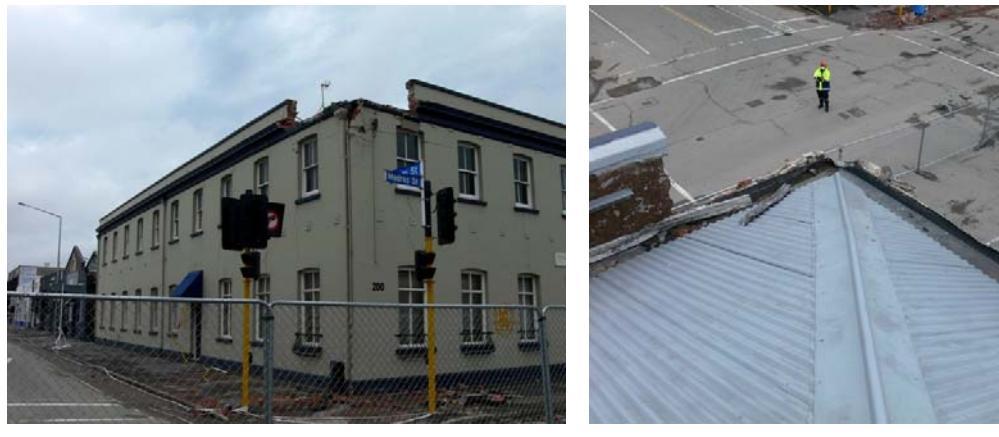
(b) Exterior view of failed parapet at corner

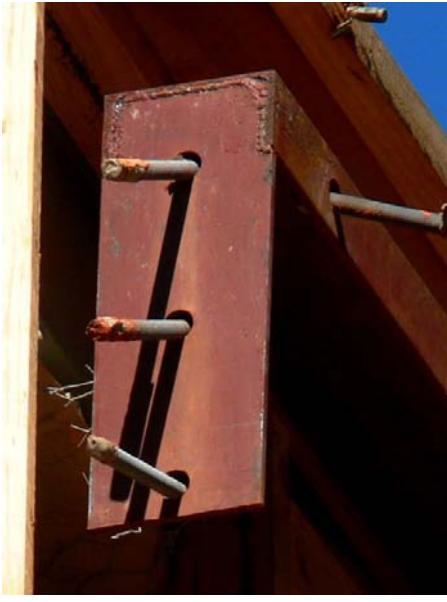
(a) Failure of a steel fixing due to anchor withdrawal
