Report to the Royal Commission of Inquiry

The Performance of Unreinforced Masonry Buildings in the 2010/2011 Canterbury Earthquake Swarm

Associate Professor Jason M. Ingham The University of Auckland and

> > August, 2011

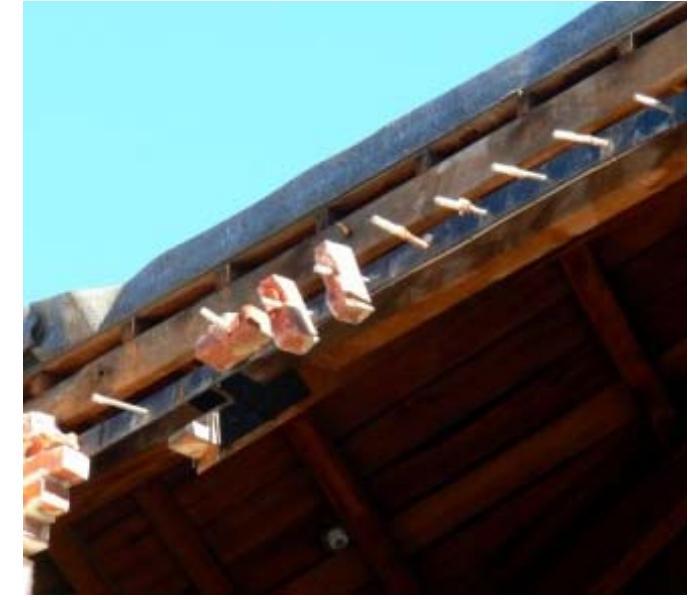
(b) Failure of a steel fixing due to both anchor withdrawal and brick detachment

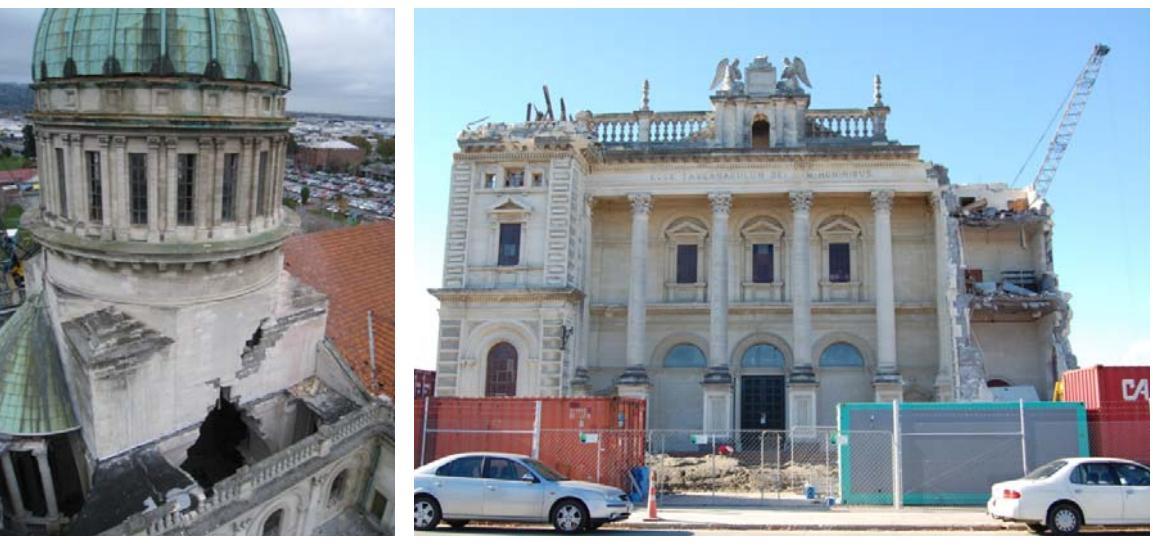
(a) Damage to drum at base of dome

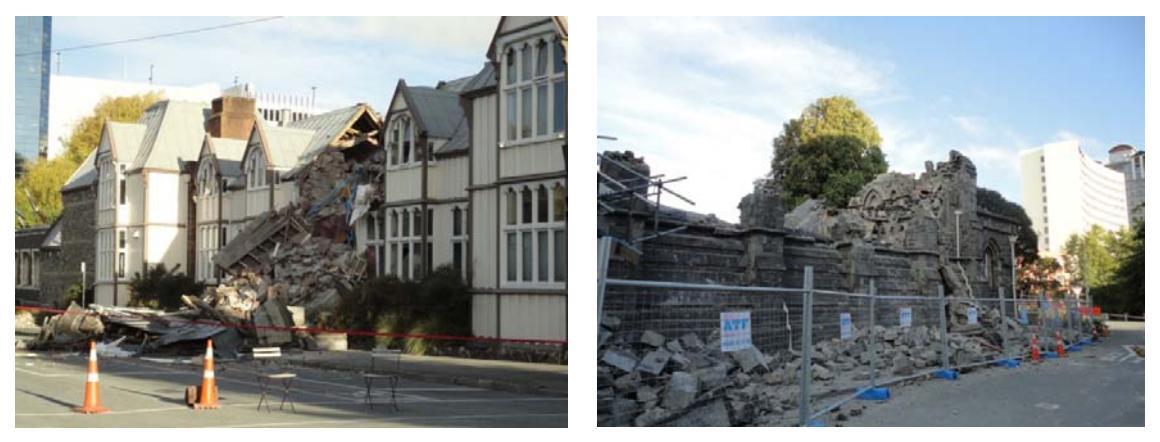
(a) Stone masonry collapse

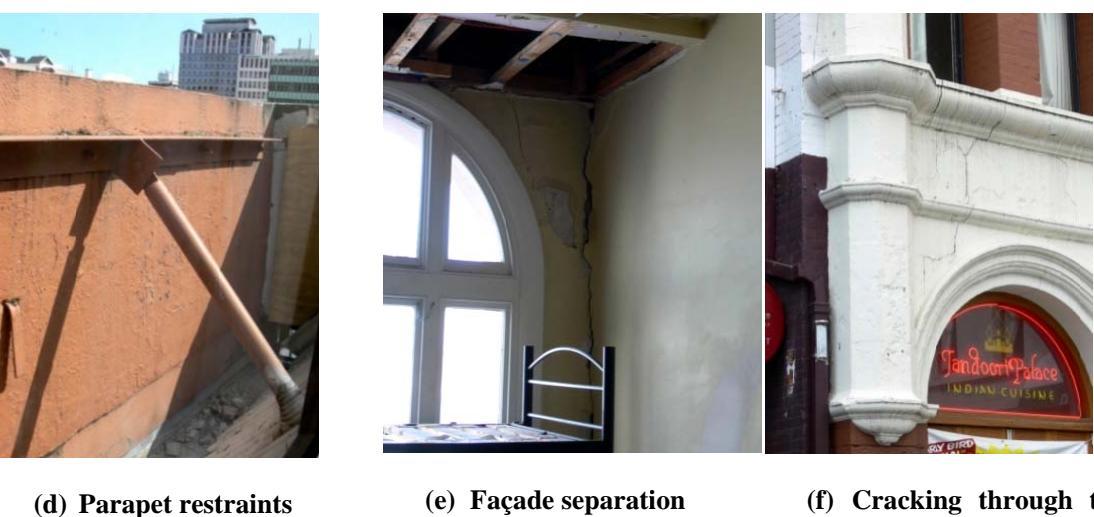
(f) Cracking through the spandrel on ground level

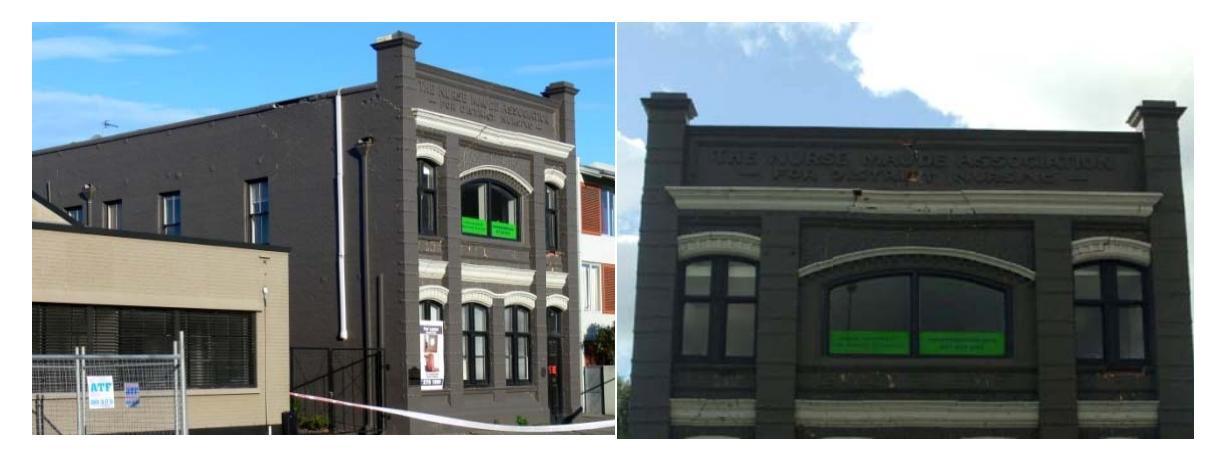
(a) cracking through top spandrel
