Canterbury Earthquakes Royal Commission

Re: 7 Riccarton Road

Canterbury Earthquakes Royal Commission – 7 Riccarton Road - response by David Elliott, Senior Structural Engineer with Aurecon New Zealand Limited, to Royal Commission's request for information dated 30 August 2011

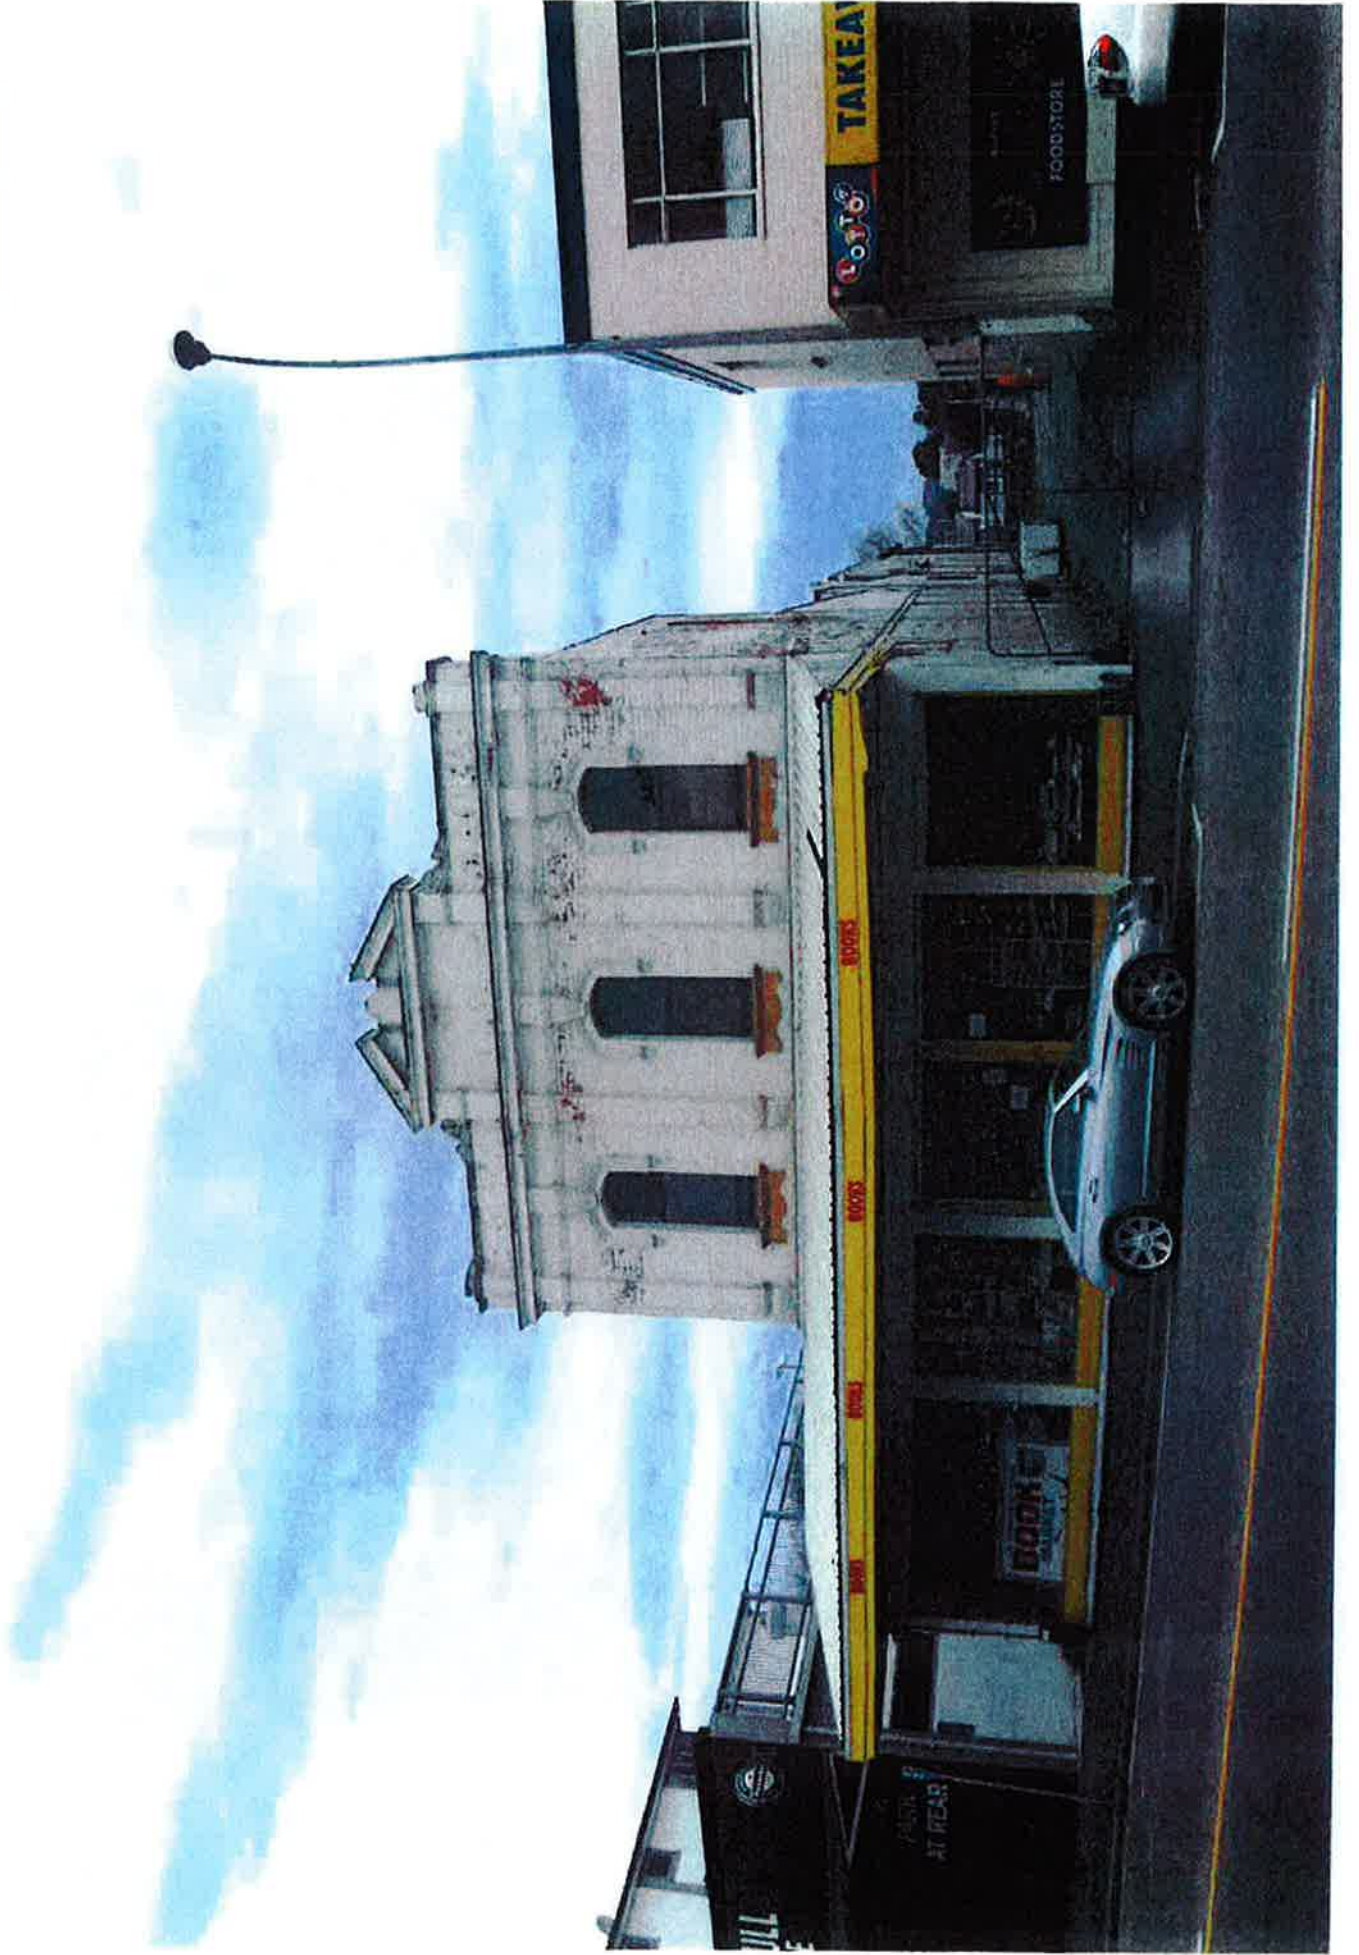
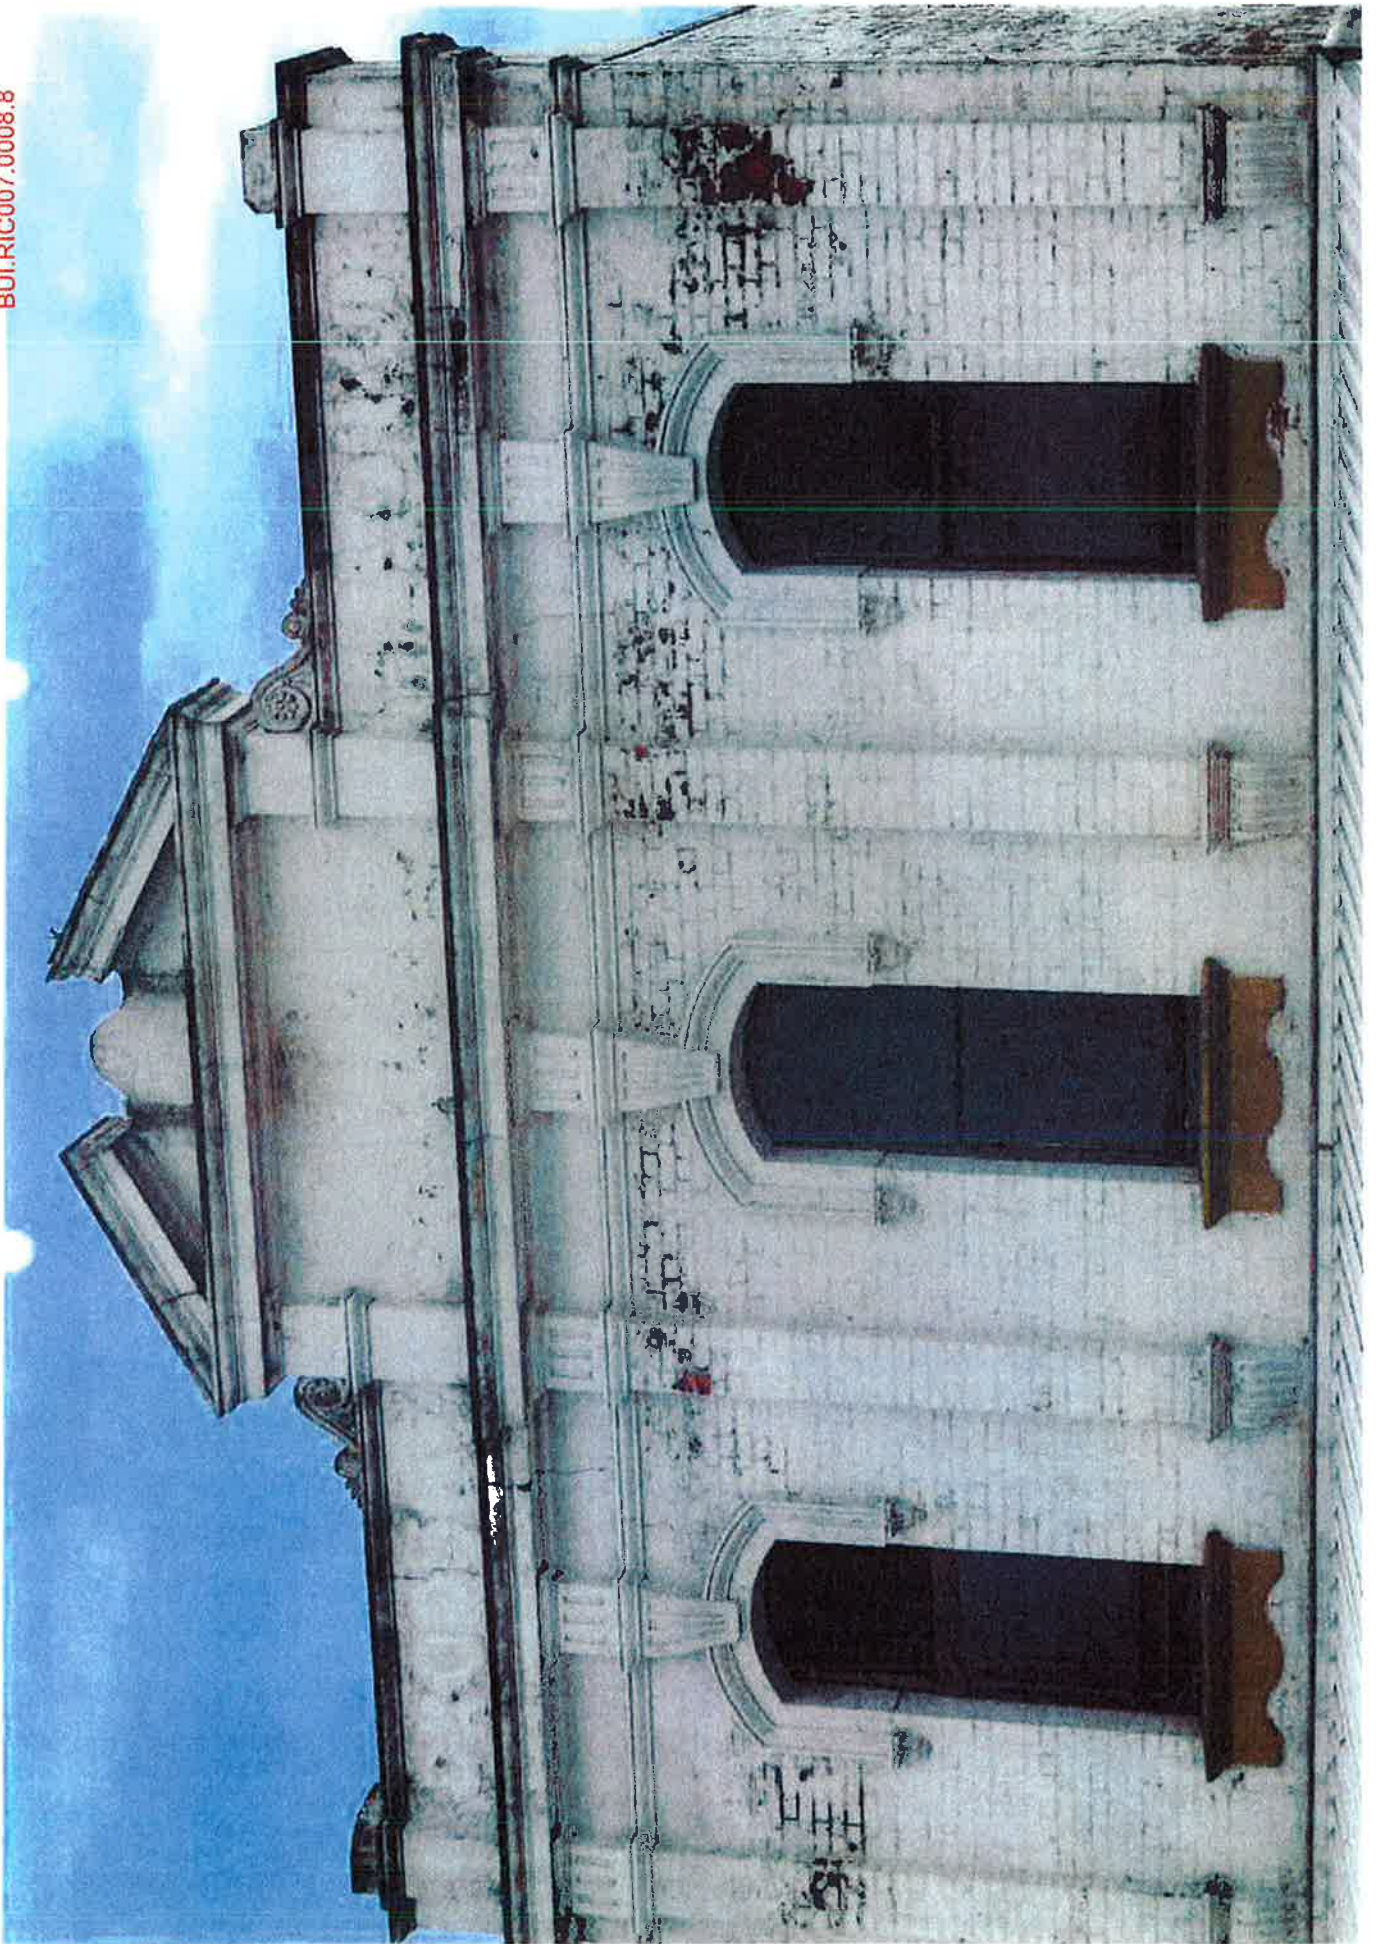
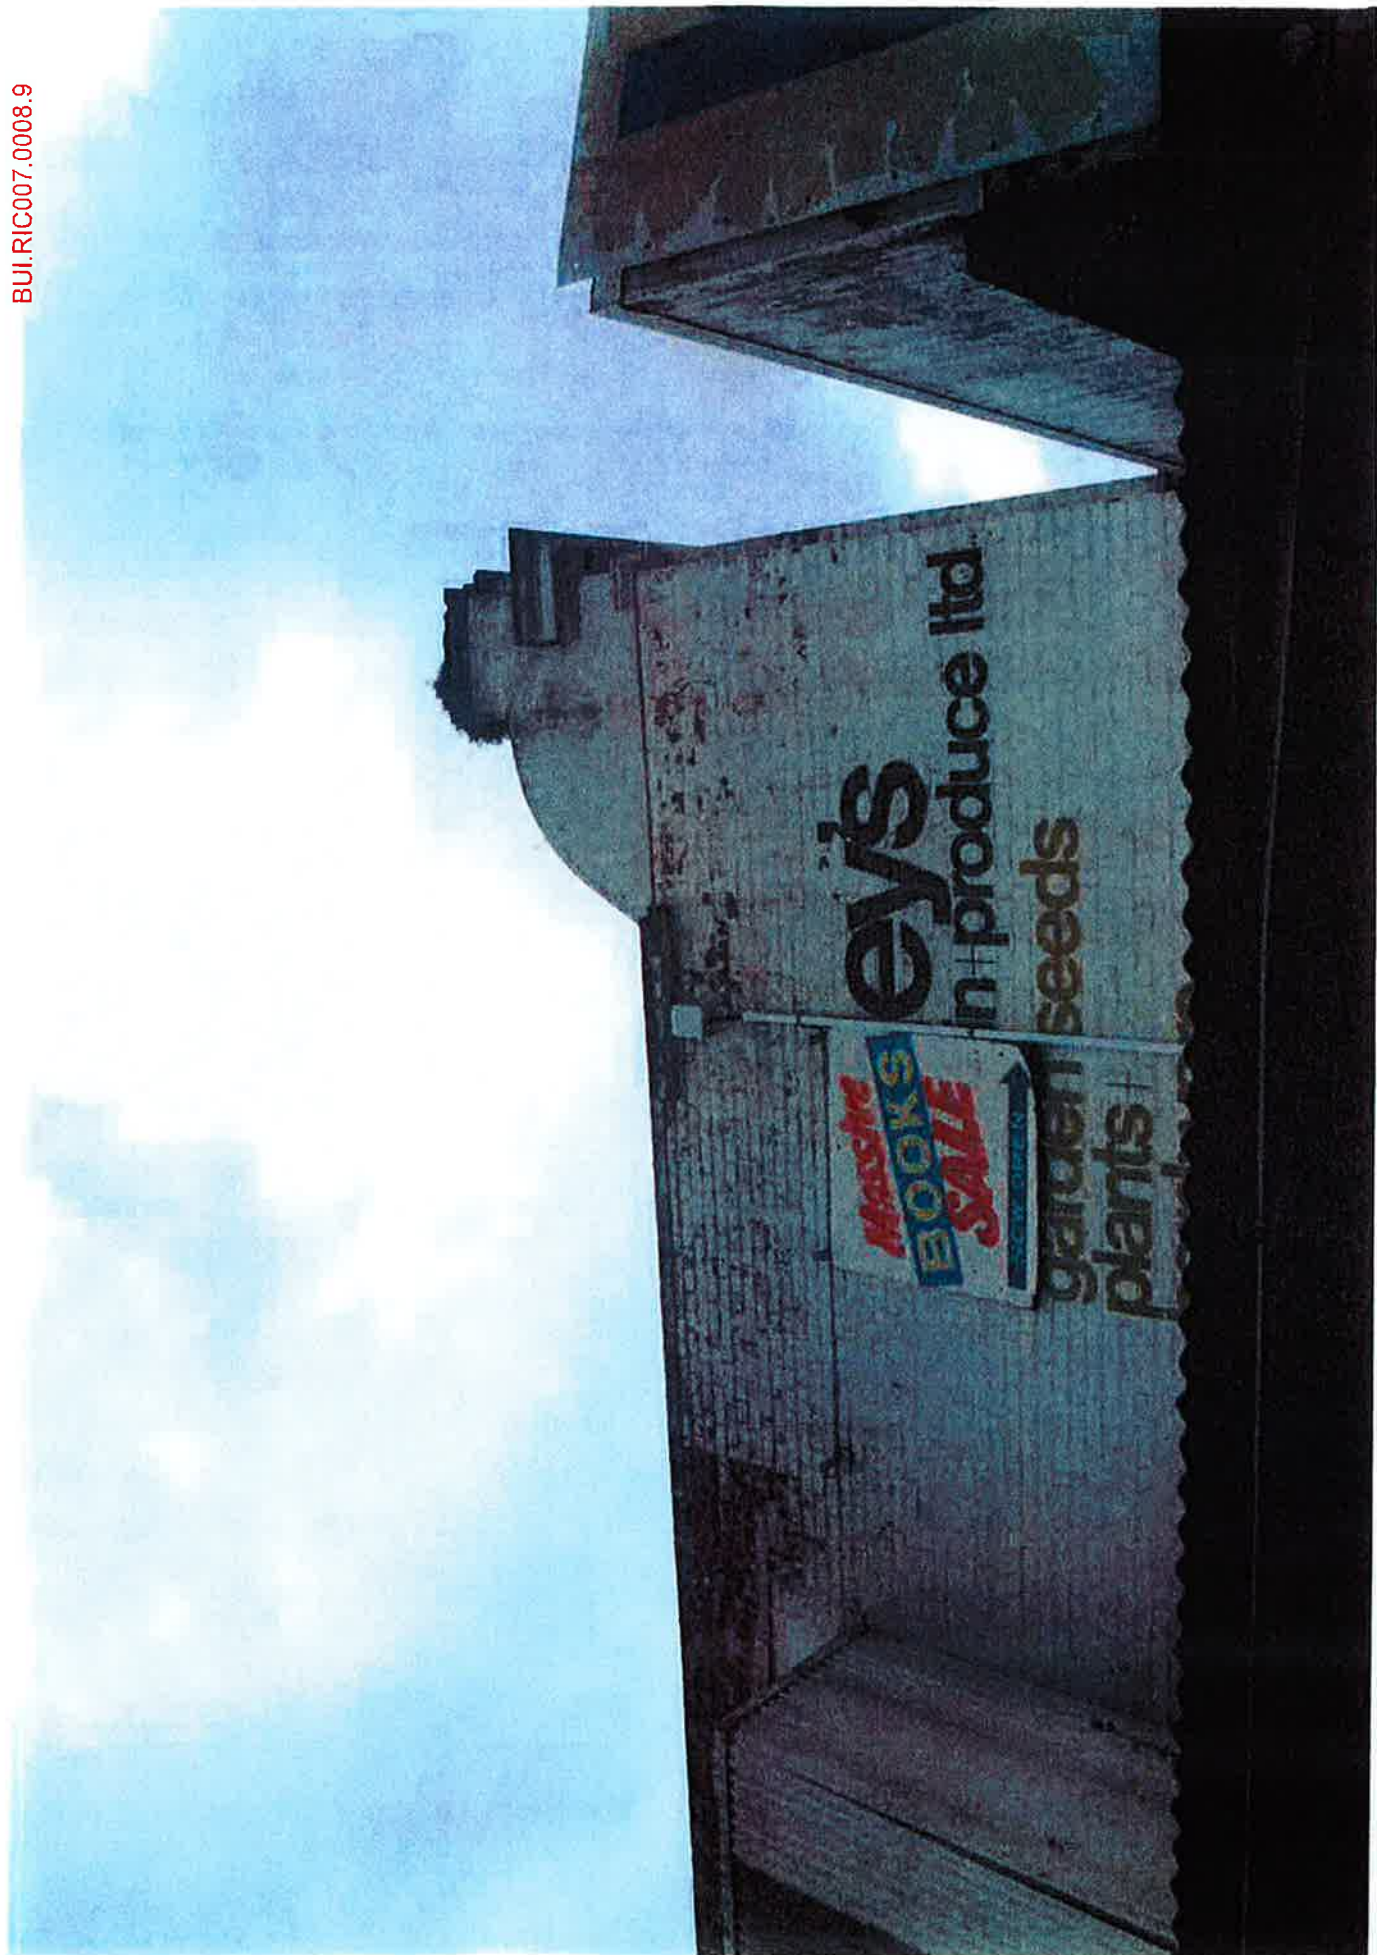
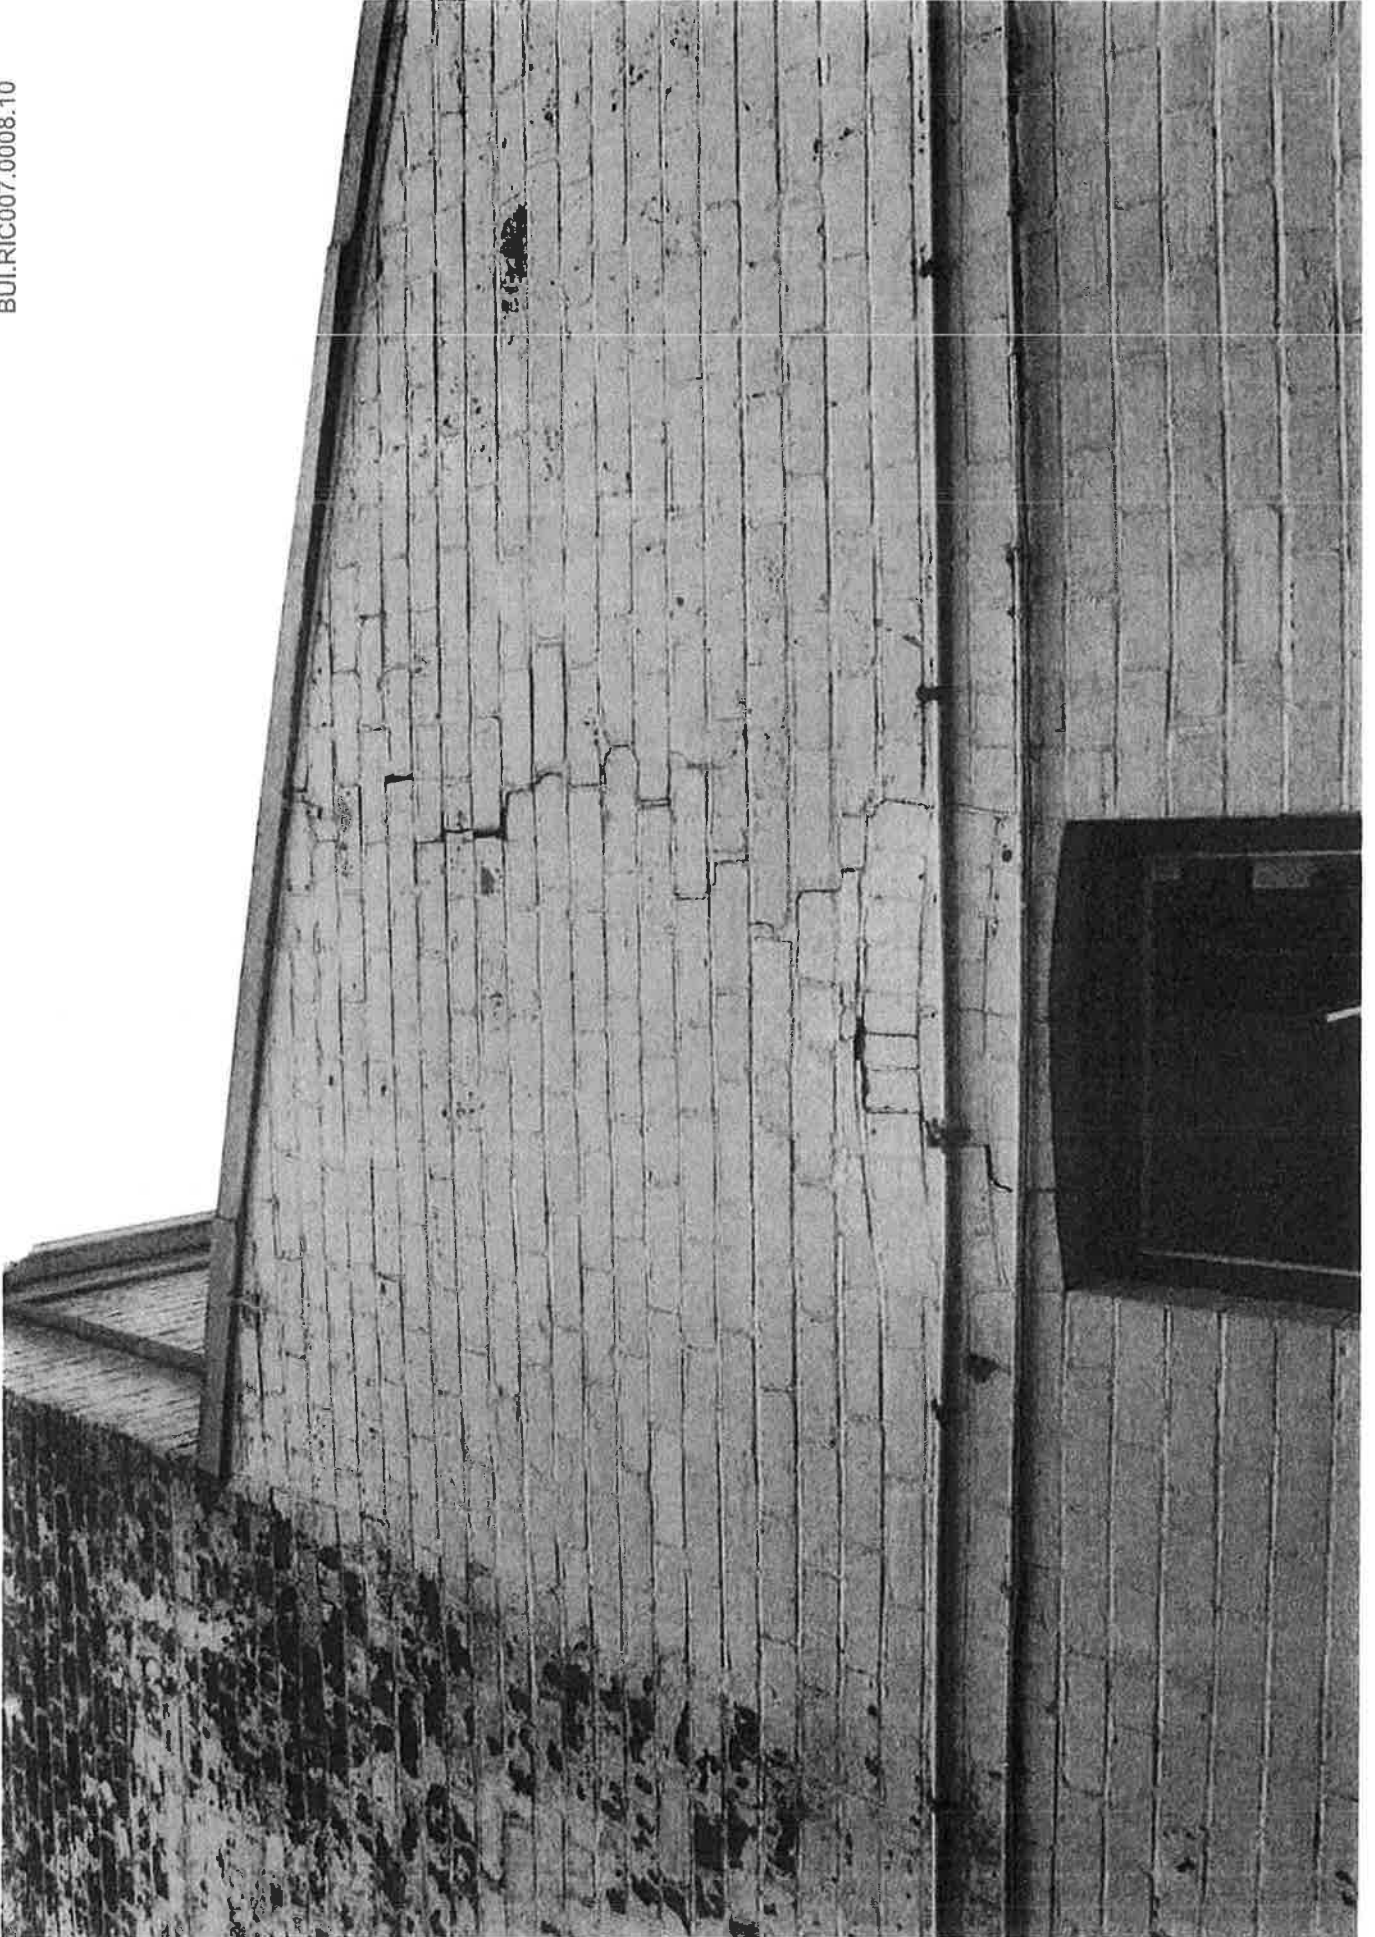
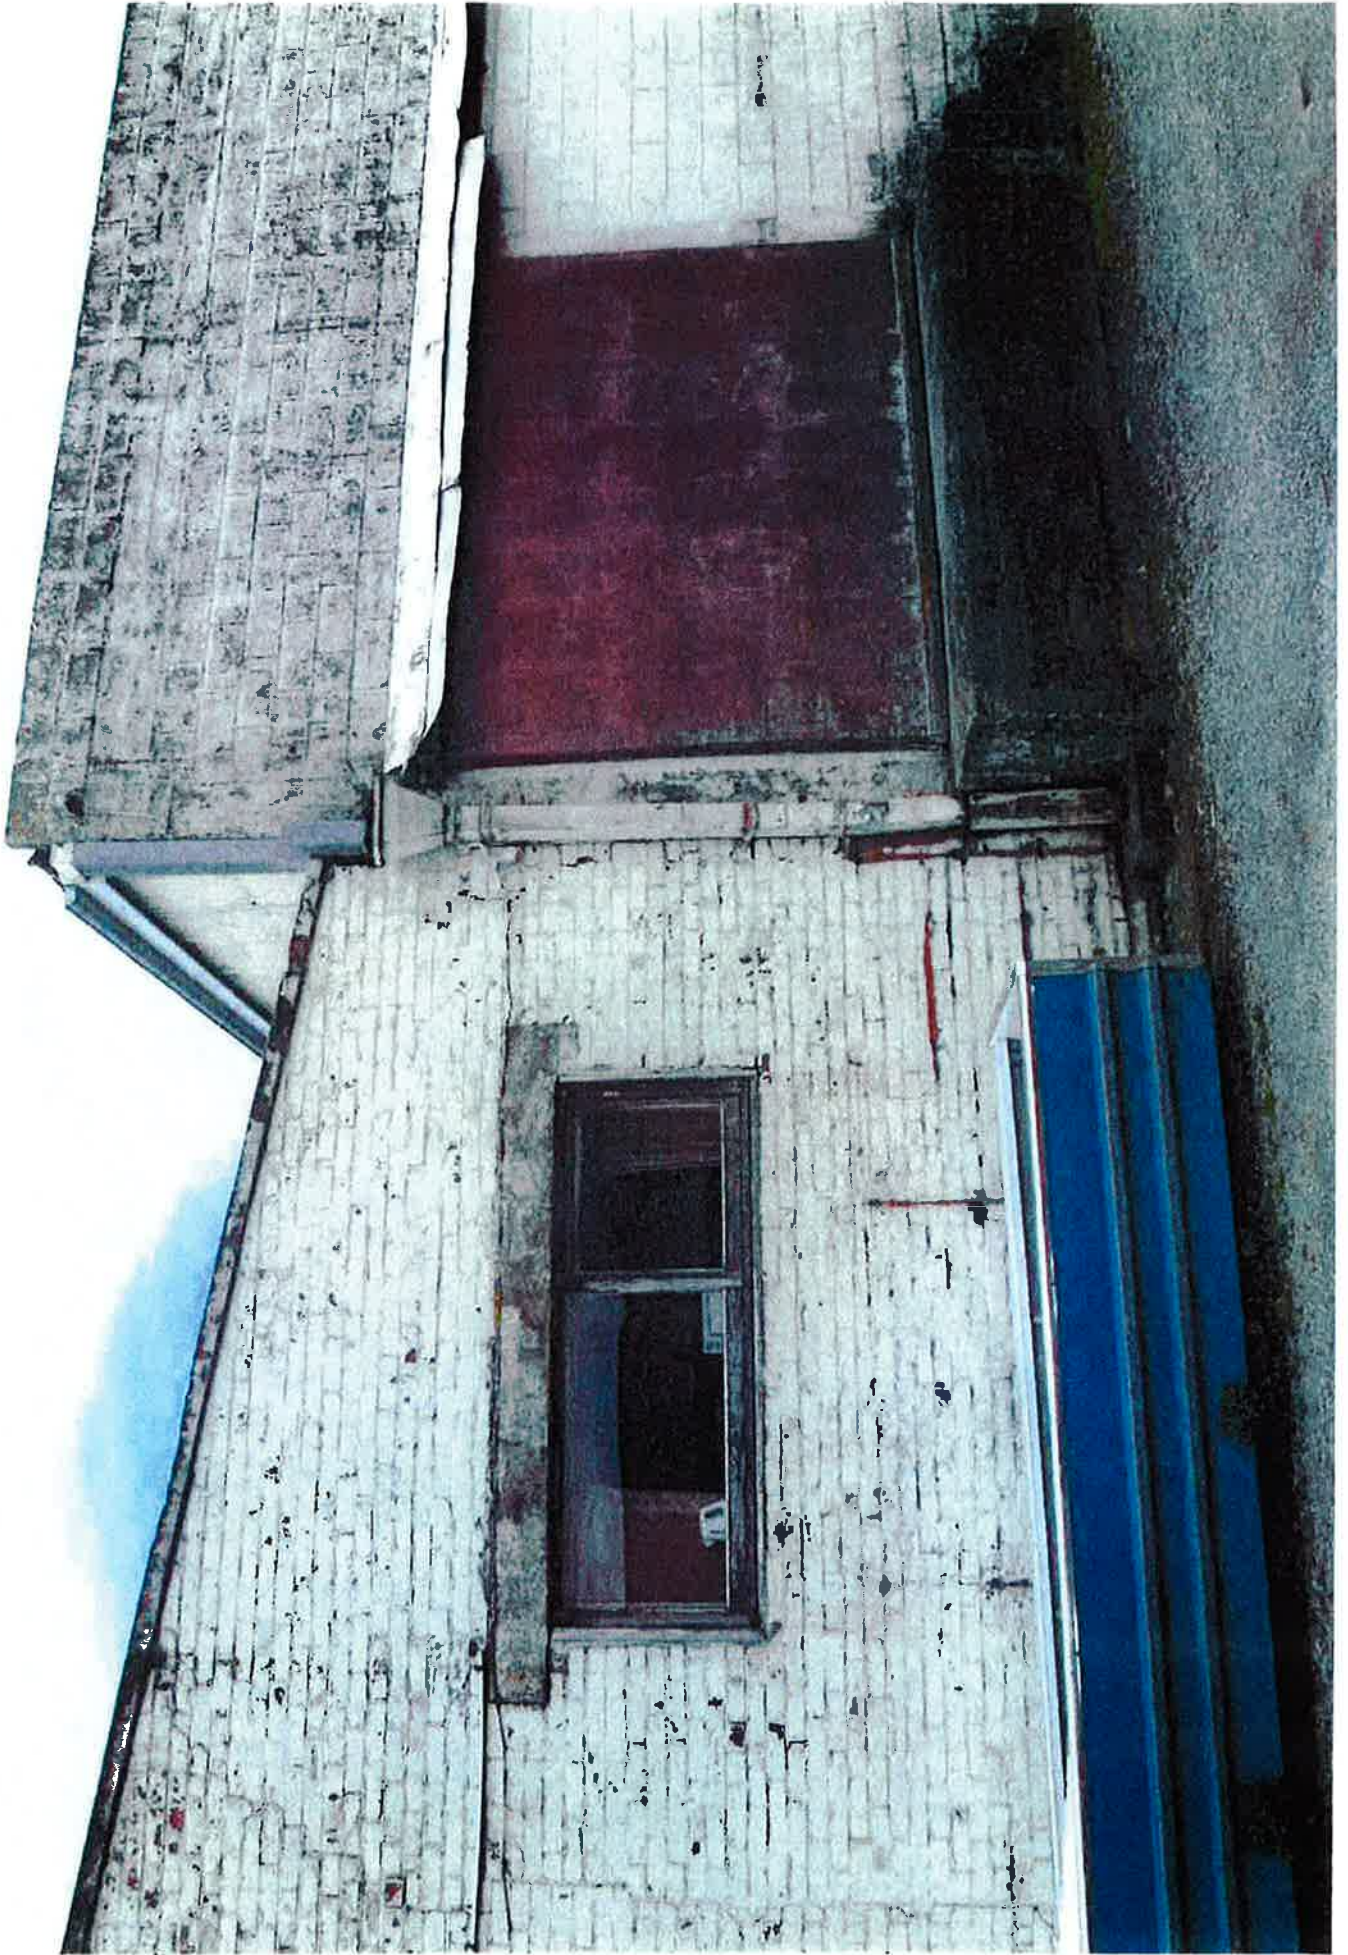
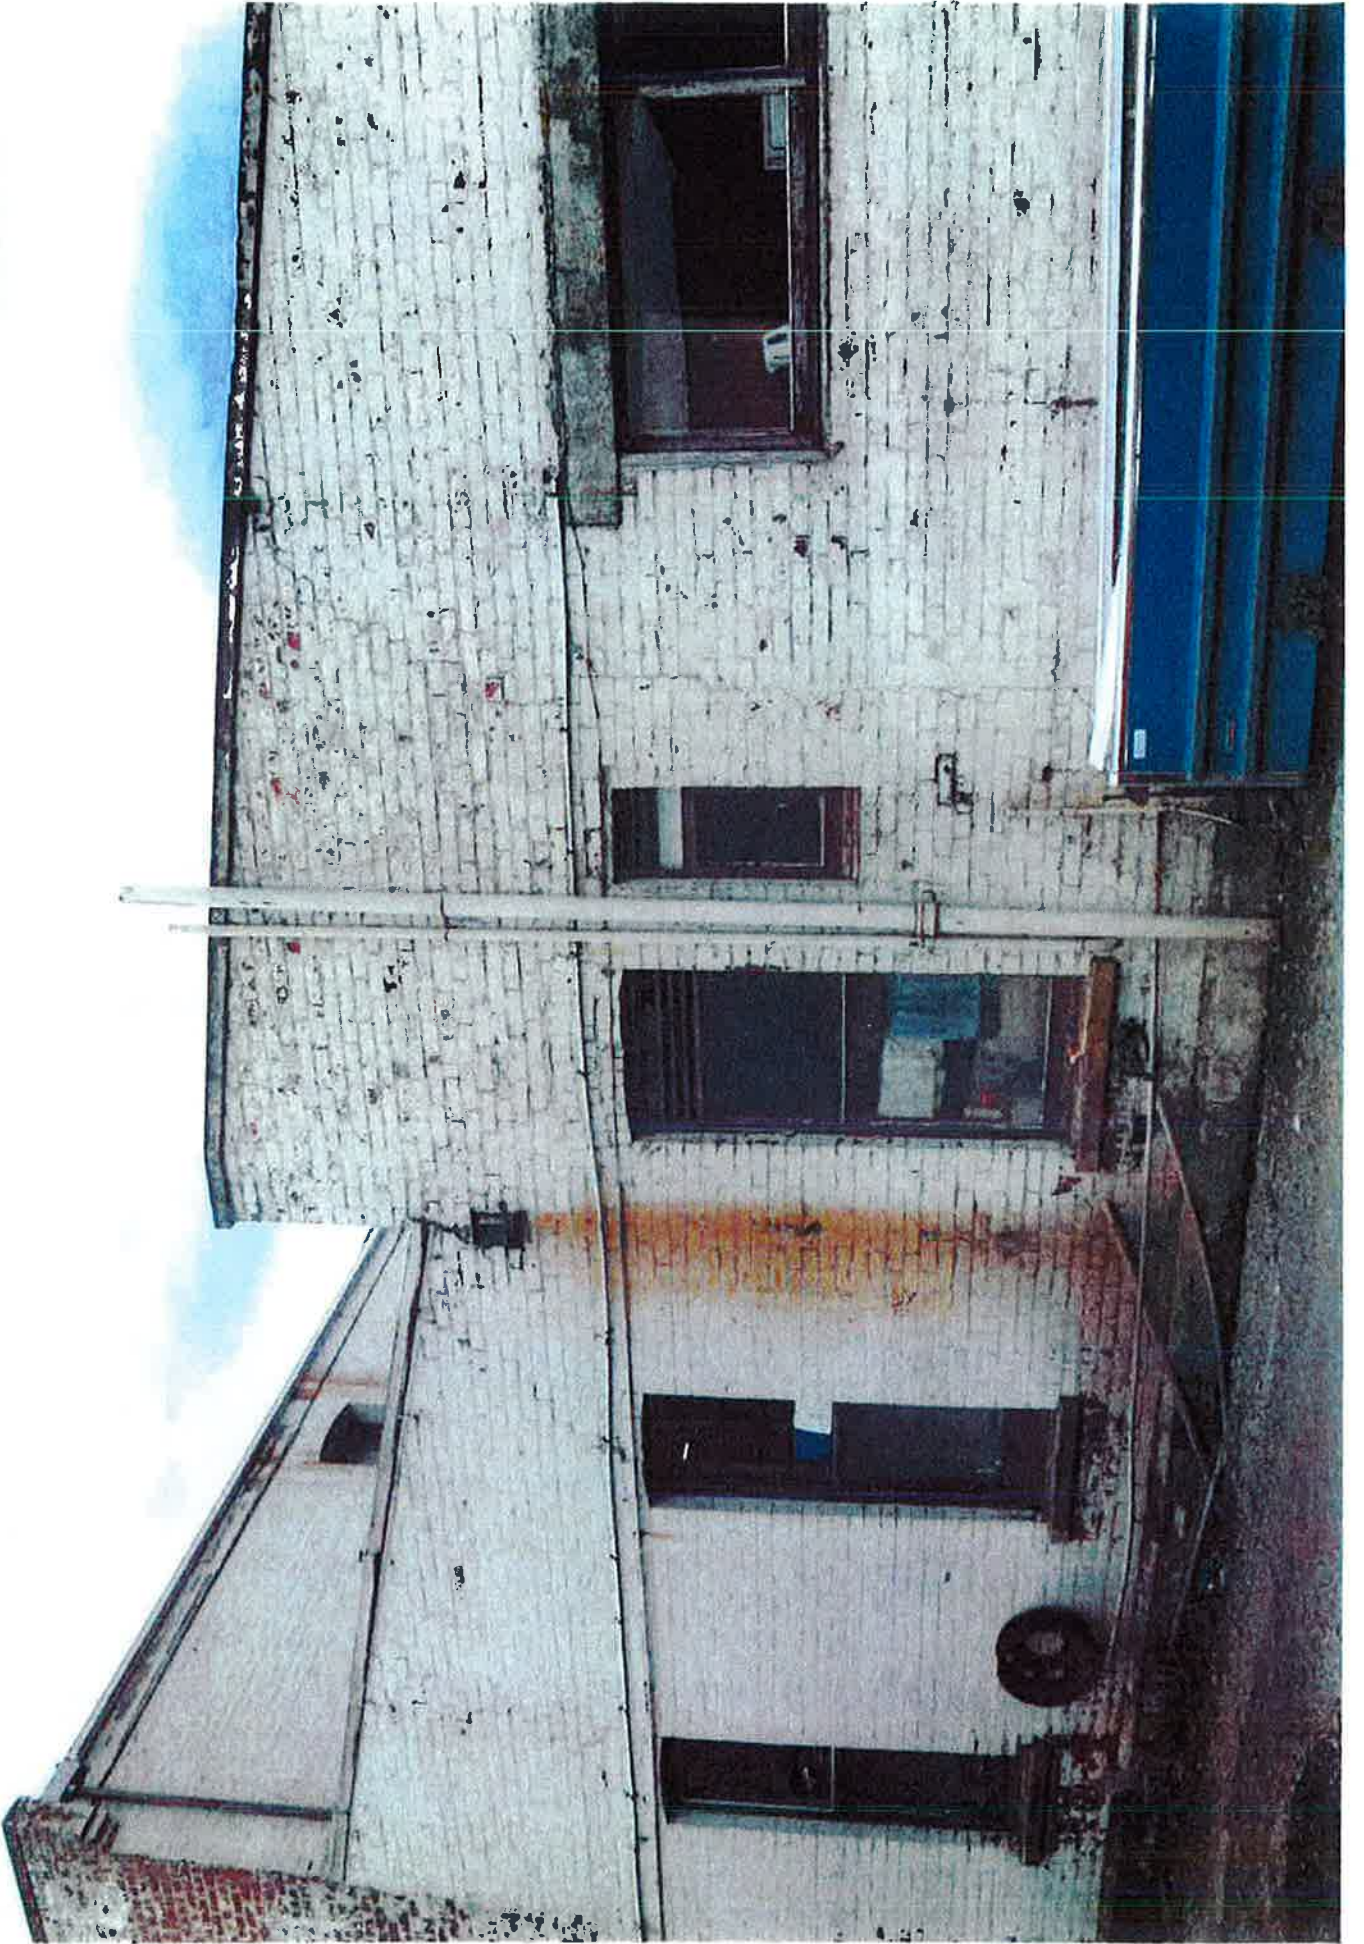
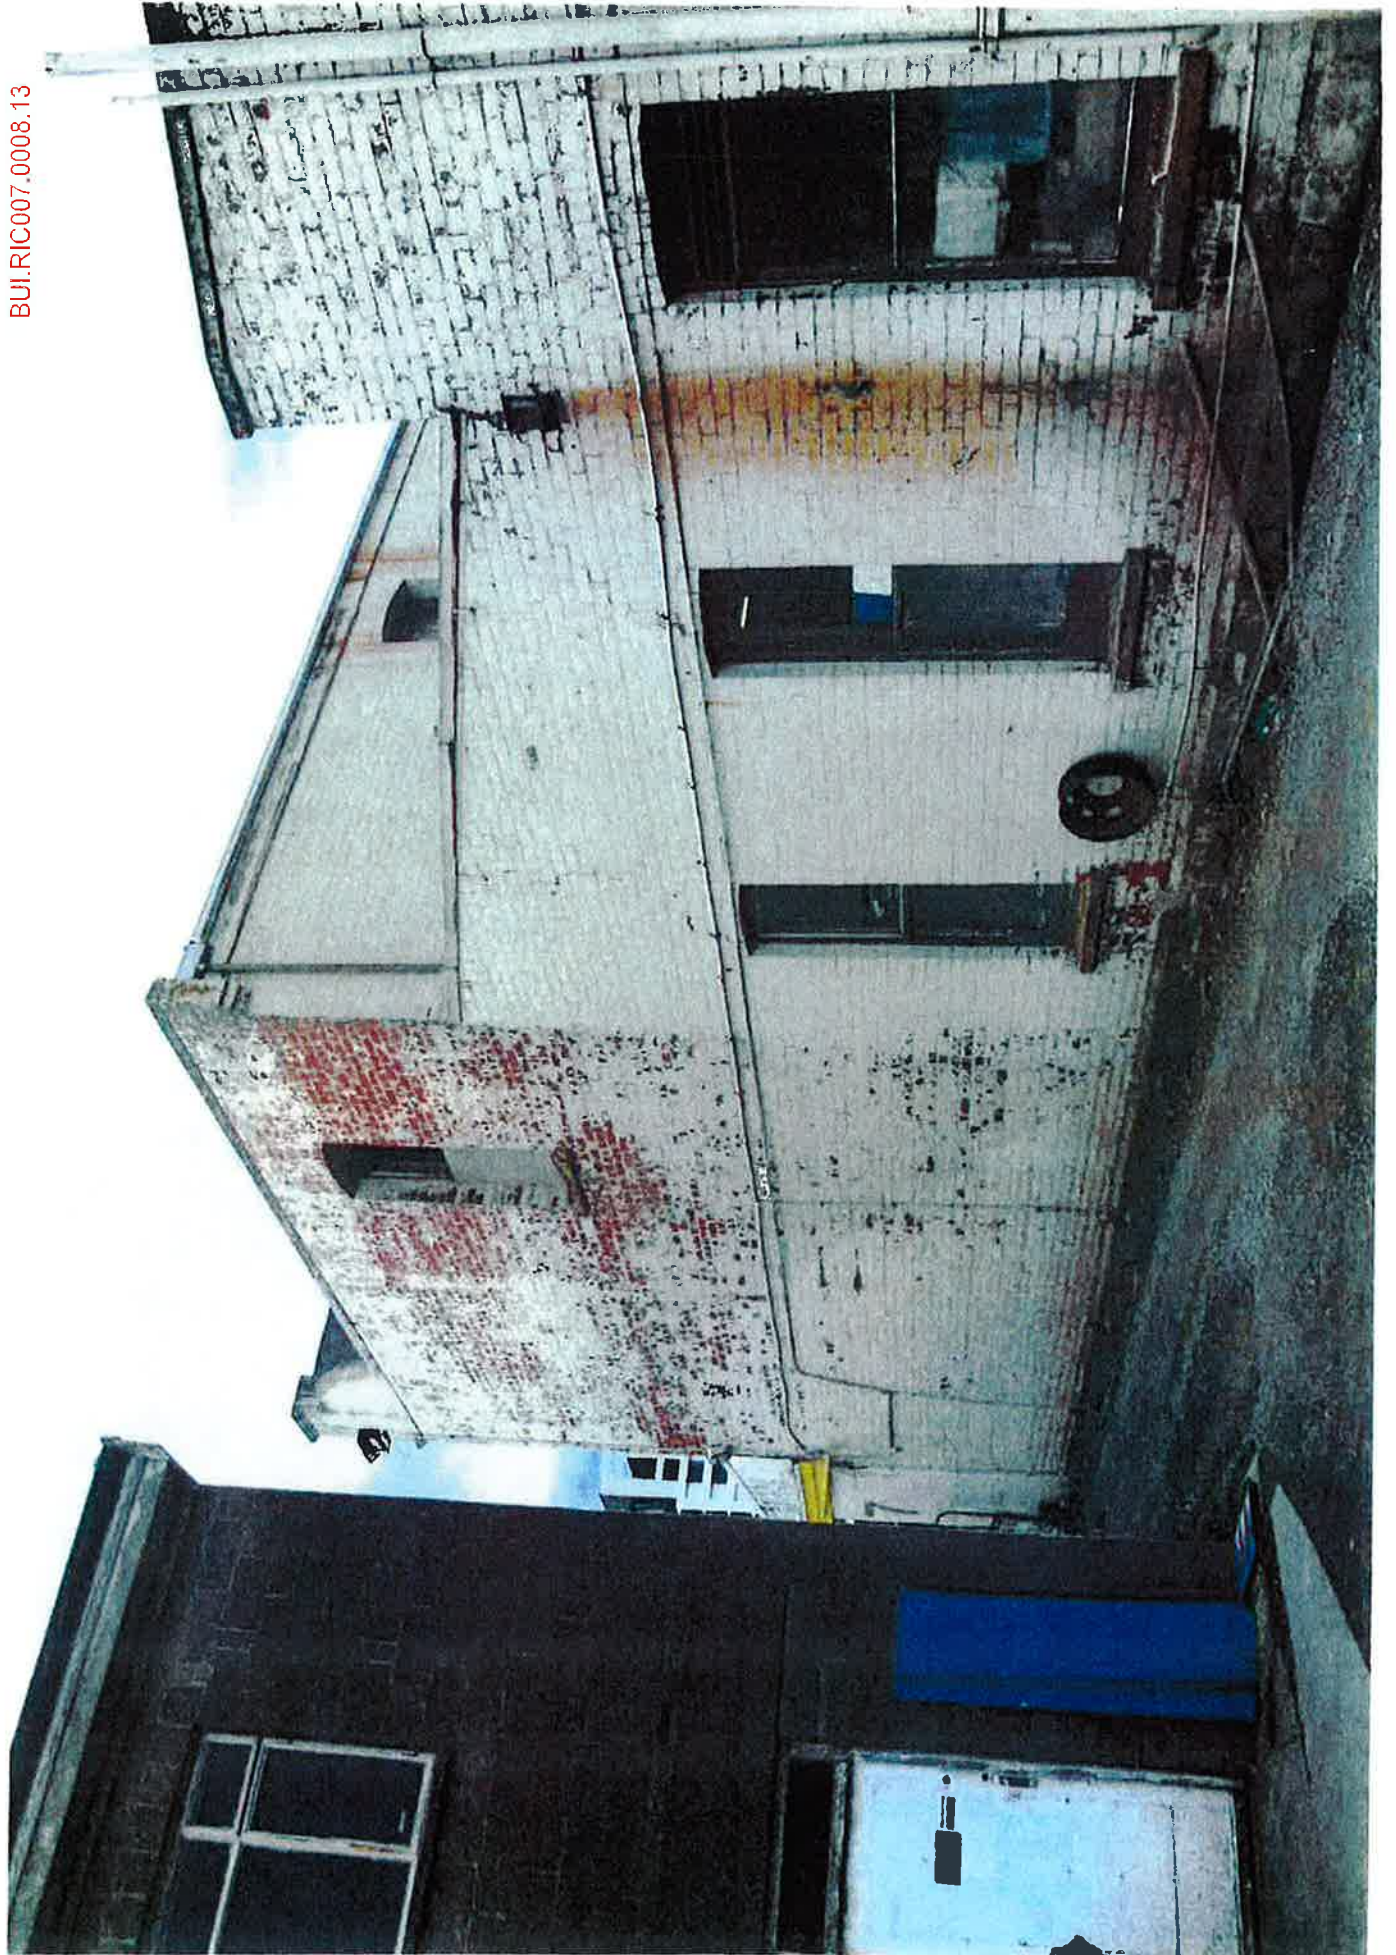
- 4.1 Yes – on or about the 17th September 2011. The cracking I observed was not what I would describe as large and it appeared to be consistent with what I had seen during my previous inspections - the condition had not worsened. I did not observe what I would describe as a large crack in the front façade and parapet. I have located photos on my lap top that were taken of the building during my first inspection. I can make those available. The cracking I saw on or about the 17th September is as recorded in these photos.

6.3 As stated in 4.1. I observed cracking in the brick walls. This cracking was consistent with what I had previously seen when inspecting the property. Further, I had been told by Mr North that this cracking pre-dated the earthquake of 4 September. This was supported by my inspection. I concluded that the building had not sustained any additional damage to that observed at the first two inspections.
