## Canterbury Earthquakes Royal Commission

### **246 High Street Information request**

## **242 HIGH STREET, CHRISTCHURCH POST 22 FEBRUARY 2011 EARTHQUAKE STRUCTURAL ASSESSMENT**

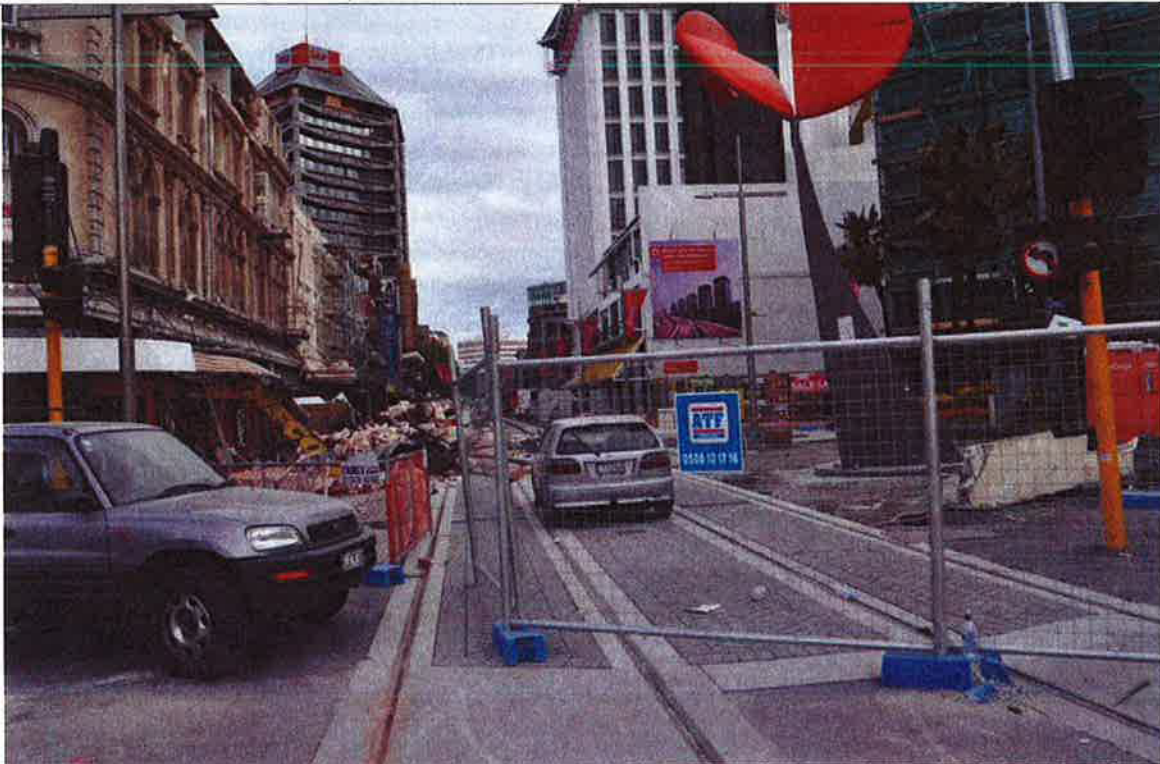
View from cnr Lichfield & High Streets

ADDRESS (BUILDING NAME)	PLACARD COLOUR	ASSESSMENT LEVEL	COMMENTS
242-246 High St	No Go	N/A	<ul style="list-style-type: none"> <li>■ Within inner city exclusion zone close to Grand Chancellor Hotel (but Grand Chancellor appears to be leaning in the opposite direction).</li> <li>■ Unable to identify building on site, client may be able to identify from site photos attached, taken from corner of Lichfield St &amp; High St.</li> <li>■ Recommend detailed engineering assessment and specification of remedial work once cordon is lifted.</li> </ul>

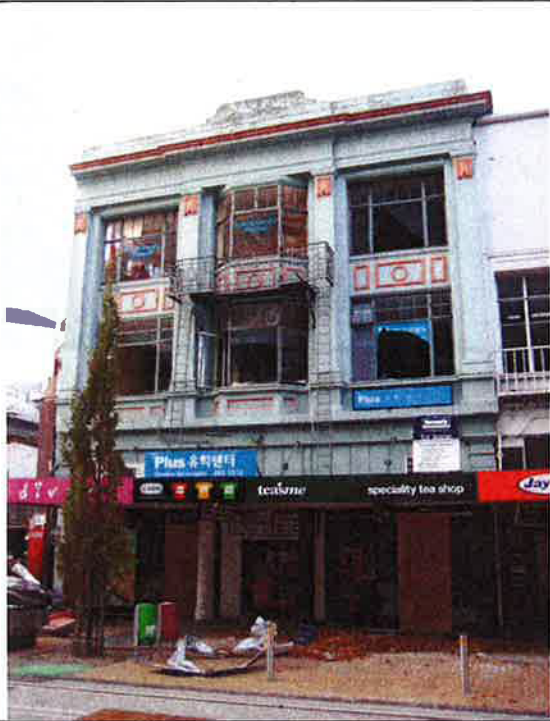
The building has been severely damaged by the 22 February earthquake. The north west side wall has collapsed down to second floor level. It was not possible to access all external walls but the top part of the rear wall has collapsed. There is extensive cracking in the remaining brick walls including the "party" wall.

1 - High Street facade

The building has been severely damaged and would need to be strengthened as well as repaired if it was to be saved. We consider the building to be an economic loss and recommend that it is demolished. If the south east wall is a party wall then this would need to remain unless the adjacent building was also being demolished.

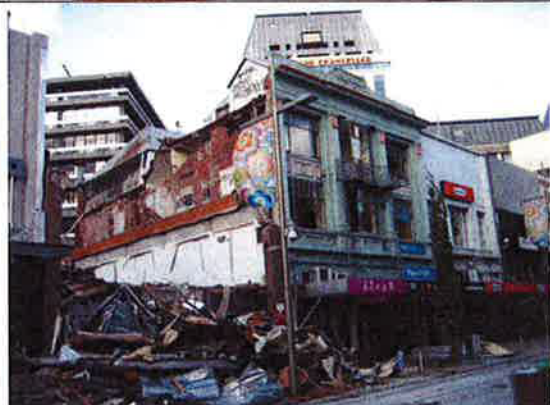
2 – High Street facade on right and north west side wall on left

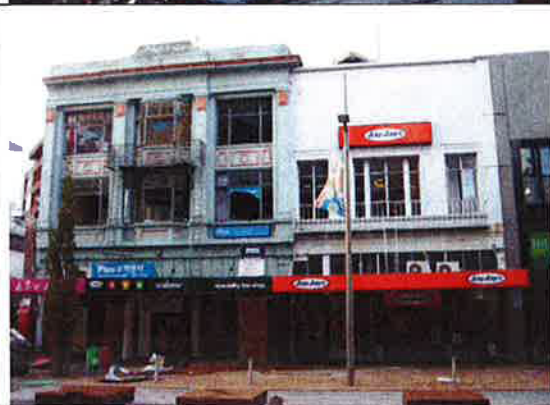
The building is a three storey masonry structure with brick walls and timber floors. Some concrete appears to have been used in the front façade. The façade at ground floor level appears to have been altered in the past to open up the retail areas. The adjacent building to the south east appears to have utilised the side wall of 242 High Street as a party wall but this would need to be confirmed.

3 – Adjacent building to south east appears to have utilised the side wall of 242 High Street as a party wall

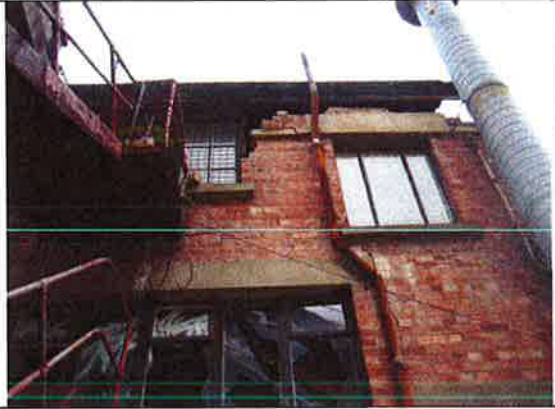
4 – Rear of building

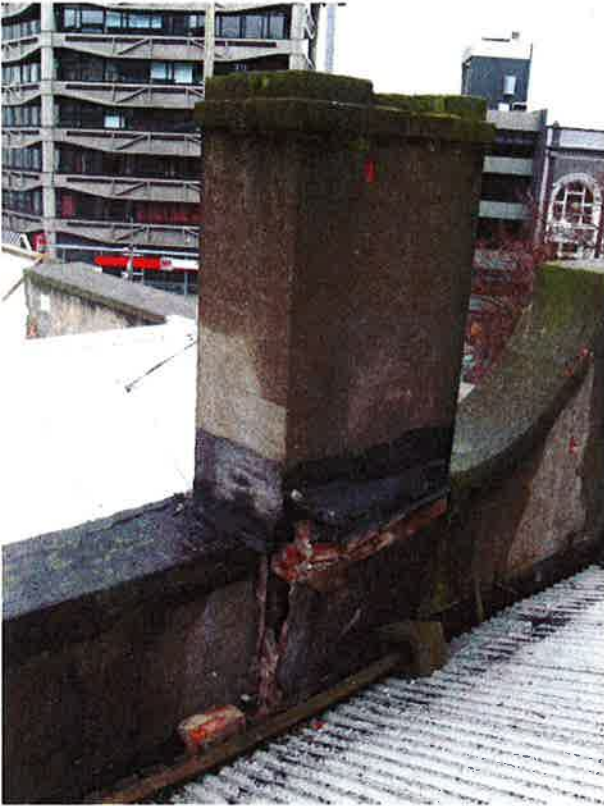
001-4Sept10.jpg

4. Make safe works were undertaken under engineers supervision/specification to secure the south eastern parapet wall – photographs labeled 001 to 003-4Sept10 show the initial damage. The Spotless \$22k invoice attached outlines the works and costs associated with these make safe works.

On the top of the bldg there is damage to the parapet/chimneys. One has fallen thru a sky light # landed on the floor inside the bldg. Others are cracked # could topple given an aftershock.

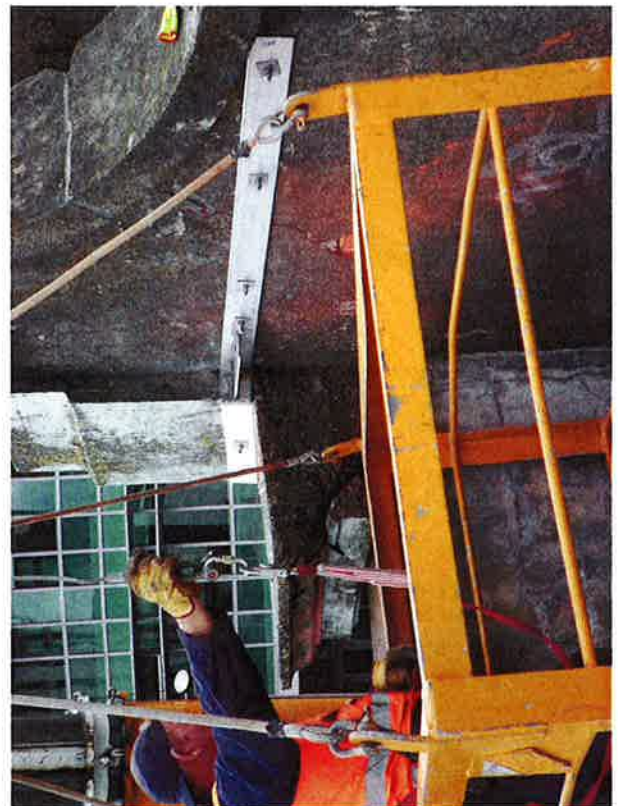
004-4Sept10.JPG

5. Following completion of those make safe works another inspection was undertaken by the engineer. A copy of that inspection report dated 20-9-2010 is attached. Photographs 004 and 005-4Sept10 show the works undertaken.

- Metal strap installed to front parapet corner as required.
- Chimneys removed from South parapet down to roof level. The majority of the parapet appears relatively undamaged except for a short segment approximately half way along the roof. Please remove this segment of parapet (approximately 2m long 0.7m high) down to roof level (also adjacent 5m long section).
- Once this work is complete the parapet is considered to be as stable as it was before the earthquake. Long term, we recommend the parapet be investigated with a view to securing the taller sections of the parapet.
