# SUBMISSION TO THE ROYAL COMMISSION OF INQUIRY:

# AN ALTERNATIVE COLLAPSE SCENARIO FOR THE CTV BUILDING

John B. Mander PhD, F.IPENZ Inaugural Zachry Professor Texas A&M University College Station, TX 77843, USA

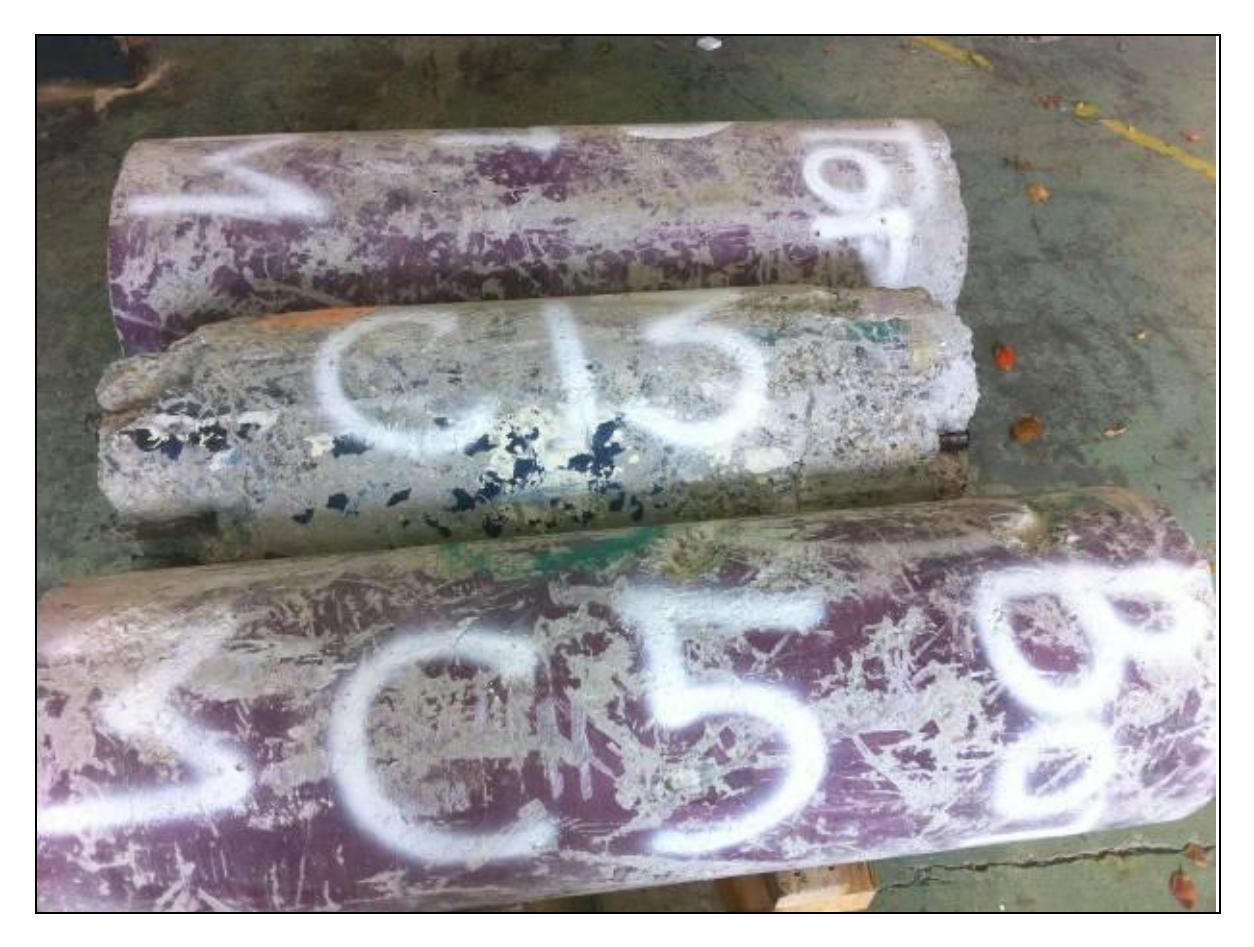
A third purpose of this testing was to examine the performance of concrete column elements that exhibited a poor post-collapse condition. The third specimen, yet to be tested, visually appears to be in poor condition; the concrete may have been damaged, either from the collapse or the fire. A photograph of the three specimens prior to testing is presented in Figure 4. The damaged central column shown in the photograph will be used to develop the third test specimen. It is expected that the performance may be inferior, but as to what degree it is not clear. The results of the third specimen test may give some insight into the low concrete strengths inferred as a result of the Opus testing.

Figure 2.4. The three column portions retrieved from the CTV Building used in the full-scale testing conducted at the University of Canterbury

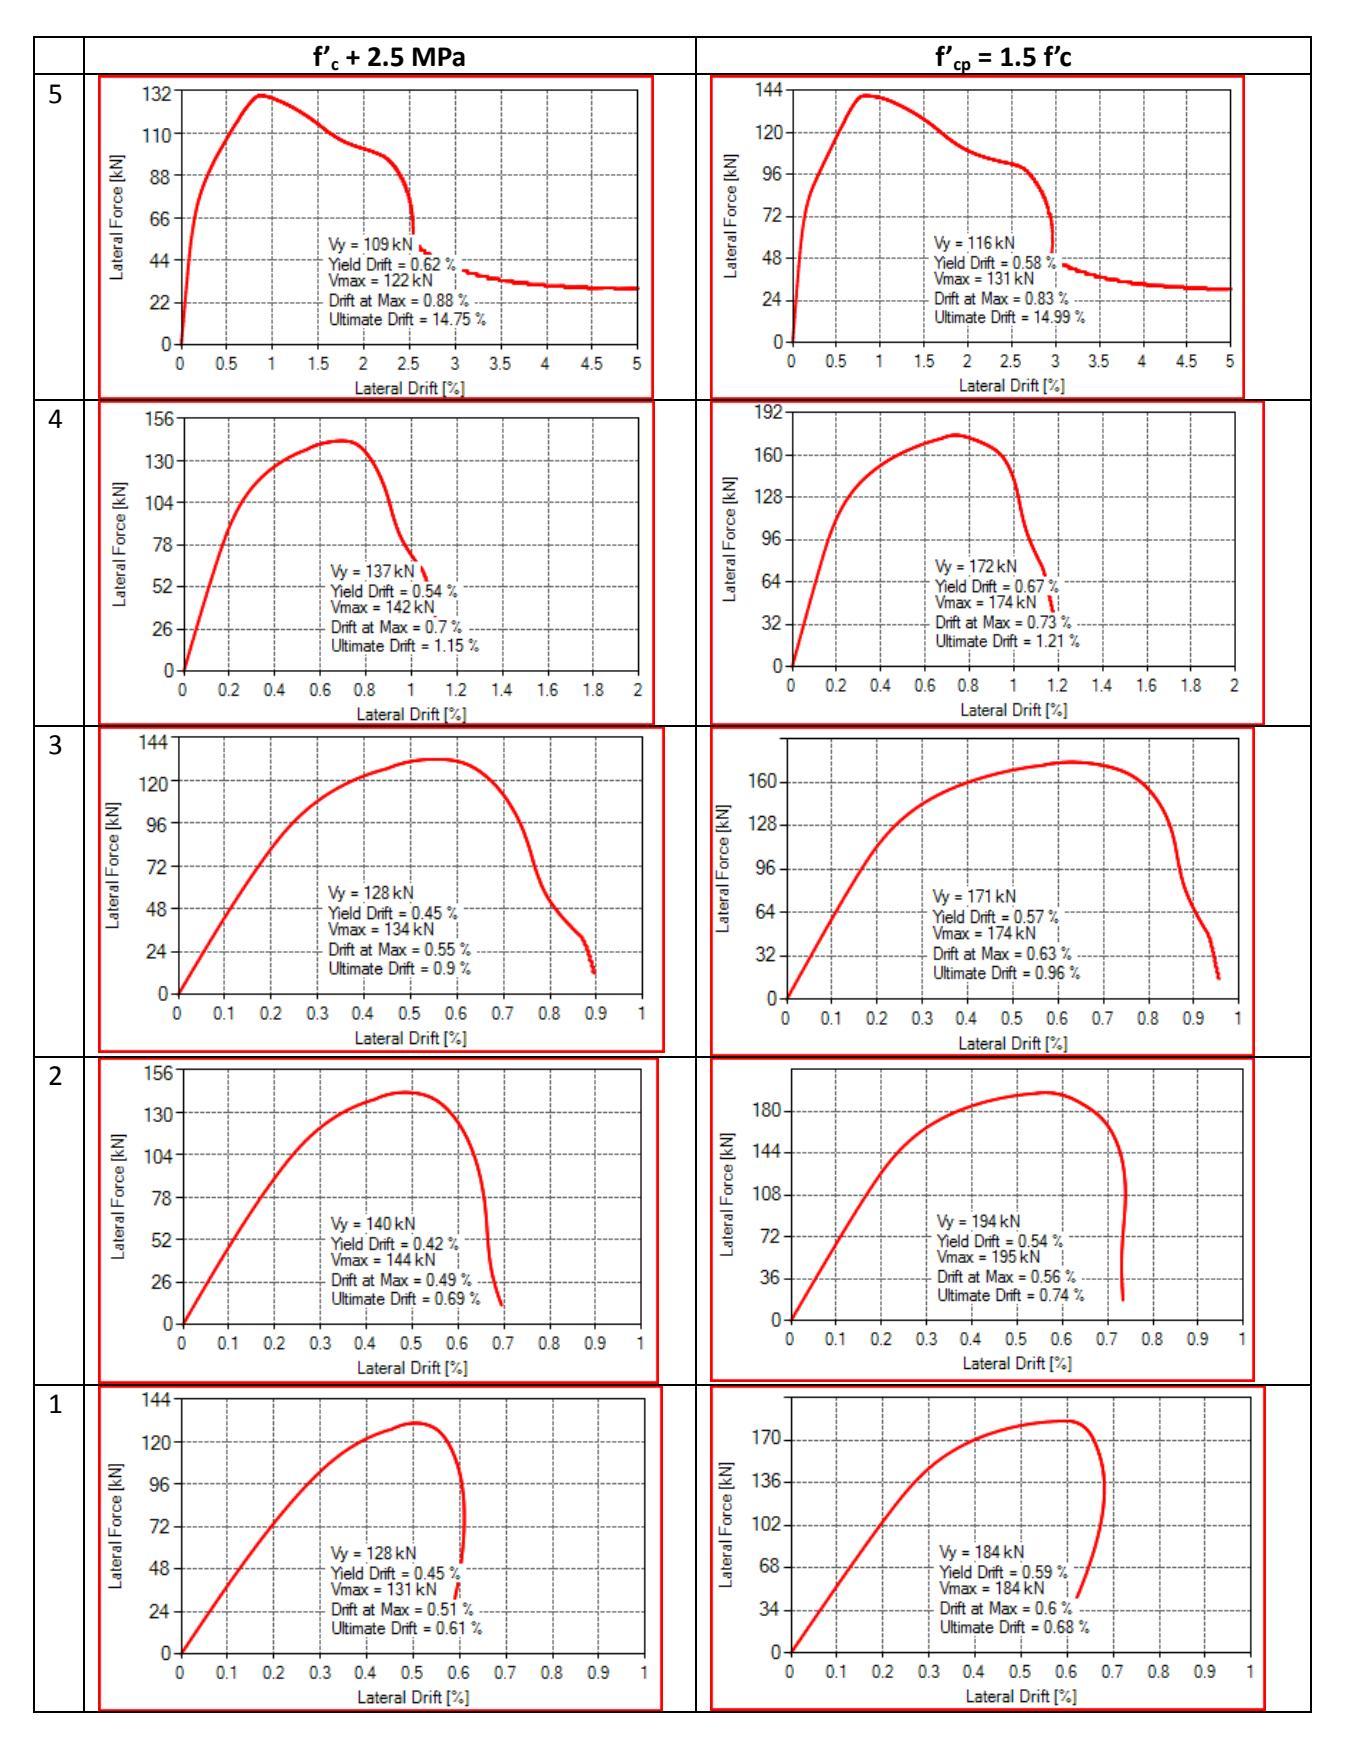
If there was a sway failure, such as that modeled in Figures 2.6 and 2.7, the structure of the CTV Building would have attained only modest drift and then collapsed; indeed a collapse following the Darfield Earthquake even would have been conceivable. Moreover, there would be supporting forensic evidence of observable damage amongst the rubble. One would expect to observe many columns, at least all of the interior columns of one story along lines 2 and 3, to fail in this way. The damage would propagate out from the joints and cover much of the length of the columns—yet this was not the failure model for the CTV Building collapse.

Figure 2.7. CTV Building column performance assuming <u>gravity axial</u> <u>plus seismic axial load effects</u>.

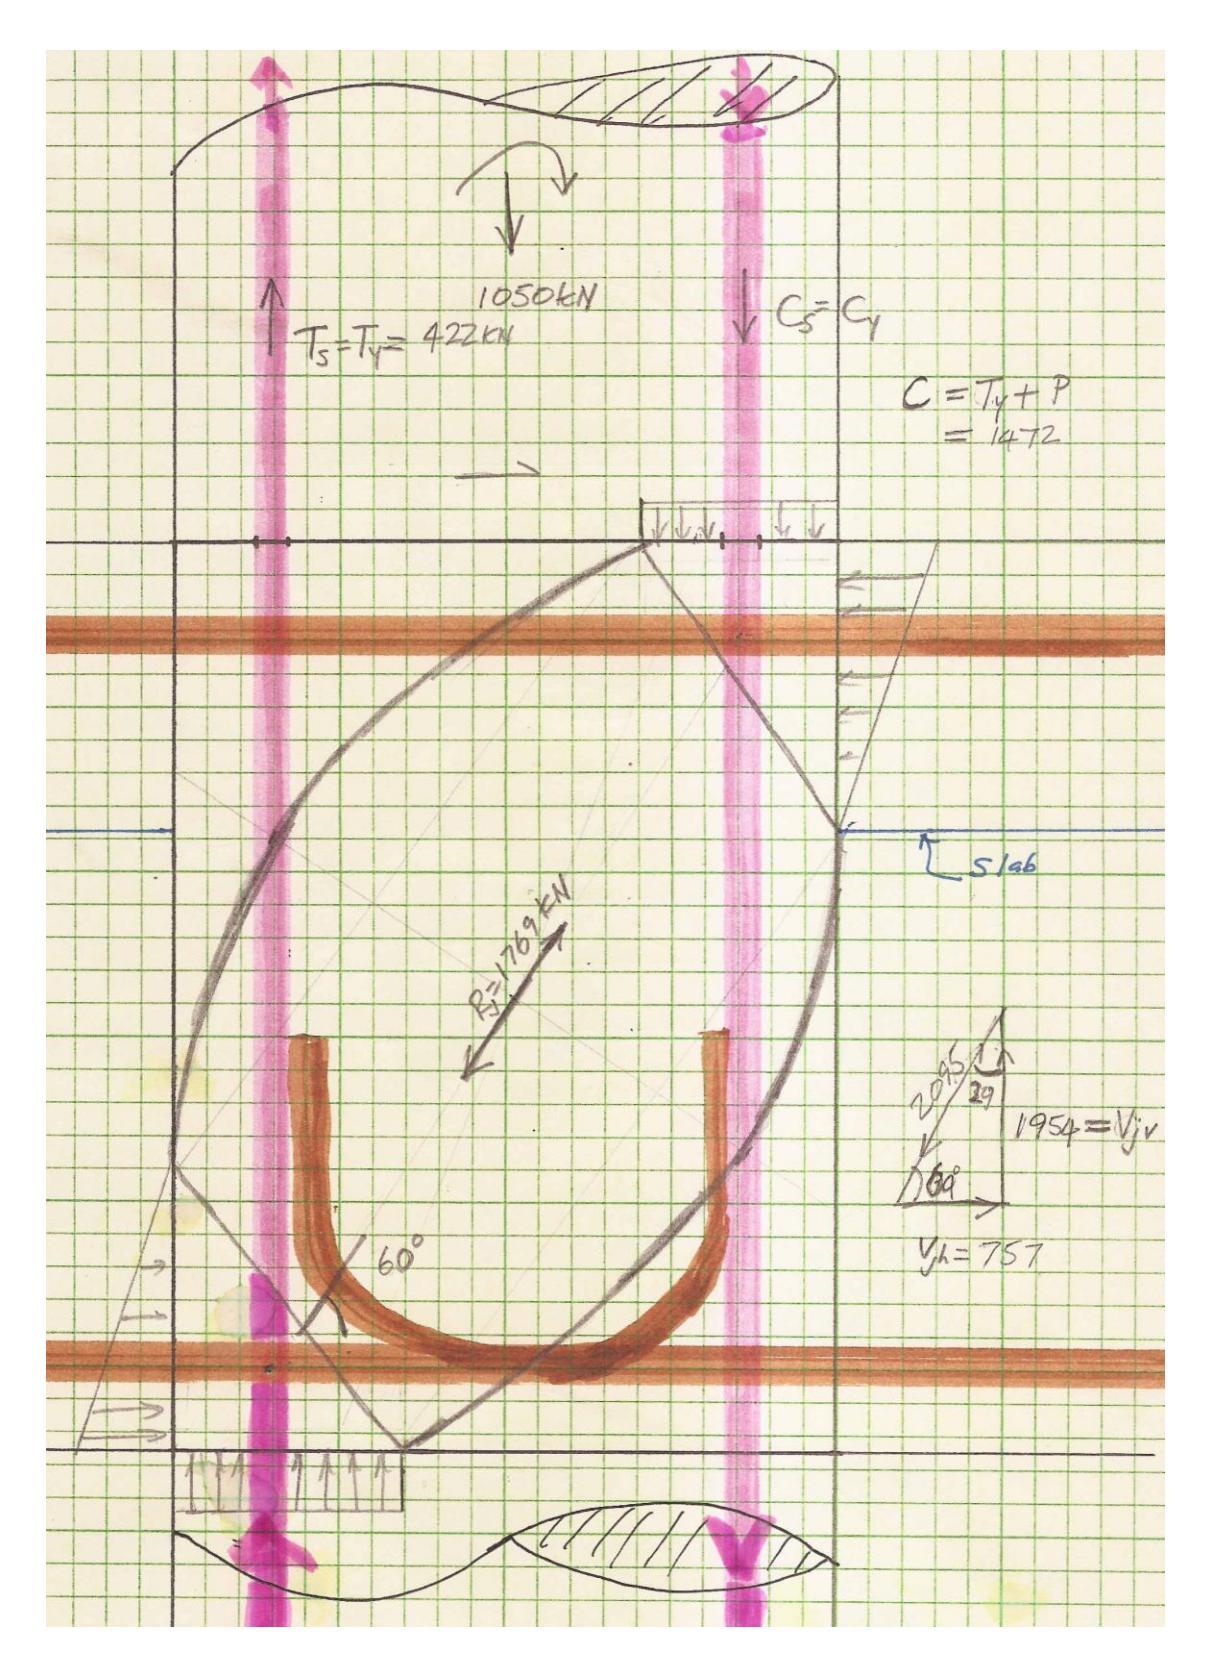
#### Figure 2.9. The beam column joint region

On the first pulse of the Christchurch Earthquake, if the inertia forces pushed the CTV Building from left to right (as shown in Figure 2.9), the forces in the joint *may* have been resisted without too much damage to the concrete. But if the axial load in the columns is high, as it was in the lower stories of the CTV Building, at least some damage will be done. It is this damage, promoted by the tensions in the off-diagonal that leads to progressive "softening" or weakening of the concrete on subsequent cycles.

Calculations have been performed that show that the overall joint forces will restrict the potential input forces from the columns to about 70% of the potential maximum of that shown in Figure 2.7. Therefore the columns, apart from during the initial cycle, will remain mostly undamaged. Yet the condition of the beam-column joints will continue to deteriorate as the cycling progresses.

Shown are the vertical column steel (pink), the beam bars (brown) and the diagonal joint-strut. The concrete strut resists the column axial load plus the bending actions from the columns and beams.

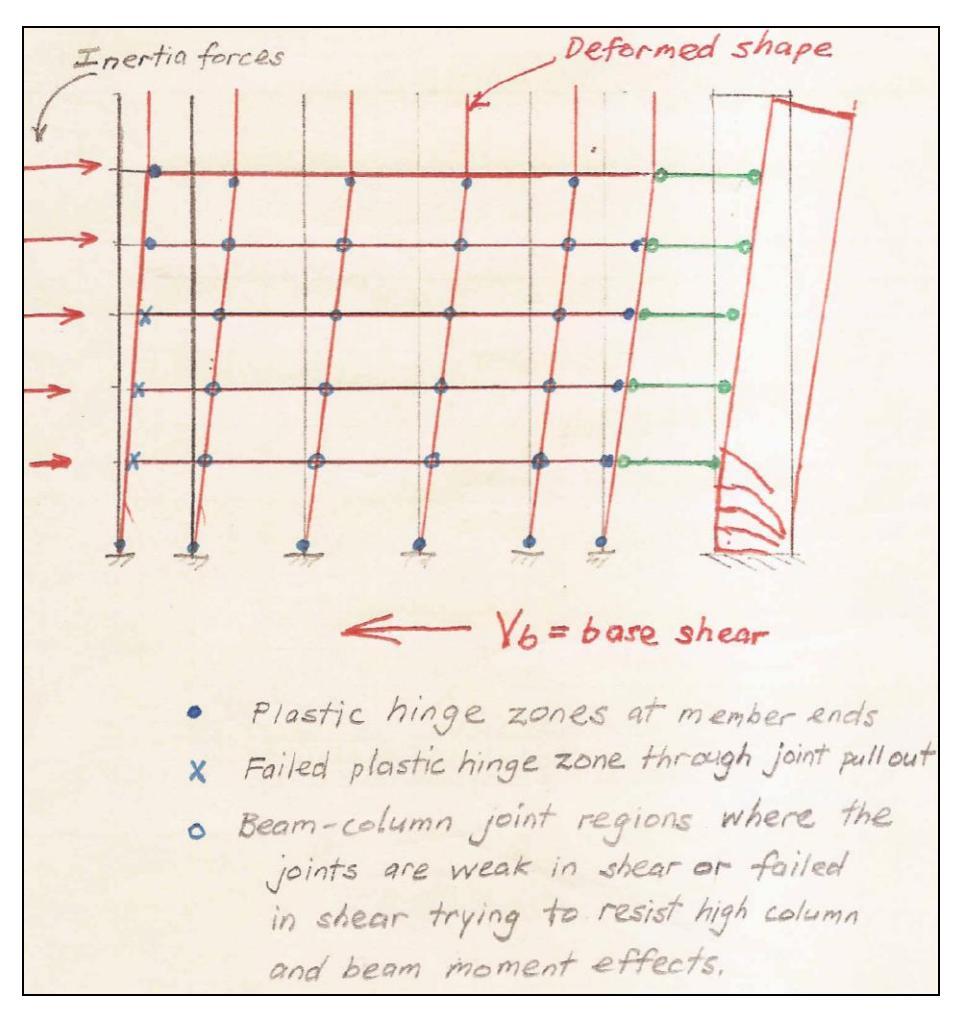
Figure 2.10. The modified sidesway mechanism arising from the presence of "weak" beam-column joint regions.

In spite of the deterioration in the beam-column joint zones, if the structure remains well tied together by the floor diaphragm, and also tied back to the shear wall system, the columns remain "trapped" and unable to fail due to a sidesway action. Of course the joints must continue to be capable of transmitting the vertical load. Providing the axial load path can be maintained and the joint concrete does not crush excessively, the joints continue function as a fuse. This initial phase of the partial failure, where the joint system acts as a fuse, is shown in Figure 2.10.

(Note the joints act like "fuses" and protect the columns from further deterioration.)

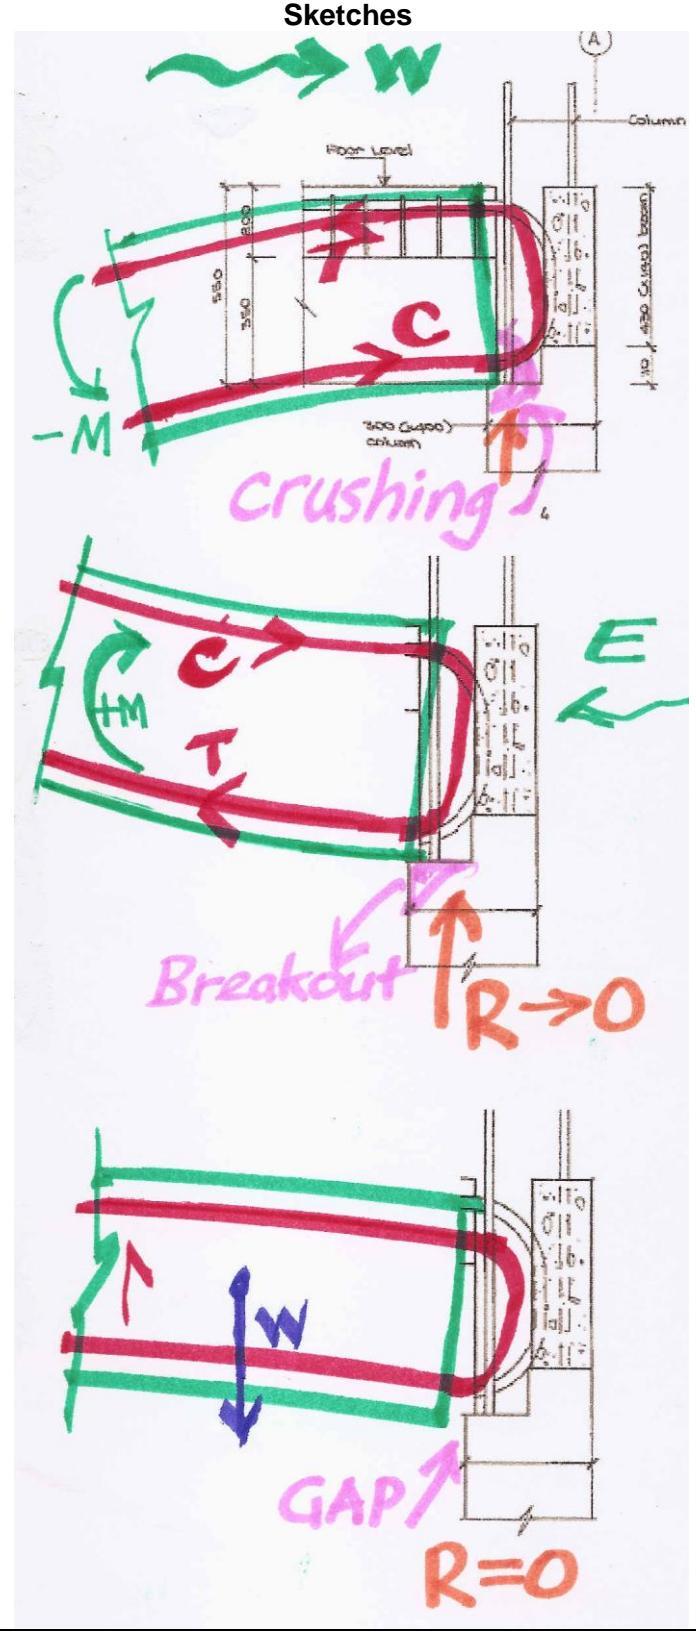
During the next half-pulse the building lurches eastward. The beam along line 2 and 3 pull away from the west wall and their line A column seats to form the alternating positive moment. The crushed cover concrete from the previous reversal spalls off and the beam slumps down a little, with a partial or full loss of seating. Due to the loss of seating at the support line A there is a transfer of the previous gravity load from the tributary area of the beam onto the neighboring columns on line B. This action an axial force increase of up to 40% the columns along line B

As the building attempts to return to an upright condition by moving west, the unseated beams are inhibited from fully returning due to the presence of the west wall.

Permanent differential deformations remain, that inhibit the columns along line be from remaining straight. This sets the columns up for a classic Euler buckling type failure, especially under further axial load derived from vertical accelerations and their consequent vibrations

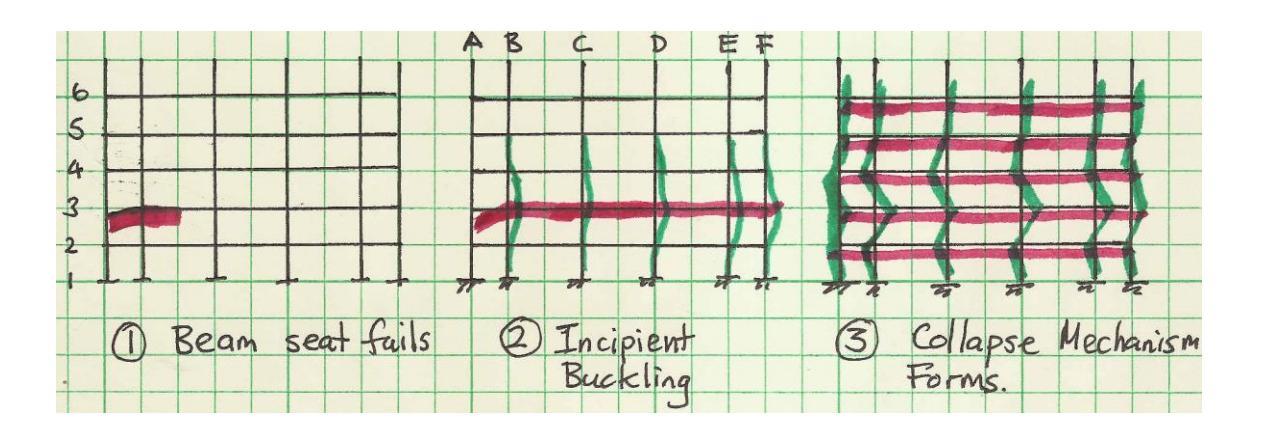
Figure 3.3. Formation of the E-W Collapse Mechanism

If the collapse is initiated at the west wall, then it follows there is an eastward failure from moving from column lines B to F. This is explains why more debris fell near the Madras Street corner of the building. The collapse mechanism is presented in Figure 3.3. It should be noted that the mechanism once fully formed, will push the walls out first at level 3 at the east end along column line F, then secondly at level 2 the lower column will blow out due to the now very large lateral displacements in the columns. This is consistent with eyewitness observations.

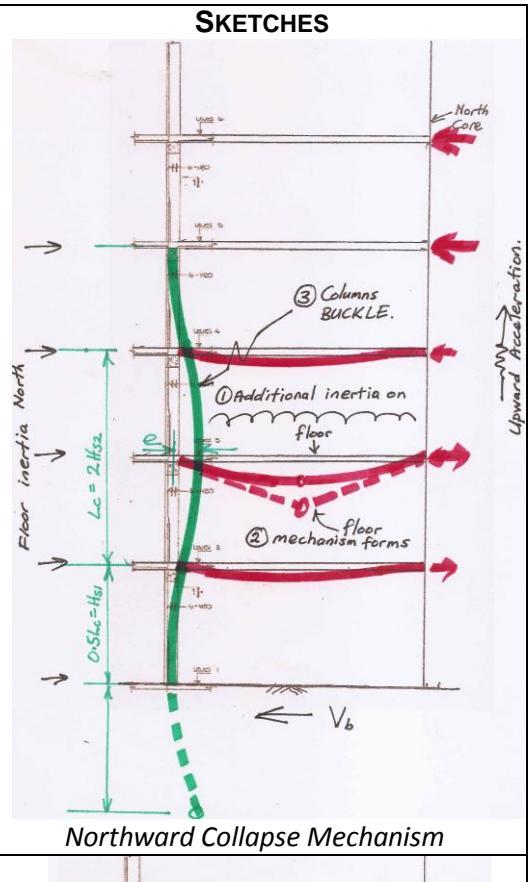
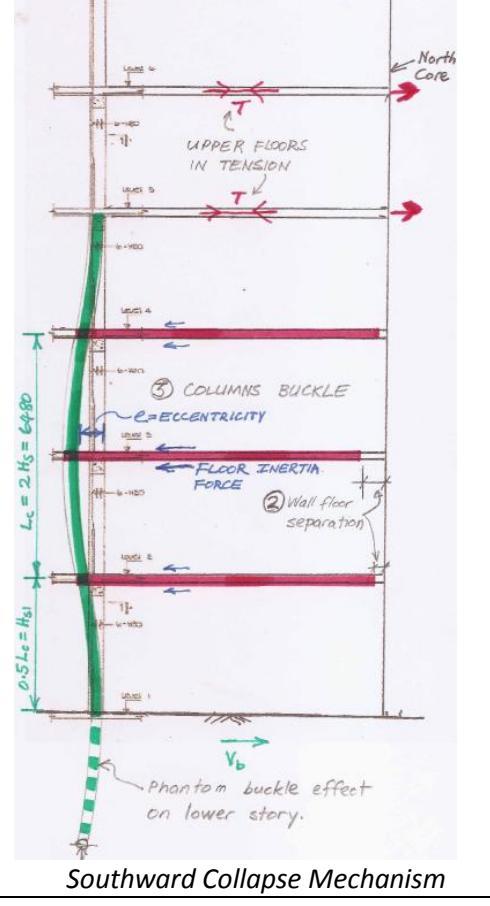
# Figure 3.4. North-South Collapse Failure Modes

Column buckles and collapses.

Due to the absence of drag bars in the lower stories, there is a large strain demand placed on the slab steel connecting with the North core. After one or two cycles the bars fracture due to low cycle fatigue.

Several columns buckle and the structure collapses downward.
