**NEW ZEALAND
GEOTECHNICAL
SOCIETY INC**

New Zealand Society for
Earthquake Engineering

THE CANTERBURY EARTHQUAKES:

Answers to critical questions about buildings

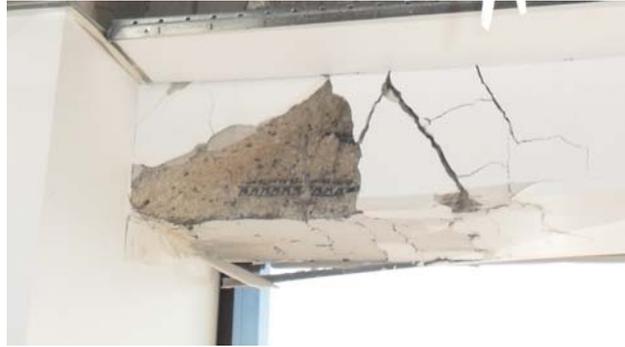
Figure 1: An energy absorbing (ductile) beam hinge in a reinforced concrete building after an earthquake. As these ductile elements yield they absorb energy without loss of strength that would lead to collapse of the building. While some of the cover has fallen off, none of the reinforcing has broken, and the concrete inside the reinforcing cage is intact, so this beam can still carry load.

- Providing “stiffness” so that buildings do not move much in small earthquake shaking and there is no damage.
- Providing “strength” so that buildings do not have any significant damage to the building frame in moderate levels of earthquake shaking.
- Providing “toughness” so that buildings do not collapse under more extreme earthquake shaking, such as that considered in the design code of the time. This toughness is the ability to absorb energy is called “ductility”. As the building absorbs energy, damage occurs without collapse.

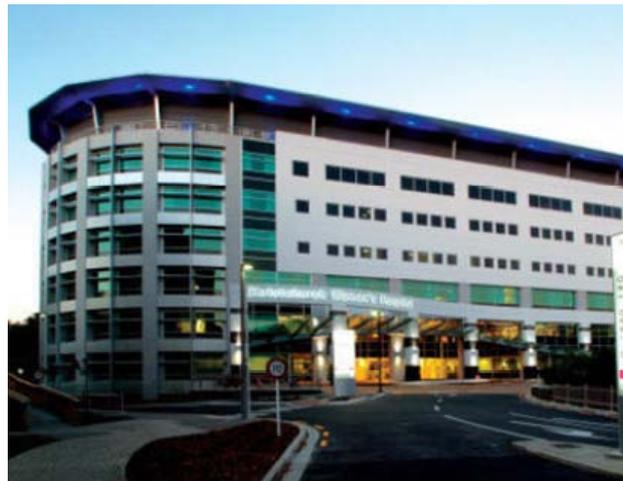
Figure 2: Christchurch Women's Hospital sits on Lead Rubber base isolators.

Lead rubber bearings, as deployed at Christchurch Women's Hospital (Figure 2 & 3), Parliament and Te Papa, are an example of a novel device developed by the former NZ Department of Scientific and Industrial Research in order to protect structures against severe ground shaking. This is called base isolation, because it allows the ground to move horizontally beneath the building thereby isolating the structure from the ground and significantly reducing the forces on the building. Te Papa's base isolators can be seen as a special exhibit just around the corner from the museum's main entrance.

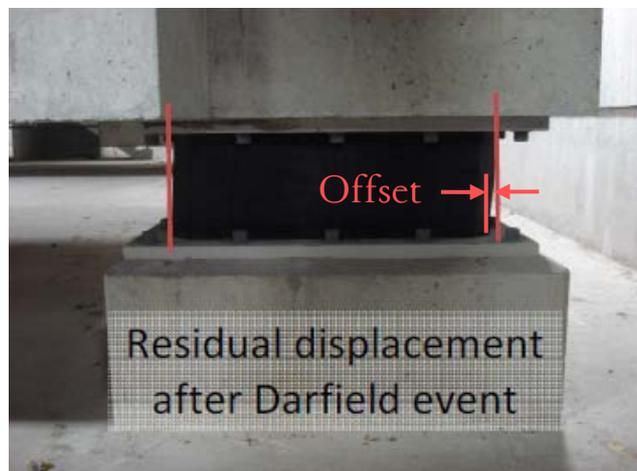
Figure 3. Lead Rubber base isolator under Christchurch Women's Hospital, showing the final resting position of the building after its oscillation during the 4 September 2010 earthquake.

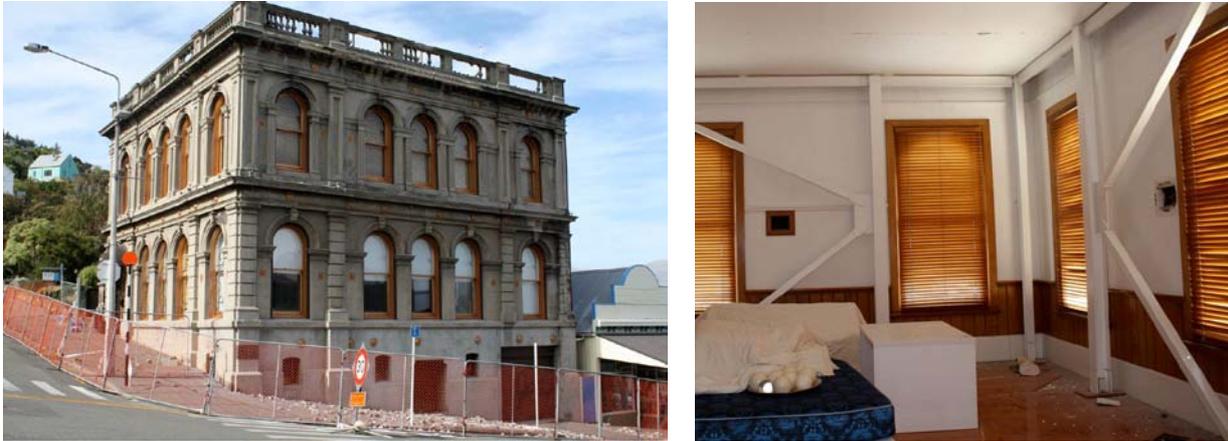
Figure 4: The Lyttelton Fire Station building suffered only minor damage as it has been strengthened with an internal steel frame (Photos Win Clark)

There has also been research on how to strengthen older buildings, and how to add further protection to vital buildings such as hospitals. Some of these methods include: removing particularly vulnerable parts of buildings (e.g. brittle façades and parapets); tying the walls together with steel bracing; bolting façades to the building's frame; adding new support structures; and, wrapping columns and joints with steel and other materials to keep them intact.

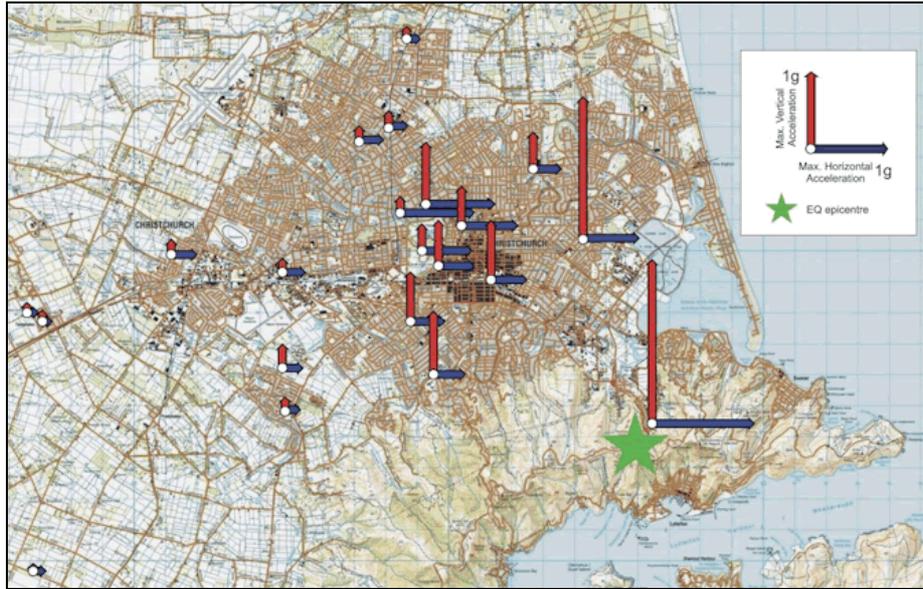
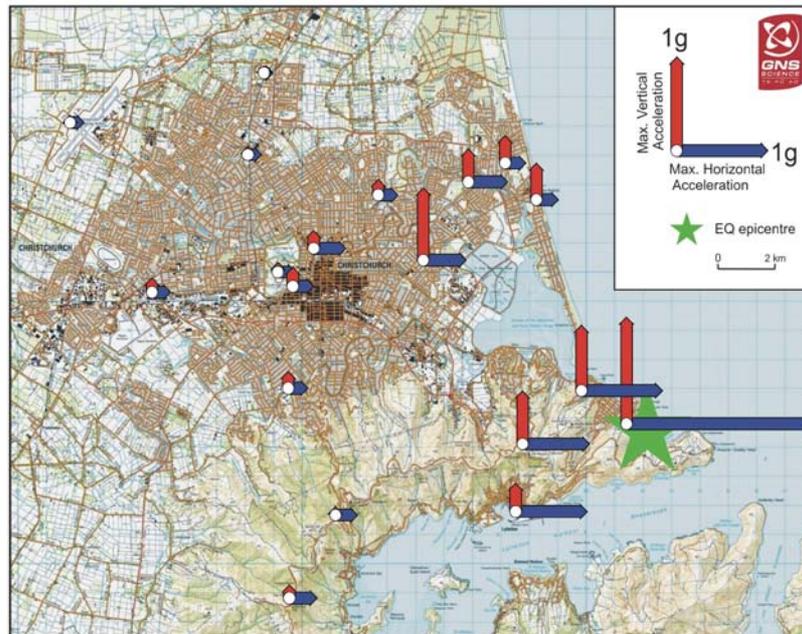
Figure 5a and 5b: Graphic showing the unusually high vertical ground accelerations in central Christchurch recorded during the magnitude 6.3 earthquakes on 22 February and on 13 June 2011. (Source: GNS Science)

Despite being only 6.3 on the earthquake magnitude scale, the proximity of the 22 February and 13 June 2011 events to the surface, and to Christchurch, caused ground shaking in the central business district several times as severe as what occurred in the magnitude 7.1 September 2010 earthquake (Figures 5a and 5b). The geology of the area made matters worse by guiding the shock waves towards the city. The peak ground accelerations, as they are called, were amongst the highest to have ever been recorded in a modern city anywhere in the world.

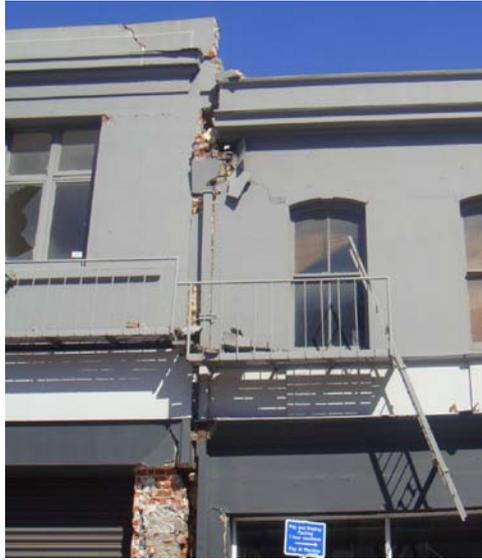
Figure 6: Pounding-induced damage of buildings in Christchurch CBD³

Other ways earthquakes cause damage to buildings include when two adjacent buildings collide as the ground movement makes them sway, causing pounding damage (Figure 6), or when sometimes, parts of one building—like parapets, chimneys or façade veneers—fall on another building and cause damage.

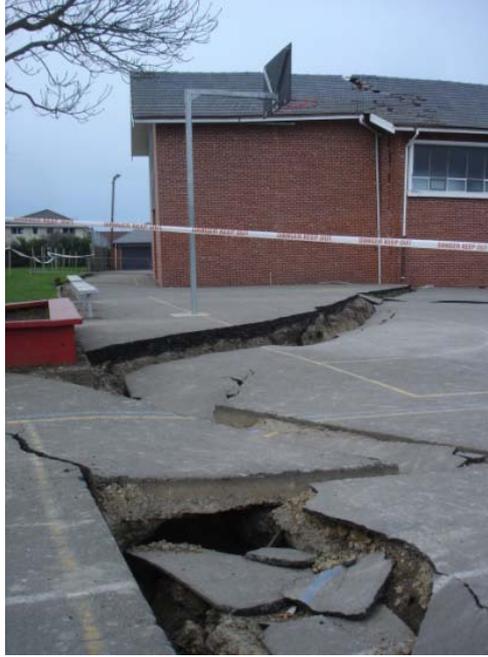
Figure 8 Lateral spread crack running through the courtyard and building at St. Paul's church, Dallington, Christchurch, New Zealand (September 2010)⁶

Most buildings did not collapse even though the levels of earthquake shaking were up to about twice the design level for buildings meeting the current code requirements. Even buildings in areas of liquefaction and lateral spreading, as well as strong shaking, did not collapse despite some being badly damaged (Figure 8) or left tilting.

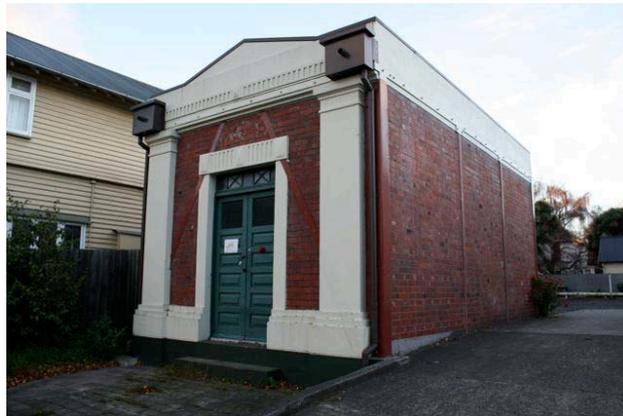
Figure 9: Orion Local Substation. Constructed in unreinforced brick masonry that has been strengthened with a steel perimeter frame (Photo Win Clark)

Just because a building is constructed in brick or stone, it is not necessarily a danger. If brick masonry is properly attached to a backing frame, as it is in most residential construction, it can behave well as can masonry blocks filled with concrete and strengthened with steel rods. Brick masonry restrained by a concrete or steel frame, if properly designed, can also behave well and it has been used effectively throughout the world, including Christchurch, as shown in Figure 9.
