Stairs & Ramps

- Critical structures for egress
- Same issues for steel and concrete stairs
- “Throughout NZ”, every building with stairs requires review of stair/ramp performance
 - *Department of Building and Housing:
Practice Advisory 13: Egress Stairs*

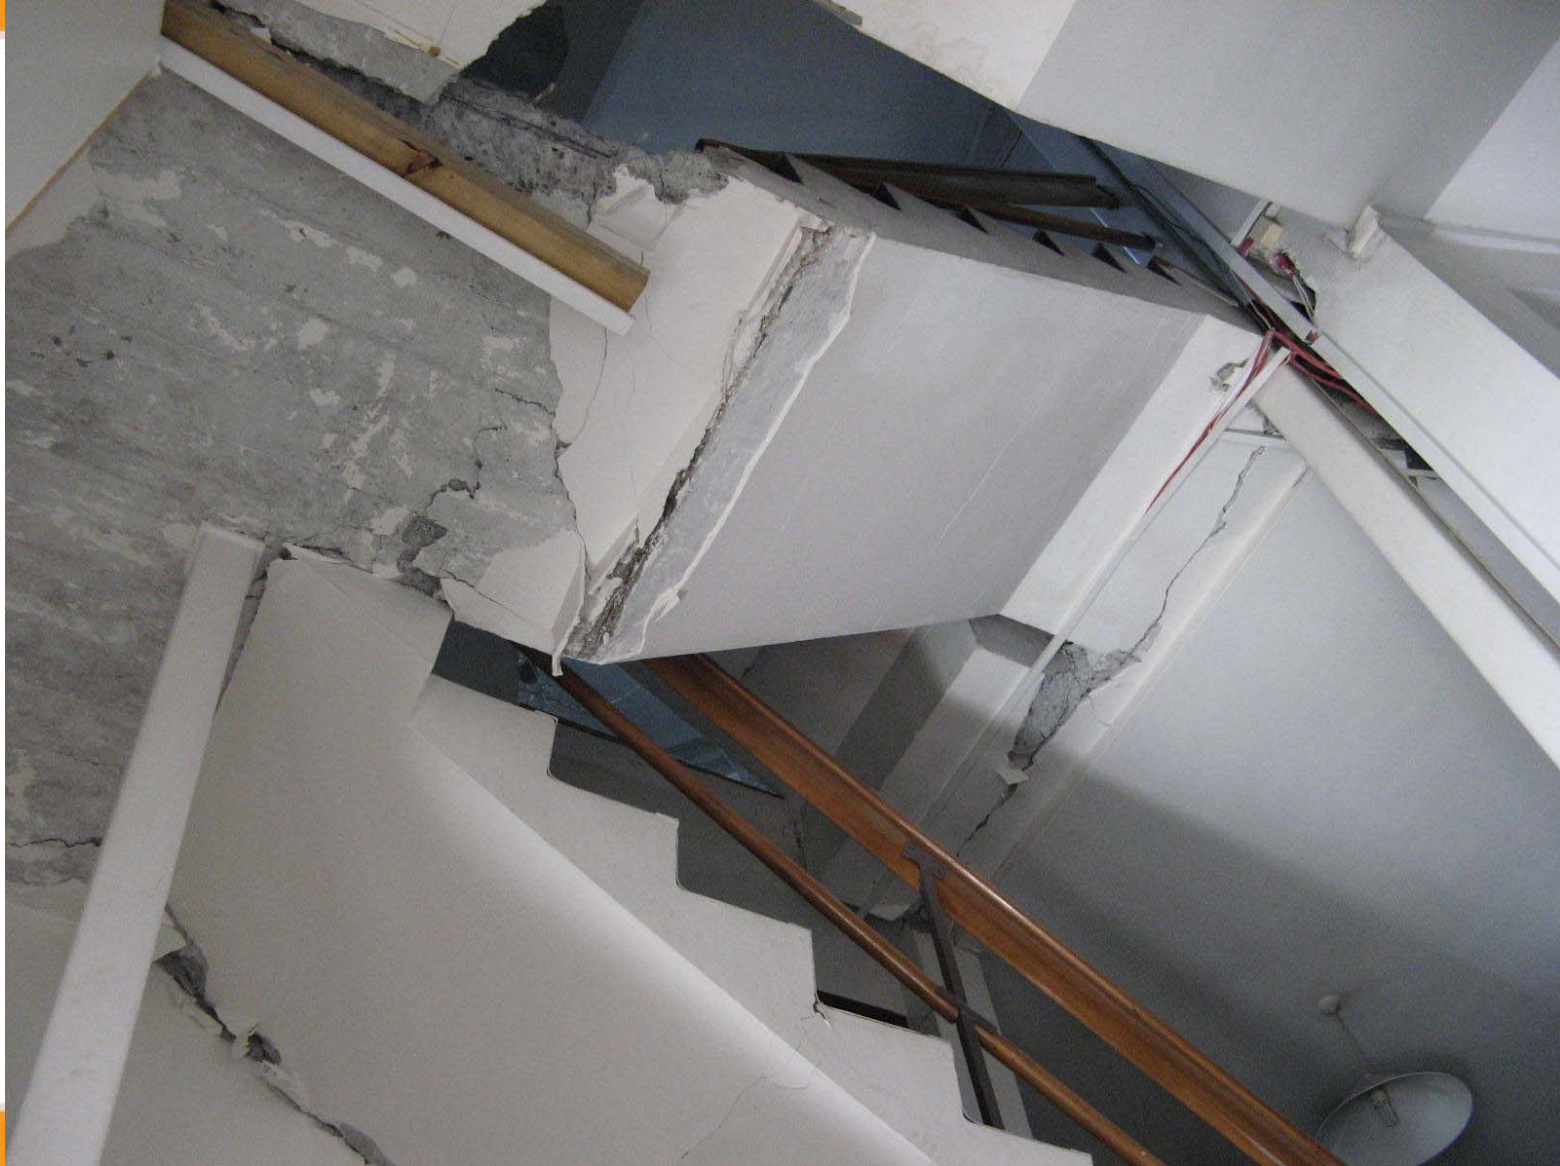
- Act as giant struts or props between floors.
- Change load paths in building
- Fail landings
- Fail the mid-height landings
- Vertical acceleration (**not likely**)
- Under axial compression –
 - Next slides...

Stairs “built in” between floors

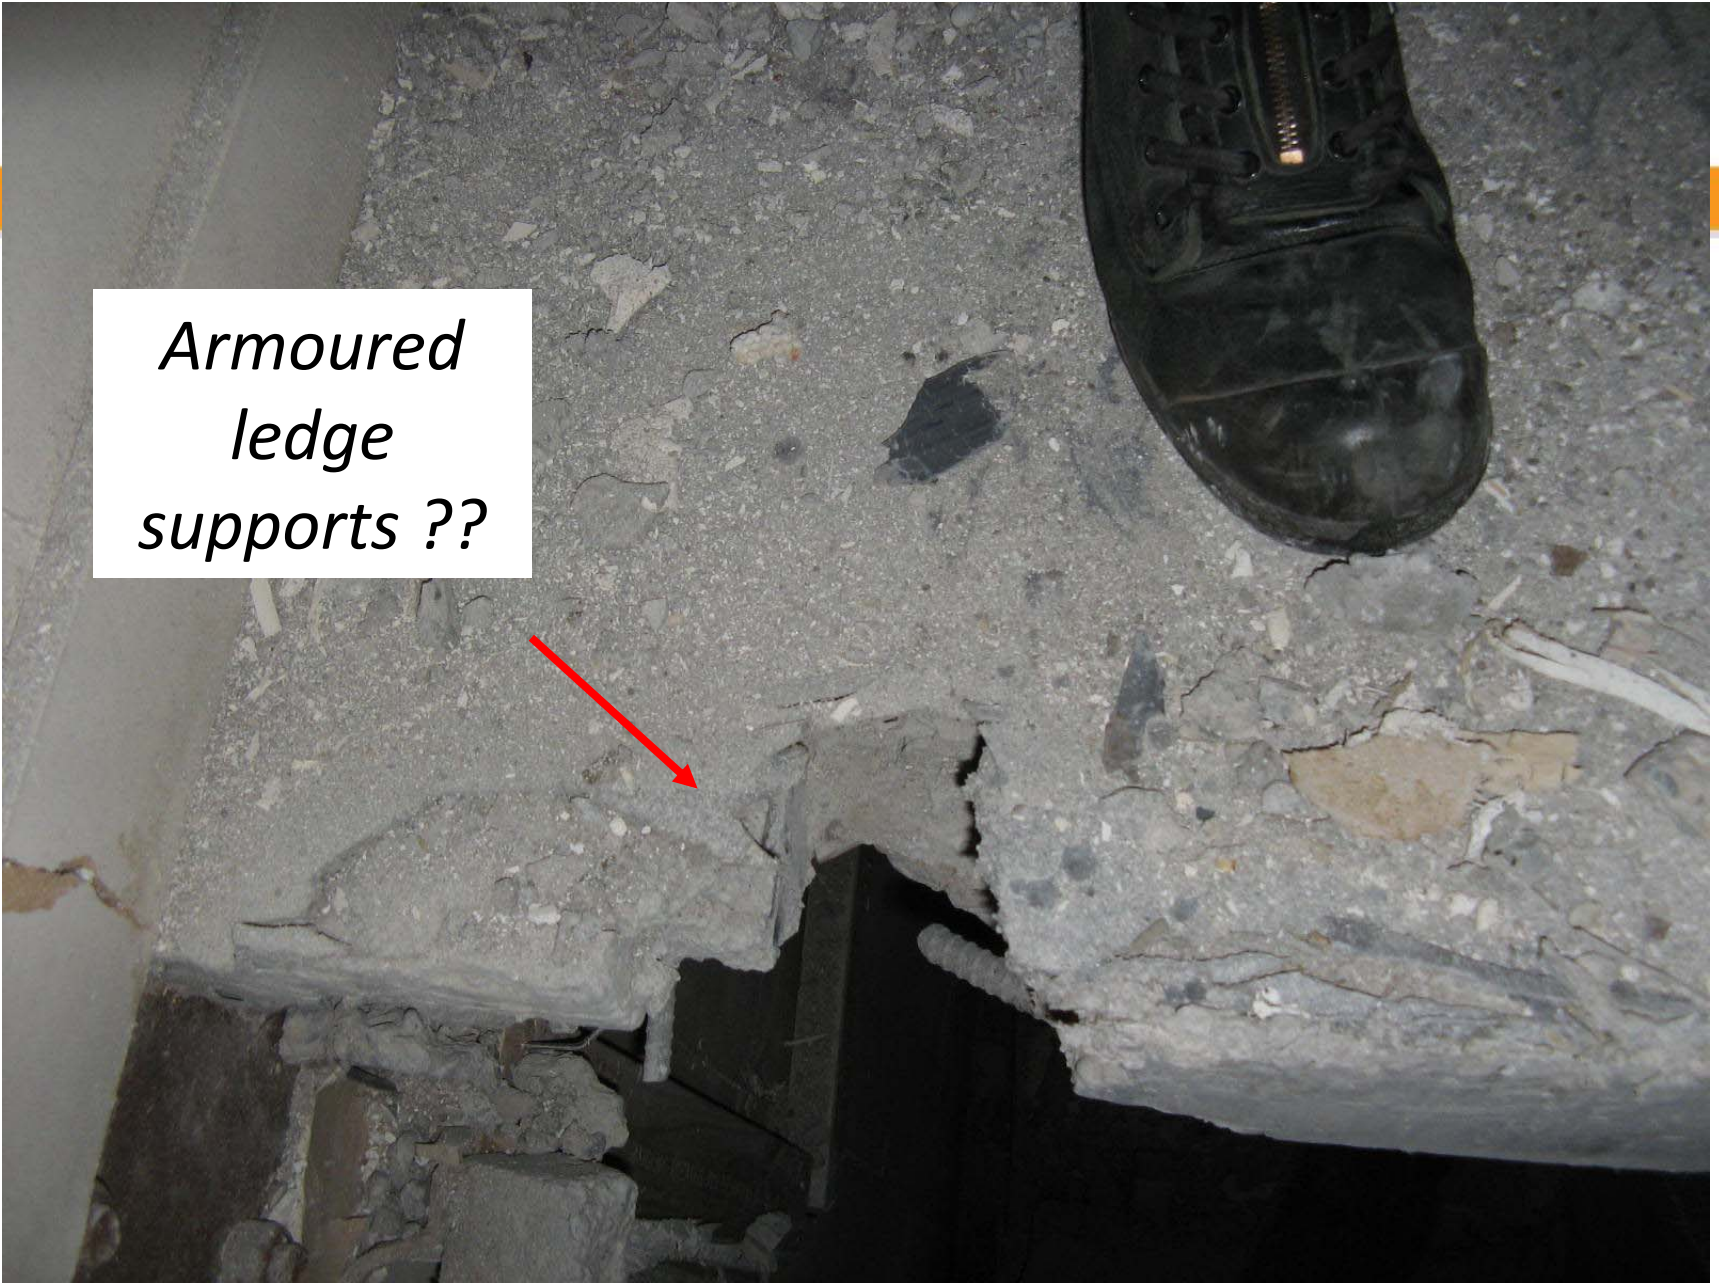
Steel corbels

*Armoured
ledge
supports ??*

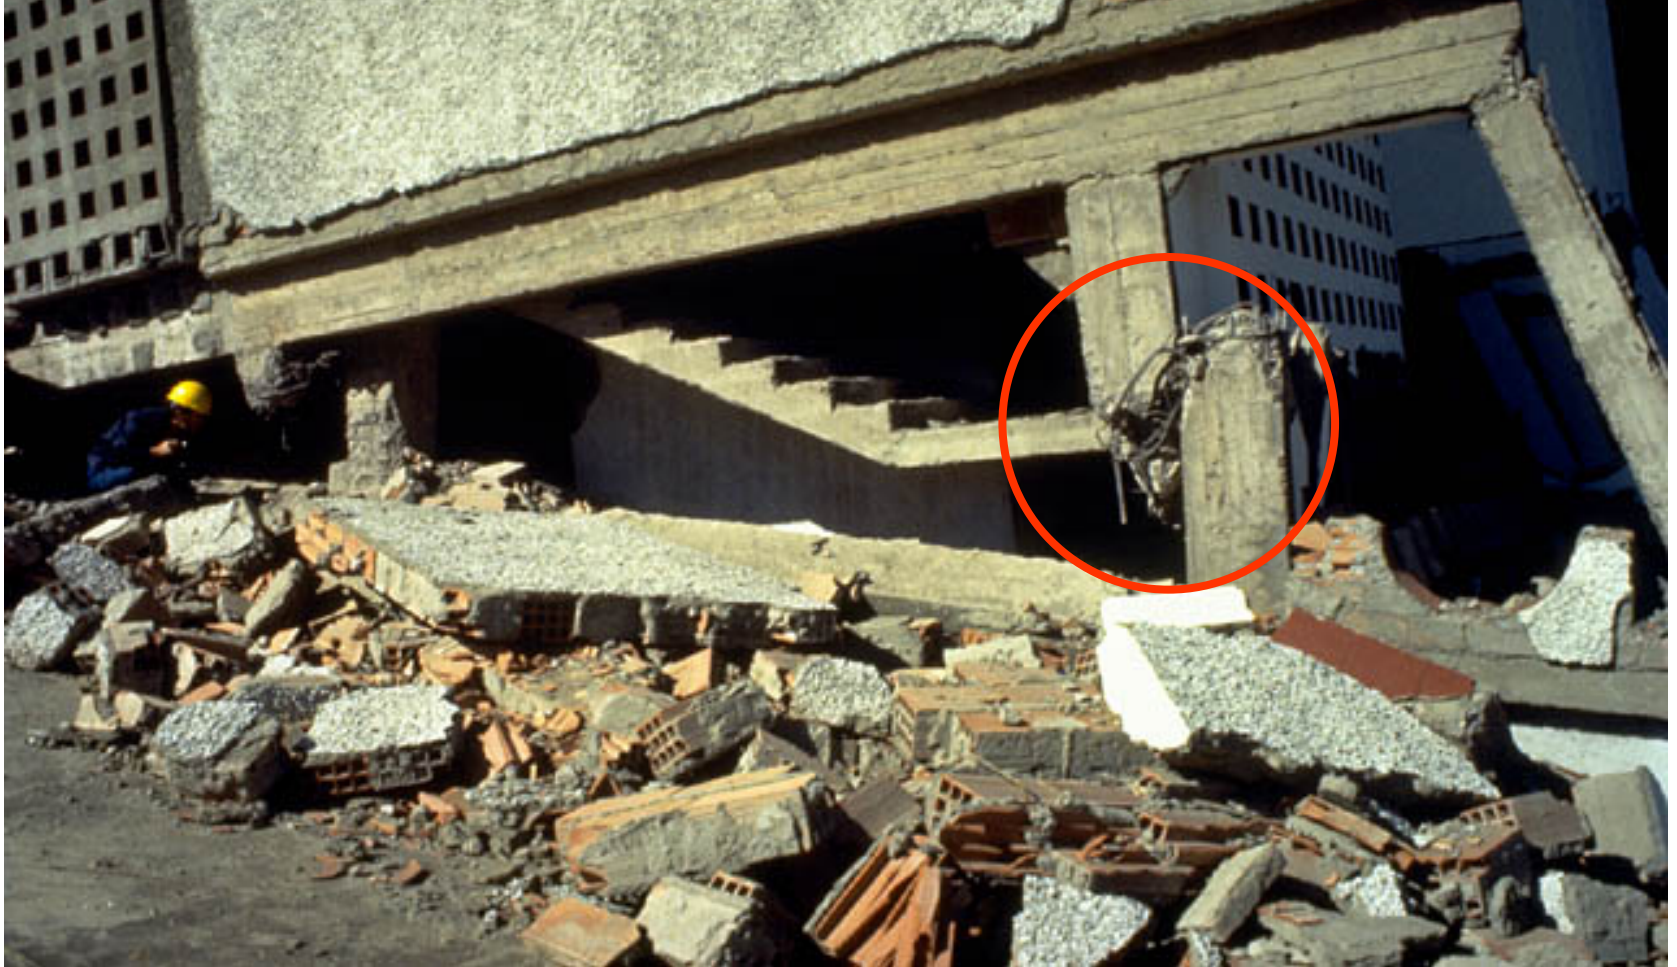
- Support of stairs and ramps mid-height of columns
 - **Must be avoided**

Structural interference - Short Column Effect
El Asnam Earthquake, Turkey 1980
[EERC archive, UC Berkeley].
