New Technologies in Reinforced Concrete

Professor Des Bull

University of Canterbury

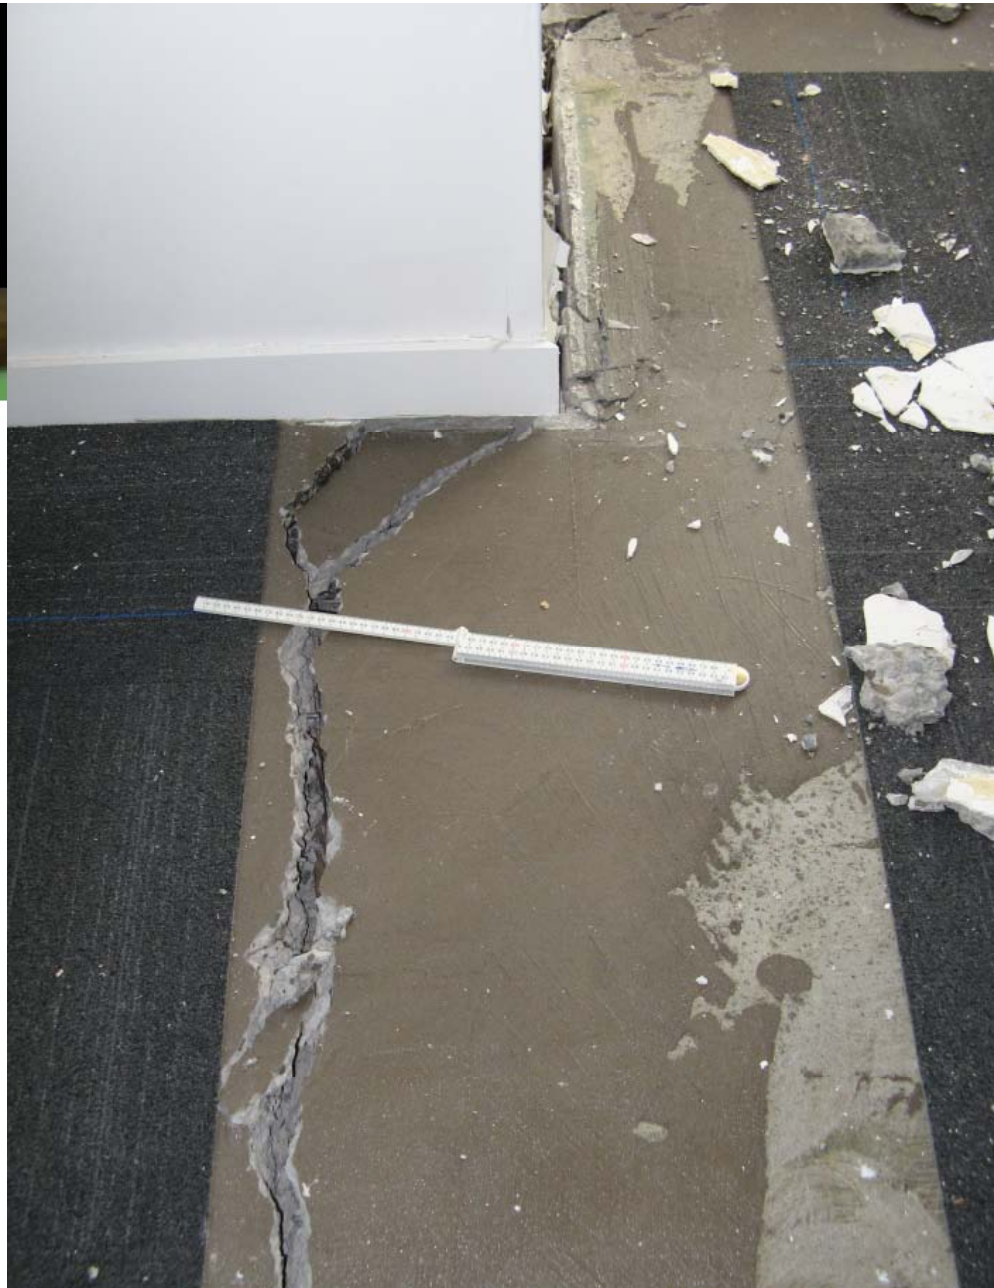
UoC testing Corner column - top view

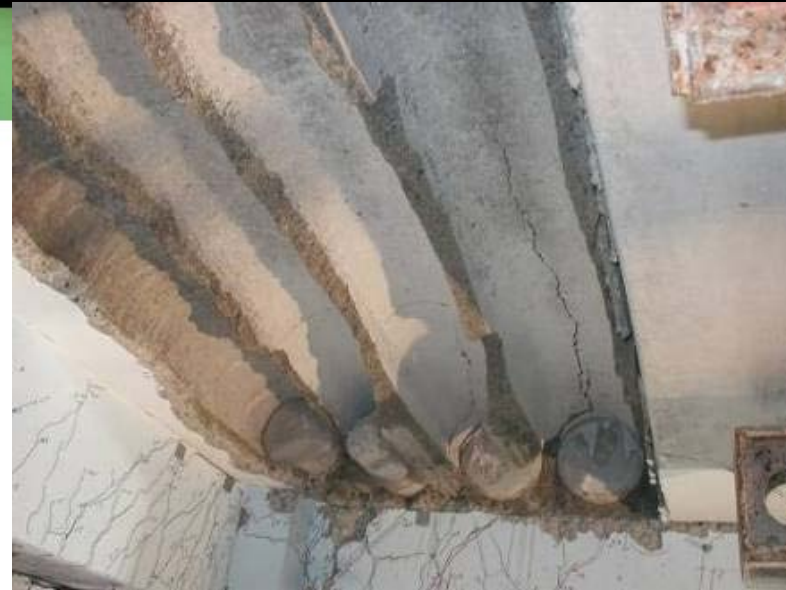
UoC testing - Total Collapse of the Floor

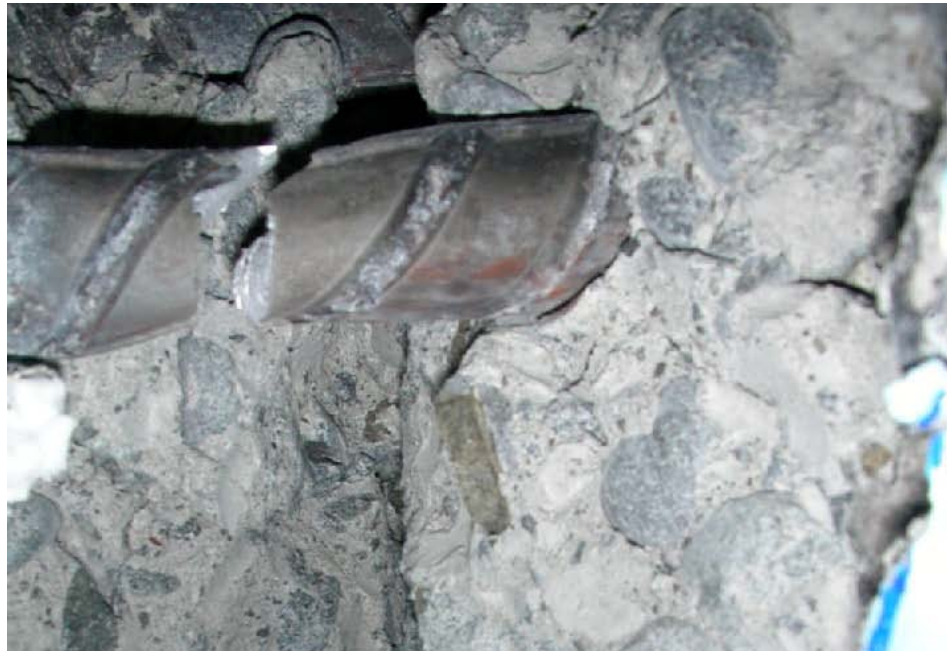
Conventional concrete frame

- Fracture of main bars

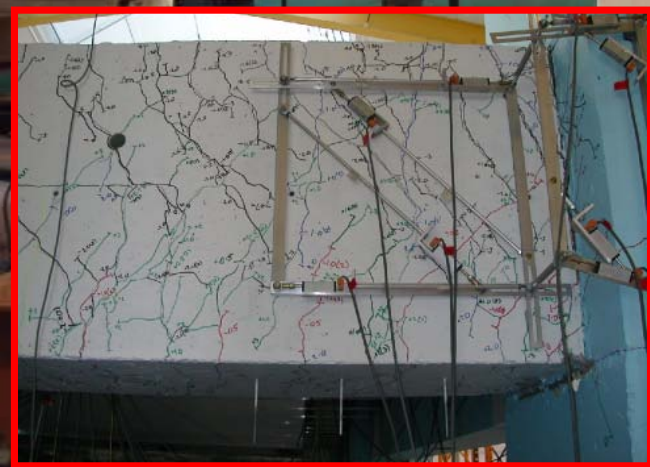
Slotted Beam

EoT 4.5% Drift

Steel tube - ✓

PVC plastic tube - ✗

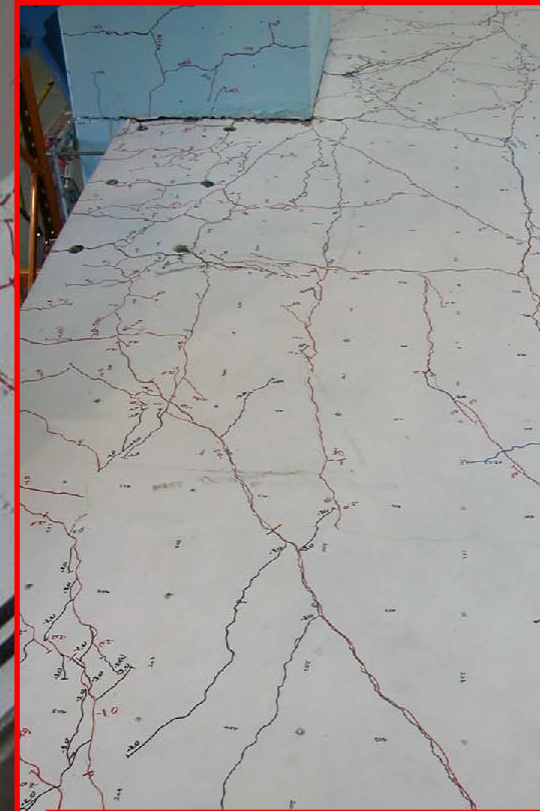
Top of beam and floor
Conventional Frame
post - 2004

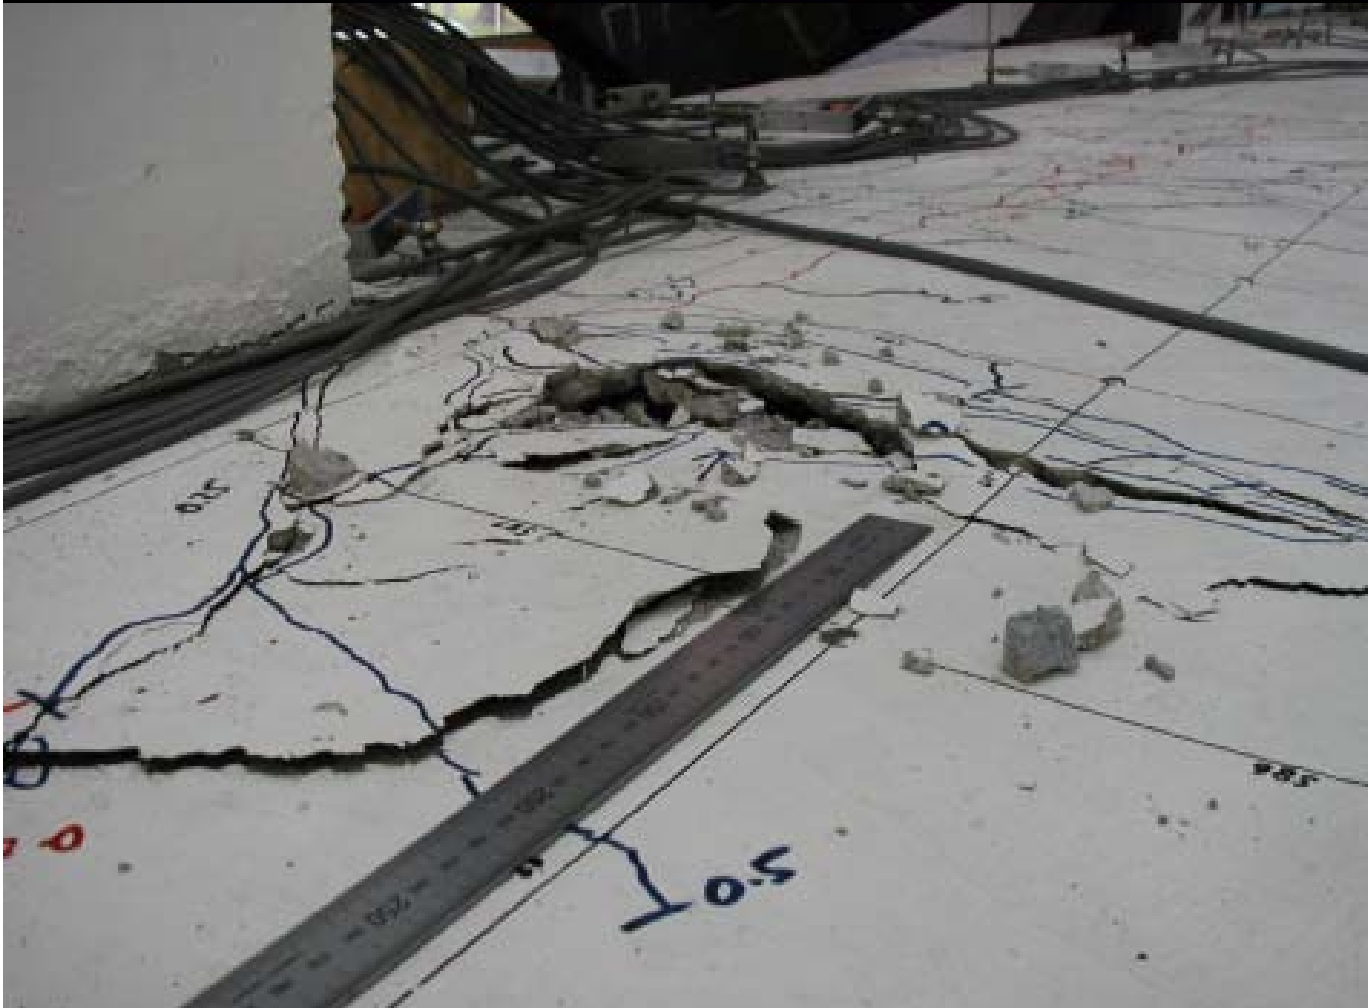
2 Storey, "Non-tearing" Precast Concrete Floor / slotted beams

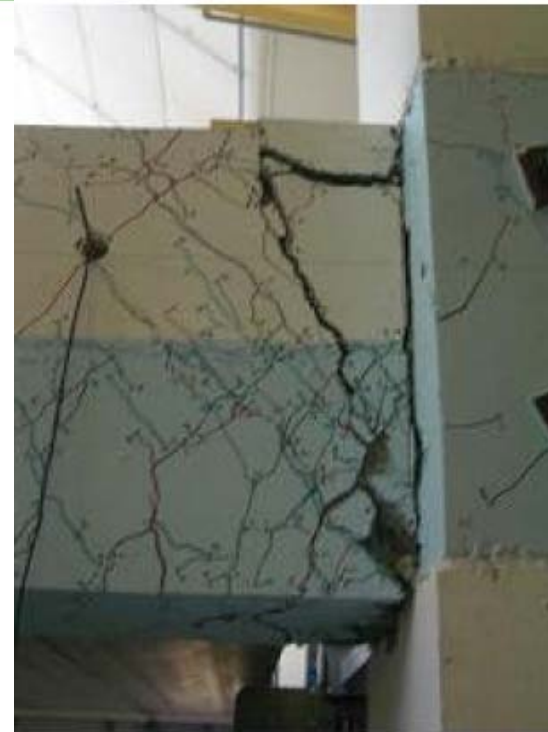
Monolithic Beam at ULS
(MacPherson, 2005)

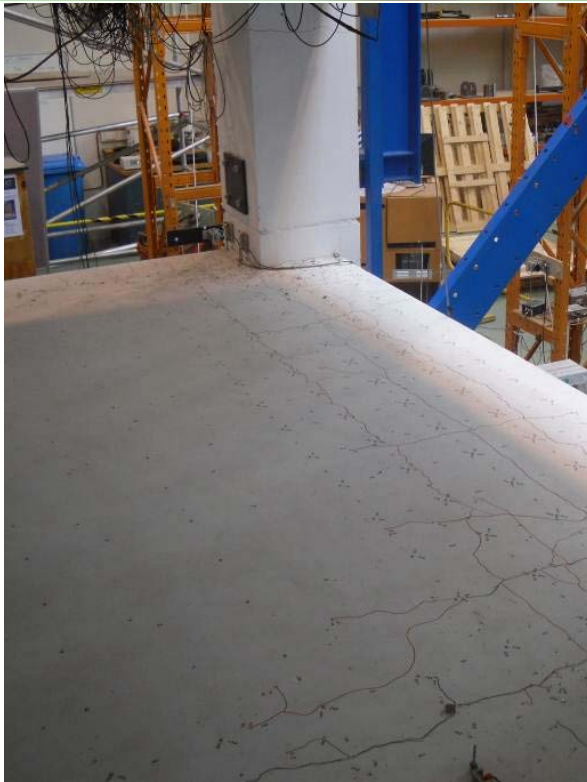
Slotted system floor at ULS

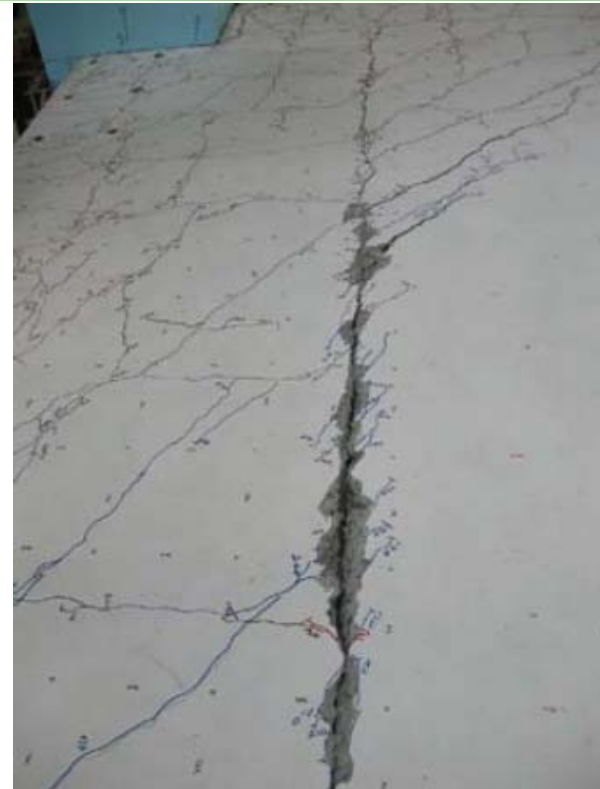
Monolithic system floor at
ULS (Lindsay, 2004)

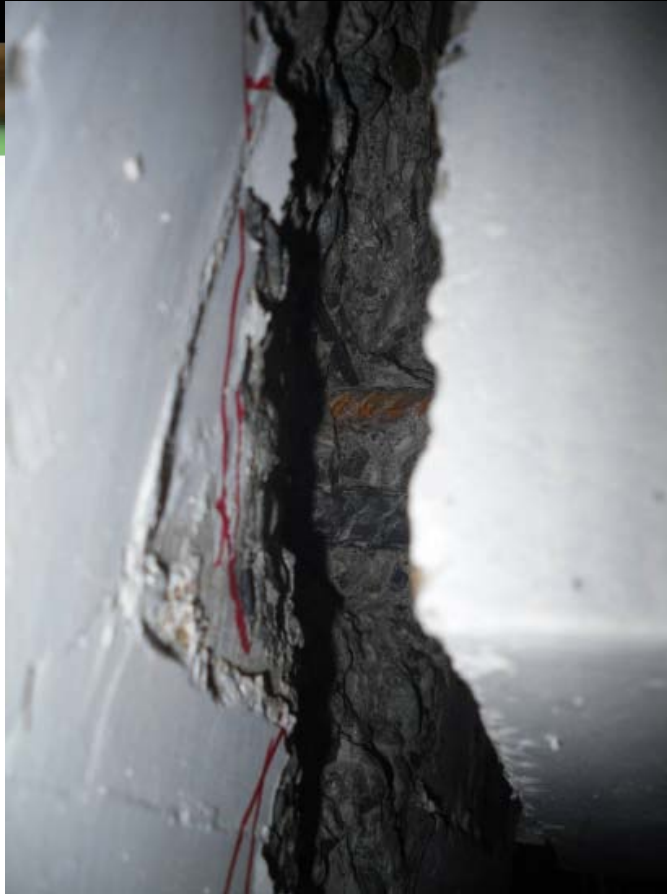
Exterior joint strain penetration

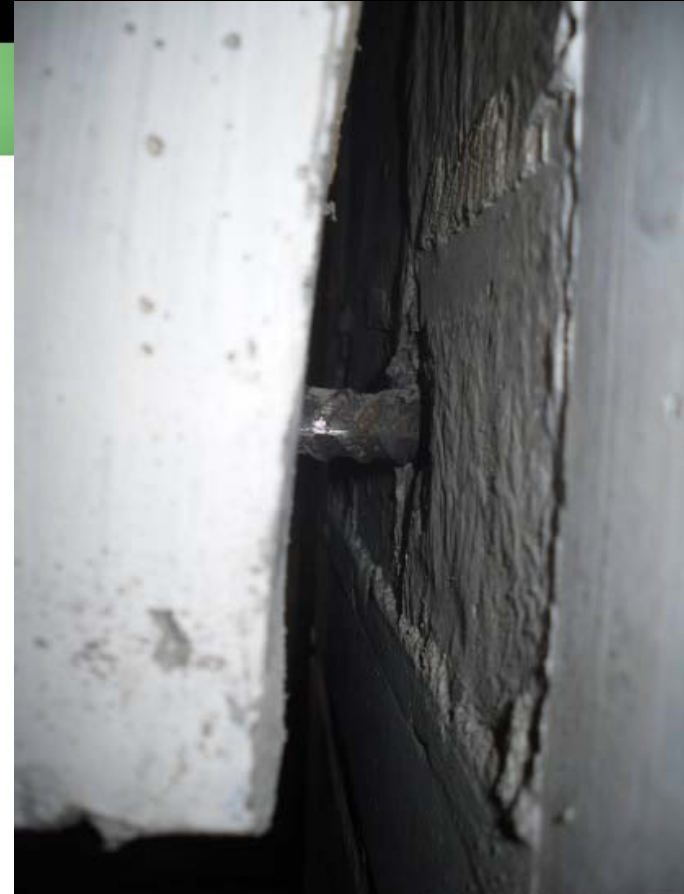
Interior joint strain penetration

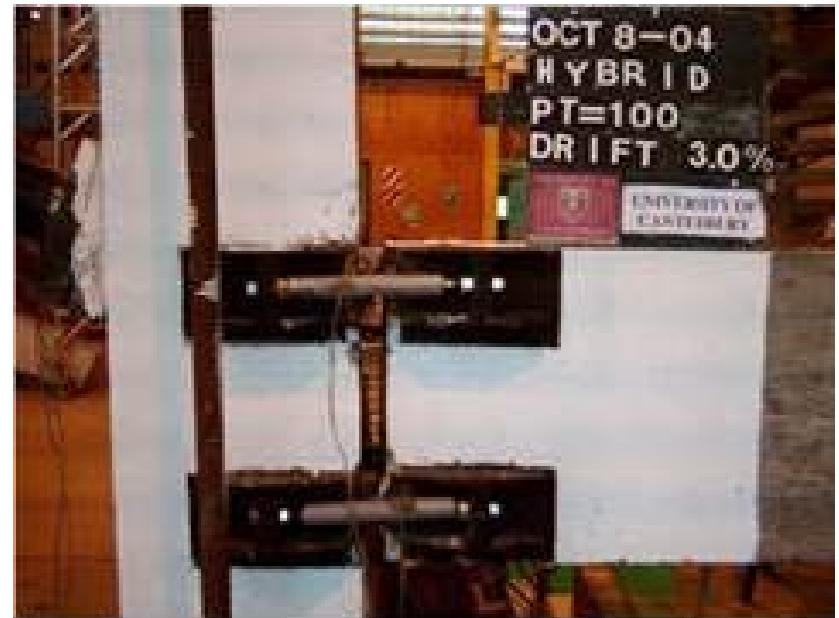
Replaceable external mild steel energy dissipaters

- Instead of internal mild steel bars
 - Very hard to repair

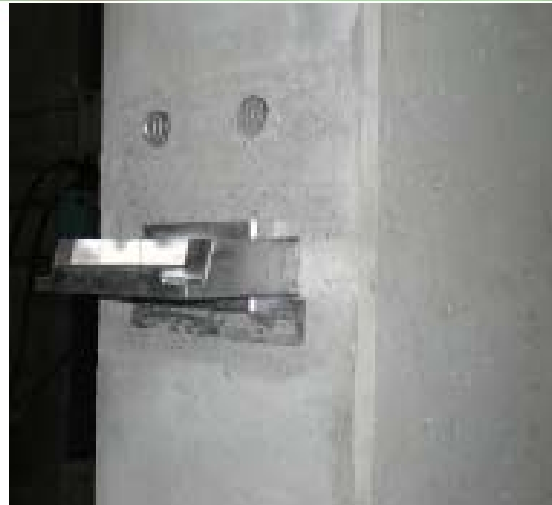
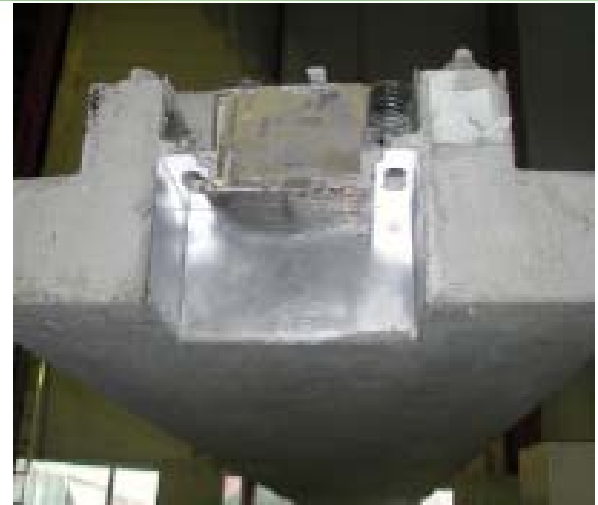
Alternative solutions of steel shear corbel/bracket

**“Hercules” systems,
proprietary of B.S. Italia srl**
