The Evaluation and Management of Buildings Following Earthquakes

Presentation to the
Canterbury Earthquakes
Royal Commission

*Bret Lizundia
Rutherford + Chekene
San Francisco*

2 September 2012

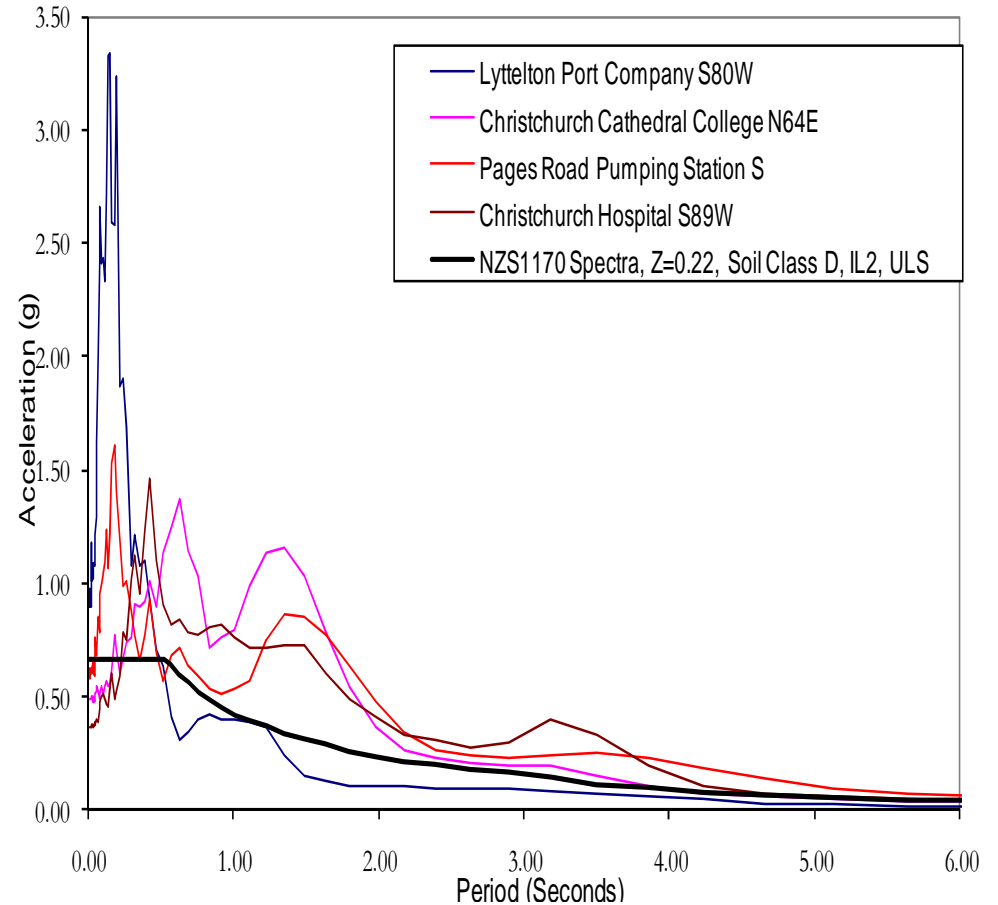
Lyttelton Earthquake 22 February 2011

The intensity and ground accelerations in Christchurch were much larger in the 22 February 2011 event.

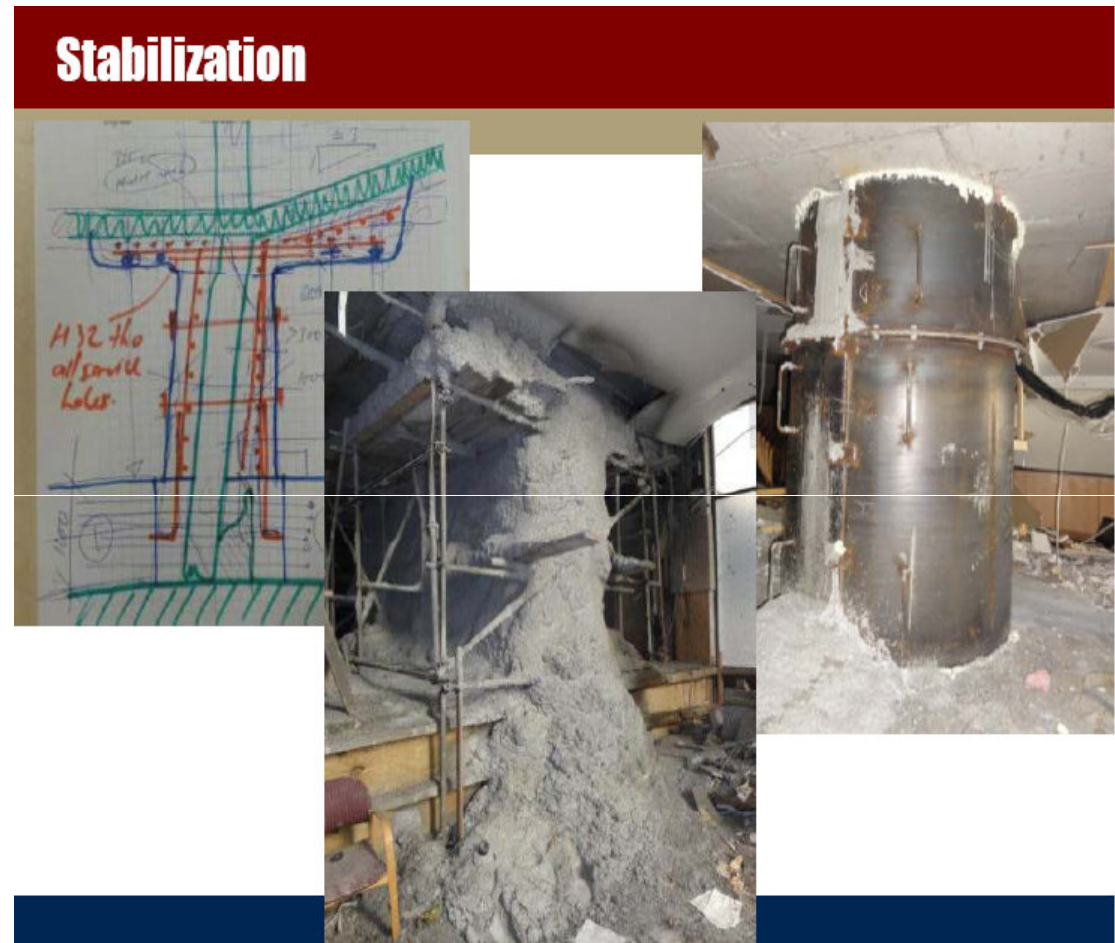
- Emergency stabilization of mid-rise and high-rise buildings

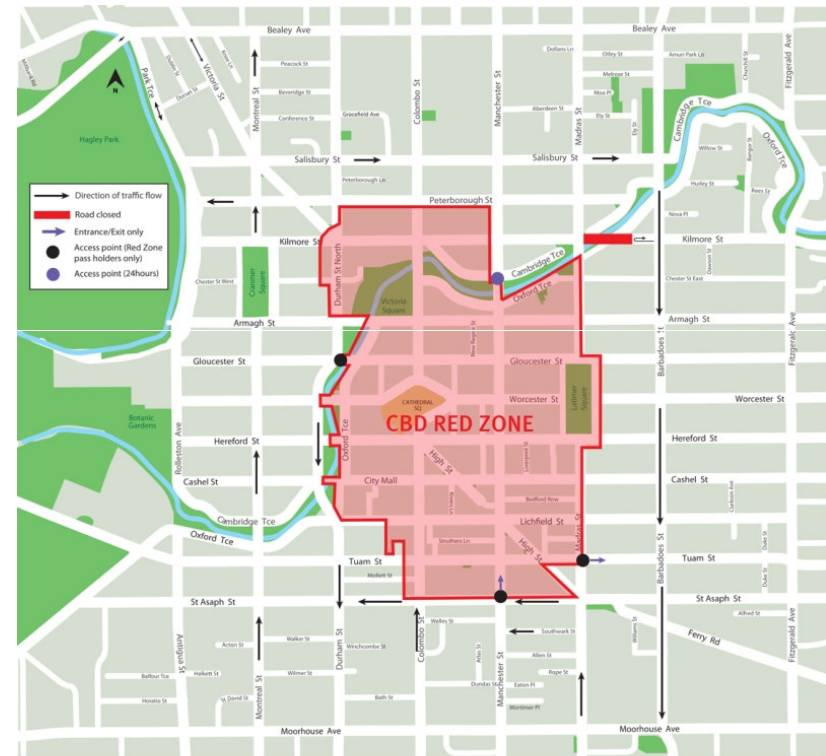
**CBD Red Zone
Cordon Map**

Current as of 12noon 27 August 2011

Temporary traffic management subject to change.
Drive with caution and obey traffic signage.
Cordon opening dates have been, and will continue to be,
dependent on the ability to make these areas safe to enter.

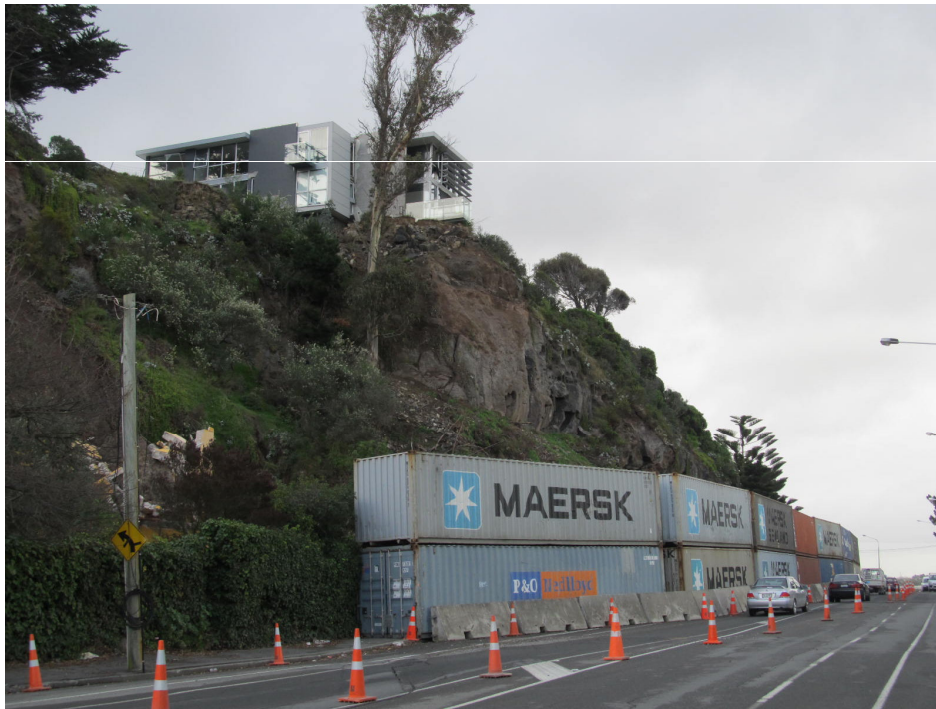
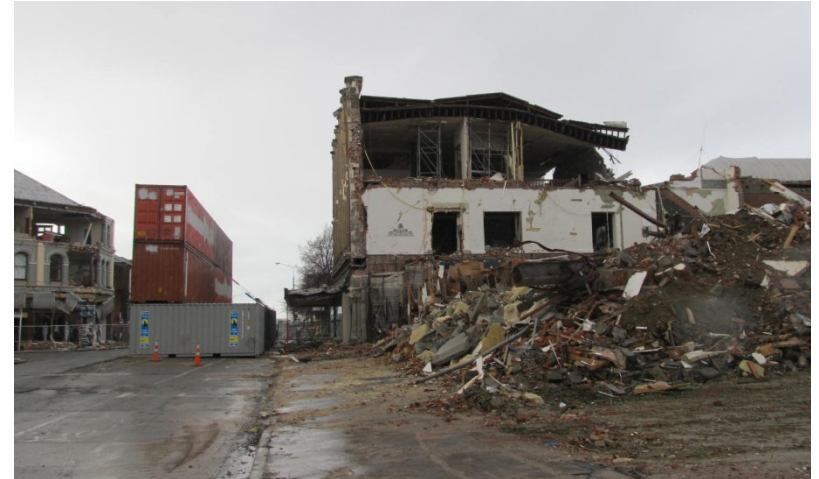
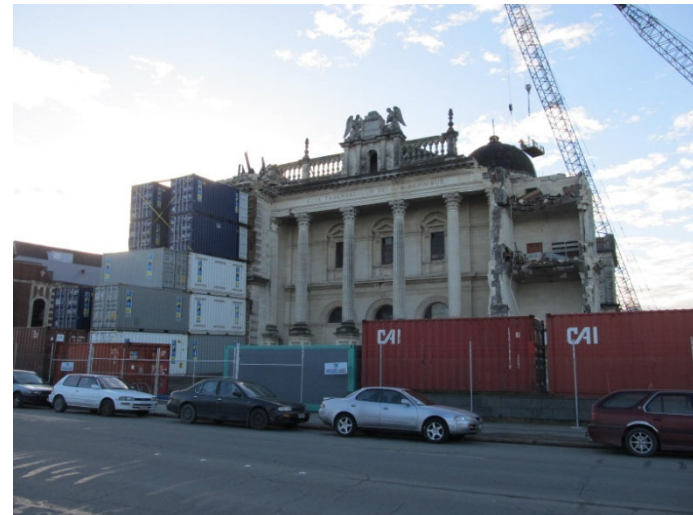
- Using shipping containers for barricades, shoring, and safe entry

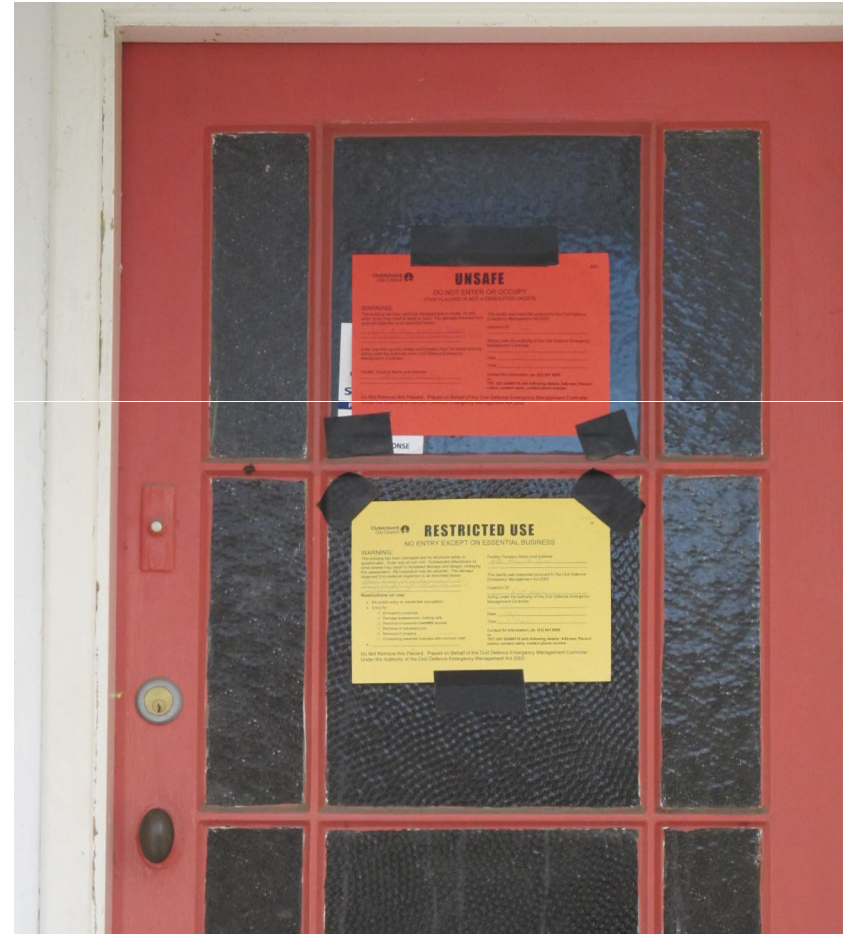
- Old placards were not consistently removed after a new placard was installed.
- Ink faded on some placards over time.
