Section 4:

Techniques for seismic improvement of unreinforced masonry buildings

The Performance of Unreinforced Masonry Buildings in the 2010/2011 Canterbury Earthquake Swarm

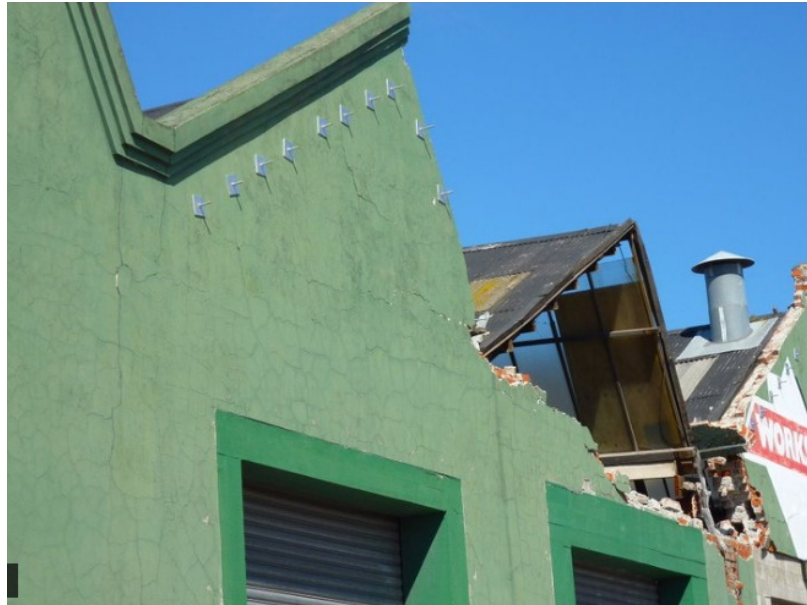
Figure 4.1 Example of a secured gable end that survived earthquake loading and a companion failed gable end that was not secured

Solid walls can also be vulnerable but they have the advantage of being less slender. Examples were observed of out-of-plane failures of solid walls. The addition of wall-to-diaphragm anchors serves to reduce the vertical slenderness of a wall as well as make the building work together as a whole, rather than as independent parts.

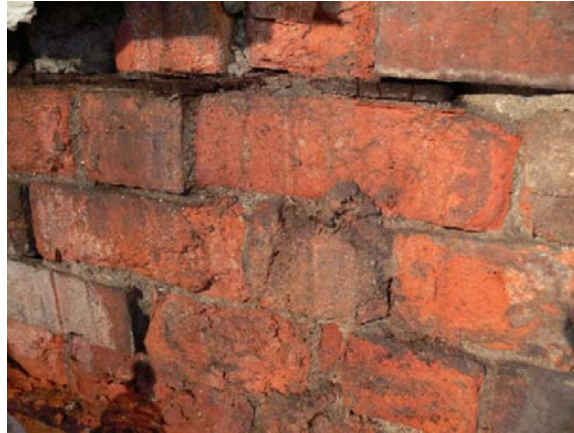
Figure 4.2 Severely degraded bricks and mortar due to moisture ingress

The bricks and particularly the mortar used in URM buildings deteriorate in the environment over time. Occasionally this deterioration will result in local failures and cracking which affect the overall effectiveness of the building. Various external actions such as dampness, subsidence, earthquakes, and impacts can also cause cracking and damage in the masonry elements. Deterioration similar to that shown in Figure 4.2 can often be remedied by reinstatement and repointing of mortar⁷, but sometimes more substantial measures are required. There are various techniques for the repair of cracks, securing of lintels, and reinstatement of damage. Bonding agents such as grout or epoxy can be injected into the mortar and there are also several metal-based types of inserts, such as shaped dowels or reinforcing bars, which can be used to reinstate and strengthen the brickwork (Crocì, 1998). The visual impact of reinstatement and strengthening can be minimal if done carefully, and the result is potentially far superior to a cracked and broken façade. However such measures are often irreversible, and care needs to be taken with colour matching and the concealment of holes drilled for inserting rods. Lintels and arches will sometimes require strengthening, particularly when these elements are constructed from URM. One of the best ways to achieve this intervention is by using drilled and inserted rods which are grouted or epoxy anchored into place. These rods provide the requisite tensile strength to the structural element while having little visual impact.

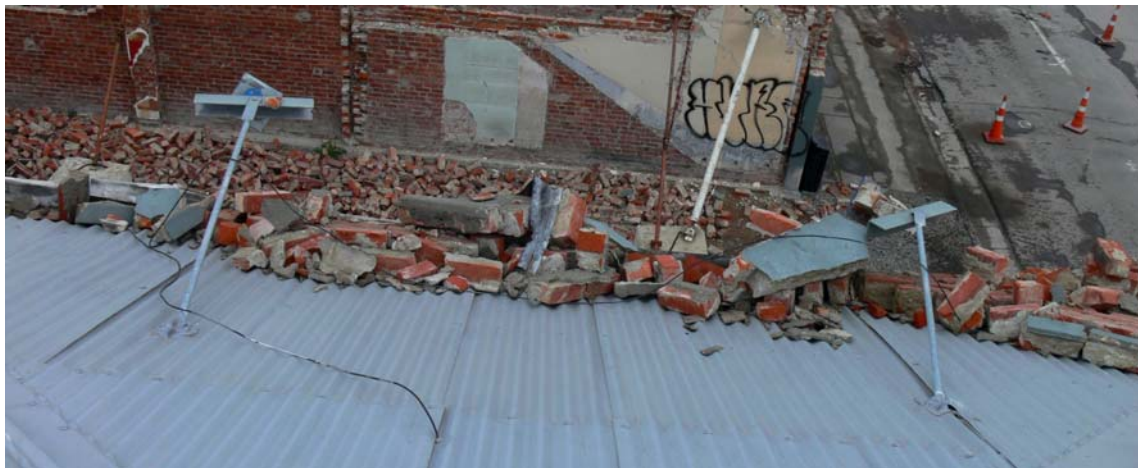
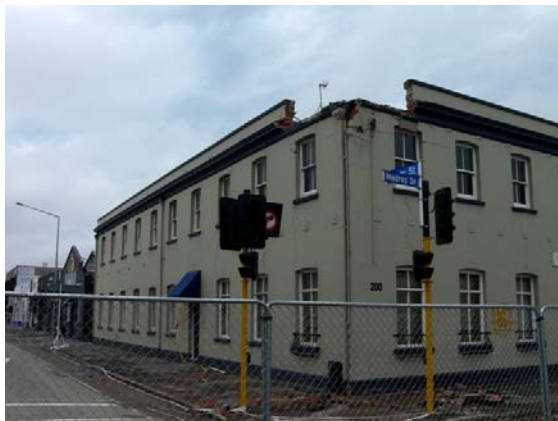
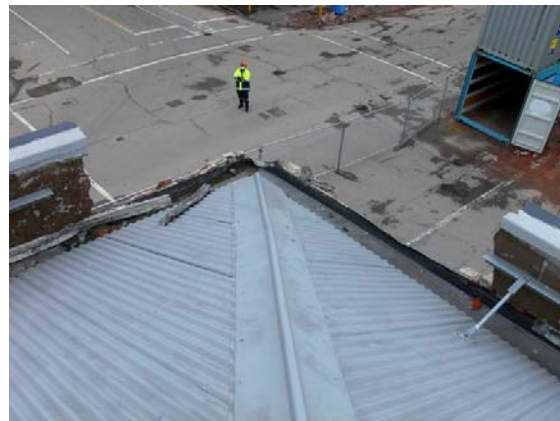
Figure 4.3 Failed parapet where the securing was discontinuous at the corner of the building

(a) Roof level view of failed parapet restraint

(b) Exterior view of failed parapet at corner

(c) Roof level view of failed parapet at corner

Several examples of unsuccessful parapet retrofits were observed following the recent Canterbury earthquakes. These failures provide an important opportunity to identify aspects that need to be considered when formulating best practice examples for use in future retrofit designs. Figure 4.3 shows two examples where discontinuous horizontal elements were installed at the rear of the parapet. In Figure 4.3(a) the distance between the braces securing the parapet to the roof structure was too large and in Figure 4.3(b) and (c) the horizontal element that was used to secure the parapet was discontinued adjacent to the corner of the building.

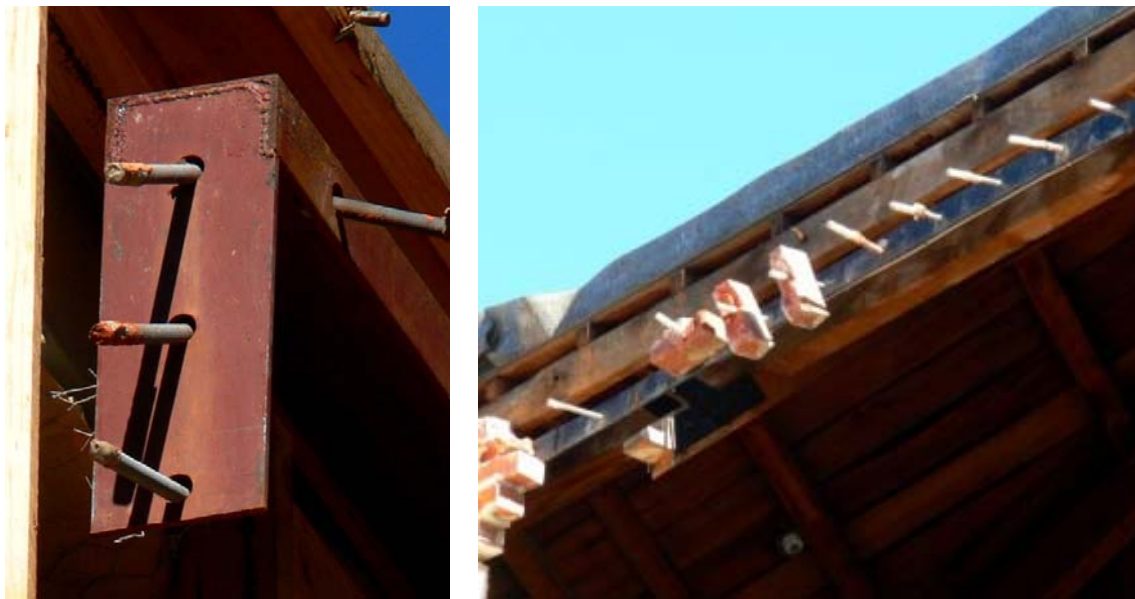
Figure 4.4 Examples showing failure of adhesive anchors

(a) Failure of a steel fixing due to anchor withdrawal

(b) Failure of a steel fixing due to both anchor withdrawal and brick detachment

- There has been a significant number of observed failures of adhesive anchors, where the anchor has withdrawn from the brick (see Figure 4.4(a)). This failure

- There are many examples where the adhesive anchor has held the brick to which it was secured, but that brick has detached from the masonry structural element and only an individual brick is retained (see Figure 4.4(b)). This failure mode demonstrates the need for application of a continuous supplementary structural element to the surface of the masonry to secure the structural element as a single component.

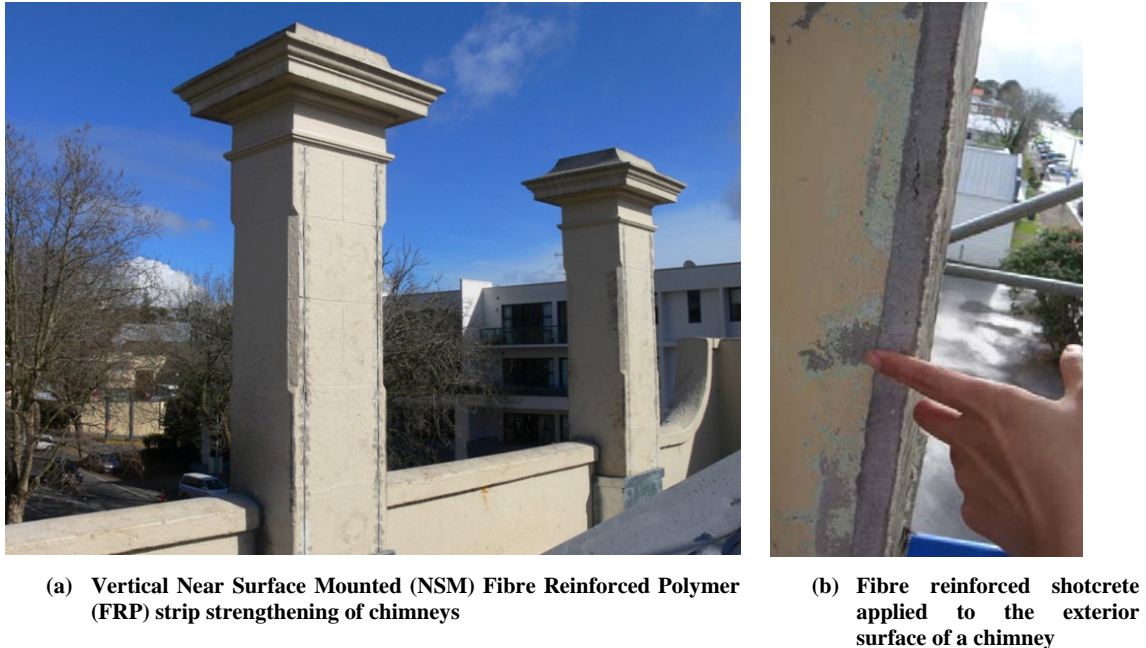
Figure 4.5 Examples of earthquake strengthened chimneys

Chimneys contribute to the architectural form of a building and often help define its roofscape, and as such should be preserved if possible. The securing of chimneys is more complex than the securing of parapets and gables, but can usually be achieved by fixing them to the building diaphragms at each level and either strengthening the projecting portion or bracing it back to the roof structure with steel members similar to the methods used for parapet restraint, or fixing steel sections to the sides to provide flexural strength. A number of strengthening solutions are available for bonding to the surface of masonry elements and may be appropriate where the exterior has been plastered. Two such techniques used to strengthen chimneys are shown in Figure 4.5.

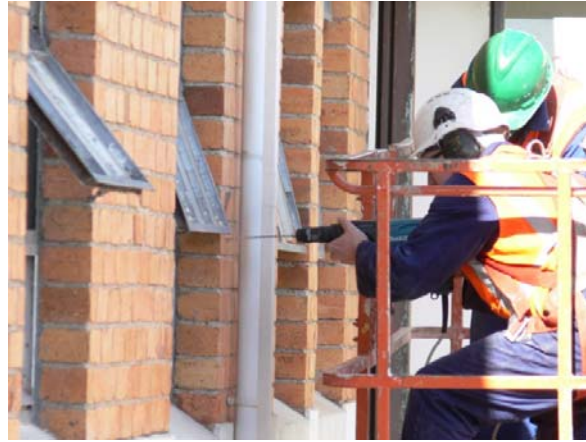
Figure 4.6 Use of drilled ties to fix external leaf to internal leaf

The current preferred approach to re-attaching the outer leaf is to use a series of proprietary corrosion resistant ties at regular centres which are drilled through the face layer and are epoxy anchored into the structure behind, as shown in Figure 4.6. This technique is effectively a retrofit of the steel ties which have either deteriorated or were omitted in the original construction. The visual impact of these ties is minimal, although care needs to be taken when concealing drilled holes. These ties are irreversible, but their presence is visually negligible.

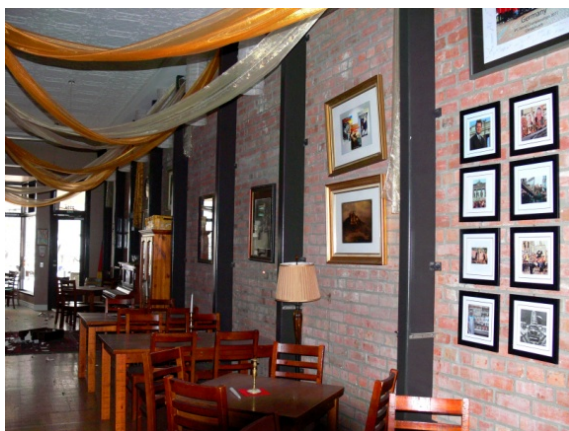
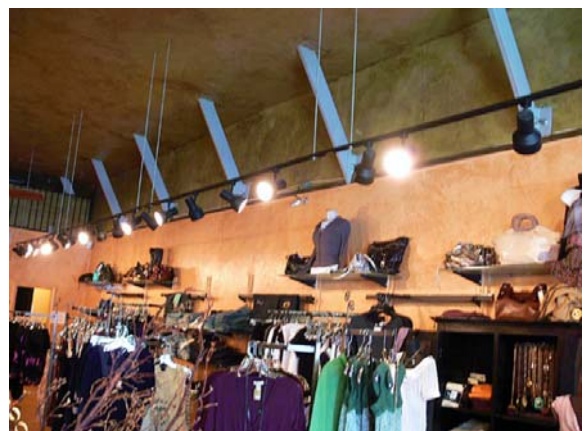
Figure 4.7 Techniques available to increase wall stability against out-of-plane failure

(a) Internal strong backs to restrain out-of-plane wall failure

(b) Struts from the floor above to improve out-of-plane performance

A series of vertical steel sections can be bolted to the inside face of the wall at sufficient spacing to ensure that the width of wall between supports is capable of resisting the out-of-plane forces (see Figure 4.7(a)). These sections act in bending to transfer wall loads to the adjacent floor diaphragms, essentially breaking up a large planar wall into a number of buttressed segments. This simple method may be appropriate in, for example, an industrial building, where visible steel bolted to the walls is in keeping with the character of the building, or in other buildings where the steel can be made to be architecturally appealing. In some other situations it may be less appropriate but less intrusive than other techniques. If there is existing internal framing with space behind for these columns, and no historic material is lost during installation, then it is a perfectly acceptable method. Sections generally fix to the historic material with bolts only, which allows a high degree of reversibility.

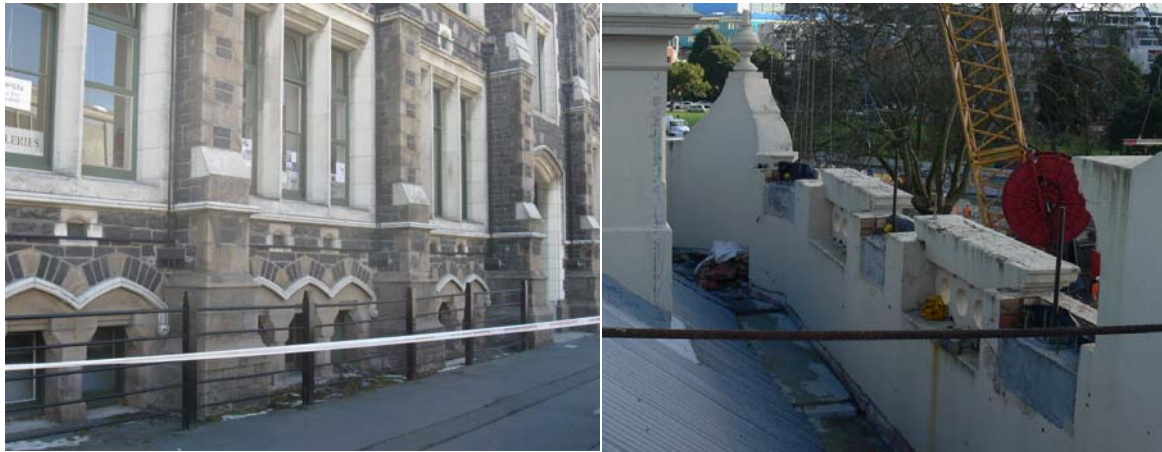
Figure 4.8 Post-tensioned seismic retrofits of URM buildings

(a) External post-tensioning used in the Christchurch Arts Centre (photo taken after 22 February 2011 earthquake)

(b) Internal post-tensioning bars used in the Birdcage hotel, Auckland

Post-tensioning is an extremely effective method for increasing the out-of-plane strength of URM walls. The post-tensioning may be applied externally as shown in Figure 4.8(a) or be installed internally (see Figure 4.8(b)) by drilling vertical cores through the middle of a URM wall and then inserting steel rods into these cores. The rods may or may not be set in grout, and are then tensioned, which provides an additional compressive force in the wall. This loading modifies the stress behaviour of the URM in bending (i.e. the result of out-of-plane loading). Instead of bending instantly and causing tensile forces, to which URM has little resistance, the wall remains in compression (Ismail et al., 2011). This modification of the material properties also results in an increase in the shear strength of the wall, making post-tensioning an attractive strengthening solution.

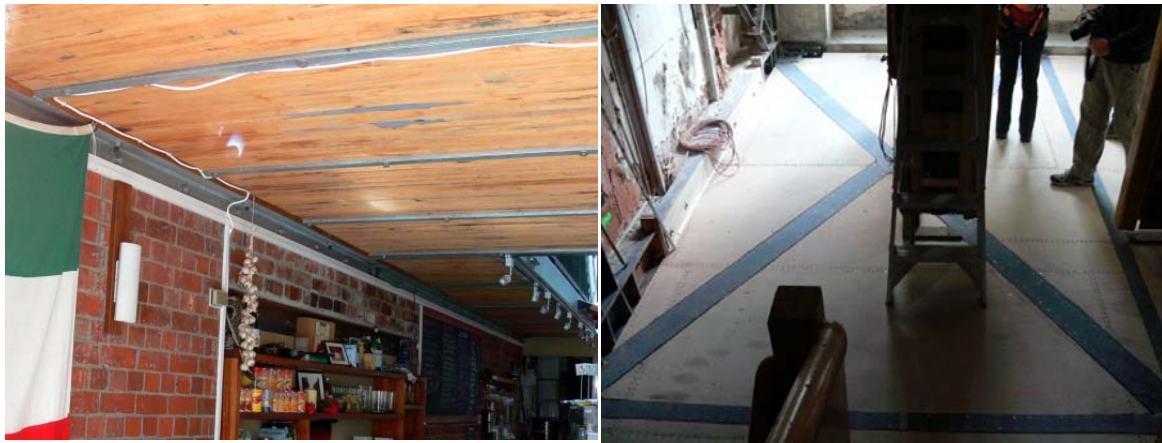
Figure 4.9 Examples of floor diaphragm stiffening

(a) Steel sections added to stiffen and secure the floor diaphragm (b) Steel strapping for floor stiffening

Timber floor diaphragms consist of three main elements; chords, sheathing material, and supplementary structure. To form a diaphragm in a typical URM building, chords need to be established, and mechanical fastenings added to take shear and tensile loads (Rutherford & Chekene, 1990). Several secondary fastenings between the chord and the floor or roof may also be required depending on the technique used. Some tensile ties will penetrate to the outside of the building and others will be drilled and epoxied in place. Existing historic sheathing may prove inadequate and require strengthening or an additional layer of more rigid material (see Figure 4.9(b)).

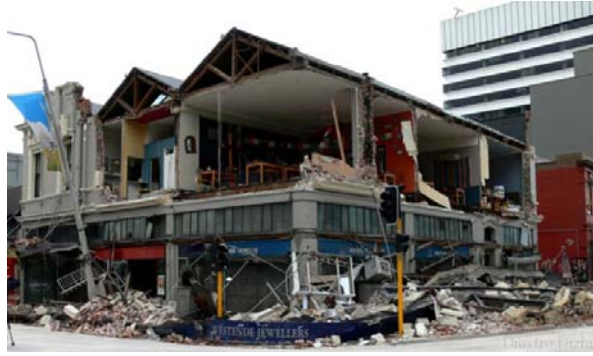
Figure 4.10 An extreme case in the 2010 Darfield earthquake where inadequate connections have resulted in wall collapse (Welstead House, 184-188 Manchester Street)

The most problematic deficiency in URM construction is inadequate connection of diaphragms to walls (FEMA, 2006), as failure of these connections can potentially lead to global collapse of the building. The addition of a network of small ties can substantially increase the strength of the building by fixing the walls to the floor and roof diaphragms (Robinson & Bowman, 2000). These ties need to resist two actions: shear from the diaphragms trying to slide across the walls; and tension from the diaphragm and wall trying to separate. If these ties are missing, the walls will be acting as a cantilever from the ground level under lateral loads, and floors and roofs are far more likely to be dislodged from their supports, which is the most common mode of failure for URM buildings in an earthquake. This failure mode is shown in Figure 4.10.

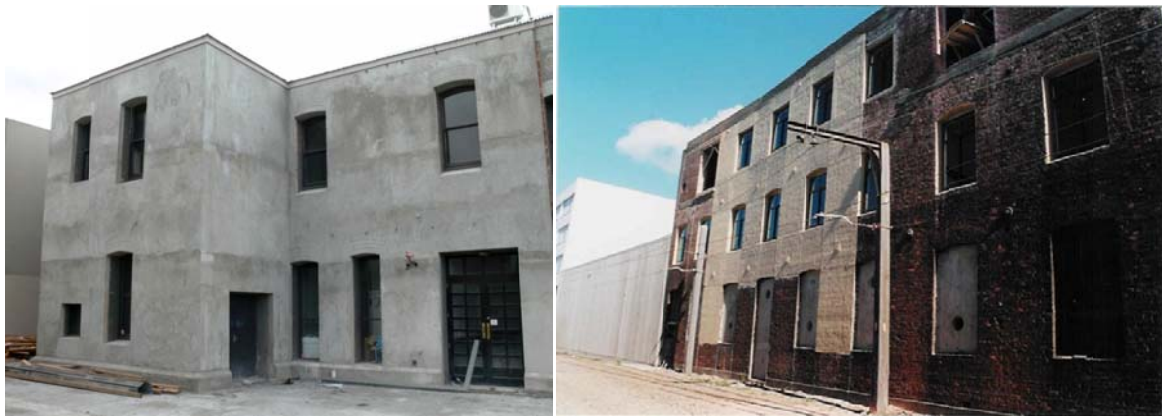
Figure 4.11 Examples of strengthened masonry shear walls

(a) Shotcrete applied to a former URM building

(b) Surface bonded FRP applied to the exterior of a URM wall

The shotcreting of shear walls was a common strengthening technique during the 1980s. This technique involves spraying concrete onto the surface of a URM wall to essentially cast a new wall against the existing wall, as shown in Figure 4.11(a). This technique provides plenty of additional strength to the wall, both in-plane and out-of-plane, but is now largely regarded as unacceptable unless absolutely necessary. The technique causes a significant increase in wall thickness and it is very difficult to remove the concrete, and even more so to restore the wall behind to any semblance of its character prior to concreting. Furthermore, the installation of shotcrete generally requires the building to be gutted, which results in the loss of much heritage material and creates an essentially new interior (Robinson & Bowman, 2000).

Another technique for forming strengthened shear walls is the addition of surface bonded fibre reinforced polymer sheets is in Figure 4.11(b). These sheets do not require the same invasive installation as shotcrete walls, but generally are equally permanent, and have potentially limited application, although new technology may soon change this. If it is possible to provide out-of-plane strength using FRP inserts, coupled with an FRP surface layer for shear, then this solution could be far superior to shotcrete from an architectural perspective. An important consideration with the use of sheets of FRP is that it is impermeable, which can lead to problems with water trapped within the building resulting in damp and mould issues, and potential de-bonding of the epoxy.

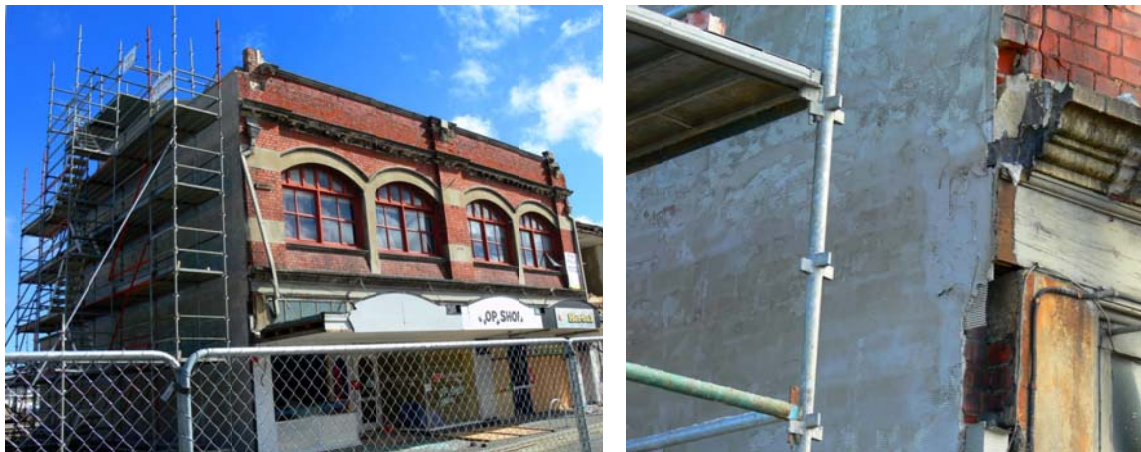
Figure 4.12 Textile reinforced render as retrofit

(a) Exterior view of retrofitted building

(b) Close up view of surface application

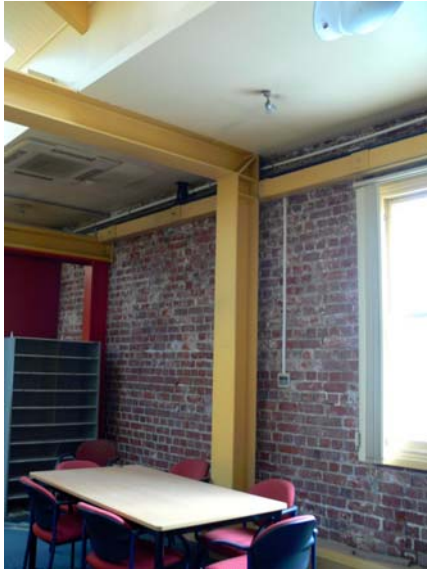
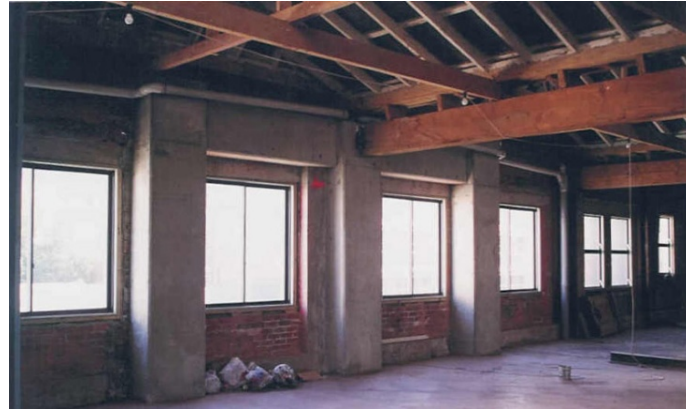
Figure 4.13 Internal moment frames installed as seismic retrofits

(a) Post-earthquake condition of a URM building having an internal steel frame retrofit

(b) Reinforced concrete moment frame retrofit

Moment frames can be an excellent strengthening technique, either to supplement an existing wall or as a new, stand alone element. If a steel frame is erected against an existing wall where weakness exists, the frame needs to be fixed either directly to the URM using bolted connections into the wall or to the diaphragm (see Figure 4.13(a)). Installing concrete frames is a more complex undertaking, as these will often be constructed by thickening existing piers, although a concrete frame which is separate from the existing structure is possible (see Figure 4.13(b)). In both situations it is important that architectural character is retained, and historic material conserved. Some considerate and artful design strategies may need to be undertaken to achieve this.

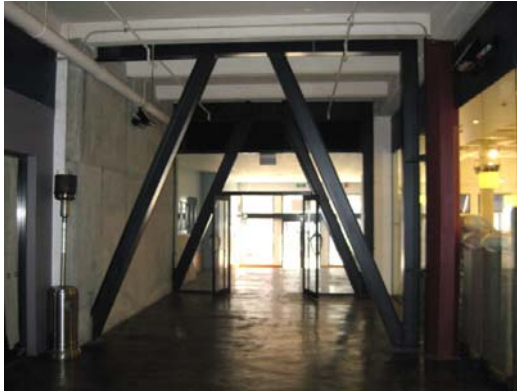
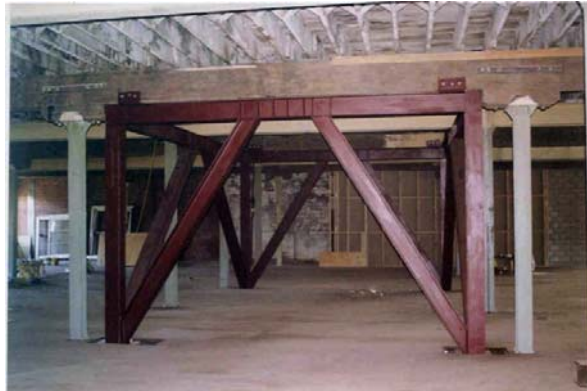
Figure 4.14 Eccentrically braced steel frame retrofits (photos courtesy of Dunning Thornton Consultants)

(a) Eccentric bracing in a walkway

(b) Eccentrically braced core

Braced frames are available in various configurations: concentric, tension only concentric, eccentric, and 'K' bracing. The key functional difference between braced frames and moment frames is that due to the diagonal braces, braced frames prevent physical continuity between spaces on either side of the frame. Braced frames are also generally constructed from steel rather than concrete, and are much more rigid than moment frames.
