## 4 THE NEED FOR DAMAGE-RESISTANT DESIGN

This chapter details the need for damage resistant design of new buildings, by giving a summary of serious damage observed in modern buildings in the 2010 and 2011 Christchurch earthquakes.

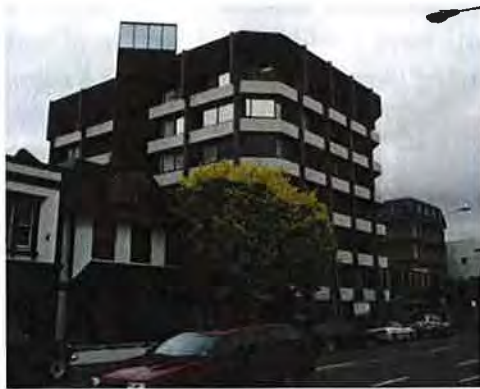
Figure 4.1 Seven storey reinforced concrete office block.

Some buildings have suffered severe localised damage to structural walls that are holding the whole building up. This severe damage has often been in the lower stories where flexural and shear stresses are highest, as shown in Figure 4.1 and 4.2. Traditionally, the strength and performance of concrete in compression has been improved by confining the concrete in the critical regions with closely spaced hoops or stirrups of reinforcing bars. The observed damage shows that insufficient confinement was provided in many cases.

Thin walls have performed much worse than expected, largely due to insufficient confinement reinforcing bars. This may be partly because of oversight in the design, or just the practical difficulty of fitting high concentrations of reinforcement into areas that will be highly stressed.

(a) Photo from street.

- Use damage-resistant design. For example, design walls which will rock back and forth on the foundations under extreme lateral loading.
- Design buildings to avoid flexural plastic hinges in structural concrete walls.
- Provide more confinement in critical regions of structural concrete walls.
- Do not allow very thin structural concrete walls to be used.

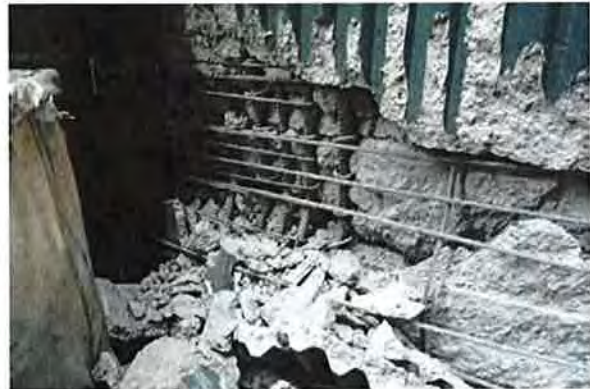
(b) Severely damaged end of structural wall.

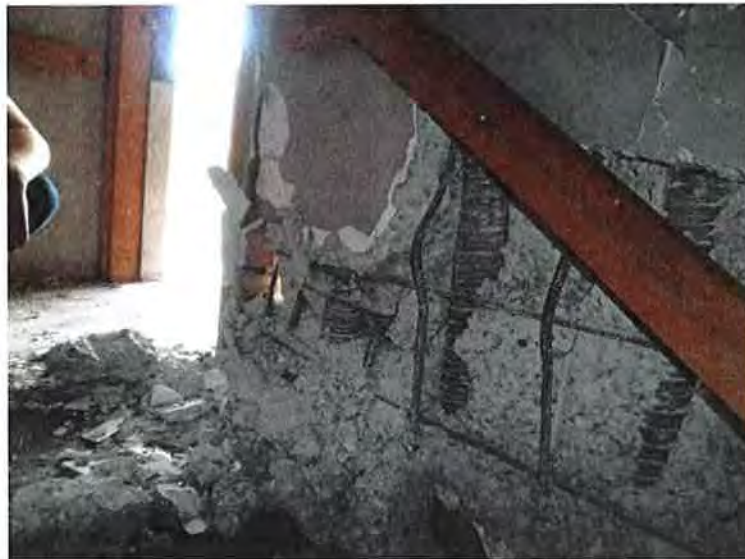
Figure 4.2 Damage to reinforced concrete walls .

(a) The system for joining precast concrete wall panels fails through insufficient confining reinforcement.

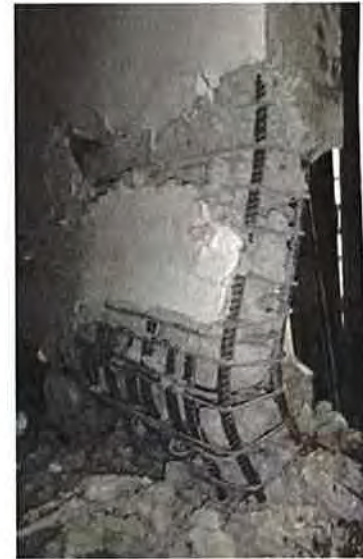
(b) Severe damage to reinforced concrete wall, with local buckling at the toe of the wall.

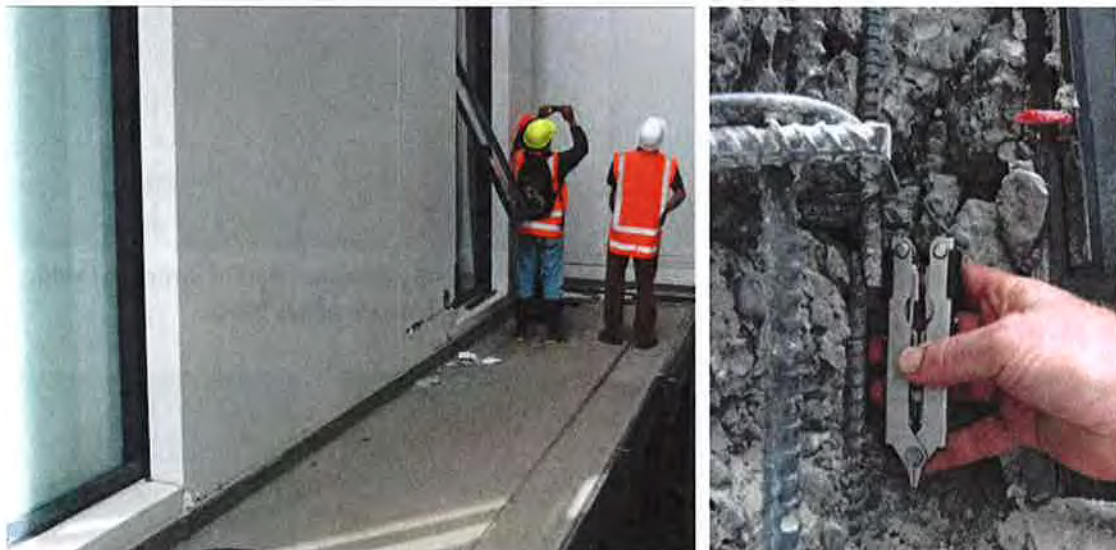
**Figure 4.3. Yielding and fracturing of wall reinforcing steel in a tall building.**

Some semi-destructive investigation of structural walls in tall reinforced concrete buildings has identified a major problem of fractured reinforcing bars inside concrete elements that only show small cracks. An example is shown in Figure 4.3. This type of damage is due to the relatively small amounts of reinforcement in the walls, and a much higher concrete strength of the aged element than specified by the original designers. Extensive laboratory testing of reinforced concrete structures in New Zealand and around the world has shown that “plastic hinges” in beams and columns usually have a widespread pattern of cracks in the concrete, so that stresses in the internal reinforcing bars are distributed over a significant length of adjacent concrete.

(a) Small crack in base of a tall wall. Note the minor damage at far end of wall.

(b) Damaged end of wall after breaking out some concrete. The vertical bars have yielded then fractured.

If the concrete in a real building is much stronger than that tested in the laboratory, only one crack (rather than an array of cracks) occurs in the critical region, placing excessive strain demands on the reinforcing steel and sometimes leading to fracture of the bars. Many buildings have critical cracks which had clearly opened several centimetres during the earthquake, enough to fracture the bars, before closing up due to gravity loading after the shaking subsides. These fractured bars are hard to find, so there may be many more in damaged buildings that are undetected. Solutions for new buildings are not straightforward; simply placing more steel bars in the walls is not a solution because it will increase the strength of wall, in precisely the location where the intended “weak link” is supposed to be (this is a region of wall that is meant to “yield”, or deform plastically; the “plastic hinge”).

- Use damage-resistant design. For example, design buildings to avoid flexural plastic hinges in structural walls.
- Place upper and lower bounds on the strength of concrete in plastic hinge regions.

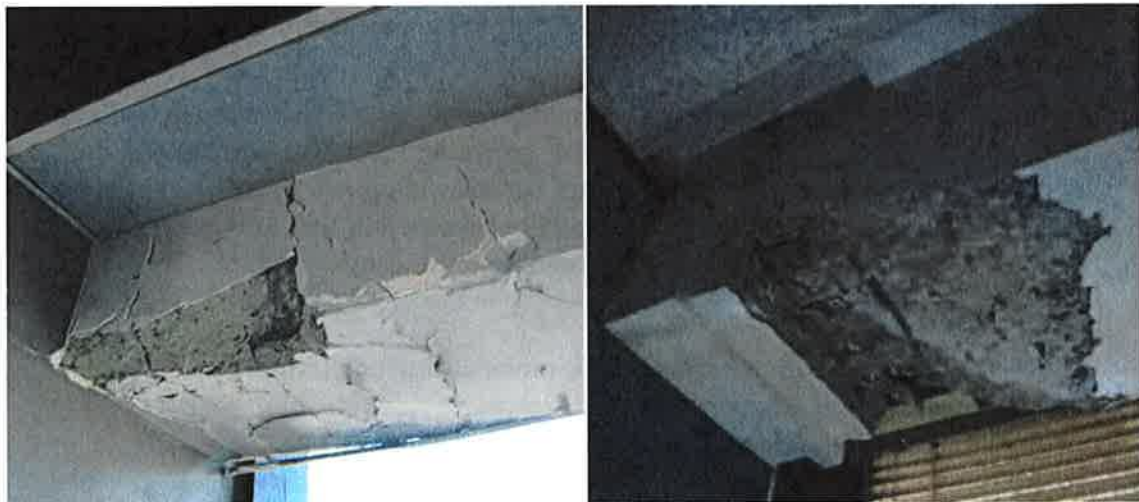
Figure 4.4. Plastic hinges at ends of beams in reinforced concrete frames.

Large inelastic deformations in moment-resisting frames result from plastic hinges occurring in the beams. Plastic hinge deformations often result in considerable lengthening of the beams, called “frame elongation”. The effect of frame elongation is to cause the building to bulge or balloon out as described later in Chapter 6. This frame elongation effect causes several problems as outlined below (Peng, 2009).

Many buildings have suffered severe damage to reinforced concrete floor diaphragms. The main reason for this damage is frame elongation, with columns being forced apart by the formation of “plastic hinges” in the beams of moment-resisting frames (Figures 4.4 and 4.5). This results in the whole building growing a bit bigger during the earthquake, causing major cracks in floor slabs, or in the topping concrete on precast concrete floor slabs. Reinforcing bars are often fractured in the cracked region. The initial concern about this cracking is the loss of the floor diaphragm action which holds the whole building together and transfers seismic forces to the lateral load resisting system.

- Use damage-resistant design. Design buildings without ductile moment-resisting frames.
- Find other ways of achieving ductility and hence dissipating seismic energy.
- Require larger amounts of reinforcing in topping concrete.
- Avoid the use of non-ductile welded wire reinforcing mesh.

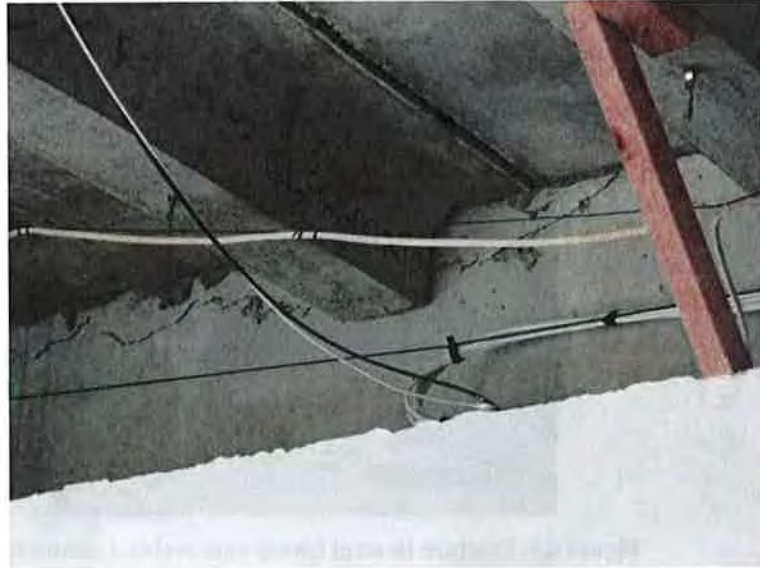
Figure 4.6. Spalling of concrete ledge supporting the flange-hung Tee units.

Traditionally, the length of seating at the ends of precast prestressed concrete floors has been insufficient. Therefore when the building grows and the slab is damaged due to frame elongation as described above, the seating becomes marginal, as shown in Figure 4.6. It is extremely fortunate that no floor slabs actually collapsed in the earthquakes, although some of the observed stair collapses may have been from this cause.

- Design buildings without using ductile moment-resisting frames.
- Find other ways of achieving ductility.
- Require much larger seating for precast floor systems.
- Consider using two-way cast-in-place reinforced concrete floors.

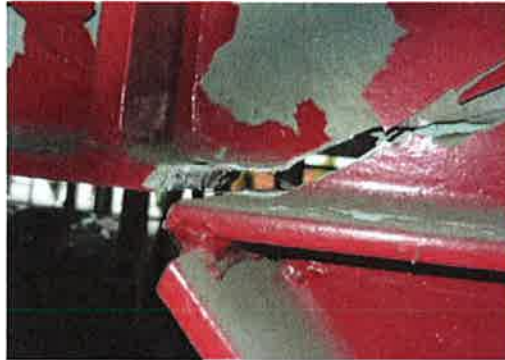
Figure 4.7. Fracture in steel frame near welded connection.

Structural steel is normally considered to be a very ductile material. However, one serious brittle fracture was reported of an eccentrically braced frame (EBF) in a hospital car-parking building, very close to an eccentric welded connection (Figure 4.7). Brittle fractures are not normally expected in steel structures, but it is known that welding of structural steel can cause strain-age-embrittlement leading to brittle failures. Some new research in this area may be needed.

- Provide guidance on welding procedures for localised regions intended to be ductile.
